**BRUNSWICK-GOLDEN ISLES AIRPORT
PAVEMENT MANAGEMENT REPORT**

**2007 GEORGIA AIRPORT
PAVEMENT MANAGEMENT REPORT**

BRUNSWICK-GOLDEN ISLES AIRPORT

PAVEMENT MANAGEMENT REPORT

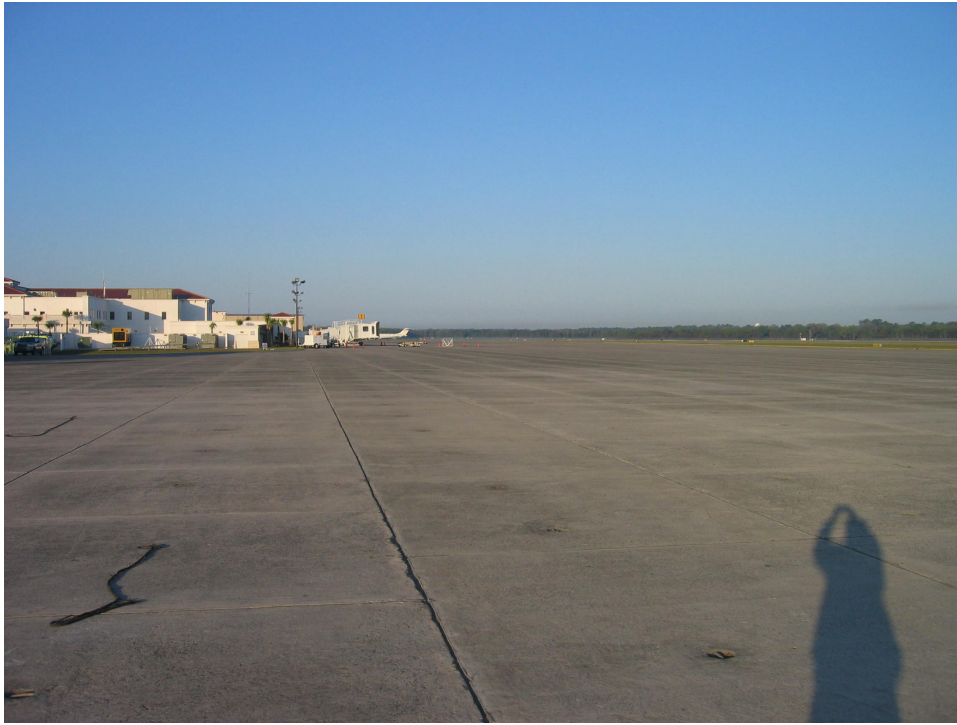
A01GJP-10 is the section defined for the main apron area on the south side of the airfield. This section is in excellent condition with a PCI value of 98. Moderate amounts of low-severity joint and corner spalling were observed throughout the section. Low-severity patching was also frequently found. A02GJP-10 is a section at the north end of TWAGJP-30 that is in good condition with a PCI value of 89. Significant amounts of medium-severity joint seal damage were identified along with moderate amounts of low and medium-severity patching, scaling, and joint and corner spalling.

A01GJP-10. Overview (N).

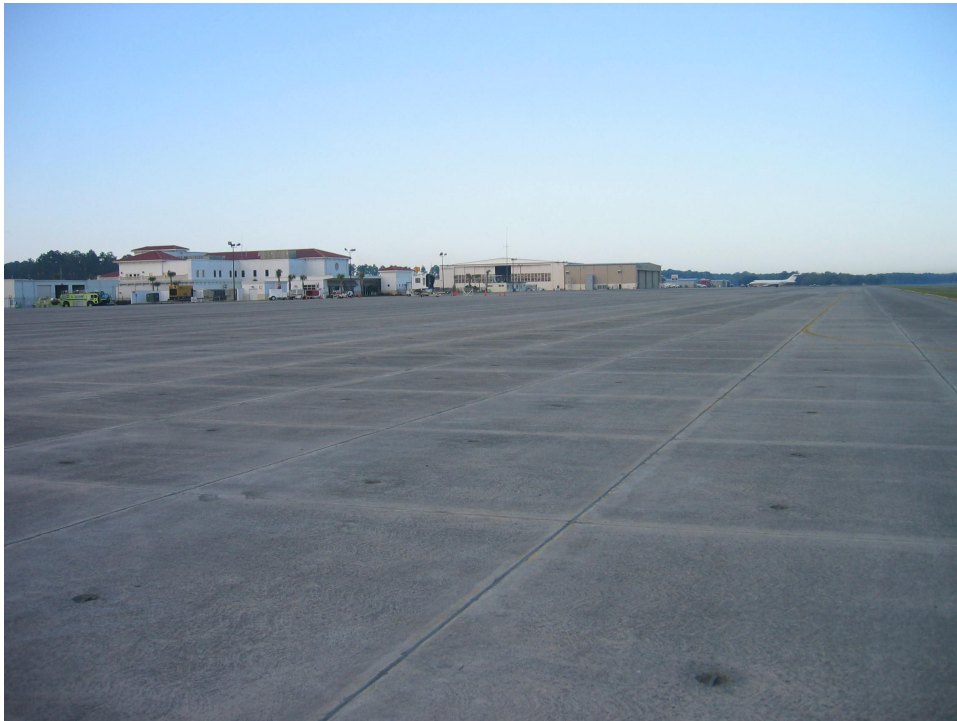
A01GJP-10. Overview (S).

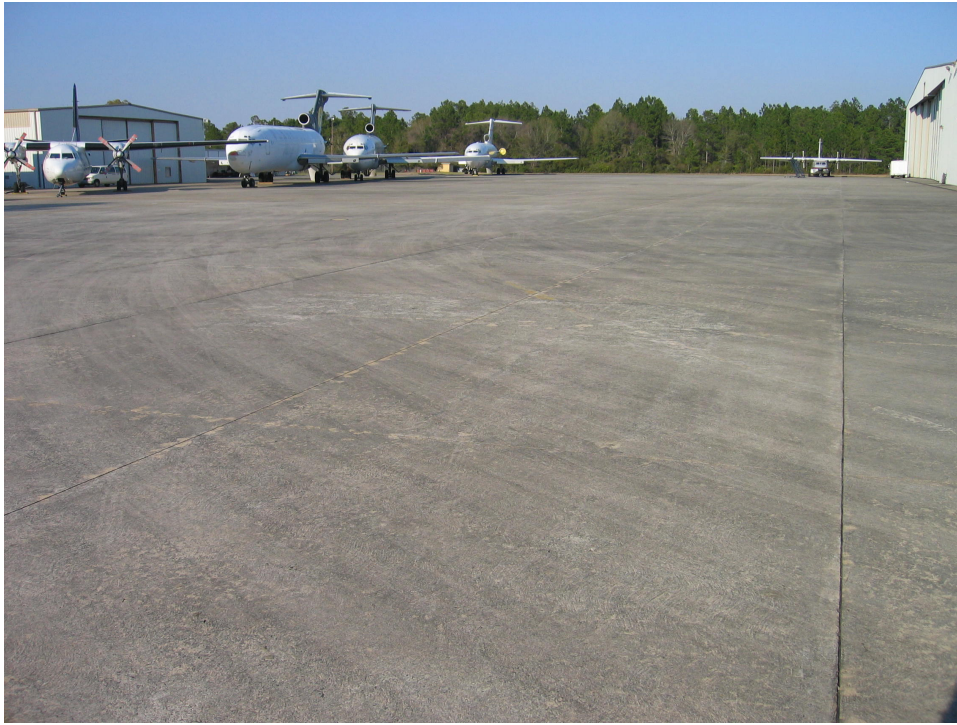
A02GJP-10. Overview.

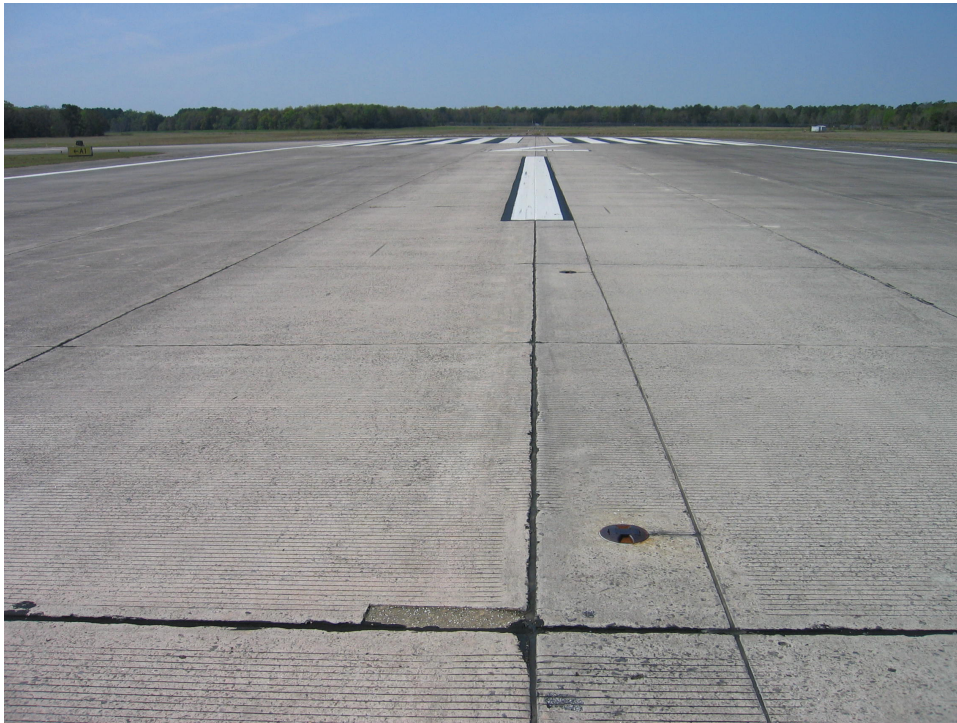
Sections R725GJP-10N, R725GJP-10C, and R725GJP-10S comprise the western 500 feet of the runway and are constructed of portland cement concrete (PCC). All three sections are in excellent condition with PCI values of 97, 96, and 95, respectively. These sections are similar in condition with only a few small patches, joint spalls, corner spalls, and joint seal damage being observed.

R725GJP-10C. Overview.

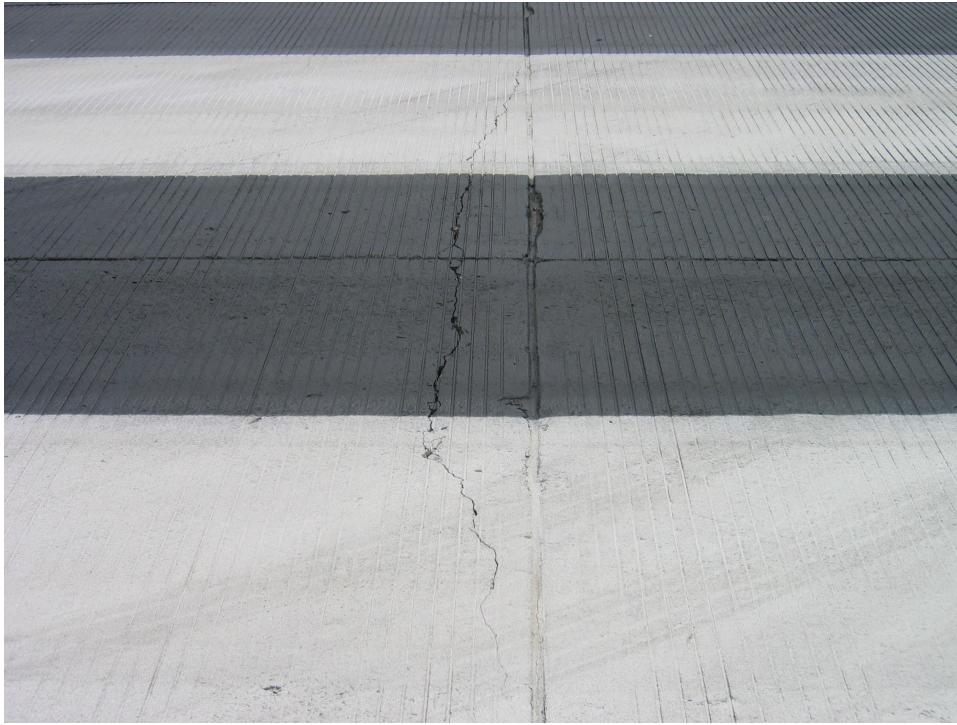
R725GJP-10S. Corner break.

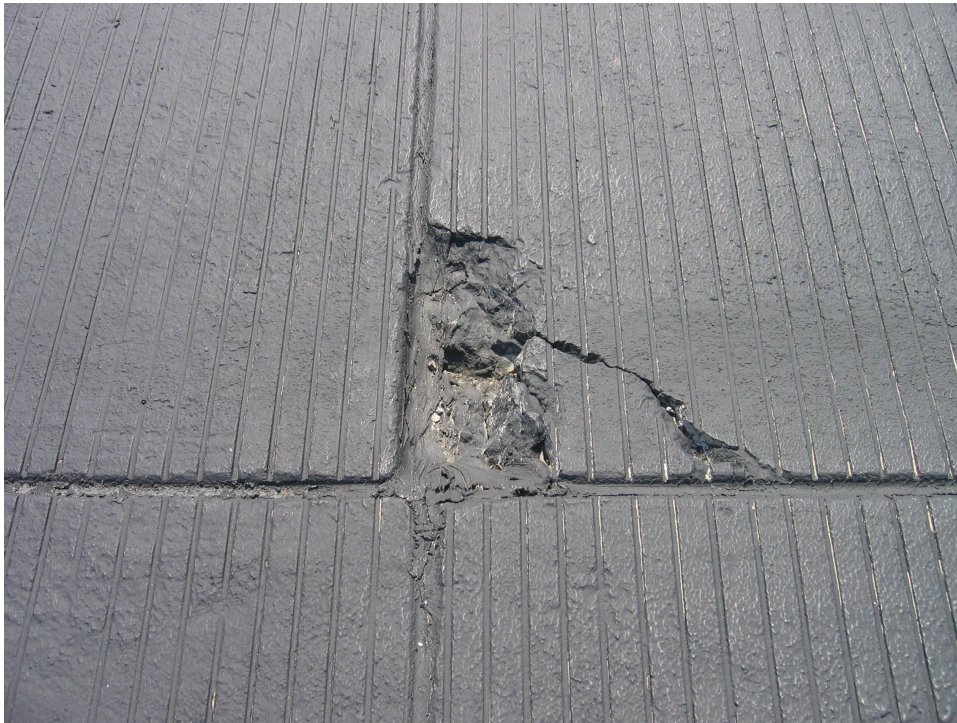
R725GJP-10S. Corner spall.

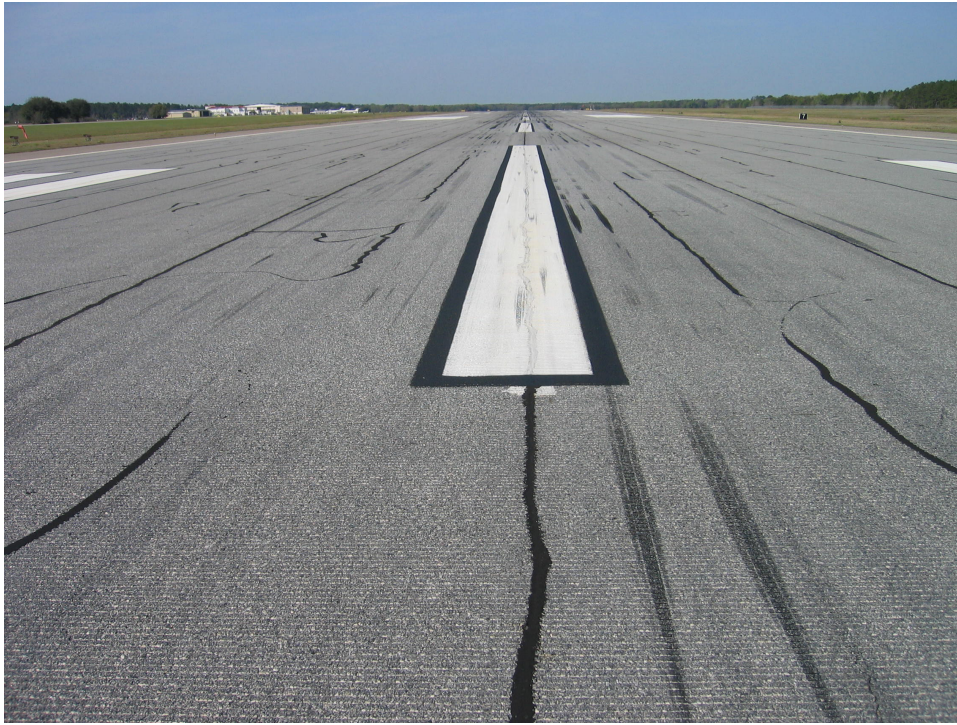
The asphalt surfaced area of Runway 7-25 defines the extent of sections R725GJP-20N, R725GJP-20C, and R725GJP-20S. These sections are in fair condition with PCI values of 71, 68, and 70, respectively. Significant amounts of low-severity longitudinal and transverse (L&T) cracking were observed in all three sections. The majority of the cracking has been sealed with only isolated amounts of unsealed cracking. Isolated amounts of swelling were observed throughout the sections as well.

R725GJP-20C. Overview.

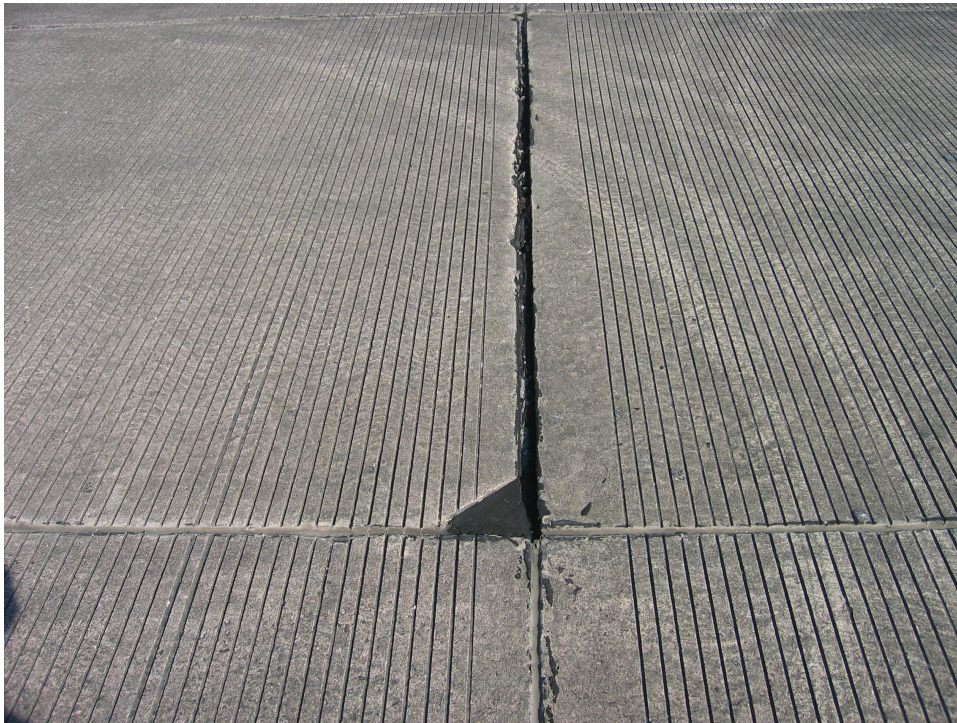
Similar in construction to the first three sections in the runway, R725GJP-30N, R725GJP-30C, and R725GJP-30S comprise the eastern 500 feet of Runway 7-25. These sections are also excellent condition with PCI values of 95, 96, and 98, respectively. Small patching, joint spalling, and corner spalling were observed in these three sections. In addition, moderate amounts of low severity joint seal damage was found.

R725GJP-30C. Joint seal damage.

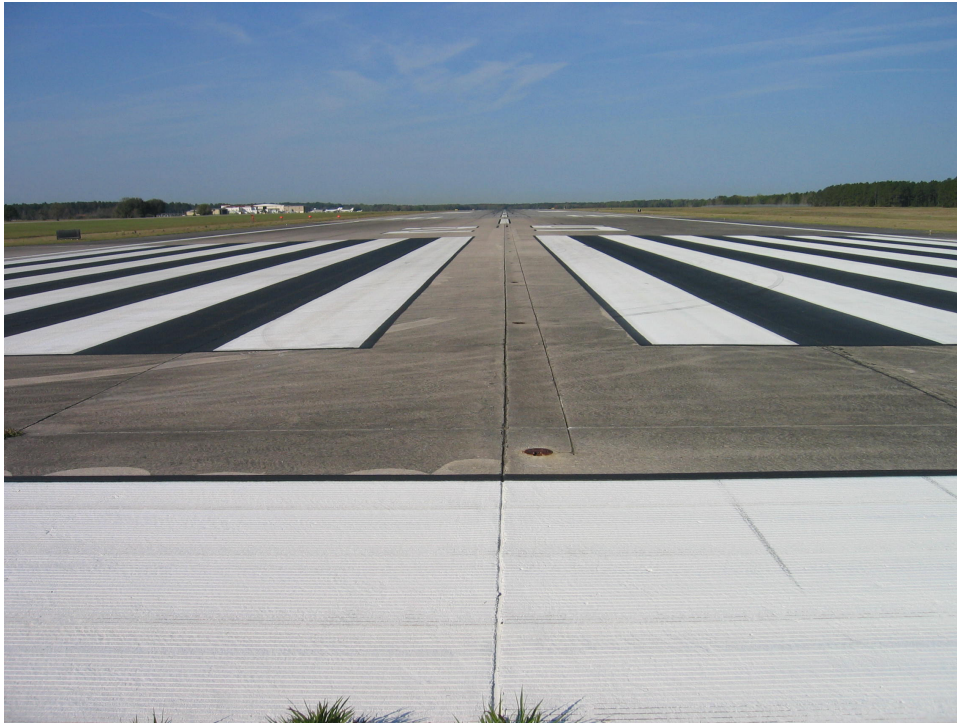
R725GJP-30C. Overview.

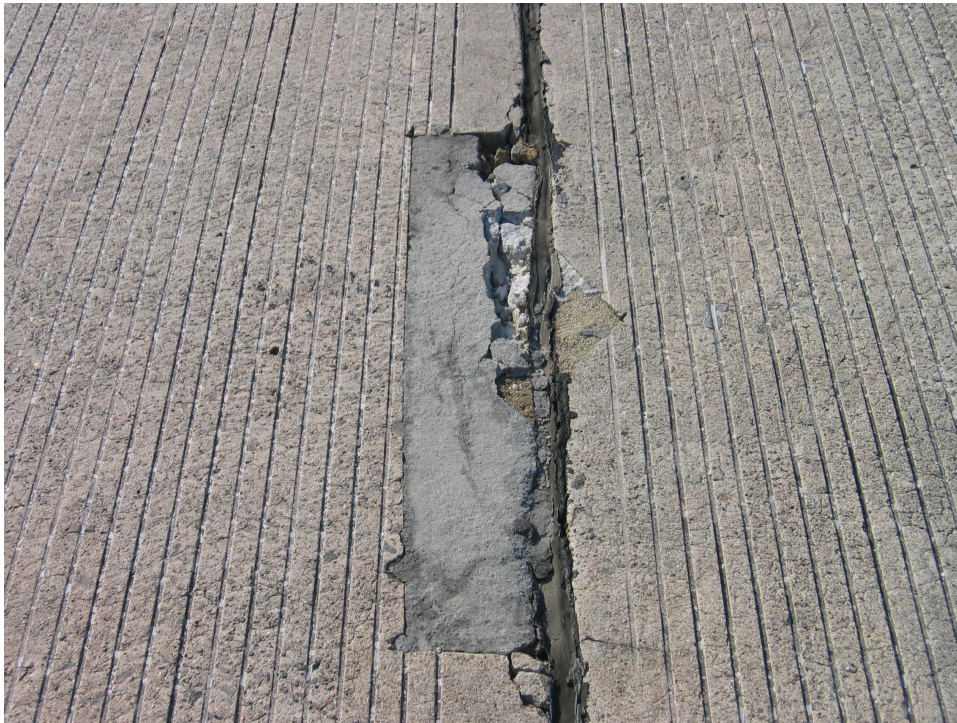
R725GJP-30C. Patch.

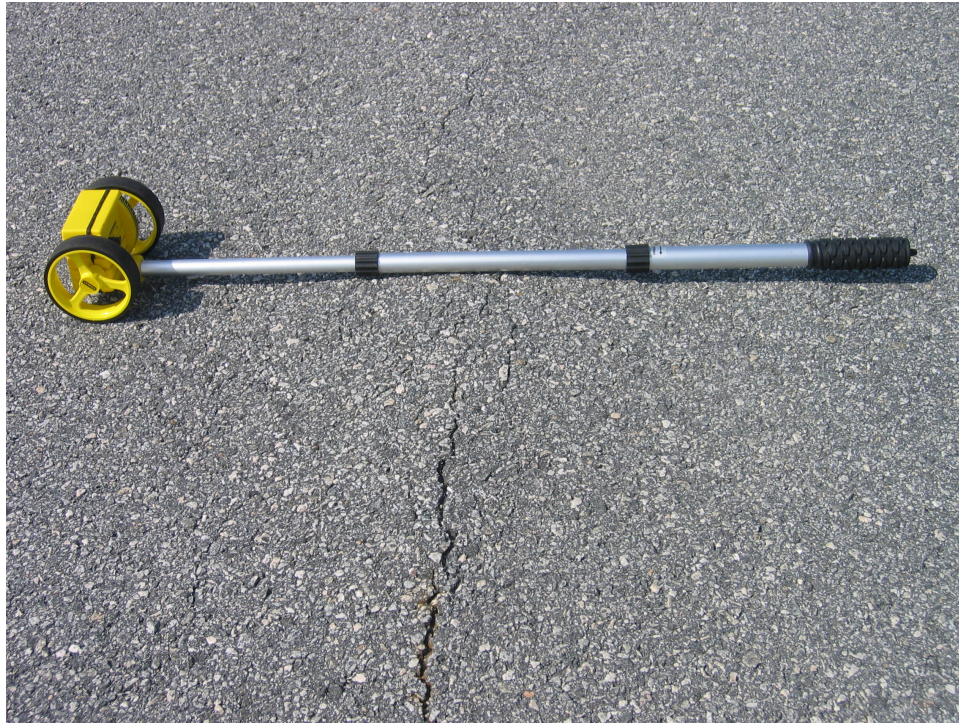
R735GJP-20. Swelling.

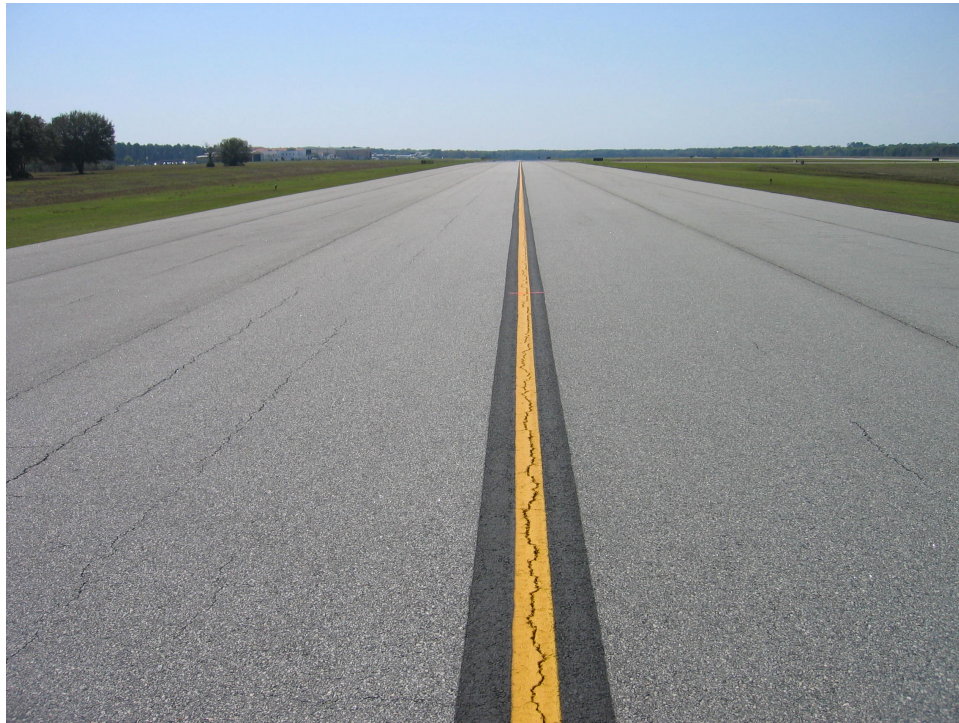
TWAGJP-10 is in fair condition with a PCI value of 64. Large amounts of low and medium-severity L&T cracking were observed. Moderate amounts of low and medium-severity swelling were also found throughout the section. An isolated area of bleeding was also recorded in this section.

TWAGJP-10. Overview.

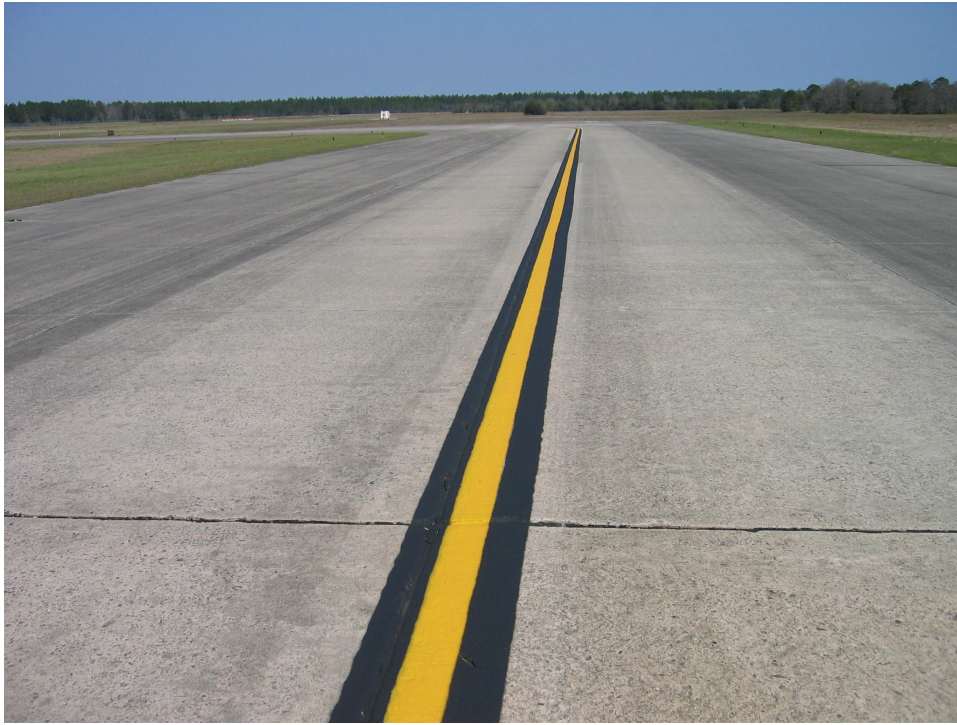
TWAGJP-20 was constructed at the same time as the PCC pavements in Runway 7-25 and is in excellent condition with a PCI value of 97. Its condition is similar to that of the runway with moderate amounts of low and medium-severity patching and corner spalling being observed. An isolated amount of medium-severity joint seal damage was found in the connector taxiway portion directly across from Section TWAGJP-30.

TWAGJP-20. Overview.

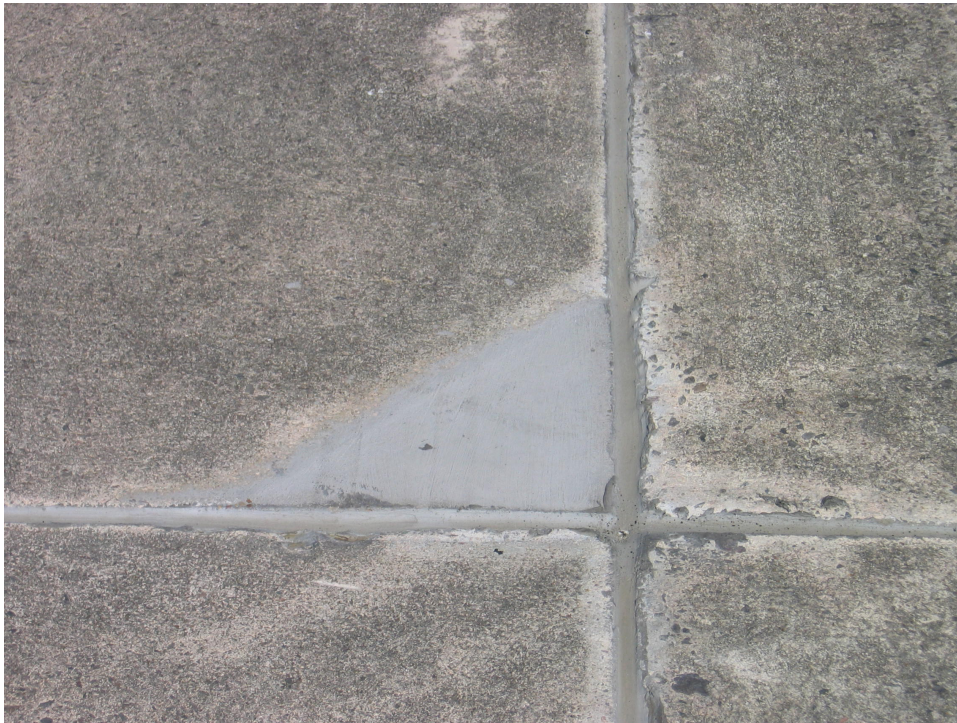
TWAGJP-20. Small patch.

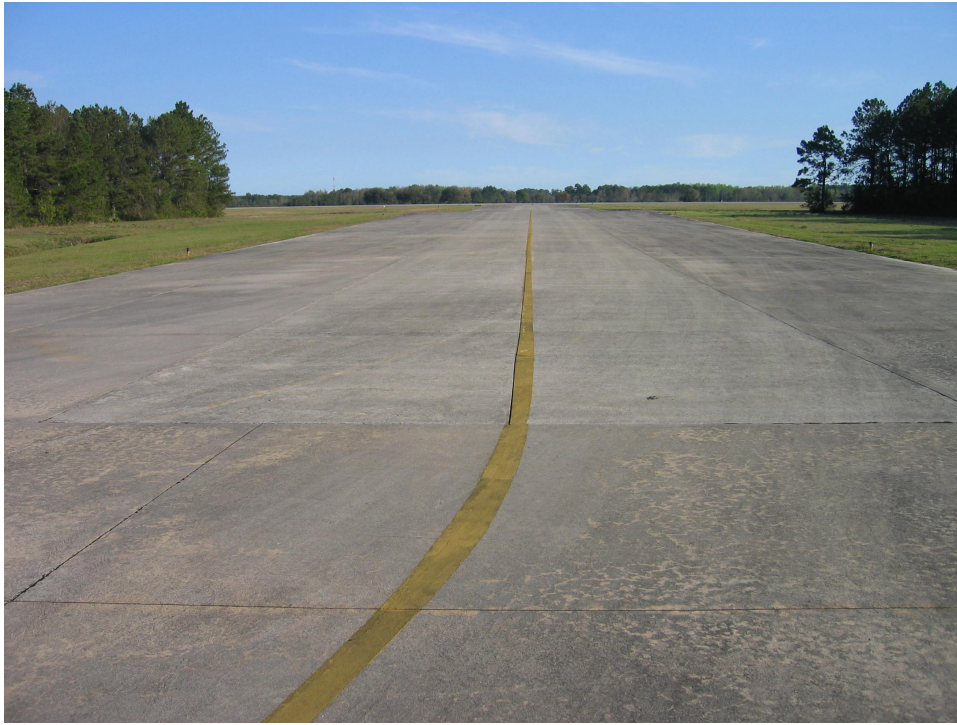
TWAGJP-30 also was constructed at the same time as the pavements in TWAGJP-20 and it is in good condition with a PCI value of 89. Significant amounts of medium-severity joint seal damage were observed along with moderate amounts of low, medium, and high-severity spalling and patching.

TWAGJP-30. Overview.
