FULTON COUNTY-BROWN FIELD  
PAVEMENT MANAGEMENT REPORT

# 2007 GEORGIA AIRPORT PAVEMENT MANAGEMENT REPORT

# FULTON COUNTY-BROWN FIELD

## PAVEMENT MANAGEMENT REPORT

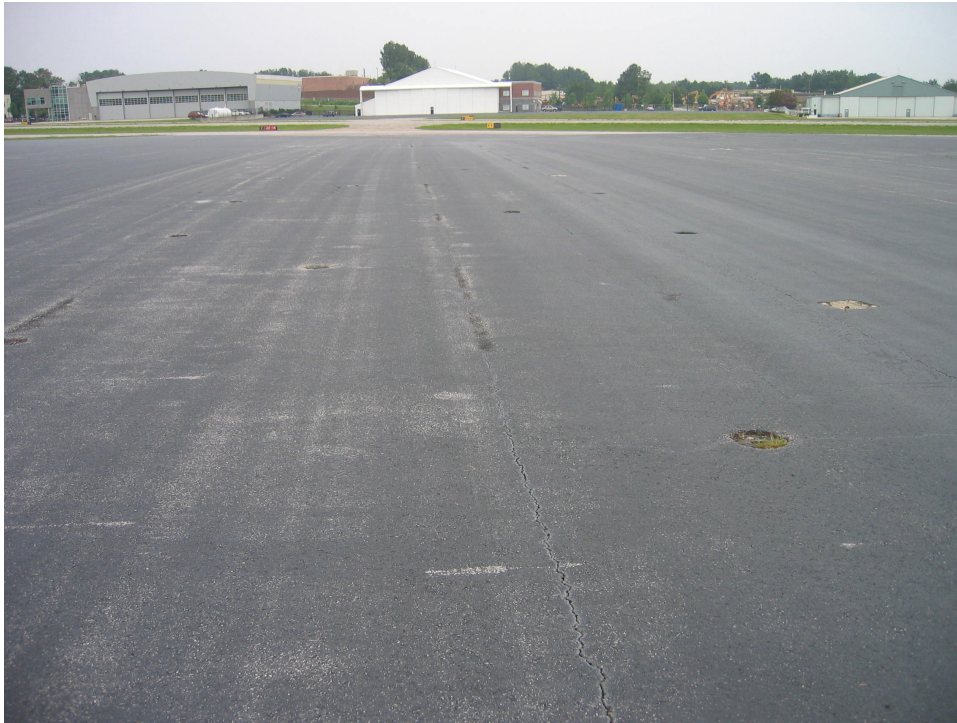
One section was defines the apron area. A01AB-10 is in fair condition with a PCI value of 70. Low-severity block and L&T cracking were identified in this section. Small quantities of medium-severity L&T cracking were also observed in this section. In addition, isolated areas of alligator cracking, raveling and weathering, patching, swelling, and bleeding were also noted. All cracks were unsealed.

A01AB-10. Overview.

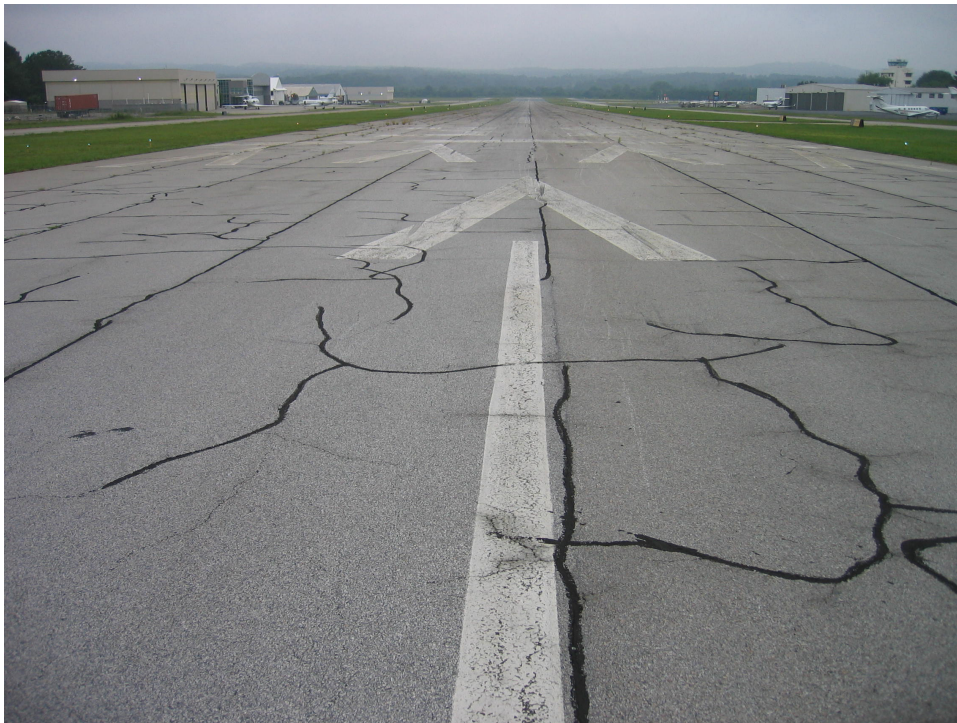
Runway 14-32 is defined by one section, R1432AB-10, that is in poor condition with a PCI value of 47. Moderate amounts of low and medium-severity block and longitudinal and transverse (L&T) cracking were found throughout the runway. In addition, isolated areas of alligator cracking, swelling, and bleeding were also recorded. Most of the cracks were sealed, but the sealant was mostly failed.

R1432AB-10. Overview.

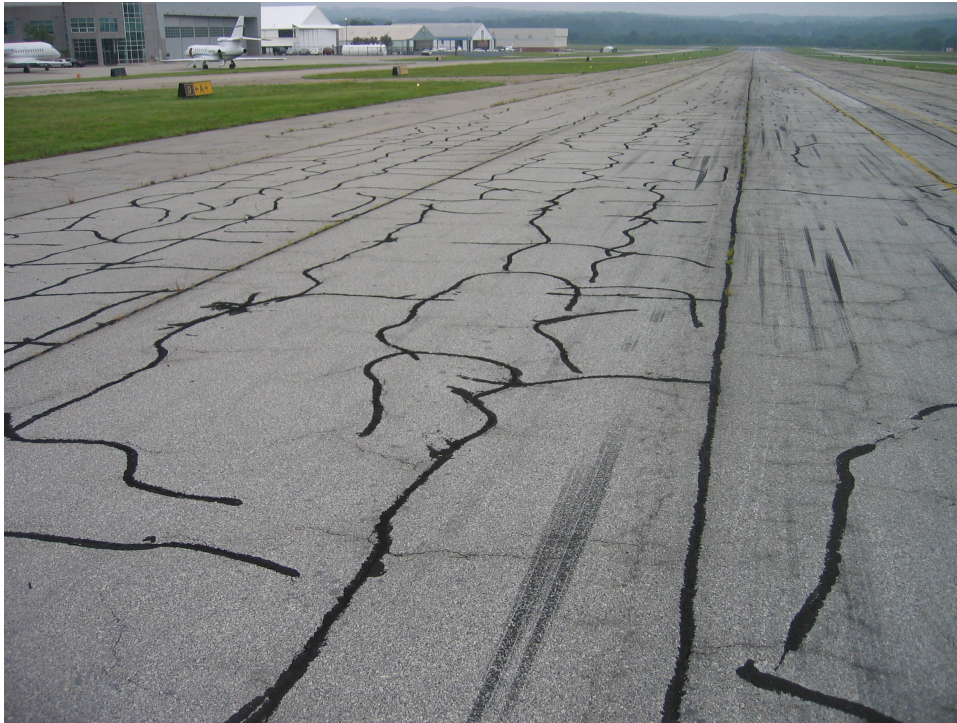
R1432AB-10. Block cracking.

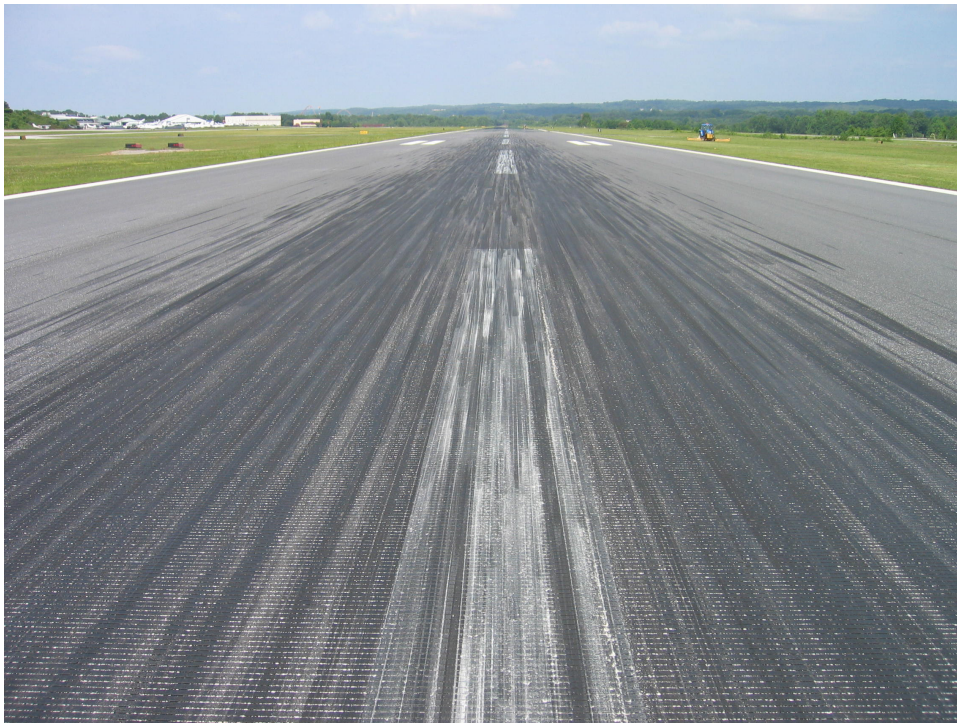
Runway 8-26 is defined by one section, R826AB-10, that was recently rehabilitated and is in excellent condition with a PCI value of 100. No distresses were observed during inspection.

R826AB-10. Overview.

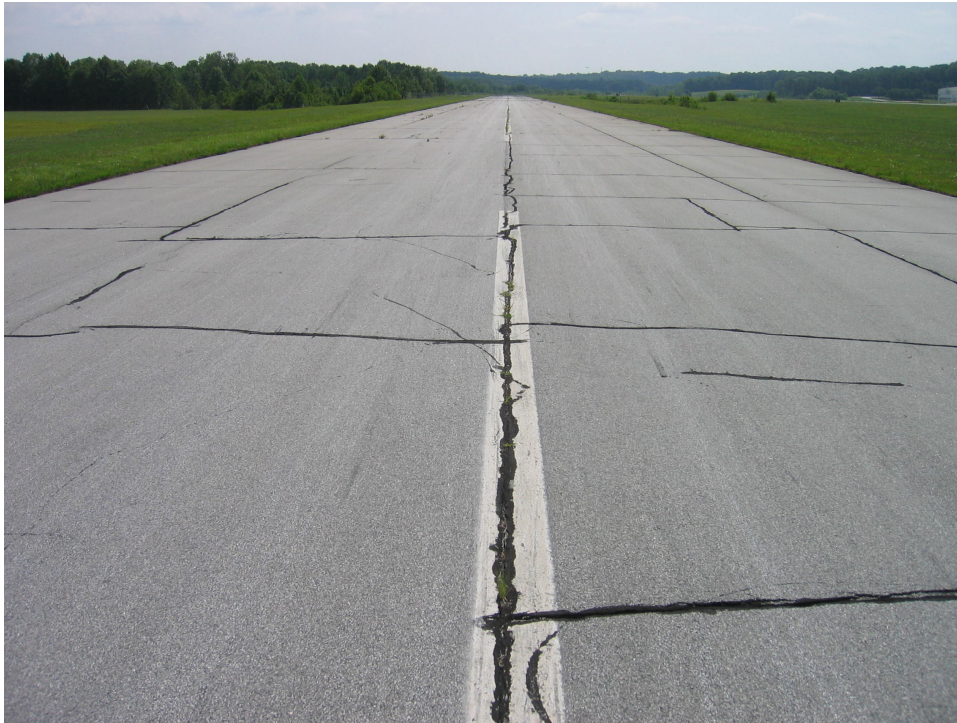
Runway 9-27 also consists of one section, R927AB-10, and is in poor condition with a PCI value of 57. The primary distresses identified on the runway were low and medium-severity, sealed and unsealed, L&T cracking. Most of the crack sealant was failed. Isolated quantities of high-severity L&T cracking were also recorded due to the width of cracking. In addition, isolated areas of swelling were observed.

R927AB-10. Overview.

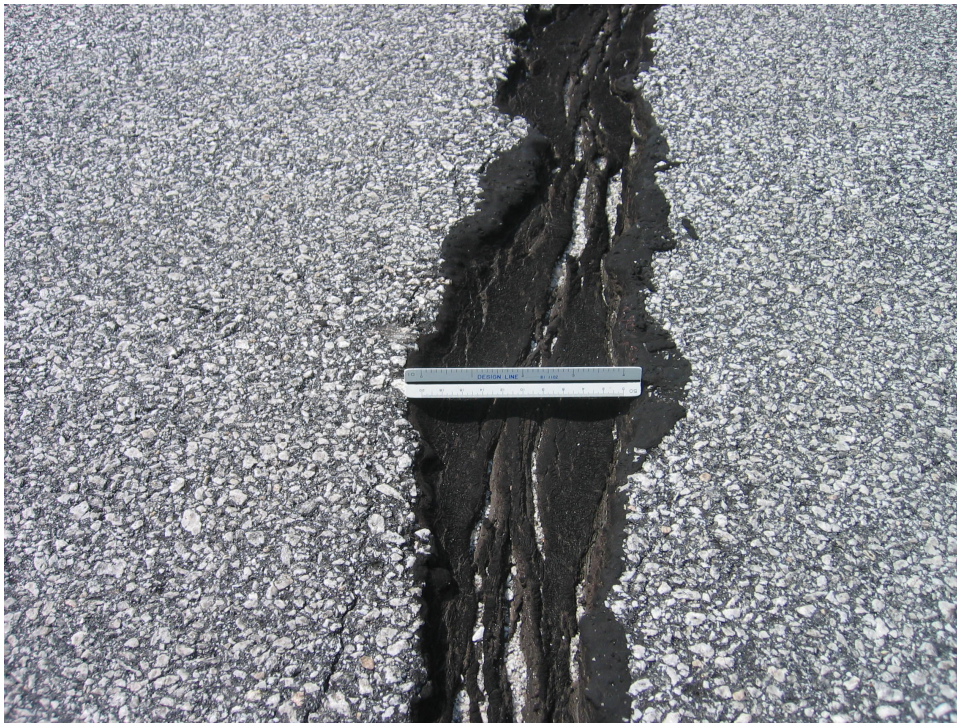
R927AB-10. L&T cracking.

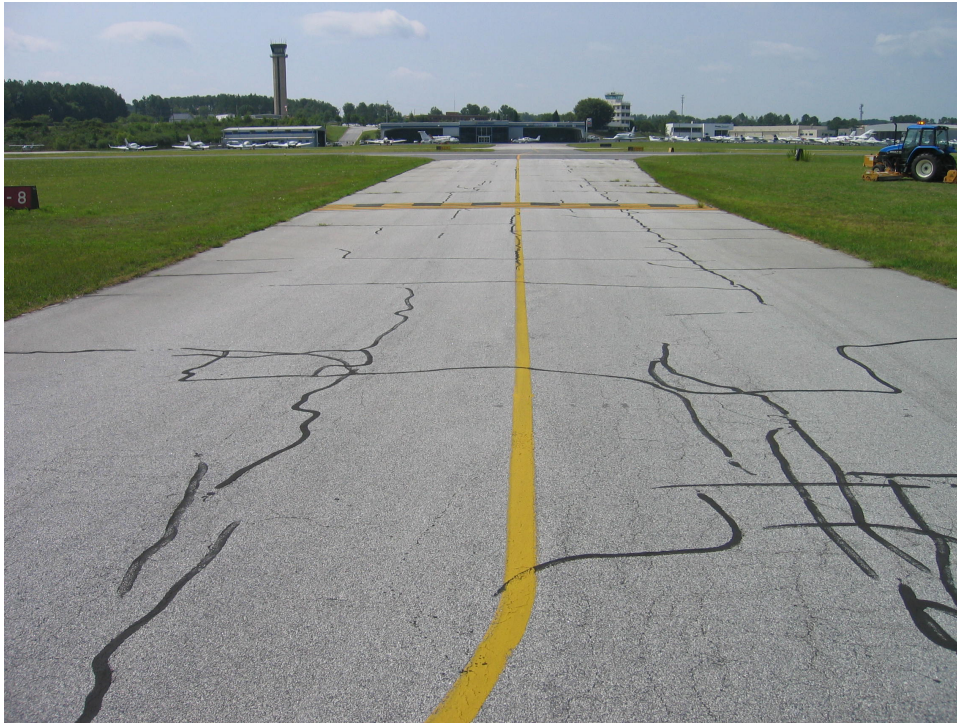
Taxiway 9-27 is defined by two sections. T927AB-10 connects Runway 9-27 and Runway 8-26, and is in poor condition with a PCI value of 57. Moderate amounts of low and medium-severity L&T cracking were observed throughout. The majority of cracking was sealed and medium-severity cracks were noted due to failed crack sealant. In addition, isolated areas of alligator cracking were identified. Section T927AB-20 includes a taxiway and run-up apron area to the north of Runway 9-27. It is in good condition with a PCI value of 84. Small amounts of low-severity, unsealed L&T cracking were the only distresses observed.

T927AB-10. Overview.

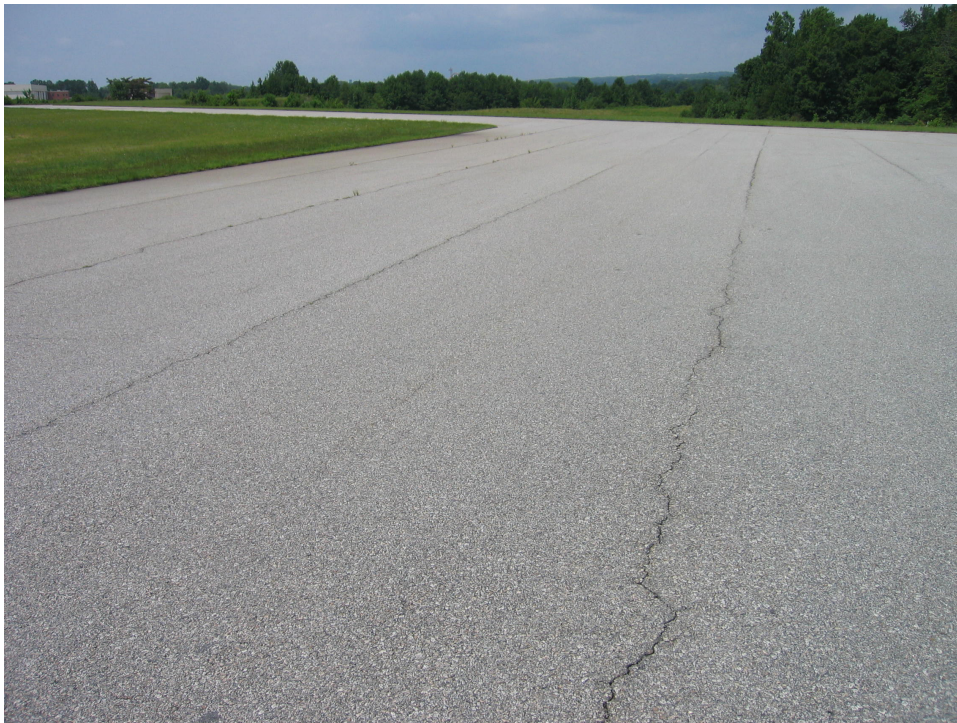
T927AB-20. Overview.

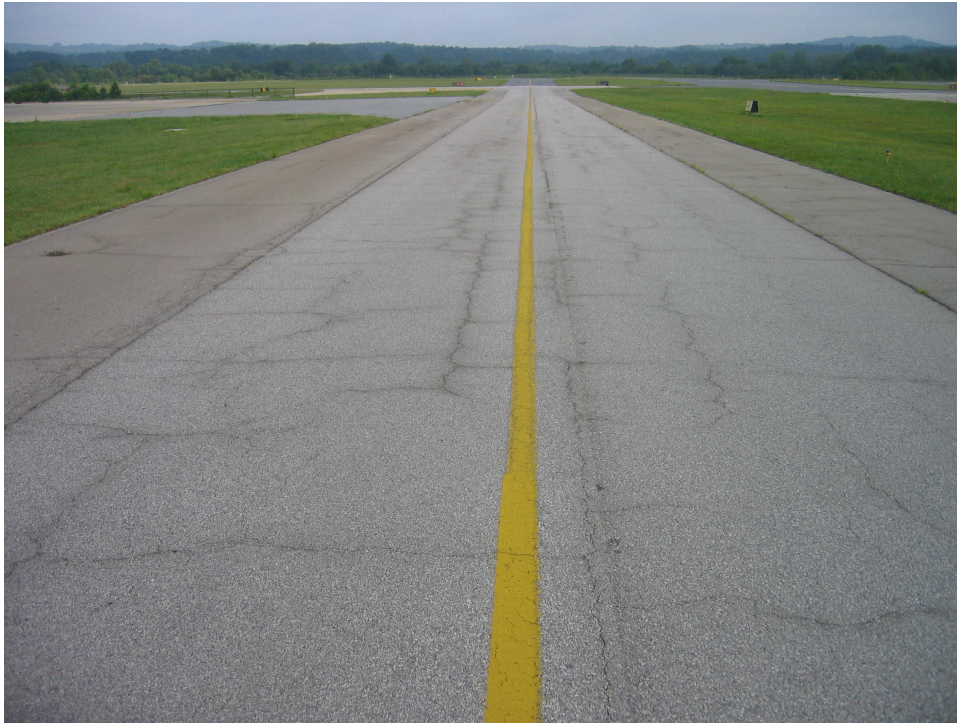
One section, running full length parallel to the Runway 14-32 on its west side, defines Taxiway A. TAAB-10 is in poor condition with a PCI value of 36. Significant amounts of low- and medium-severity block and L&T cracking were observed. The majority of the cracking was unsealed. Moderate amounts of medium-severity alligator cracking and small amounts of bleeding were also identified.

TAAB-10. Overview.

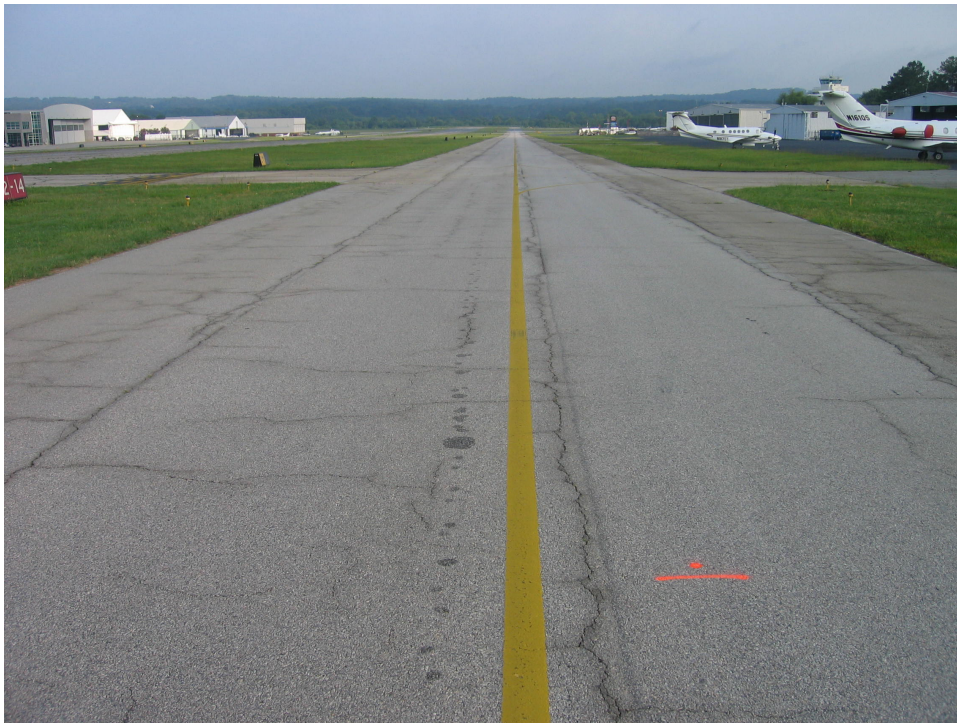
Similar to Taxiway A, Taxiway B runs parallel to the Runway 14-32 on its east side and is also in poor condition with a PCI value of 39. Significant amounts of low and medium-severity block cracking, L&T cracking, and alligator cracking were identified on this taxiway. Isolated areas of bleeding, swelling, and raveling and weathering were also recorded in this section. The majority of the cracking was unsealed.

TBAB-10. Overview.

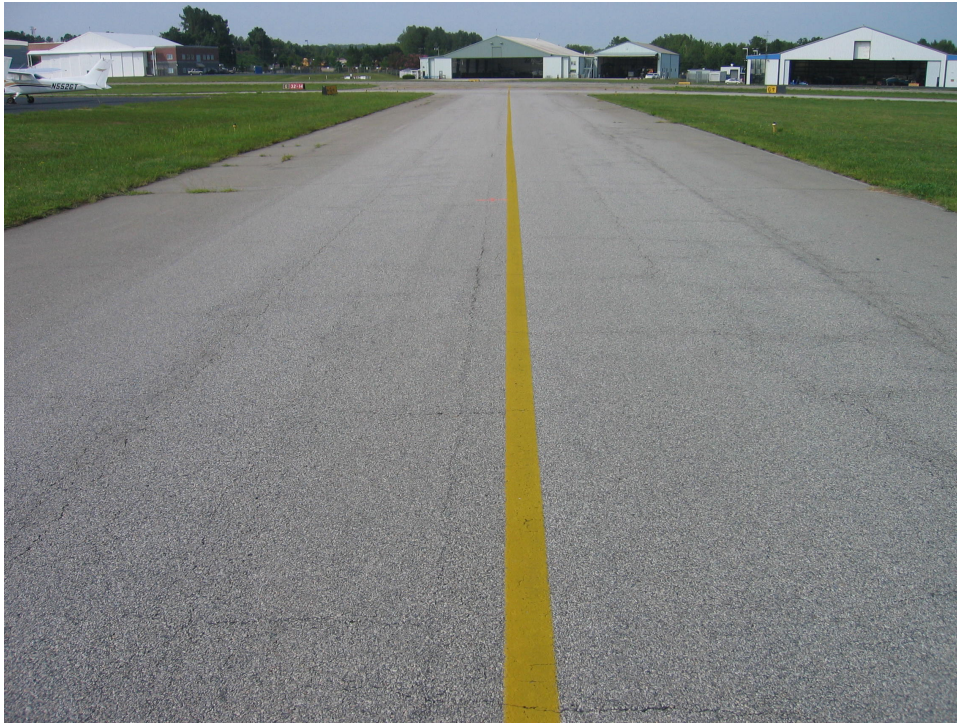
Taxiway G consists of one section connecting Taxiway B and Taxiway I. TGAB-10 is in serious condition with a PCI value of 23. Significant amounts of low-severity, unsealed, block cracking were observed throughout the pavement section. Isolated quantities of medium-severity block,

L&T, as well as alligator cracking were also recorded on this taxiway. Vegetation growth was observed in some of the cracks.

TGAB-10. Overview.

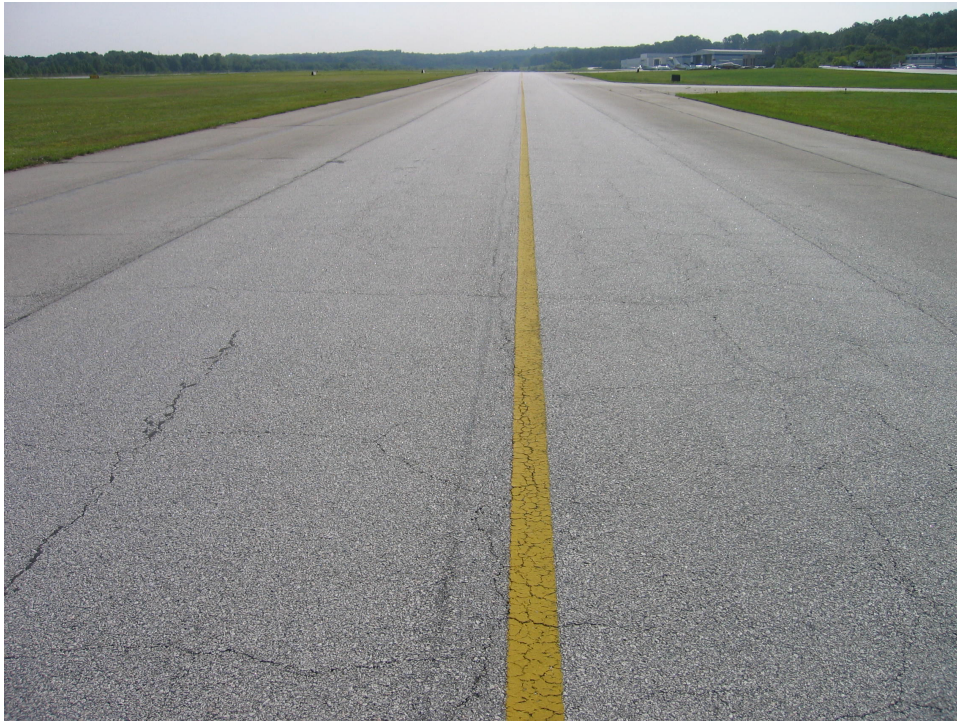
Taxiway I consists of one section and runs parallel to the Runway 8-26. TIAB-10 is in poor condition with a PCI value of 30. Significant amounts of low and medium-severity L&T, block, and alligator cracking were identified. In addition, isolated areas of raveling and weathering, rutting, and bleeding were observed. All cracks were unsealed. Medium-severity cracking was recorded due to the presence of secondary cracking and had vegetation growth.

TIAB-10. Overview.

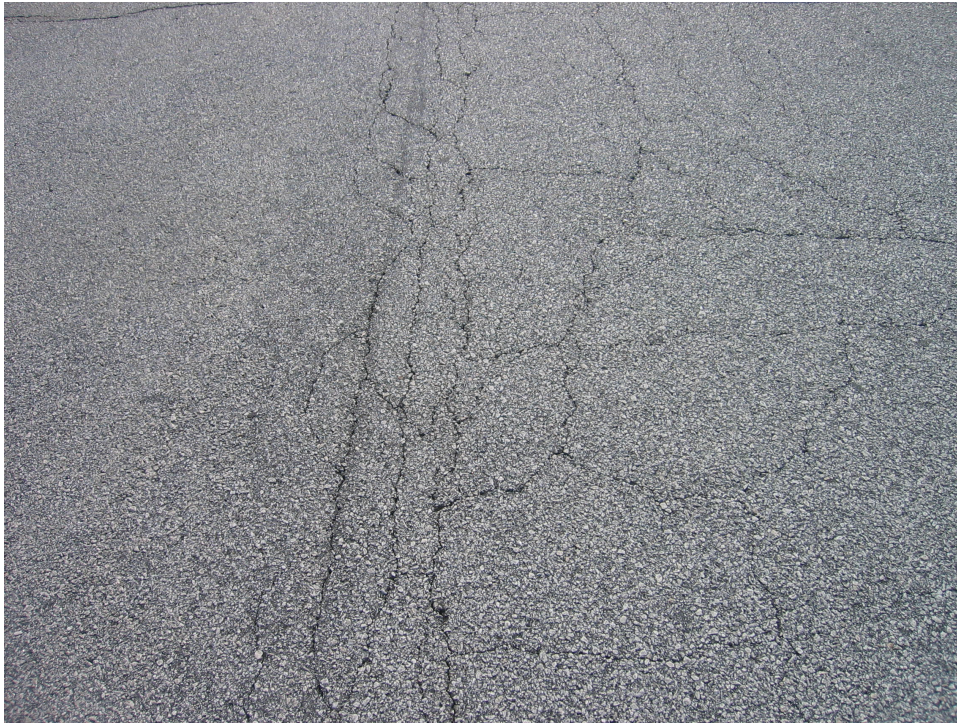
TIAB-10. Alligator cracking.
