MIDDLE GEORGIA REGIONAL AIRPORT
PAVEMENT MANAGEMENT REPORT

**2007 GEORGIA AIRPORT
PAVEMENT MANAGEMENT REPORT**

MIDDLE GEORGIA REGIONAL AIRPORT

PAVEMENT MANAGEMENT REPORT

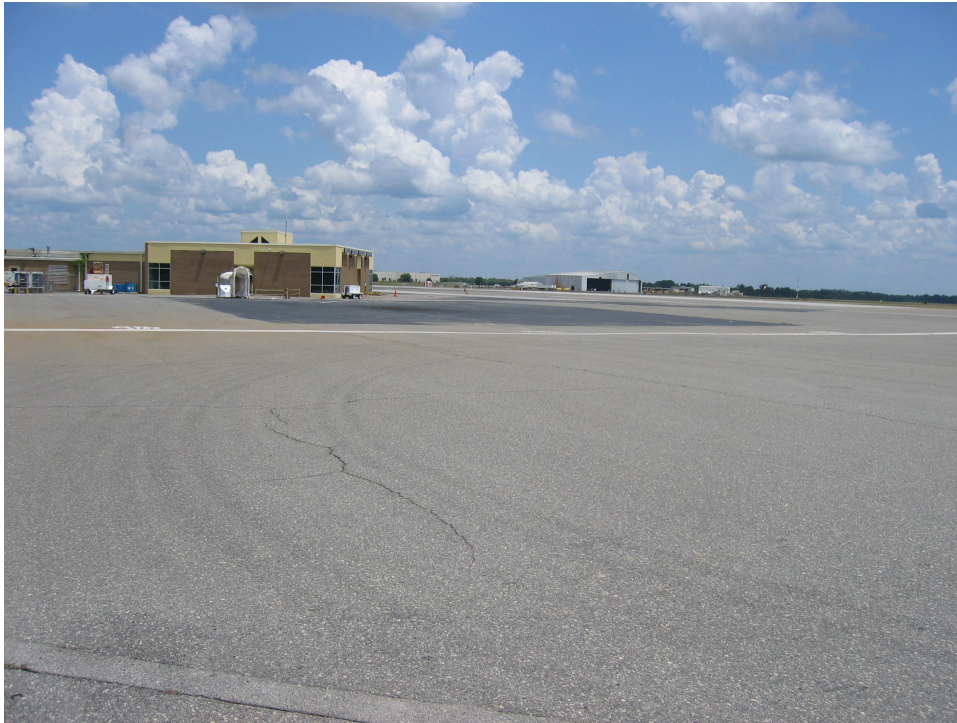
The apron at Middle Georgia Regional Airport is defined by eight sections. Section A01MGRA-10 is in poor condition with a PCI value of 59. Significant amounts of both low and medium severity block cracking and low-severity raveling and weathering were identified in this section.

A01MGRA-10. Overview.

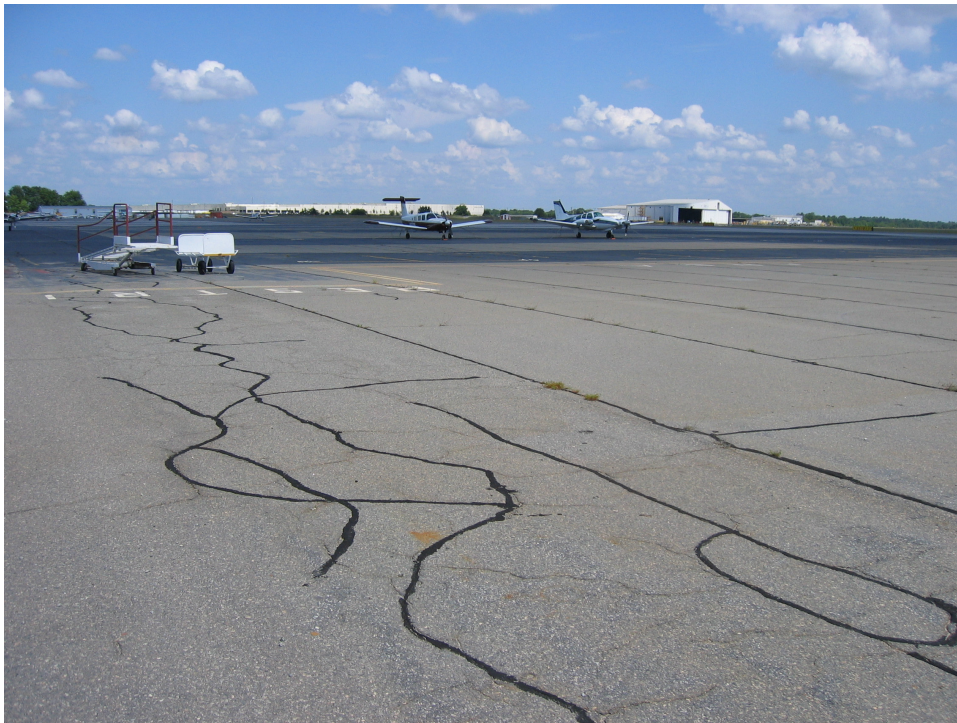
Section A01MGRA-20 is in poor condition with a PCI value of 48. Distresses observed in this section included low-severity block cracking, low and medium-severity L&T cracking, and large areas of low-severity rutting and swelling. Additionally, large areas of low-severity raveling and weathering were recorded. Smaller amounts of oil spillage and medium-severity raveling and weathering were also identified.

A01MGRA-20. Overview.

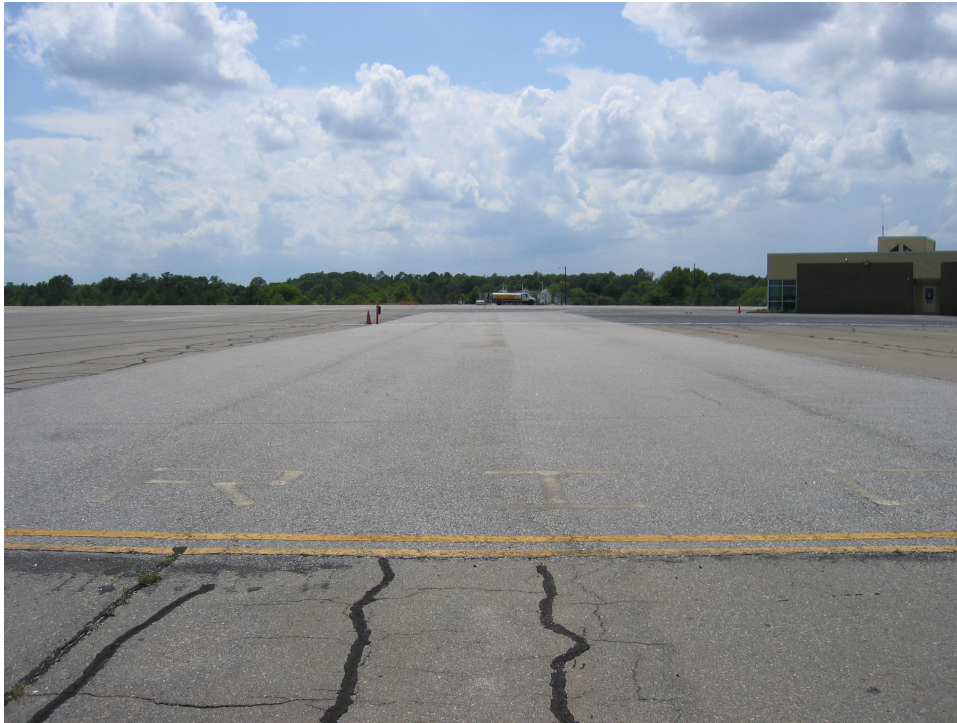
Section A01MGRA-30 is fair condition with a PCI value of 75. Distresses observed in this section included low and medium-severity L&T cracking, an isolated area of low-severity depression, and a small area of raveling and weathering.

A01MGRA-30. Overview.

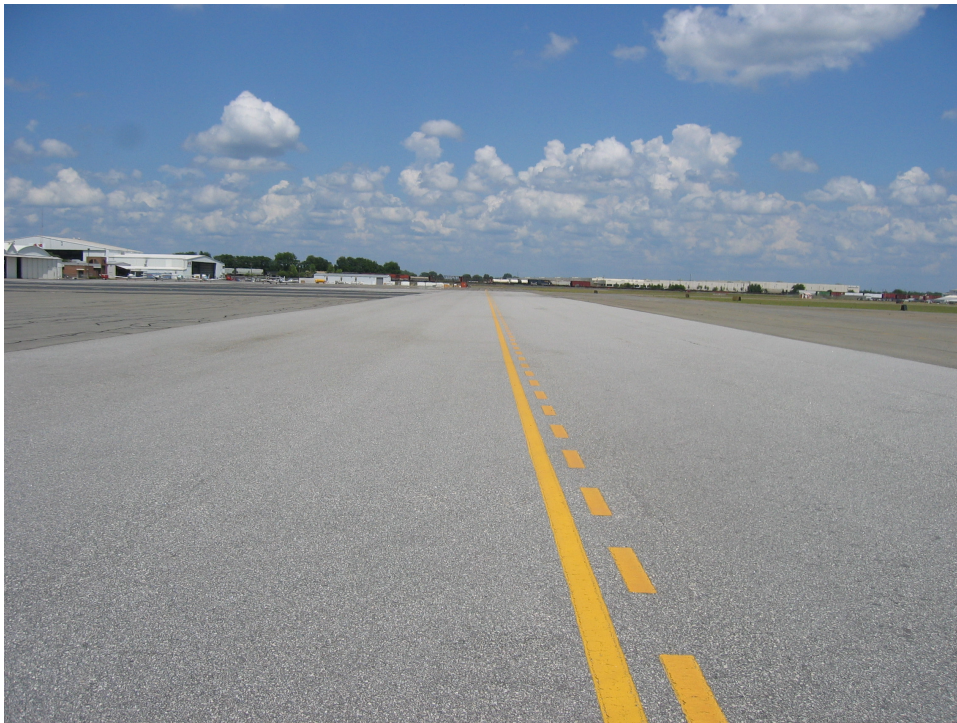
Section A01MGRA-40 is in good condition with a PCI value of 82. Small amounts of low and medium-severity L&T cracking along with small amounts of swelling, patching, and raveling and weathering were observed in this section.

A01MGRA-40. Overview.

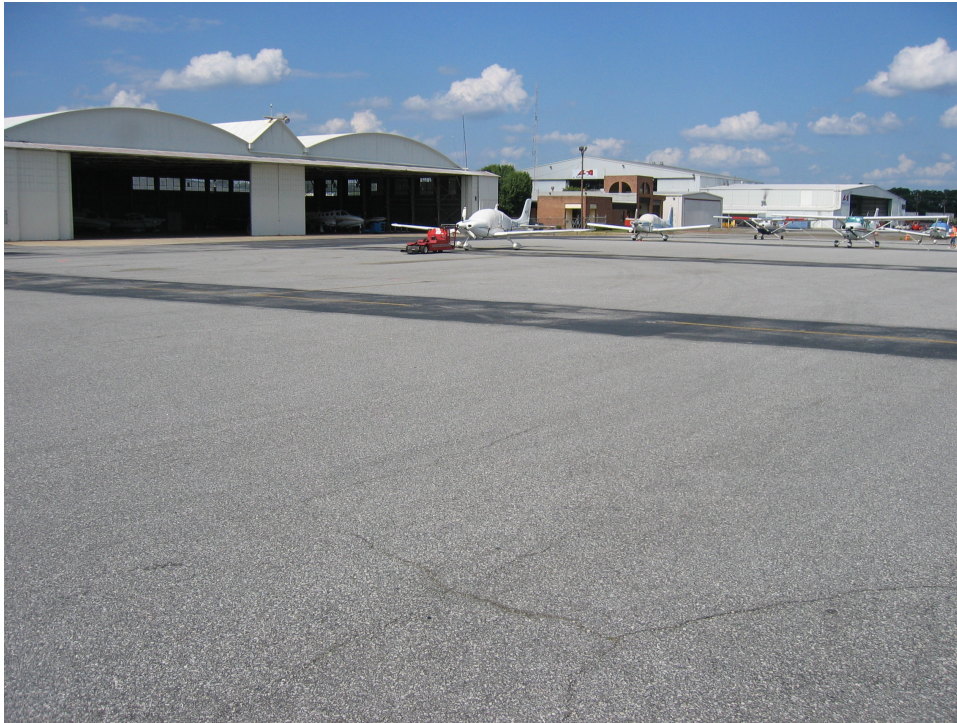
Section A01MGRA-50 is in fair condition with a PCI value of 79. Distresses observed in this section included bleeding, low and medium-severity L&T cracking, low-severity swelling, and low and medium-severity raveling and weathering.

A01MGRA-50. Overview.

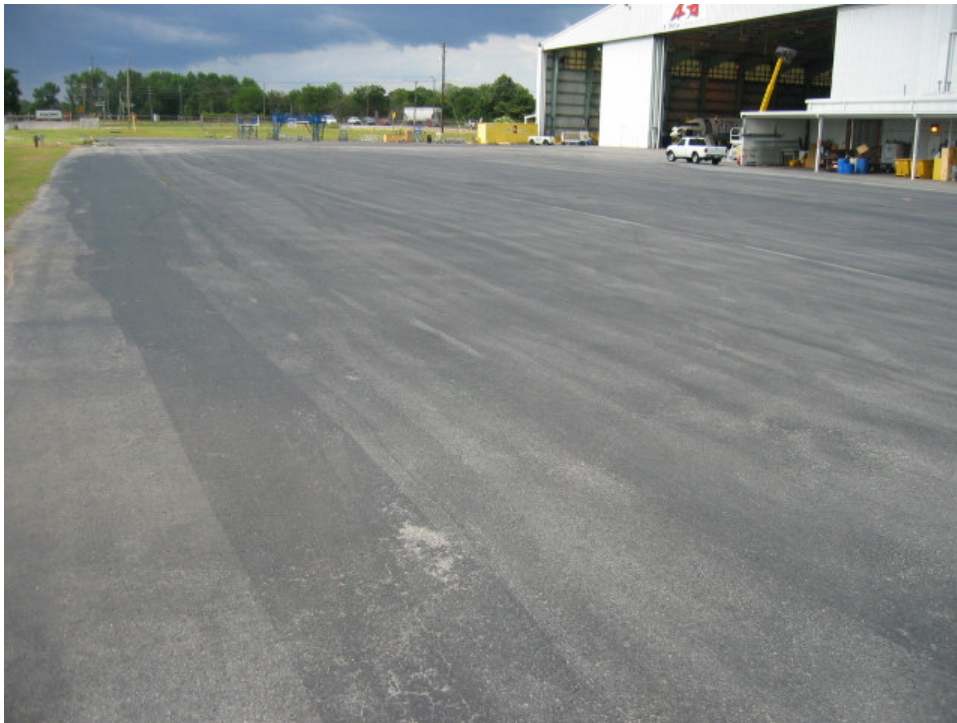
Section A01MGRA-80 is in fair condition with a PCI value of 65. This apron section serves as the maintenance apron for ASA Airlines. Alligator cracking was observed in this section at low, medium and high severity levels. A large amount of low-severity block cracking was also identified along with areas of low-severity depression, low and medium-severity L&T cracking, and low-severity swelling.

A01MGRA-80. Overview.

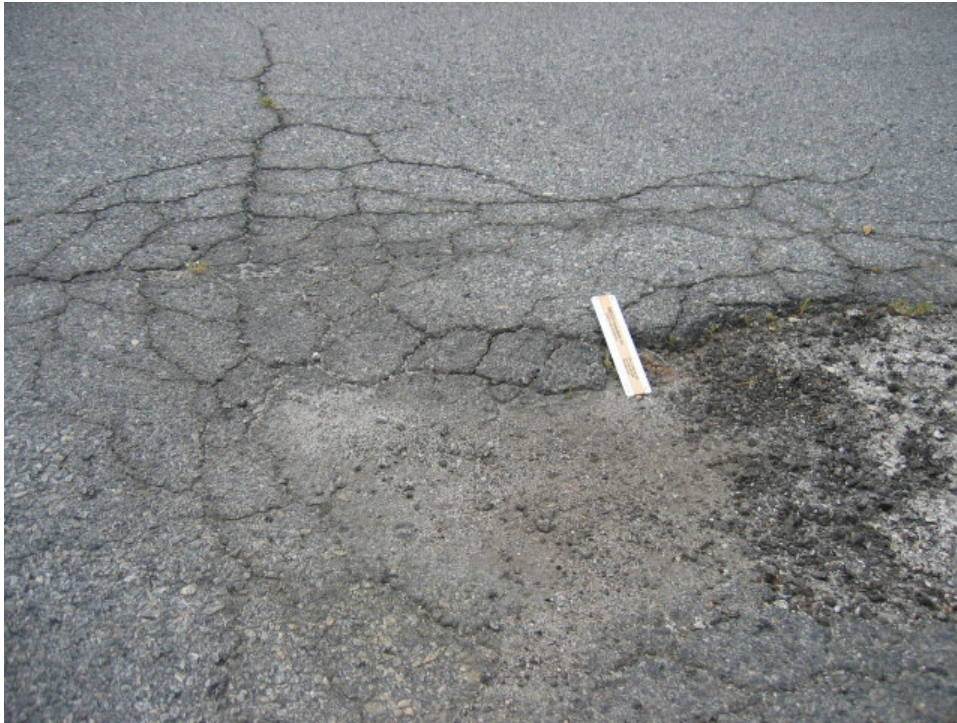
A01MGRA-80. Alligator cracking.

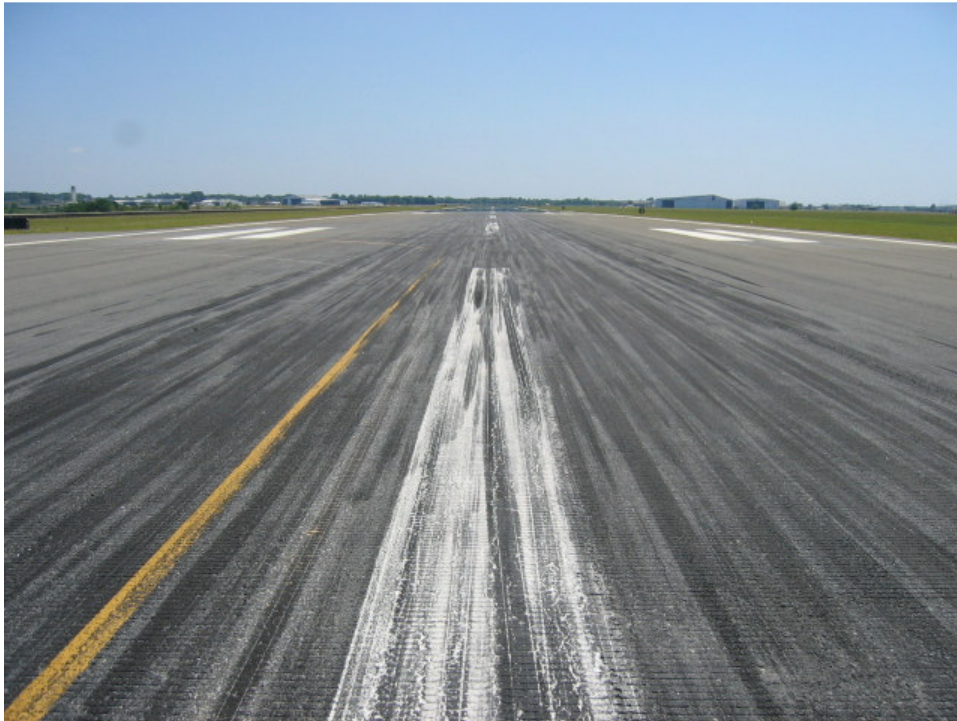
Runway 5-23 at Middle Georgia Regional Airport is defined by six pavement sections. Section R523MGRA-10C is in fair condition with a PCI value of 68. Substantial quantities of low and medium-severity L&T cracking and low-severity raveling and weathering were observed in this section.

R0523MGRA-10C. Overview.

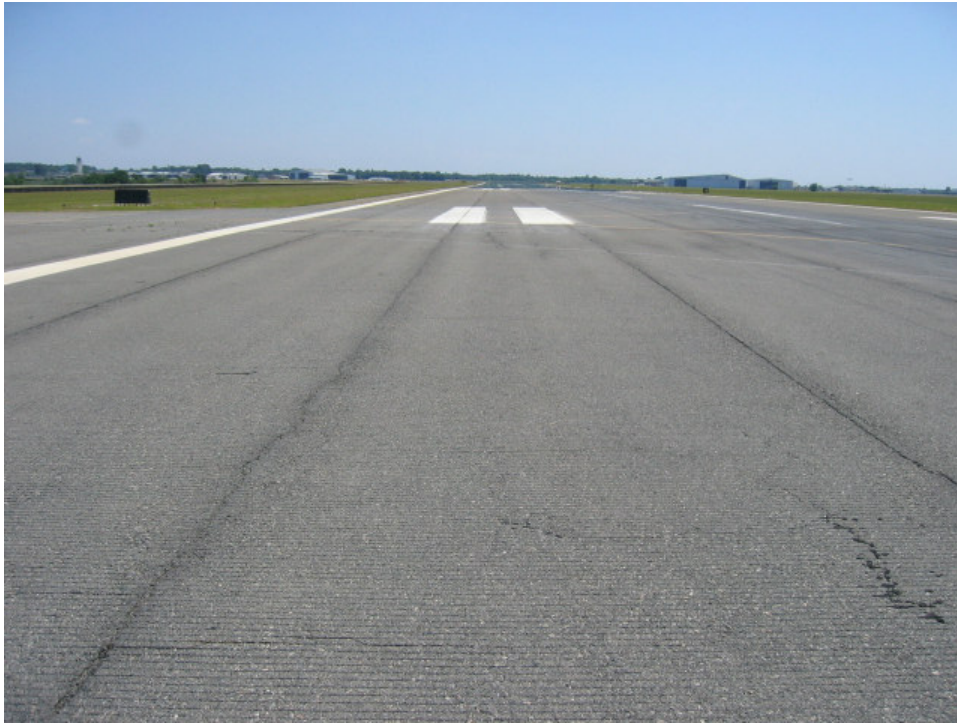
Sections R523MGRA-10N and R523MGRA-10S are in fair condition both with PCI values of 62. Distresses observed in these sections include low and medium-severity L&T cracking and raveling and weathering. A small amount of low-severity swelling was also recorded.

R0523MGRA-10N. Overview.

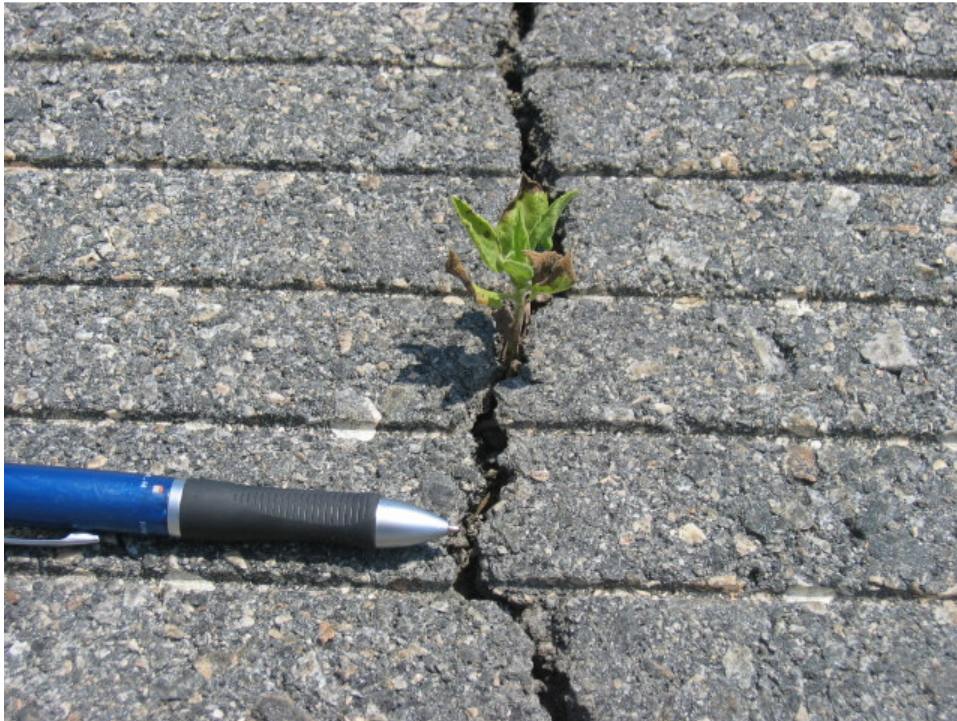
R0523MGRA-10N. L&T cracking.

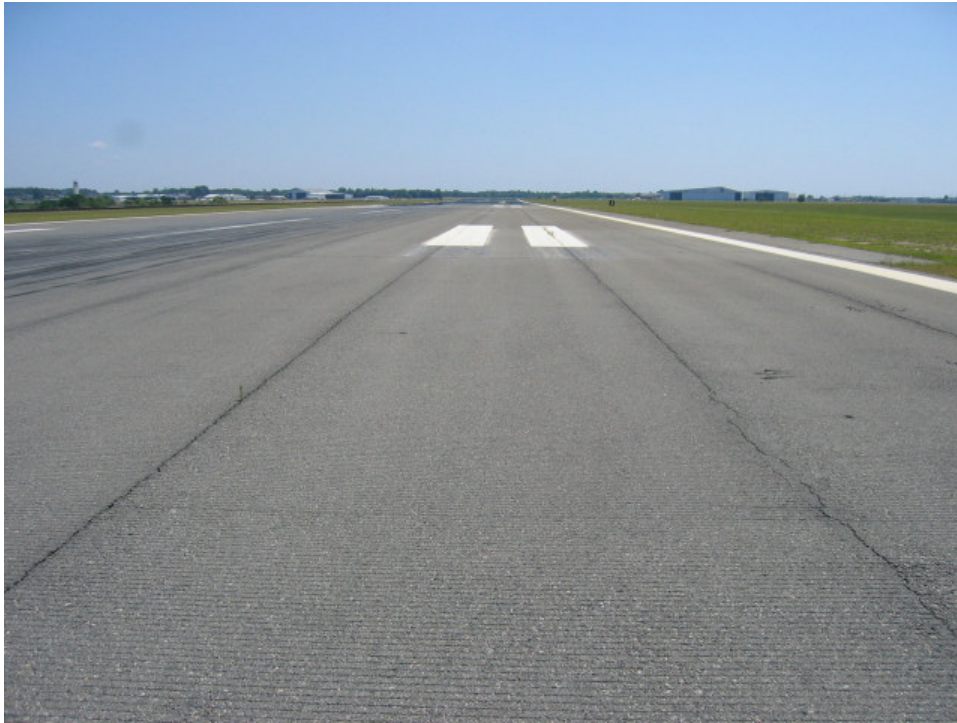
R0523MGRA-10S. Overview.

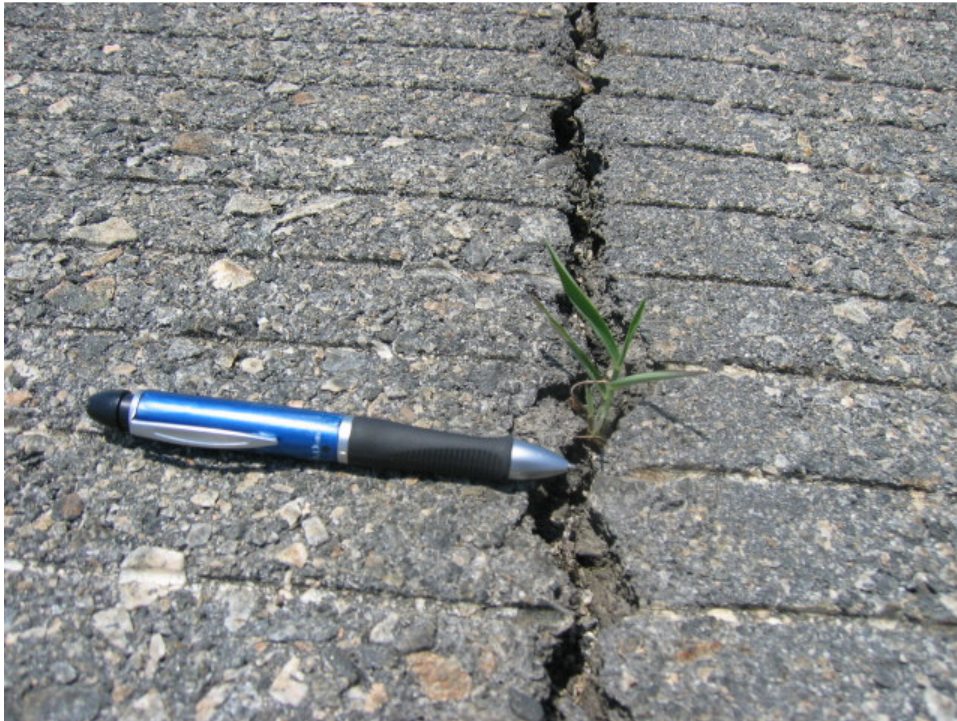
R0523MGRA-10S. L&T cracking.

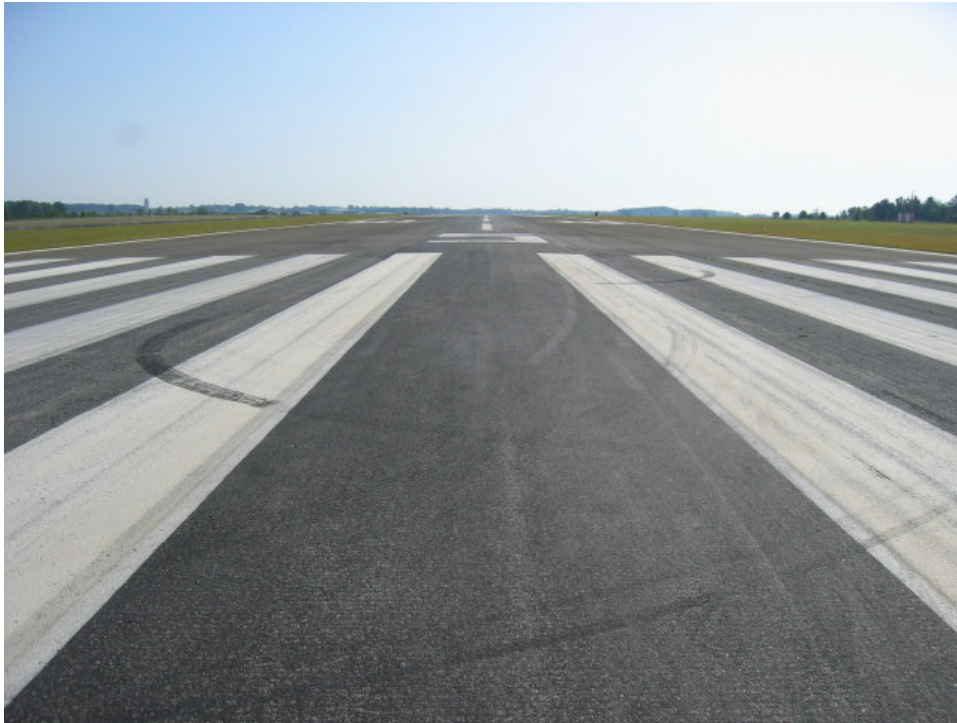
Section R523MGRA-20C is in poor condition with a PCI value of 36. A large quantity of bleeding as well as low-severity raveling and weathering were observed in this section. Low and medium-severity L&T cracking were also identified.

R0523MGRA-20C. Overview.

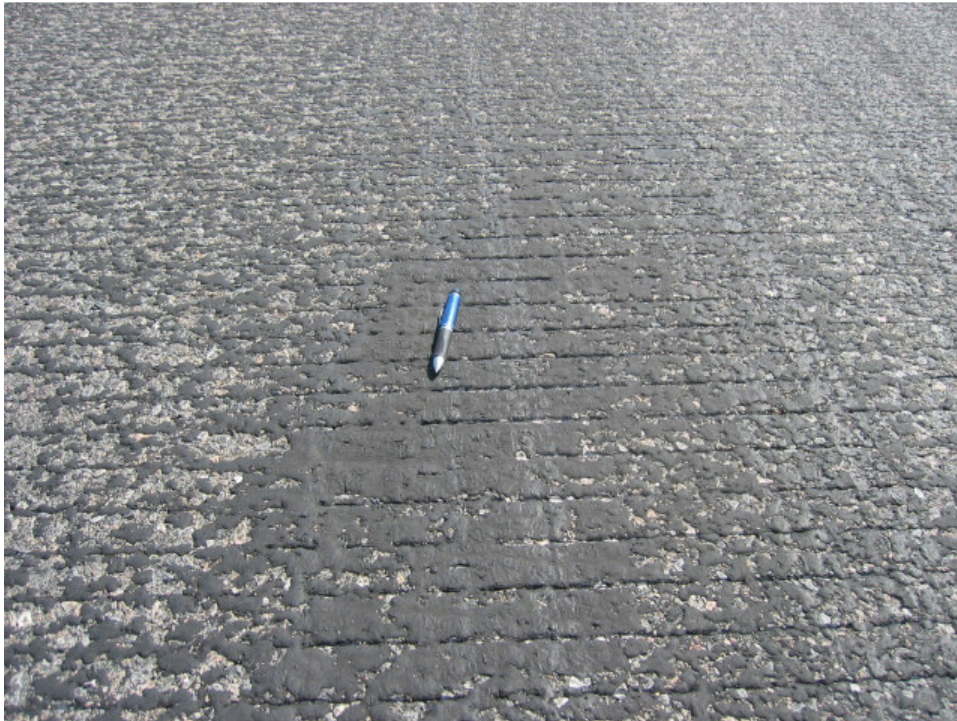
R0523MGRA-20C. Bleeding.

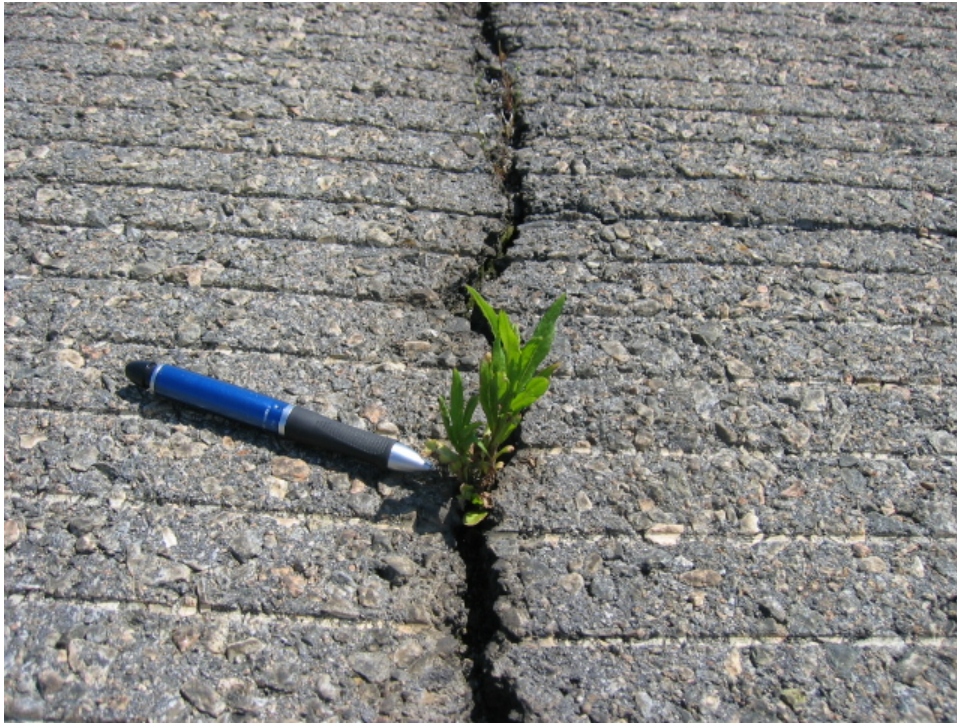
R0523MGRA-20C. L&T cracking.

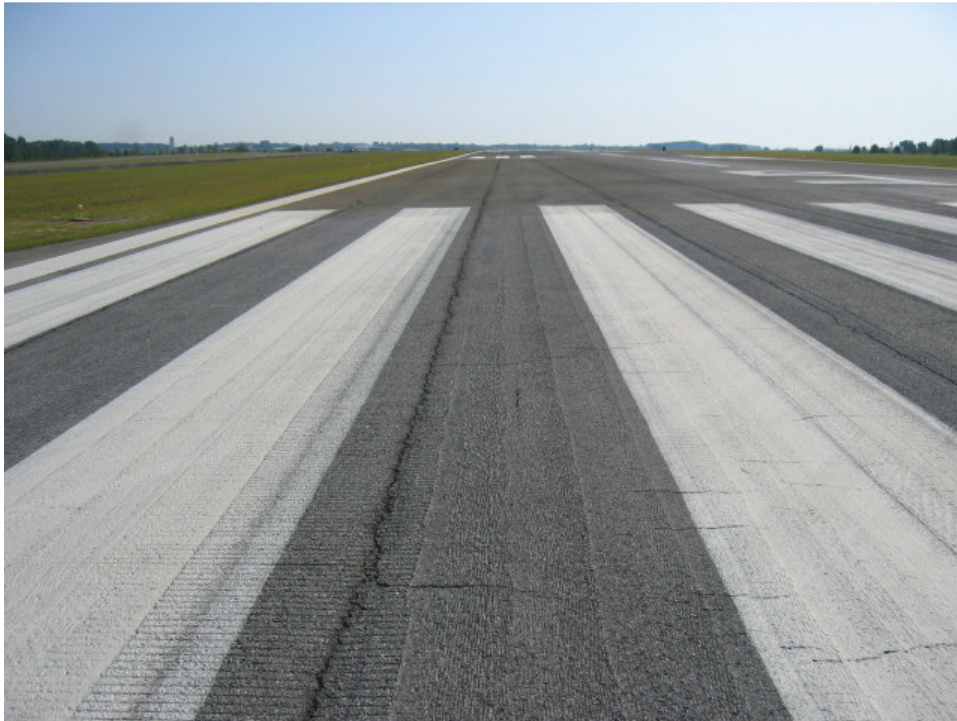
Section R523MGRA-20N is in poor condition with a PCI value of 53. Low and medium-severity L&T cracking and low-severity raveling and weathering were recorded in significant quantities. A small amount of patching was also observed.

R0523MGRA-20N. Overview.

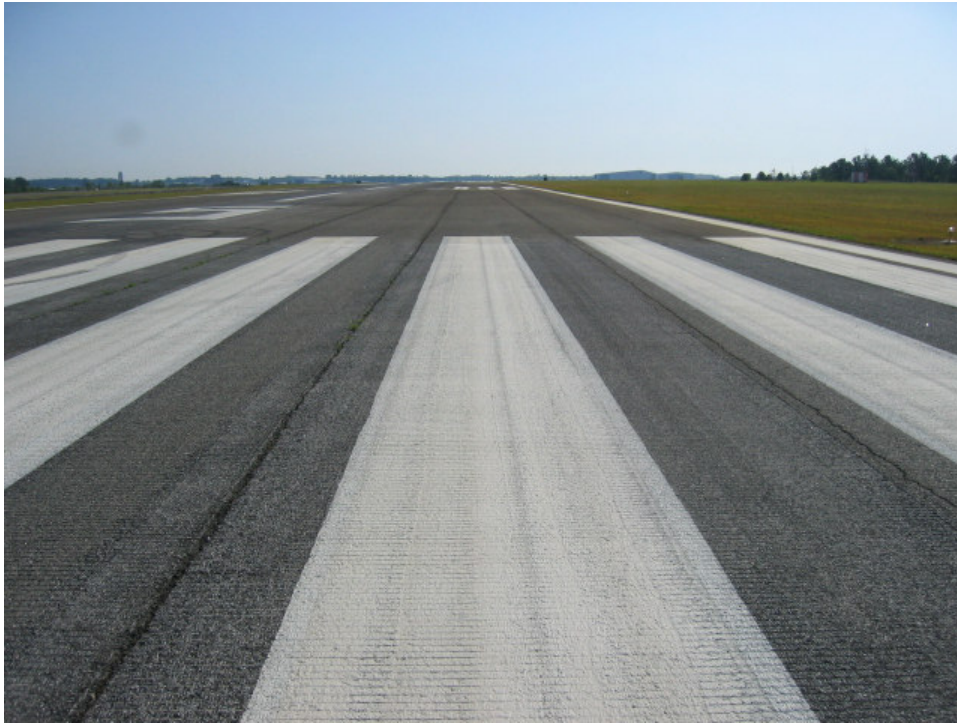
Section R523MGRA-20S is in poor condition with a PCI value of 55. A large quantity of low-severity raveling and weathering as well as substantial quantities of both low and medium-severity L&T cracking was observed in this section.

R0523MGRA-20S. Overview.

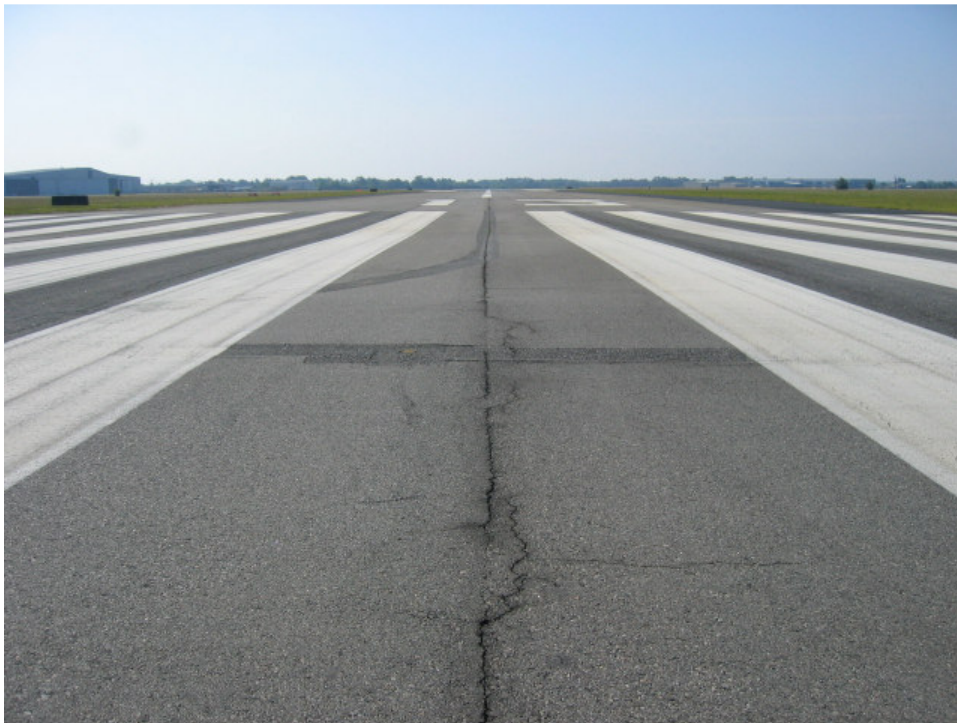
Runway 13-31 at Middle Georgia Regional Airport is defined by three pavement sections. Section R1331MGRA-10C is in fair condition with a PCI value of 65. Large amounts of low and medium-severity longitudinal and transverse (L&T) cracking as well as substantial amounts of low-severity block cracking were observed for this section. Isolated amounts of low-severity swelling and patching were also identified.

R1331MGRA-10C. Overview.

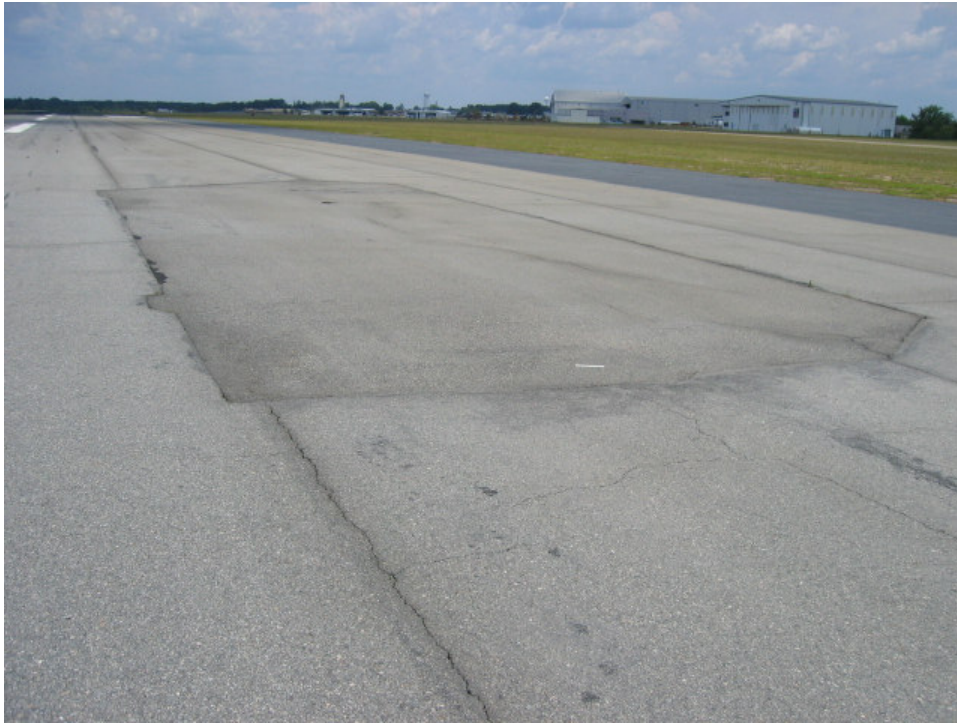
R1331MGRA-10C. Patch (1).

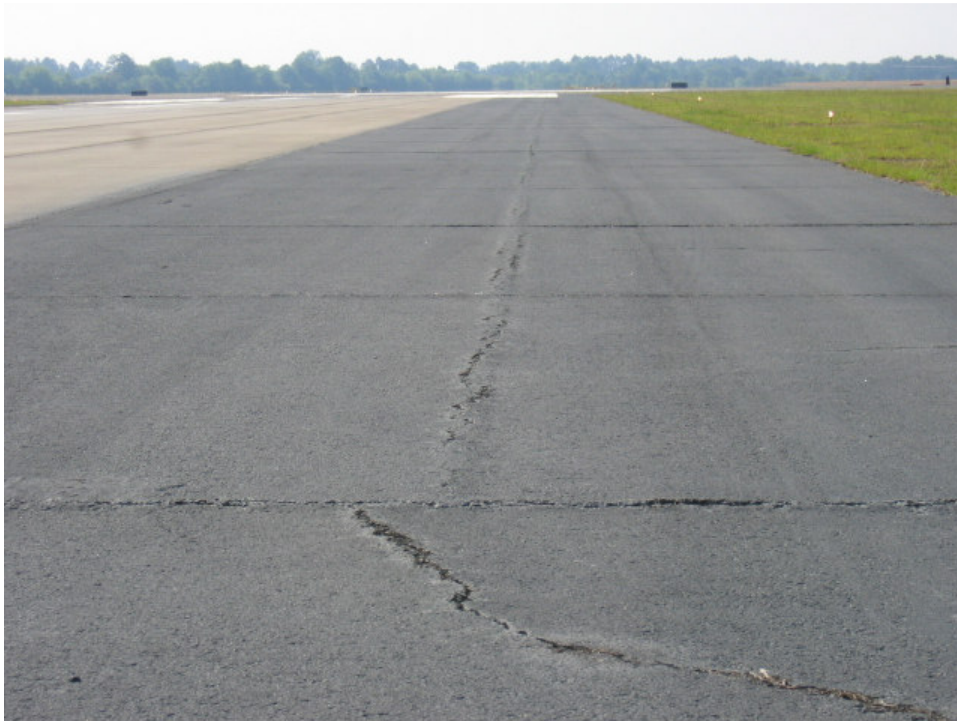
Section R1331MGRA-10N is in poor condition with a PCI value of 43. Large amounts of both low and medium severity L&T cracking were observed in this section. Moderate amounts of low-severity patching and low and medium-severity swelling and block cracking were also identified. A substantial area of low-severity raveling and weathering was also recorded.

R1331MGRA-10N. Overview.

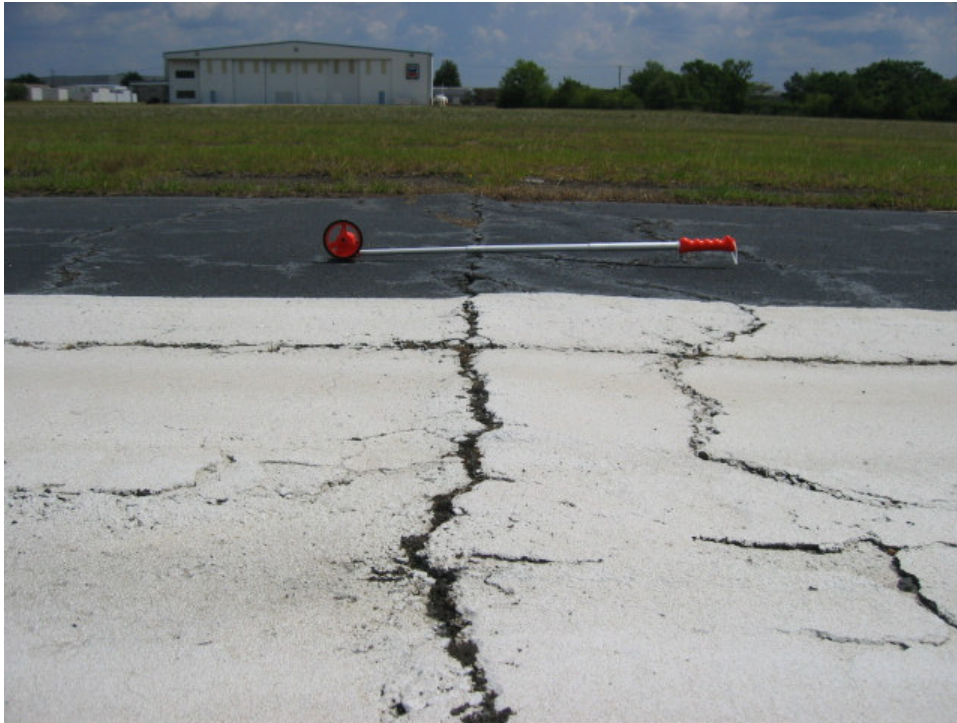
R1331MGRA-10N. Swelling (1).

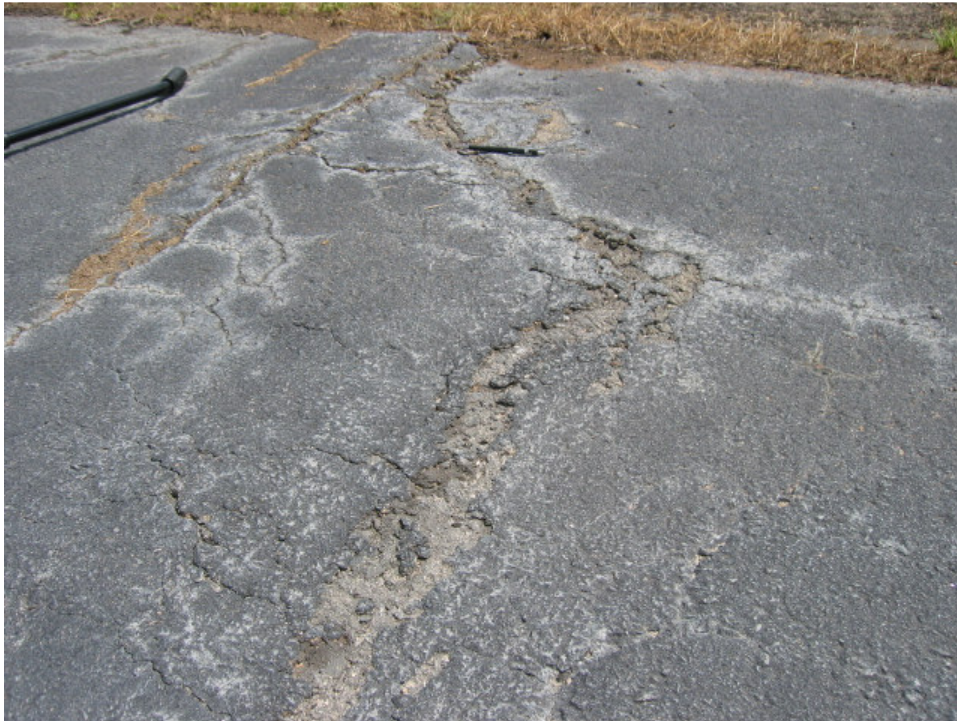
R1331MGRA-10N. Swelling (2).

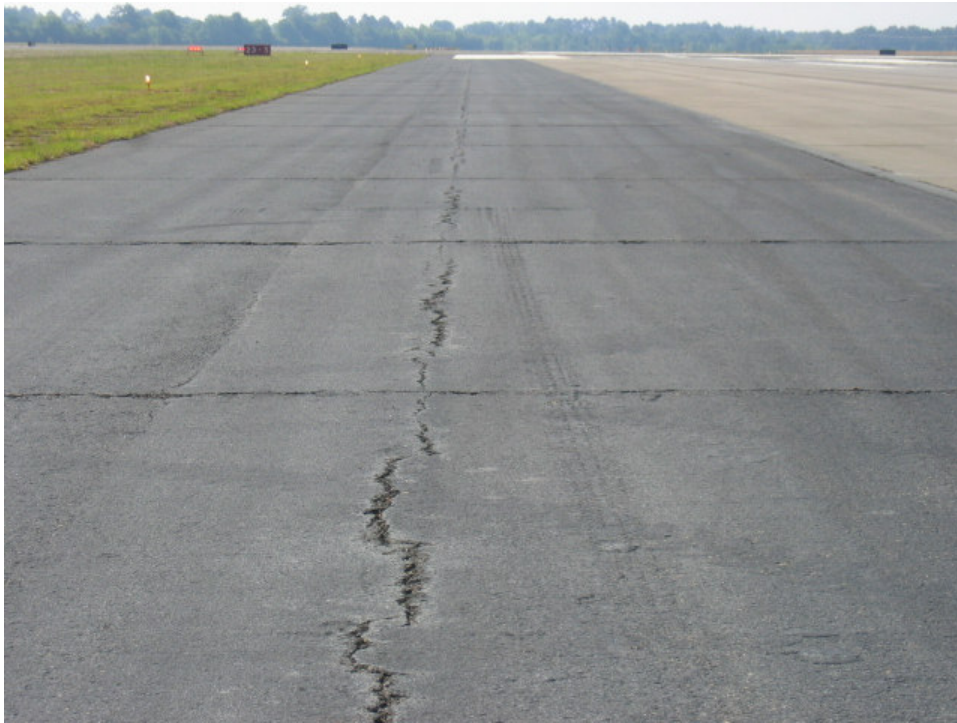
Section R1331MGRA-10S is in poor condition with a PCI value of 52. Large quantities of medium-severity L&T cracking and low-severity swelling were observed throughout the section. Low-severity and high-severity L&T cracking as well as medium-severity swelling were observed in lesser quantities. Low-severity raveling and weathering was also identified.

R1331MGRA-10S. Overview.

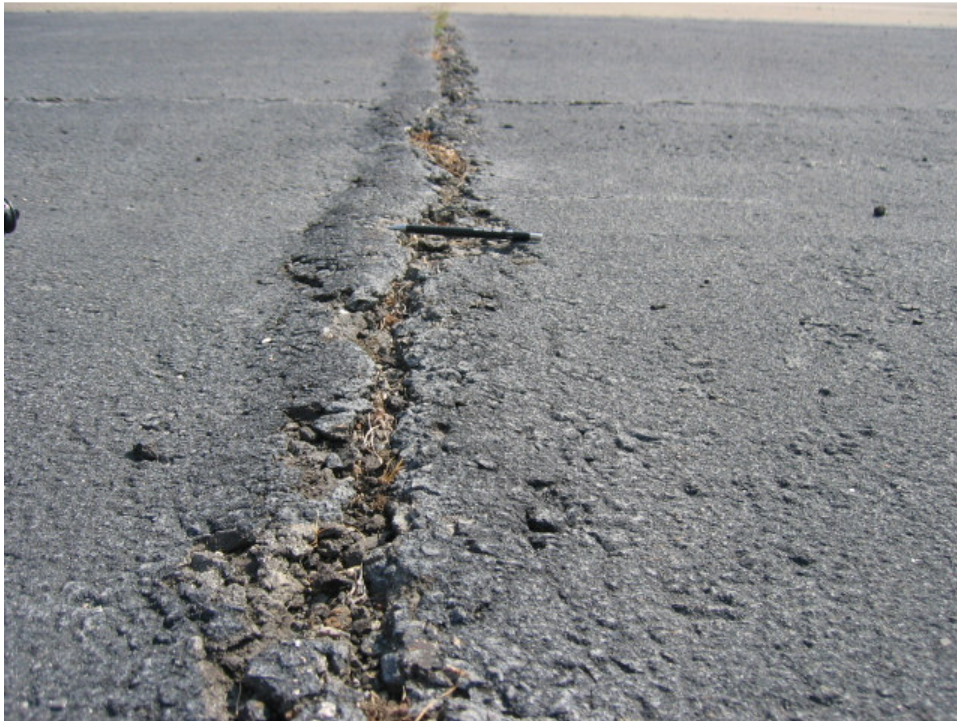
R1331MGRA-10S. L&T cracking (1).

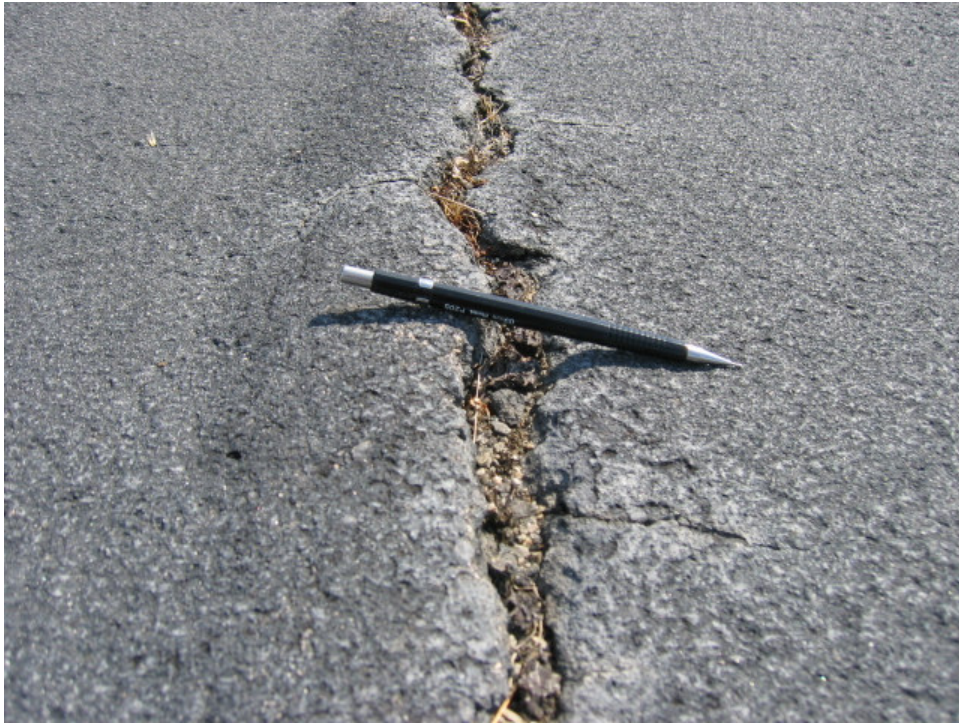
R1331MGRA-10S. Swelling (1).

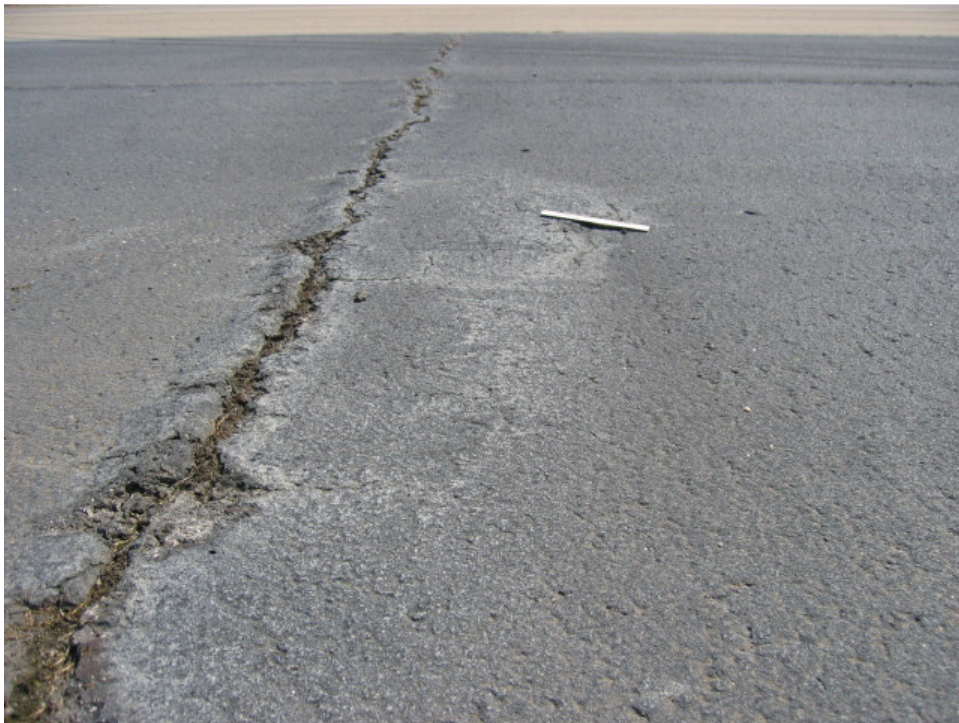
R1331MGRA-10S. Swelling (2).

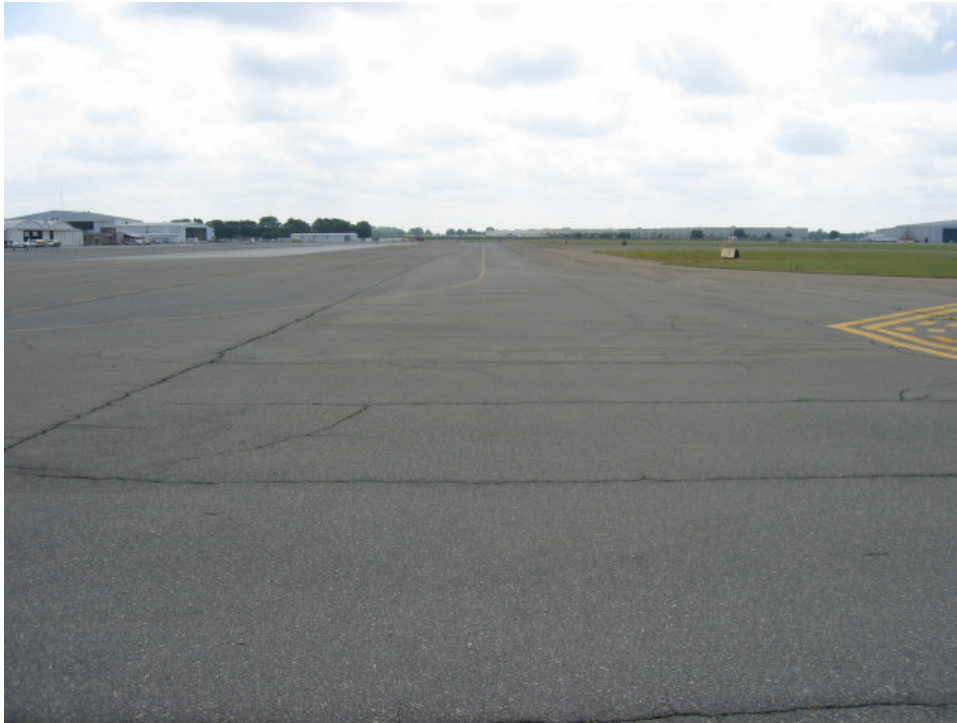
Taxiway A at Middle Georgia Regional Airport is composed of a single pavement section. Section TAMGRA-10 is in poor condition with a PCI value of 48. Substantial quantities of low and medium-severity L&T cracking and block cracking were observed. Large areas of low-severity swelling were also identified. Vegetation growth was observed in many of the cracks on this taxiway.

TAMGRA-10. Overview.

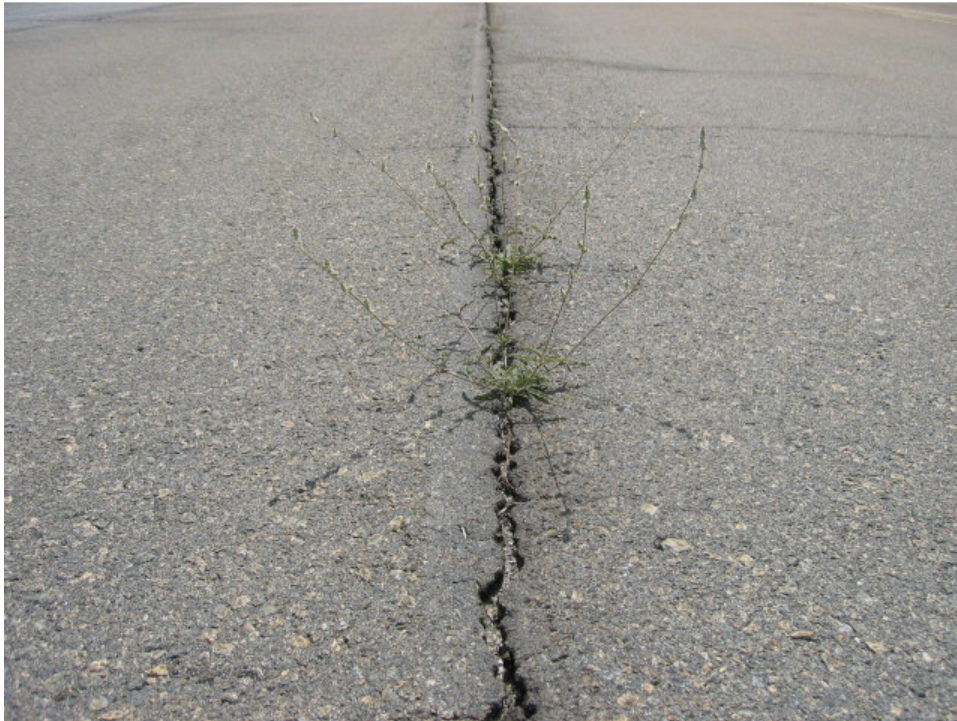
TAMGRA-10. L&T cracking.

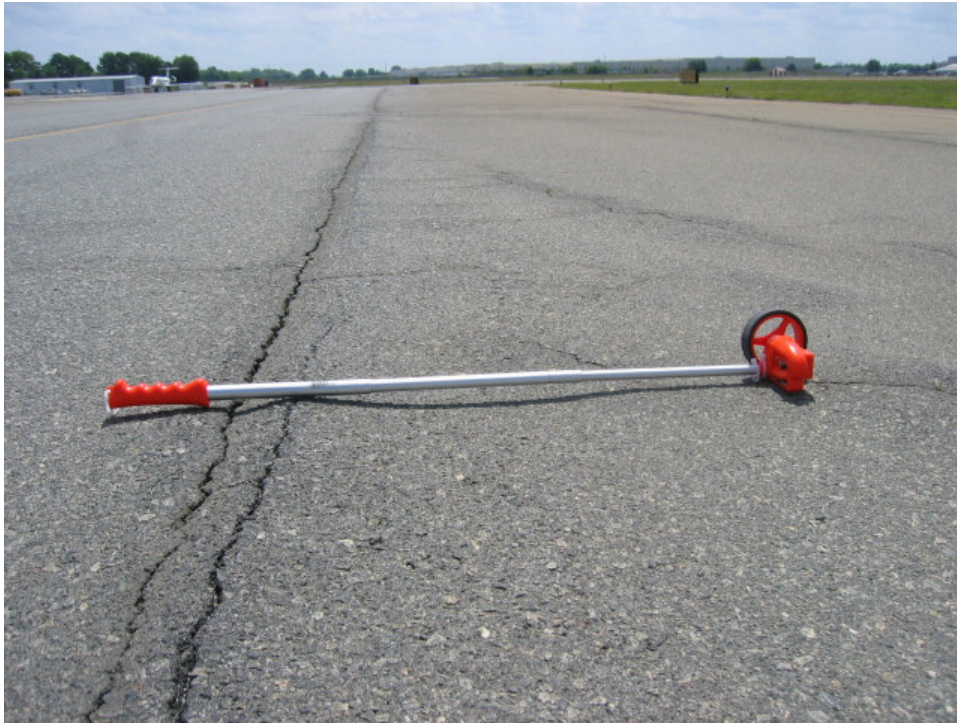
TAMGRA-10. Swelling.

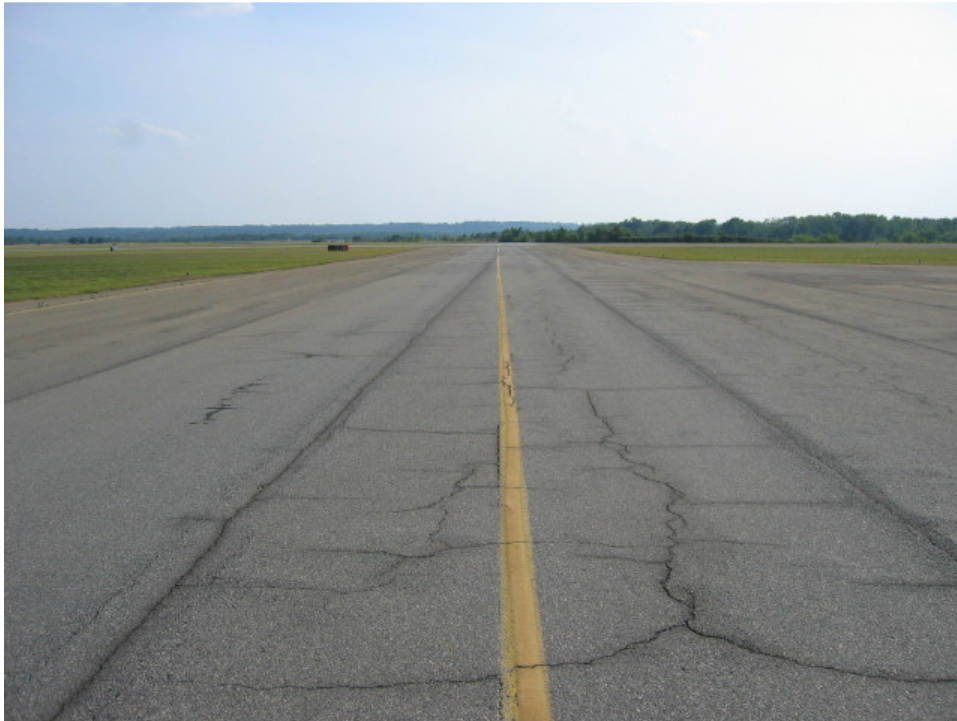
Taxiway B consists of three pavement sections. Section TBMGRA-10 is in poor condition with a PCI value of 40. Large quantities of low and medium-severity swelling along with low and medium-severity block cracking and L&T cracking were observed. Medium-severity patching and bleeding were also identified in this section. Vegetation growth was observed in many of the cracks in this section.

TBMGRA-10. Overview.

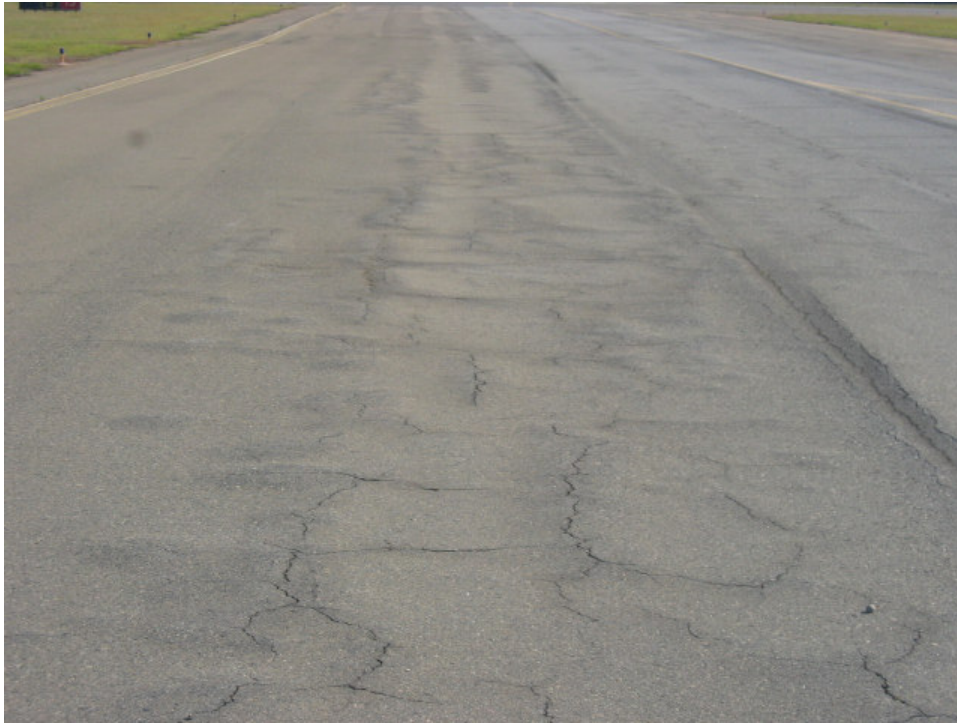
TBMGRA-10. Block cracking.
