MIDDLE GEORGIA REGIONAL AIRPORT
PAVEMENT MANAGEMENT REPORT

**2007 GEORGIA AIRPORT
PAVEMENT MANAGEMENT REPORT**

MIDDLE GEORGIA REGIONAL AIRPORT

PAVEMENT MANAGEMENT REPORT

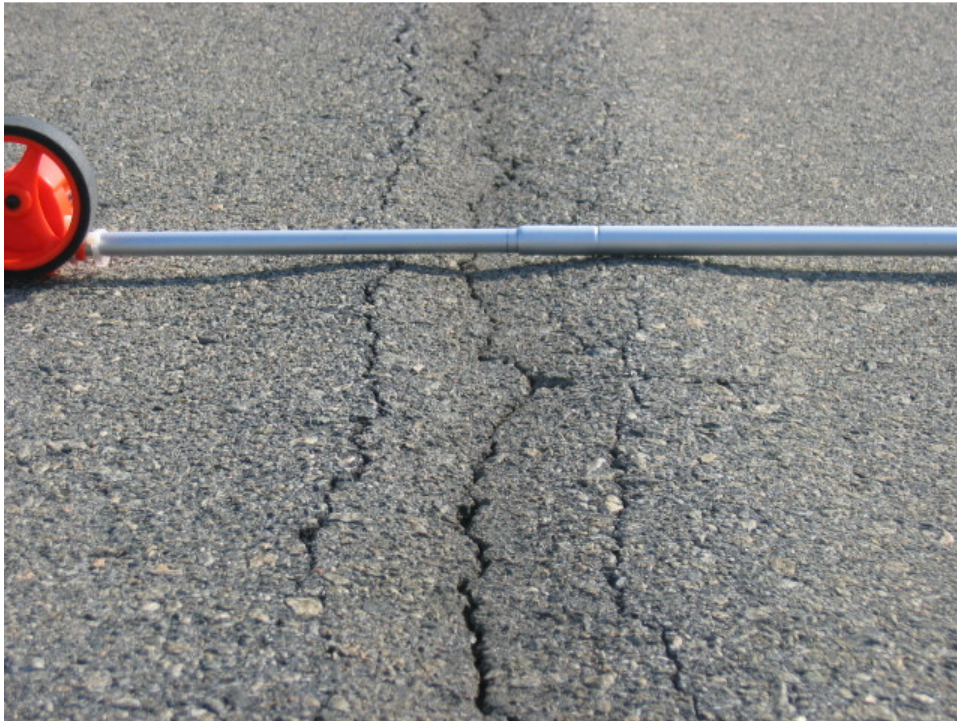
Taxiway B consists of three pavement sections. Section TBMGRA-10 is in poor condition with a PCI value of 40. Large quantities of low and medium-severity swelling along with low and medium-severity block cracking and L&T cracking were observed. Medium-severity patching and bleeding were also identified in this section. Vegetation growth was observed in many of the cracks in this section.

TBMGRA-10. Swelling (1).

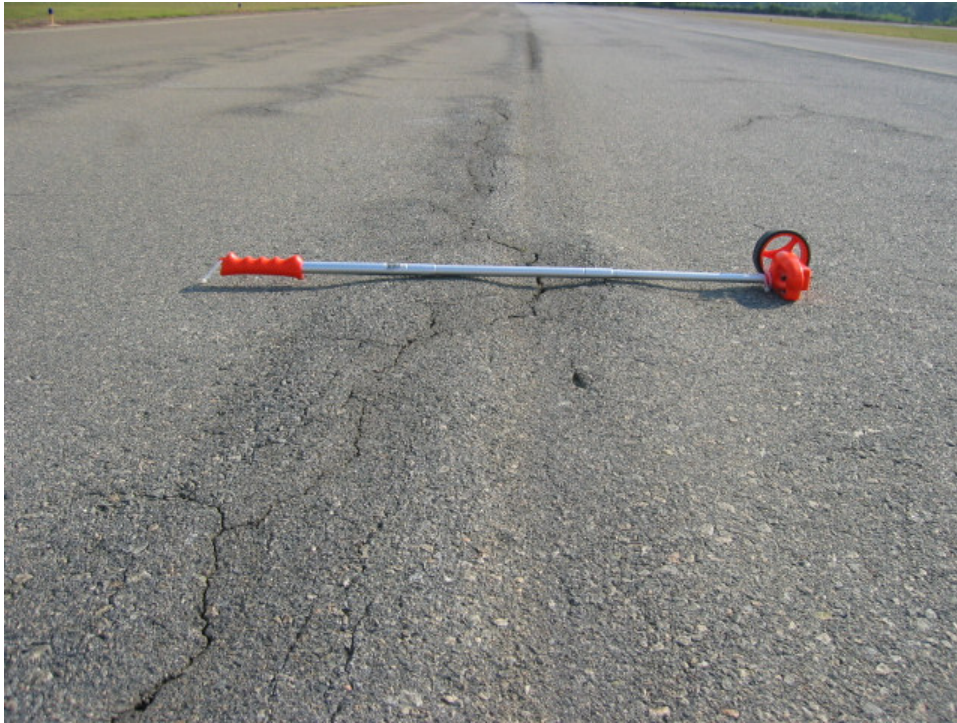
TBMGRA-10. Swelling (2).

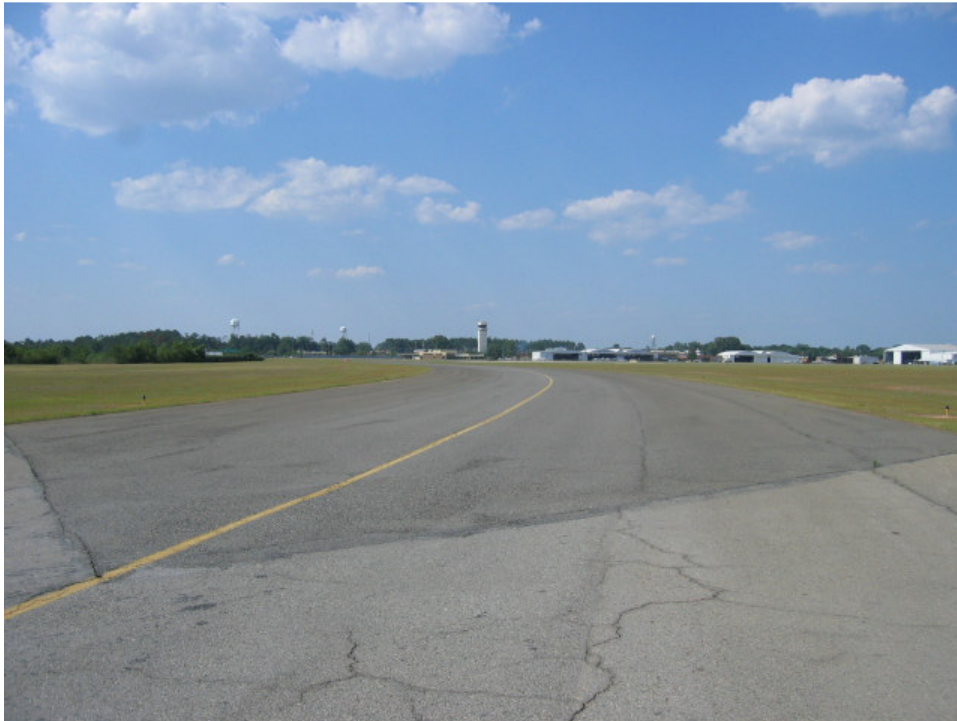
Section TBMGRA-20 is in poor condition with a PCI value of 59. Low and medium-severity L&T cracking and low-severity raveling and weathering were recorded in significant amounts in this section.

TBMGRA-20. Overview.

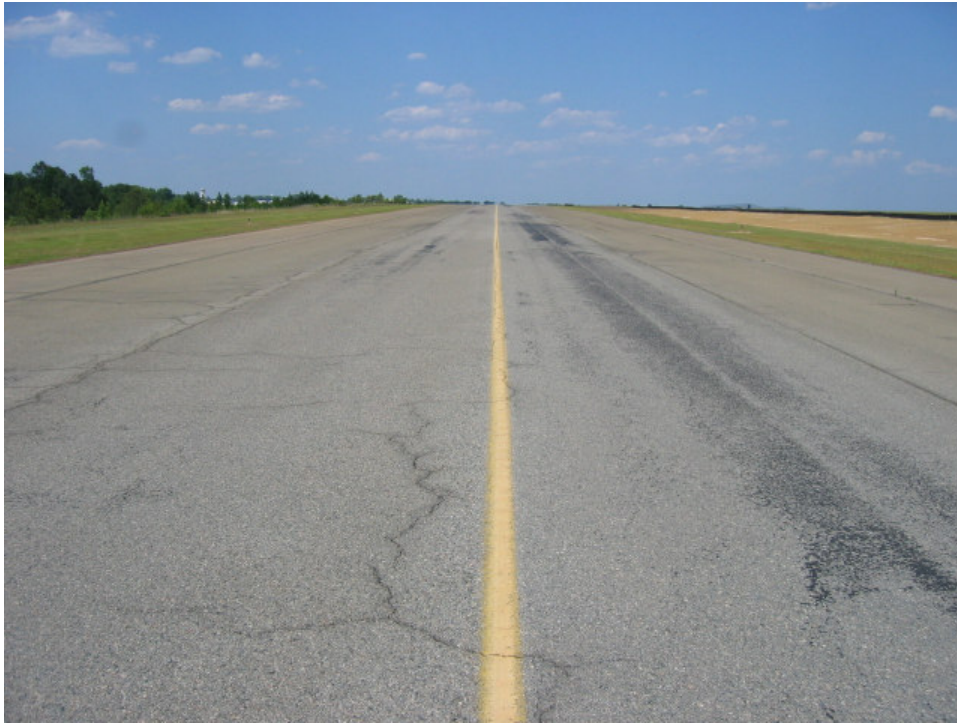
Section TBMGRA-30 is in poor condition with a PCI value of 53. Large quantities of low-severity block cracking, low and medium-severity L&T cracking, low-severity raveling and weathering, and bleeding were observed in this section. Prevalent vegetation growth in the cracks was also noted.

TBMGRA-30. Overview.

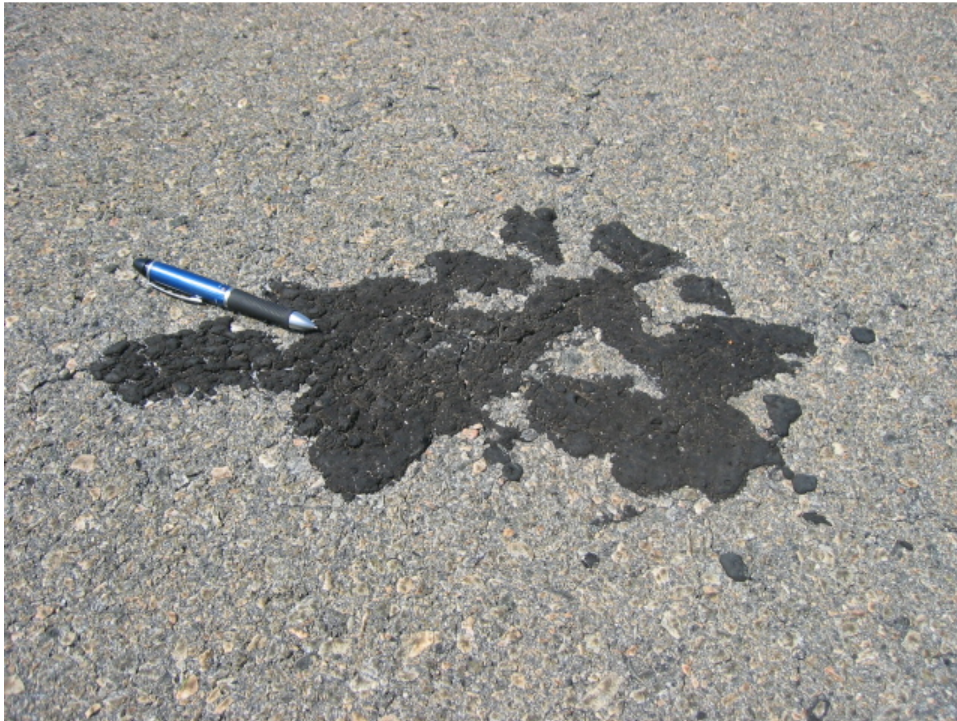
TBMGRA-30. Bleeding.

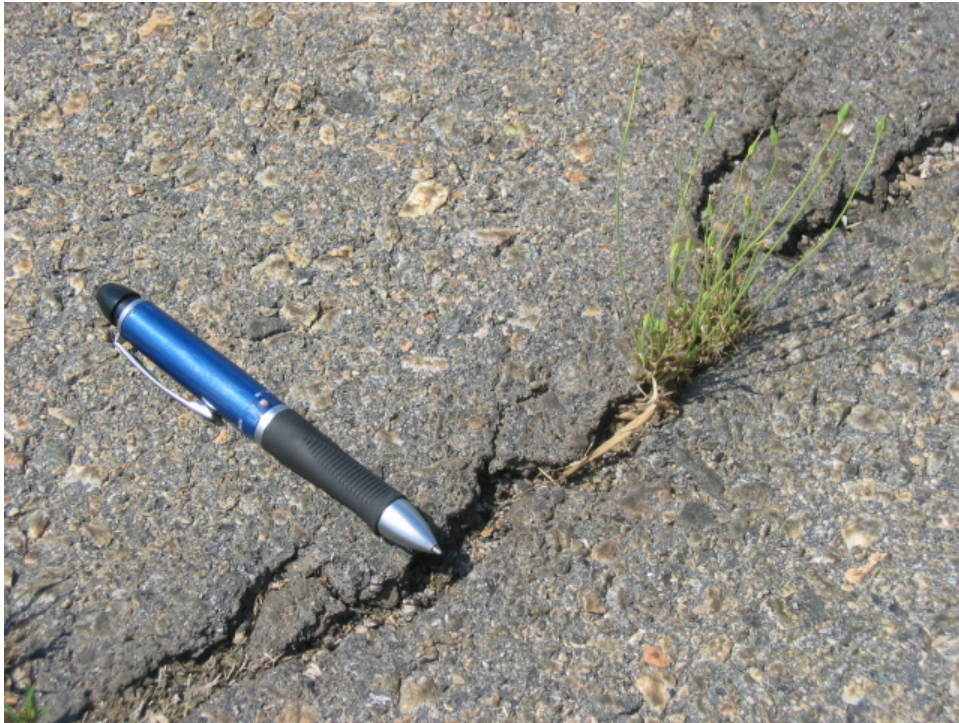
TBMGRA-30. L&T cracking.

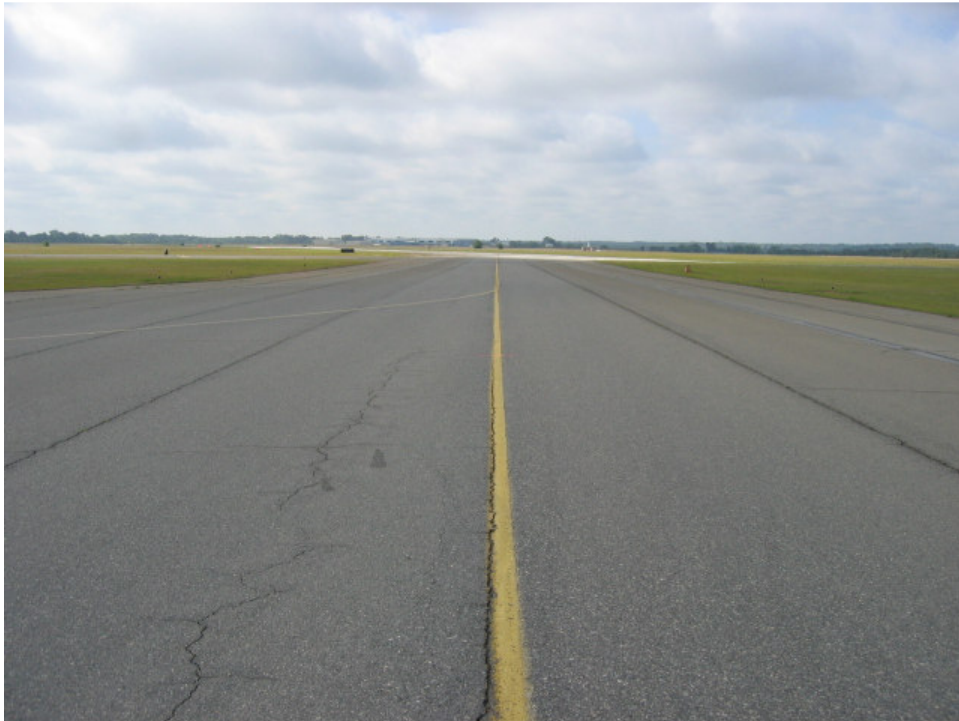
Taxiway B3 is consists of a single pavement section. Section TB3MGRA-10 is in poor condition with a PCI value of 50. Low-severity block cracking, L&T cracking, and swelling were observed in significant quantities in this section. Low-severity raveling and weathering as well as a small amount of bleeding were also noted.

TB3MGRA-10. Overview.

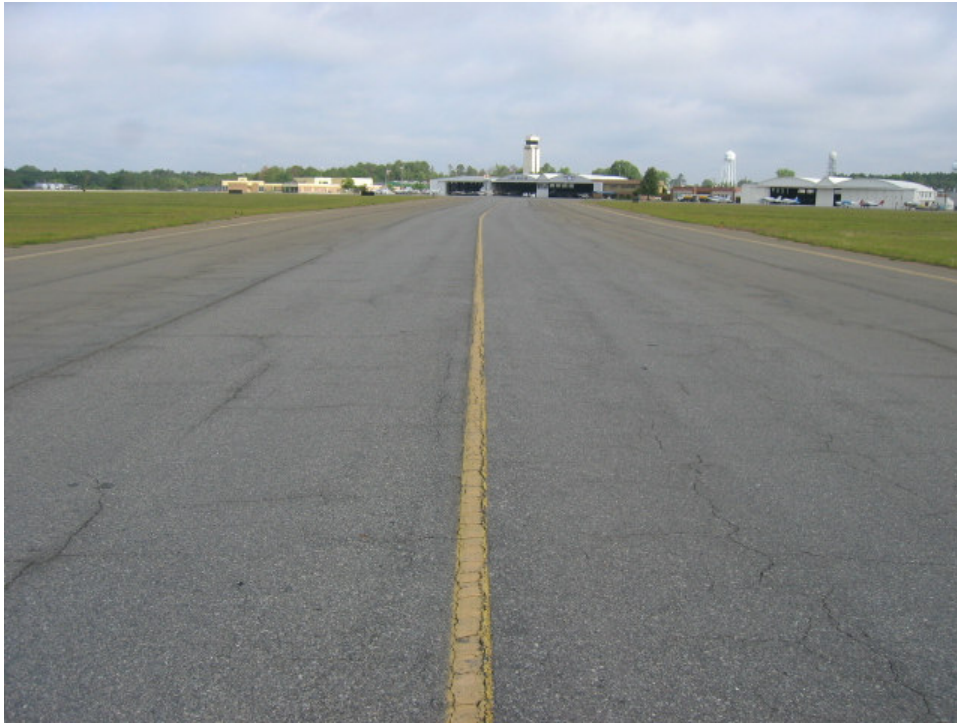
Taxiway C consists of two pavement sections. TCMGRA-10 is in poor condition with a PCI value of 39. Large quantities of low and medium-severity block cracking and swelling were observed in this section. Smaller amounts of low, medium, and high-severity L&T cracking were also identified. In addition, a small amount of bleeding was noted.

TCMGRA-10. Overview.

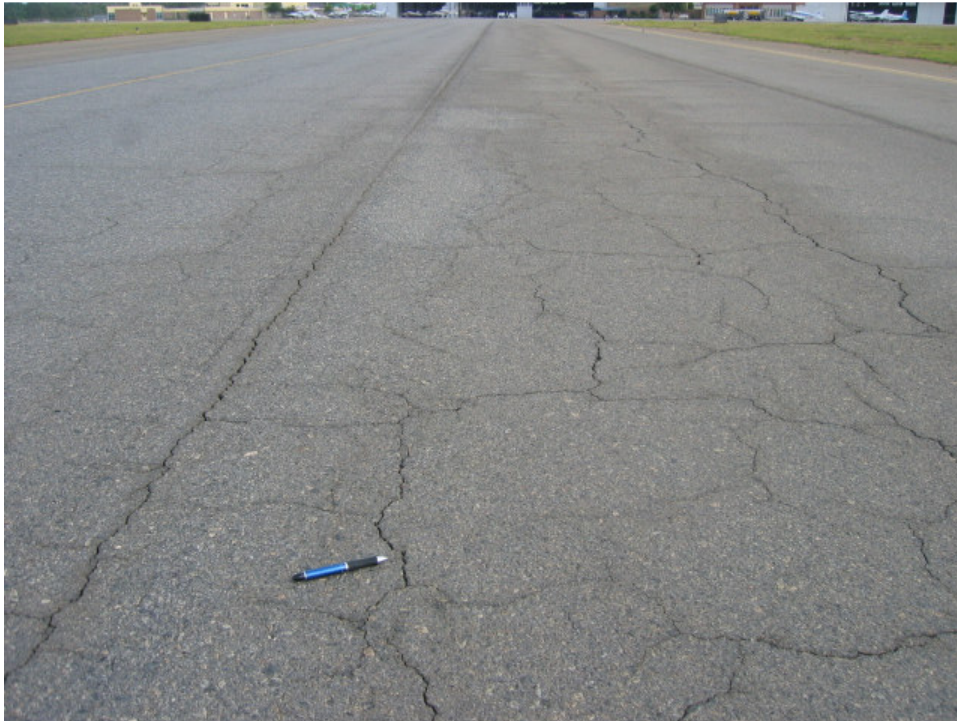
TCMGRA-10. Block cracking.

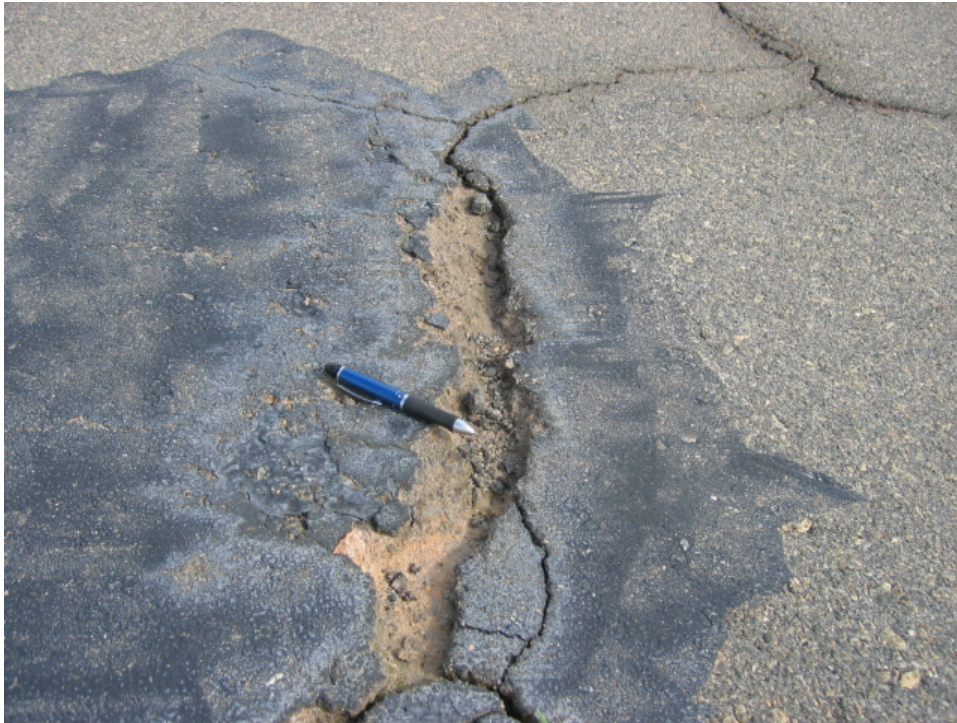
TCMGRA-10. L&T cracking.

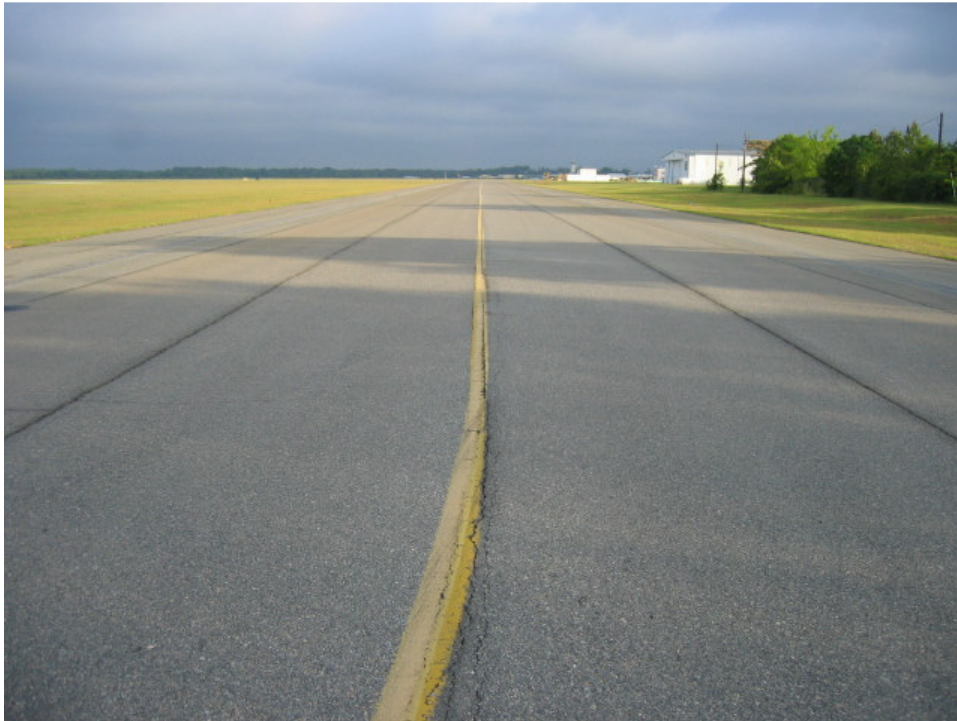
Section TCMGRA-20 is in poor condition with a PCI value of 49. Large quantities of low and medium-severity L&T cracking were observed in this section. Substantial amounts of low-severity alligator cracking, block cracking, swelling, and raveling and weathering were also recorded. Additionally, medium-severity shoving was observed at locations where the asphalt comes in contact with PCC slabs.

TCMGRA-20. Overview.

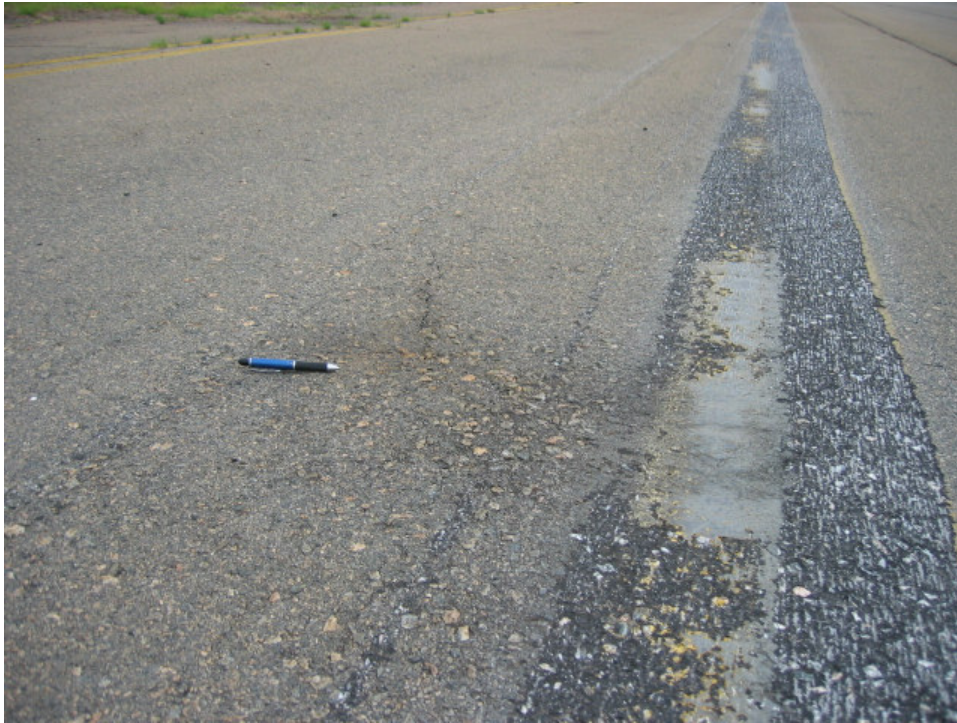
TCMGRA-20. Depression (1).

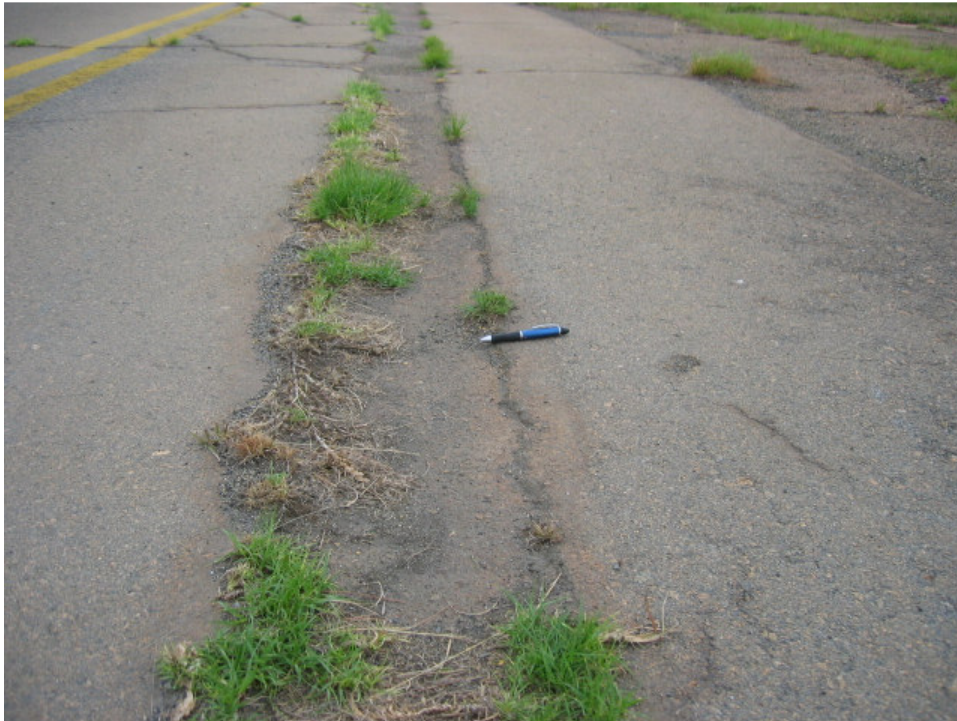
TCMGRA-20. Depression (2).

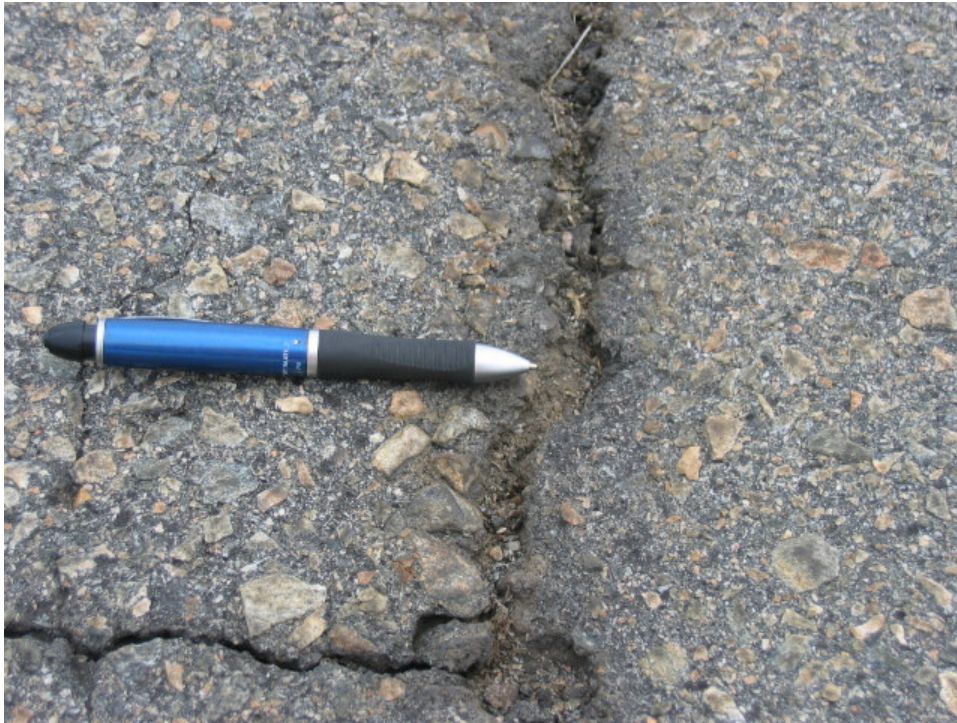
TCMGRA-20. L&T cracking.

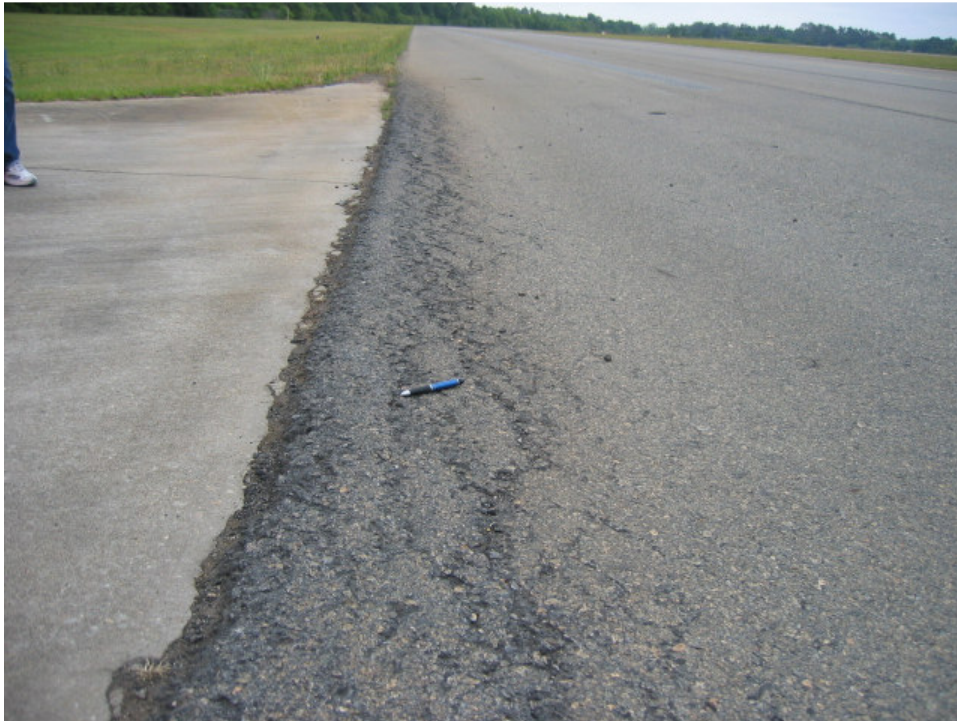
TCMGRA-20. Shoving.

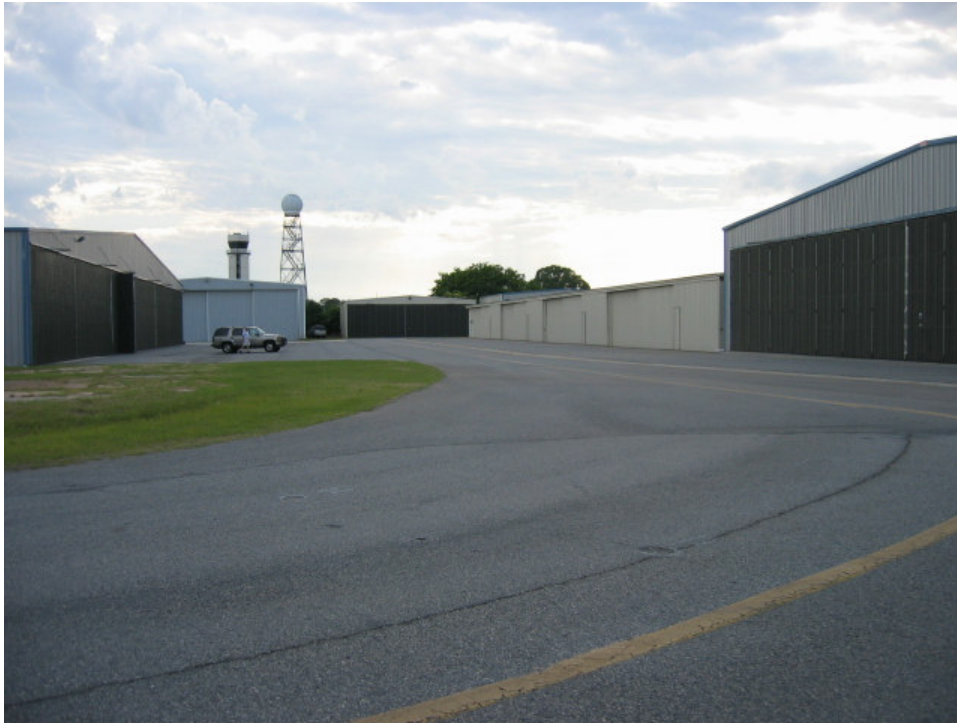
The T-Hangar area at Middle Georgia Regional Airport consists of a single pavement section. Section TGAMGRA-10 is in fair condition with a PCI value of 67. A considerable amount of low-severity raveling and weathering was observed. Additionally, significant amounts of both low and medium-severity L&T cracking were identified. Smaller amounts of low and medium-severity alligator cracking, bleeding, low-severity depression, medium-severity patching, low-severity rutting, and swelling were also observed.

TGAMGRA-10. Overview.
