COBB COUNTY-MCCOLLUM FIELD
PAVEMENT MANAGEMENT REPORT

2007 GEORGIA AIRPORT PAVEMENT MANAGEMENT REPORT

COBB COUNTY-MCCOLLUM FIELD

PAVEMENT MANAGEMENT REPORT

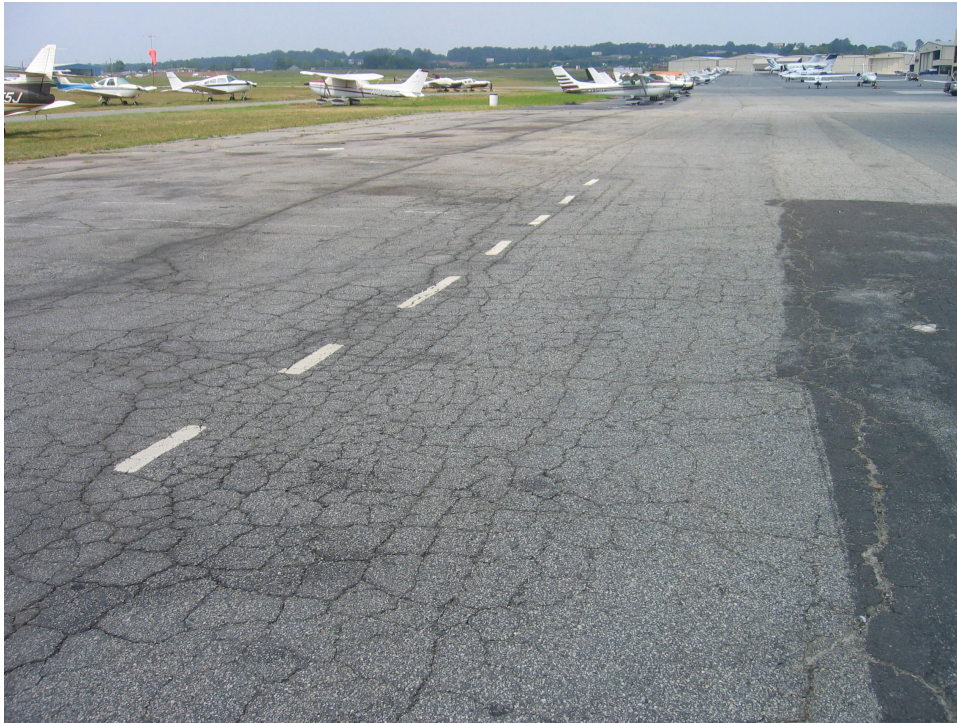
A01MR-10, located north of the runway at the southeast corner of the main apron, is in serious condition with a PCI value of 28. Significant amounts of medium-severity alligator cracking, unsealed block cracking, and oil spillage were observed throughout. Moderate quantities of low-severity L&T cracking and patching were also found.

A01MR-10. Overview.

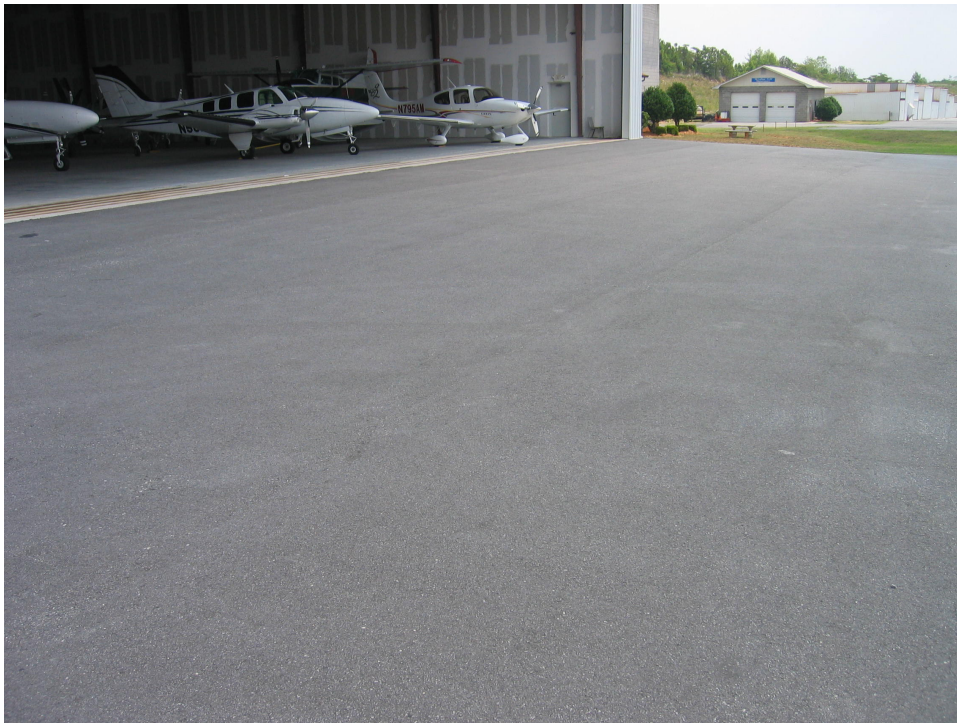
A01MR-20 is located next to A01MR-10 and is in excellent condition with a PCI value of 100. No distress was observed in this section as it had just been rehabilitated.

A01MR-20. Overview.

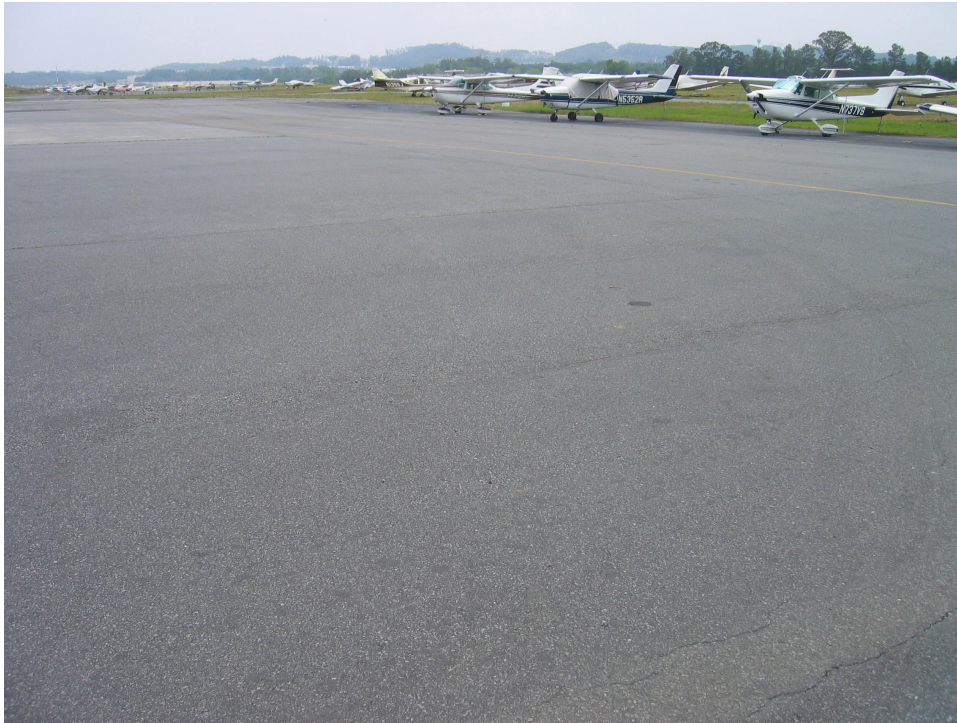
A01MR-30, located in the center of the main apron north of the runway is in good condition with a PCI value of 83. Moderate amounts of low and medium-severity, unsealed, L&T cracking were observed in this section, along with an isolated area of alligator cracking.

A01MR-30. Overview.

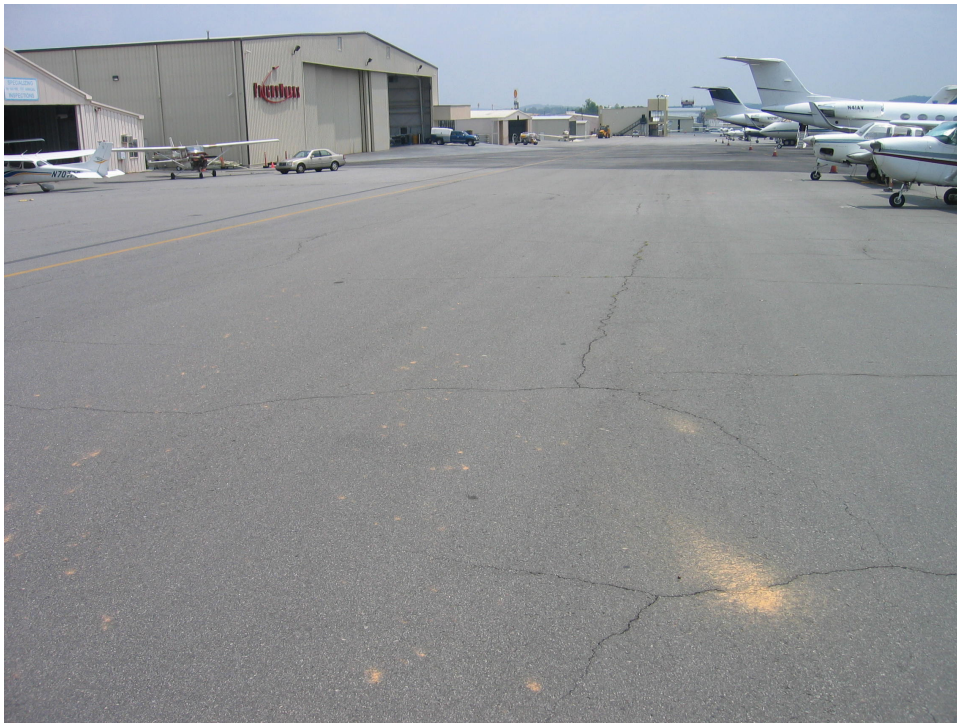
A01MR-40 covers the west side of the north apron. This section is in good condition with a PCI value of 85. Low-severity, unsealed, L&T cracking, located mainly along paving lane joints,

was observed throughout the section, along with small amounts of raveling and weathering and alligator cracking.

A01MR-40. Overview.

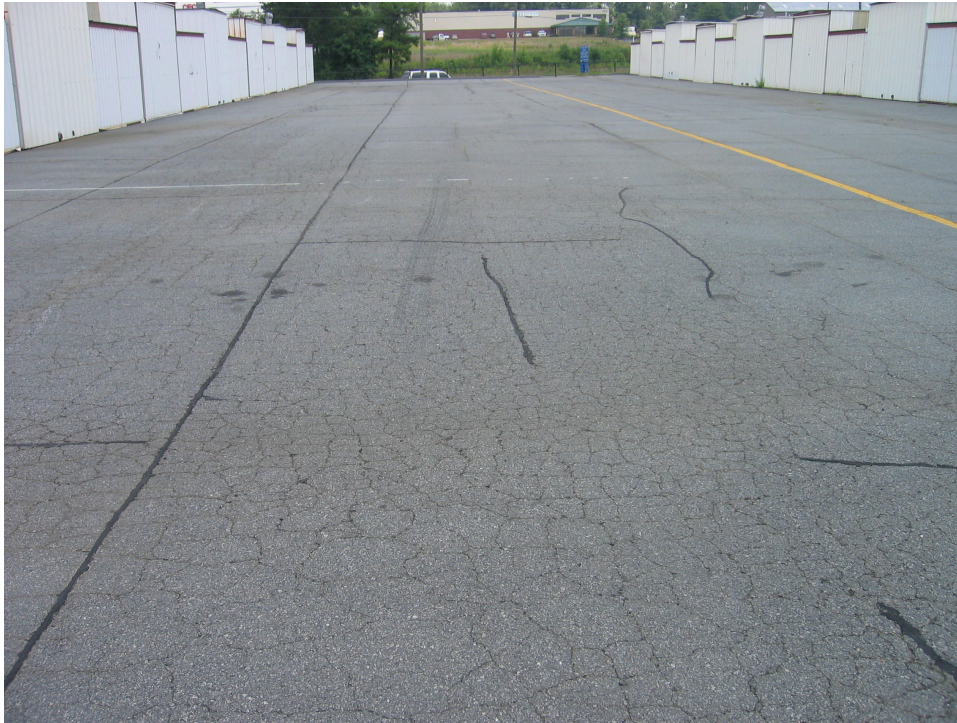
A01MR-50 is located in the northern part of the main apron and is in serious condition with a PCI value of 29. Significant amounts of medium-severity alligator and L&T cracking were identified in this section. Moderate quantities of medium-severity block cracking, raveling and weathering, and patching were also observed. Most of the low-severity cracking was unsealed while medium-severity cracking was recorded due to failed sealant.

A01MR-50. Overview.

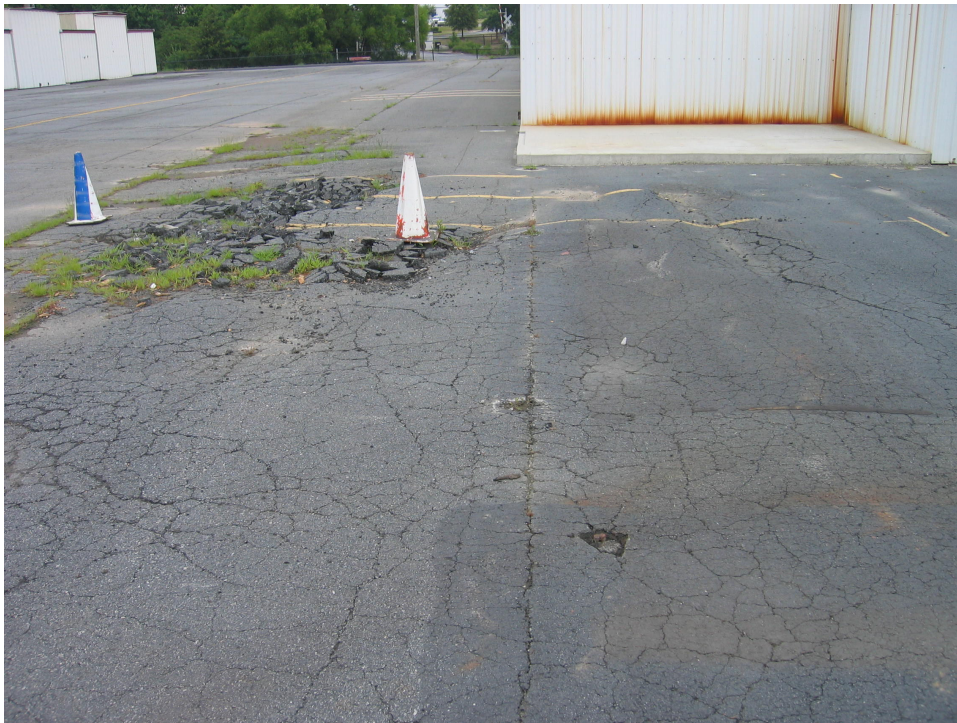
A01MR-50. Rutting.

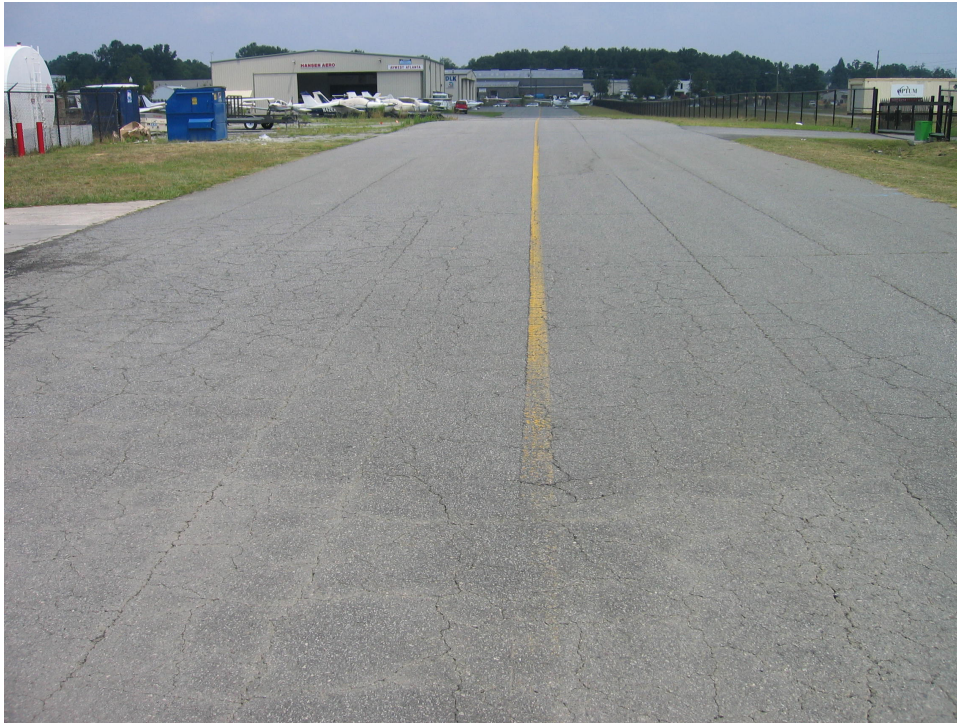
A01MR-60 is located on the east edge of the north apron running parallel to the main road. This section is in poor condition with a PCI value of 56. Moderate amounts of low and medium-severity L&T cracking and raveling and weathering were recorded. In addition, isolated areas of patching, alligator cracking, and depression were observed. The majority of the cracking was unsealed.

A01MR-60. Overview.

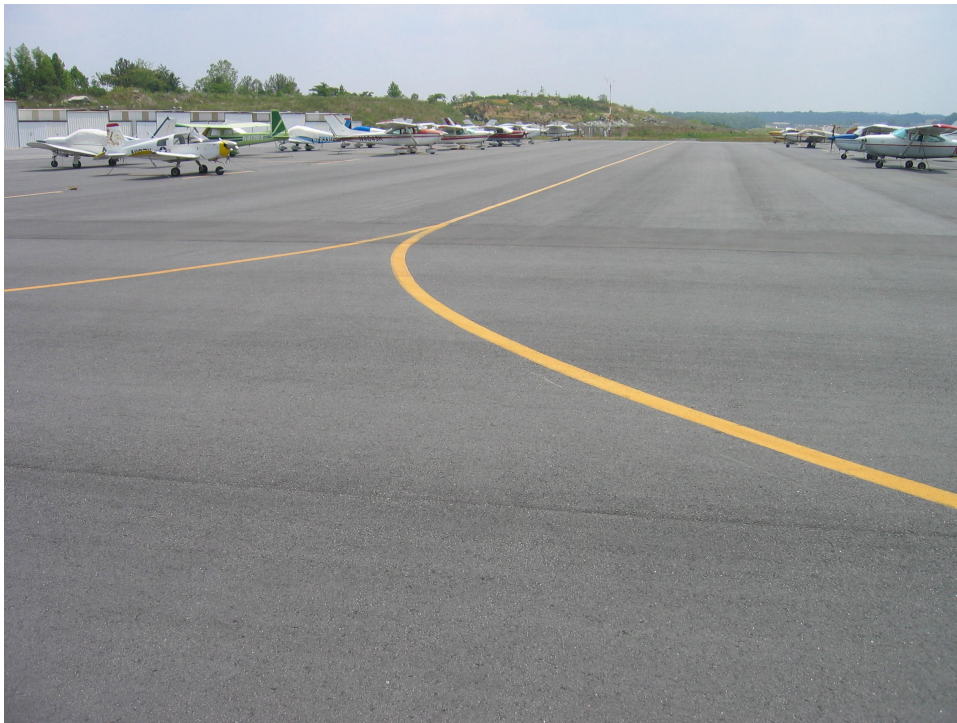
A01MR-70 is a newly constructed section located to the east of section A01MR-10 by the Air Traffic Control tower. It is in excellent condition with a PCI value of 100 and no observed distresses during the inspection.

A01MR-70. Overview.

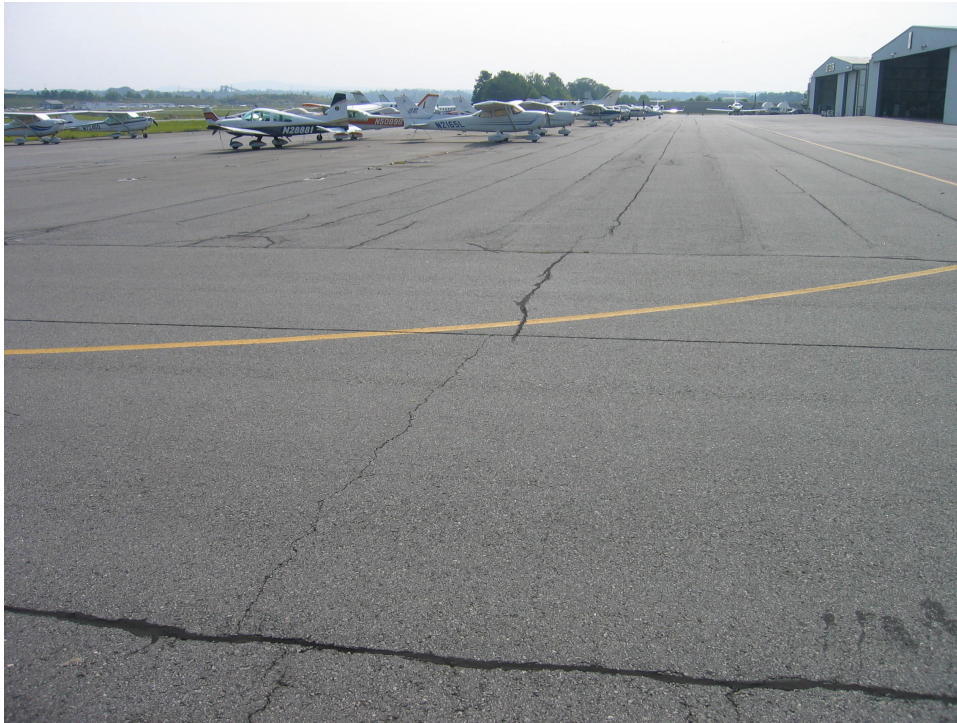
A02MR-10, located in the center of the south apron, is in fair condition with a PCI value of 67. Moderate amounts of low-severity block and L&T cracking were identified throughout the section. Moderate amounts of medium-severity L&T, alligator cracking, and raveling and weathering were also observed. The majority of the cracking was sealed, most of which was failed.

A02MR-10. Overview.

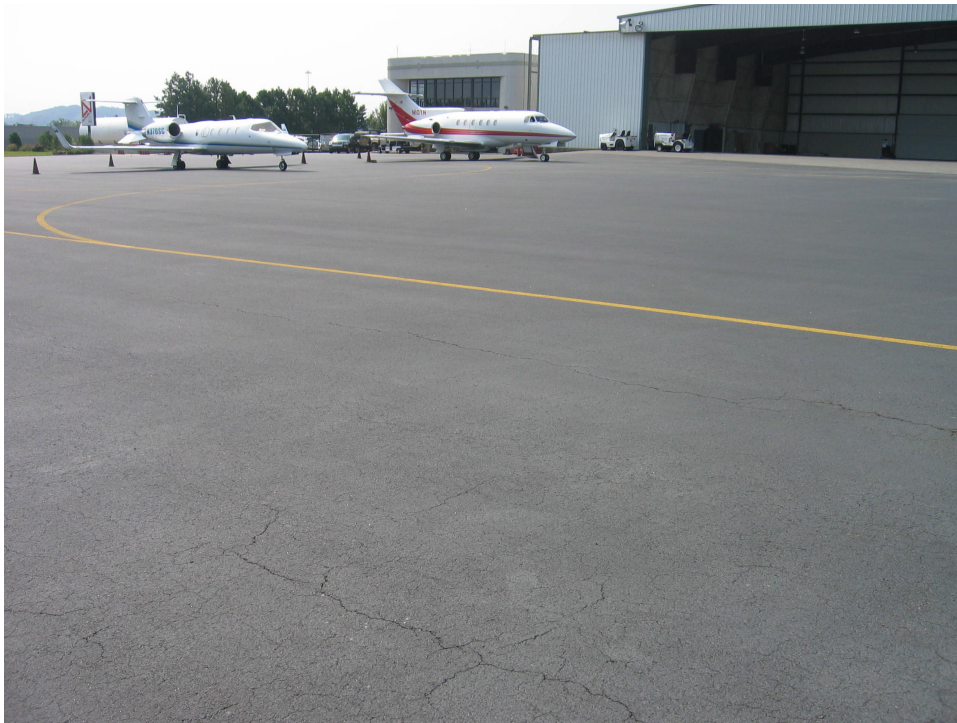
A02MR-20 covers the eastern part of the south apron and is in good condition with a PCI value of 85. Small amounts of low and medium-severity L&T cracking were recorded along with isolated areas of patching and bleeding.

A02MR-20. Overview.

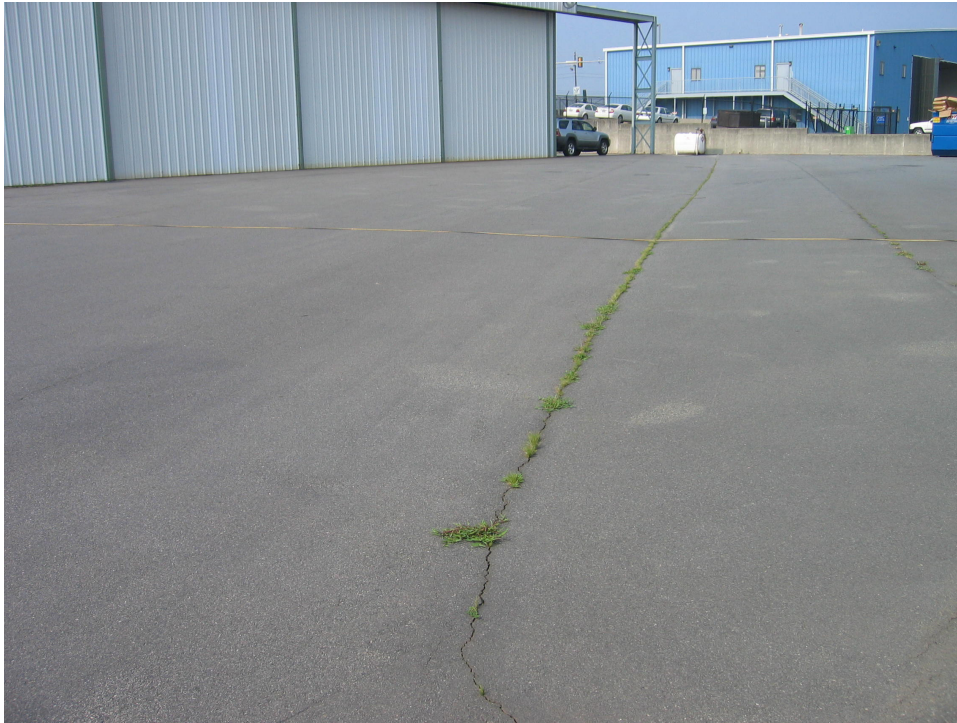
A02MR-30 is located to the west of A02MR-10. This section is also in good condition with a PCI value of 88. Small amounts of low and medium-severity L&T cracking were observed along with an area of low-severity rutting.

A02MR-30. Overview.

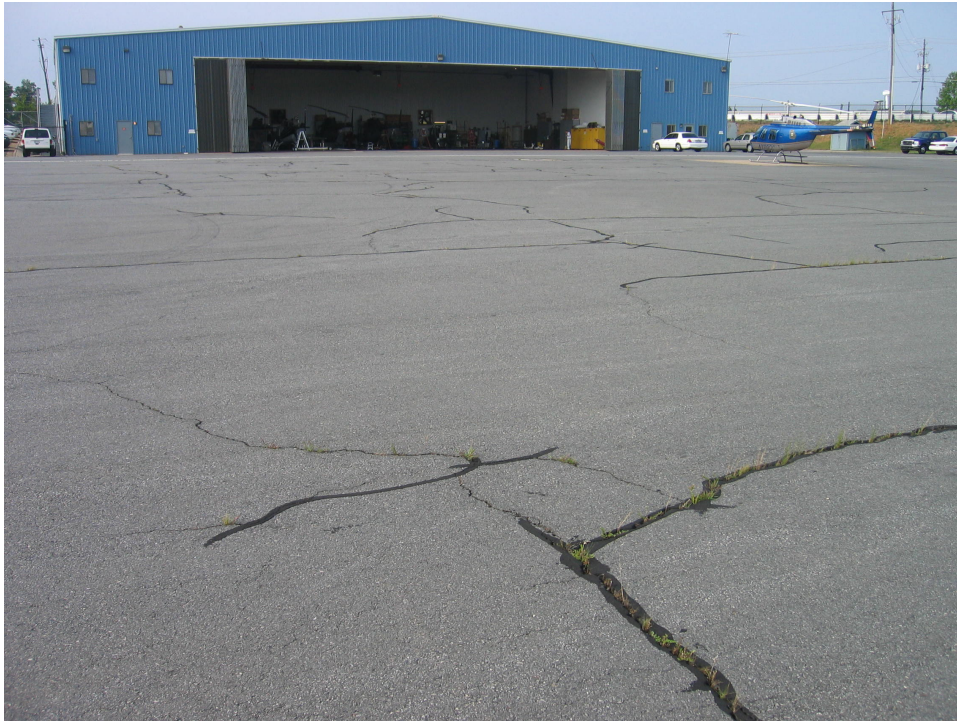
A03MR-10 consists of one section, and is located on the west end of the south apron. This section is in poor condition with a PCI value of 49. Moderate amounts of low and medium-severity L&T cracking, patching, raveling and weathering, and alligator cracking were identified throughout the section. Most of the cracking was sealed, however most of the crack sealant was failed and the cracks had vegetation growing in them.

A03MR-10. Overview.

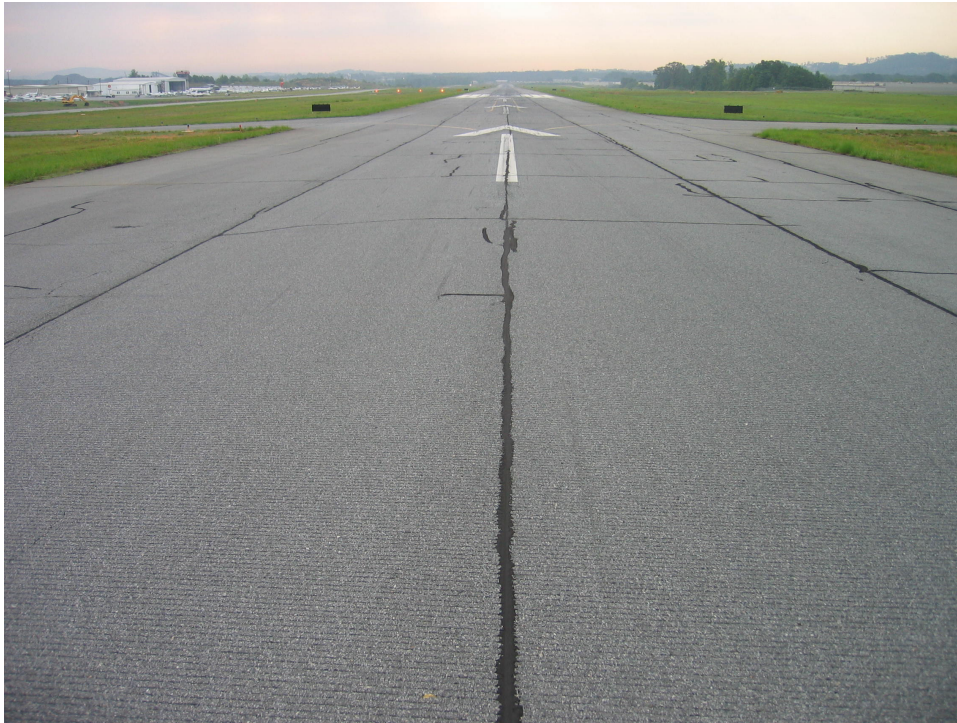
Runway 9-27 is defined by two sections. R927MR-10 is in fair condition with a PCI value of 69. Low and medium-severity longitudinal and transverse (L&T) cracking were identified throughout the section. The majority of cracking was sealed, however most of the sealant was failed. In addition, isolated areas of bleeding and patching were recorded. Section R927MR-20 is the new 950 foot extension to the east end of the runway that is in excellent condition with a PCI of 100. No distress was observed in this section at the time of inspection.

R927MR-10. Overview.

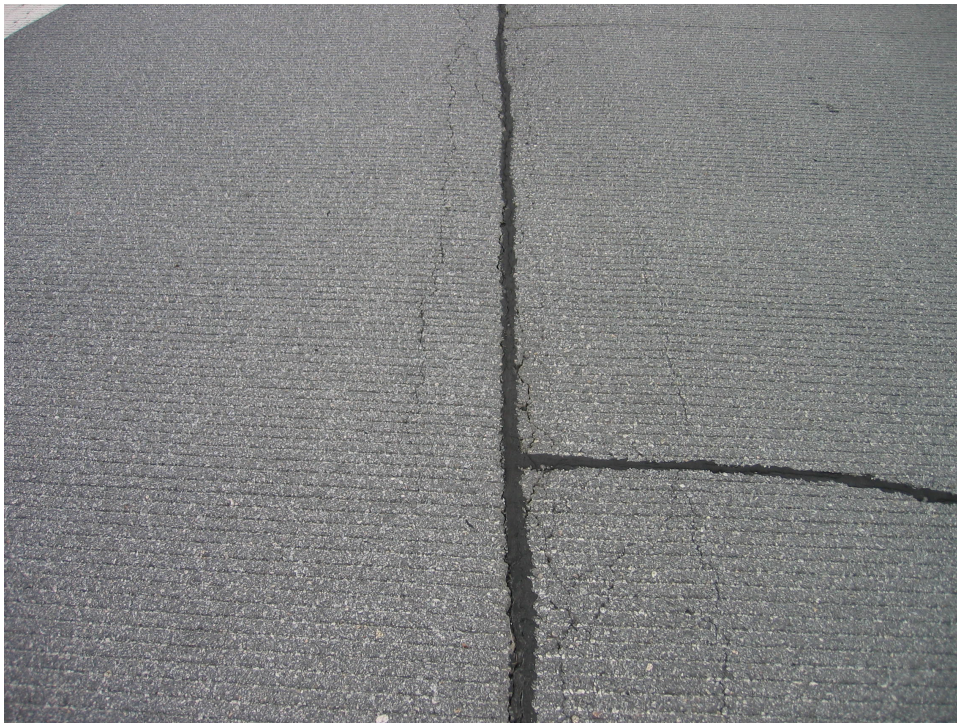
R927MR-10. L&T cracking.

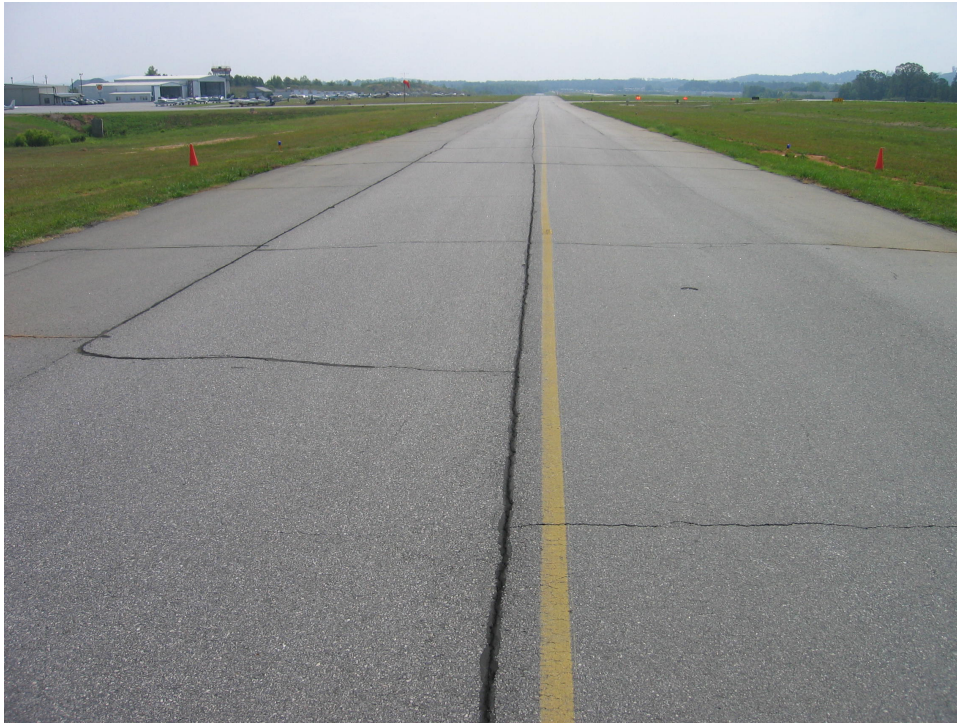
Taxiway A runs parallel to the Runway on the north side. This taxiway is defined by three sections. Section TAMR-10 is in poor condition with a PCI value of 40. Significant amounts of low and medium-severity L&T cracking were identified. The majority of the cracking was sealed, however most of sealant was failed. In addition, moderate amounts of medium-severity alligator cracking and low-severity rutting, patching, and raveling and weathering were recorded throughout the section. Section TAMR-20 was split out separately from TAMR-10 due to the high quantities of medium-severity alligator cracking and rutting causing it to be in serious condition with a PCI value of 14. TAMR-30 was recently constructed along with the runway extension and is in excellent condition with a PCI value of 100 and no distress observed.

TAMR-10. Overview.

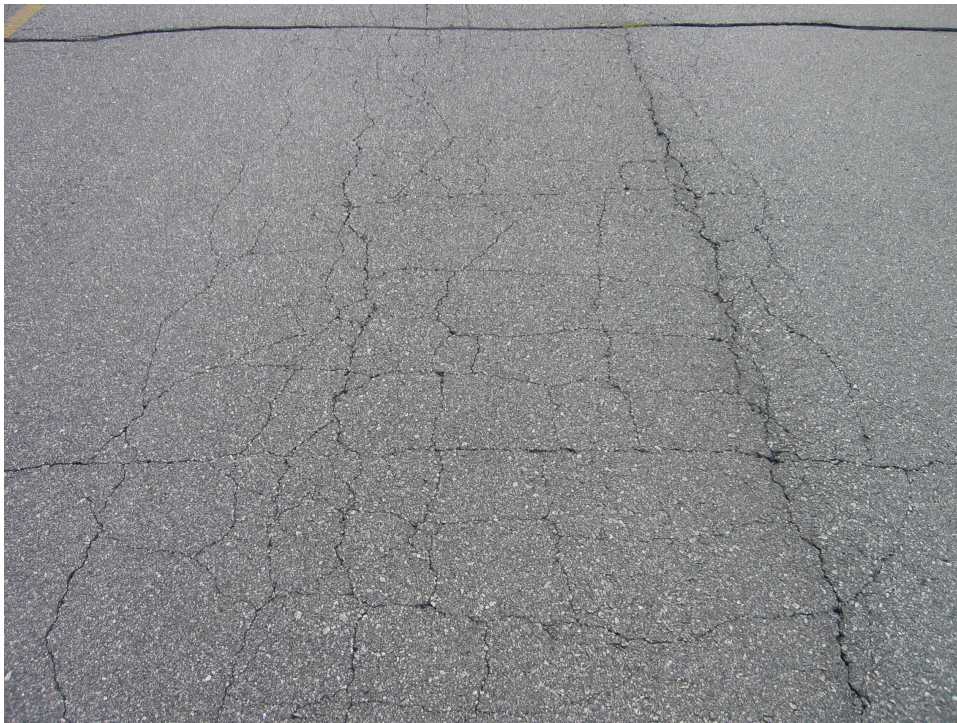
TAMR-10. Alligator cracking.

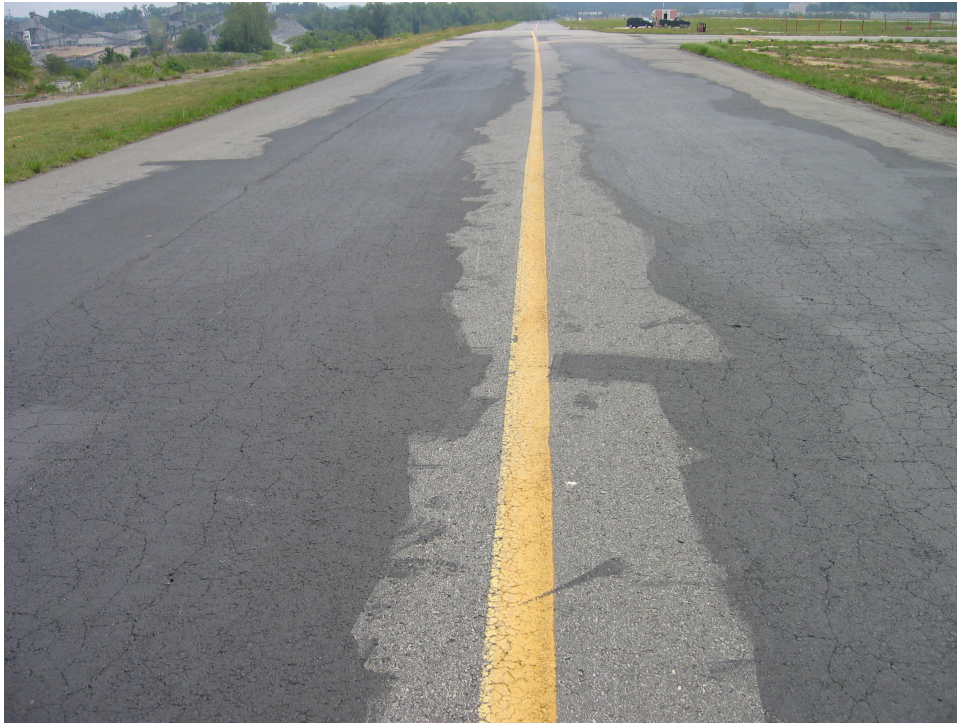
TAMR-20. Overview.

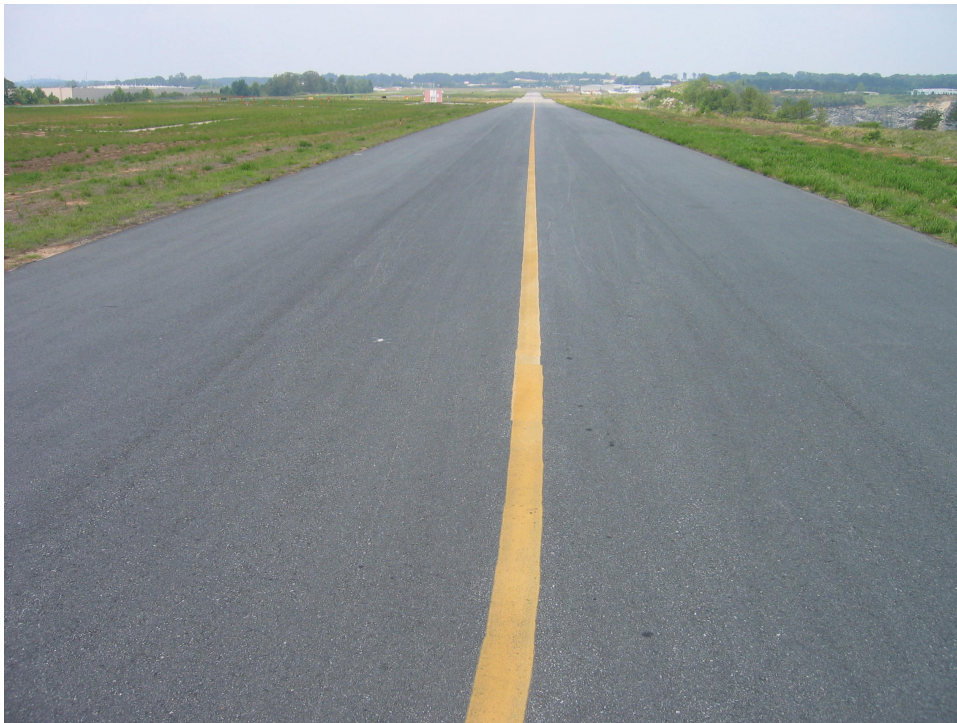
TAMR-30. Overview.

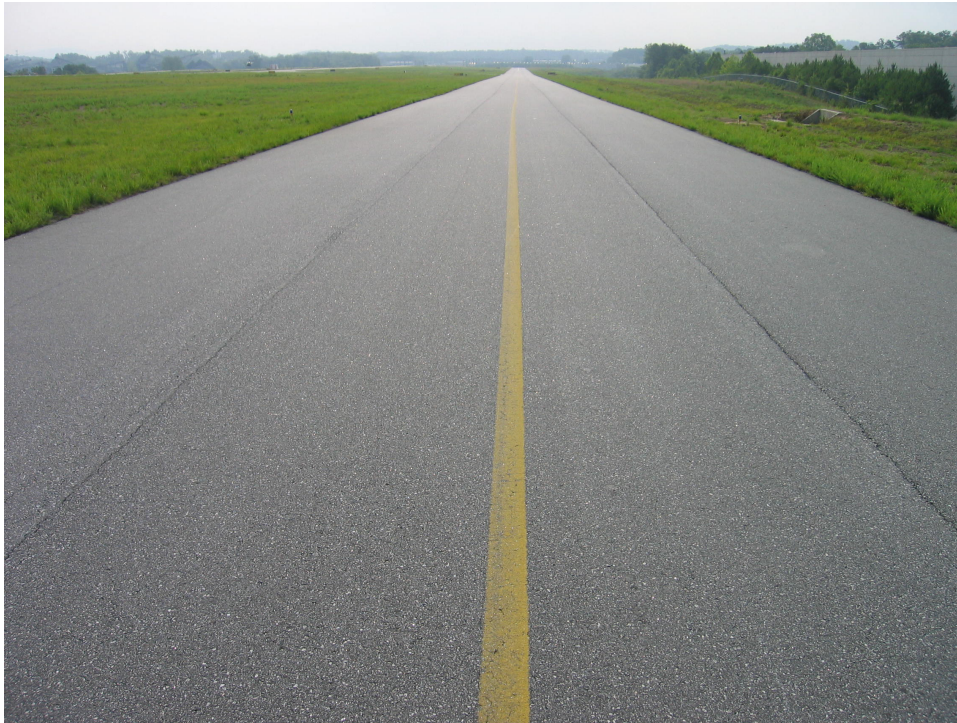
Taxiway B is defined by one section, TBMR-10, that runs parallel to the runway on the south side. TBMR-10 was recently rehabilitated and is in excellent condition with a PCI value of 96. Only small amounts of low-severity L&T cracking and patching were observed, mostly along the paving lane joints.

TBMR-10. Overview.
