**VALDOSTA REGIONAL AIRPORT  
PAVEMENT MANAGEMENT REPORT**

**2007 GEORGIA AIRPORT  
PAVEMENT MANAGEMENT REPORT**

# VALDOSTA REGIONAL AIRPORT

## PAVEMENT MANAGEMENT REPORT

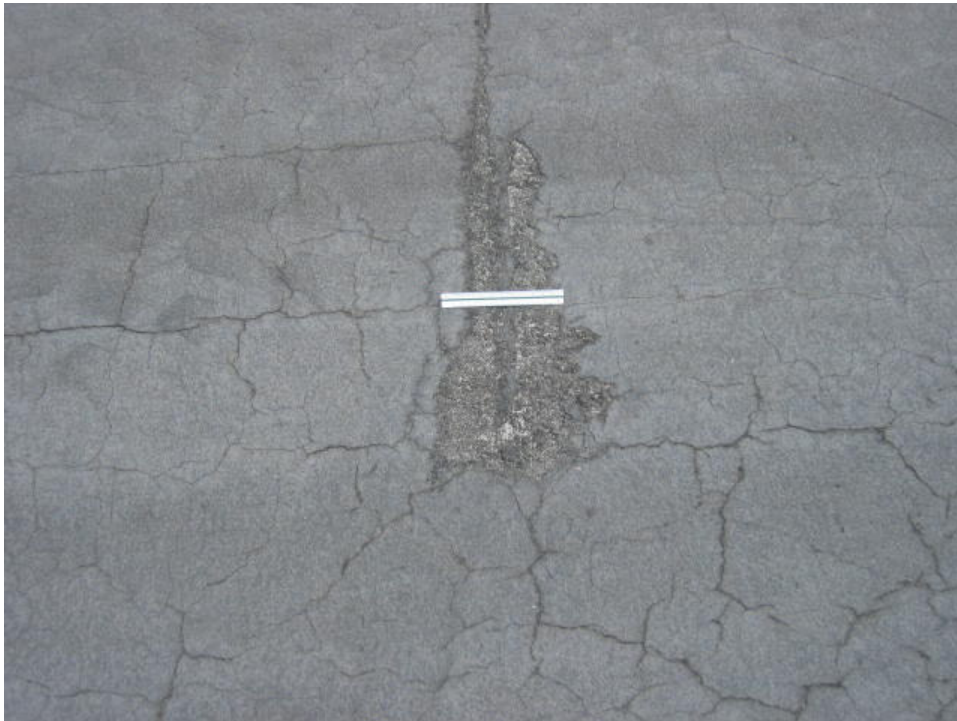
Sections A01VL-20 and A01VL-40 are in excellent condition with PCI values of 97 and 95, respectively. Small amounts of oil spillage and low-severity rutting and L&T cracking were observed in both of these sections.

A01VL-40. Rutting.

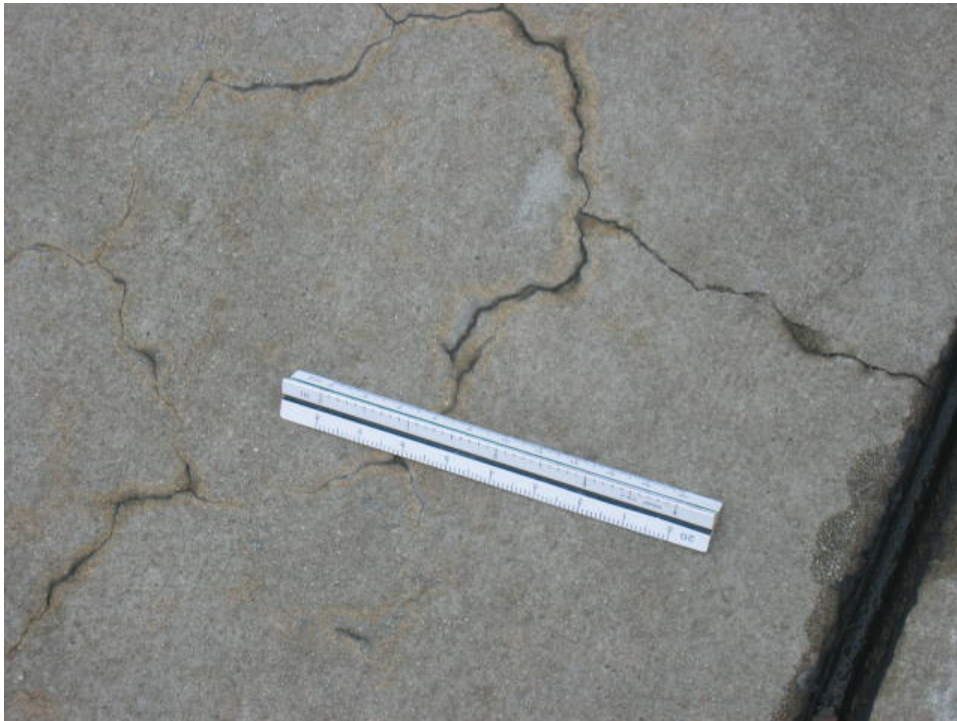
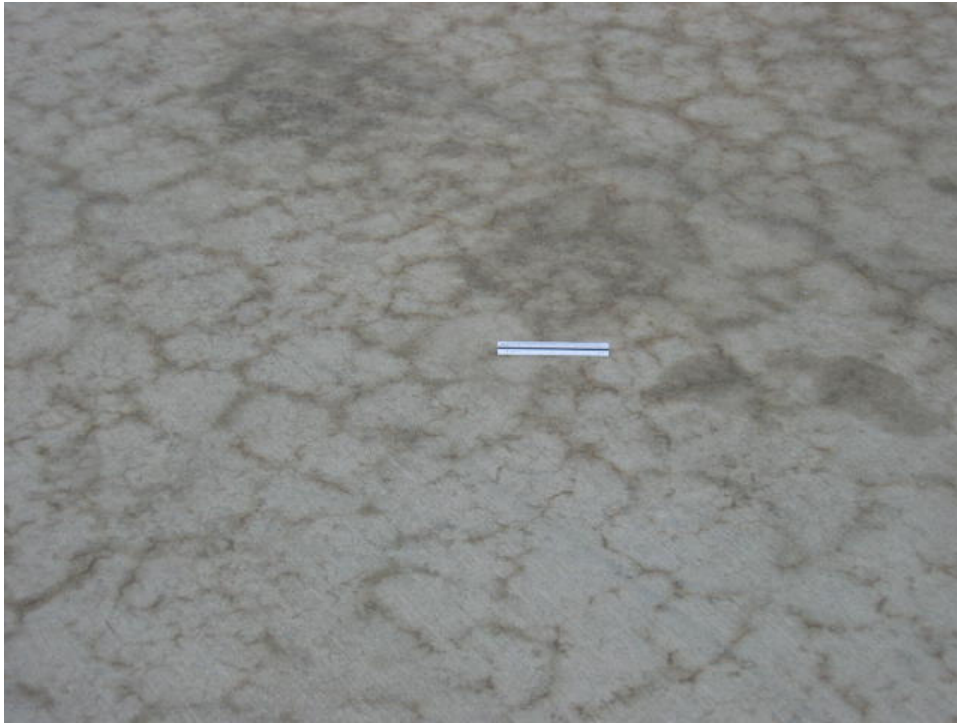
The terminal apron area is defined by one section (ATERMVL-10) and is in good condition with a PCI value of 81. Extensive amounts of low-severity scaling and joint seal damage were observed in this section along with small quantities of shrinkage cracking and low-severity faulting.

ATERMVL-10. Scaling (1).

ATERMVL-10. Scaling (2).

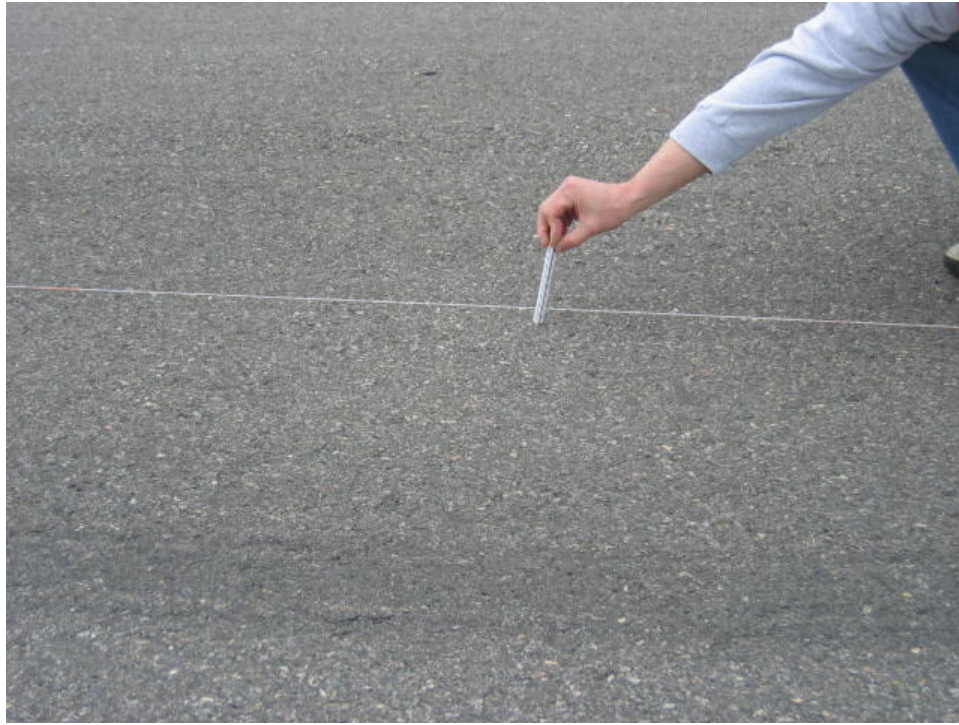
Section R1331VL-20 is in good condition with a PCI value of 86. Moderate amounts of low-severity L&T cracking were recorded along with smaller quantities of medium-severity L&T cracking and low-severity rutting. An additional sample unit was identified where an area of bleeding and medium-severity depression was observed.

R1331VL-20. Depression (additional sample).

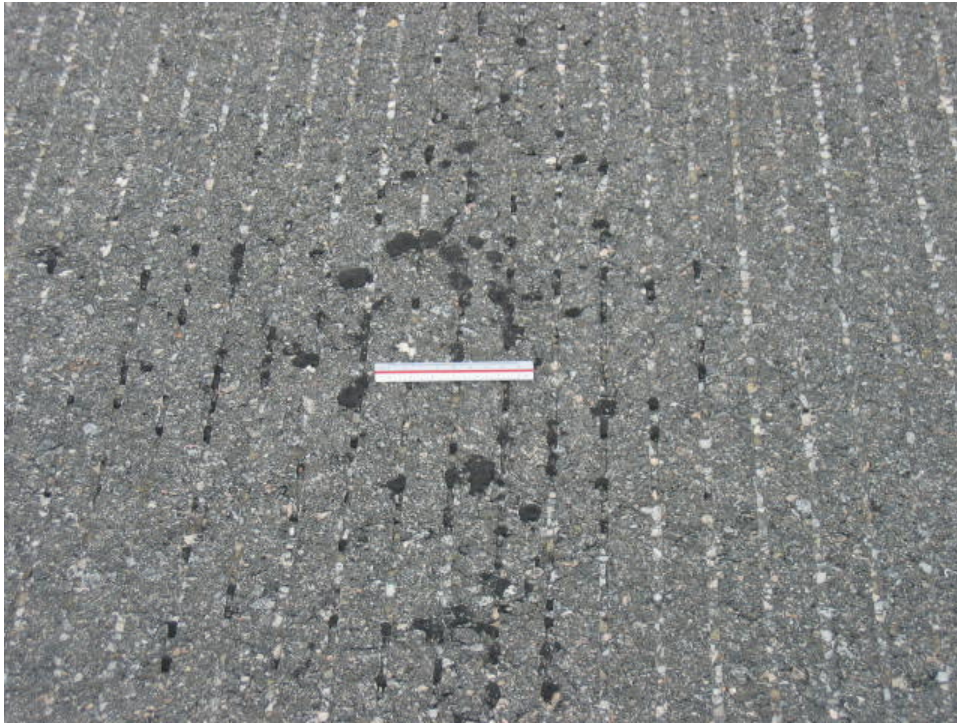
Runway 4-22 is defined by one section. Section R422VL-10 is in good condition with a PCI value of 87. Moderate amounts of bleeding and small amounts of low-severity L&T cracking were observed in this section.

R422VL-10. Bleeding.

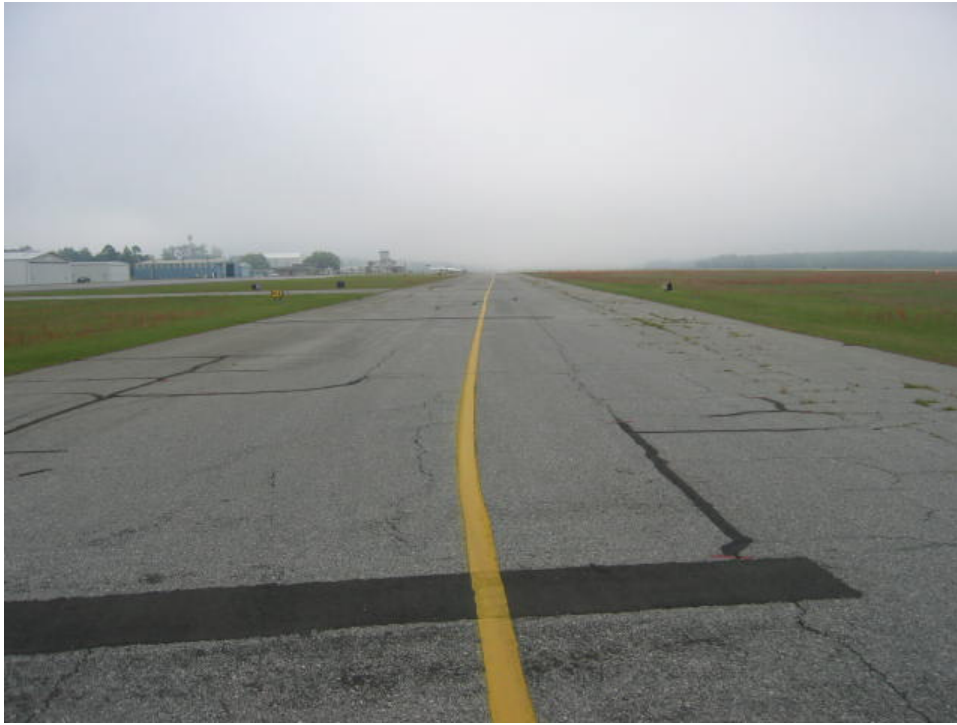
TAVL-10. Overview.

Taxiway A is comprised of two sections. Section TAVL-10 is in poor condition with a PCI value of 58. Moderate to extensive quantities of low and medium-severity L&T and block cracking were observed. A small portion of this cracking was sealed. In addition, smaller quantities of low-severity patching and swelling were identified in the section.

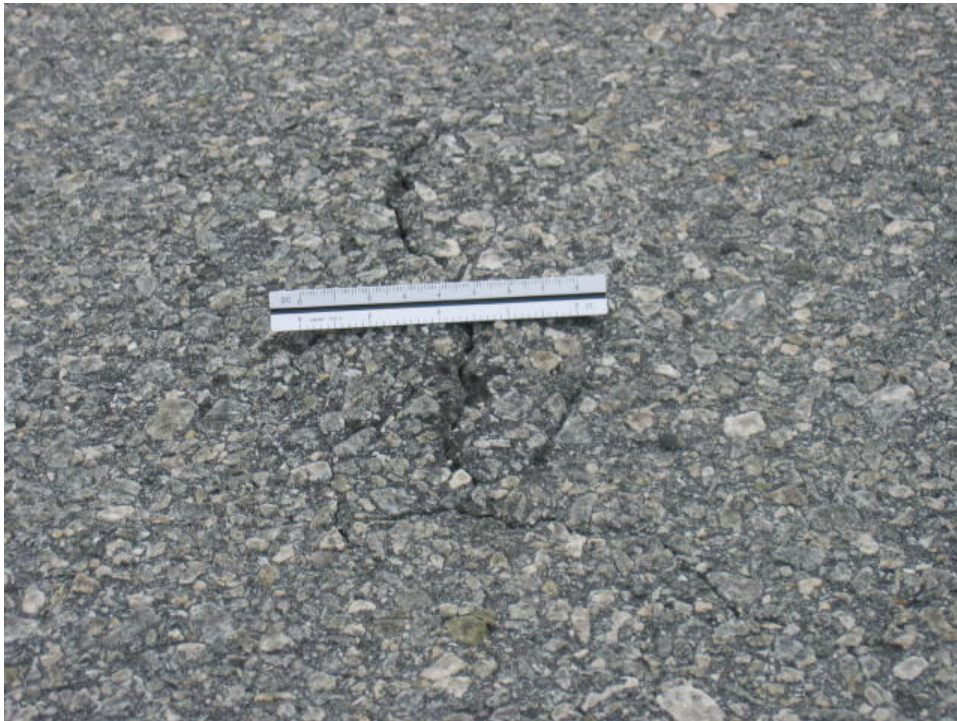
TAVL-10. Swelling.

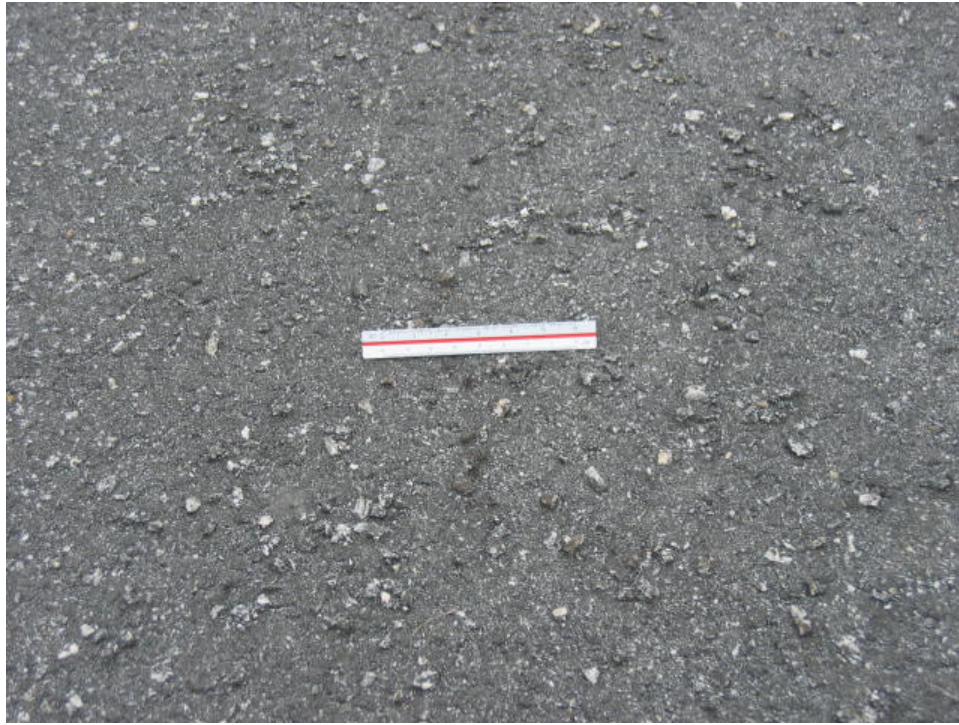
Taxiway C is defined by one section. Section TCVL-10 was recently rehabilitated and is in excellent condition with a PCI value of 99. Isolated quantities of low-severity patching and raveling and weathering were observed in this section.

TCVL-10. Raveling and weathering.

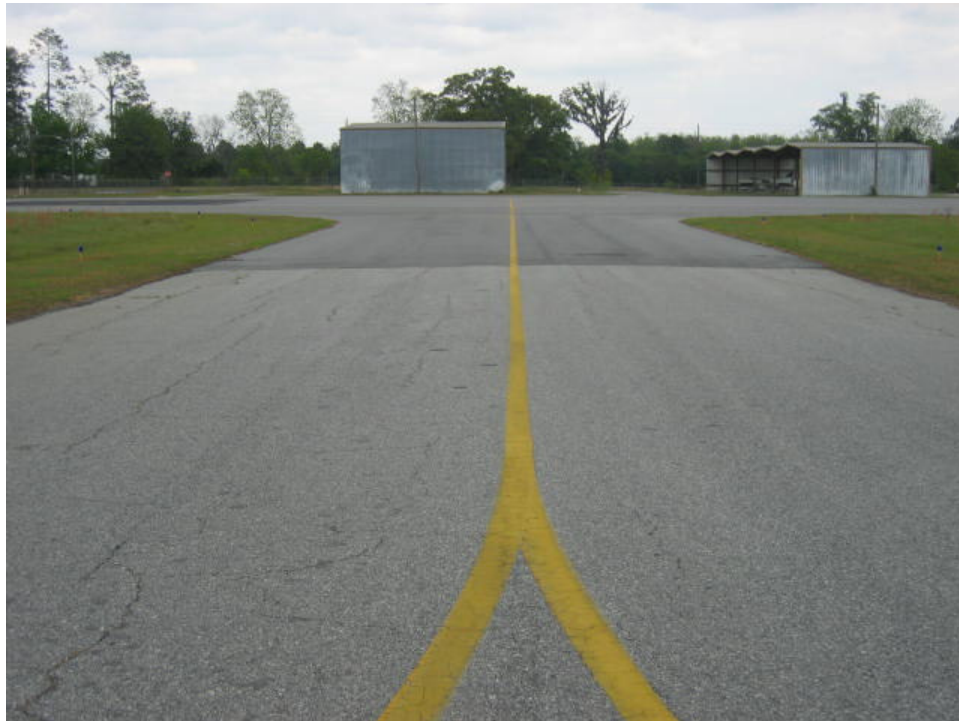
TDVL-10. Overview.

Taxiway D is comprised of one section. Section TDVL-10 is in fair condition with a PCI value of 64. Low-severity block cracking was the only distress identified in this section.

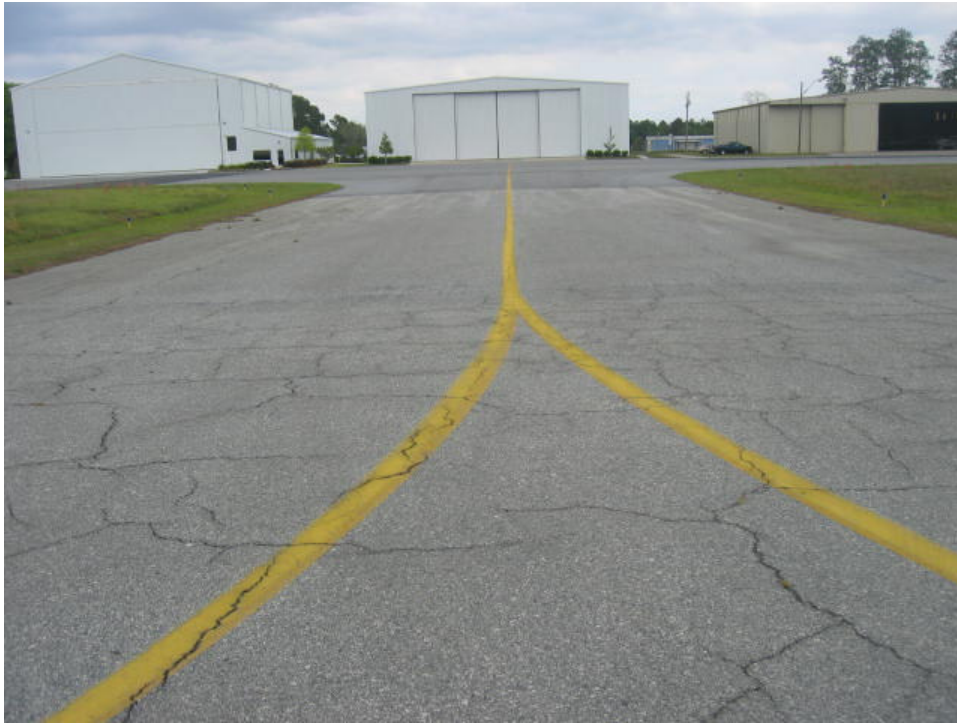
TEVL-10. Overview.

Taxiway E is defined by one section. Section TEVL-10 is in poor condition with a PCI value of 56. Low-severity block cracking and low and medium-severity L&T cracking were observed in this section.

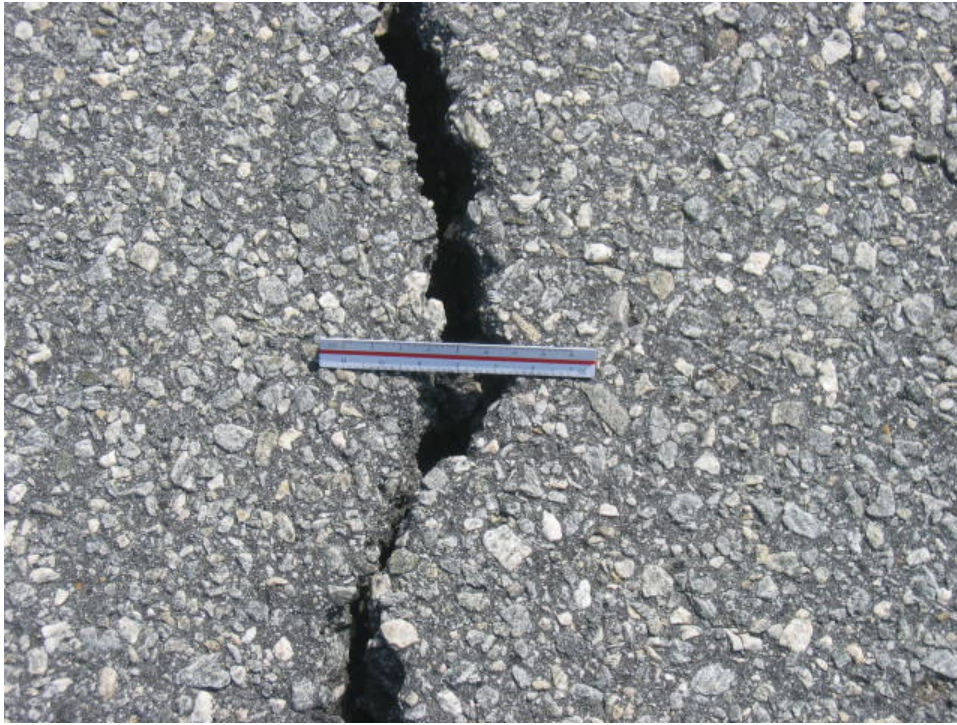
Section TFVL-20 is in fair condition with a PCI value of 63. Moderate amounts of medium-severity L&T cracking were recorded along with small quantities of low-severity L&T cracking and medium-severity depression.

TFVL-20. L&T cracking.

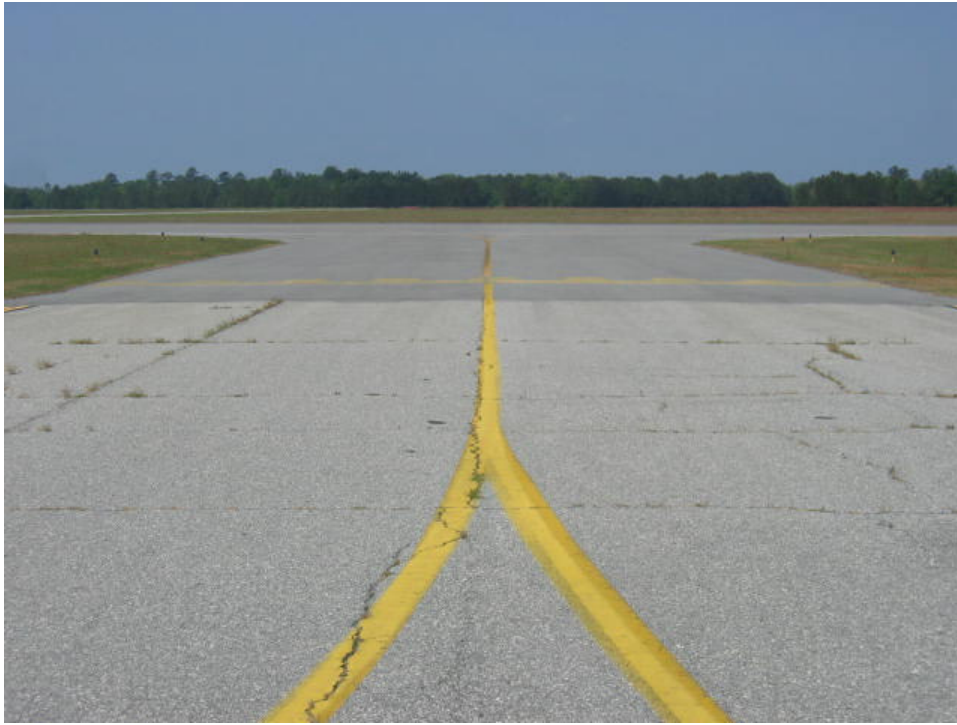
TGVL-10. Overview.

Taxiway G contains one section. Section TGVL-10 is in poor condition with a PCI value of 56. Moderate amounts of low and medium-severity L&T cracking and low-severity raveling and weathering were observed. A small quantity of low-severity swelling was also identified.

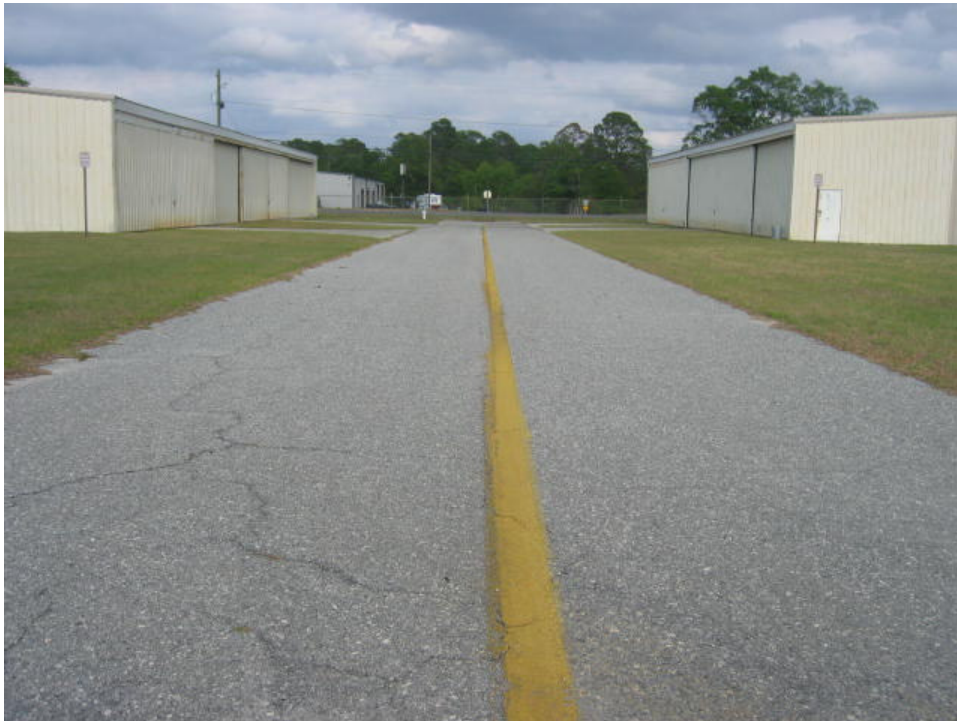
THANG01VL-10. Overview.

The north T-Hangar area (THANG01VL) is defined by three sections. Section THANG01VL-10 is in fair condition with a PCI value of 72. Moderate amounts of low and medium-severity L&T cracking were observed in this section along with small amounts of bleeding and medium-severity patching.

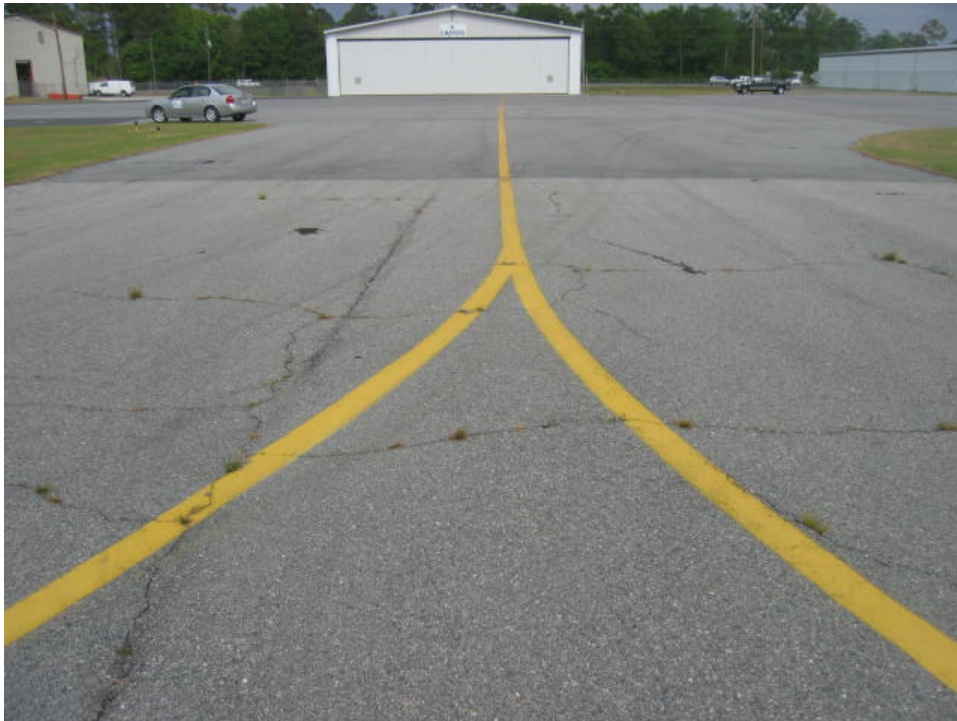
TKVL-10. Overview.

Taxiway K contains one section. Section TKVL-10 is in poor condition with a PCI value of 58. Moderate quantities of low and medium-severity L&T cracking were identified in this section along with smaller quantities of bleeding and low-severity depression and swelling.

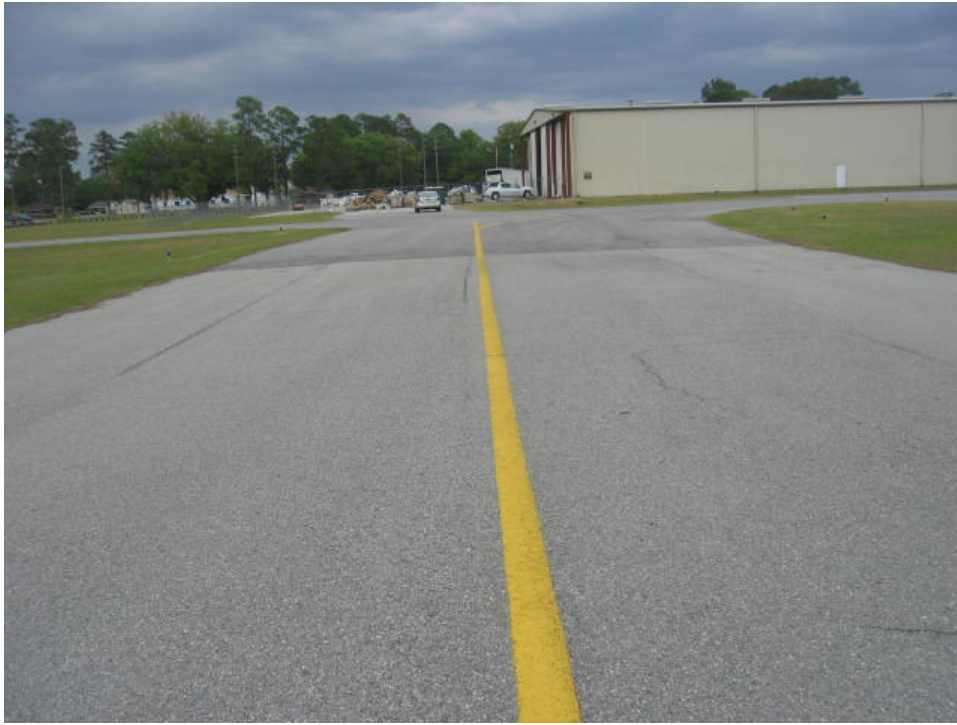
TLVL-10. Overview.

Taxiway L is comprised of three sections. Section TLVL-10 is in fair condition with a PCI value of 68. Moderate amounts of low-severity L&T cracking were identified in this section along with small quantities of bleeding, medium-severity L&T cracking, and low-severity rutting.
