**JEKYLL ISLAND AIRPORT
PAVEMENT MANAGEMENT REPORT**

**2007 GEORGIA AIRPORT
PAVEMENT MANAGEMENT REPORT**

JEKYLL ISLAND AIRPORT

PAVEMENT MANAGEMENT REPORT

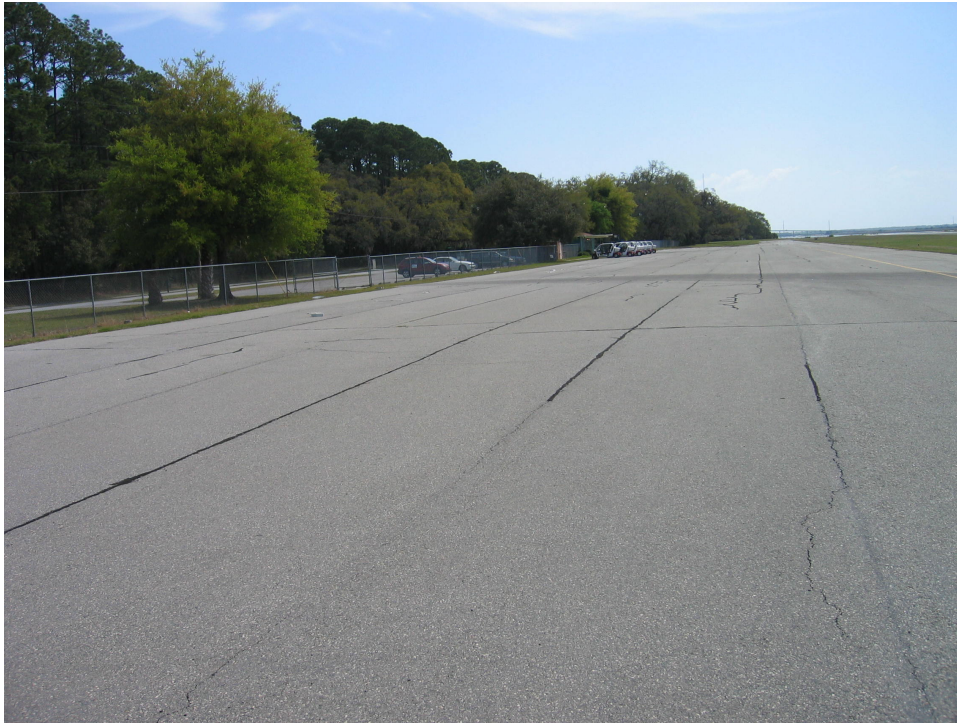
The taxiway (TAJK-10) and apron (A01JK-10) are each defined by one section. Both are in fair condition with PCI values of 69 and 65, respectively. Substantial amounts of low and medium-severity, both sealed and unsealed, L&T cracking were recorded in both sections. Significant amounts of block cracking, raveling and weathering, and swelling were observed in A01JK-10 only.

A01JK-10. Overview.

Branch¹	Section	Year	Type of Repair²	Estimated Cost³
A01JK	10	2008	Preventive Maintenance	\$1,001
TAJK	10	2008	Preventive Maintenance	\$5,561
A01JK	10	2011	Major M&R	\$86,218
R1836JK	10	2012	Preventive Maintenance	\$55
TAJK	10	2012	Preventive Maintenance	\$26,527

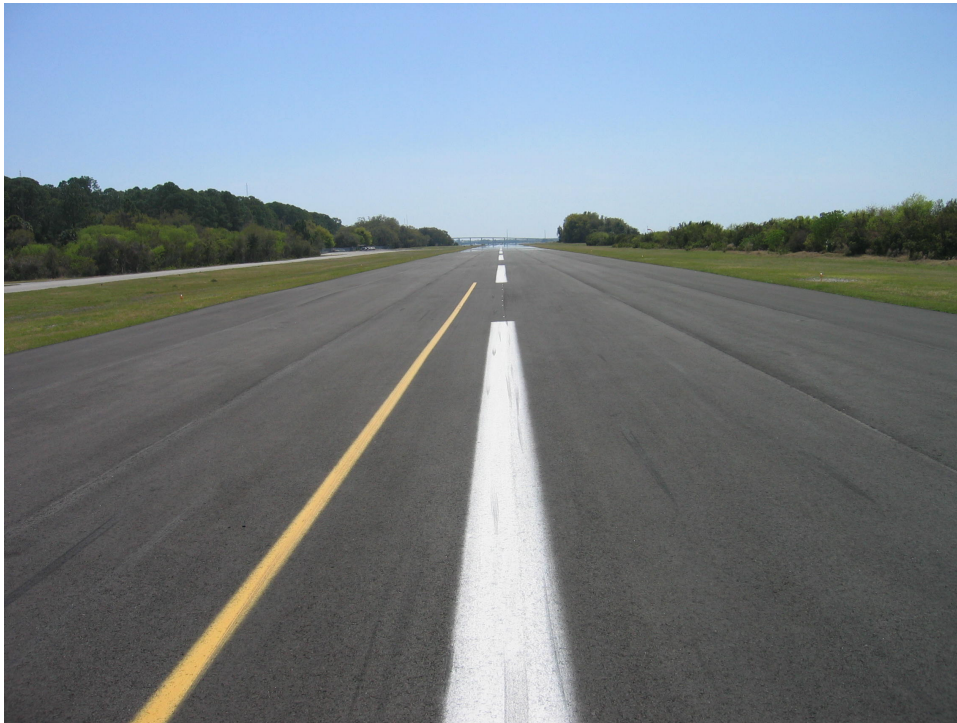
Runway 18-36 consists of one section, R1836JK-10, that is in excellent condition with a PCI value of 99. Only isolated amounts of low-severity longitudinal and transverse (L&T) cracking were observed, as the runway had recently been rehabilitated. An additional sample unit was identified where an area of low-severity depression was observed.

R1836JK-10. Overview.

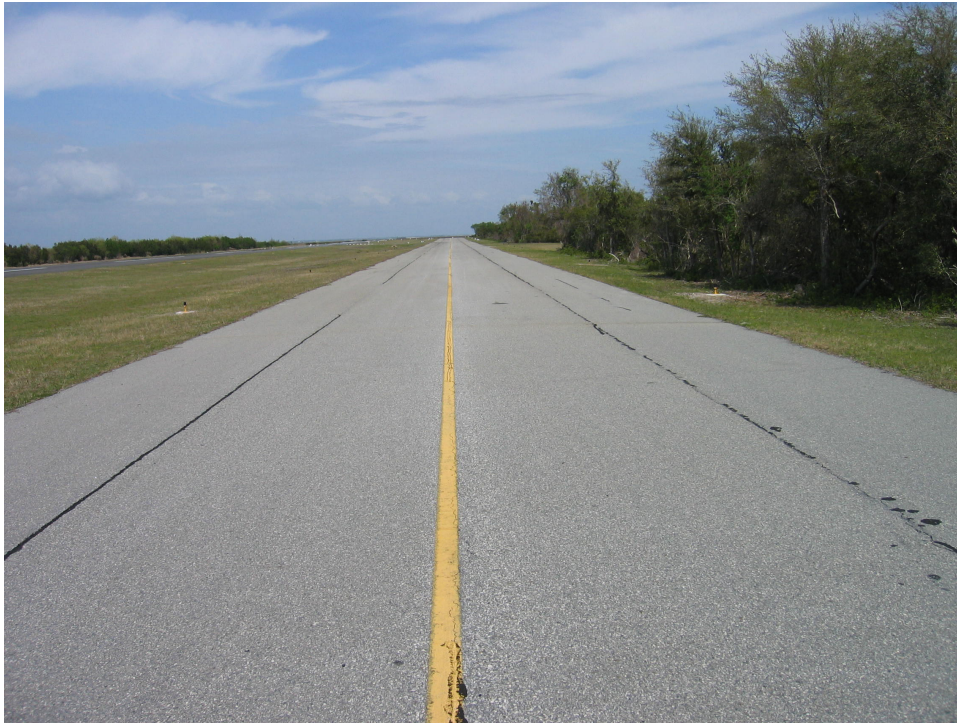
TAJK-10. Overview.
