MILLEN AIRPORT

PAVEMENT EVALUATION REPORT

JULY 2002

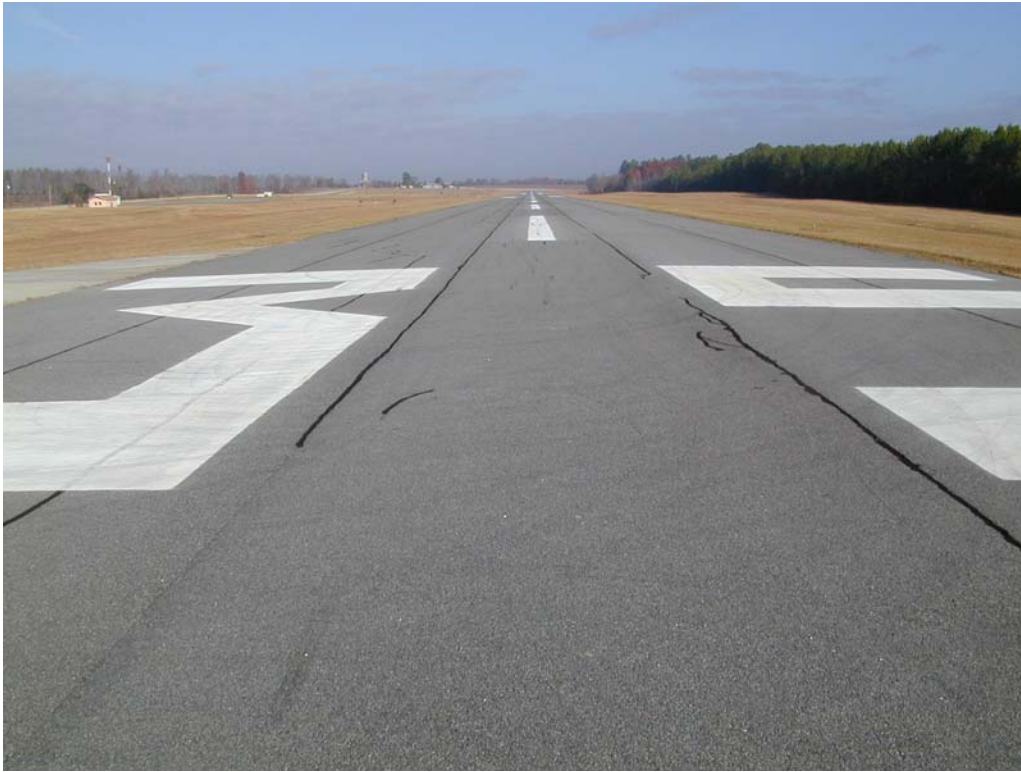
R1735ML-10 is in good condition. Extensive amounts of low-severity longitudinal & transverse (L&T) cracking were observed throughout. Moderate amounts of medium-severity L&T cracking and low-severity raveling and weathering were also found.

Overview of section R1735ML-10.

Plan Year	Network	Branch	Section	Distress Description	Severity	Work Description	Work Qty.	Work Unit	Unit Cost	Work Cost
2002	MILLEN	A01ML	10	L & T CR	M	Crack Sealing	1,335	LF	\$1.28	\$1,708
2002	MILLEN	R1735ML	10	L & T CR	M	Crack Sealing	819	LF	\$1.28	\$1,048

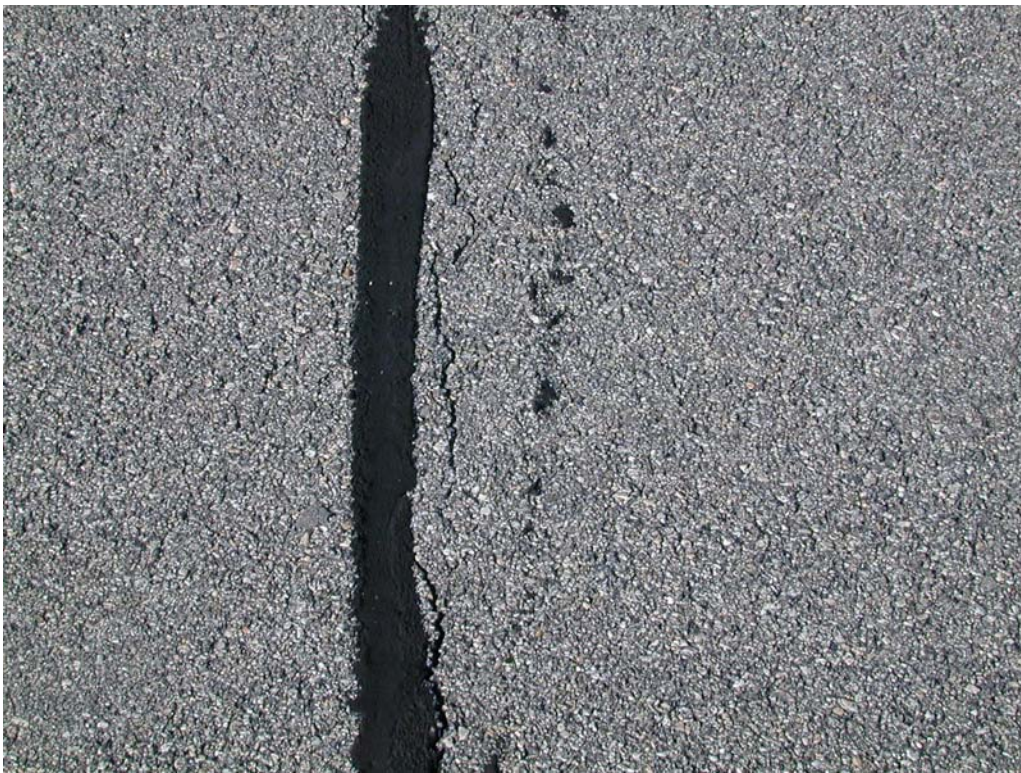
L&T cracking in section R1735ML-10.

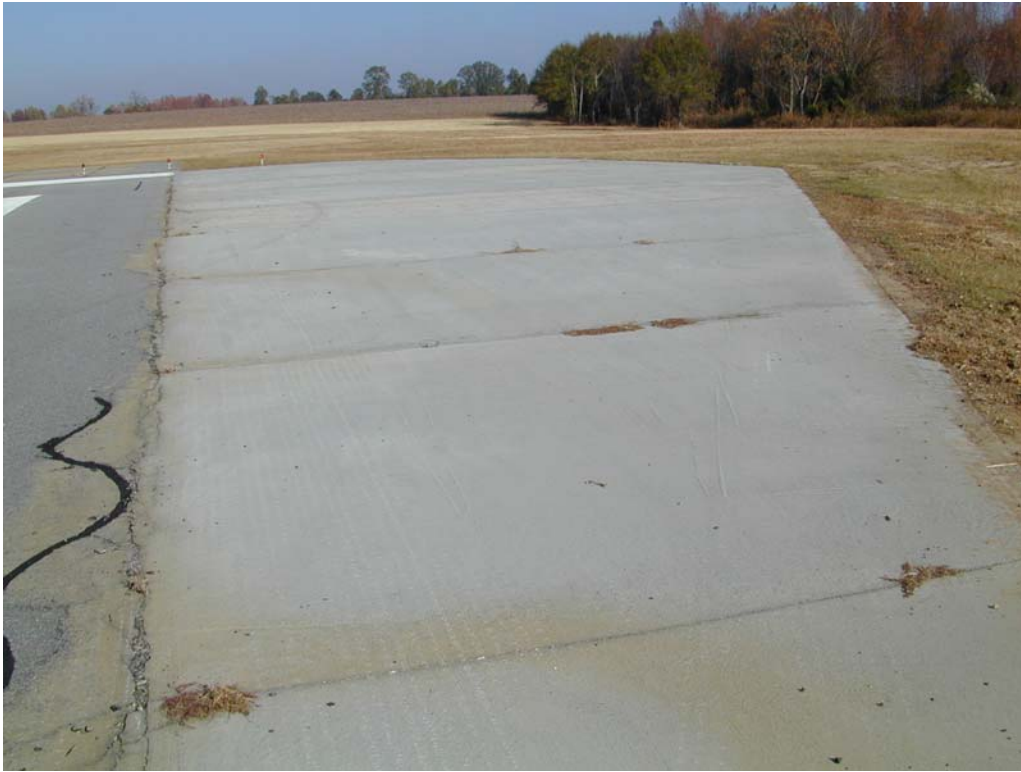
R1735ML-20 is the small concrete section at the approach end of Runway 17. This section is in fair condition. High-severity joint spalling and joint seal damage was found throughout the section.

Overview of section R1735ML-20.

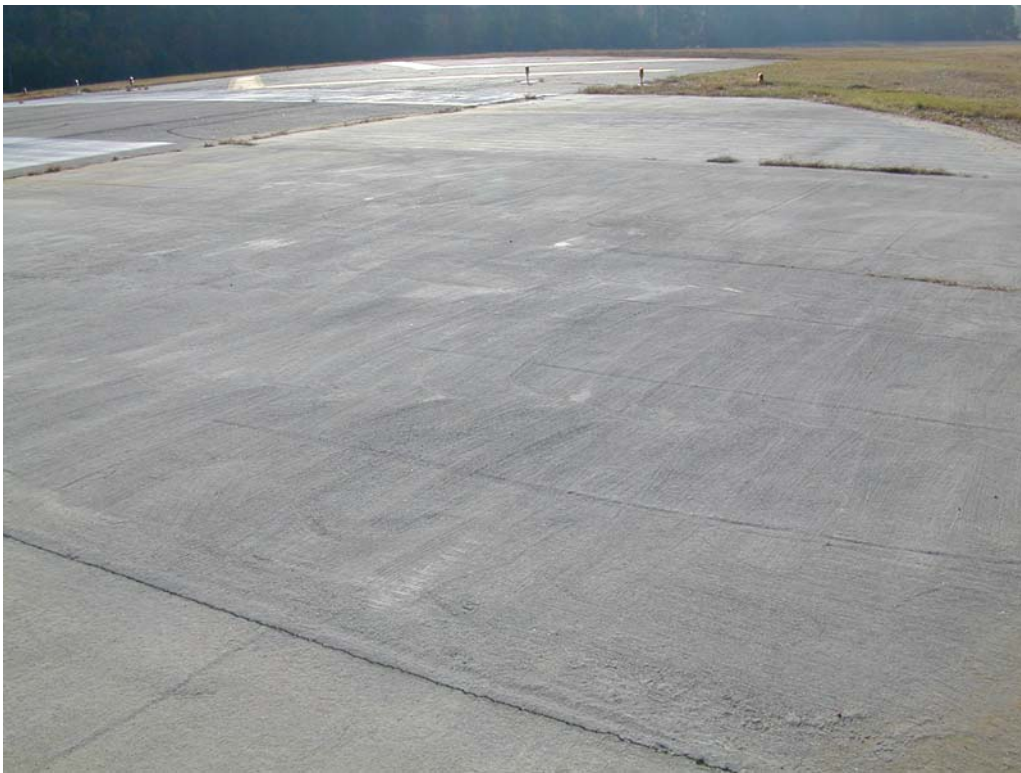
R1735ML-30 is the PCC section at the approach end of Runway 35. This section is similar in condition to R1735ML-20.

Overview of section R1735ML-30.

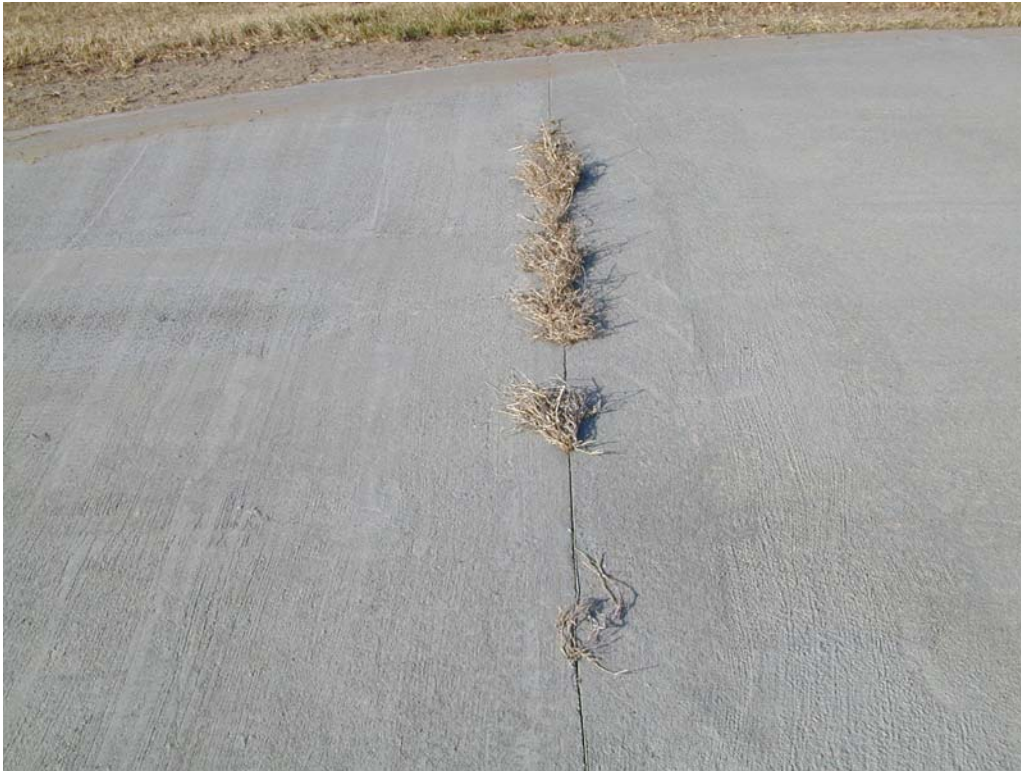
Joint seal damage in section R1735ML-30.

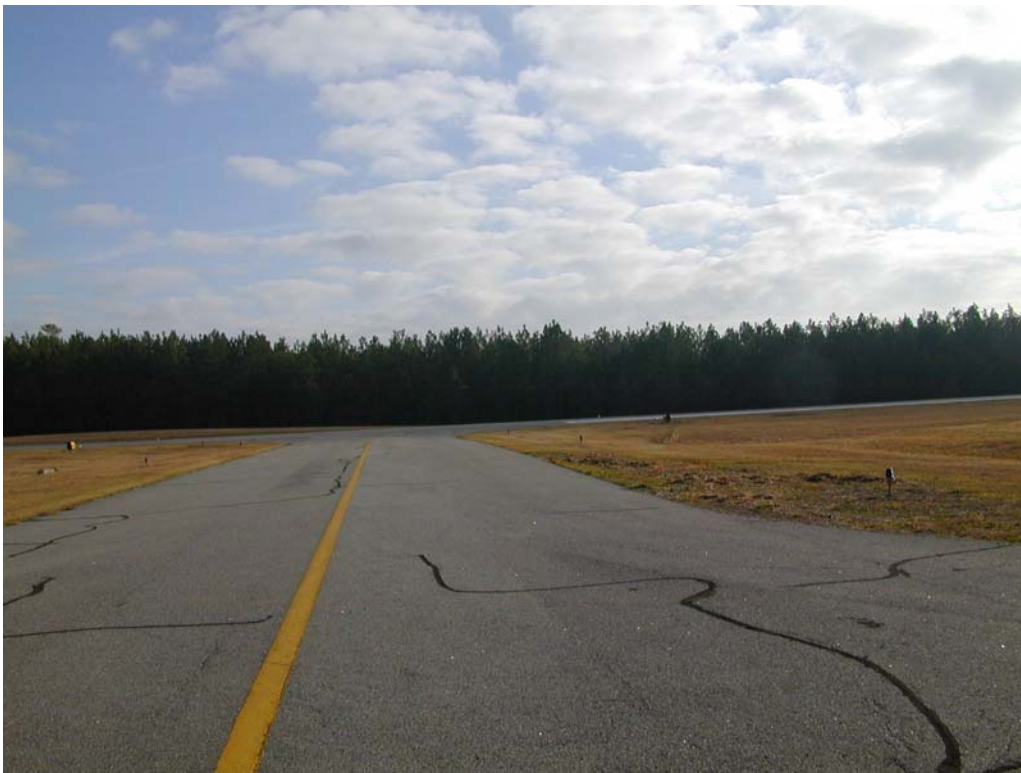
One section, running full length, defines Taxiway A. TAML-10 is in good condition with extensive amounts of low and medium-severity L&T cracking and low-severity raveling and weathering observed throughout the section. Medium-severity L&T cracking was recorded where joint sealant has failed or secondary cracking was found. Raveling and weathering was found in the section with the majority located in the fillet areas of the section.

Overview of section TAML-10.

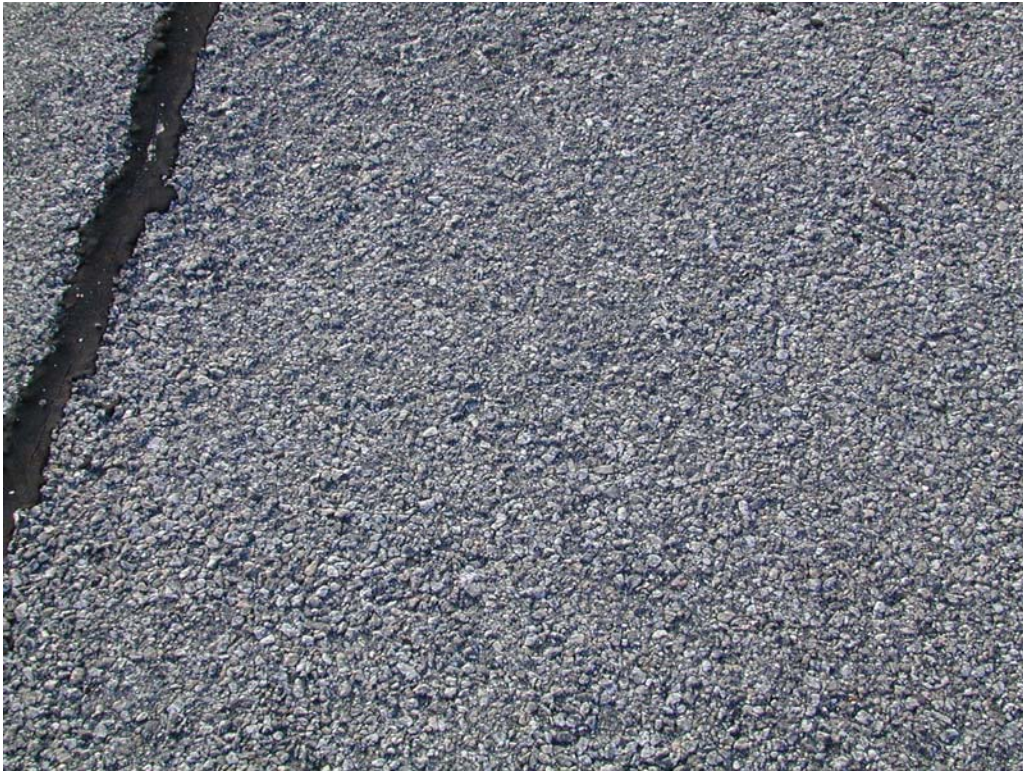
Raveling and weathering in section TAML-10.

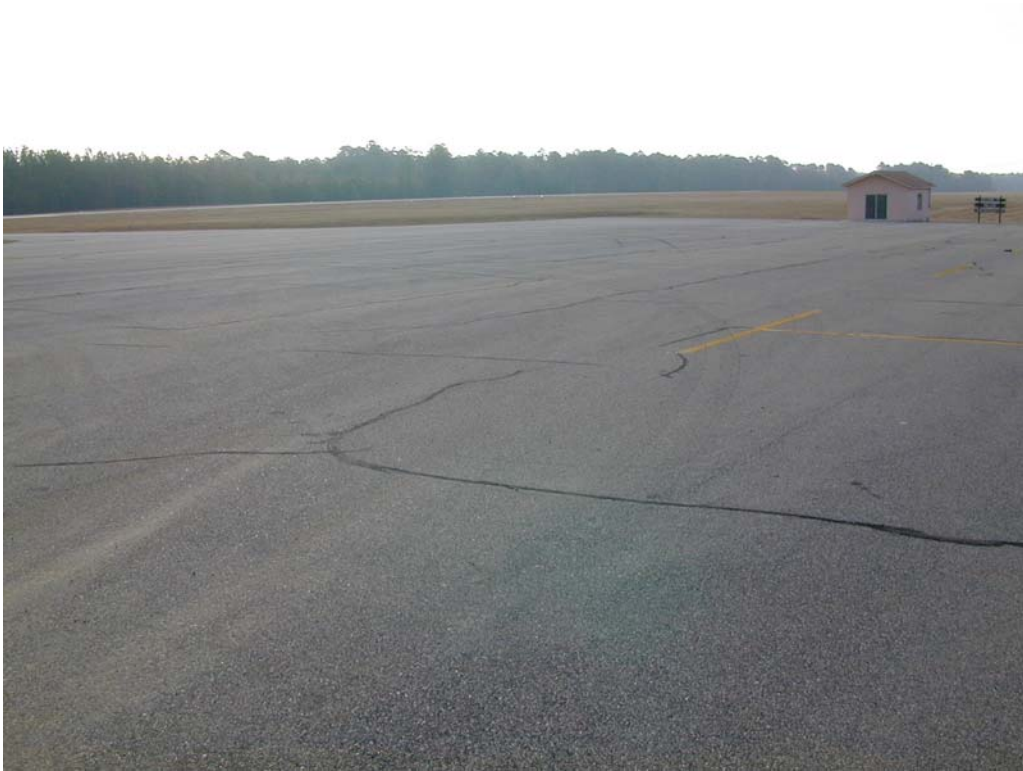
The apron at Millen airport is defined by one section. A01ML-10 is in good condition with significant amounts of low and medium-severity L&T cracking found throughout. Isolated areas with low-severity raveling and weathering and bleeding were also observed in this section.

Overview of section A01ML-10.

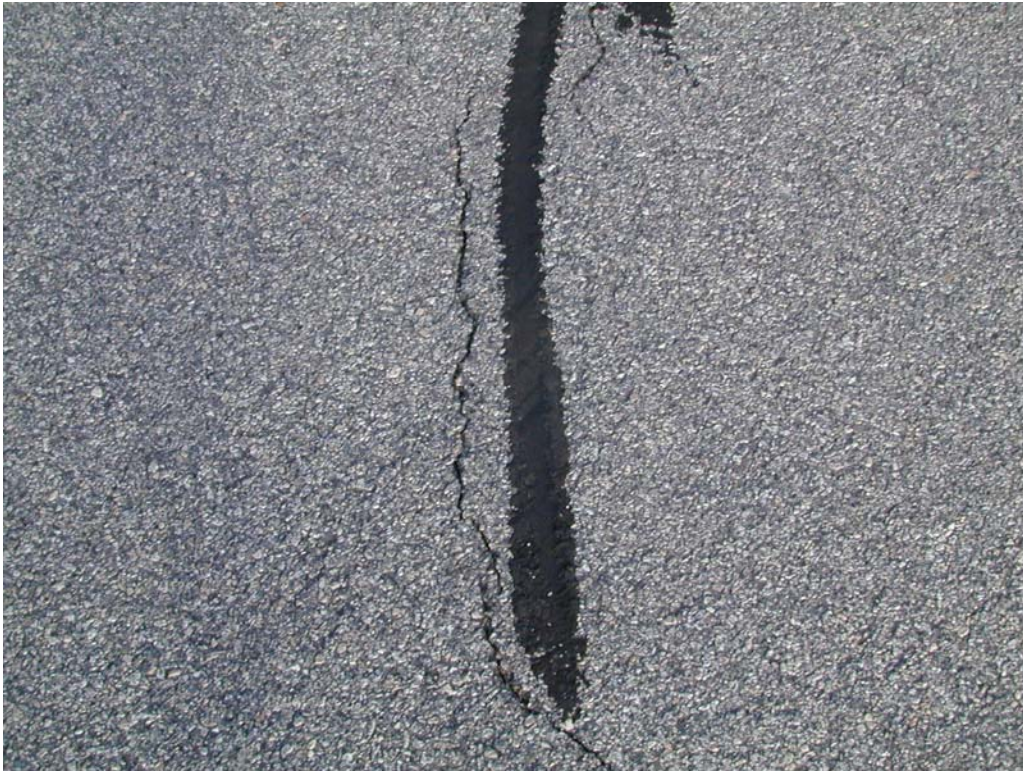
L&T cracking in section A01ML-10.
