GRIFFIN - SPALDING COUNTY AIRPORT

PAVEMENT EVALUATION REPORT

JULY 2002

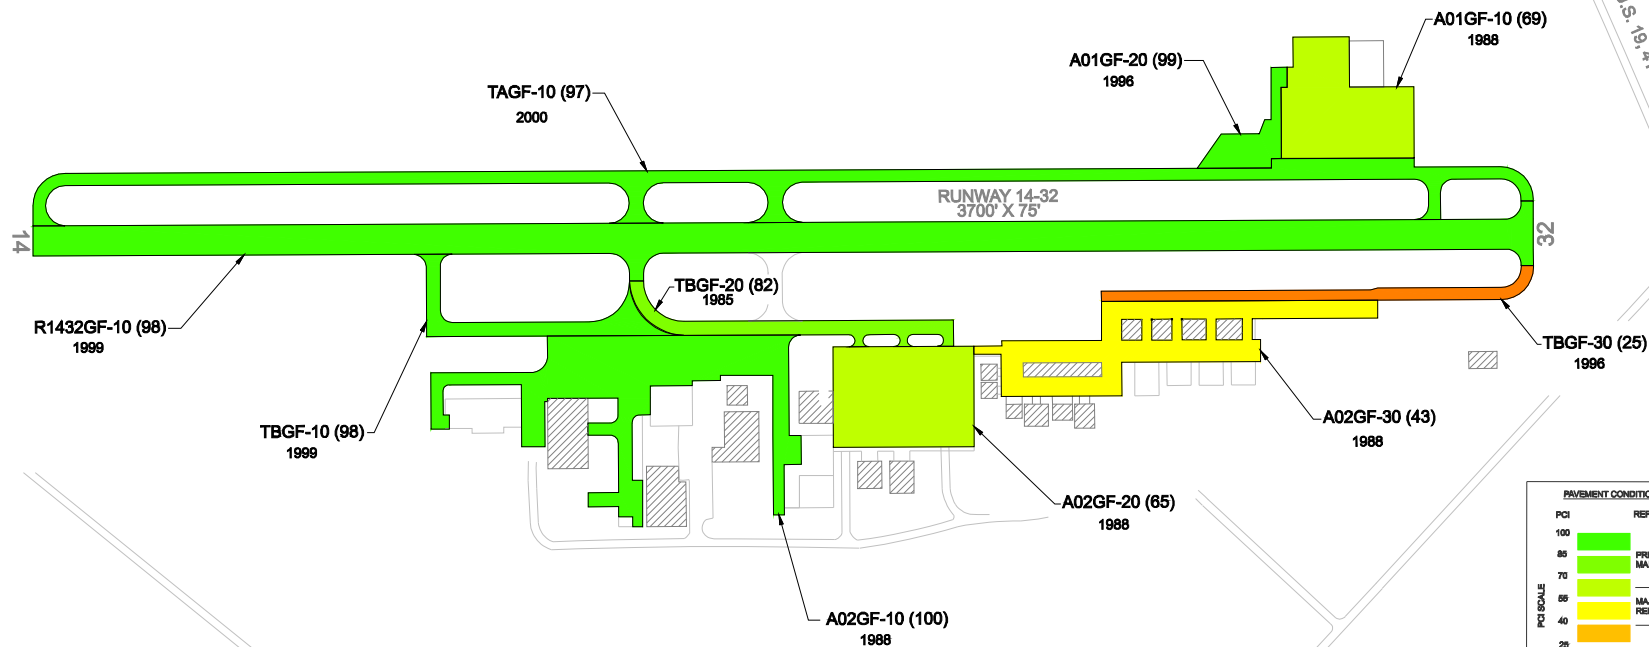
Figure 8. INSERT PCI MAP
(11 x 17)

The 2001 area-weighted condition of Griffin - Spalding County Airport is 84, with conditions ranging from 25 to 100 [on a scale of 0 (failed) to 100 (excellent)]. Figures 6 and 7 provide graphs summarizing the overall condition of the pavements at Griffin - Spalding County Airport. Figure 8 is a map that displays the condition of the pavements evaluated. Table 1 summarizes the results of the pavement evaluation.

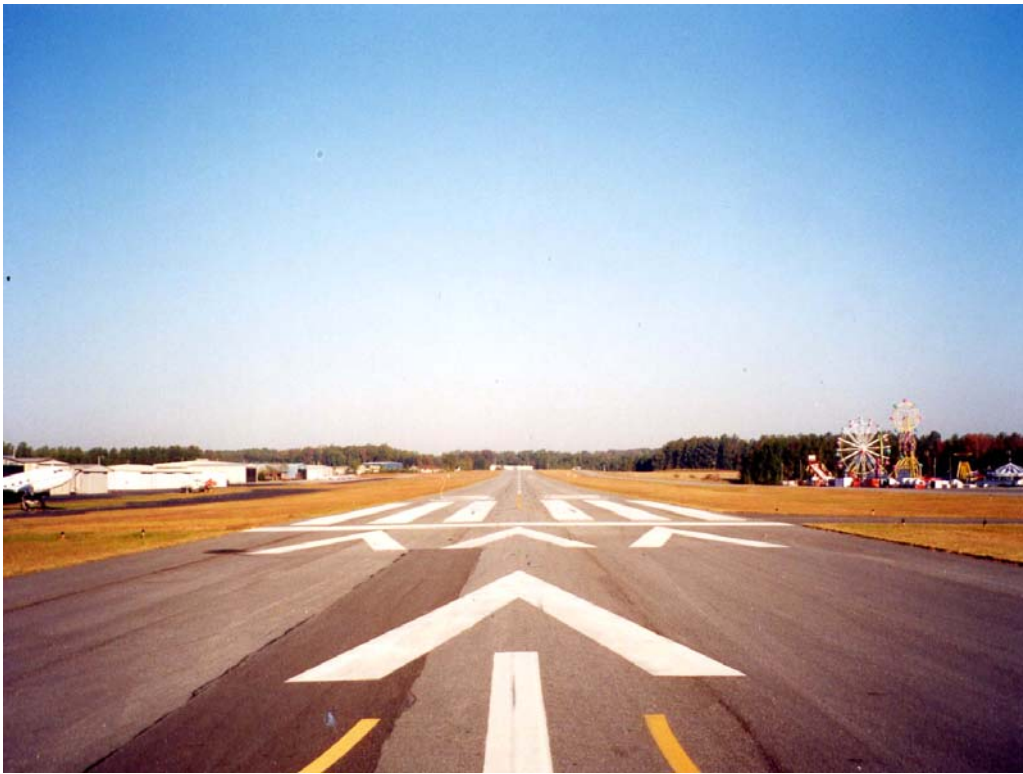
Overview of section R1432GF-10.

Runway 14-32 is composed of just one section, R1432AM-10, is in very good condition with very little distress. The only distress type noted on the section is low-severity patching in several areas along the length. The patched areas are relatively large and are scattered along the length of the runway.

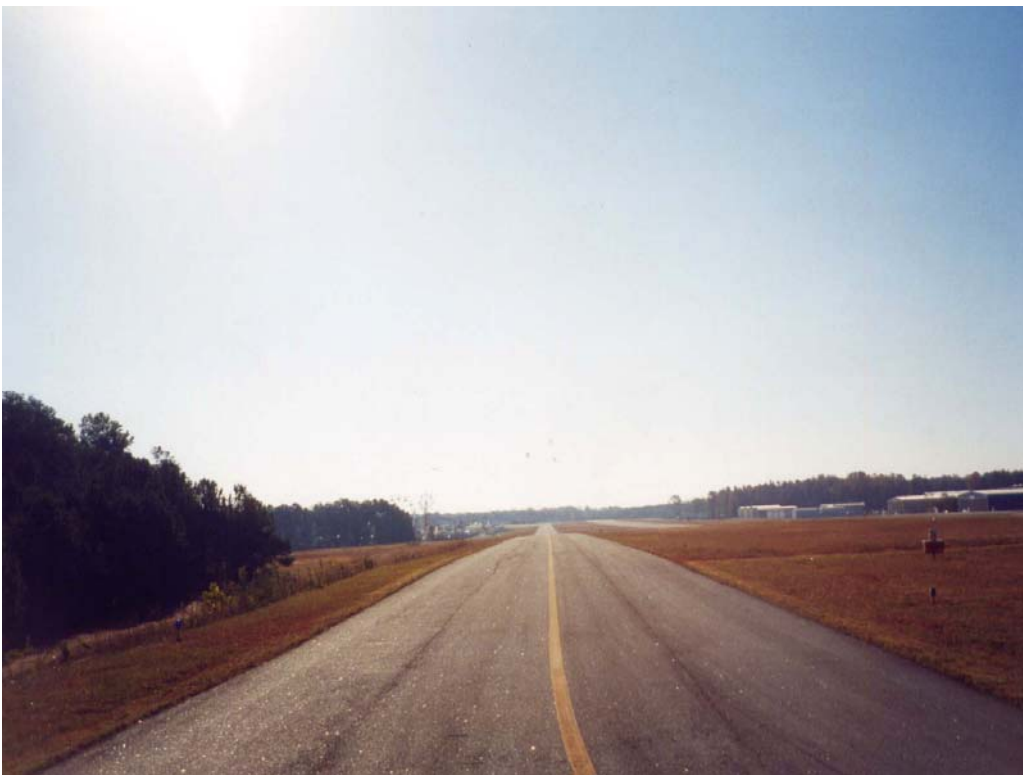
Overview of section TAGF-10.

The airport taxiway includes two separate branches with a total of four sections. The parallel taxiway, TAGFM-10, is in very condition with isolated distresses. The distresses include unsealed, low-severity longitudinal and transverse (L&T) cracks, oil spillage, and a low-severity patch.

Branch ¹	Section	Year	Type of Repair ²	Estimated Cost ³
TBGF	30	2002	Major M&R	\$66,921
A01GF	10	2002	Preventive	\$635
A02GF	20	2002	Preventive	\$8,432
A02GF	30	2002	Major M&R	\$75,542
A02GF	20	2004	Major M&R	\$71,504
A01GF	10	2005	Major M&R	\$62,990
TAGF	10	2006	Preventive	\$562
TBGF	20	2006	Preventive	\$1,832

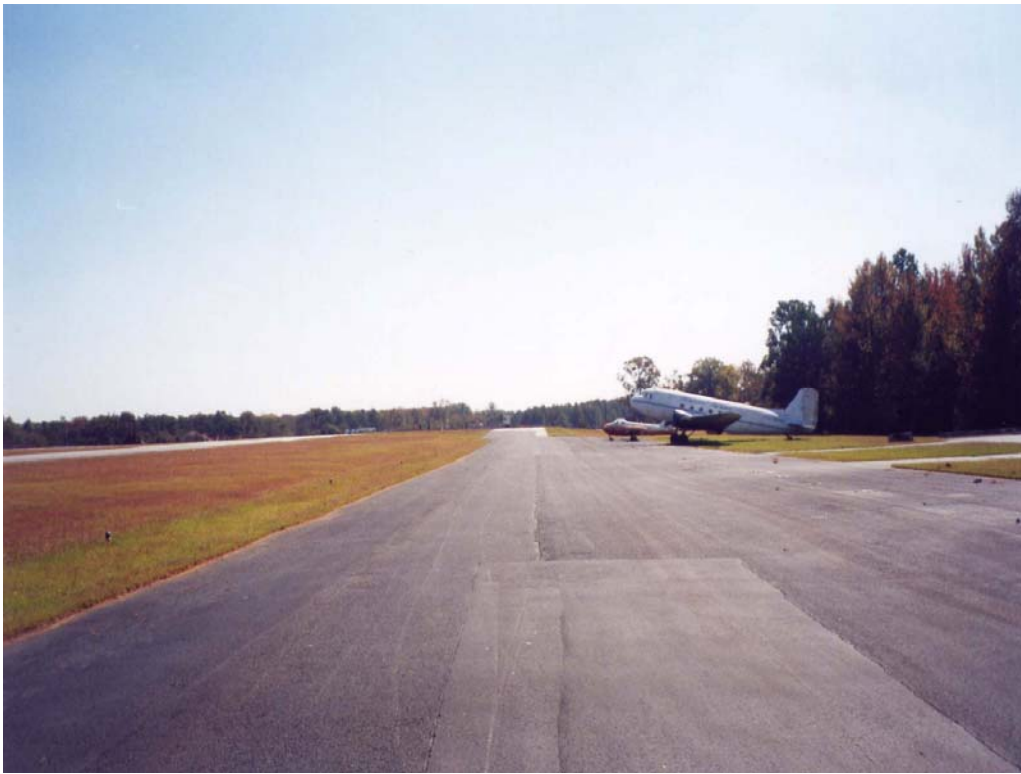
Overview of sections TBGF-30 and A02GF-30.

Three sections comprise Taxiway B, sections TBGF-10, TBGF-20, and TBGF-30. Section TBGF-10 is in very good condition with minor quantities unsealed, low-severity L&T cracking. Section TBGF-20 is in good condition with unsealed, low and medium-severity L&T cracks and low-severity patching noted as distresses. Section TBGF-30 is in poor condition and is exhibiting significant quantities of load and environmental distresses. The load-associated distresses include low, medium, and high-severity alligator cracking along the sections length. The environmental related distresses include low-severity block cracking, medium-severity L&T cracking, and medium severity weathering. Also noted on the sections were relatively large areas of low-severity patching.

Section A02GF-10 is in excellent condition with no noted distress. Section A02GF-20 is in good condition with moderate amounts of unsealed, low and medium-severity L&T cracking. Section A02GF-30 is in poor condition and is exhibiting significant quantities of load and environmental distresses. The load-associated distresses include all severity levels of alligator cracking and medium-severity rutting. The environmental-associated distresses include low and medium-severity L&T cracking, and medium and high-severity weathering. Other distresses include oil spillage and low and medium-severity patching.

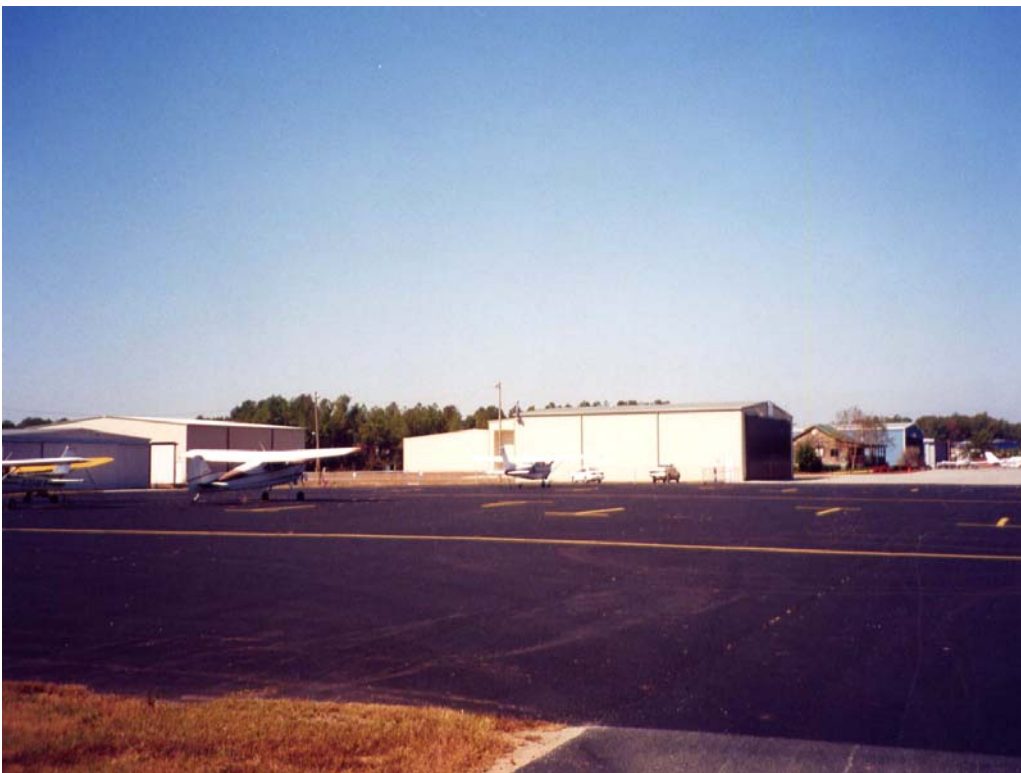
Overview of section A01GF-10.

The airport has five sections spread between two distinct areas. Branch A01 is located along Taxiway A and is composed of two sections A01GF-10 and A01GF-20. Branch A02 is located along Taxiway B and is made of three sections, A02GF-10, A02GF-20, and A02GF-30. A01GF-10 is in fair condition with the following distresses noted: sealed and unsealed, low and medium-severity L&T cracking, oil spillage, low-severity swelling, and all severity levels of patching. Section A01GF-20 is in very good condition with the only noted distress being an oil spill.

Plan Year	Network	Branch	Section	Distress Description	Severity	Work Description	Work Qty.	Work Unit	Unit Cost	Work Cost
2002	GRIFFIN	A01GF	10	L & T CR	M	Crack Sealing	496	LF	\$1.28	\$635
