BACON COUNTY AIRPORT

PAVEMENT EVALUATION REPORT

JULY 2002

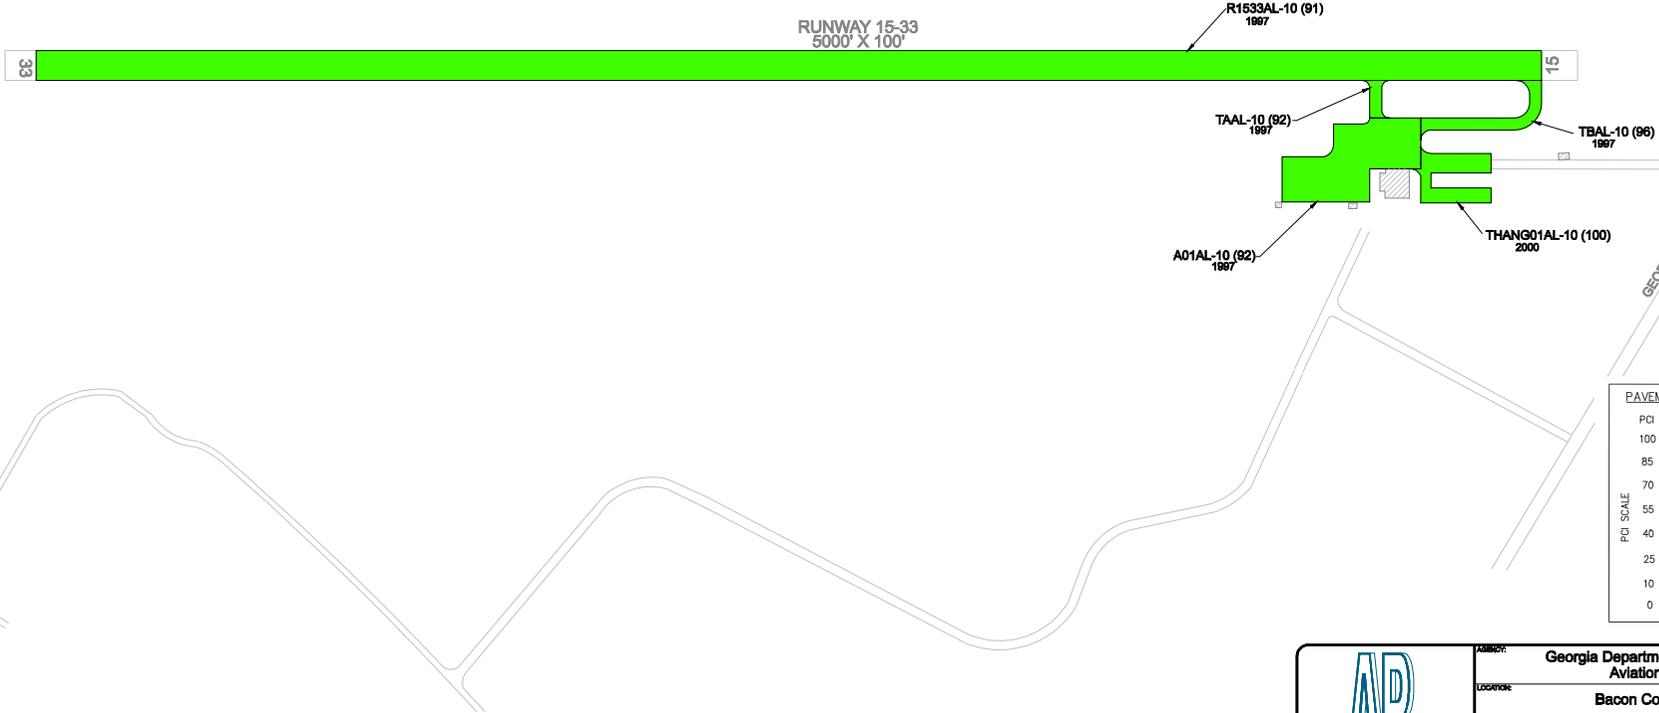
Figure 8. INSERT PCI MAP
(11 x 17)

The 2001 area-weighted condition of Bacon County Airport is 92, with conditions ranging from 91 to 100 [on a scale of 0 (failed) to 100 (excellent)]. Figures 6 and 7 provide graphs summarizing the overall condition of the pavements at Bacon County Airport. Figure 8 is a map that displays the condition of the pavements evaluated. Table 1 summarizes the results of the pavement evaluation.

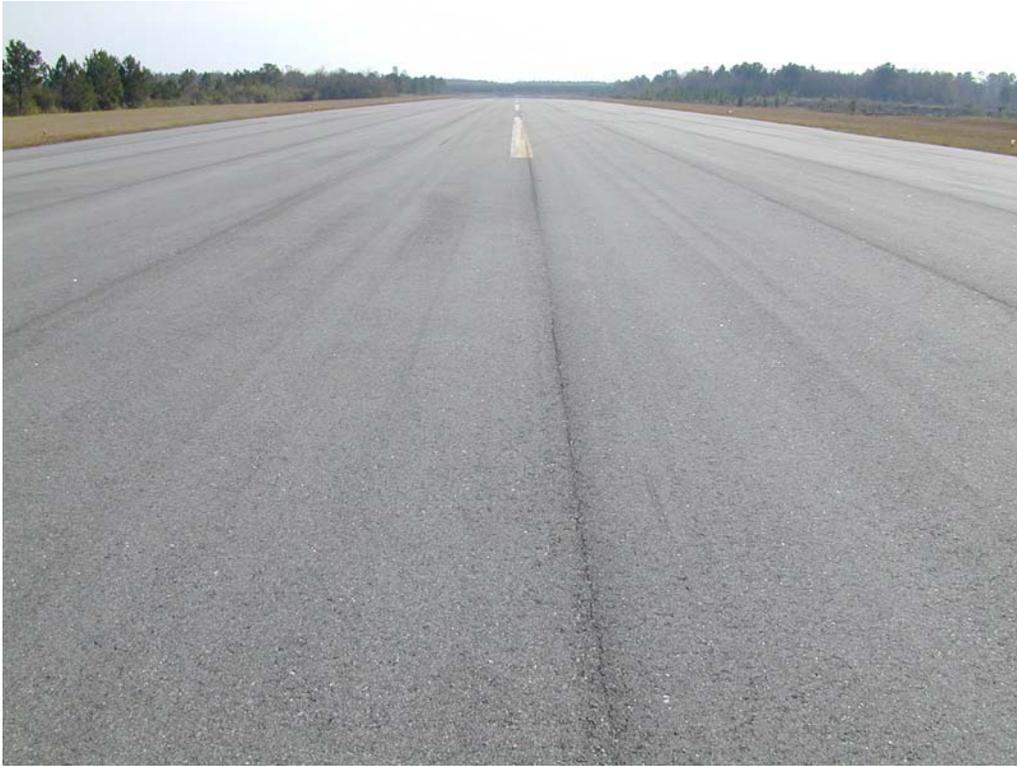
One section was defined in Runway 15-33. RW1533-10 is excellent condition with moderate amounts of low-severity longitudinal and transverse (L&T) cracking being found. Isolated amounts of medium-severity L&T cracking were also observed throughout the section.

Overview of section R1533AL-10.

Branch ¹	Section	Year	Type of Repair ²	Estimated Cost ³
R1533AL	10	2006	Preventive	\$17,677

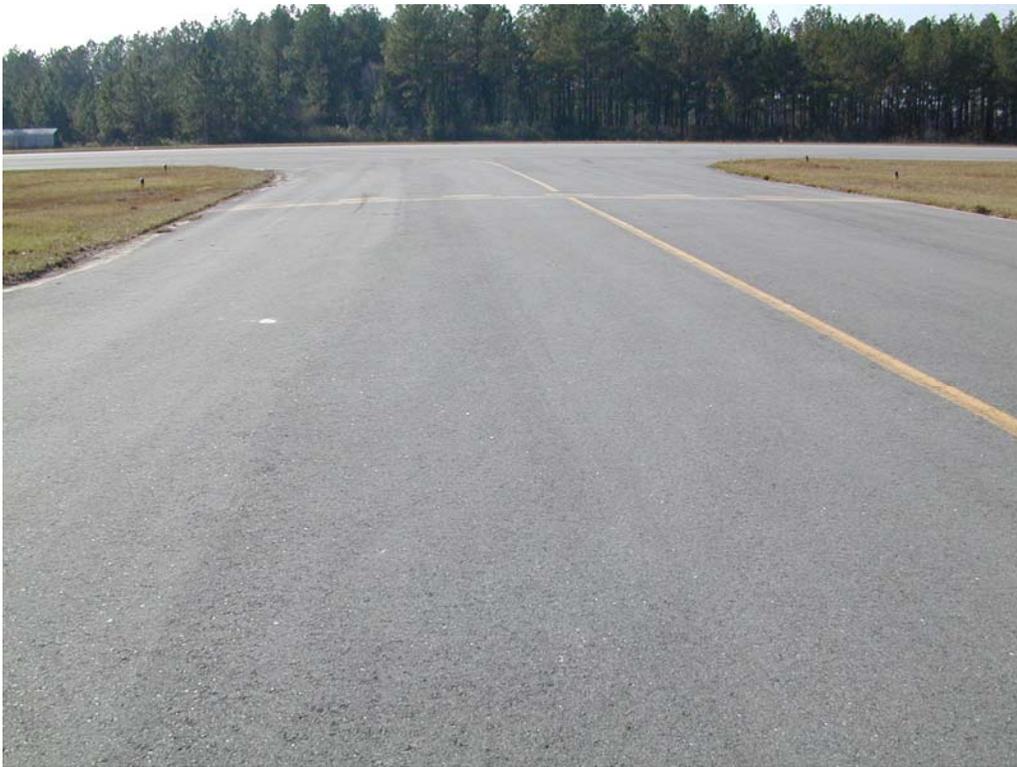
Taxiway A consists of one section and is in excellent condition. Only a small amount of low-severity L&T cracking was found in the section.

Overview of section TAAL-10.

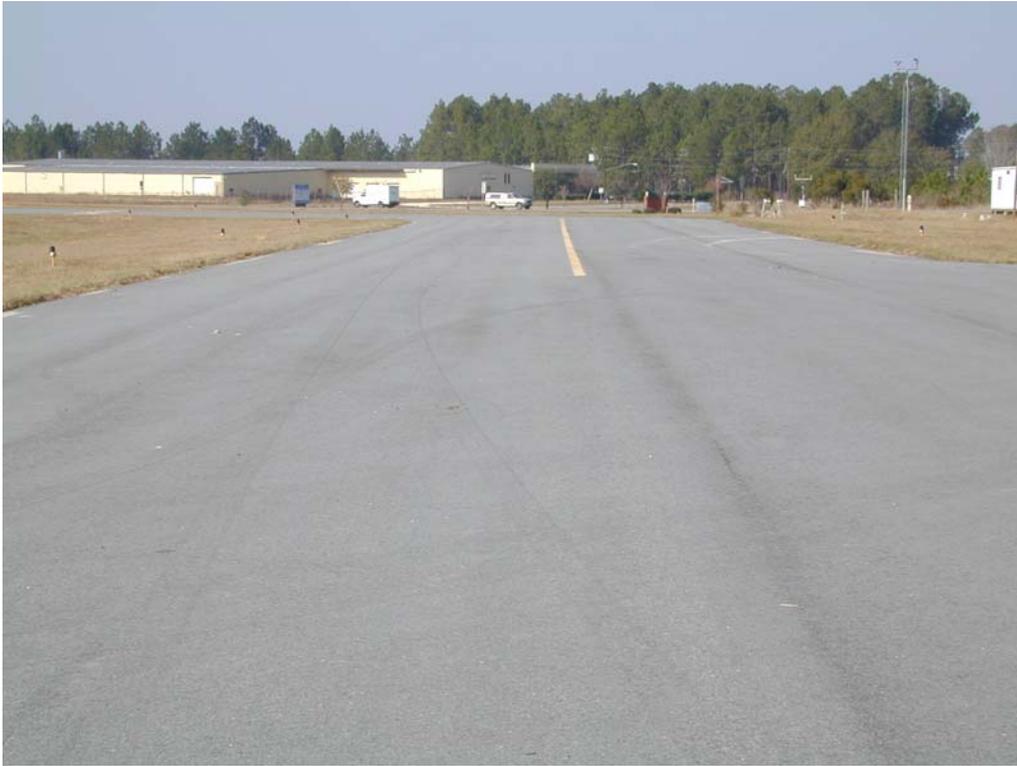
Taxiway B is in similar condition to Taxiway A with only small amounts of low-severity L&T cracking being observed.

Overview of section TBAL-10.

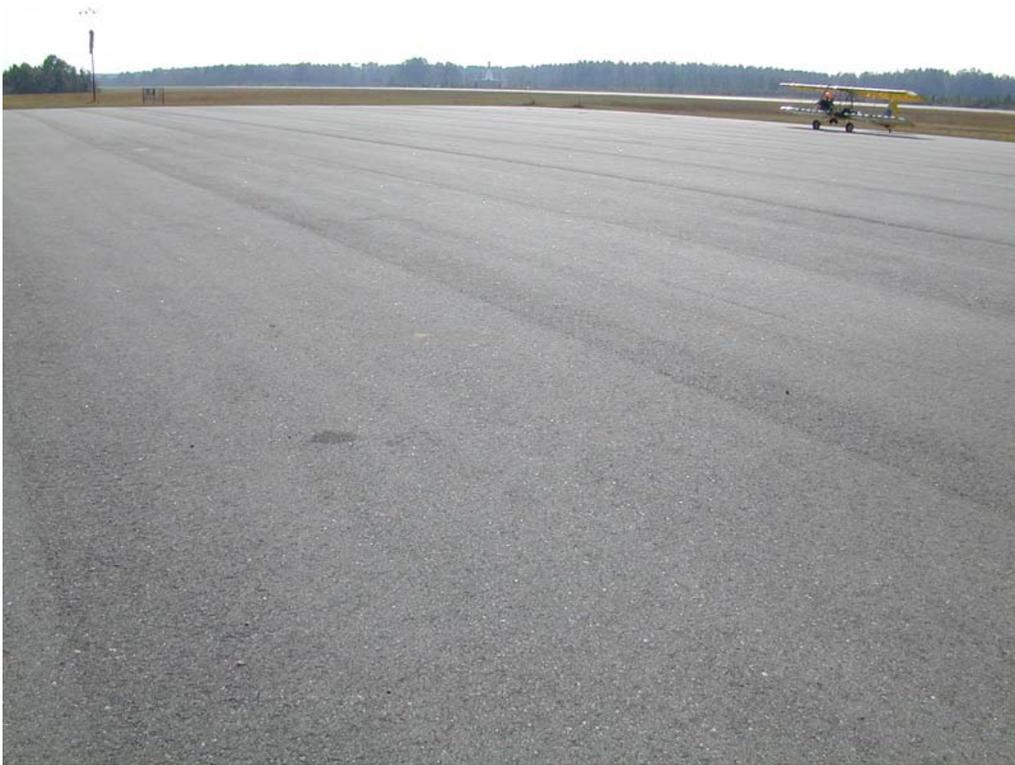
One section was defined in the apron. A01-10 is in excellent condition with small amounts of low-severity L&T cracking being observed throughout the section. Isolated amounts of swelling were also observed in the section; however, the amount was minimal. A few small areas of oil spillage were identified near the gas tanks.

Overview of section A01AL-10.

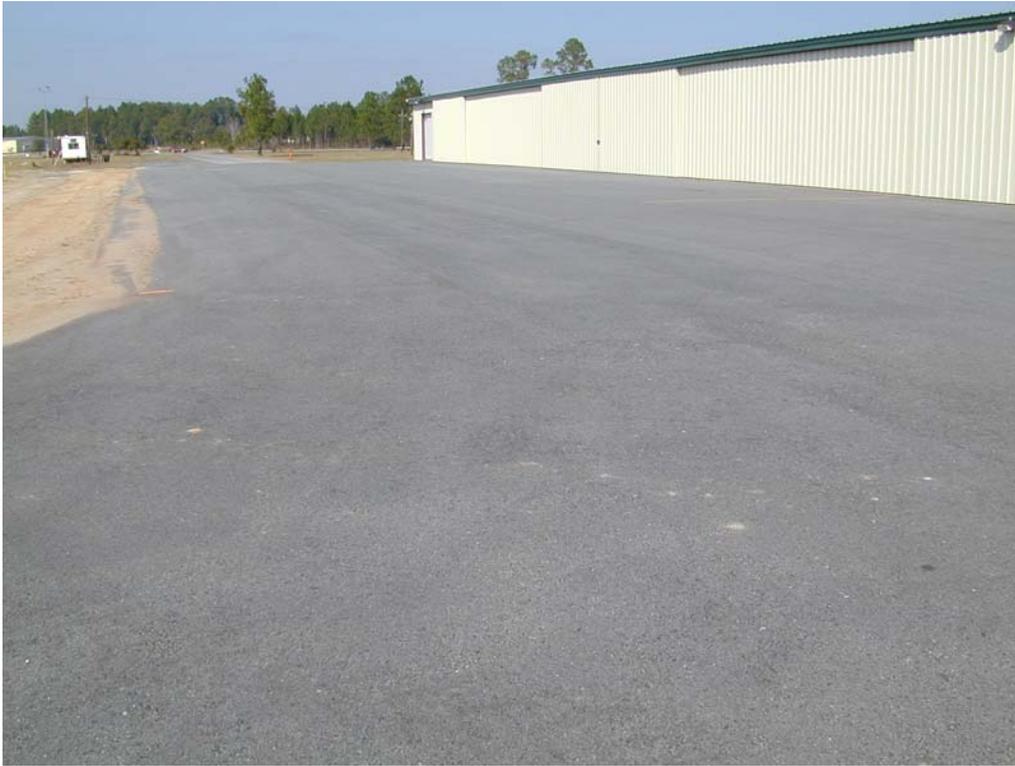
The t-hangar taxiways were recently constructed and found to be free of any distress

Overview of section TH01AL-10.
