BURKE COUNTY AIRPORT

PAVEMENT EVALUATION REPORT

JULY 2002

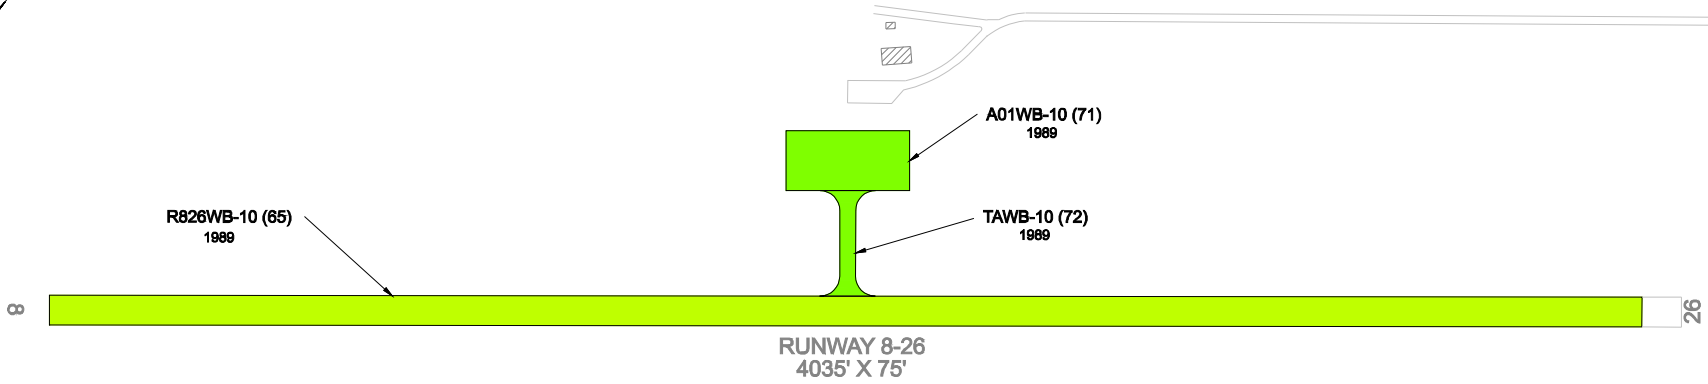
Figure 8. INSERT PCI MAP
(11 x 17)

The 2001 area-weighted condition of Burke County Airport is 66, with conditions ranging from 65 to 72 [on a scale of 0 (failed) to 100 (excellent)]. Figures 6 and 7 provide graphs summarizing the overall condition of the pavements at Burke County Airport. Figure 8 is a map that displays the condition of the pavements evaluated. Table 1 summarizes the results of the pavement evaluation.

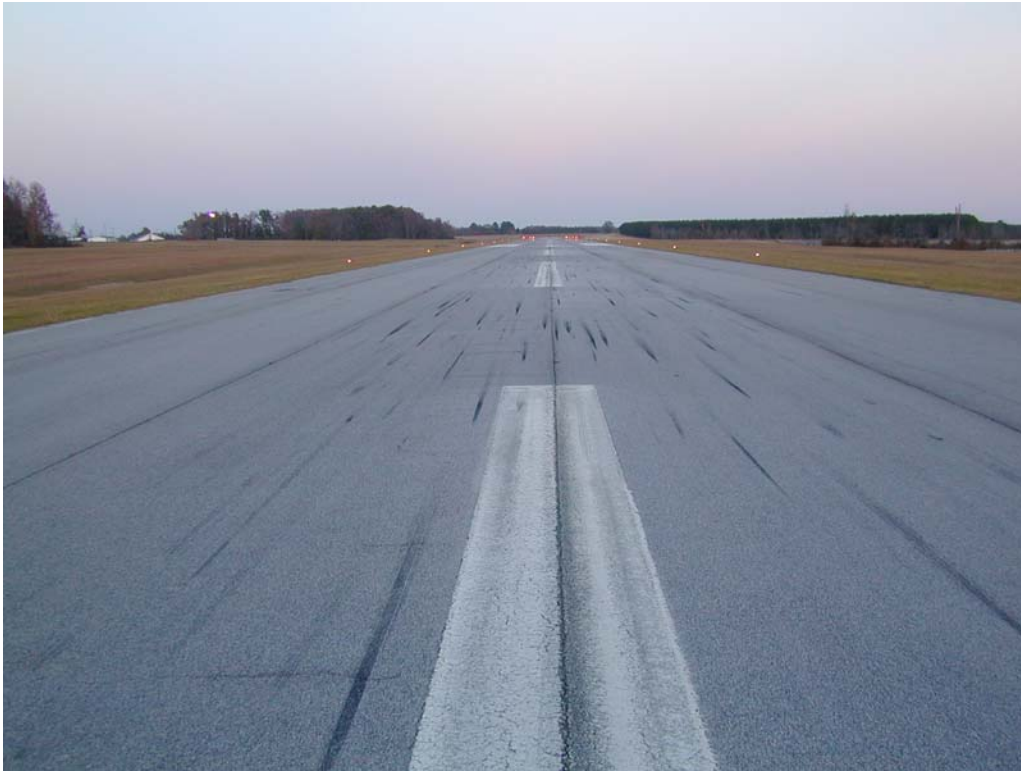
Runway 8-26 is defined by one section. Extensive amounts of low-severity block cracking and lesser quantities of medium-severity block cracking were found throughout the runway. Low-severity depression, rutting, alligator cracking, low and medium-severity longitudinal and transverse (L&T) cracking were also observed.

Overview of section R826WB-10.

Branch ¹	Section	Year	Type of Repair ²	Estimated Cost ³
R826WB	10	2002	Major M&R	\$195,336
A01WB	10	2002	Preventive	\$775
TAWB	10	2006	Preventive	\$970
A01WB	10	2006	Preventive	\$5,970

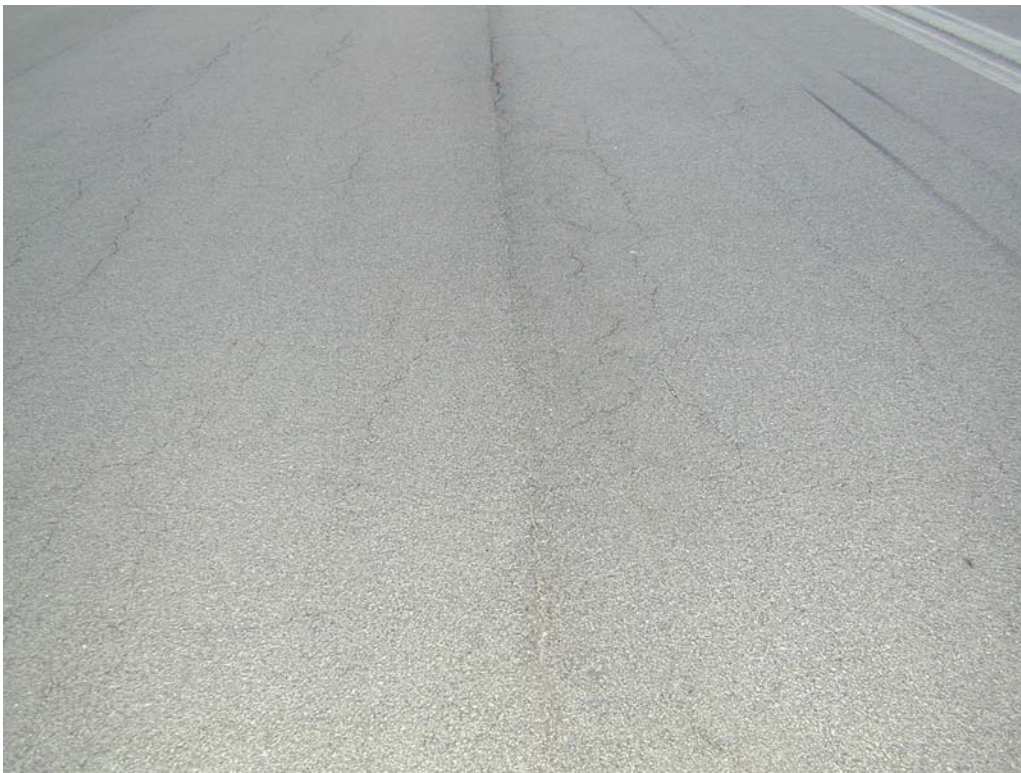
Alligator cracking in section R826WB-10.

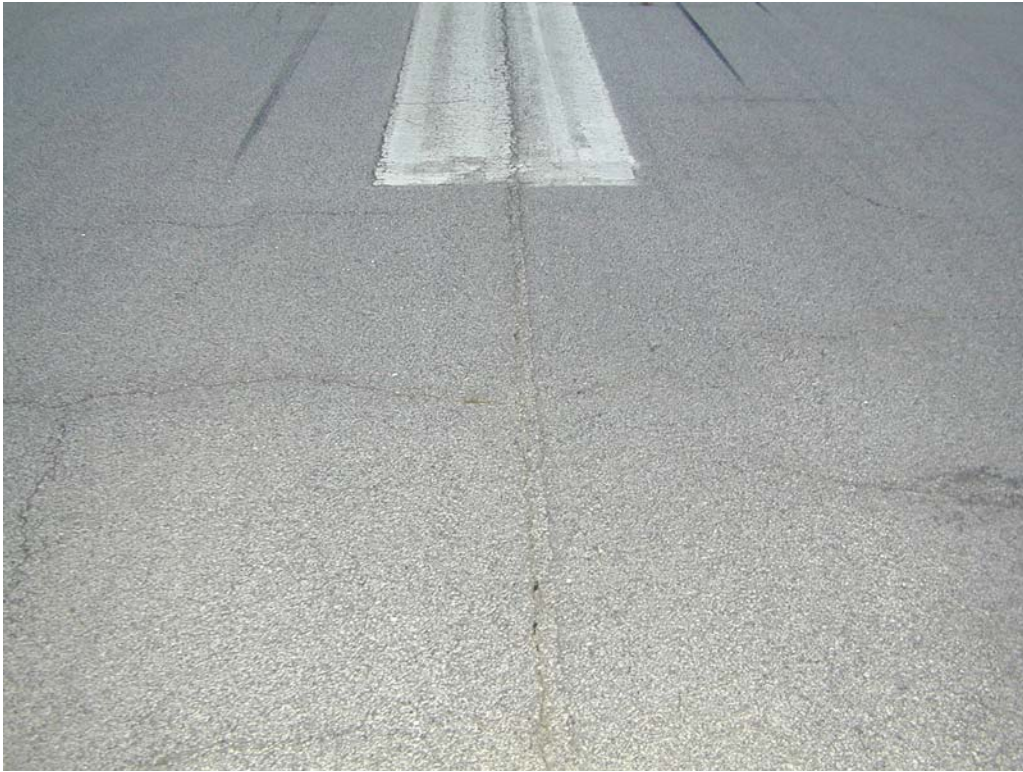
Block cracking in section R826WB-10.

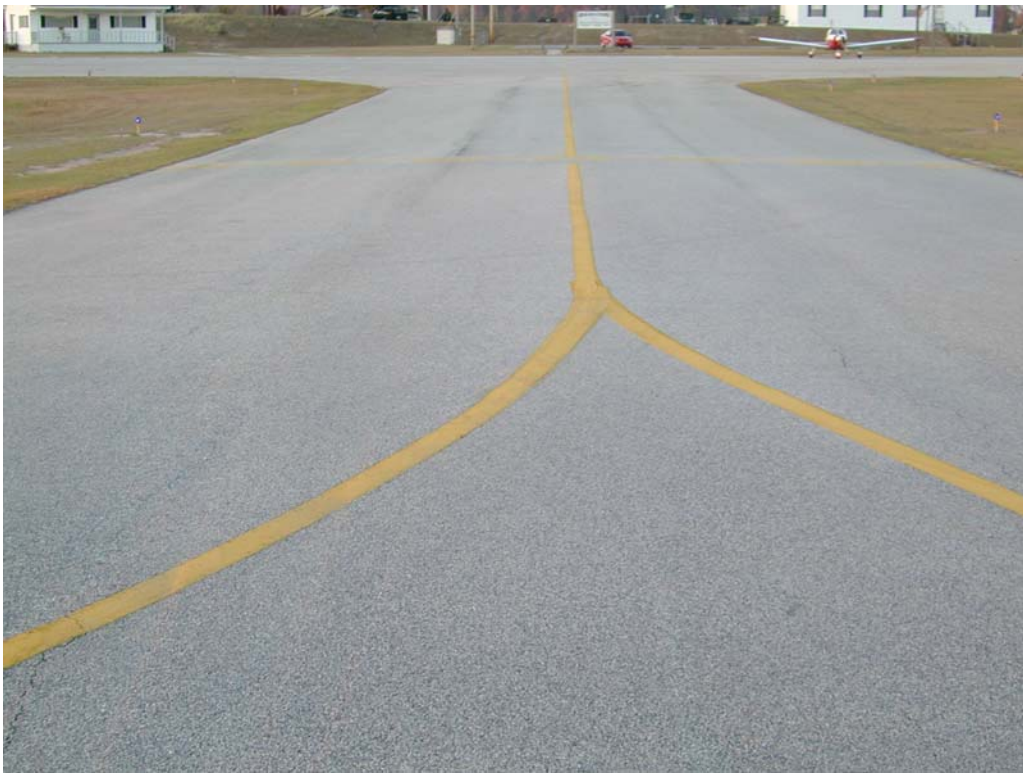
One section, running full length, defines Taxiway A. TAWB-10 is in good condition. Small amounts of low-severity depression, L&T cracking, raveling and weathering and rutting were found throughout the taxiway.

Overview of section TAWB-10.

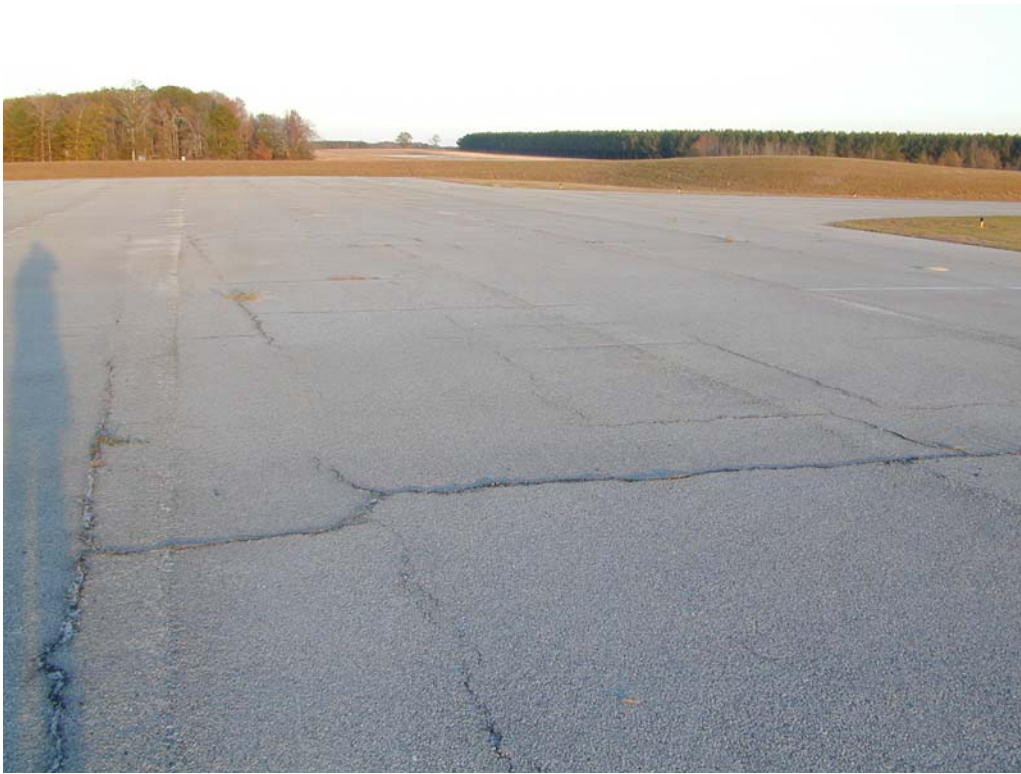
The apron is in good condition. Extensive amounts of low and medium-severity block cracking were observed throughout section. Other distresses noted in this section include low-severity depression, raveling and weathering, swelling and low and medium-severity L&T cracking.

Overview of section A01WB-10.

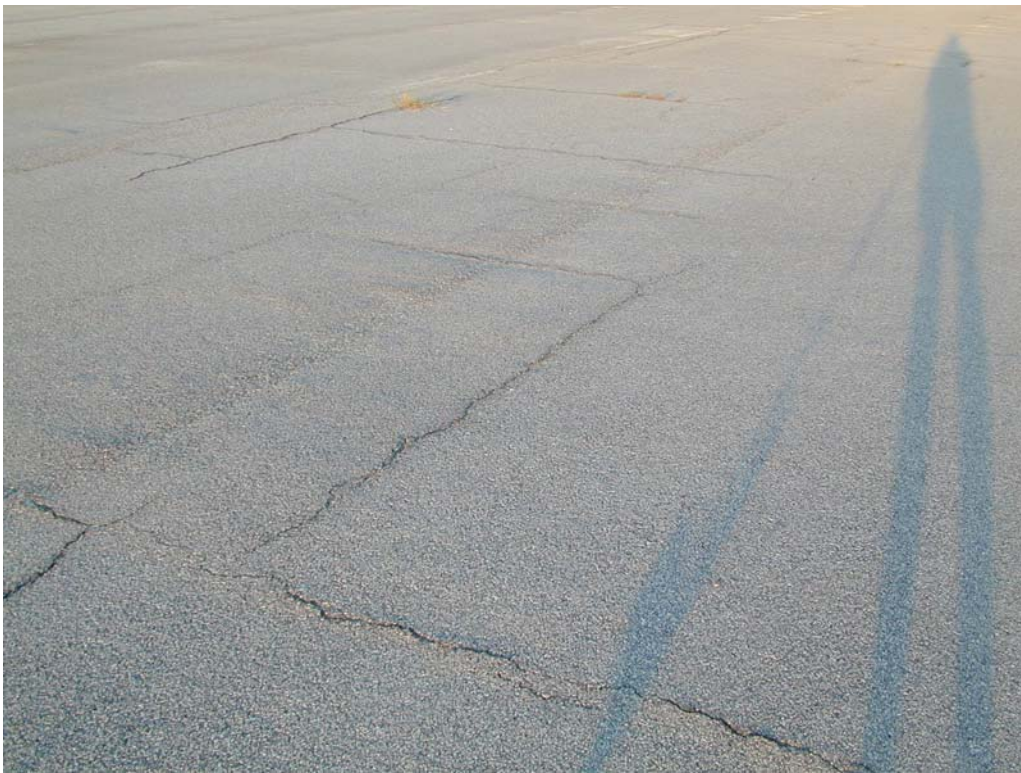
Block cracking in section A01WB-10.

Plan Year	Network	Branch	Section	Distress Description	Severity	Work Description	Work Qty.	Work Unit	Unit Cost	Work Cost
2002	WAYNESBORO	A01WB	10	BLOCK CR	M	Crack Sealing	589	LF	\$1.28	\$755

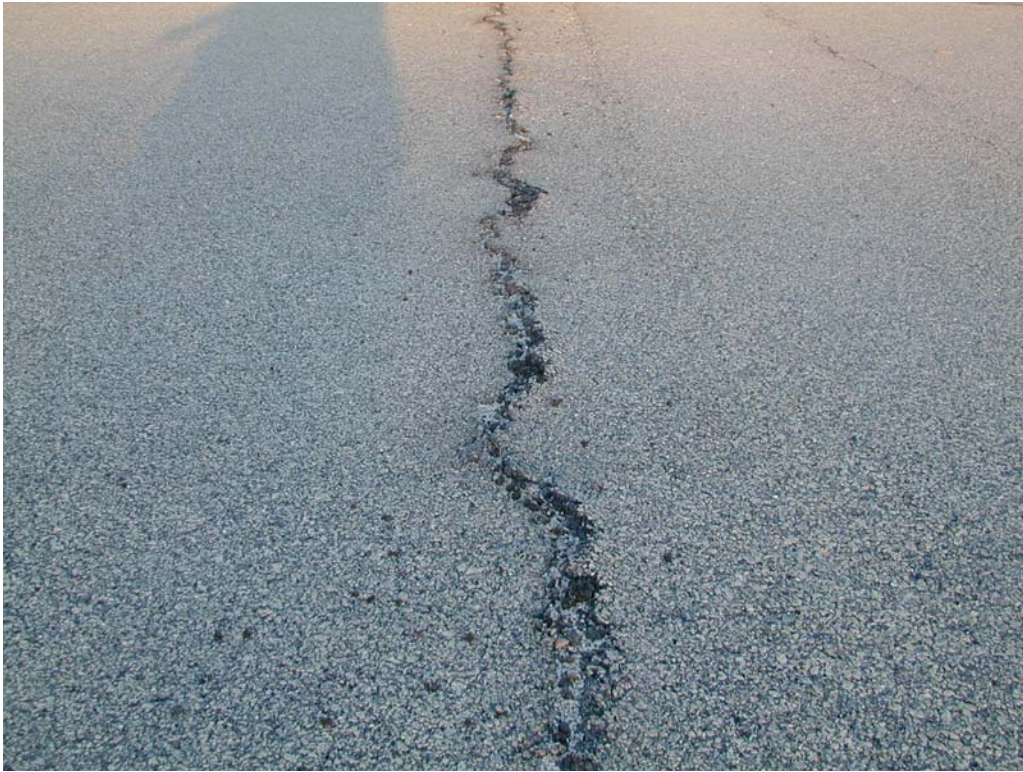
Swell in section A01WB-10.
