# HOMERVILLE AIRPORT

## PAVEMENT EVALUATION REPORT

JULY 2002

As part of the GASP Update, an evaluation of the pavement conditions at Homerville Airport was conducted in 2001. The results of this evaluation are presented within this report and can be used by GDOT, the Federal Aviation Administration (FAA), and Homerville Airport to monitor the condition of pavements and to identify, prioritize, and schedule pavement maintenance and rehabilitation actions at the airport.

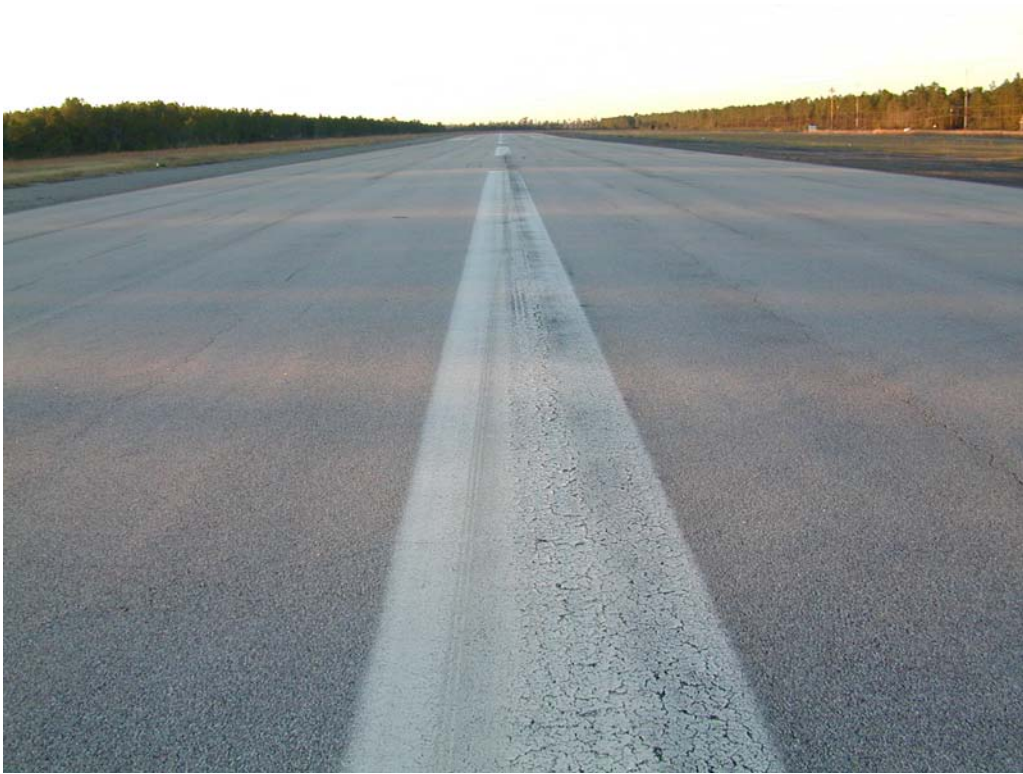
Runway 14-32 is in good condition. Large quantities of low-severity, unsealed, longitudinal and transverse (L&T) cracking were found throughout the pavement. Occasional amounts of swelling were also found, primarily toward the outside edges of the runway.

Overview of section R1432HO-10.

Branch <sup>1</sup>	Section	Year	Type of Repair <sup>2</sup>	Estimated Cost <sup>3</sup>
R1432HO	10	2006	Preventive	\$47,194

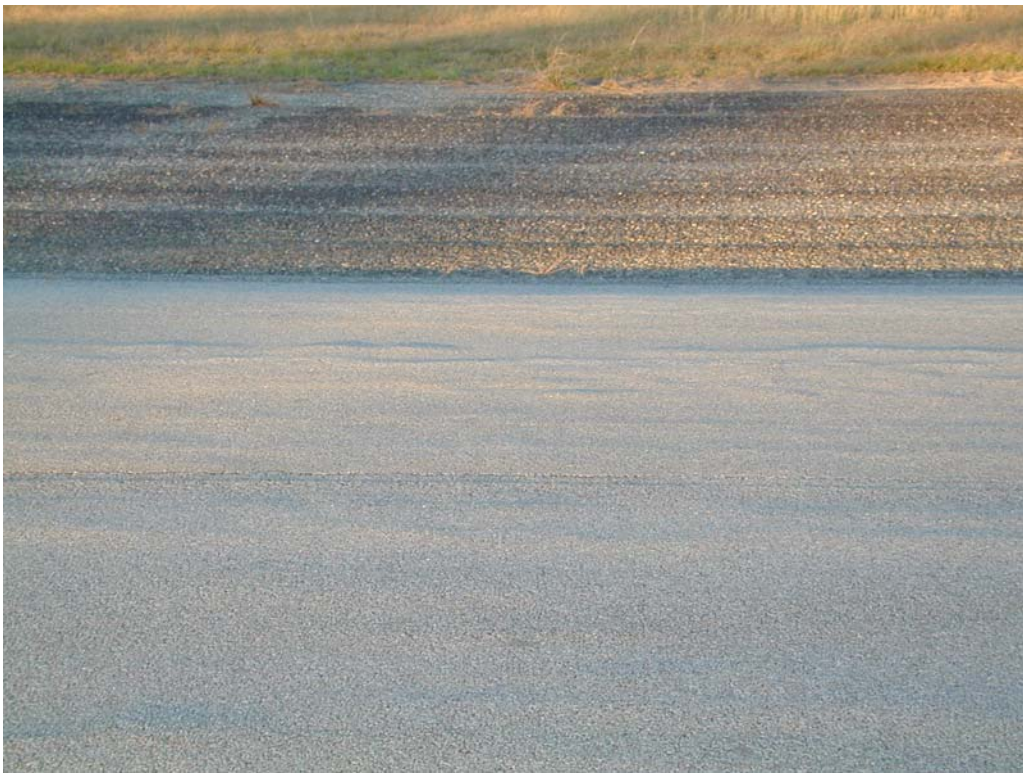
Swell in section R1432HO-10.

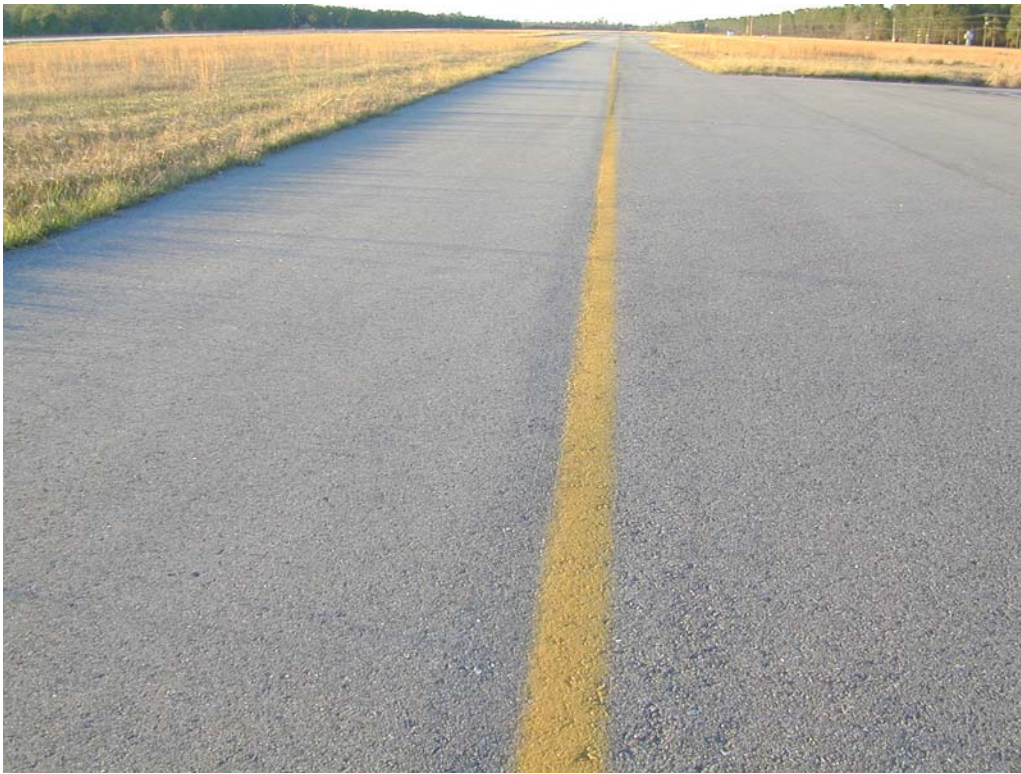
Taxiway A is in excellent condition. A small area at the north end of the taxiway had a recent skin patch repair performed that was not considered atypical and therefore not inspected as an additional sample unit. The rest of the taxiway was free of any distress.

Overview of section TAHO-10.

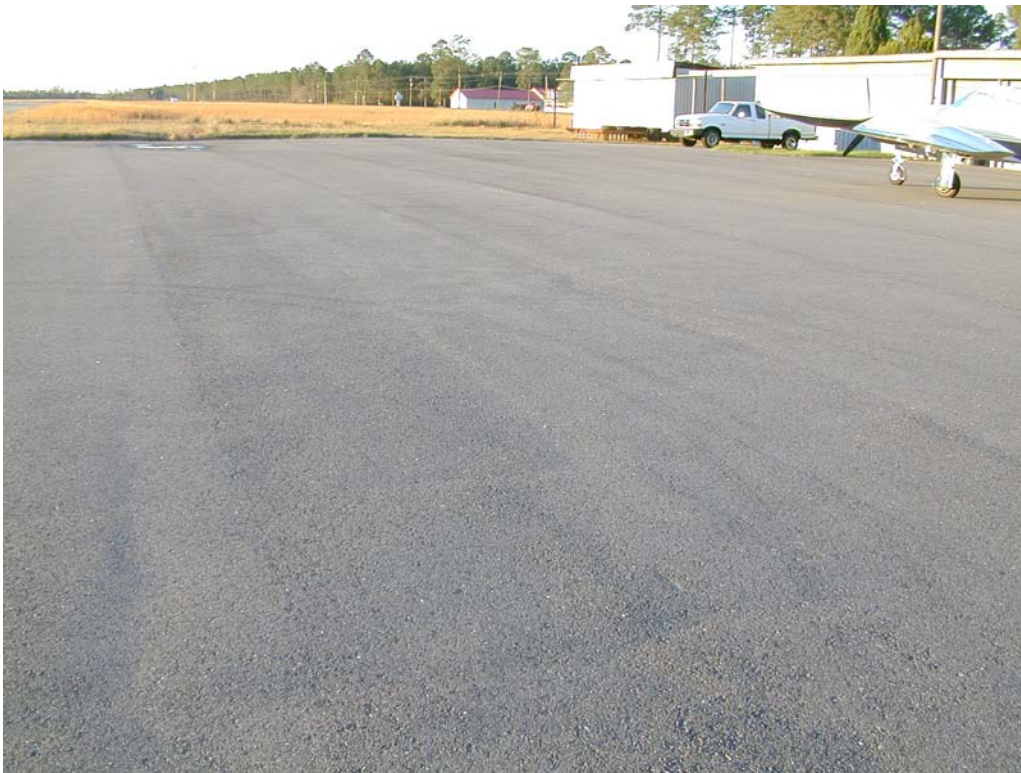
The apron is also in excellent condition with only small amounts of swelling being observed throughout the pavement. Grooves in the pavement approximately  $\frac{1}{4}$  of an inch deep appear to be caused by the edges of compaction equipment.

Overview of section A01HO-10.
