2012 Bacon County Airport Pavement Management Plan

BACON COUNTY AIRPORT

PAVEMENT MANAGEMENT REPORT

DECEMBER 2012

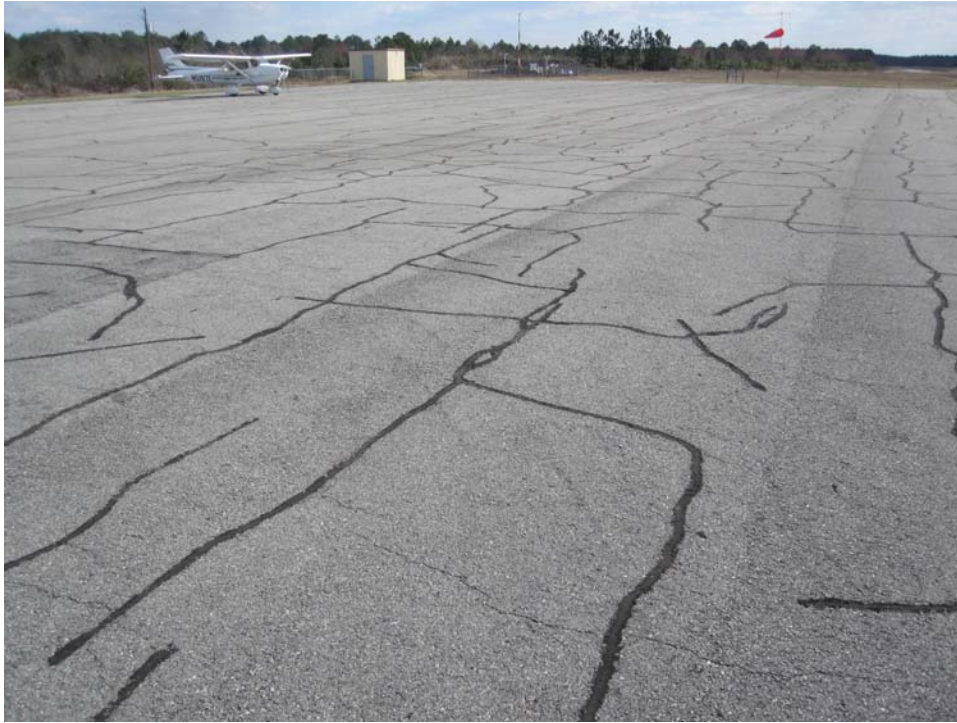
The apron area consisted of one section with a PCI value of 62. Large quantities of low-severity block cracking, L&T cracking, and weathering were observed. The majority of the cracking was sealed. Low-severity patching and swelling were also noted in isolated quantities.

A01AL-10. Overview.

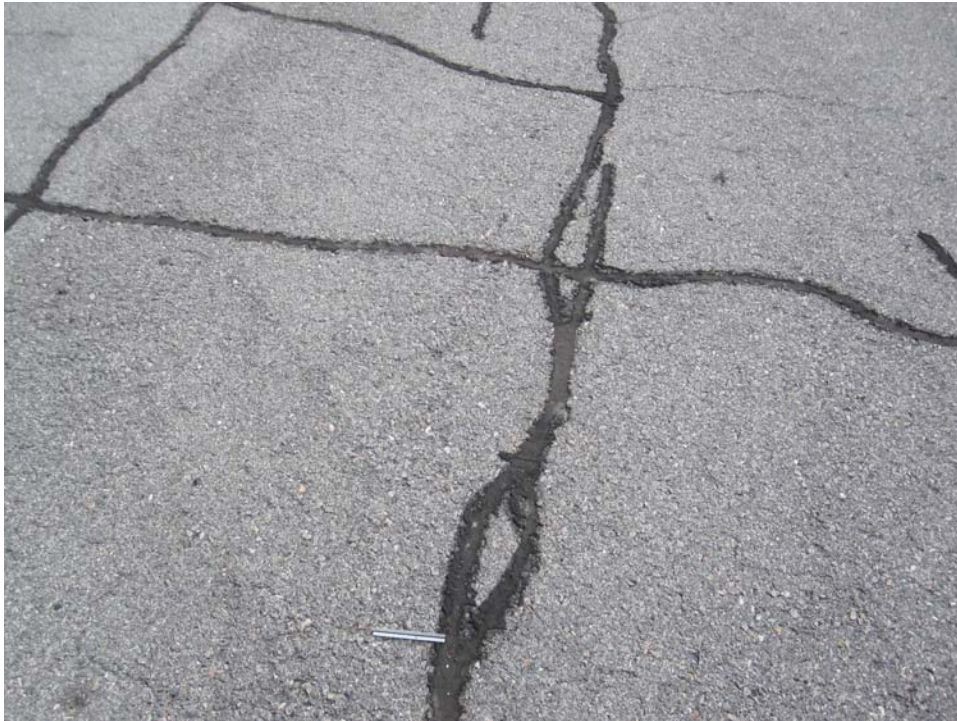
A01AL-10. Block Cracking (Sample Unit #01).

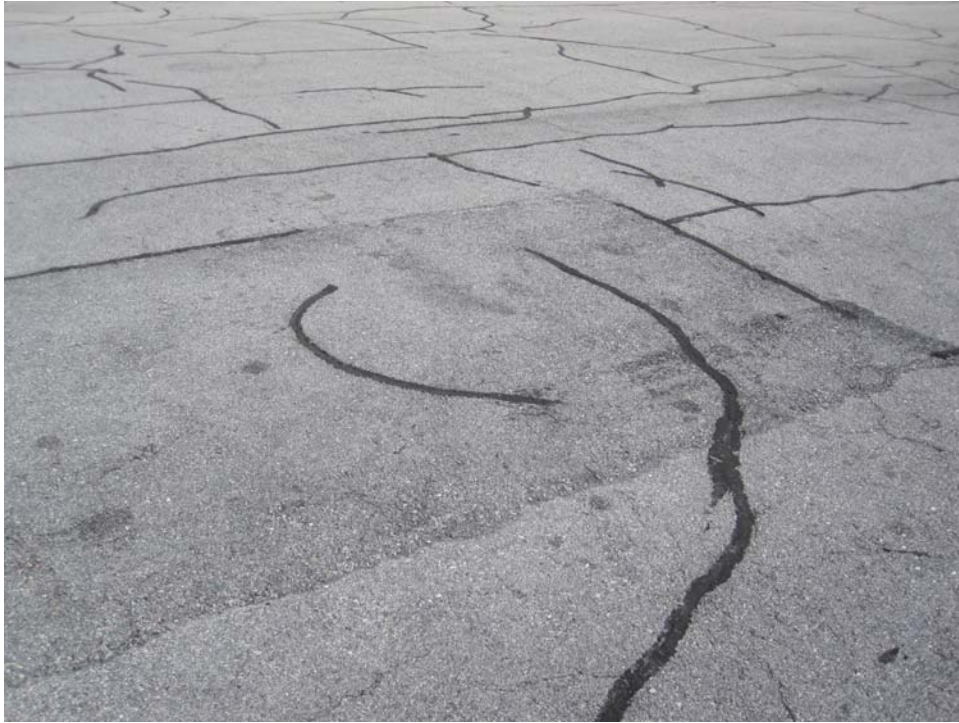
A01AL-10. Patching (Sample Unit #09).

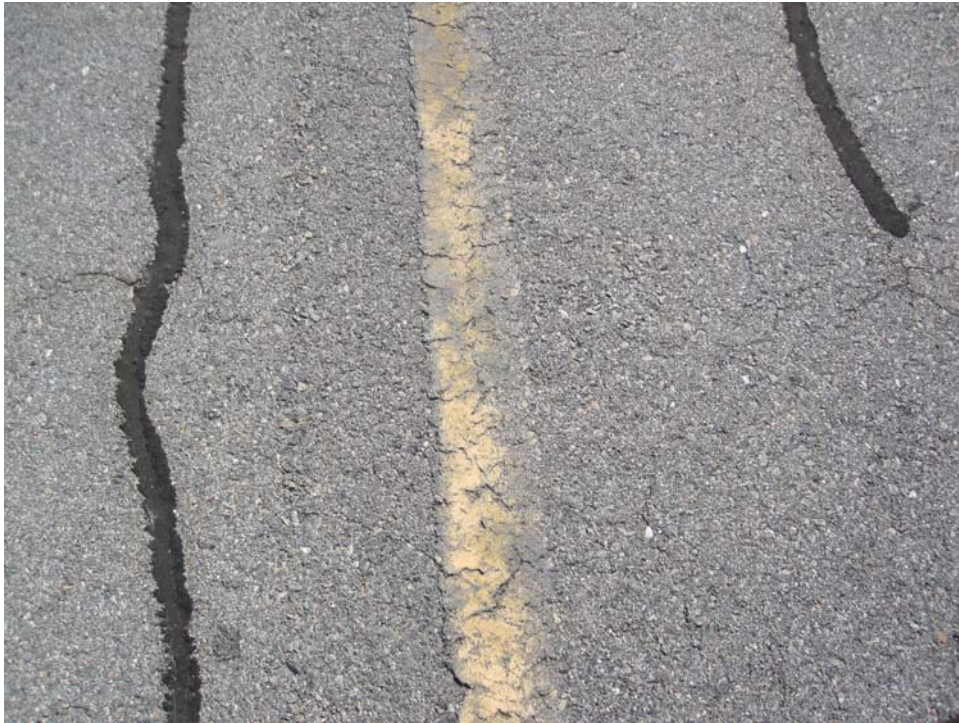
A01AL-10. Unsatisfactory Paint.

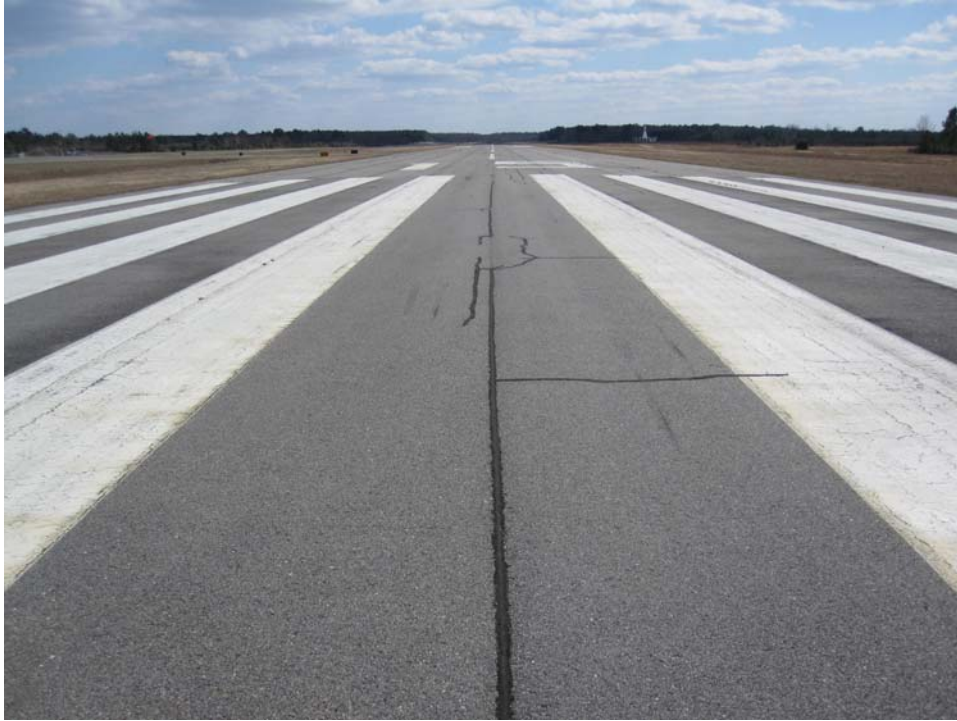
Runway 15-33 contained one section with a PCI value of 77. Low-severity longitudinal and transverse (L&T) cracking was observed throughout the section. The majority of the low-severity cracking was sealed. Bleeding was also recorded in smaller quantities.

R1533AL-10. Overview.

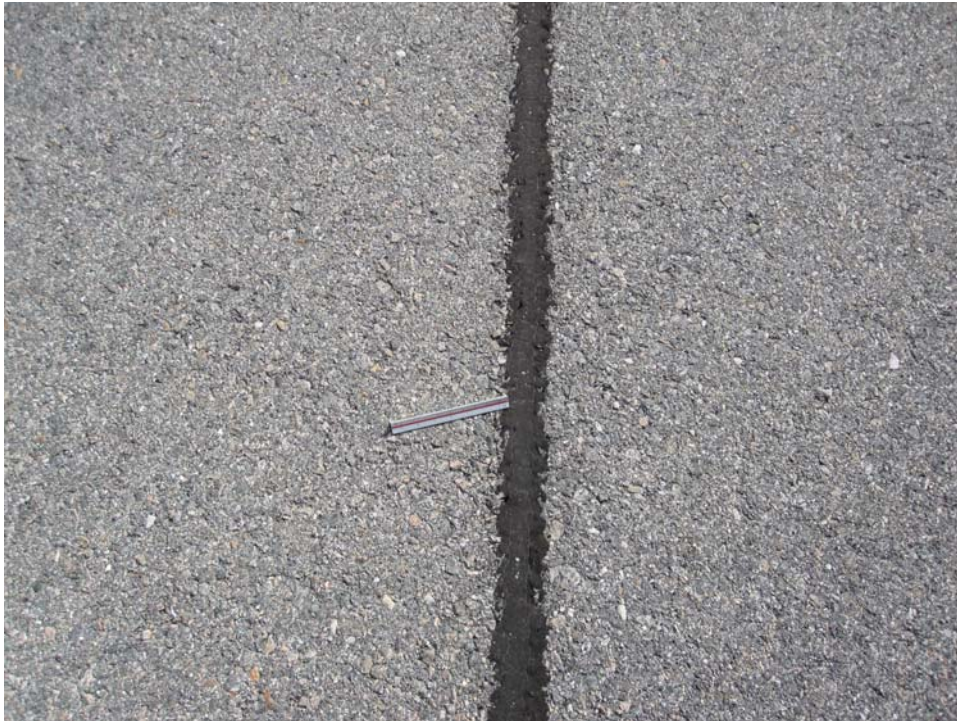
R1533AL-10. Longitudinal and Transverse Cracking (Sample Unit #95).

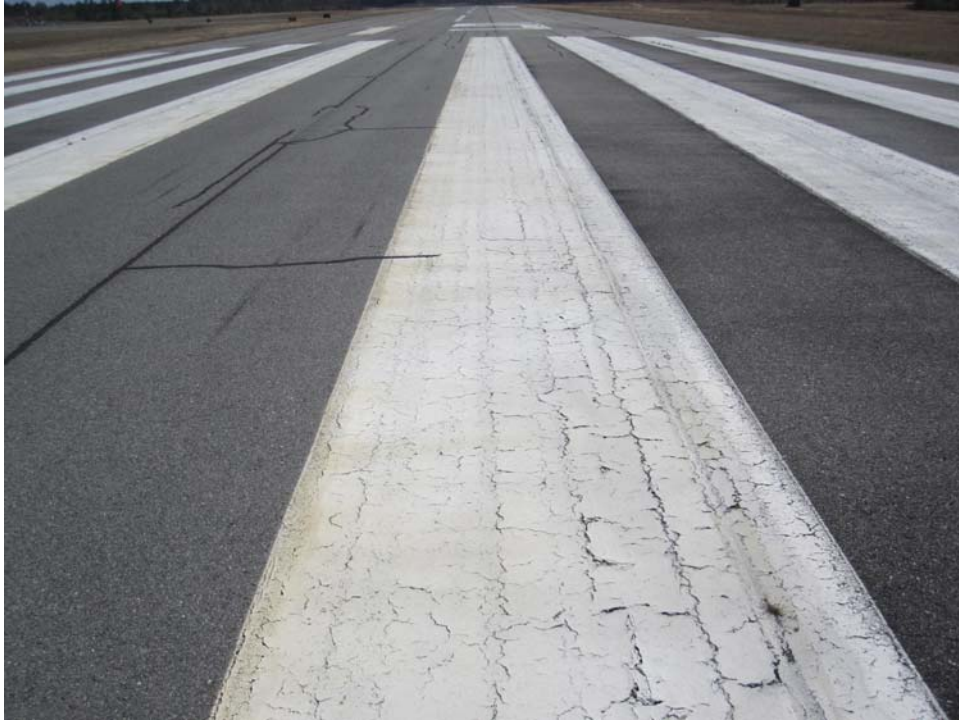
R1533AL-10. Satisfactory Paint.

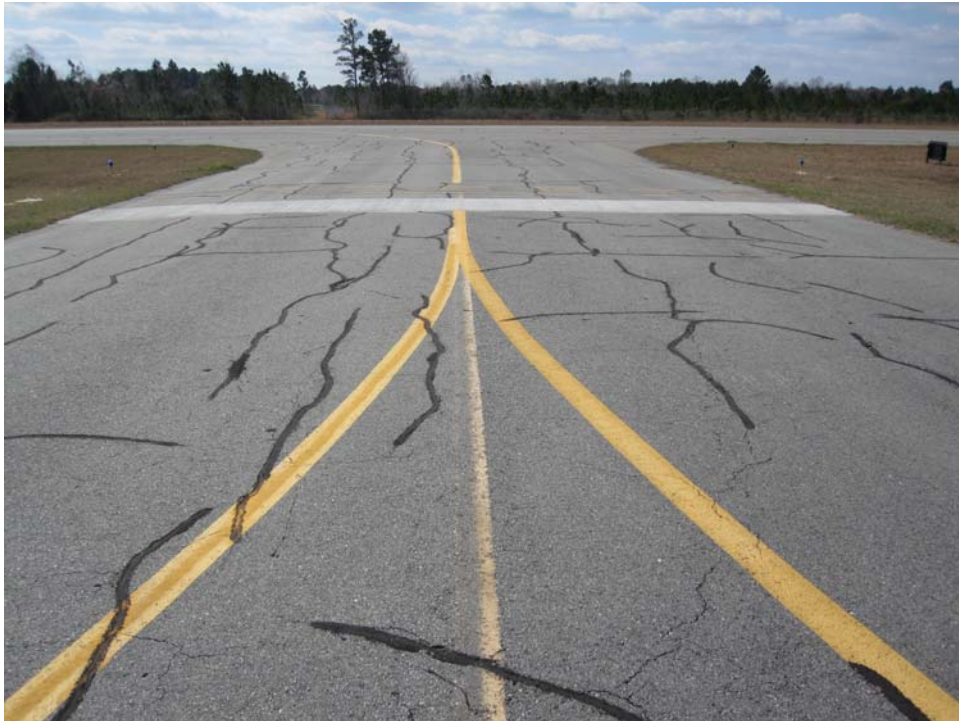
Taxiway A was defined by one section with a PCI value of 68. The primary distress identified in Section 10 was low-severity L&T cracking, the majority of which was sealed. Low-severity weathering was recorded where the asphalt binder appeared to be missing, leaving aggregate exposed along with low-severity swelling.

TAAL-10. Overview.

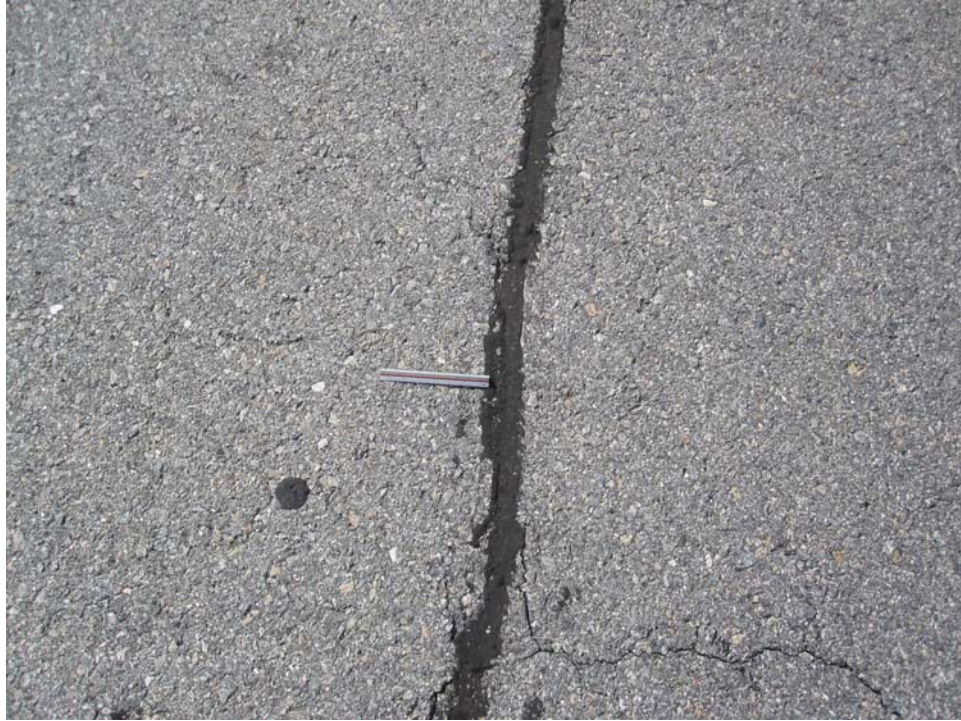
TAAL-10. Longitudinal and Transverse Cracking (Sample Unit #01).

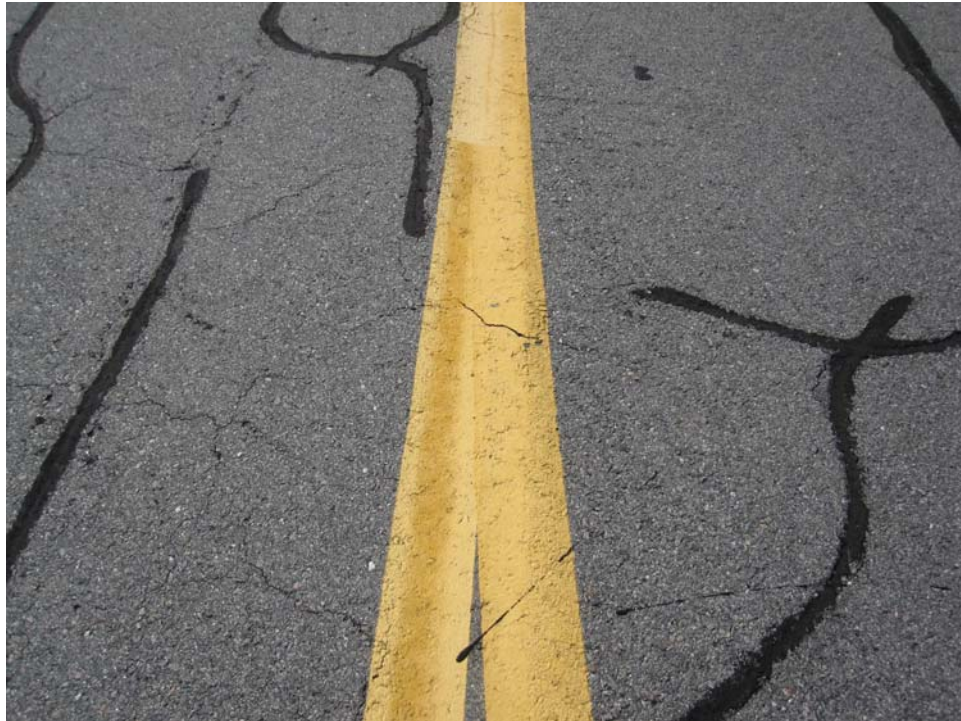
TAAL-10. Satisfactory Paint.

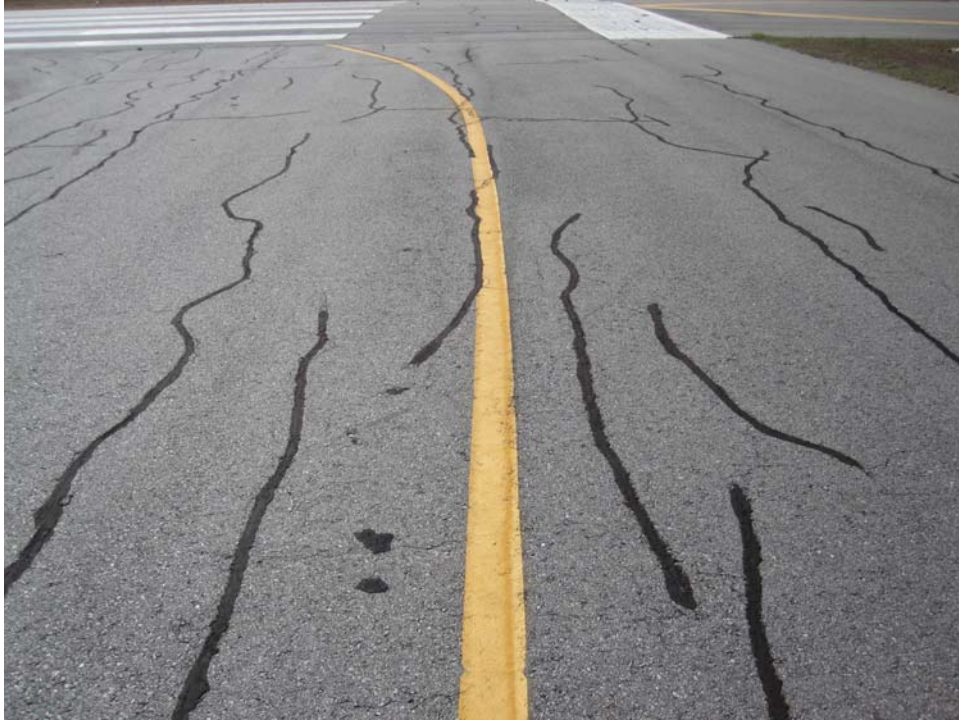
Taxiway B was comprised of four sections. Section 10 had a PCI value of 72. Low-severity L&T cracking was observed. The majority of the low-severity cracking was sealed. Low-severity weathering was also recorded. Section 20 had a PCI value of 89. Low-severity, unsealed L&T cracking was the only distress identified. Section 30 was in excellent condition with a PCI value of 96. Isolated quantities of low-severity, unsealed L&T cracking were observed. Section 40 was also in excellent condition with a PCI value of 100. No distresses were identified at the time of inspection.

TBAL-10. Overview.

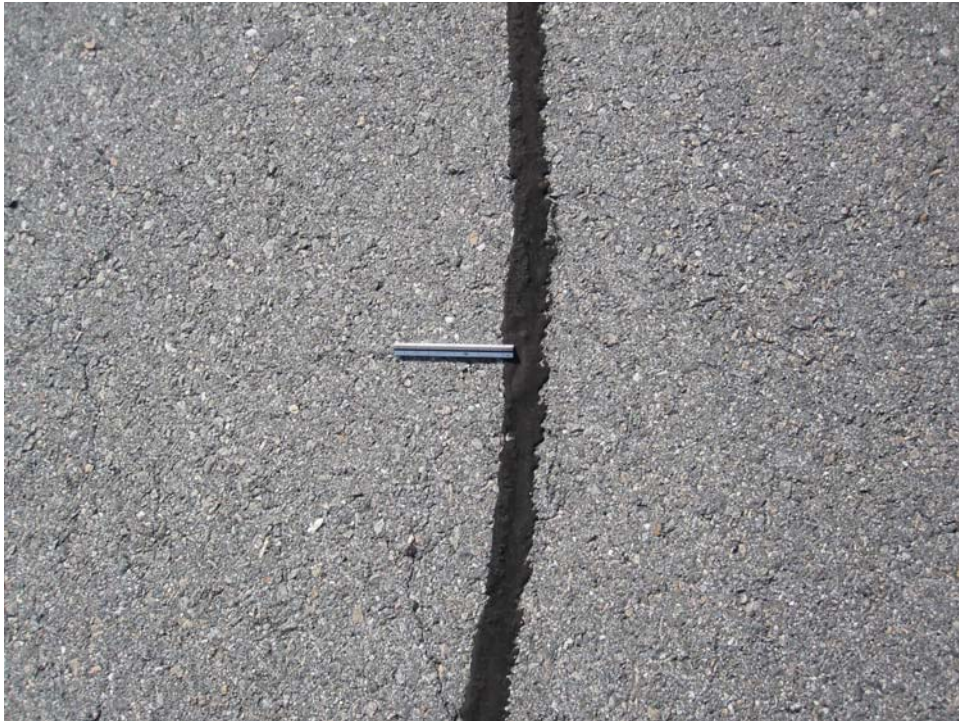
TBAL-10. Longitudinal and Transverse Cracking (Sample Unit #01).

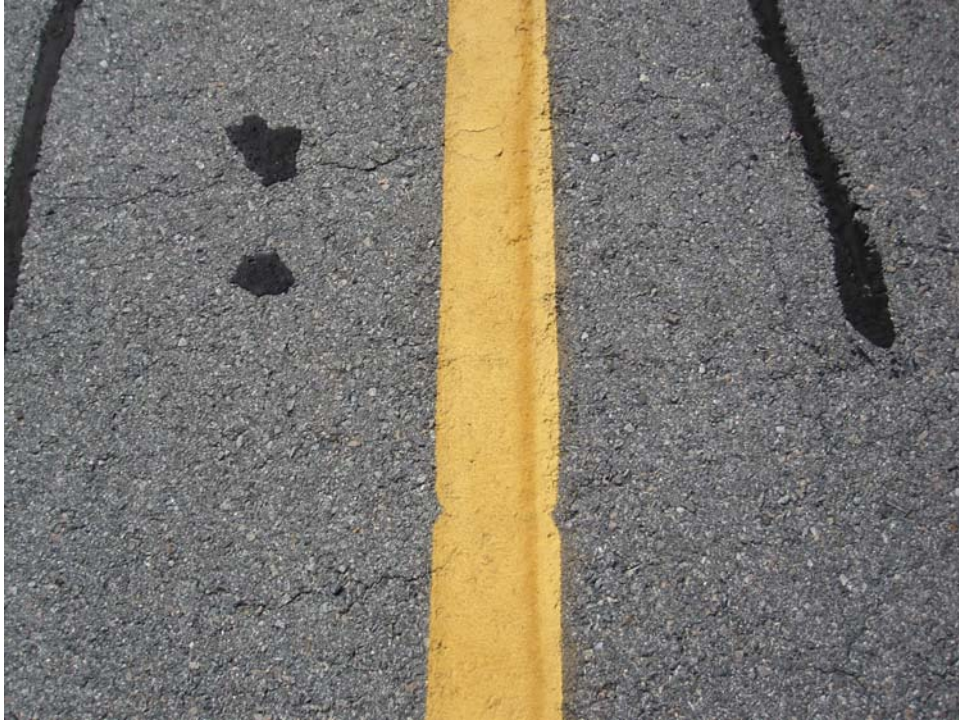
TBAL-10. Satisfactory Paint.

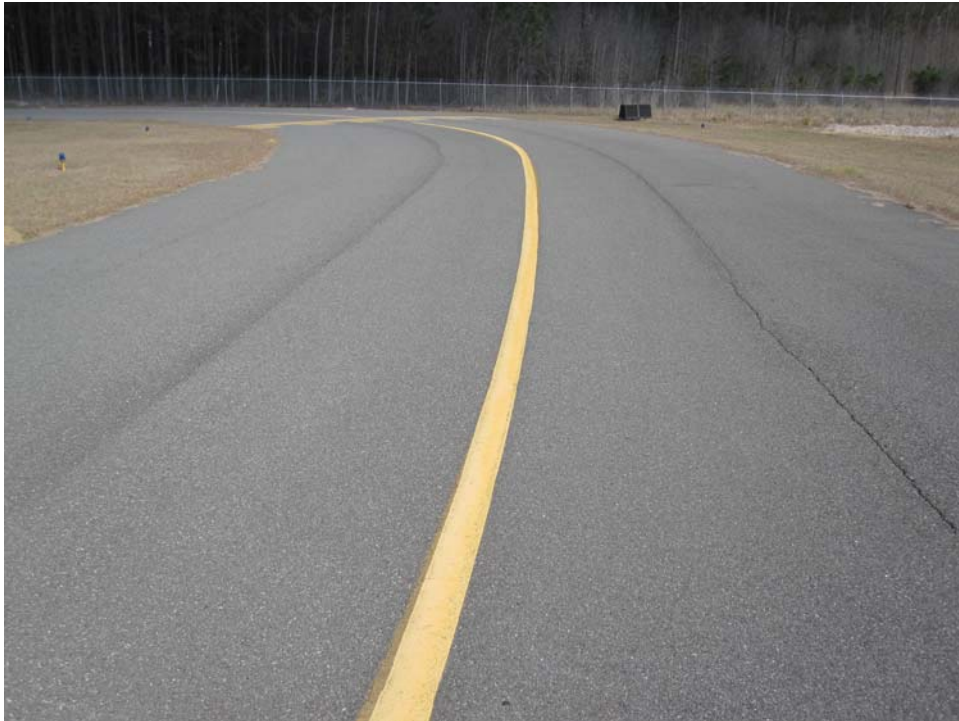
TBAL-20. Overview.

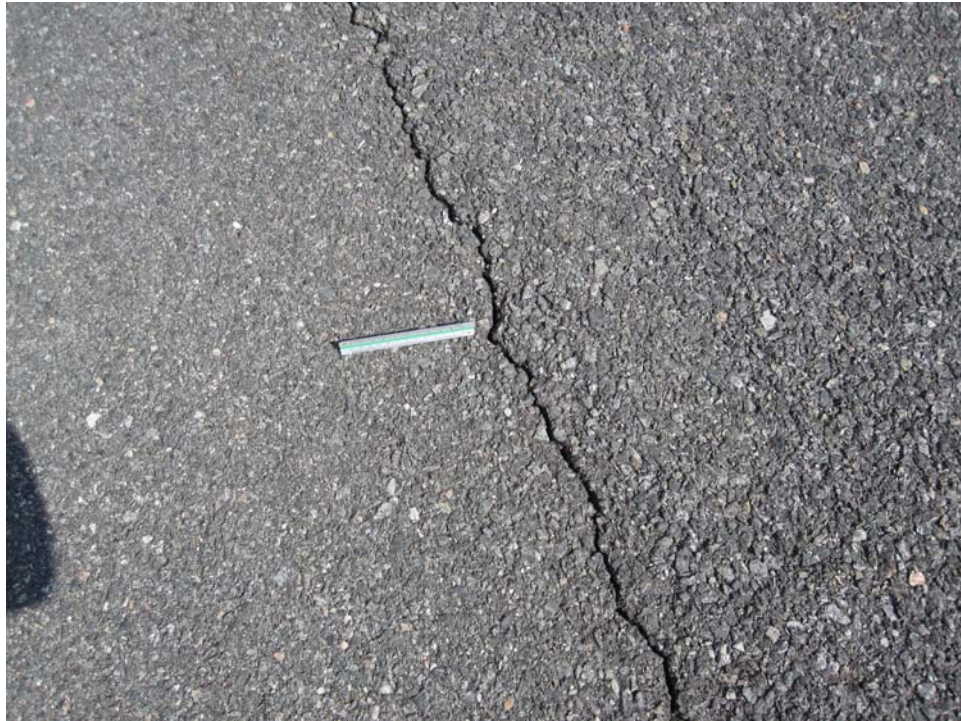
TBAL-20. Longitudinal and Transverse Cracking (Sample Unit #01).

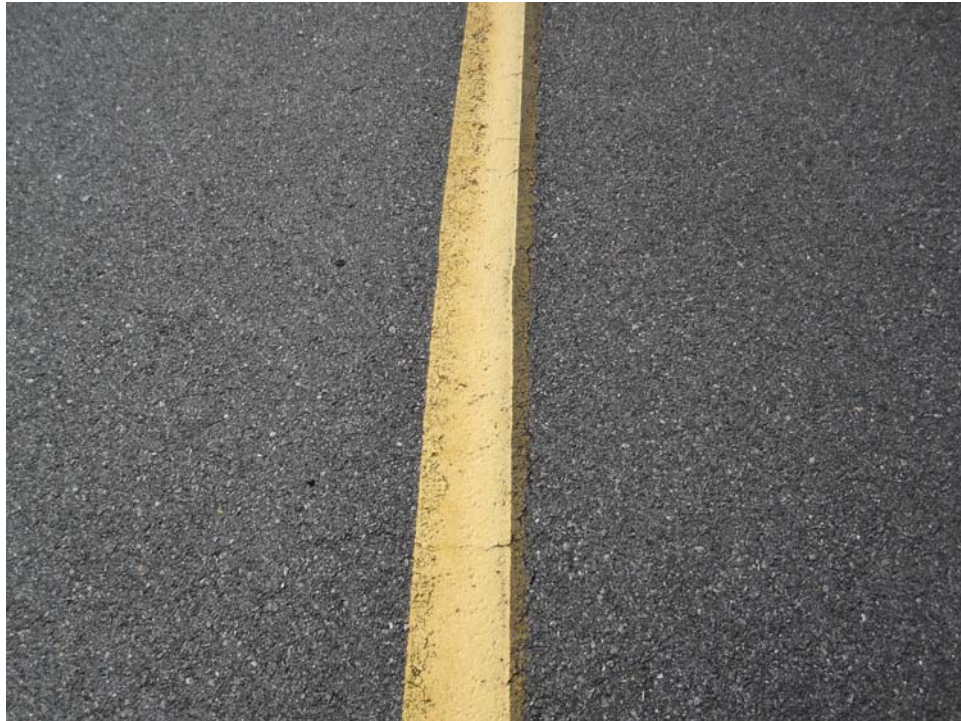
TBAL-20. Satisfactory Paint.

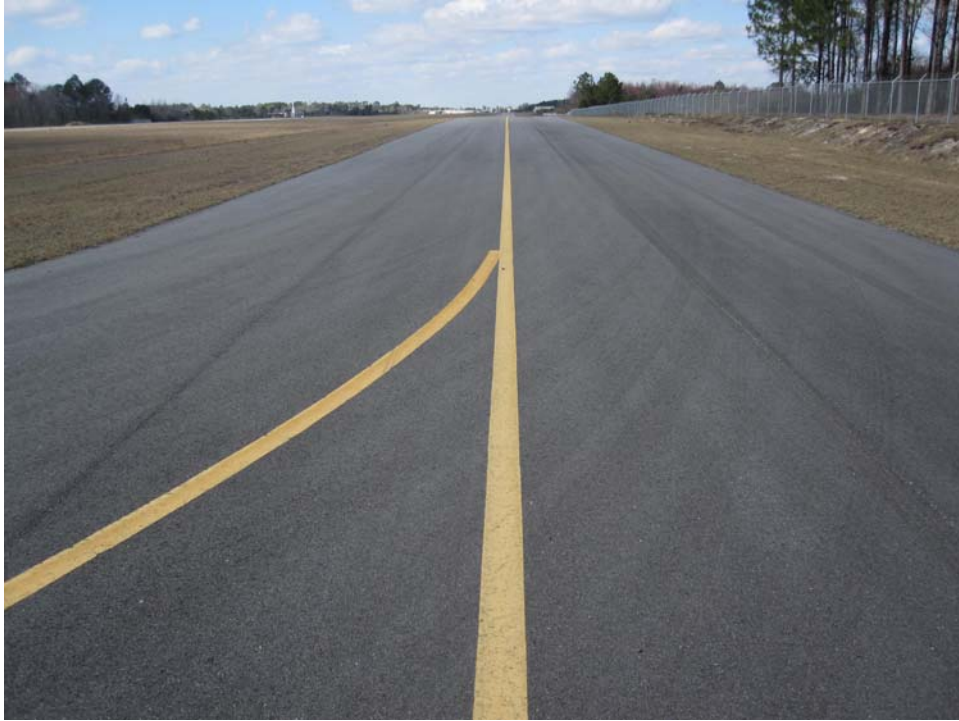
TBAL-30. Overview.

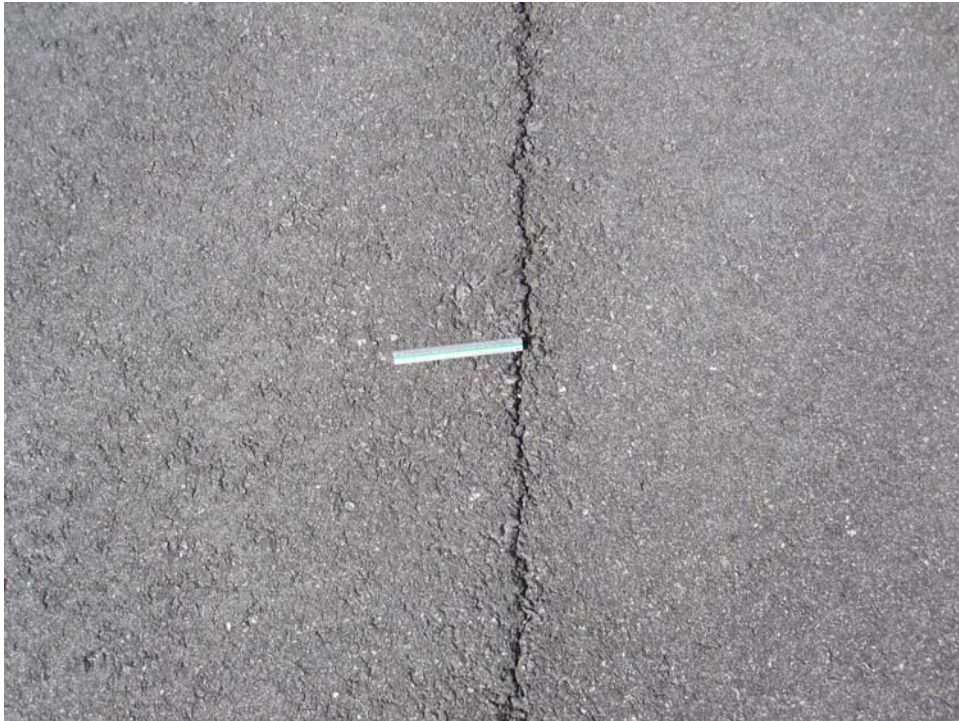
TBAL-30. Longitudinal and Transverse Cracking (Sample Unit #03).

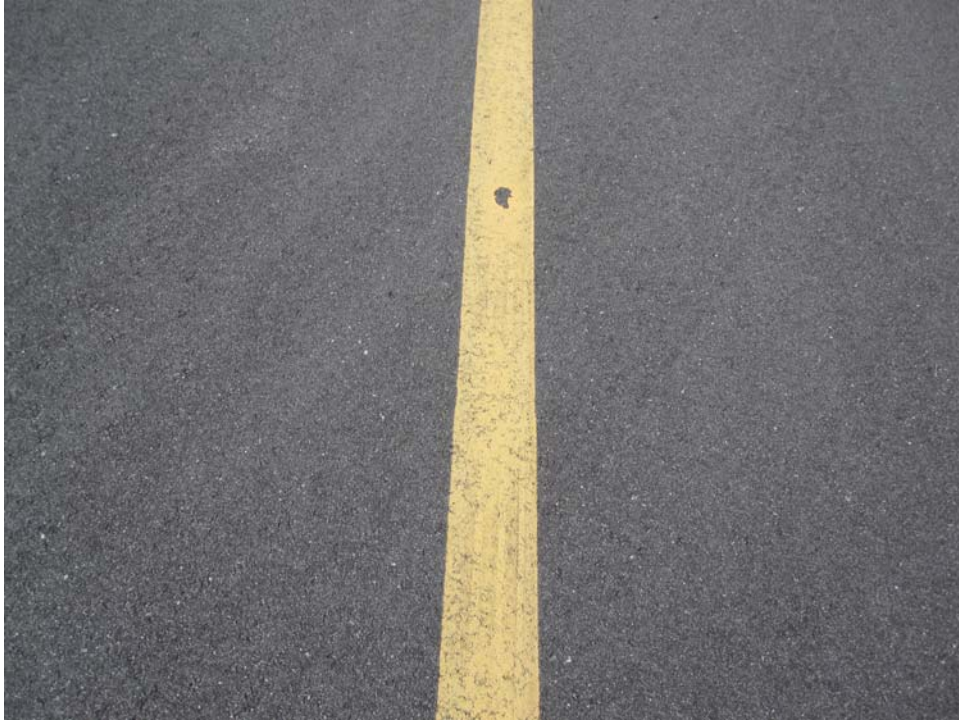
TBAL-30. Satisfactory Paint.

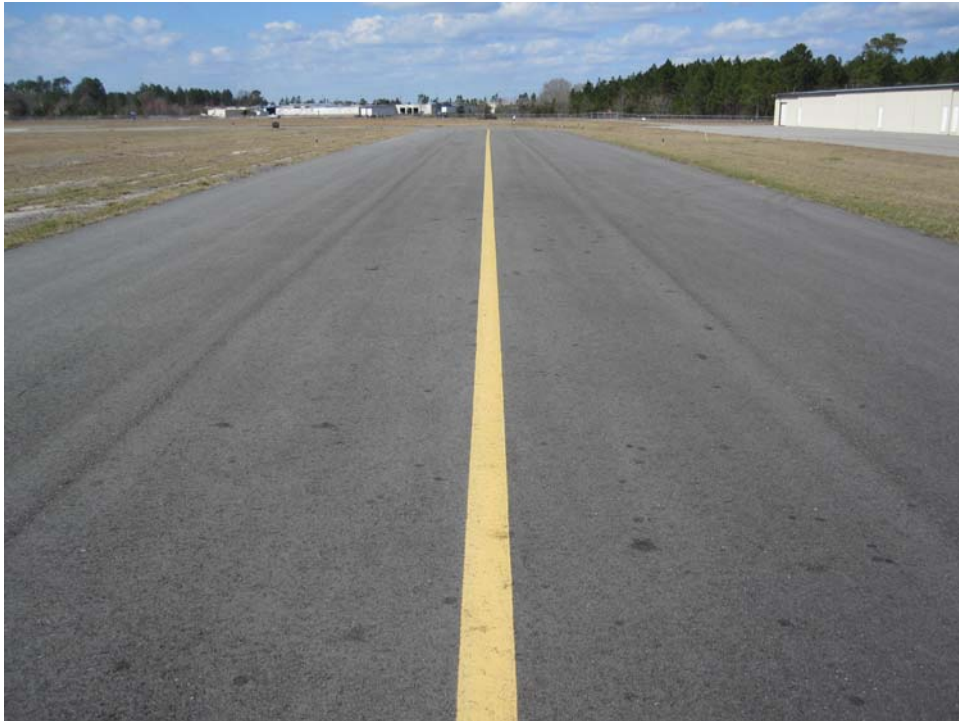
TBAL-40. Overview.

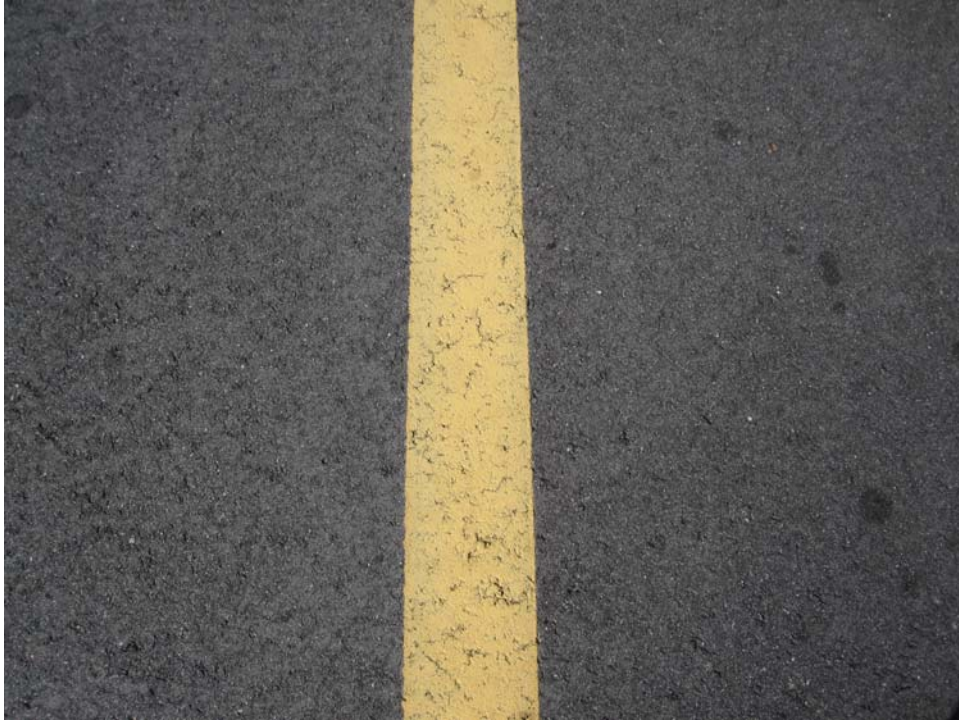
TBAL-40. Satisfactory Paint.

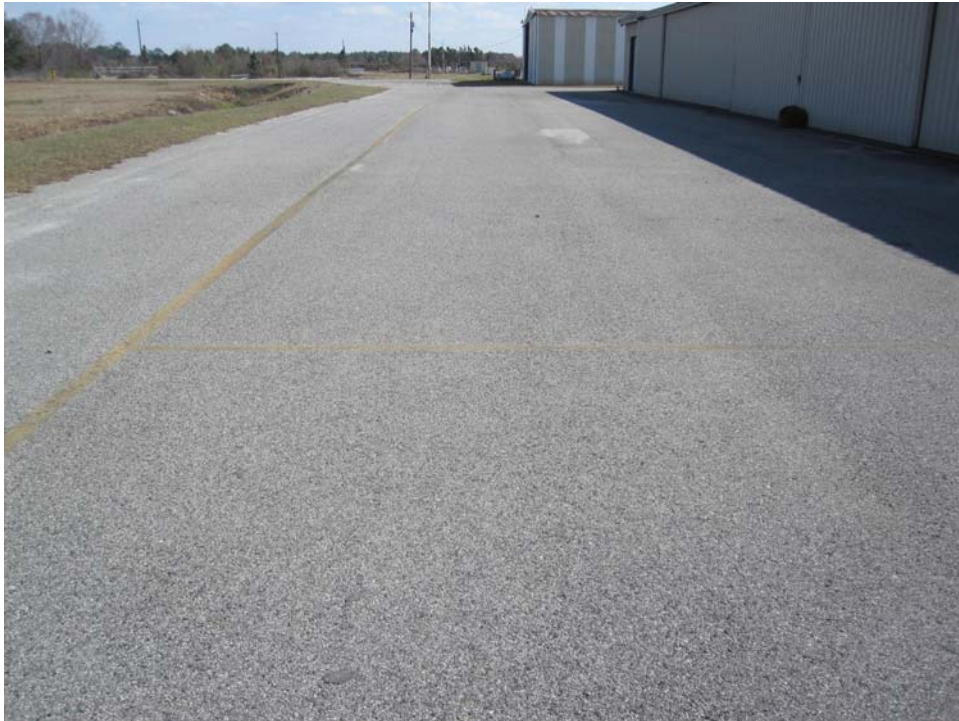
The T-Hangar area was defined by one section with a PCI value of 89. Low-severity weathering was recorded in areas where asphalt binder appeared to be missing, leaving aggregate exposed. Isolated quantities of low-severity, unsealed L&T cracking and low-severity raveling and alligator cracking were also identified.

THANGAL-10. Overview.

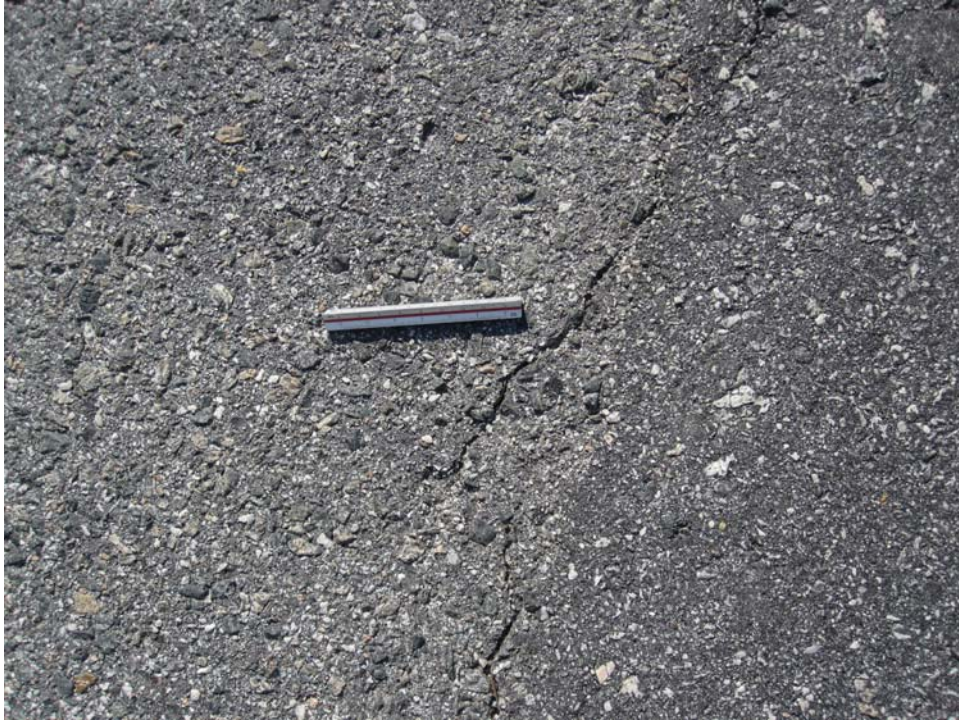
THANGAL-10. Longitudinal and Transverse Cracking (Sample Unit #03).

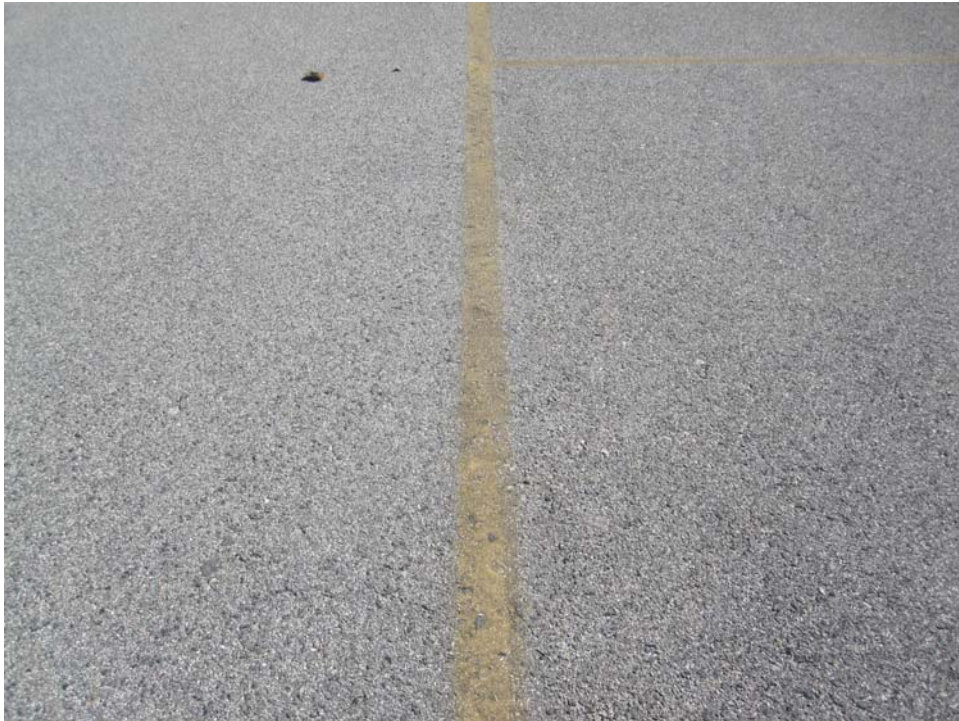
THANGAL-10. Unsatisfactory Paint.
