2012 Homerville Airport Pavement Management Plan

HOMERVILLE AIRPORT

PAVEMENT MANAGEMENT REPORT

DECEMBER 2012

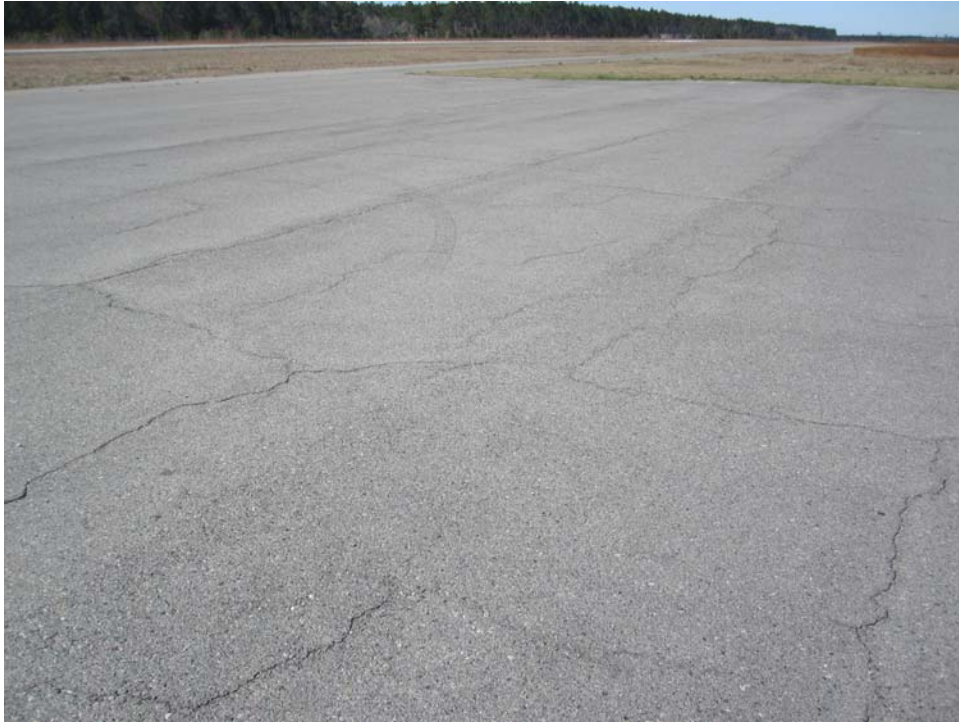
The apron area was defined by two sections. Section 10 had a PCI value of 56. Substantial quantities of low-severity block cracking and weathering were identified throughout. Isolated quantities of low-severity swelling and raveling were also observed. Section 20 had a PCI value of 96. Distresses identified were low-severity, unsealed L&T cracking and low-severity raveling and swelling.

A01HO-10. Overview.

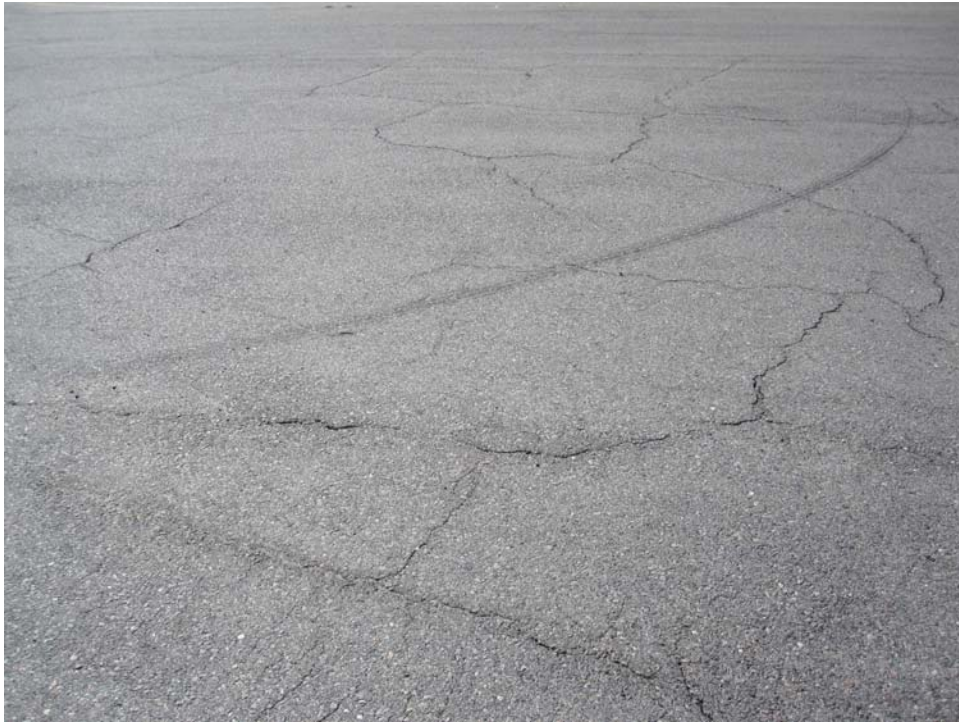
A01HO-10. Block Cracking (Sample Unit #03).

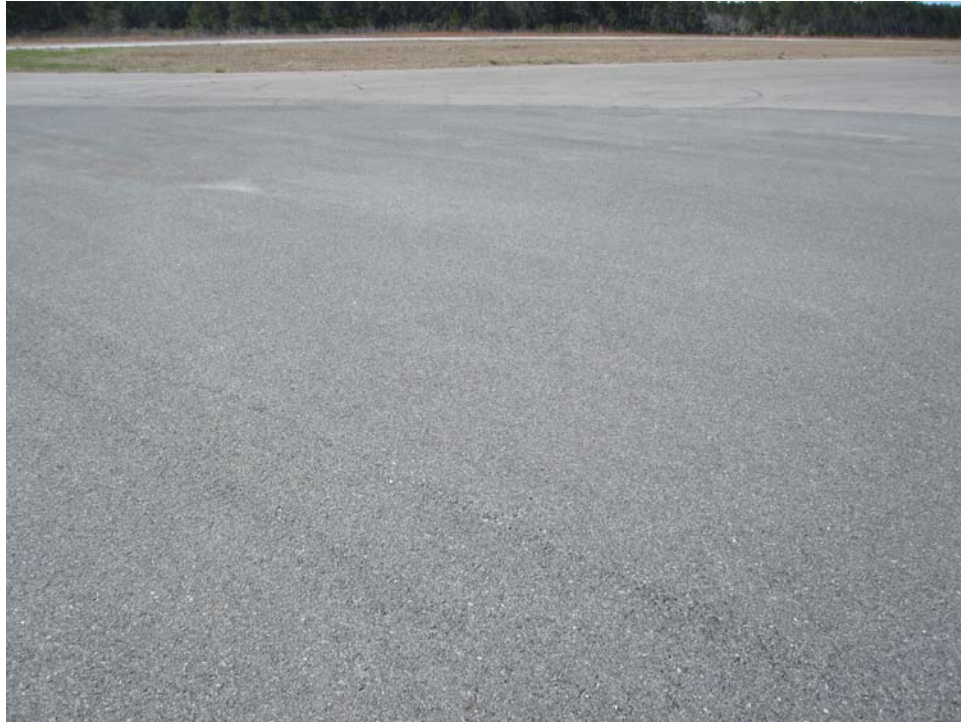
A01HO-20. Overview.

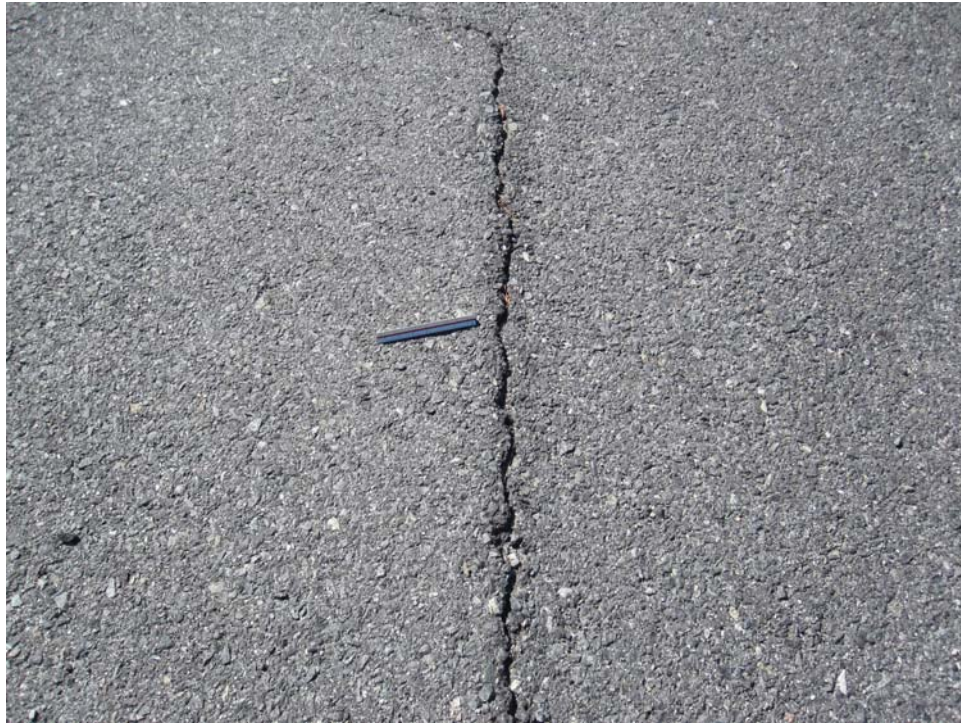
A01HO-20. Longitudinal and Transverse Cracking (Sample Unit #02).

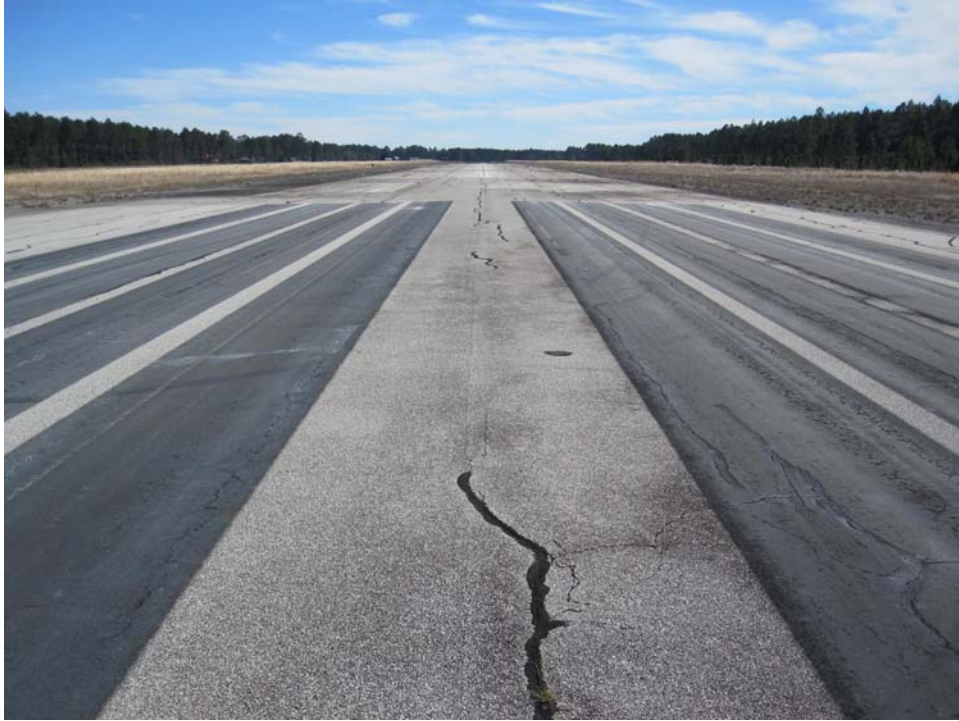
Runway 14-32 was defined by one section with a PCI value of 56. Several distresses were recorded, including low- and medium-severity longitudinal and transverse (L&T) cracking and low-severity block cracking, weathering, and swelling. Low-severity cracking was observed in both sealed and unsealed conditions, while medium-severity cracking was recorded where the crack sealant was performing unsatisfactorily and no longer prevented water from penetrating the pavement surface.

R1432HO-10. Overview.

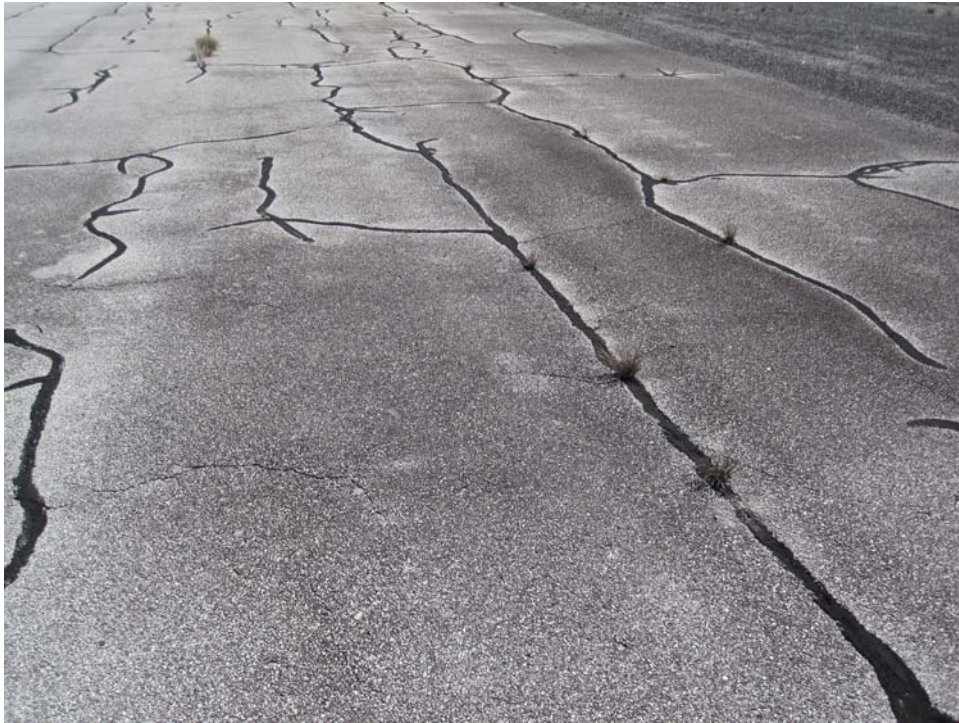
R1432HO-10. Block Cracking (Sample Unit #06).

Sample Number: 06 Type: R Area: 5,625.00SqFt PCI = 51
Sample Comments:
43 BLOCK CRACKING L 1,000.00 SqFt Comments:
57 WEATHERING L 400.00 SqFt Comments:
48 LONGITUDINAL/TRANSVERSE CRACKING M 611.00 Ft Comments:fs
48 LONGITUDINAL/TRANSVERSE CRACKING L 72.00 Ft Comments:lu

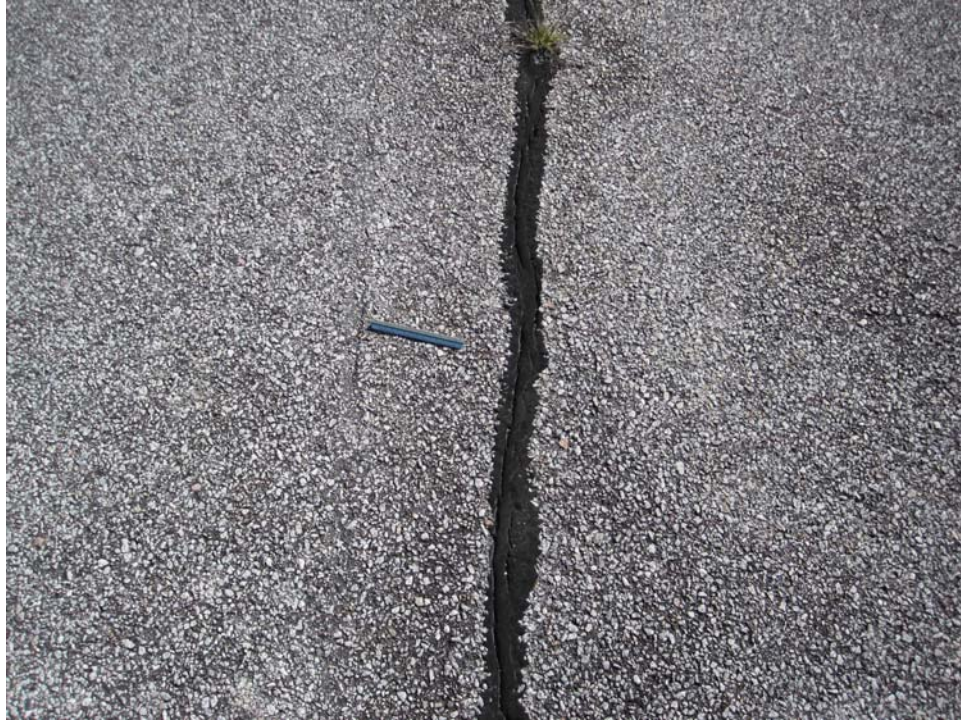
R1432HO-10. Longitudinal and Transverse Cracking (Sample Unit #06).

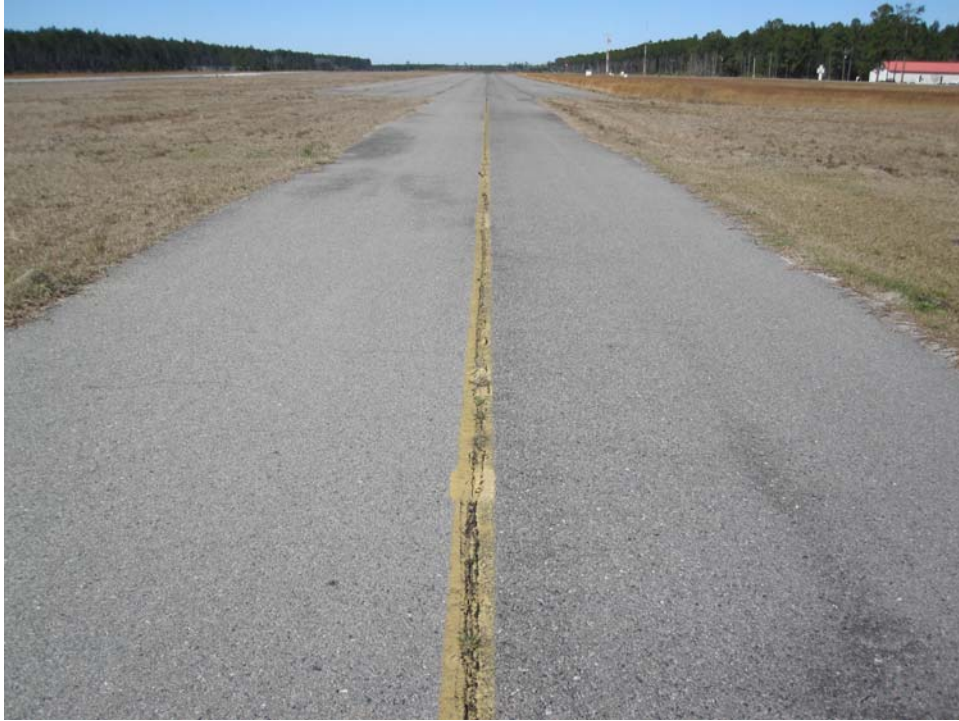
Taxiway A consisted of one section with a PCI value of 66. The primary distress identified was medium-severity L&T cracking where the crack sealant was no longer performing satisfactorily. In addition, low-severity, unsealed L&T cracking was observed in smaller quantities. Low-severity weathering was also recorded throughout Section 10.

TAHO-10. Overview.

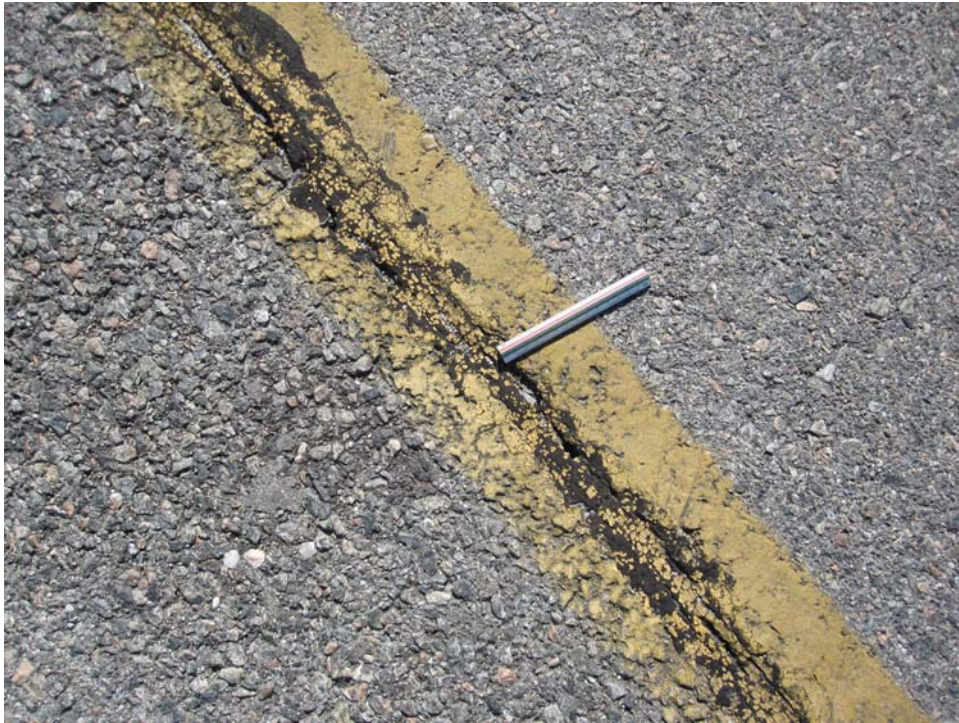
TAHO-10. Longitudinal and Transverse Cracking (Sample Unit #25).

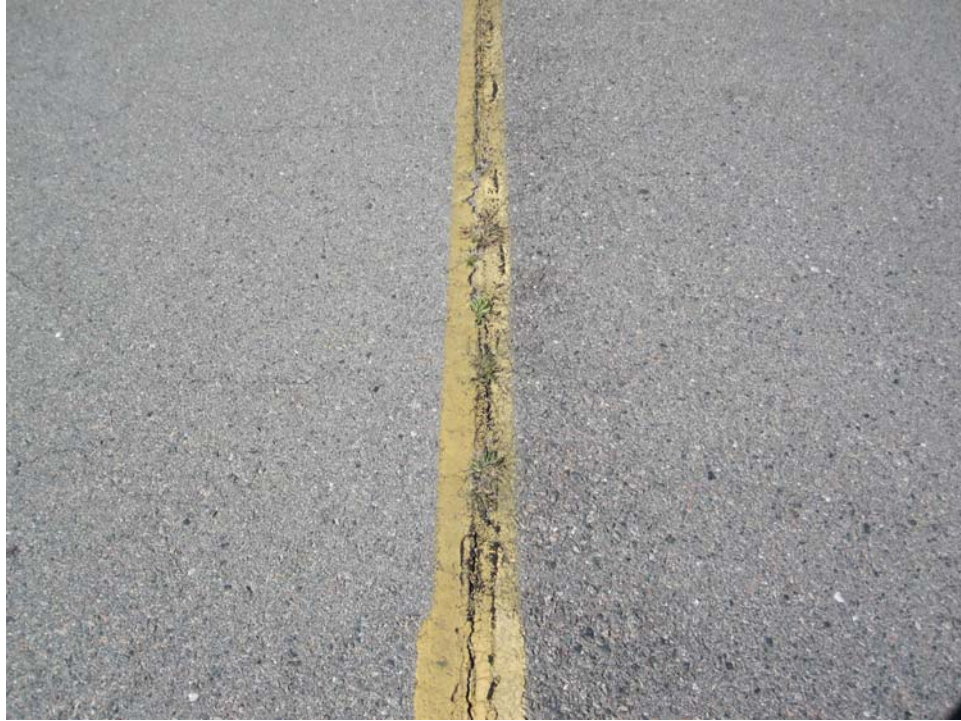
TAHO-10. Unsatisfactory Paint.
