# 2012 Jekyll Island Airport Pavement Management Plan

# JEKYLL ISLAND AIRPORT

## PAVEMENT MANAGEMENT REPORT

**DECEMBER 2012**

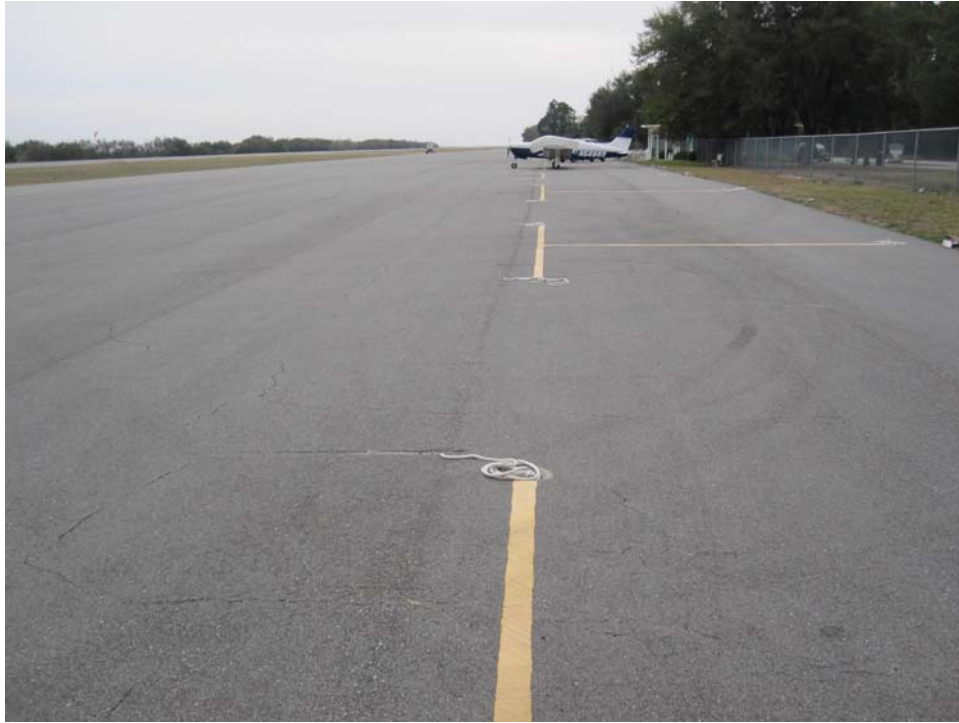
The apron area was comprised of one section in similar condition to the taxiway pavement with a PCI value of 67. Large amounts of low-severity, unsealed L&T cracking were identified throughout the section along with smaller quantities of low-severity swelling.

A01JK-10. Overview.

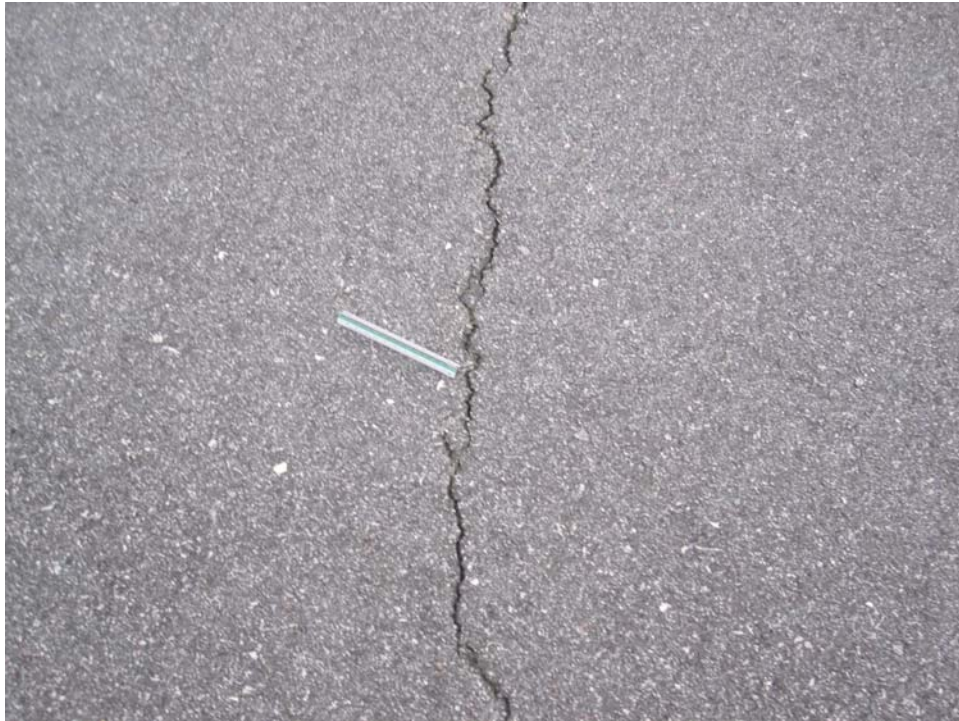
A01JK-10. Longitudinal and Transverse Cracking (Sample Unit #02).

Sample Number: 02 Type: R Area: 5,400.00SqFt PCI = 74  
Sample Comments:  
48 LONGITUDINAL/TRANSVERSE CRACKING L 505.00 Ft Comments:lu  
56 SWELLING L 65.00 SqFt Comments:

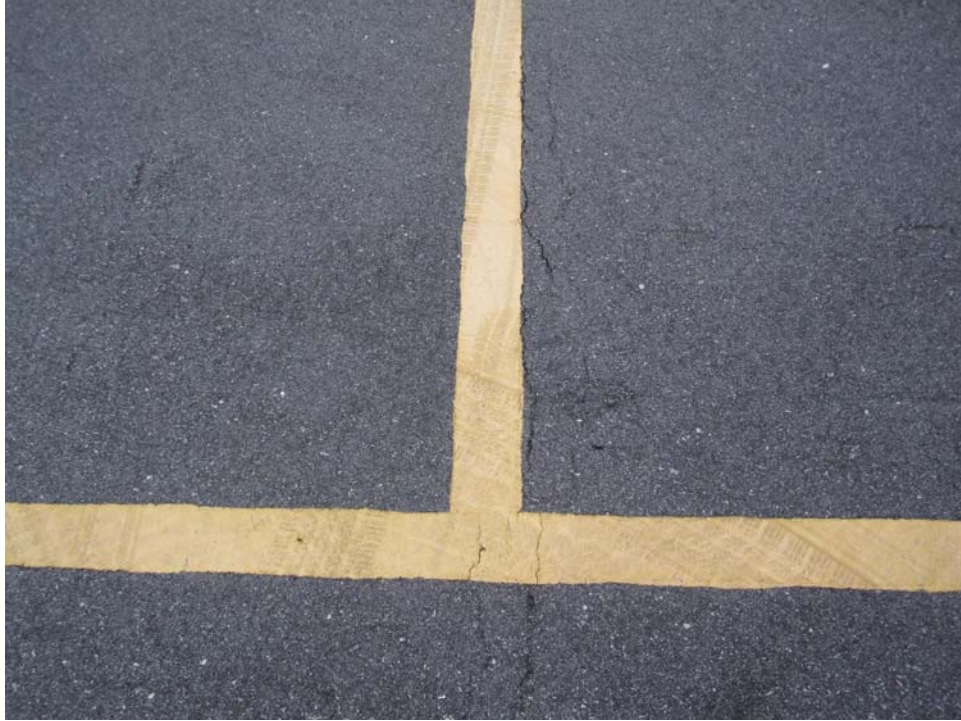
A01JK-10. Satisfactory Paint.

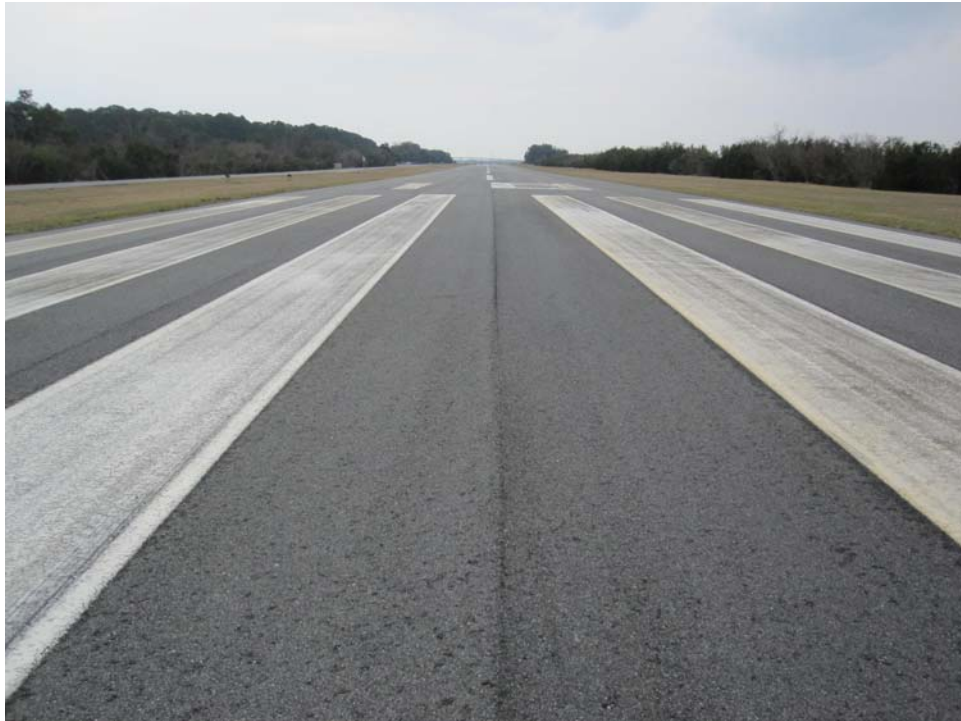
Runway 18-36 was defined by one section with a PCI of 86. Low-severity, unsealed longitudinal and transverse (L&T) cracking was observed mostly along the paving seams. An isolated area with a large low-severity patch was inspected as an additional sample unit in accordance with ASTM D5340.

R1836JK-10. Overview.

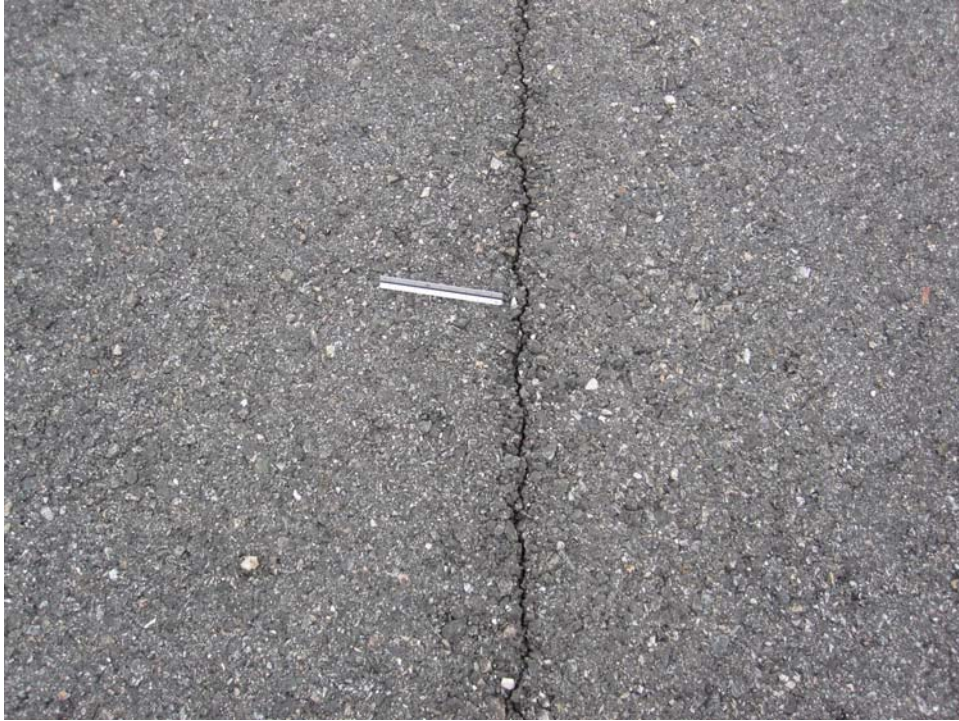
R1836JK-10. Longitudinal and Transverse Cracking (Sample Unit #45).

Sample Number: 45 Type: R Area: 5,625.00SqFt PCI = 89  
Sample Comments:  
48 LONGITUDINAL/TRANSVERSE CRACKING L 190.00 Ft Comments:lu

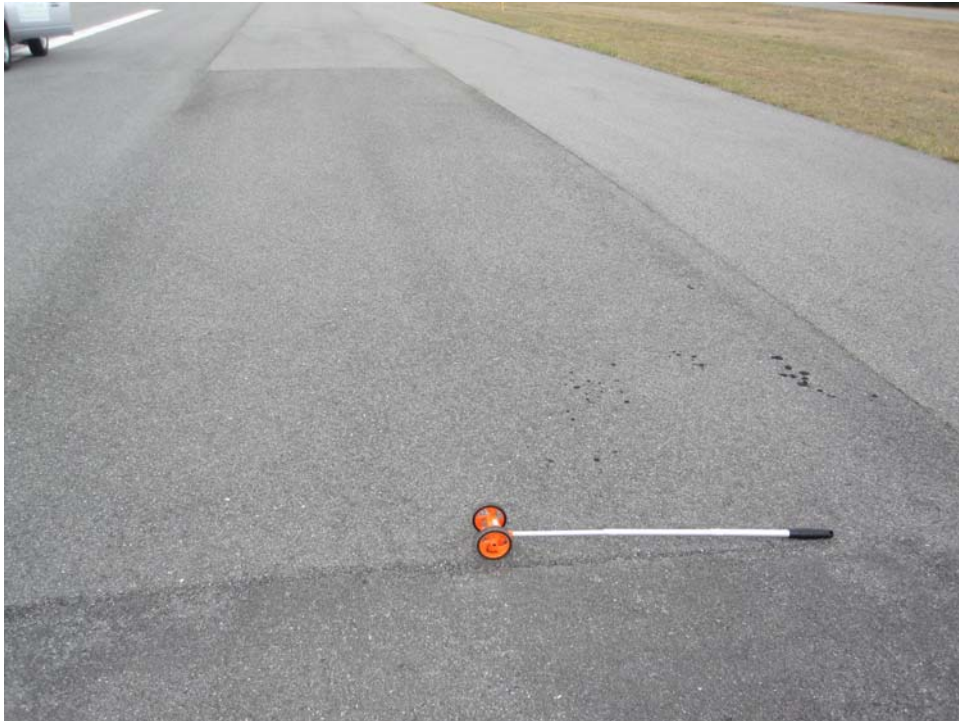
R1836JK-10. Patching (Additional Sample Unit #31).

Sample Number: 31 Type: A Area: 5,625.00SqFt PCI = 75  
Sample Comments:  
50 PATCHING L 1,125.00 SqFt Comments:  
48 LONGITUDINAL/TRANSVERSE CRACKING L 149.00 Ft Comments:lu

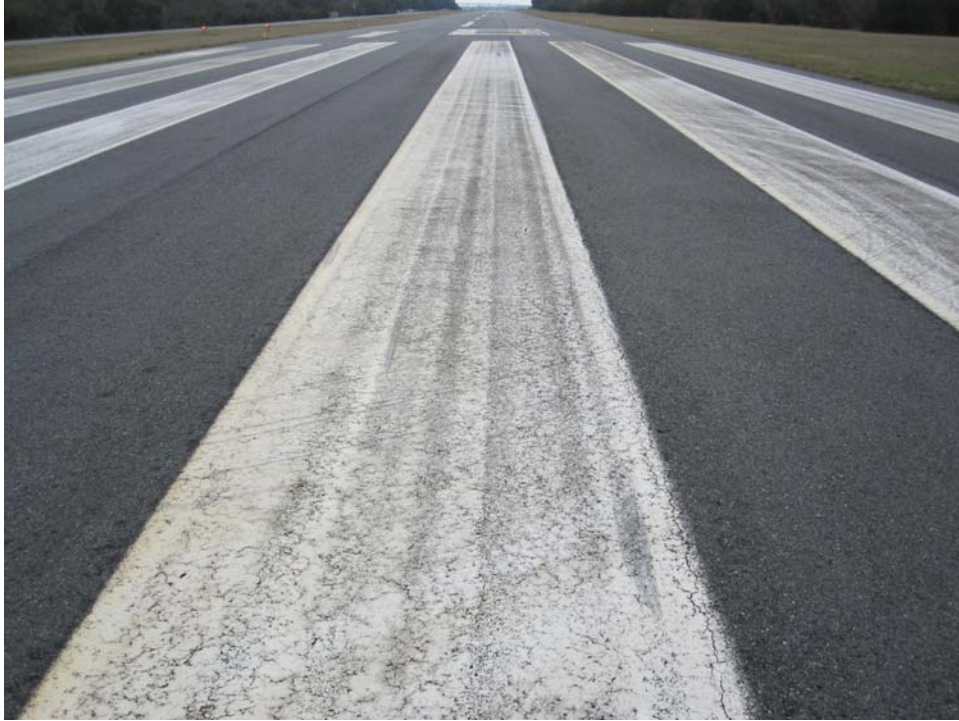
R1836JK-10. Satisfactory Paint.

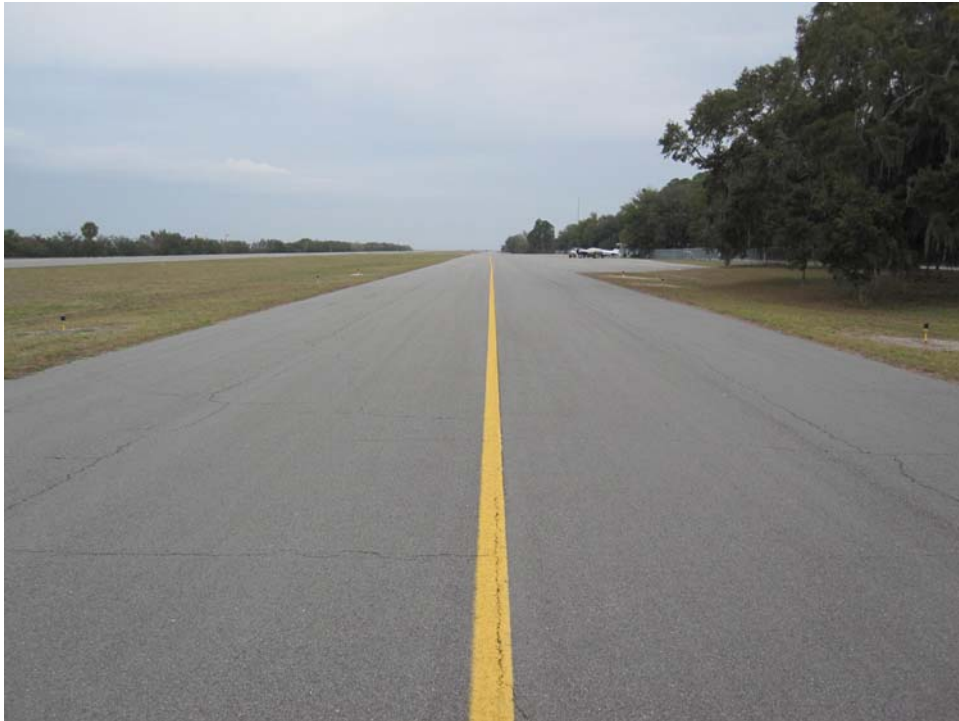
Taxiway A consisted of one section with a PCI value of 70. Substantial quantities of low-severity, unsealed L&T cracking were observed throughout Section 10. Low-severity swelling was also recorded in smaller quantities.

TAJK-10. Overview.

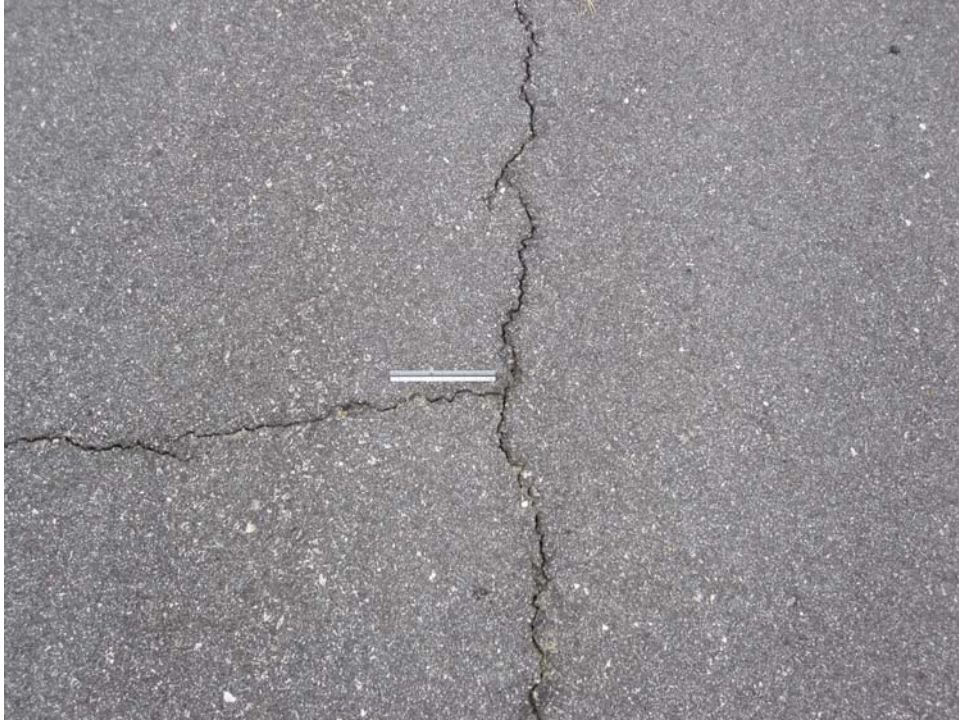
TAJK-10. Longitudinal and Transverse Cracking (Sample Unit #03).

Sample Number: 03 Type: R Area: 5,000.00SqFt PCI = 66  
Sample Comments:  
56 SWELLING L 50.00 SqFt Comments:  
48 LONGITUDINAL/TRANSVERSE CRACKING L 871.00 Ft Comments:lu

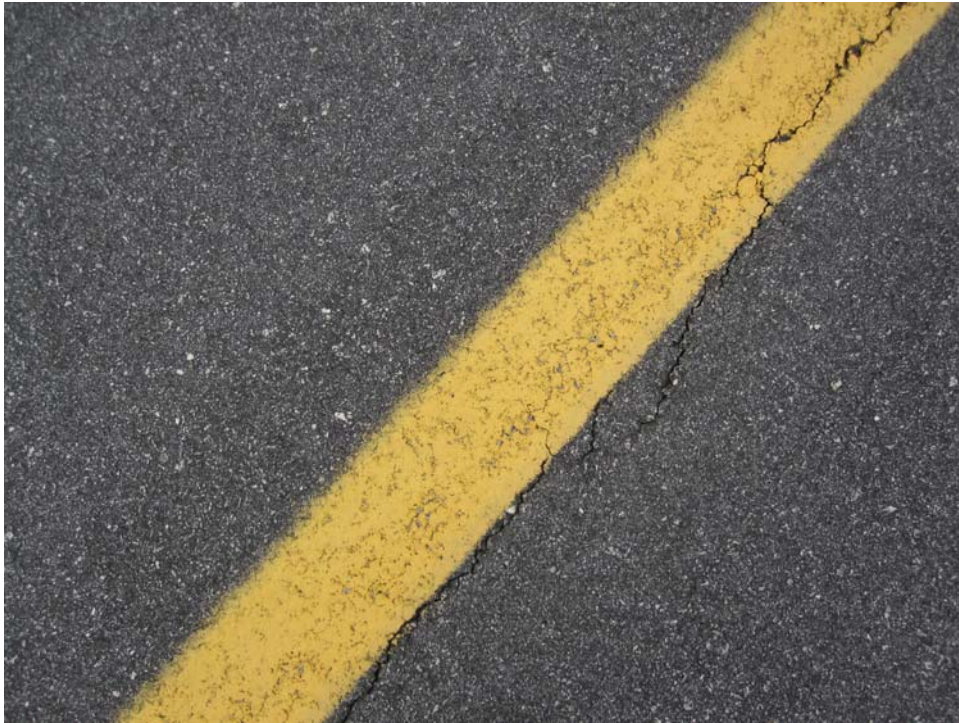
TAJK-10. Satisfactory Paint.
