2012 Millen Airport Pavement Management Plan

MILLEN AIRPORT

PAVEMENT MANAGEMENT REPORT

DECEMBER 2012

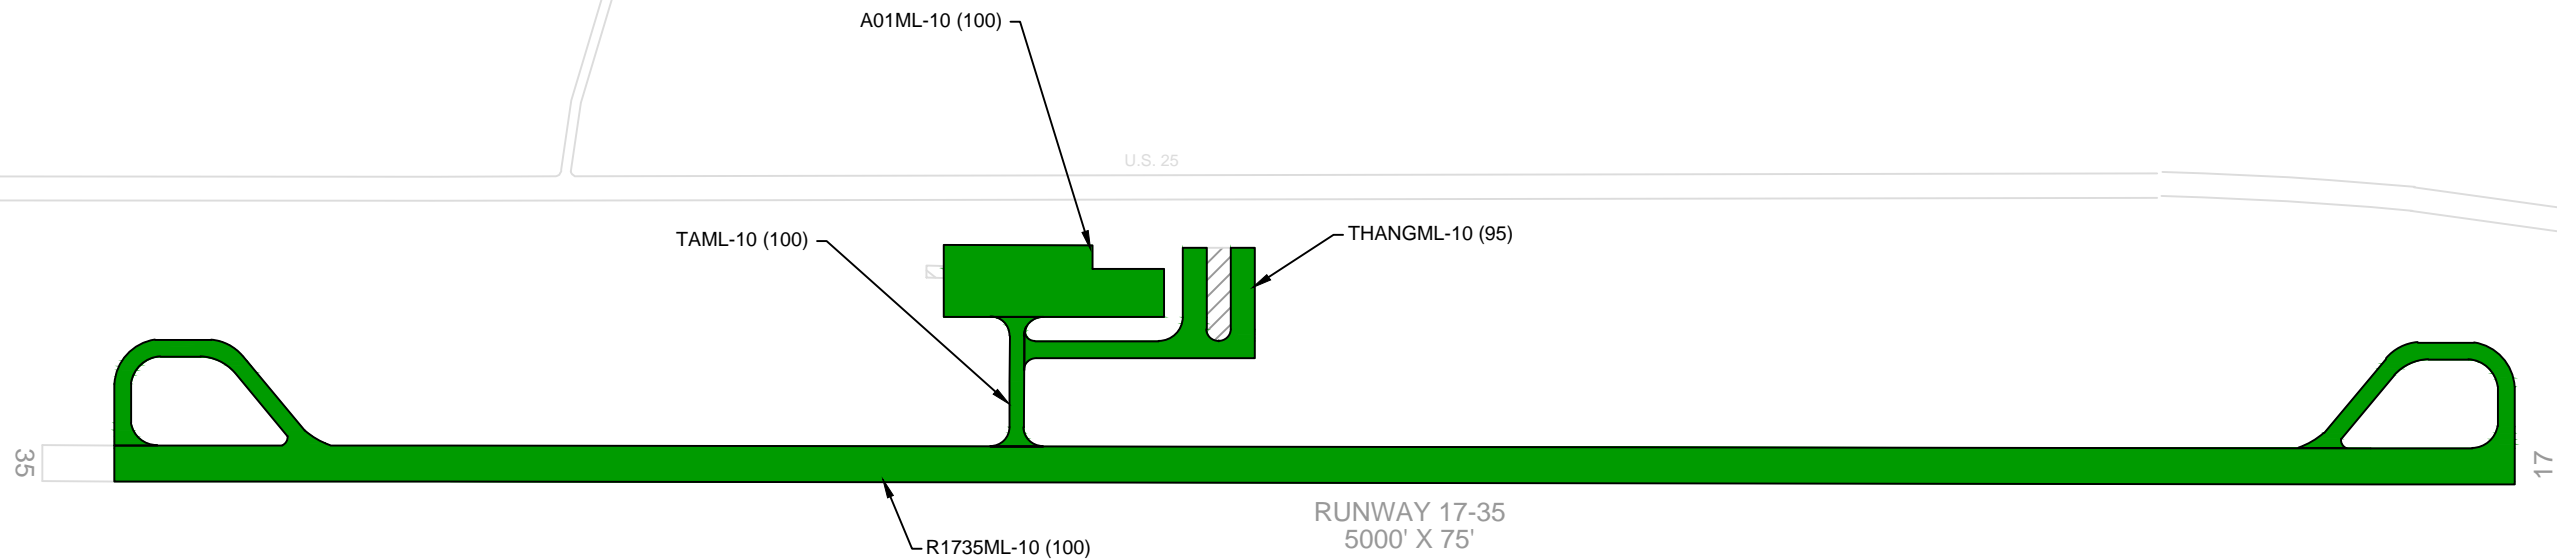
The 2012 area-weighted condition of Millen Airport is 100, with conditions ranging from 95 to 100 [on a scale of 0 (failed) to 100 (excellent)]. This compares to a 2007 PCI of 79.

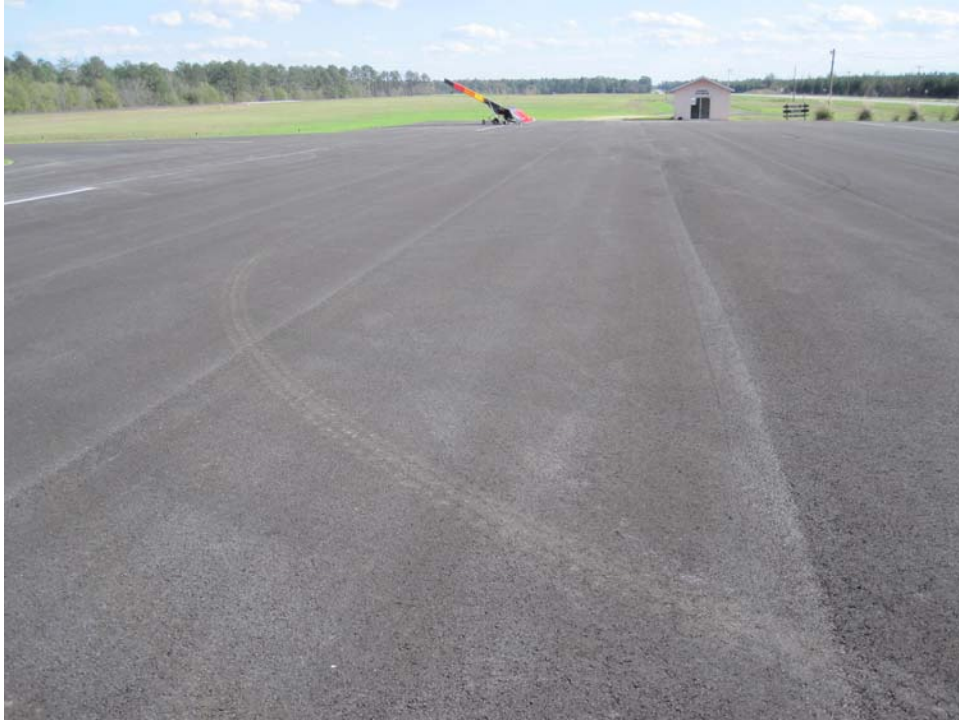
Taxiway A was defined by one section. Section 10 was in excellent condition with a PCI value of 100. No distresses were identified in this section.

A01ML-10. Overview.

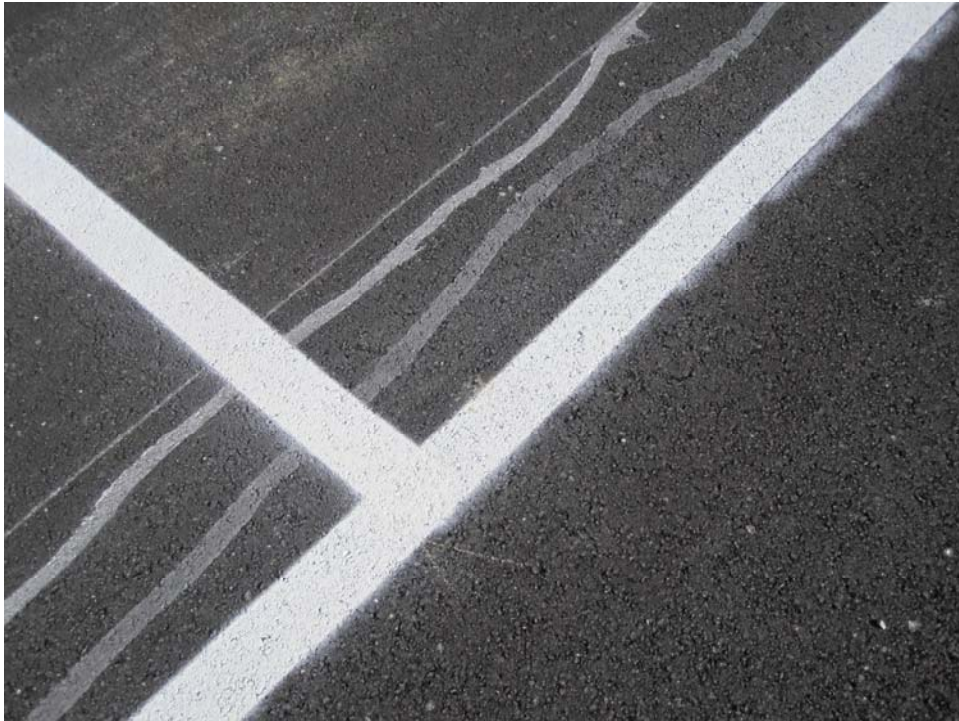
A01ML-10. Satisfactory Paint.

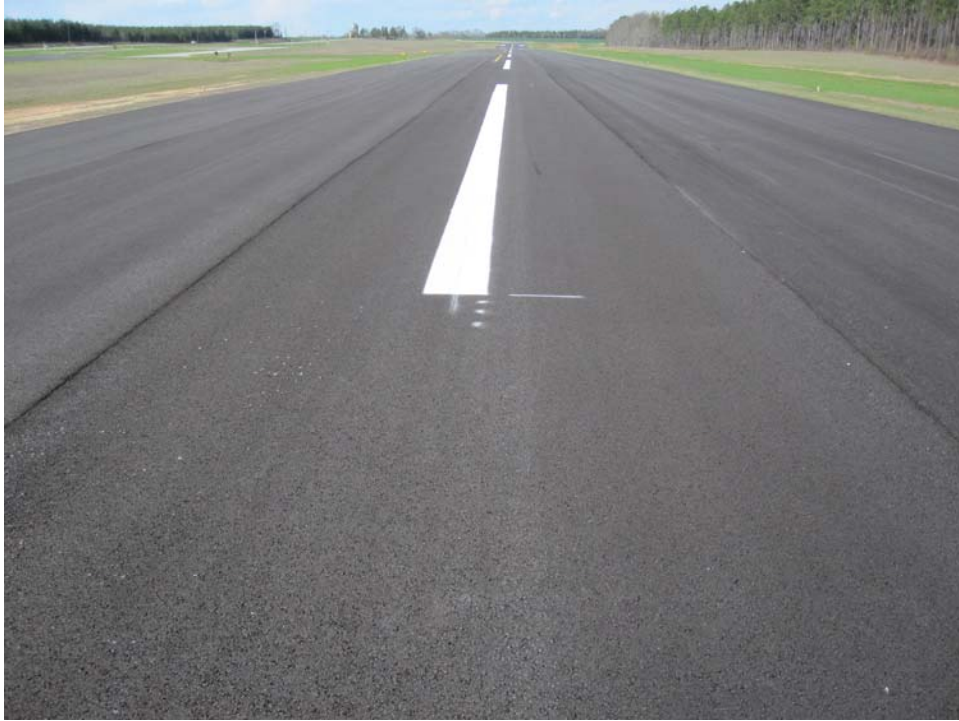
Runway 17-35 was comprised of one section in excellent condition with a PCI value of 100. No distresses were observed in Section 10 at the time of inspection.

R1735ML-10. Overview.

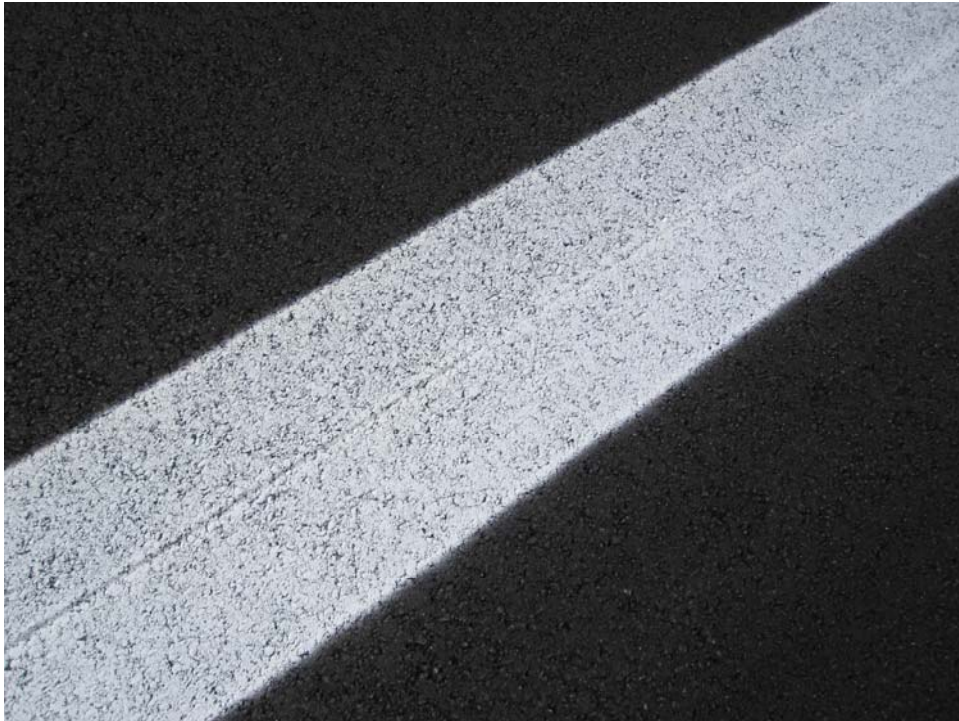
R1735ML-10. Satisfactory Paint.

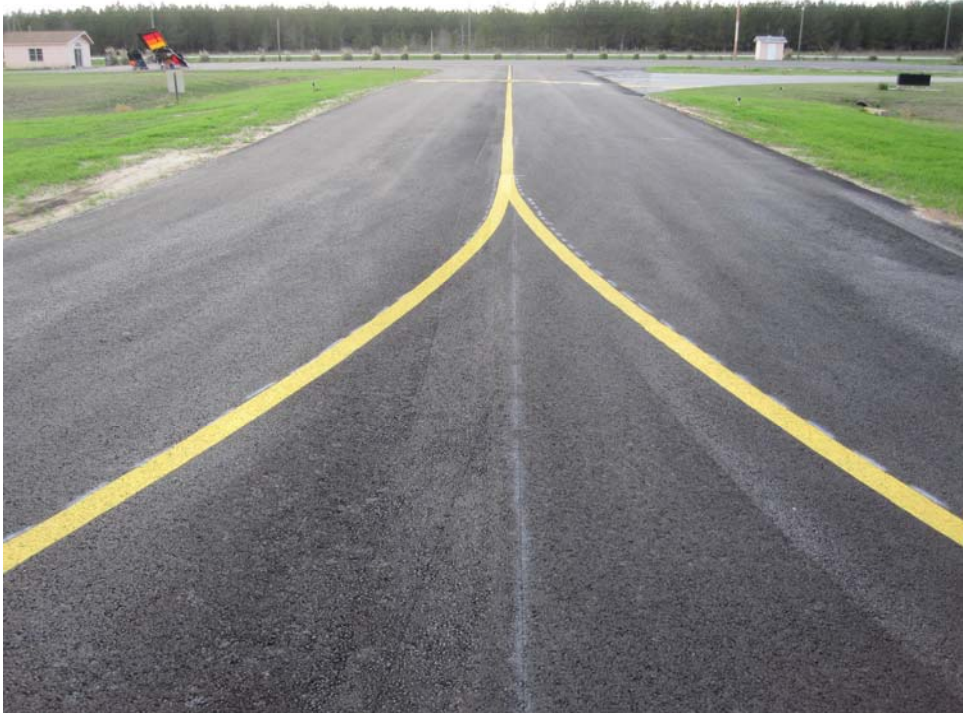
TAML-10. Overview.

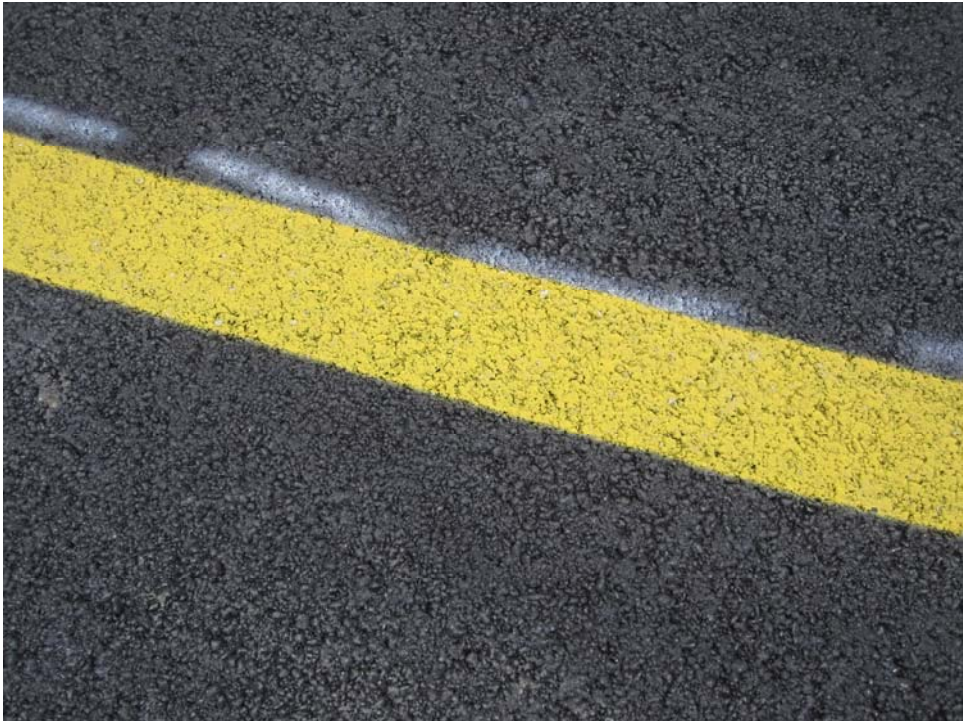
TAML-10. Satisfactory Paint.

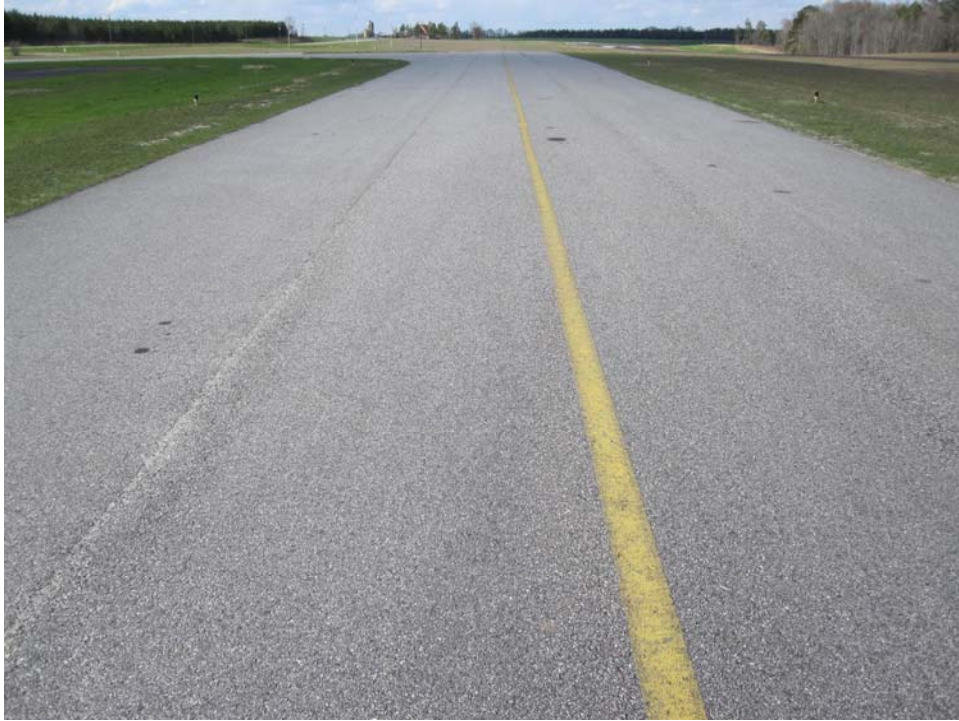
The T-Hangar area contained one section with a PCI value of 95. Only small quantities of low-severity, unsealed longitudinal and transverse (L&T) cracking were recorded.

THANGML-10. Overview.

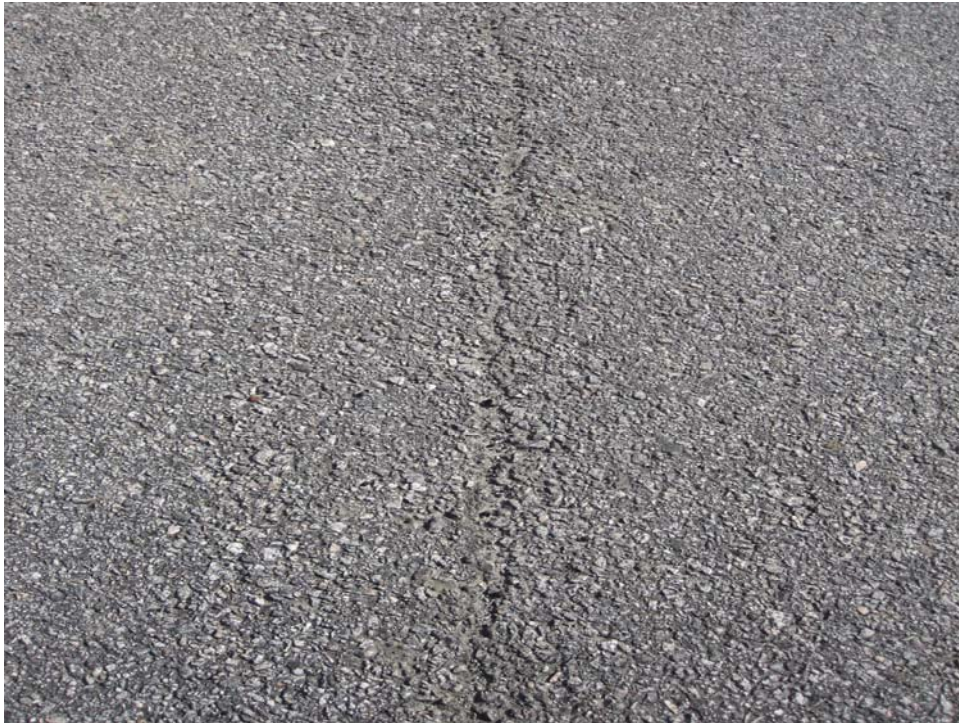
THANGML-10. Longitudinal and Transverse Cracking (Sample Unit #01).

2. Implement a periodic crack sealing program. Sealing cracks is a proven method for cost-effectively keeping water and debris out of the pavement system and extending its life.

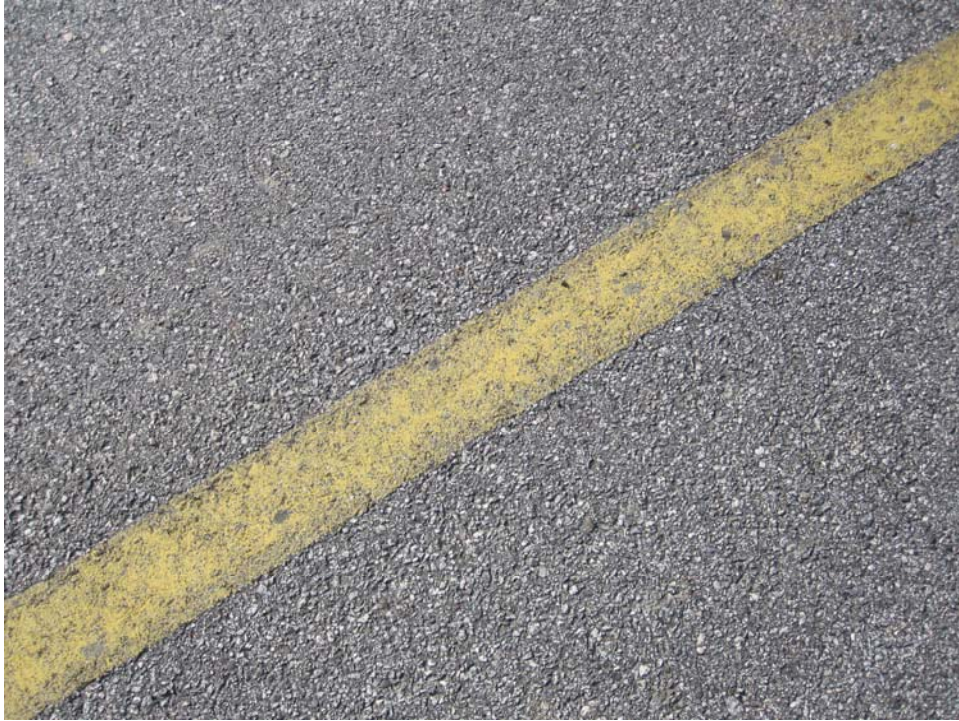
THANGML-10. Unsatisfactory Paint.

5. Other maintenance necessities include keeping all pavement markings well painted, keeping safety signage clear of debris and weeds, ensuring the continuous operation of lighting systems (bulb replacement), and the frequent removal of any debris found in any of the operating areas. In addition, failed pavement areas should be remediated as necessary.
