2012 Burke County Airport Pavement Management Plan

BURKE COUNTY AIRPORT

PAVEMENT MANAGEMENT REPORT

DECEMBER 2012

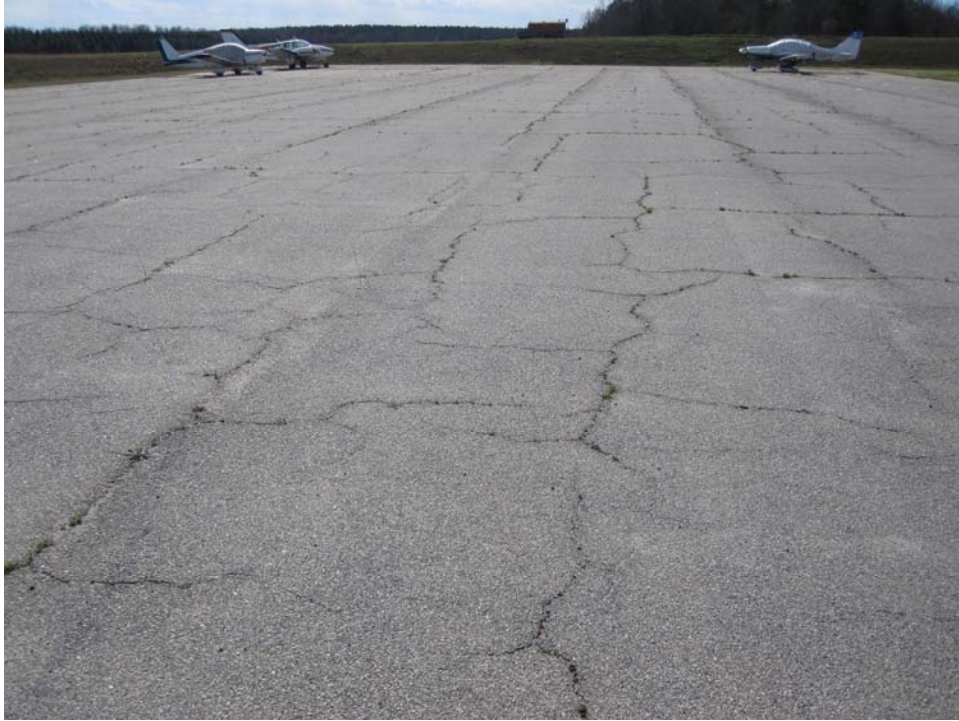
The apron area consisted of one section with a PCI value of 43. Extensive amounts of medium-severity block cracking and low-severity weathering were identified throughout Section 10.

A01WB-10. Overview.

Branch¹	Section	Year	Type of Repair²	Estimated Cost³
A01WB	10	2013	Major M&R	\$237,090
R826WB	10	2013	Major M&R	\$1,593,200
TAWB	10	2013	Major M&R	\$34,840

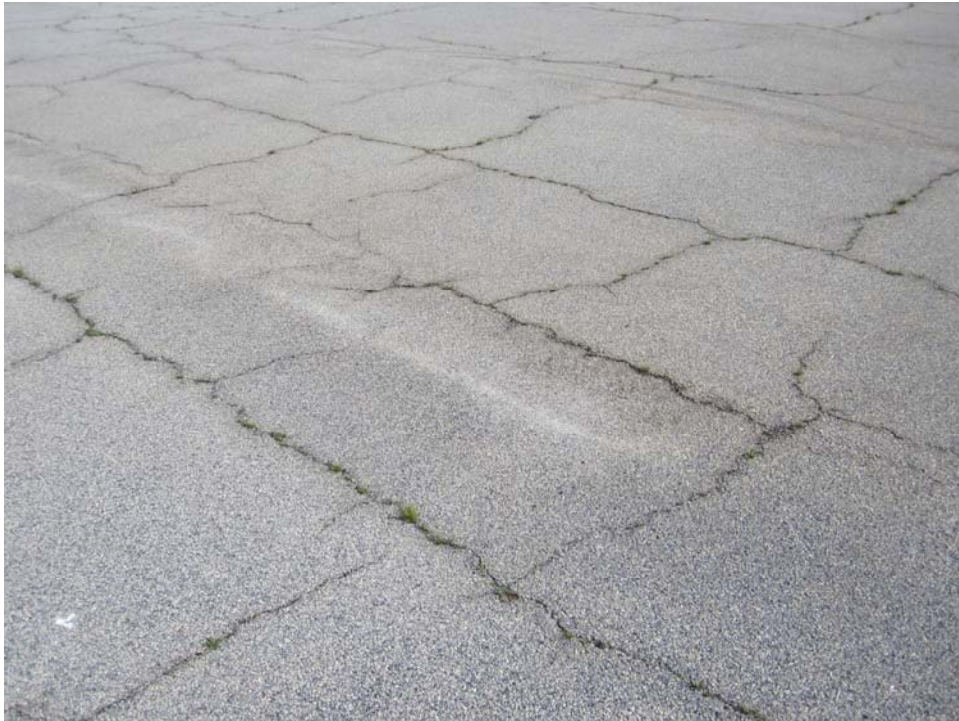
A01WB-10. Block Cracking (Sample Unit #06).

Sample Number: 06 Type: R Area: 3,750.00SqFt PCI = 42
Sample Comments:
43 BLOCK CRACKING M 3,750.00 SqFt Comments:
57 WEATHERING L 3,750.00 SqFt Comments:

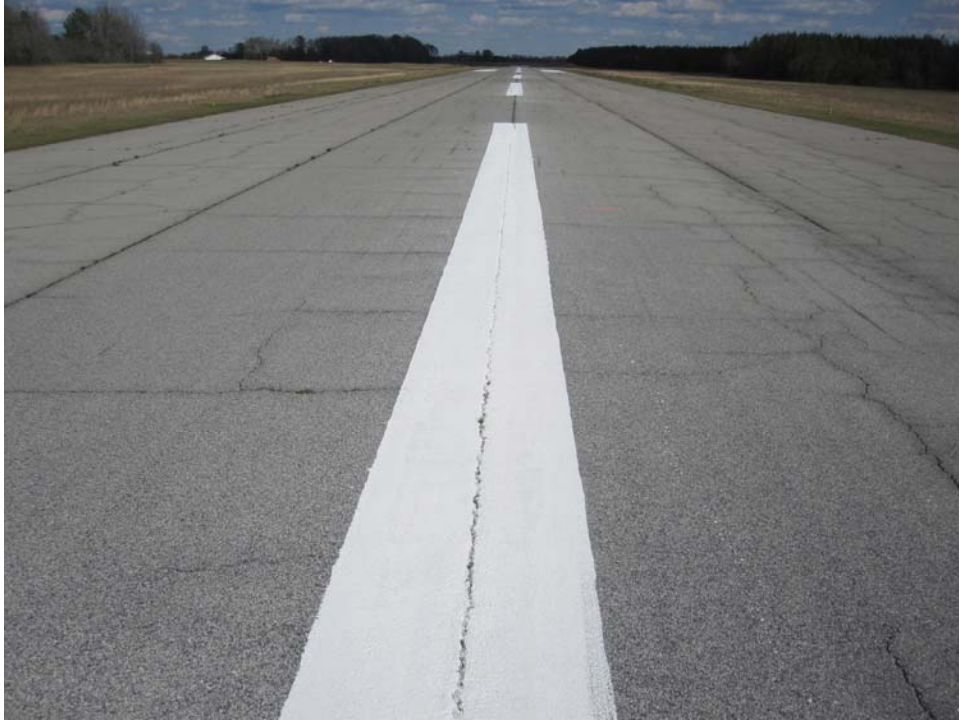
Runway 8-26 was comprised of one section with a PCI value of 48. Extensive amounts of medium-severity block cracking and low-severity weathering were identified throughout Section 10. Moderate amounts of low- and medium-severity longitudinal and transverse (L&T) cracking and smaller quantities of low-severity swelling were also observed.

R826WB-10. Overview.

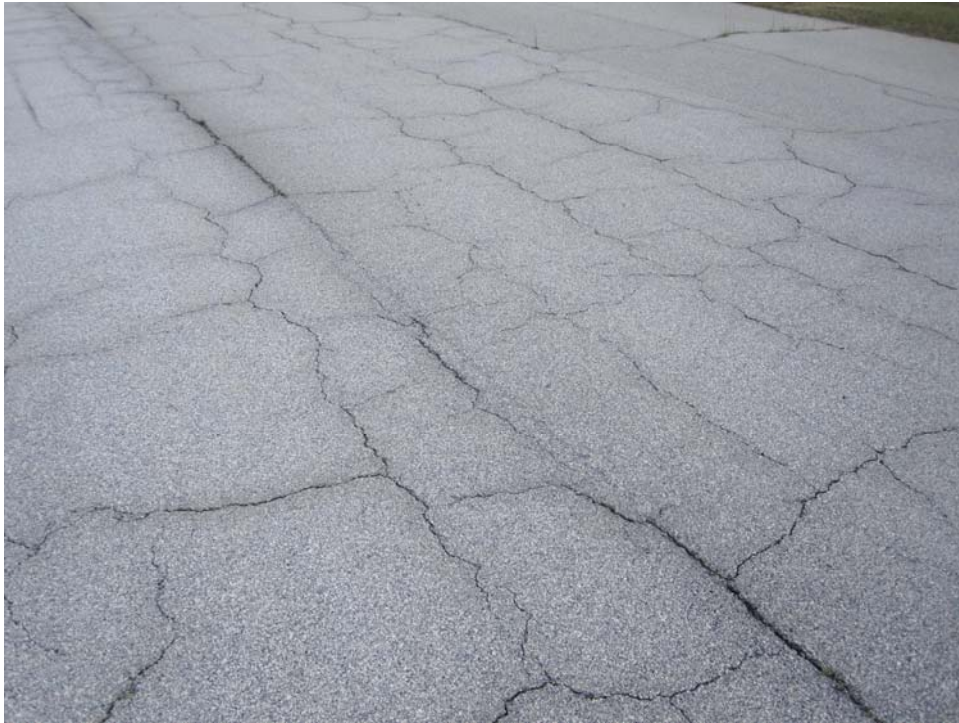
R826WB-10. Block Cracking (Sample Unit #05).

Sample Number: 05 Type: R Area: 5,625.00SqFt PCI = 40
Sample Comments:
43 BLOCK CRACKING M 3,750.00 SqFt Comments:w
57 WEATHERING L 5,625.00 SqFt Comments:
48 LONGITUDINAL/TRANSVERSE CRACKING L 180.00 Ft Comments:lu
48 LONGITUDINAL/TRANSVERSE CRACKING M 76.00 Ft Comments:w

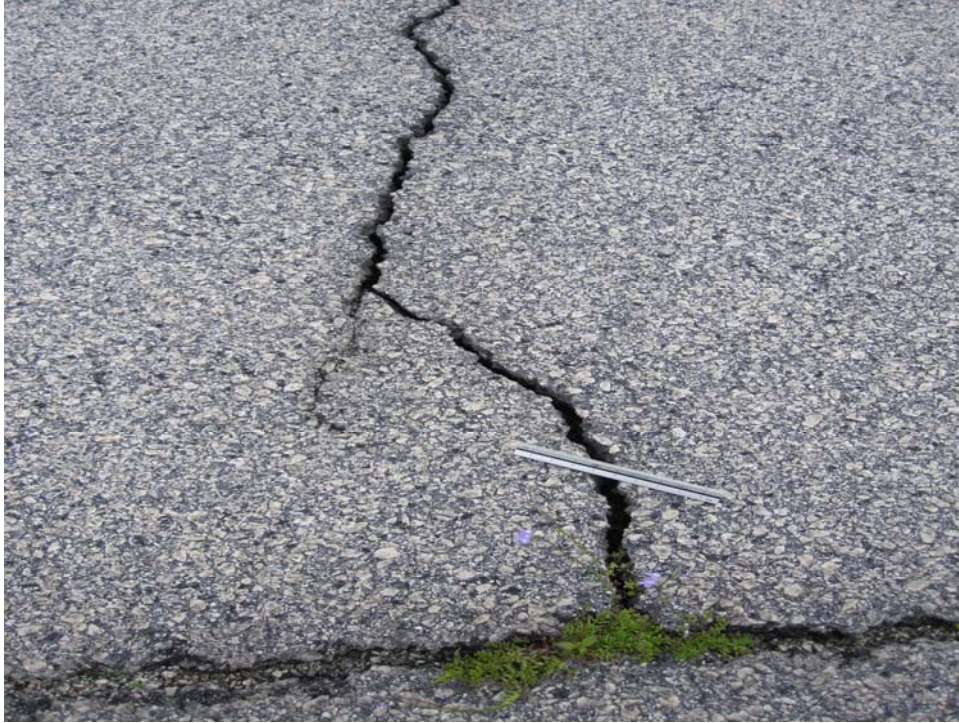
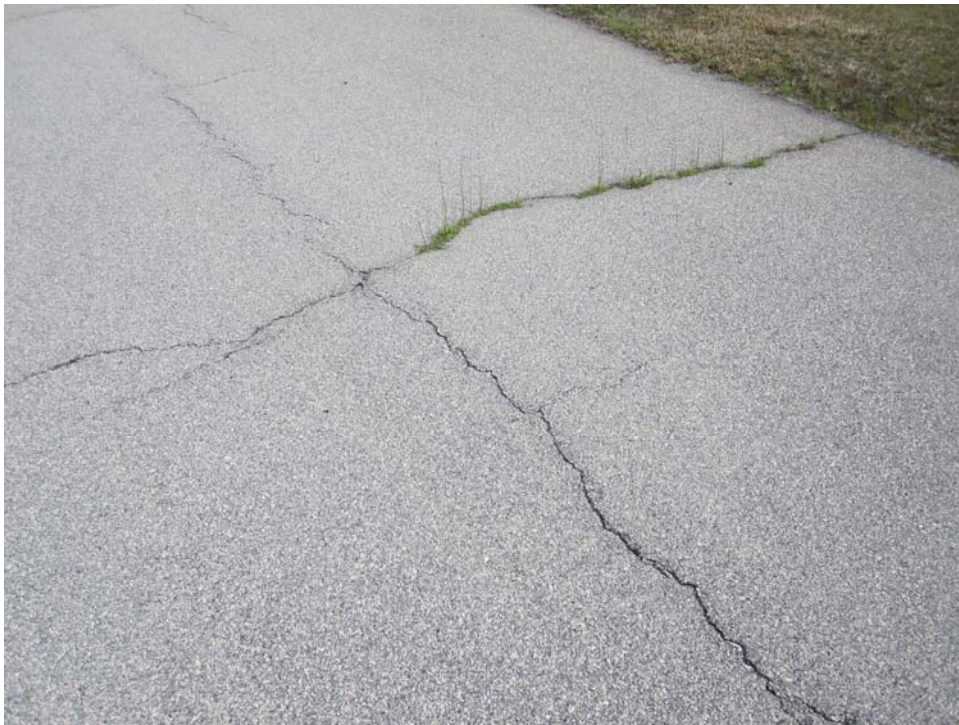
R826WB-10. Longitudinal and Transverse Cracking (Sample Unit #14) (1).

R826WB-10. Longitudinal and Transverse Cracking (Sample Unit #14) (2).

Sample Number: 14 Type: R Area: 5,625.00SqFt PCI = 42
Sample Comments:
57 WEATHERING L 5,625.00 SqFt Comments:
43 BLOCK CRACKING M 5,625.00 SqFt Comments:w

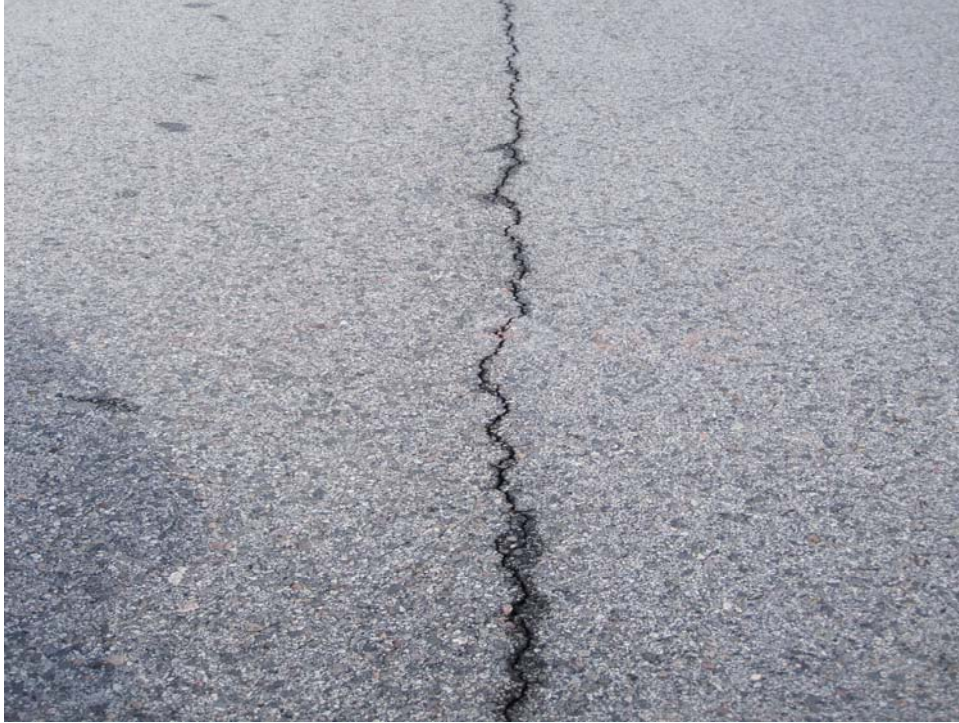
R826WB-10. Longitudinal and Transverse Cracking (Sample Unit #50).

Sample Number: 50 Type: R Area: 5,625.00SqFt PCI = 84
Sample Comments:
48 LONGITUDINAL/TRANSVERSE CRACKING L 317.00 Ft Comments:lu

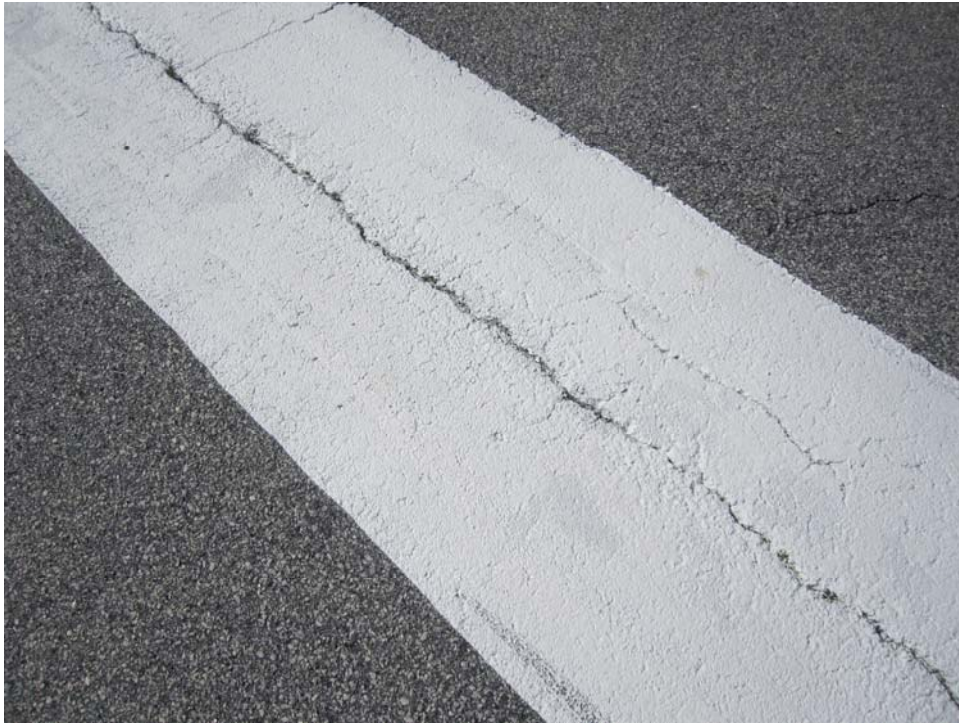
R826WB-10. Satisfactory Paint.

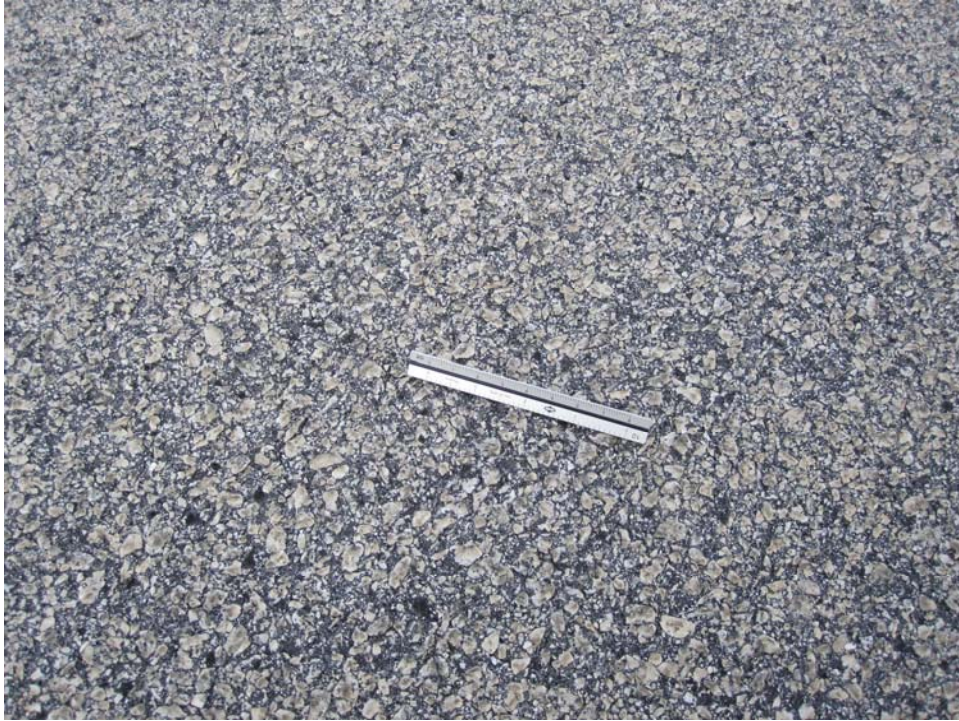
R826WB-10. Weathering (Sample Unit #23).

Sample Number: 23 Type: R Area: 5,625.00SqFt PCI = 41
Sample Comments:
43 BLOCK CRACKING M 4,687.00 SqFt Comments:w
48 LONGITUDINAL/TRANSVERSE CRACKING M 138.00 Ft Comments:w
57 WEATHERING L 5,625.00 SqFt Comments:

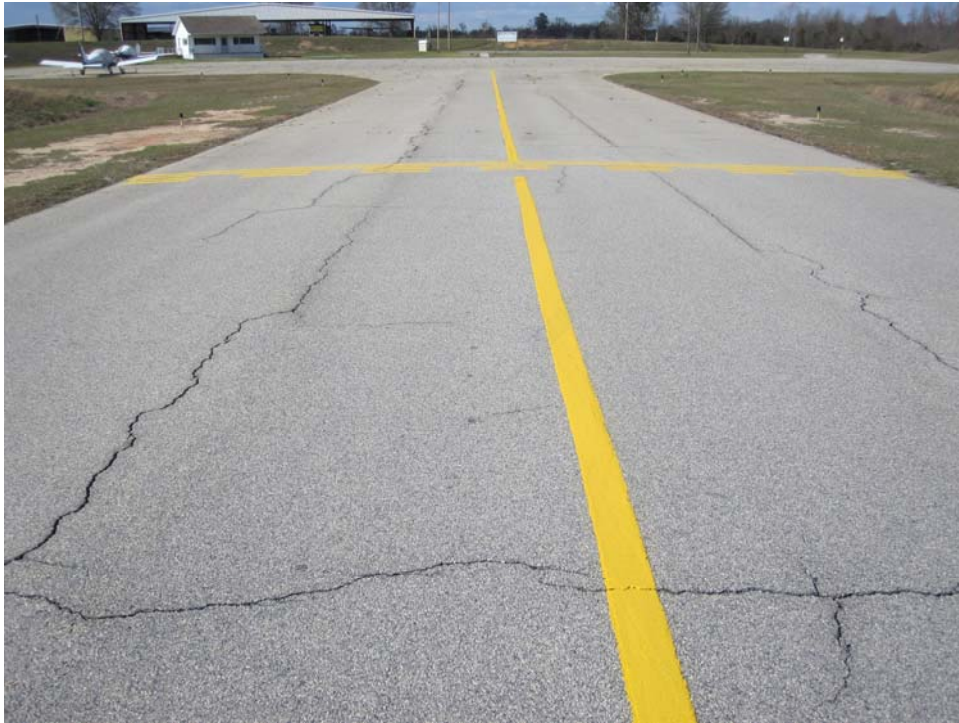
Taxiway A was defined by one section with a PCI value of 59. Substantial quantities of low-severity weathering were recorded in this section along with moderate amounts of low- and medium-severity L&T cracking.

TAWB-10. Overview.

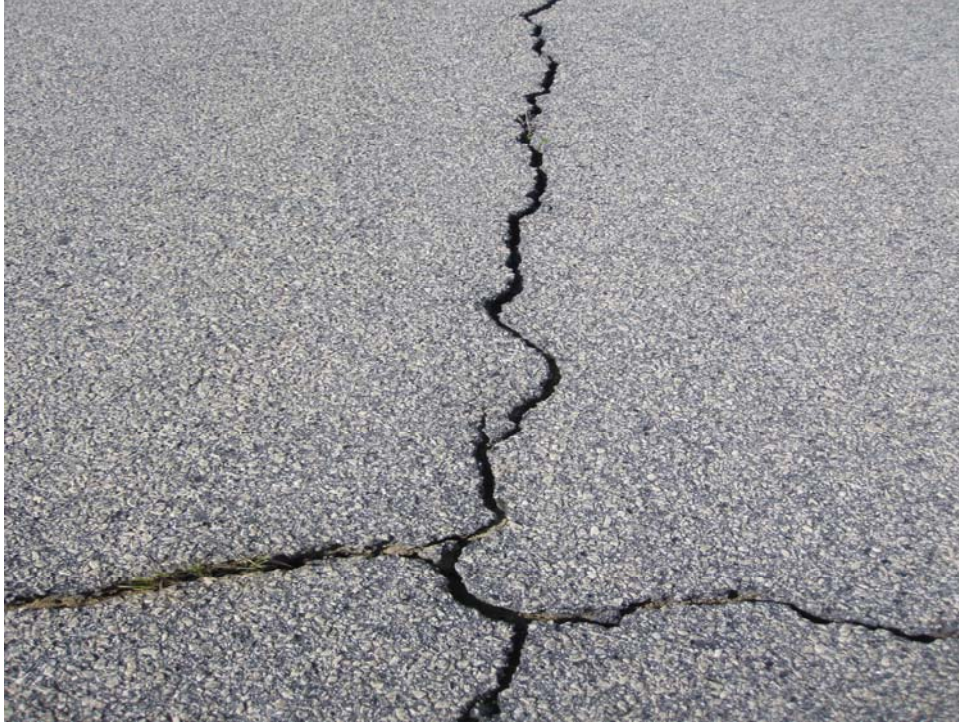
TAWB-10. Longitudinal and Transverse Cracking (Sample Unit #02).

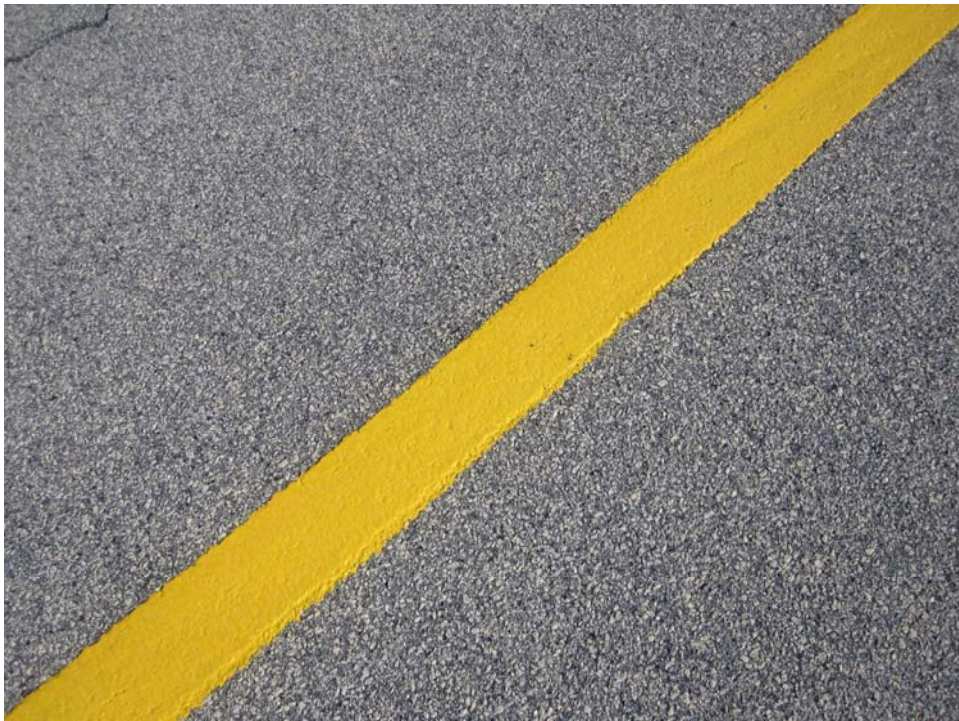
TAWB-10. Satisfactory Paint.
