MILLEN AIRPORT
PAVEMENT MANAGEMENT REPORT

2007 GEORGIA AIRPORT PAVEMENT MANAGEMENT REPORT

MILLEN AIRPORT

JANUARY 2008

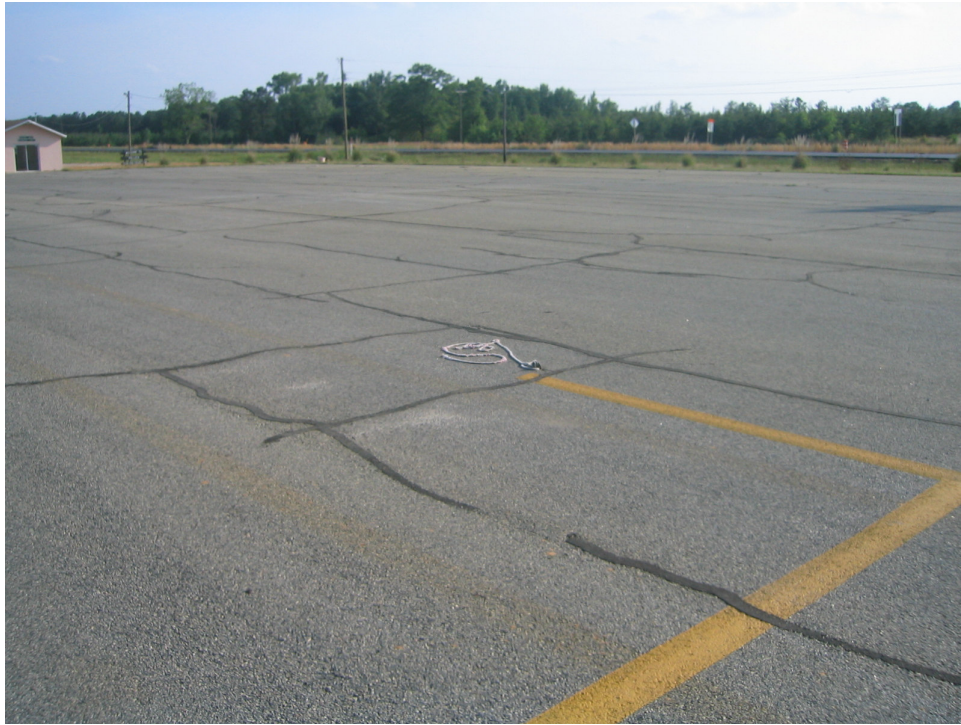
A01ML-10. Overview.

The apron is comprised of one section, A01ML-10, and is in fair condition with a PCI value of 69. Sealed and unsealed low-severity L&T cracking, block cracking, and raveling and weathering were observed during the inspection.

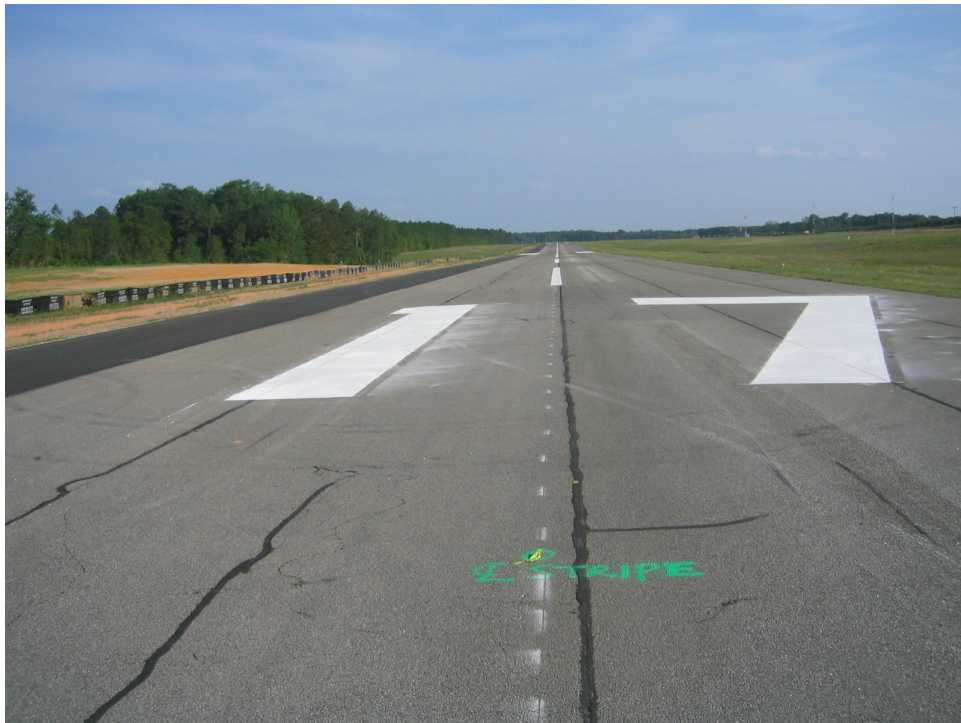
R1735ML-10. Overview.

Runway 17-35 is defined by four sections. R1735ML-10, which makes up the main part of the runway, is in fair condition with a PCI value of 74. A significant amount of sealed low-severity longitudinal and transverse (L&T) cracking was observed throughout. R1735ML-20 serves as a turn around area at the north end of the runway and is in poor condition with a PCI value of 43. High-severity joint spalling and joint seal damage were identified in this section. R1735ML-30 serves as the turn around area at the south end of the runway and is in poor condition with a PCI value of 43 due to high-severity joint spalling as well as high-severity joint seal damage. R1735ML-40 was recently constructed and is in excellent condition with a PCI value of 100. No distresses were identified in this section at the time of inspection.

Branch¹	Section	Year	Type of Repair²	Estimated Cost³
R1735ML	20	2008	Major M&R	\$4,454
R1735ML	30	2008	Major M&R	\$4,525
R1735ML	10	2010	Major M&R	\$317,531
A01ML	10	2012	Preventive Maintenance	\$7,712
TAML	10	2012	Preventive Maintenance	\$1,514

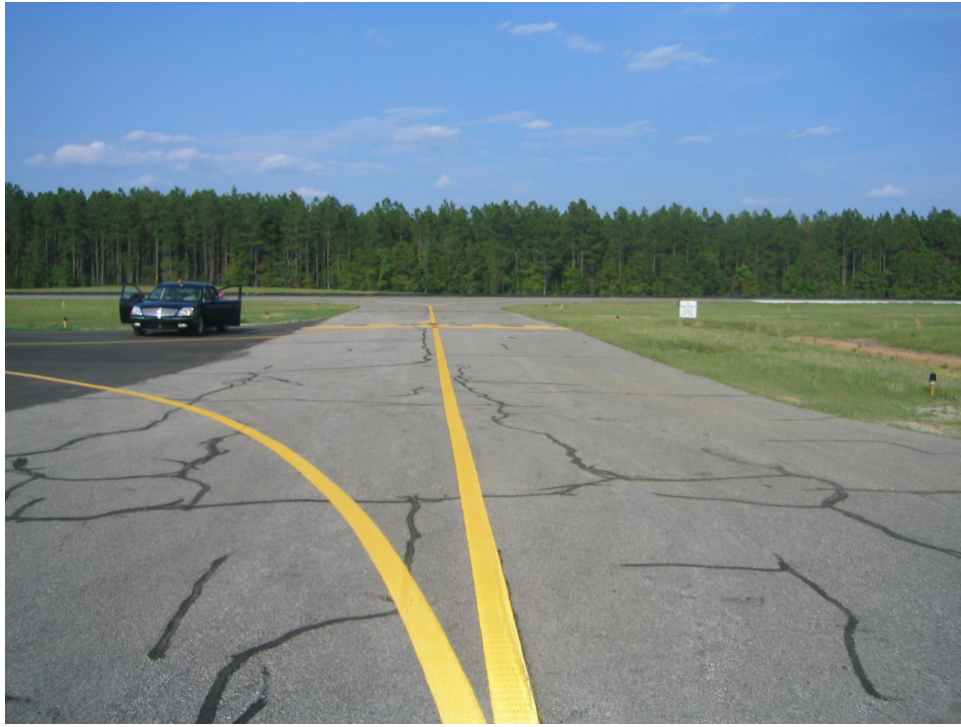
TAML-10. Overview.

Taxiway A consists of one section, TAML-10, and is in fair condition with a PCI value of 67. Low-severity L&T cracking and raveling and weathering were observed during the inspection.

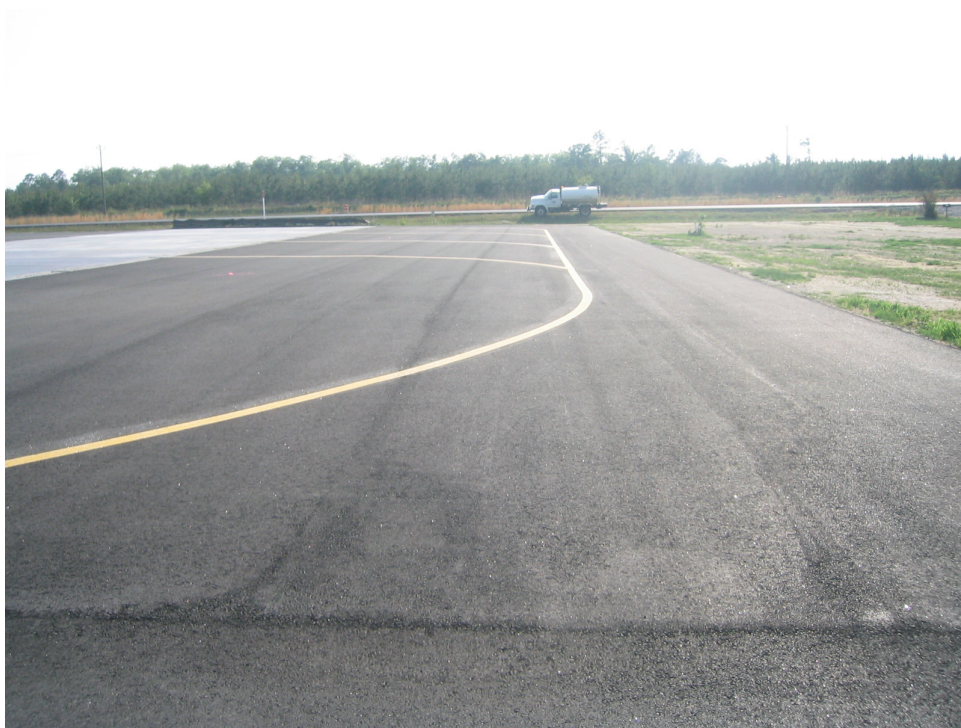
THANGML-10. Overview.

The T-Hanger area is defined by one section and is in excellent condition, with a PCI value of 100 and no distress observed during inspection.
