**SOUTHWEST GEORGIA REGIONAL AIRPORT
PAVEMENT MANAGEMENT REPORT**

**2007 GEORGIA AIRPORT
PAVEMENT MANAGEMENT REPORT**

SOUTHWEST GEORGIA REGIONAL AIRPORT

PAVEMENT MANAGEMENT REPORT

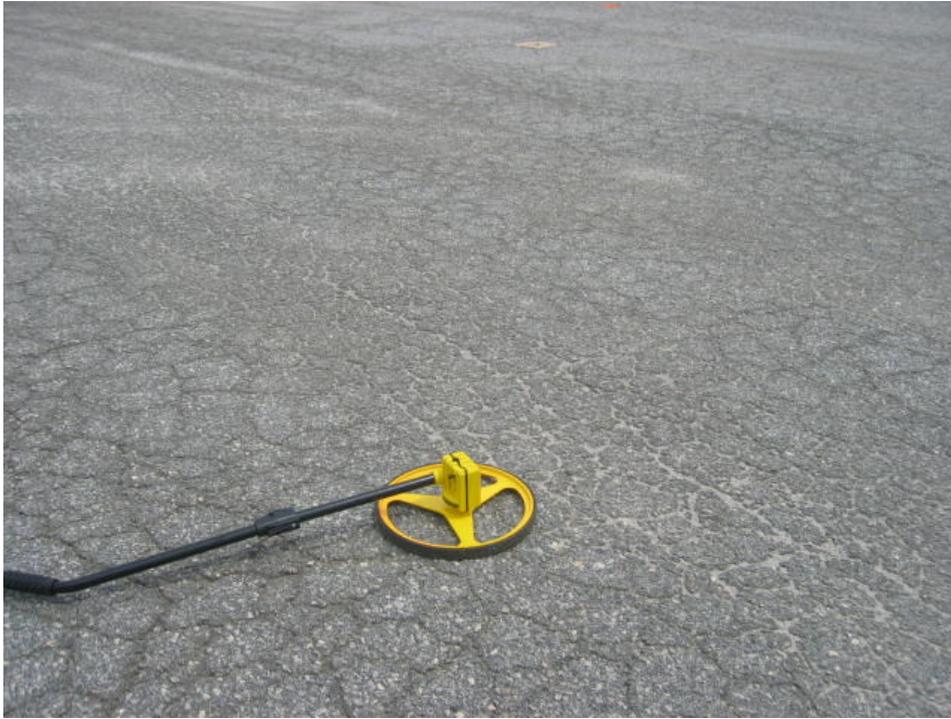
The apron area to the southwest of the terminal apron (A01AB) is comprised of two sections. Section A01AB-10 is in serious condition with a PCI value of 25. Moderate to extensive amounts of medium and high-severity alligator cracking and medium-severity block cracking and raveling and weathering were recorded in this section. Smaller quantities of low and medium-severity depression and patching along with high-severity raveling and weathering were also observed in this section. Section A01AB-20 is in poor condition with a PCI value of 57. Moderate to extensive amounts of low-severity linear cracking and shattered slabs and high-severity joint seal damage were observed.

A01AB-10. Alligator cracking.

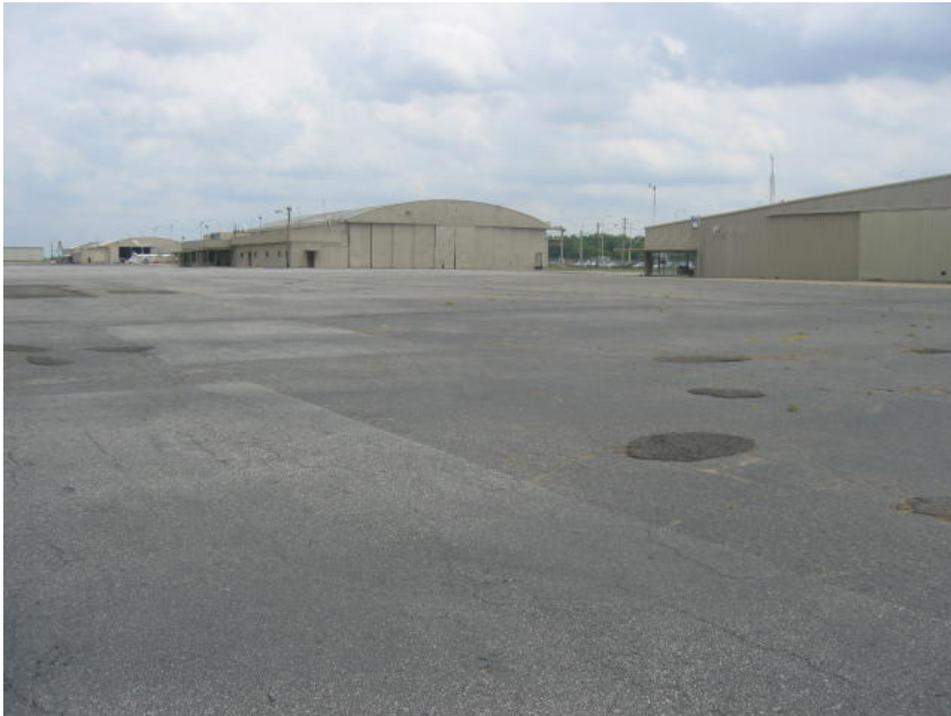
A01AB-10. Overview.

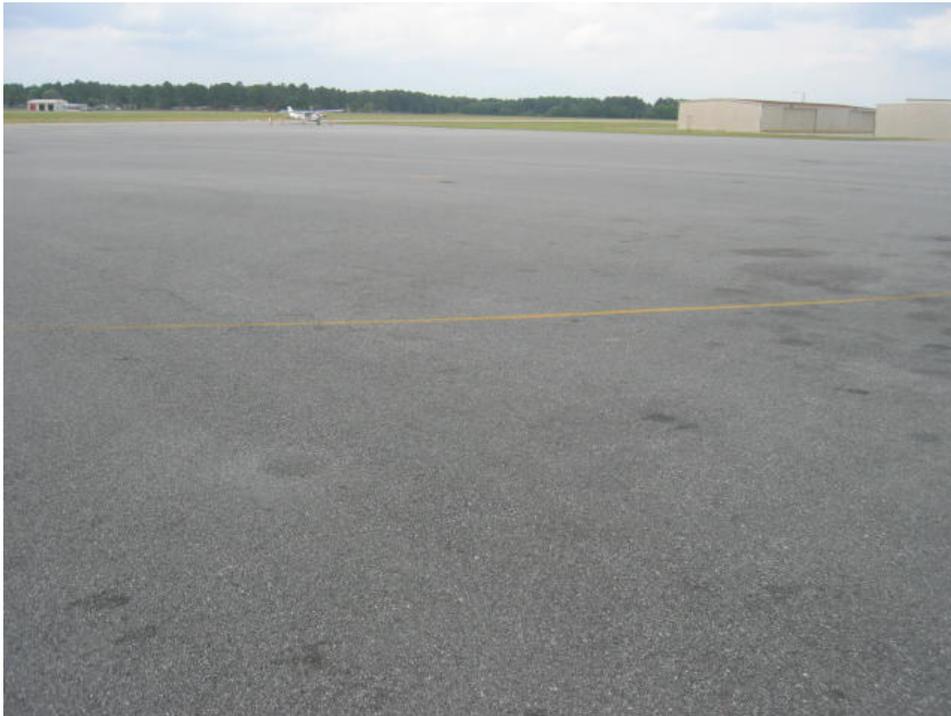
The FBO apron area (A02AB) to the northeast of the terminal apron contains two sections. Section A02AB-10 is in excellent condition with a PCI value of 98. Small quantities of low-severity L&T cracking were recorded along with isolated areas of oil spillage. Section A02AB-10 is in serious condition with a PCI value of 2. Extensive quantities of medium-severity linear cracking, high-severity joint seal damage, low and medium-severity corner breaks, and medium and high-severity shattered slabs were identified.

A02AB-10. Overview.

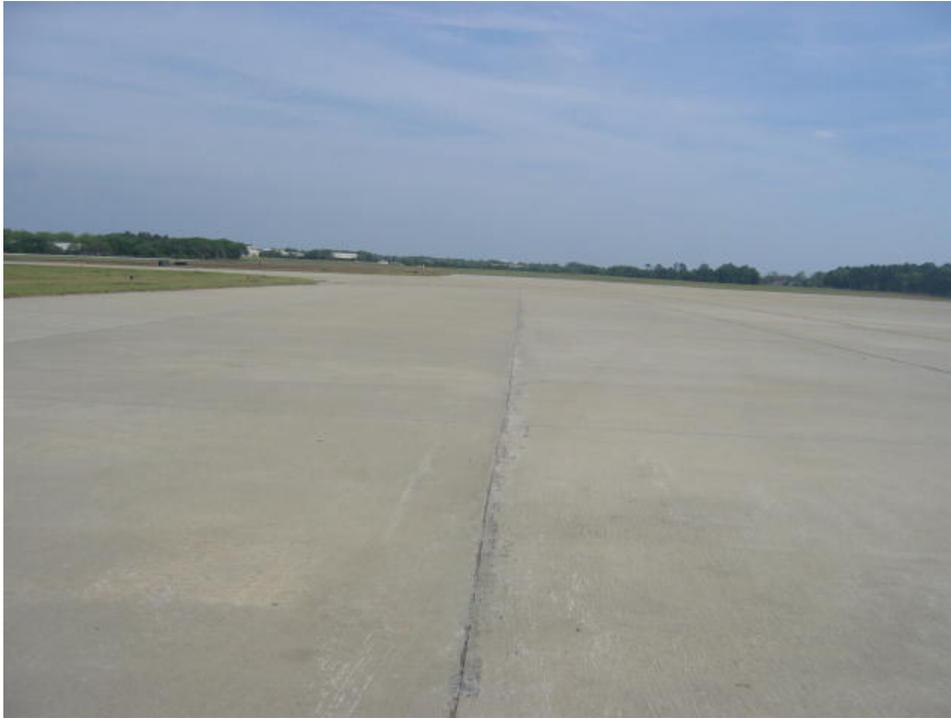
The cargo apron area is defined by five sections. Sections ACARGOAB-10, ACARGOAB-20, ACARGOAB-40, and ACARGOAB-50 are all PCC sections that are in excellent condition with PCI values of 100. A low-severity patch was identified in ACARGOAB-20.

ACARGOAB-20. Overview.

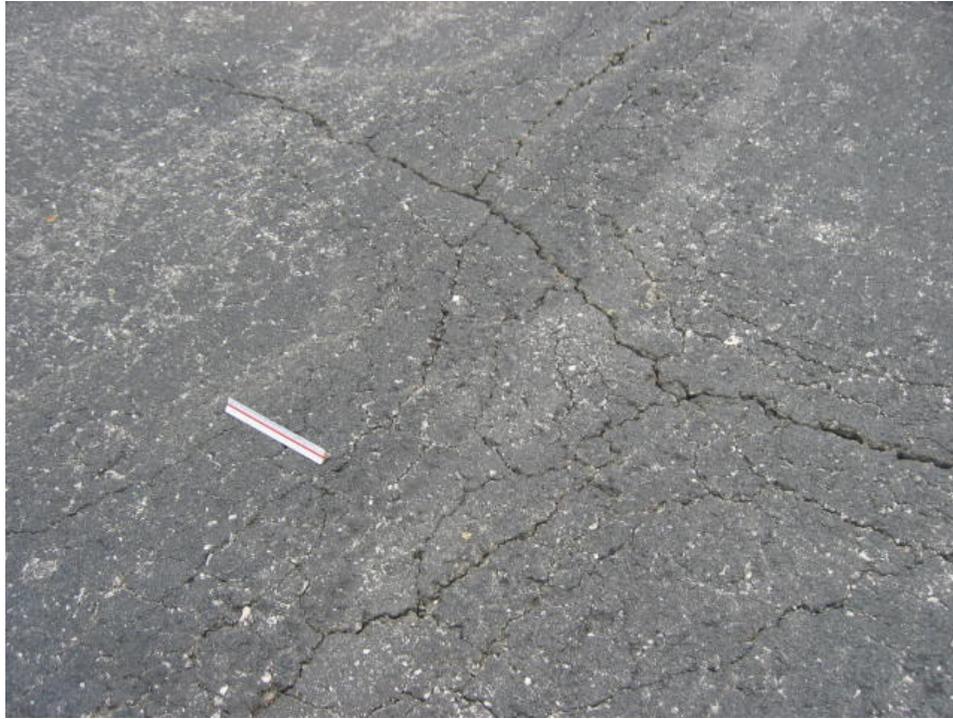
The terminal apron is defined by one section (ATERMAB-10) and is in poor condition with a PCI value of 46. Extensive quantities of medium-severity L&T cracking and block cracking were identified. Moderate amounts of low-severity L&T cracking and raveling and weathering were also recorded in this section along with smaller quantities of low-severity alligator cracking, depression, rutting, swelling, and low and medium-severity patching.

ATERMAB-10. Alligator cracking.

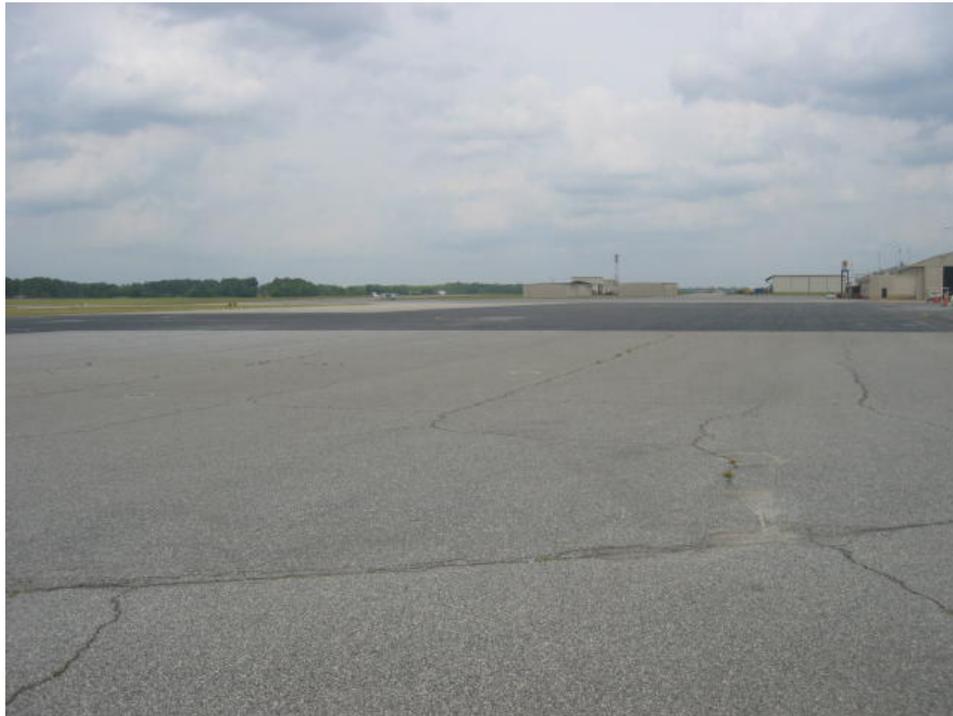
ATERMAB-10. Overview.

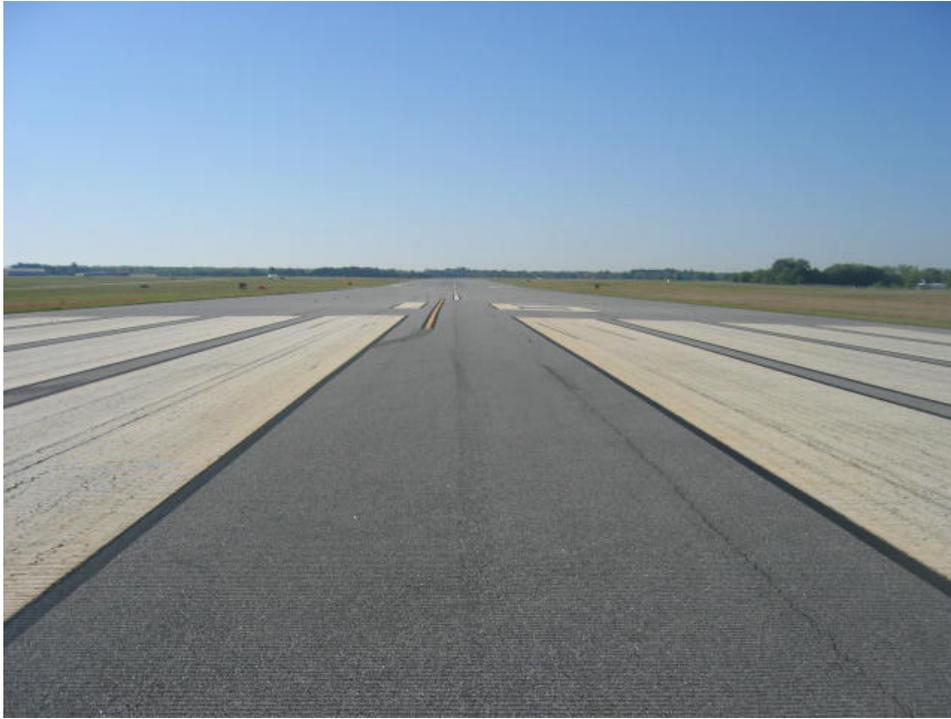
Runway 16-34 is defined by one section. Section R1634AB-10 is in fair condition with a PCI value of 66. Substantial amounts of low and medium-severity L&T cracking were observed in this section along with smaller quantities of low-severity rutting and swelling.

R1634AB-10. Overview.

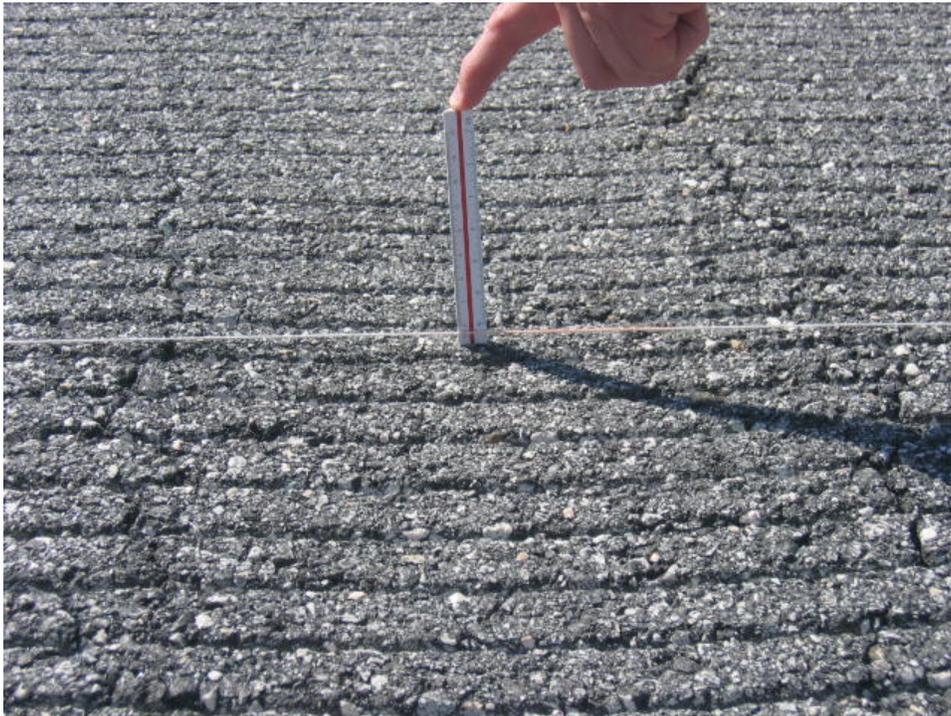
R1634AB-10. Rutting.

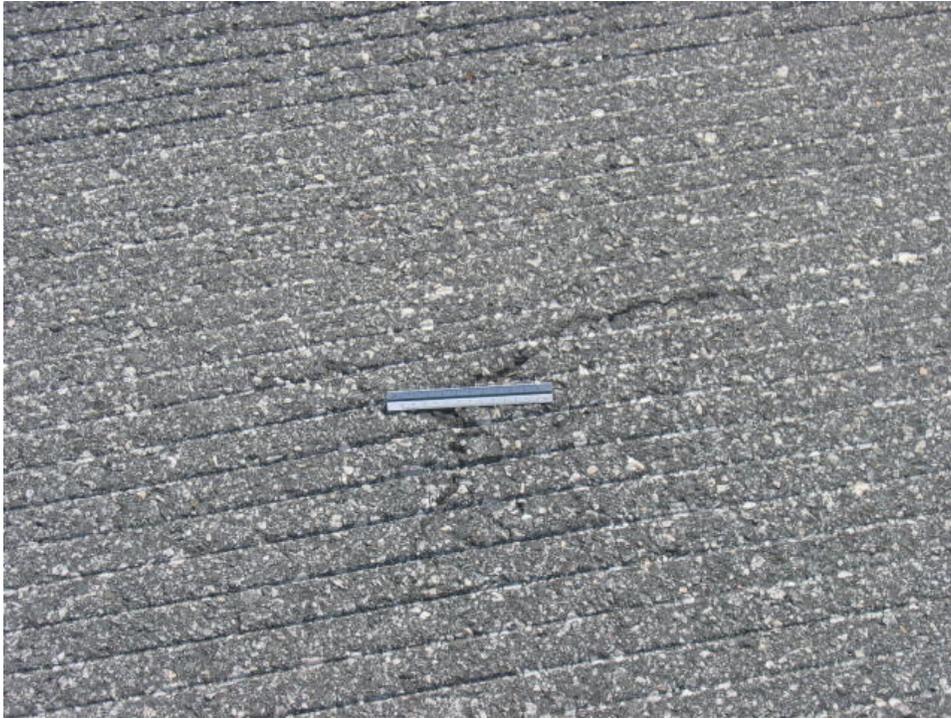
R1634AB-10. Swelling.

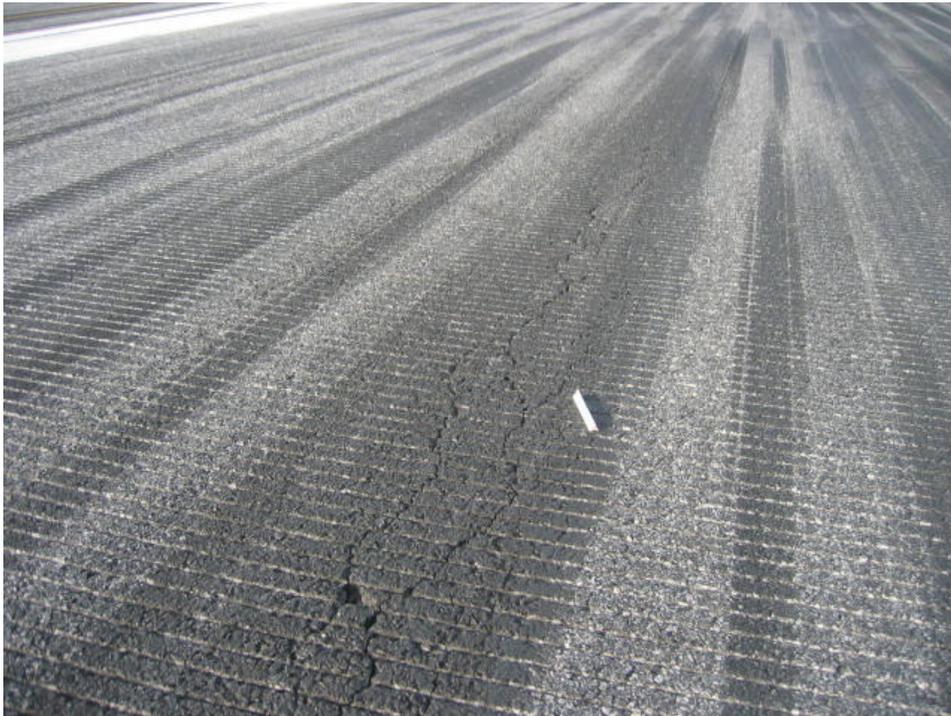
Runway 4-22 is comprised of one section. Section R422AB-10 is in good condition with a PCI value of 83. The primary distress identified in this section was low-severity longitudinal and transverse (L&T) cracking. Low-severity alligator cracking, medium-severity L&T cracking, low-severity swelling, and low and medium-severity raveling and weathering were also observed in smaller quantities.

R422AB-10. Alligator cracking.

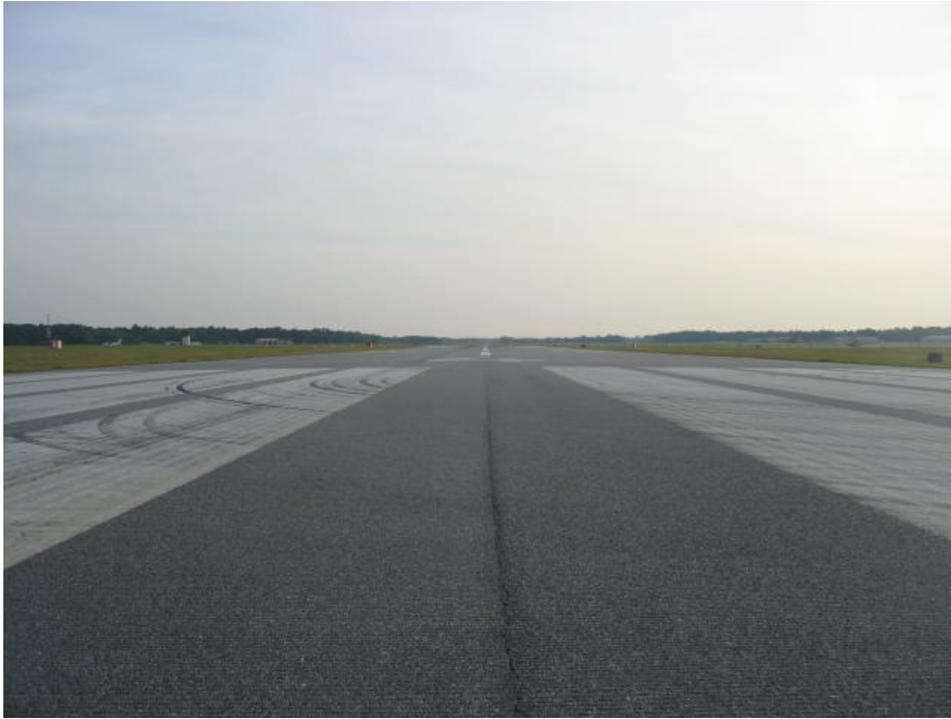
R422AB-10. Overview.

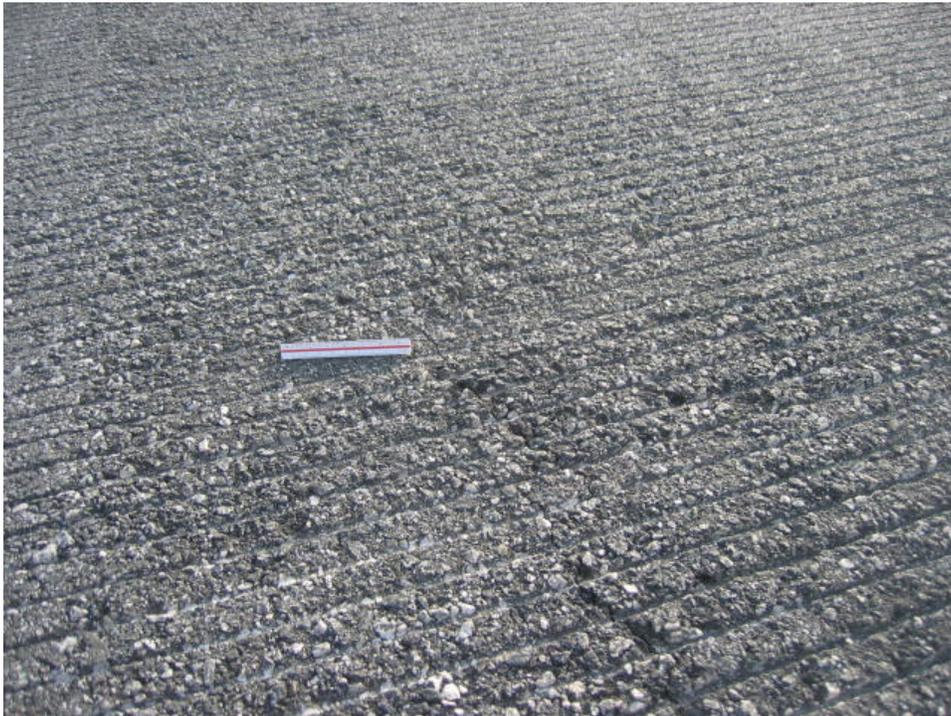
R422AB-10. Raveling and weathering.

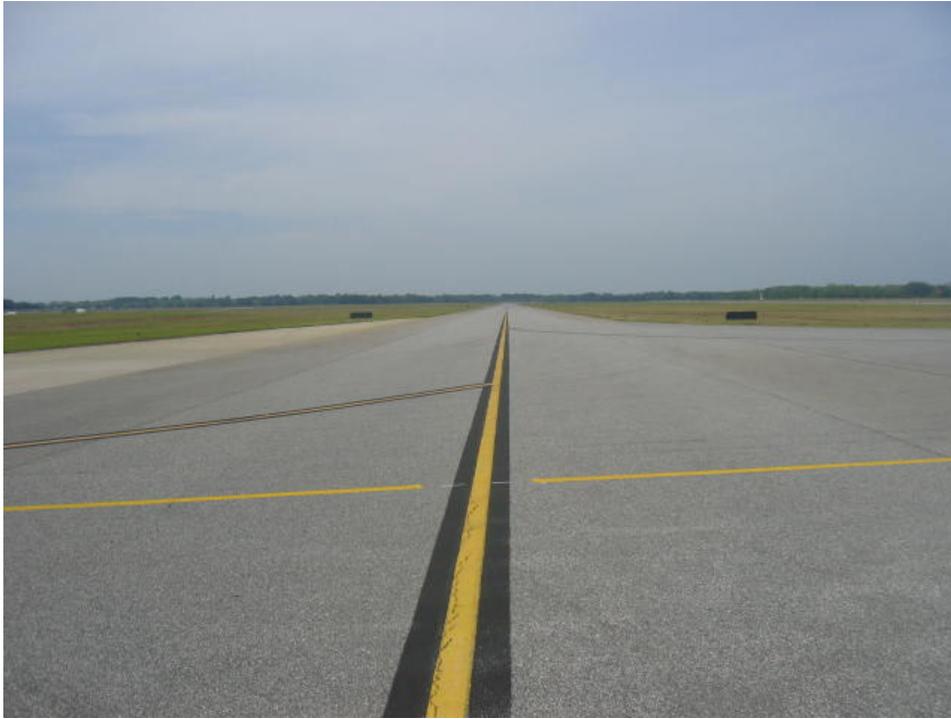
TAAB-10. Overview (to be rehabilitated in 2007).

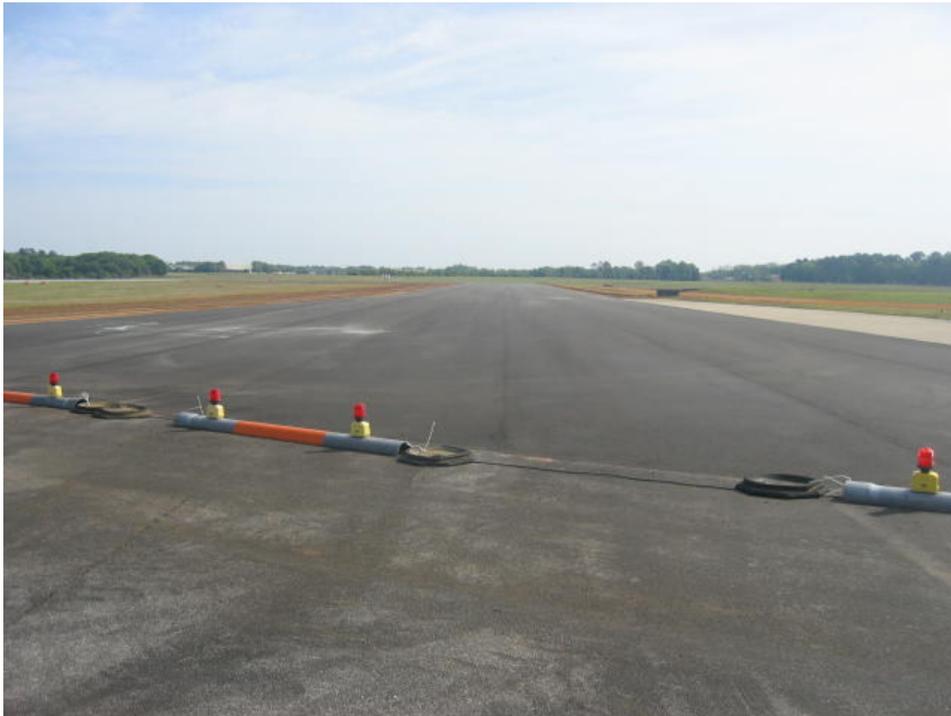
Section TAAB-20 is the portion of the Taxiway A rehabilitation work to the northeast of Taxiway H that had already been completed by the time of inspection. The pavement was not open to aircraft traffic at the time of inspection and was in excellent condition with a PCI value of 100. No distress was observed.

TAAB-20. Overview.

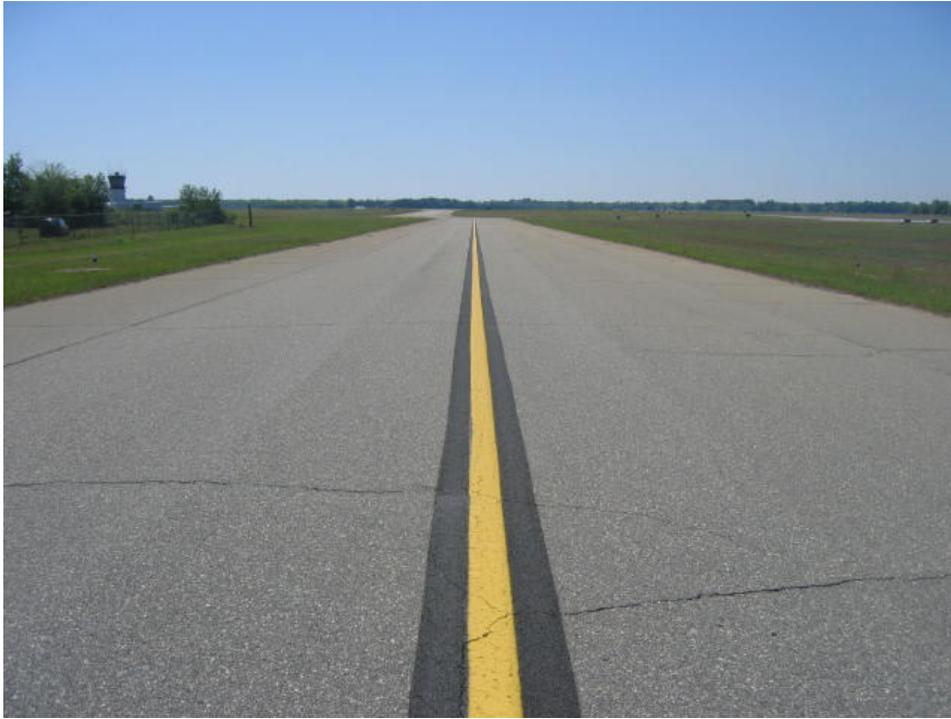
Taxiway B is defined by two sections. Section TBAB-10 is in fair condition with a PCI value of 61. Substantial amounts of low and medium-severity L&T cracking were observed along with small quantities of low-severity swelling.

TBAB-10. Overview.

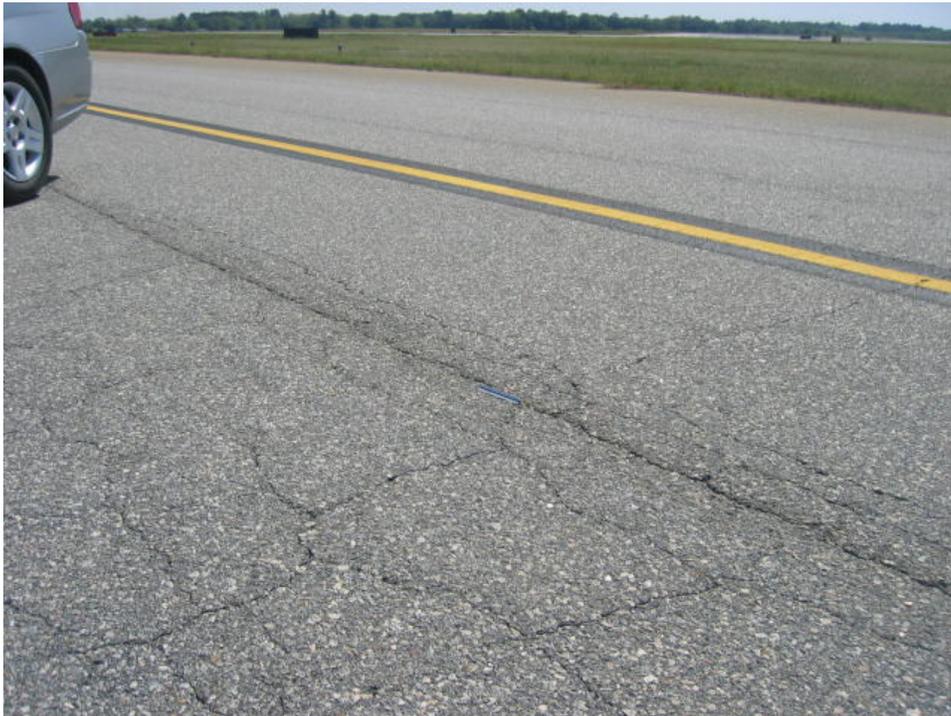
Section TBAB-20 is in poor condition with a PCI value of 41. Extensive amounts of medium-severity alligator cracking, low-severity block cracking, and low and medium-severity L&T cracking were identified. Moderate quantities of medium-severity block cracking and low-severity swelling were also observed along with smaller quantities of high-severity alligator cracking.

TBAB-20. Alligator cracking and block cracking.

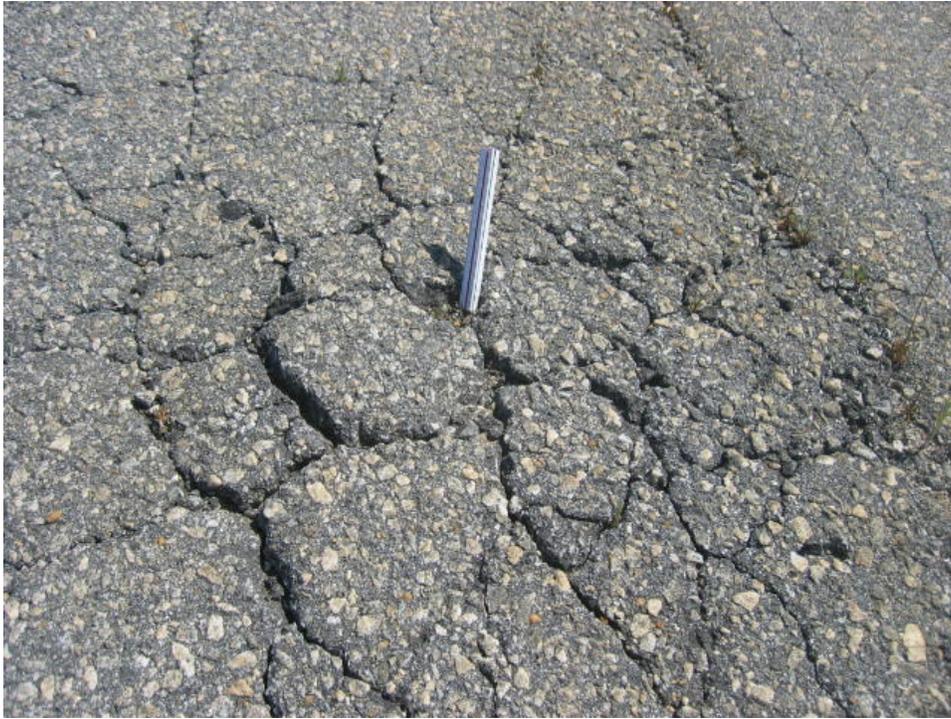
TBAB-20. Alligator cracking.

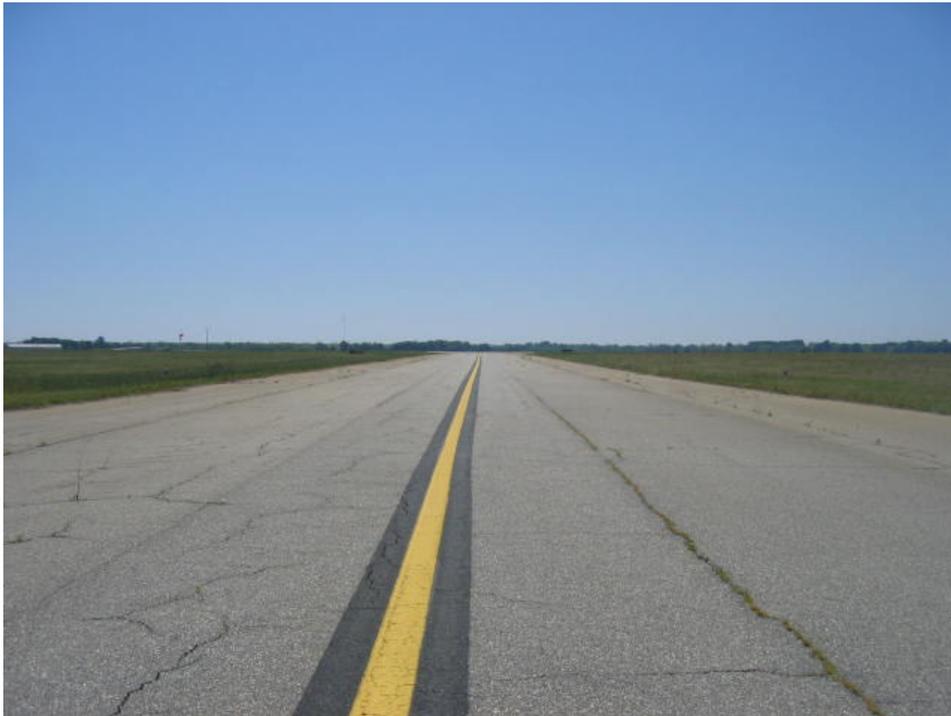
TBAB-20. Overview.

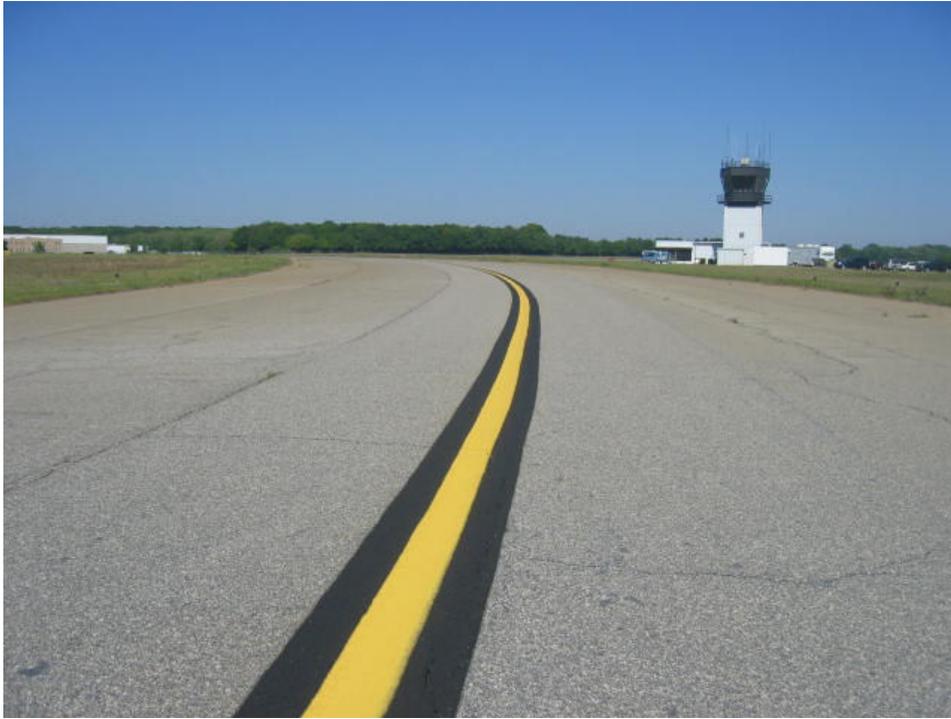
Taxiway C is defined by three sections. Section TCAB-10 is in poor condition with a PCI value of 52. The primary distresses identified in this section were low-severity block cracking, low and medium-severity L&T cracking, and low-severity swelling. Low-severity depression and medium-severity block cracking were also observed in smaller quantities.

TCAB-10. Overview.

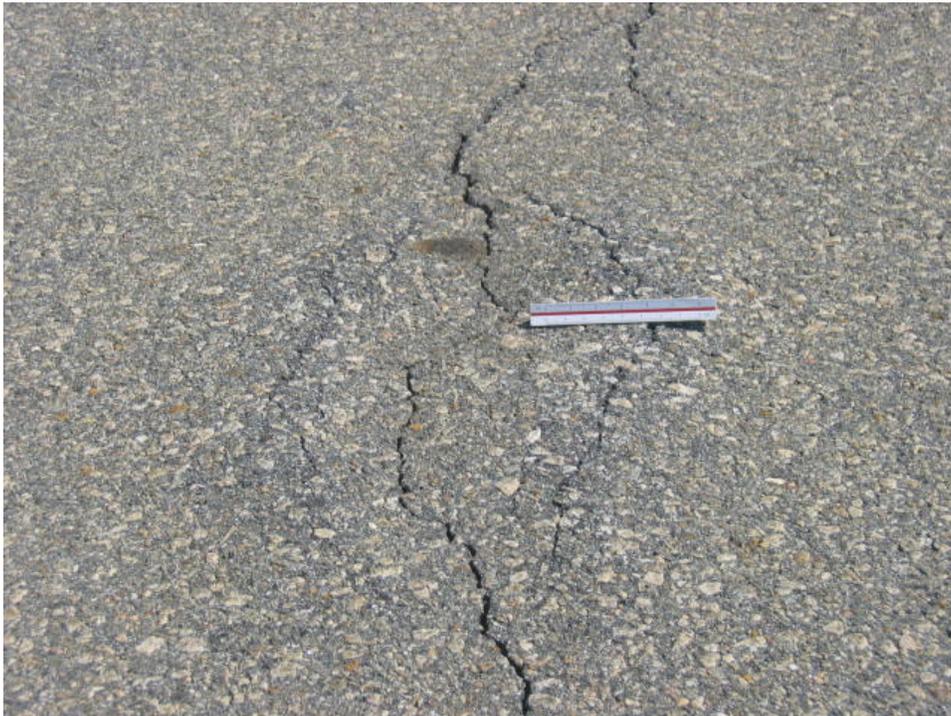
TCAB-10. Swelling.

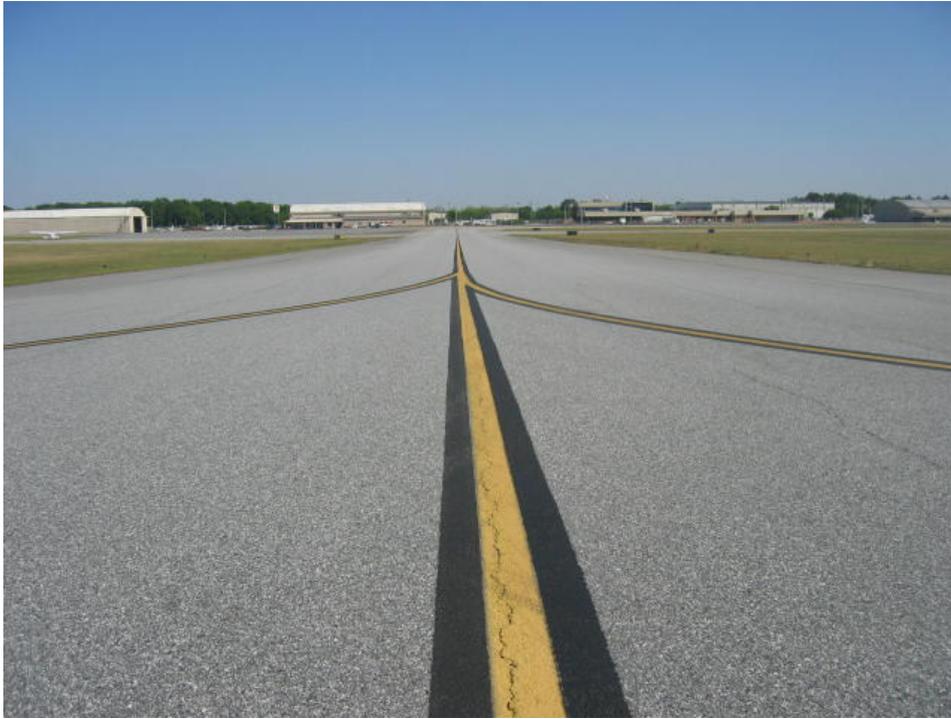
Section TCAB-20 is in fair condition with a PCI value of 75. Moderate amounts of low and medium-severity L&T cracking were observed in this section along with smaller quantities low-severity alligator cracking.

TCAB-20. Overview.

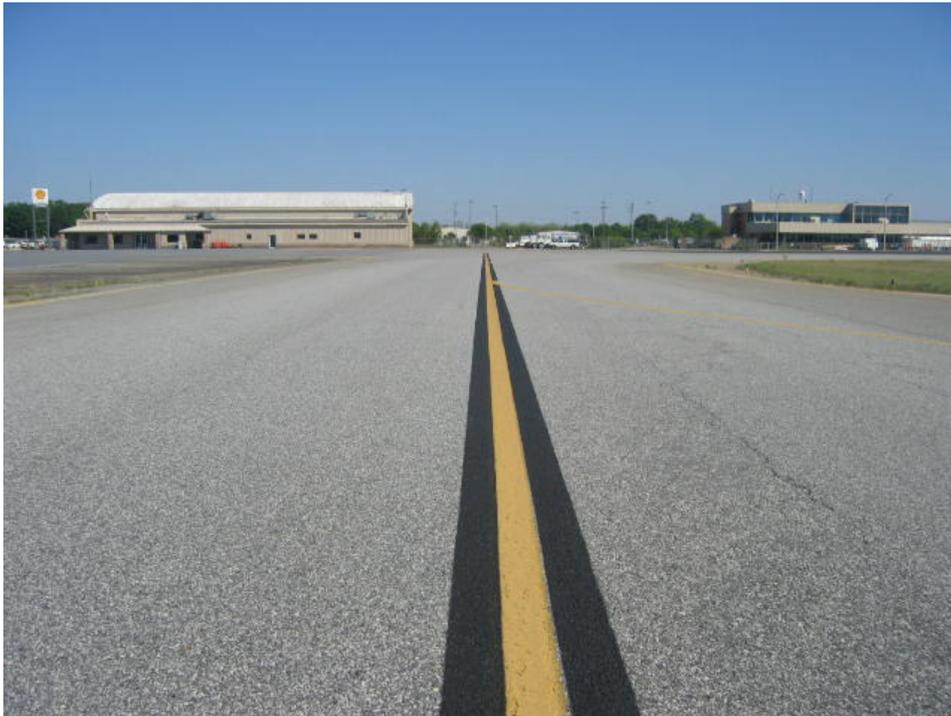
Section TCAB-30 is in fair condition with a PCI value of 78. Moderate amounts of low and medium-severity L&T cracking were observed in this section.

TCAB-30. Overview.

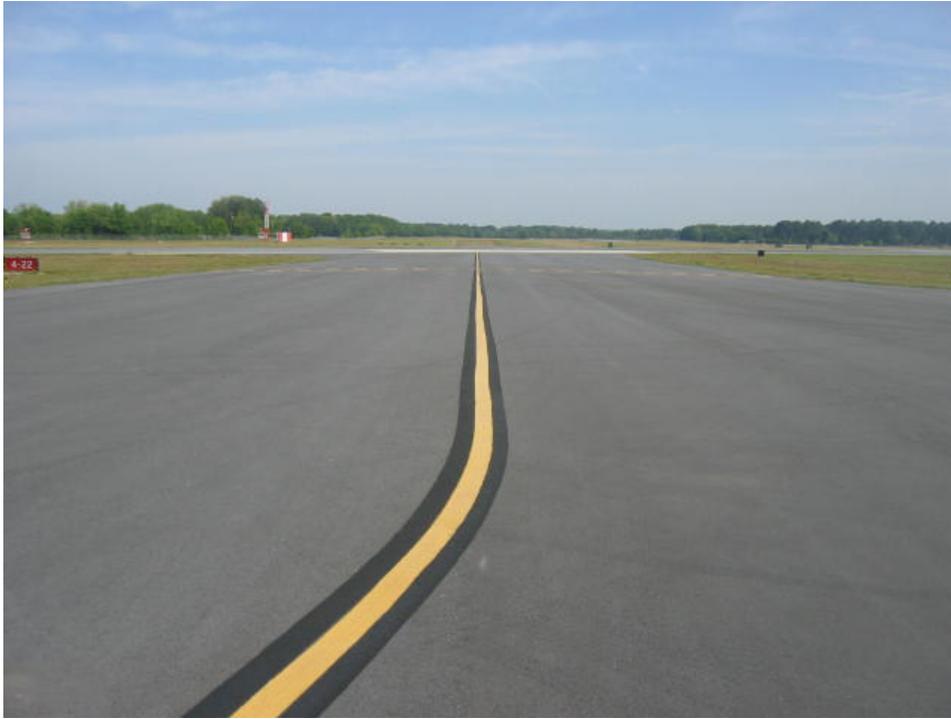
Taxiway D is comprised of one section. Section TDAB-10 was recently rehabilitated and is in excellent condition with a PCI value of 100. No distress was observed in this section.

TDAB-10. Overview.

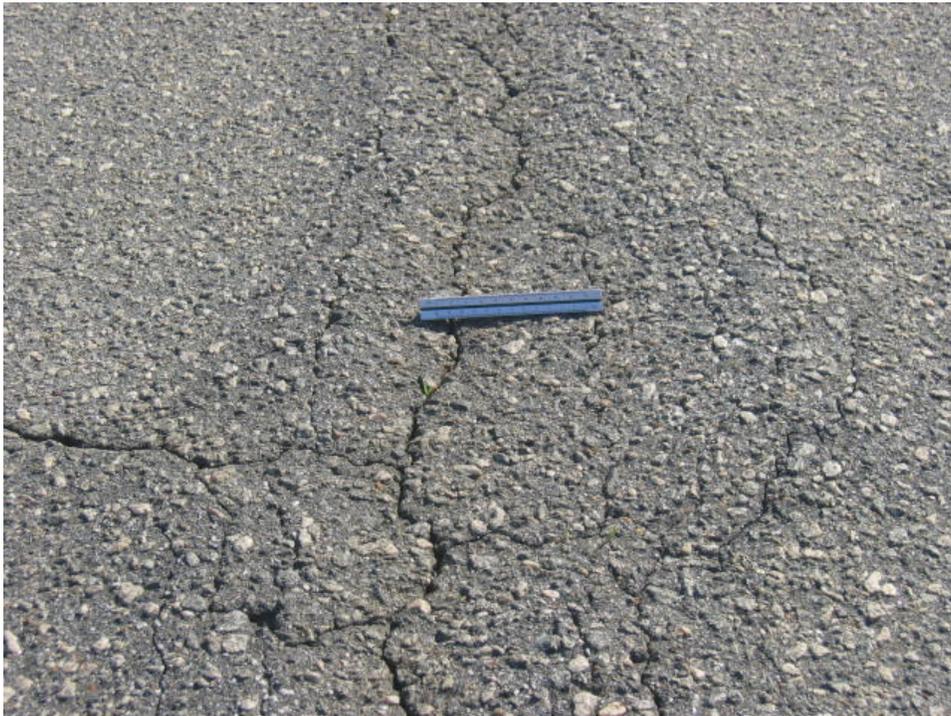
Taxiway E is defined by three sections. Section TEAB-10 is in poor condition with a PCI value of 59. Moderate quantities of low and medium-severity L&T cracking were recorded along with small amounts of low and medium-severity swelling and alligator cracking.

TEAB-10. Alligator cracking and swelling.

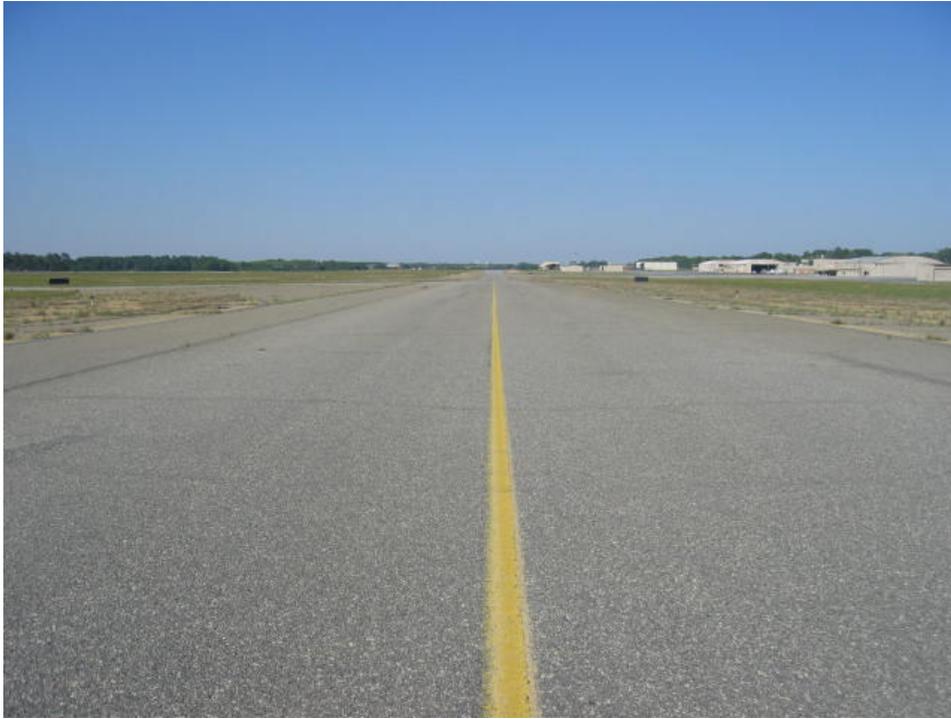
TEAB-10. Overview.

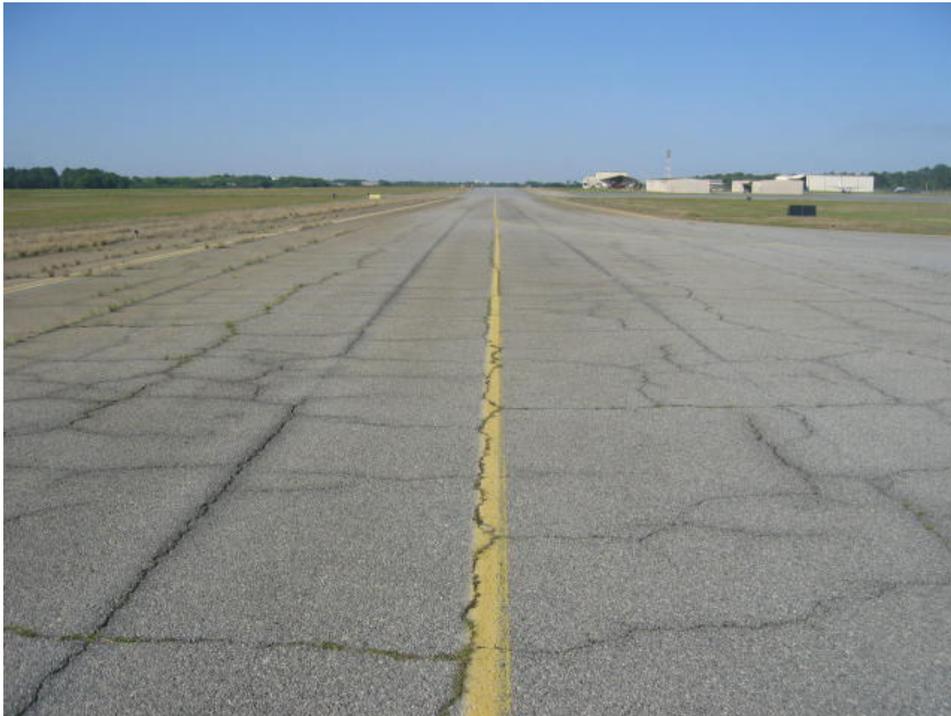
Section TEAB-20 is in poor condition with a PCI value of 33. Extensive amounts of medium-severity block cracking and low-severity raveling and weathering were identified. Smaller quantities of medium-severity alligator cracking and patching and low-severity depression and swelling were also observed.

TEAB-20. Overview.

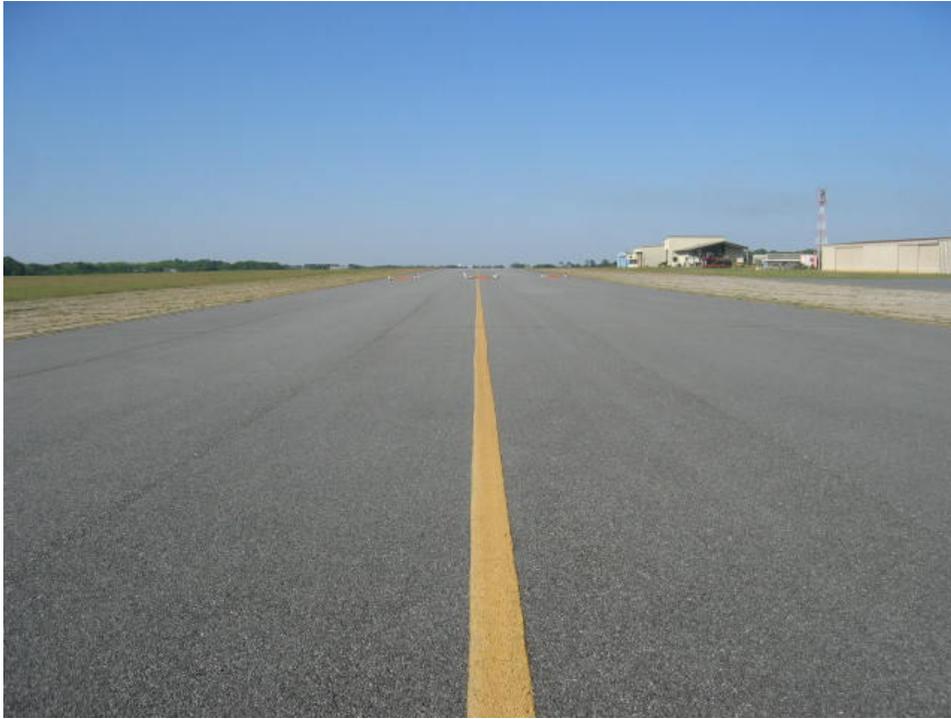
Section TEAB-30 was recently rehabilitated and is in excellent condition with a PCI value of 95. Small quantities of low-severity L&T cracking and swelling were the only distresses observed in this section.

TEAB-30. Overview.

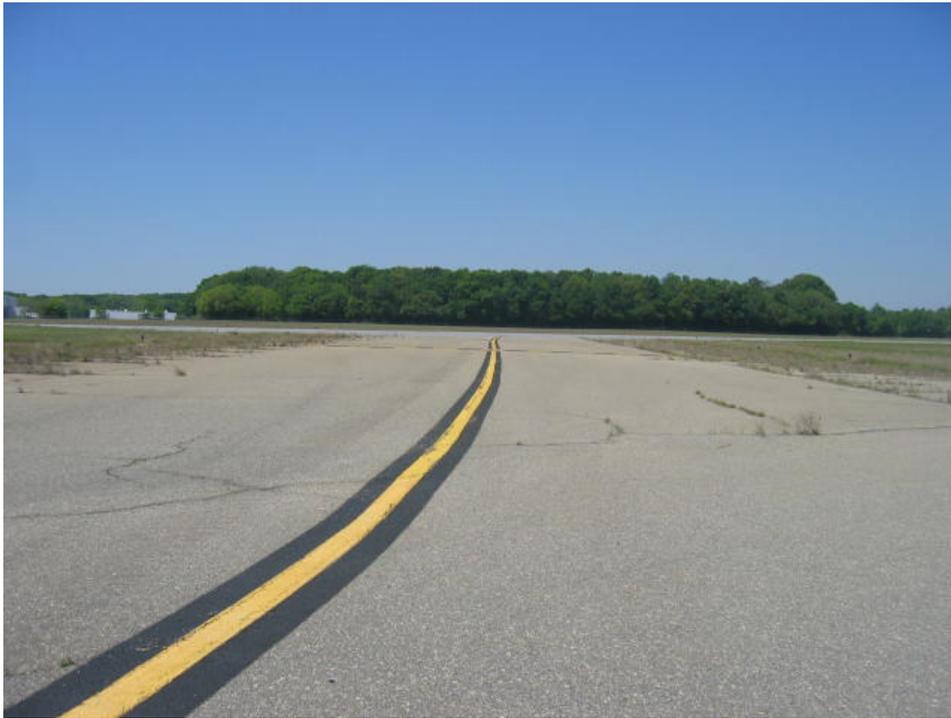
Taxiway F contains one section. Section TFAB-10 is in poor condition with a PCI value of 54. Moderate to extensive amounts of low and medium-severity L&T cracking and medium-severity block cracking were observed in this section.

TFAB-10. Overview.

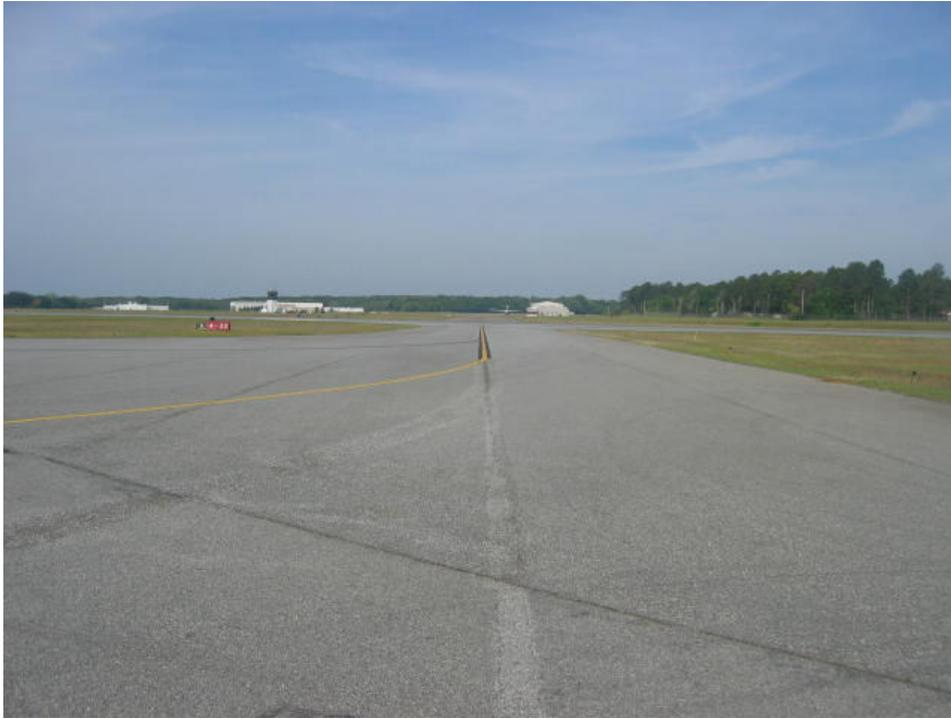
THAB-10. Overview (to be rehabilitated in 2007).

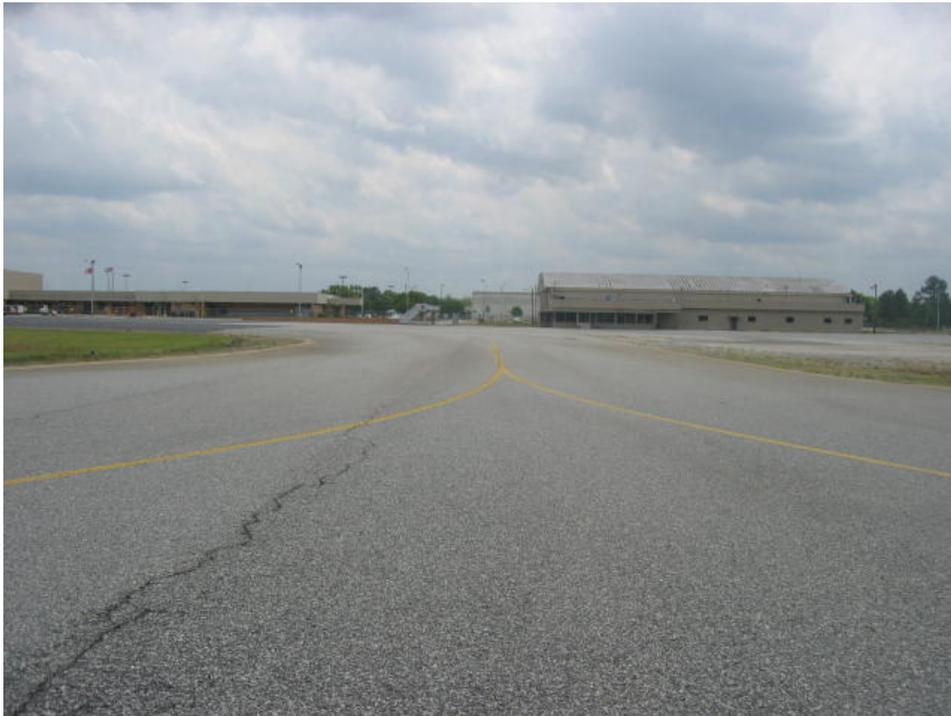
Taxiway S is comprised of one section. Section TSAB-10 is in fair condition with a PCI value of 78. Moderate amounts of low-severity L&T cracking were observed in this section along with smaller quantities of medium-severity L&T cracking, low-severity swelling, and low and medium-severity raveling and weathering.

TSAB-10. Overview.

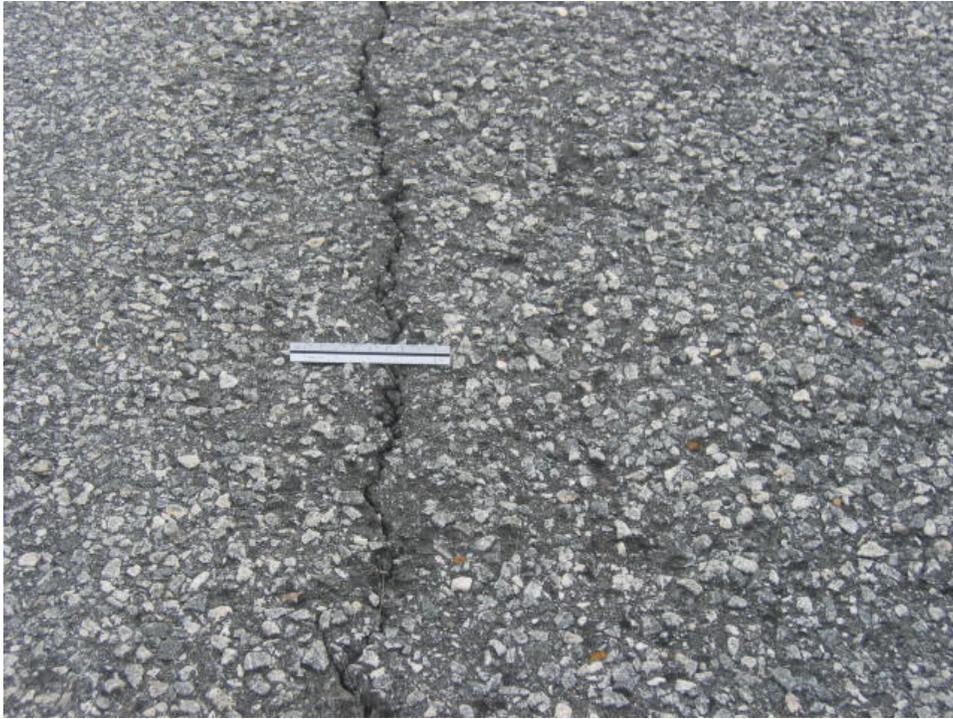
TSAB-10. Raveling and weathering.
