**BURKE COUNTY AIRPORT
PAVEMENT MANAGEMENT REPORT**

**2007 GEORGIA AIRPORT
PAVEMENT MANAGEMENT REPORT**

BURKE COUNTY AIRPORT

JANUARY 2008

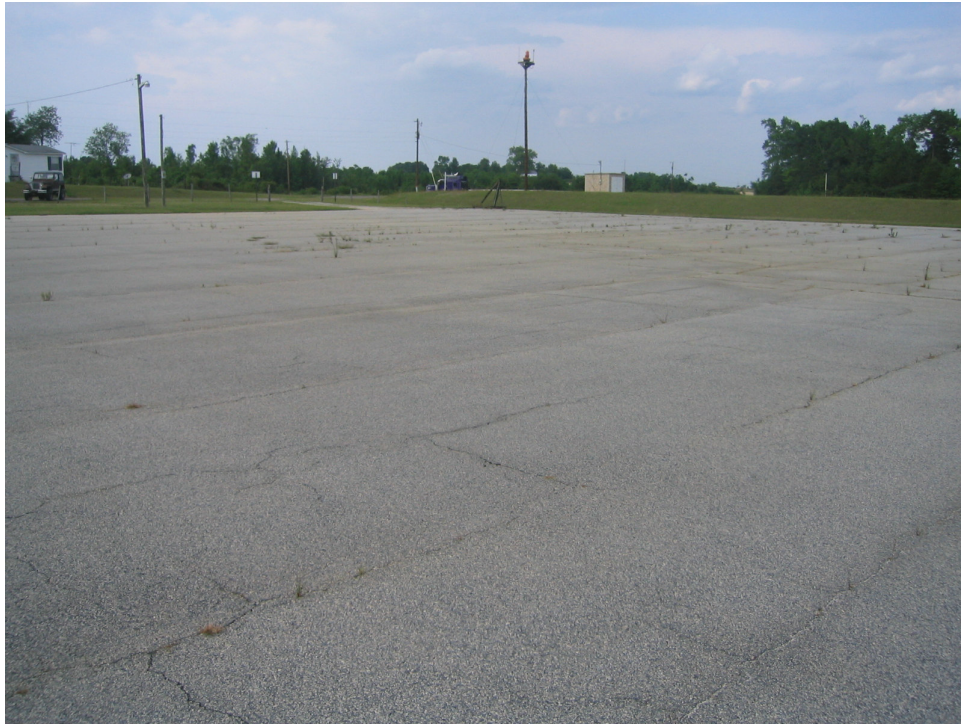
A01WB-10. Overview.

The apron is defined by one section, A01WB-10, and is in poor condition with a PCI value of 45. Low and medium-severity block and L&T cracking and a significant amount of low-severity raveling and weathering were observed during inspection.

Branch ¹	Section ¹	Surface Type ²	Section Area (sf)	LCD ³	2001 PCI	2007 PCI	% Distress due to:		Distress Types Present ⁶
							Load ⁴	Climate or Durability ⁵	
A01WB	10	AAC	46,500	6/1/1989	70	45	0	100	Block cracking, L&T Cracking, Raveling & Weathering
R826WB	10	AAC	302,625	6/1/1989	65	58	0	100	Block cracking, L&T Cracking, Raveling & Weathering
TAWB	10	AAC	12,766	6/1/1989	72	60	0	100	L&T Cracking, Raveling & Weathering

Branch¹	Section	Year	Type of Repair²	Estimated Cost³
A01WB	10	2008	Major M&R	\$53,735
R826WB	10	2008	Major M&R	\$349,713
TAWB	10	2008	Major M&R	\$14,752

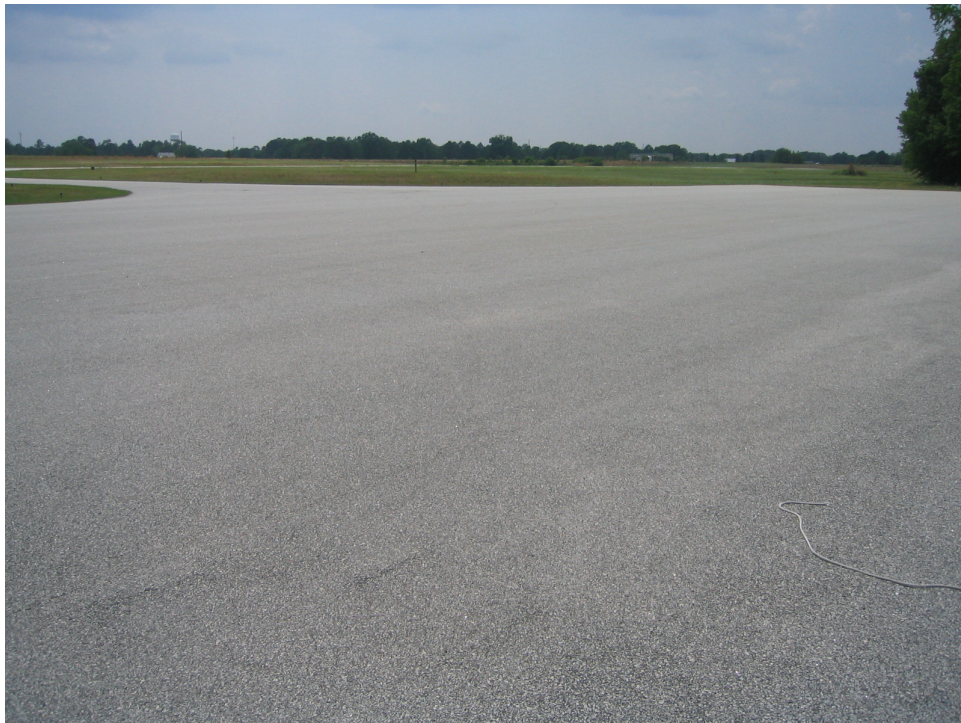
R826WB-10. Overview.

Runway 8-26 is defined by one section and is in poor condition with a PCI value of 58. A significant amount of unsealed low and medium-severity longitudinal and transverse (L&T) and block cracking and low-severity raveling and weathering were observed throughout.

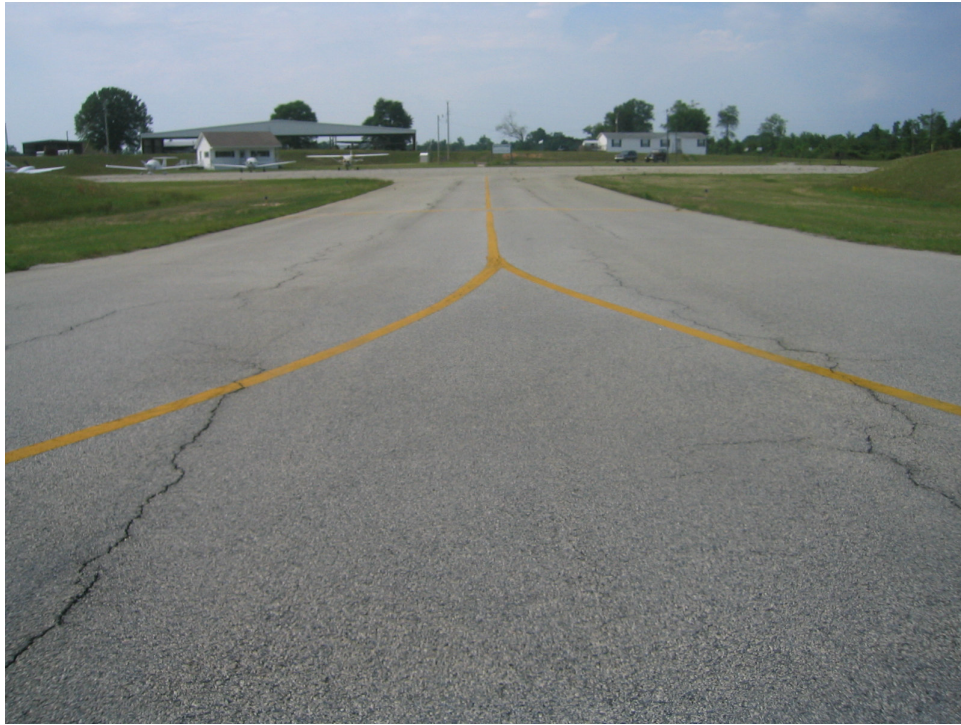
TAWB-10. Overview.

Taxiway A consists of one section and is in fair condition with a PCI value of 60. Low and medium-severity L&T cracking and a significant amount of low-severity raveling and weathering were observed during the inspection.
