Report:

Heart of Georgia Regional Airport Pavement Management Plan

PRESERVING
GEORGIA'S
CRITICAL
PAVEMENT
INFRASTRUCTURE

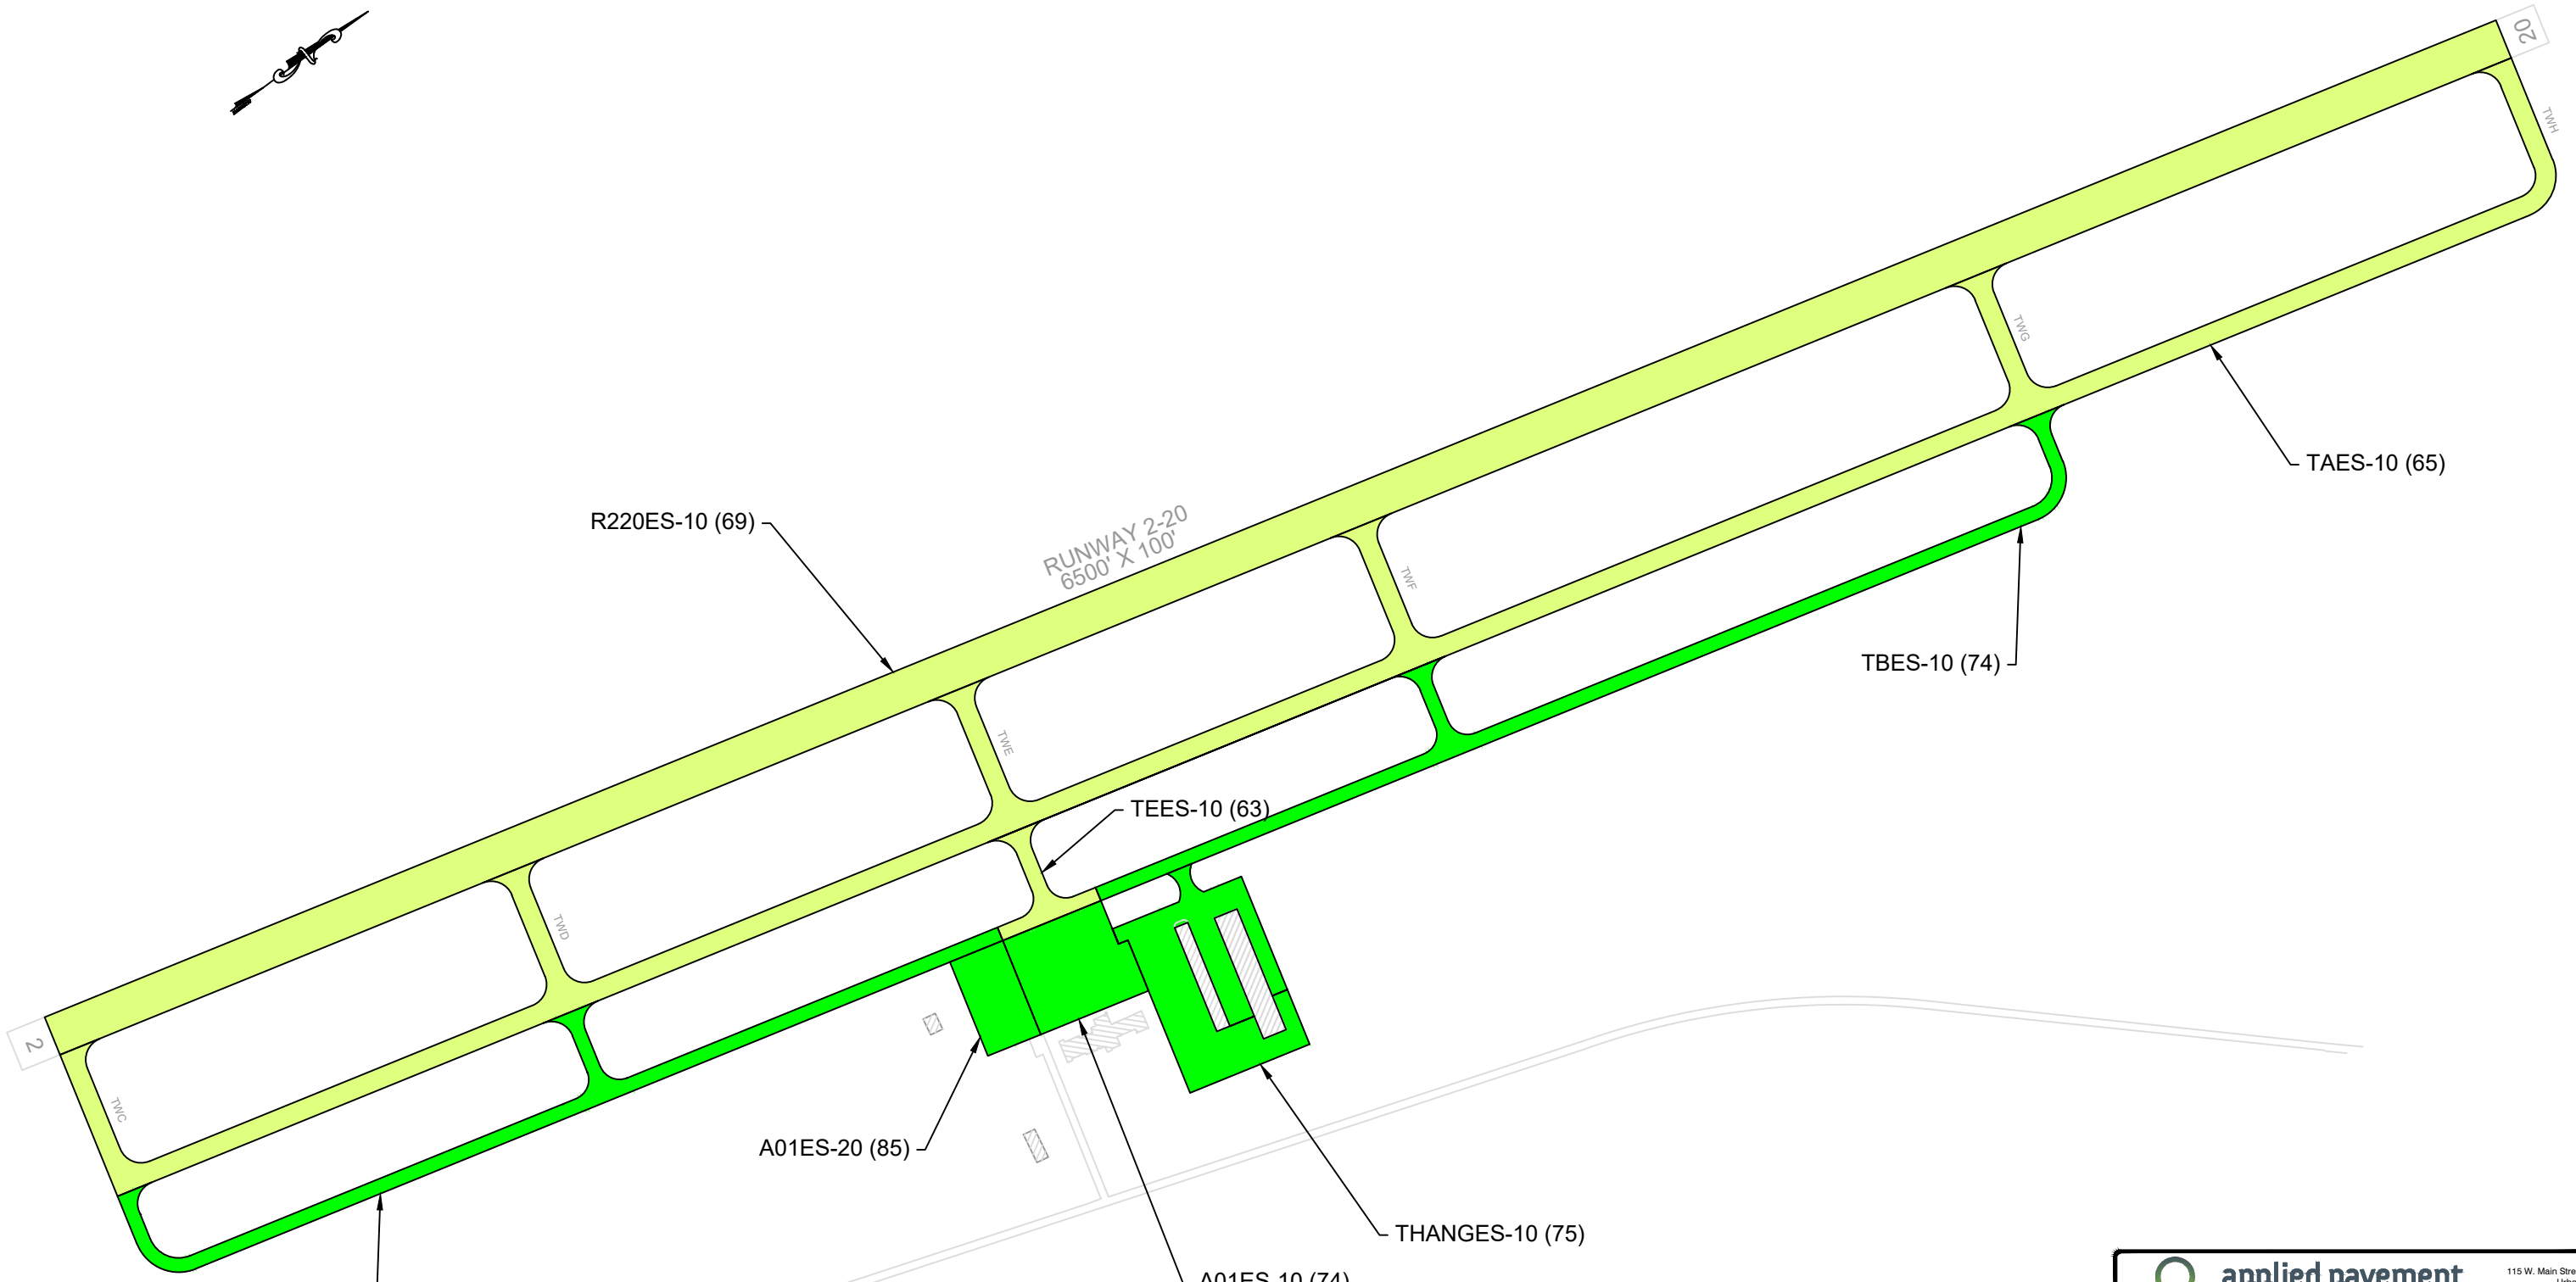
The 2018 area-weighted condition of Heart of Georgia Regional Airport is 70, with conditions ranging from 63 to 85 [on a scale of 0 (failed) to 100 (excellent)]. This compares to a 2012 PCI of 85.

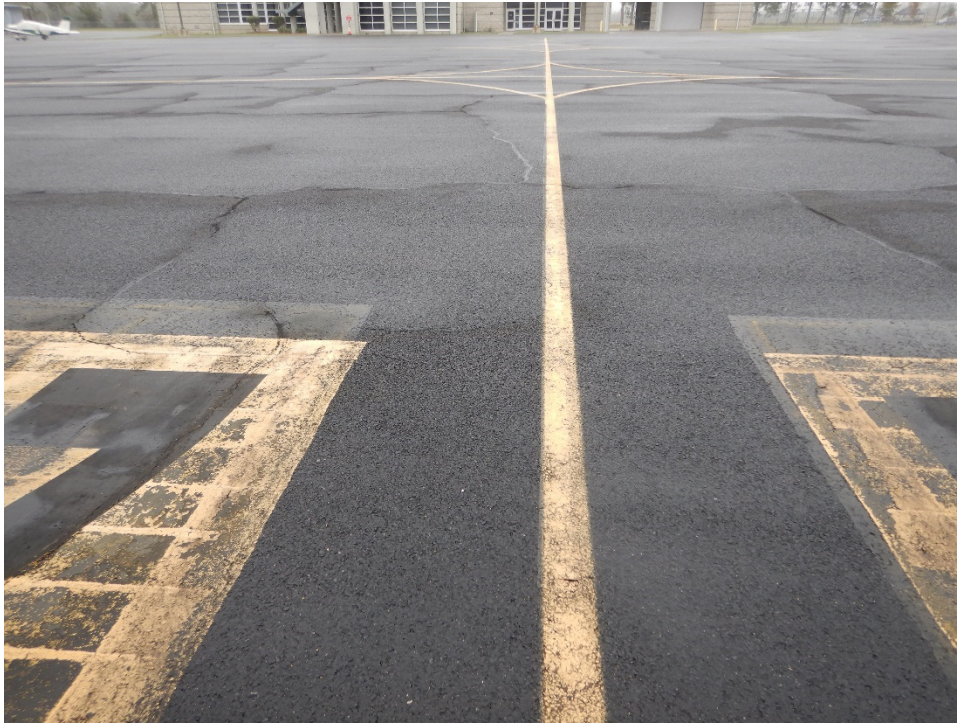
A01ES-10. Overview.

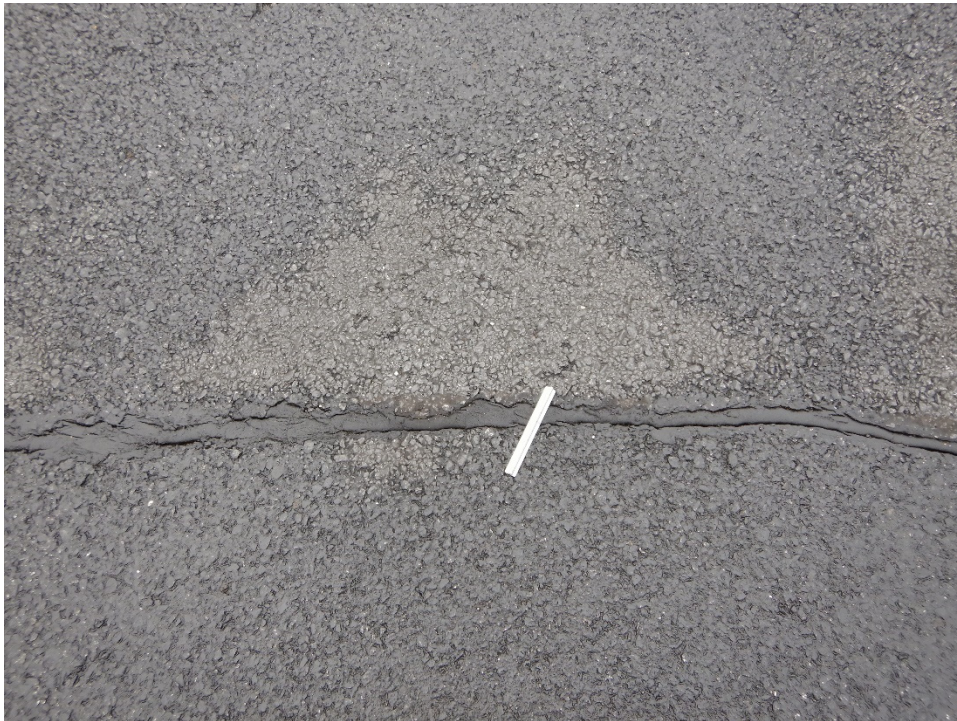
A01ES-10. L&T Cracking (Sample Unit No. 04).

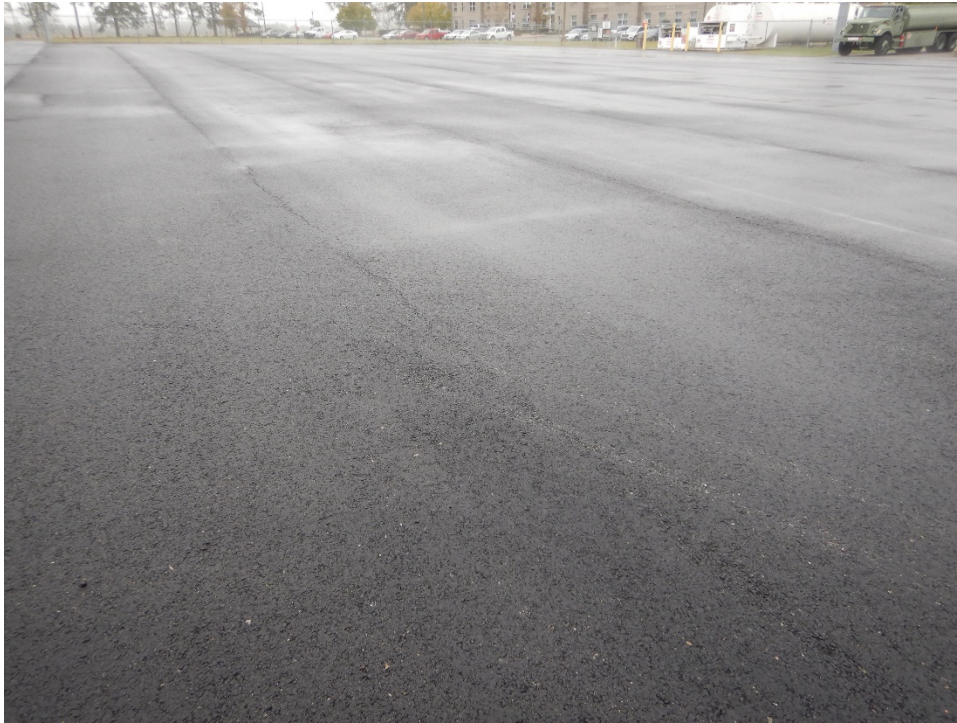
A01ES-20. Overview.

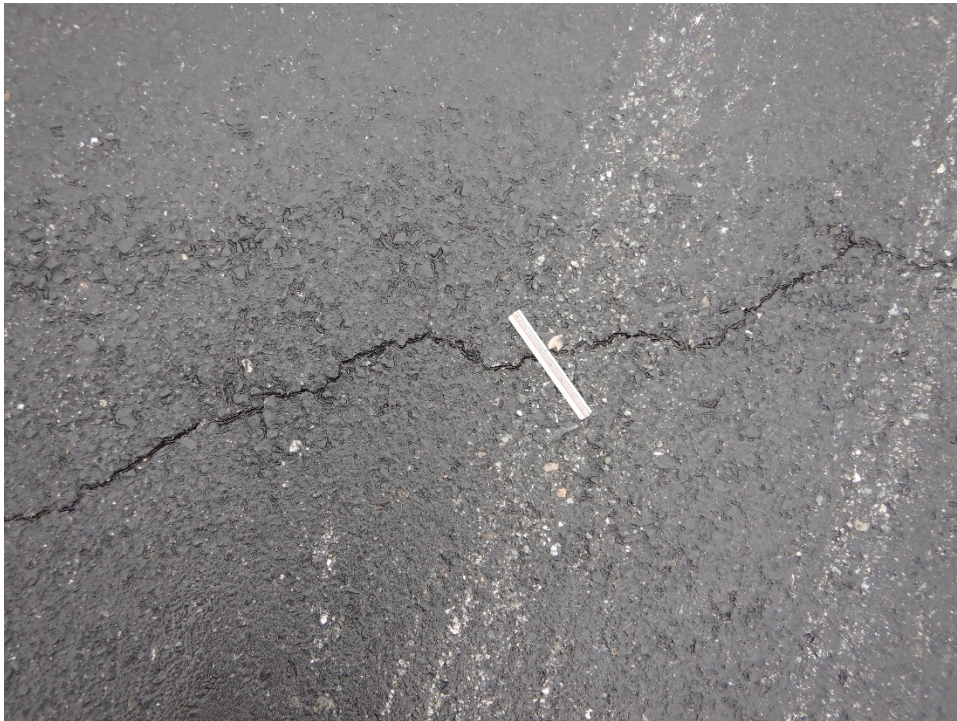
A01ES-20. L&T Cracking (Sample Unit No. 02).

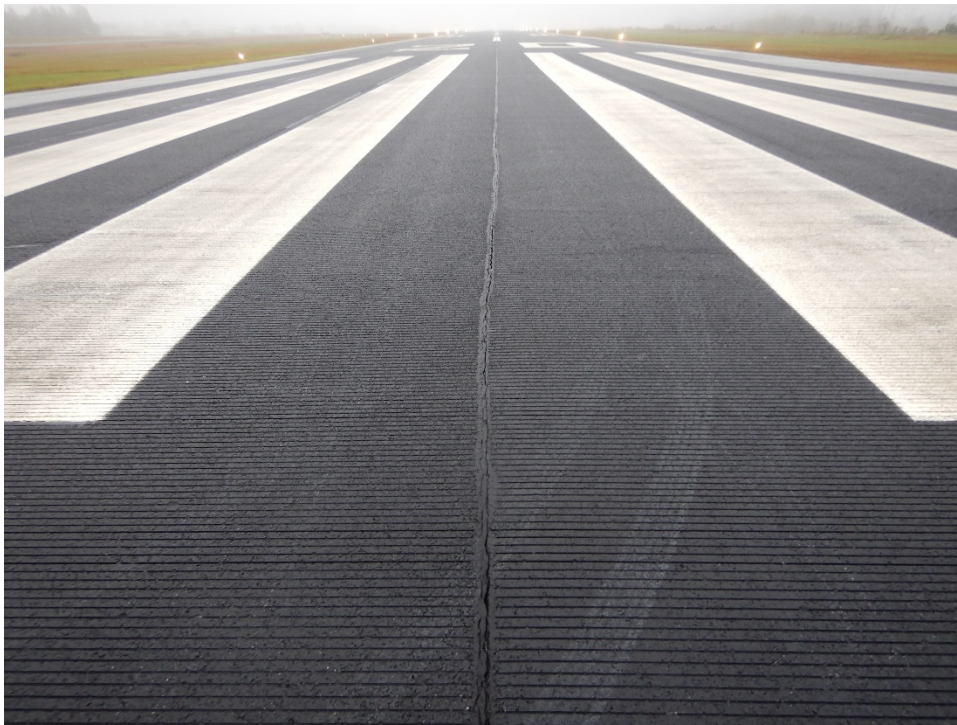
R220ES-10. Overview.

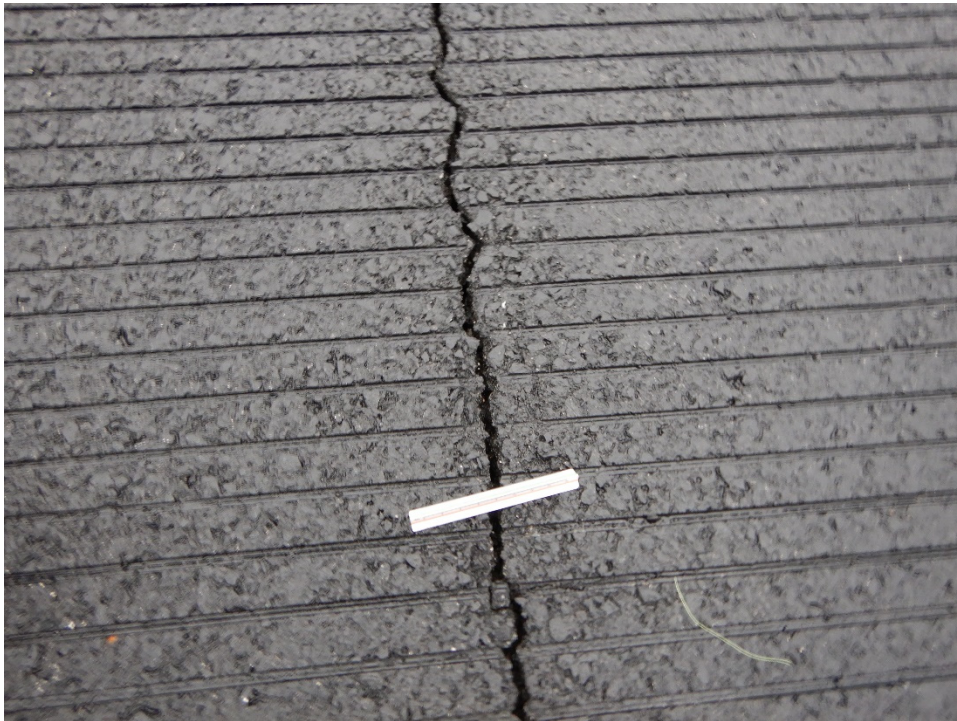
R220ES-10. L&T Cracking (Sample Unit No. 125).

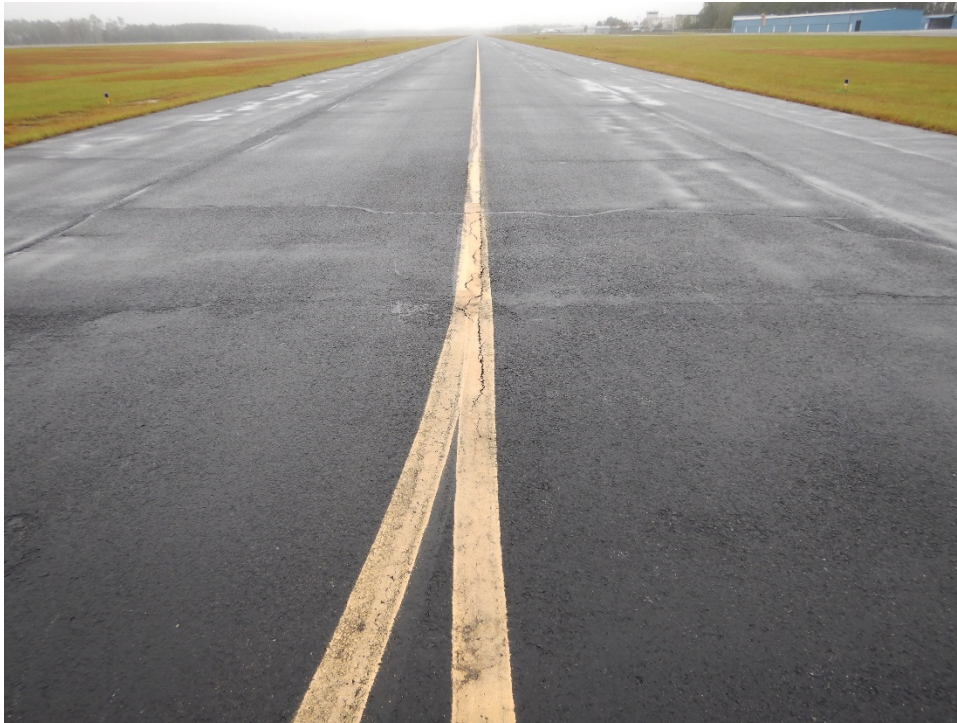
TAES-10. Overview.

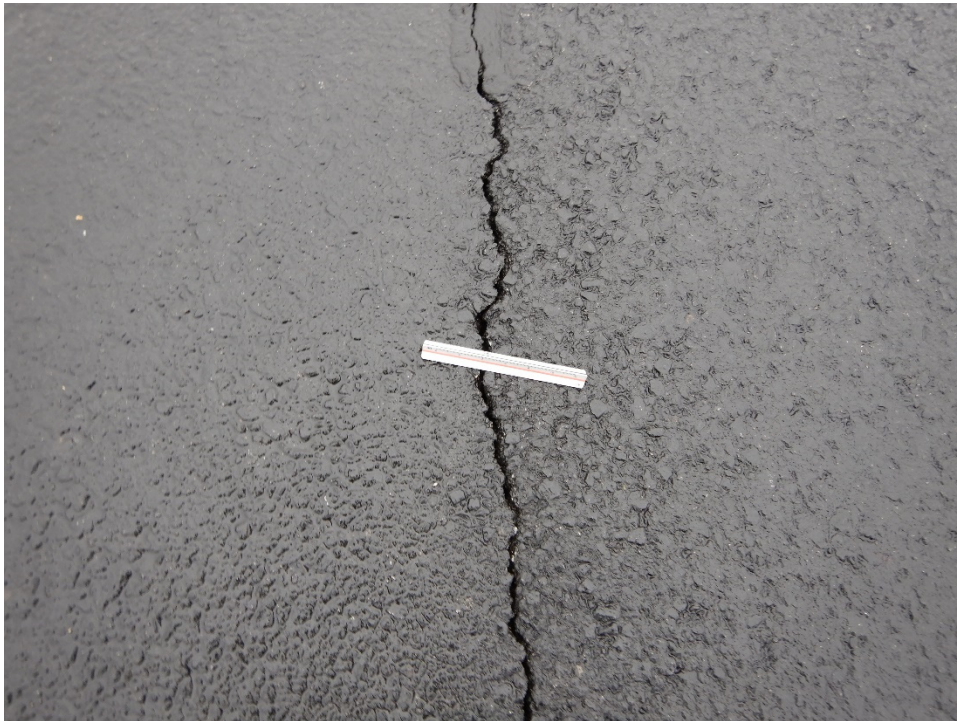
TAES-10. L&T Cracking (Sample Unit No. 93).

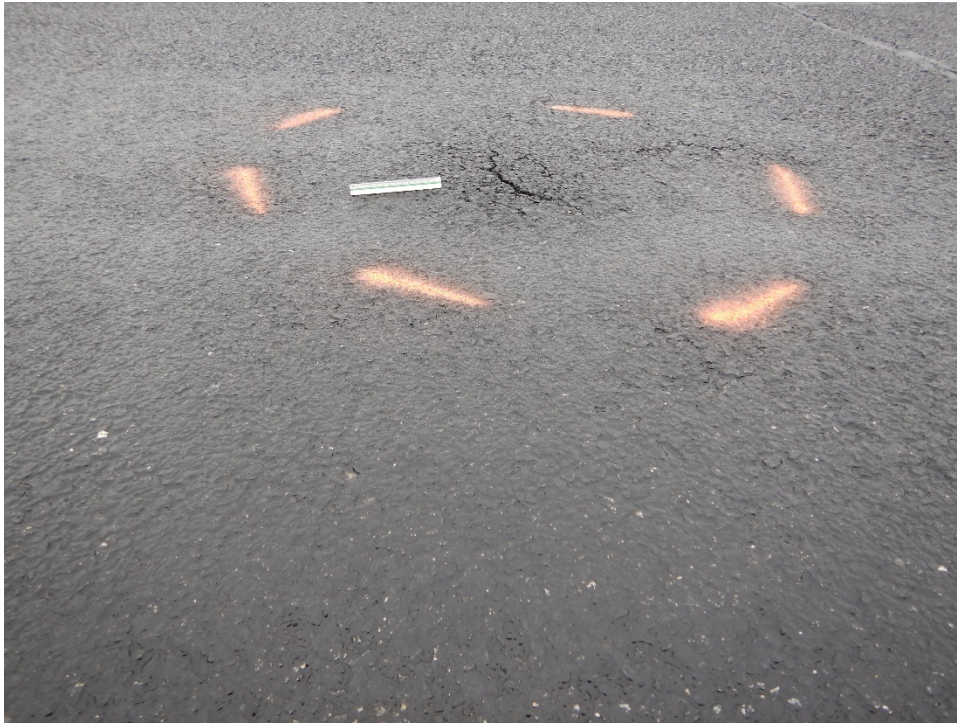
TAES-10. Swelling (Sample Unit No. 11).

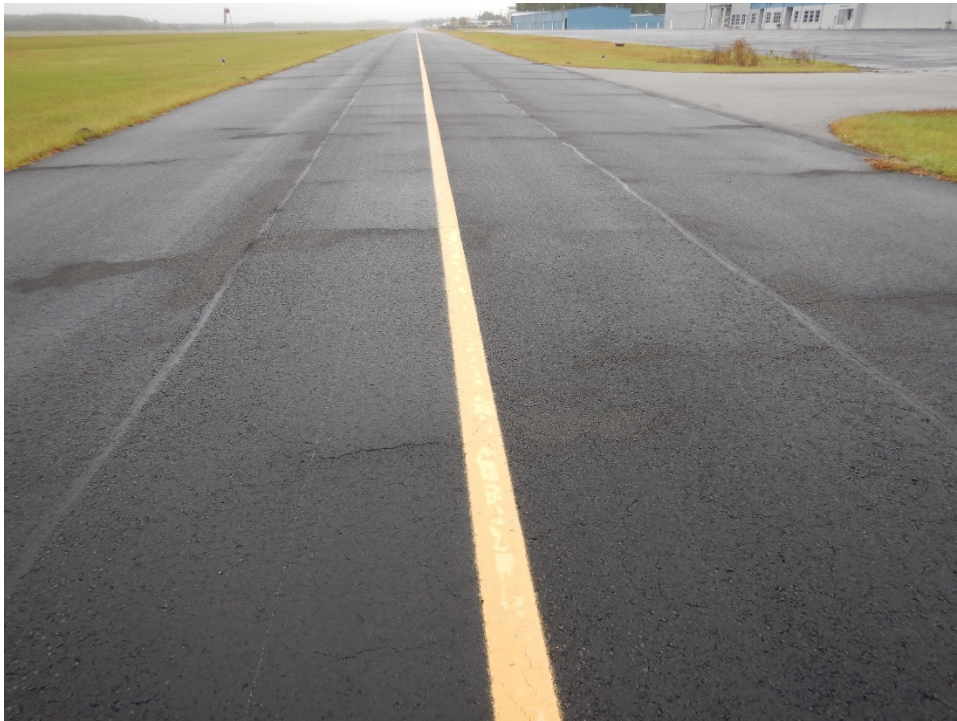
TBES-10. Overview.

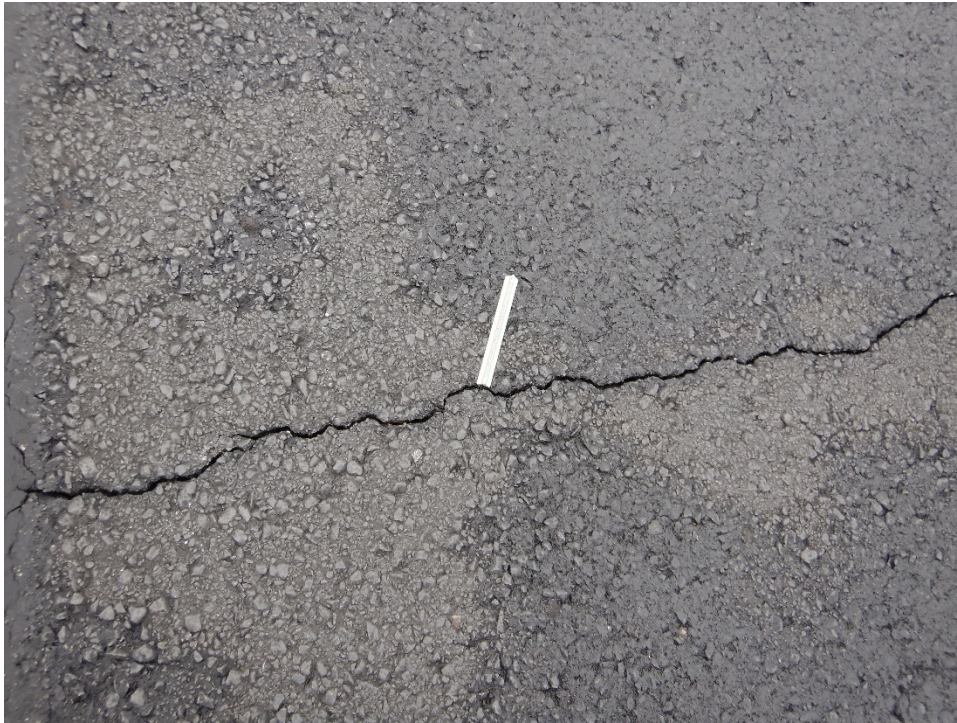
TBES-10. L&T Cracking (Sample Unit No. 03).

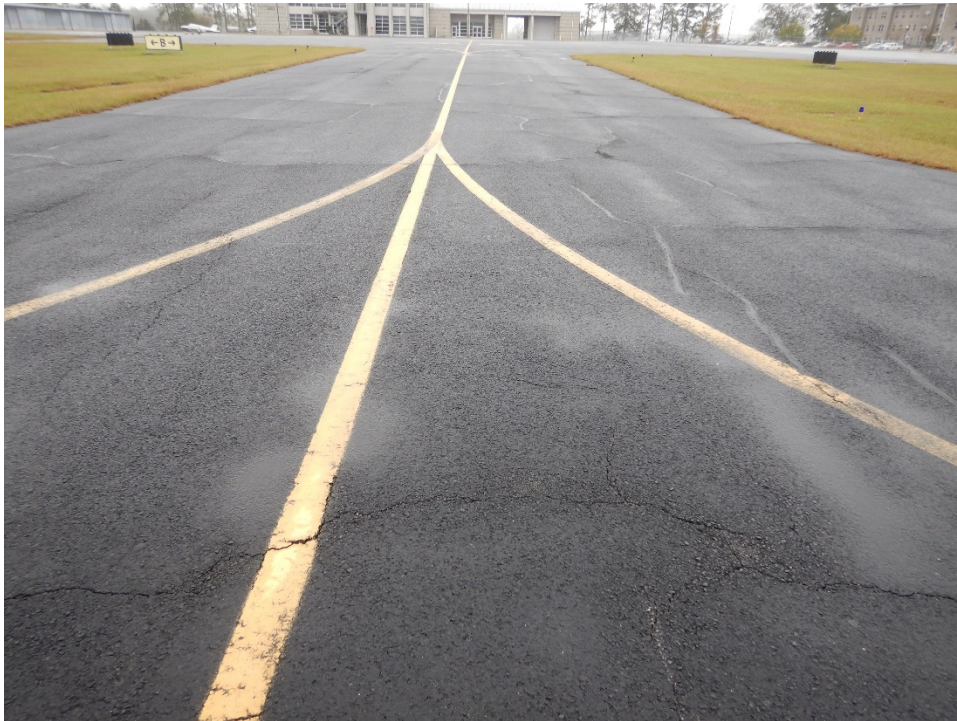
TEES-10. Overview.

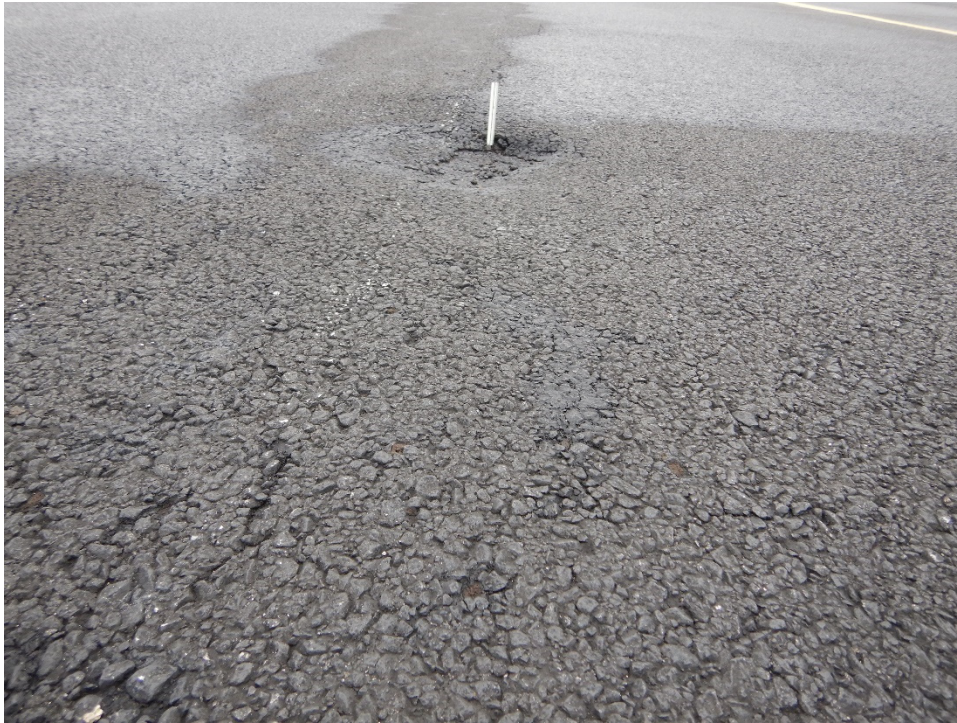
TEES-10. Depression (Additional Sample Unit No. 01).

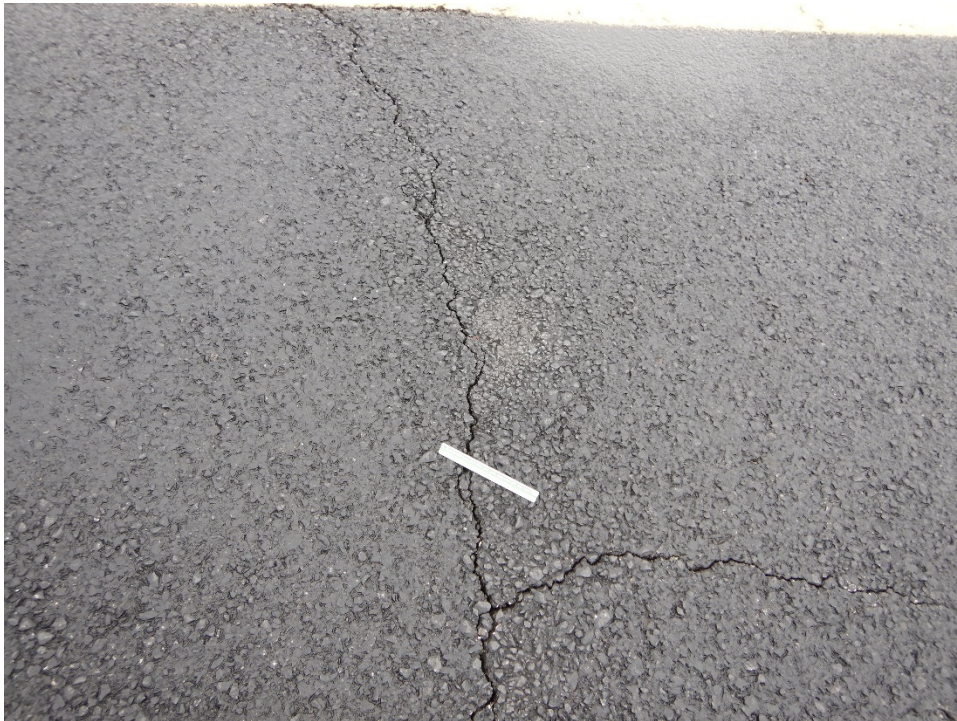
TEES-10. L&T Cracking (Sample Unit No. 04).

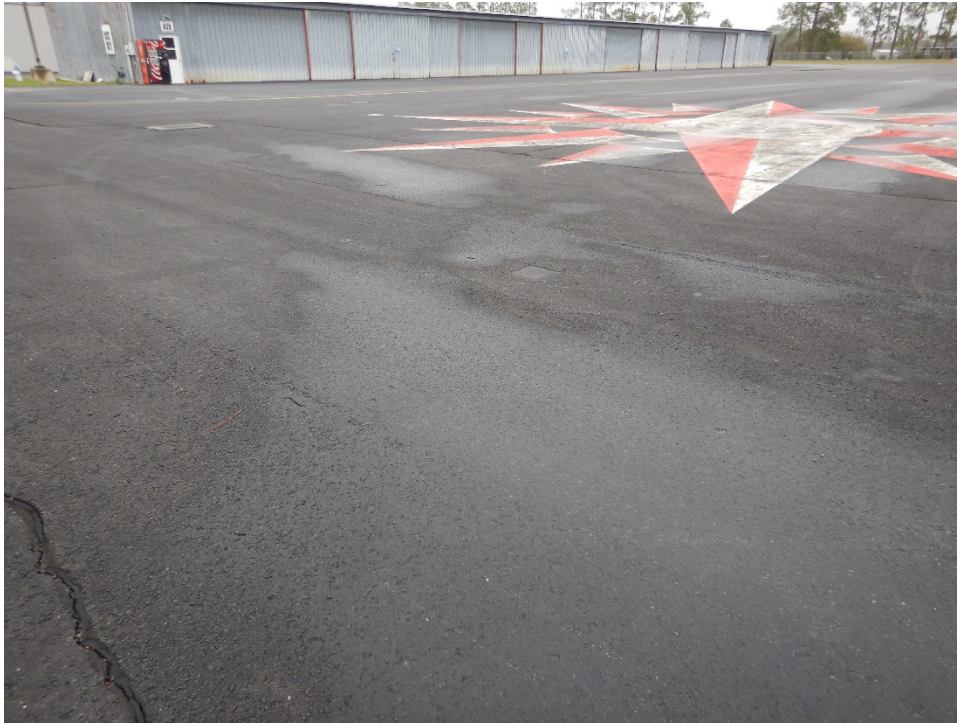
THANGES-10. Overview.

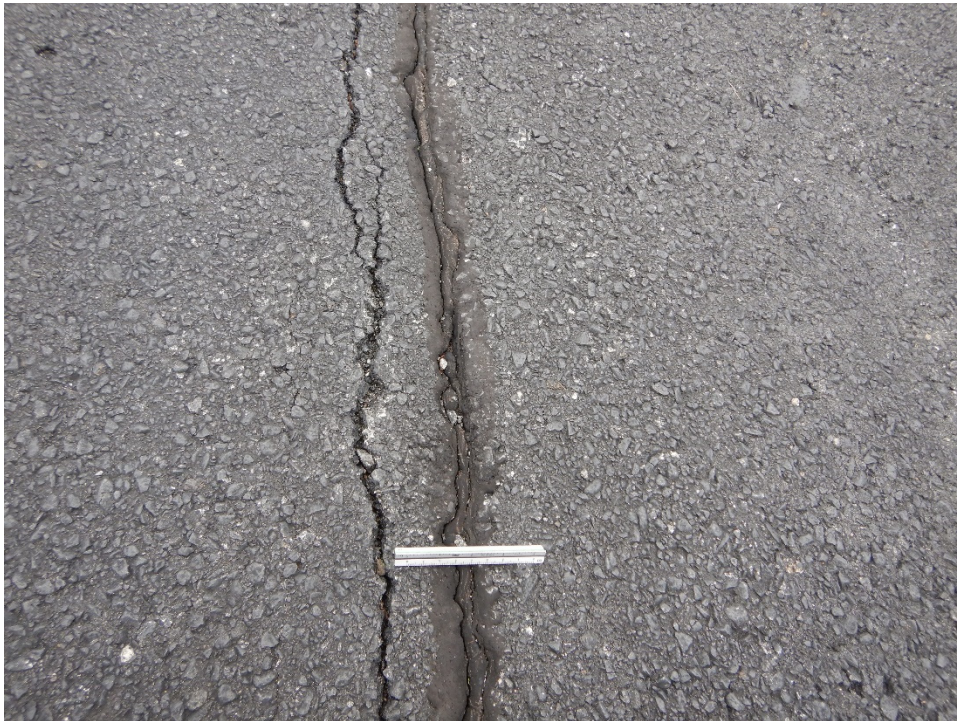
THANGES-10. L&T Cracking (Sample Unit No. 02).
