HOMERVILLE AIRPORT
PAVEMENT MANAGEMENT REPORT

2007 GEORGIA AIRPORT PAVEMENT MANAGEMENT REPORT

HOMERVILLE AIRPORT

JANUARY 2008

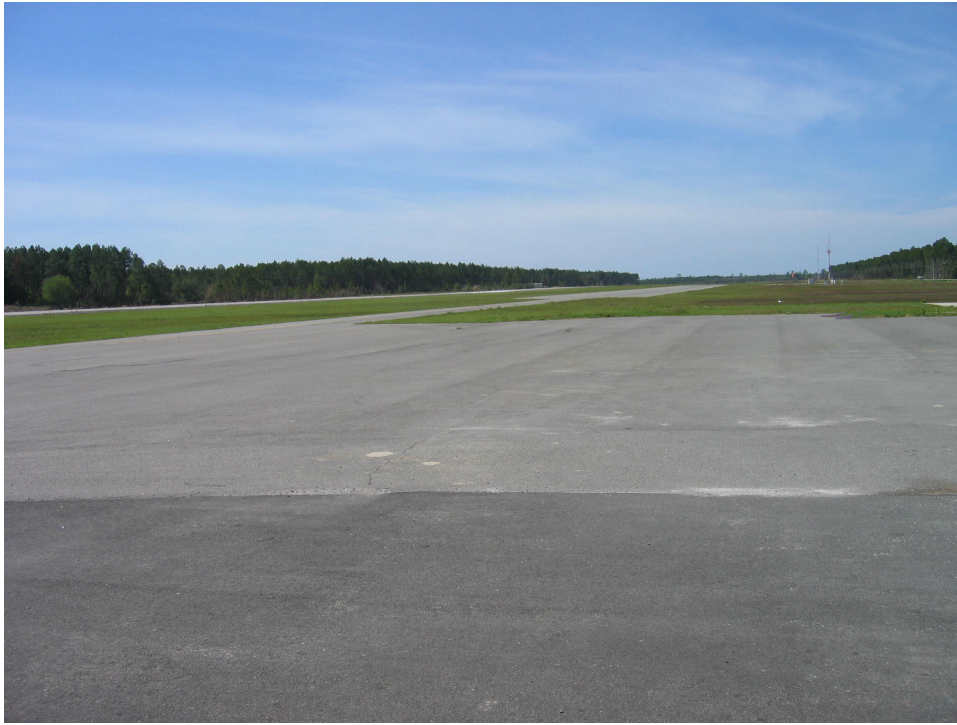
The apron area consists of two sections. Section A01HO-10 is in fair condition with a PCI value of 75. Small amounts of low-severity L&T cracking, raveling and weathering, depression, and swelling were observed throughout the pavement section. Section A01HO-20 is in excellent condition with a PCI value of 100 and no distresses identified at the time of inspection.

A01HO-10. Overview.

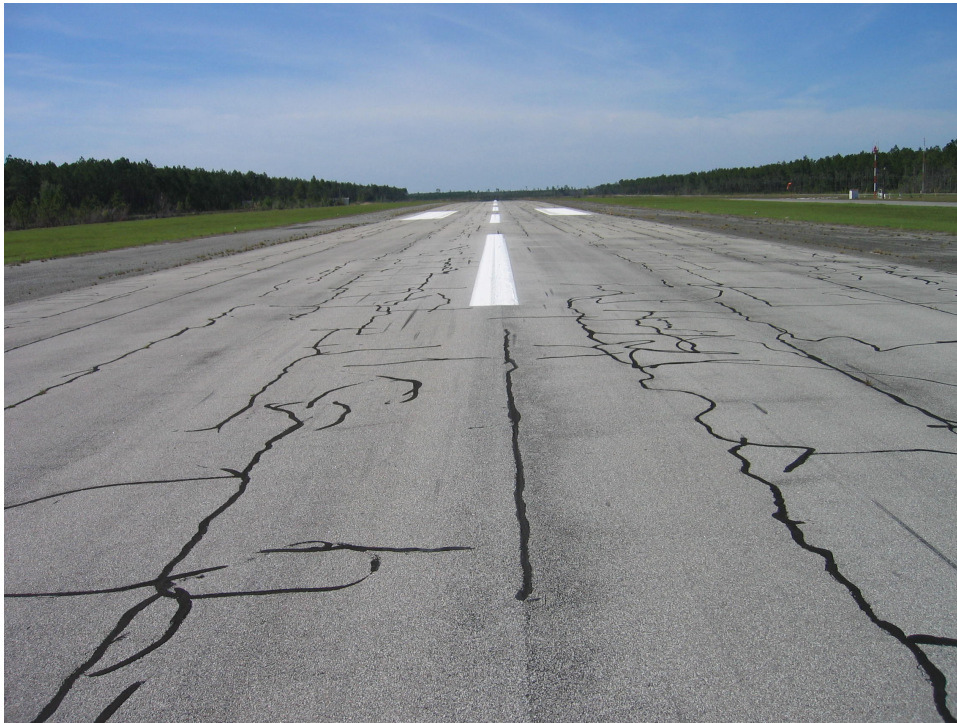
Runway 14-32 consists of one section, R1432HO-10, that is in fair condition with a PCI value of 62. Large quantities of low-severity, both sealed and unsealed, longitudinal and transverse (L&T) cracking were identified throughout the pavement. Significant amounts of low-severity block cracking and raveling and weathering were also observed throughout the section. Occasional amounts of swelling were also identified, primarily toward the outside edges of the runway.

R1432HO-10. Overview.

Branch¹	Section	Year	Type of Repair²	Estimated Cost³
R1432HO	10	2008	Major M&R	\$366,631
TAHO	10	2008	Rejuvenator	\$22,121
A01HO	10	2012	Preventive Maintenance	\$976
TAHO	10	2012	Preventive Maintenance	\$8,418

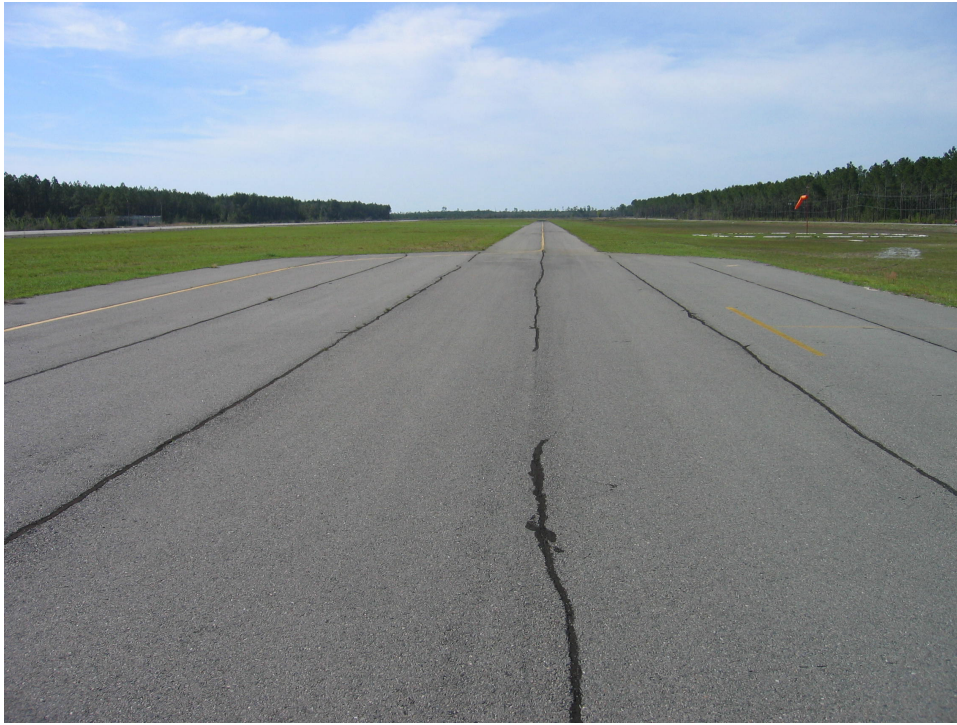
Taxiway A is defined by one section, TAHO-10, that is in good condition with a PCI value of 81. Significant amounts of low-severity L&T cracking, the majority of which was sealed, were observed throughout the section. Moderate amounts of low-severity raveling and weathering were also identified along with small amounts of low-severity patching and rutting.

TAHO-10. Overview.

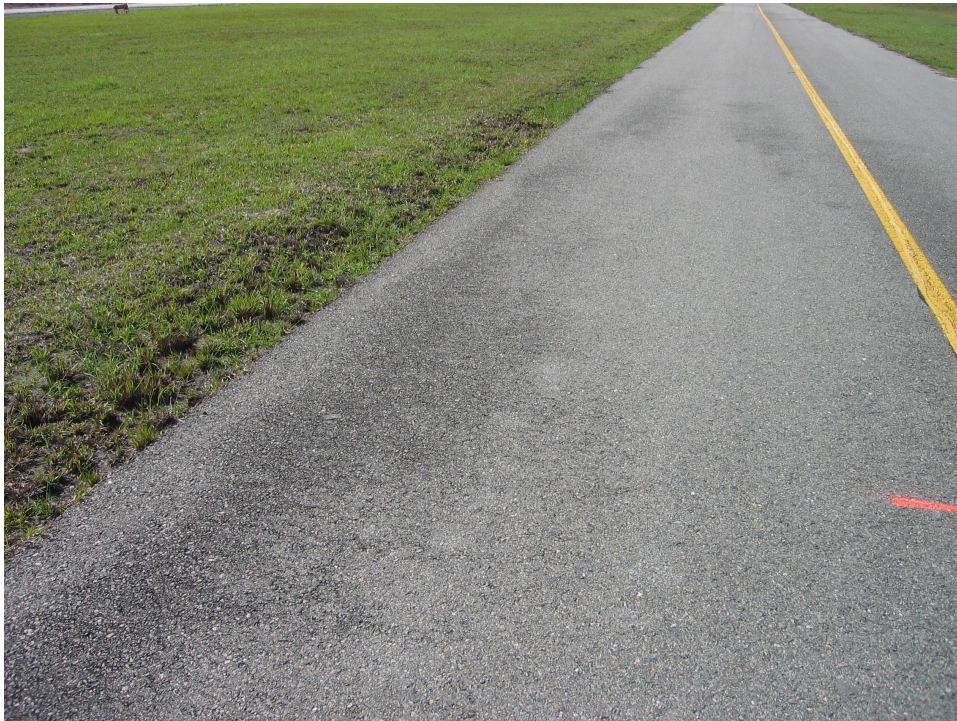
TAHO-10. Raveling and weathering.
