Report:

Homerville Airport Pavement Management Plan

PRESERVING
GEORGIA'S
CRITICAL
PAVEMENT
INFRASTRUCTURE

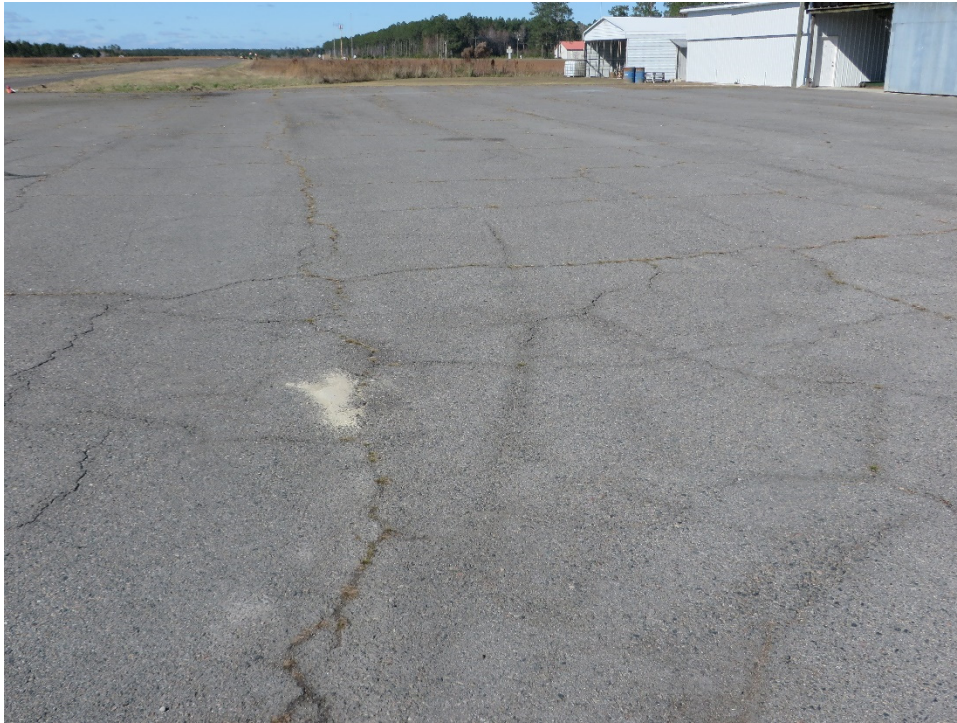
A01HO-10. Overview.

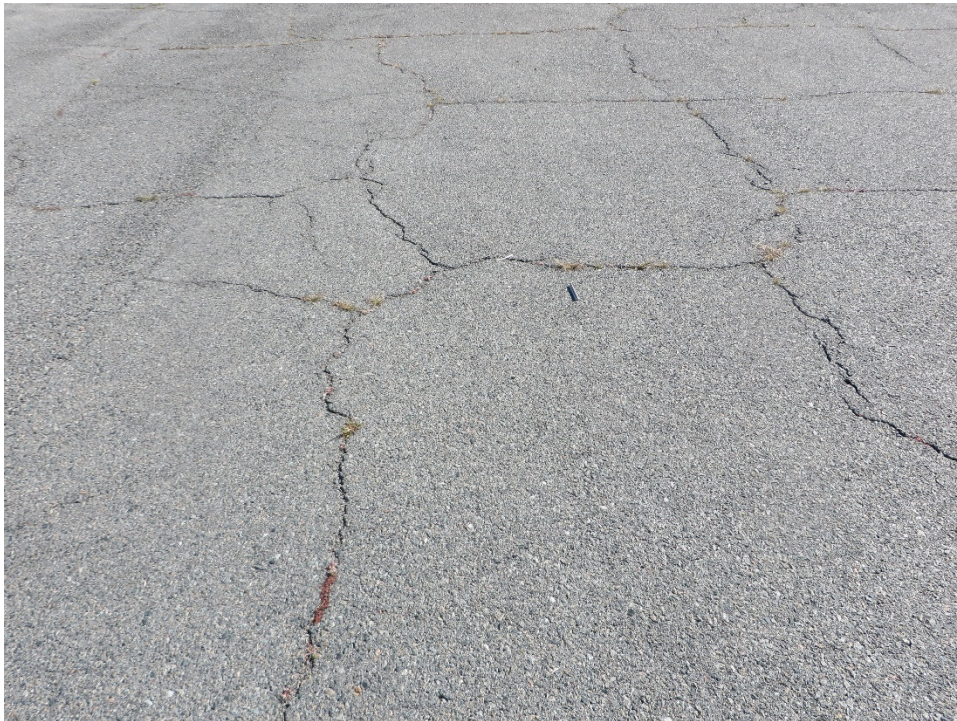
A01HO-10. Block Cracking (Sample Unit No. 03).

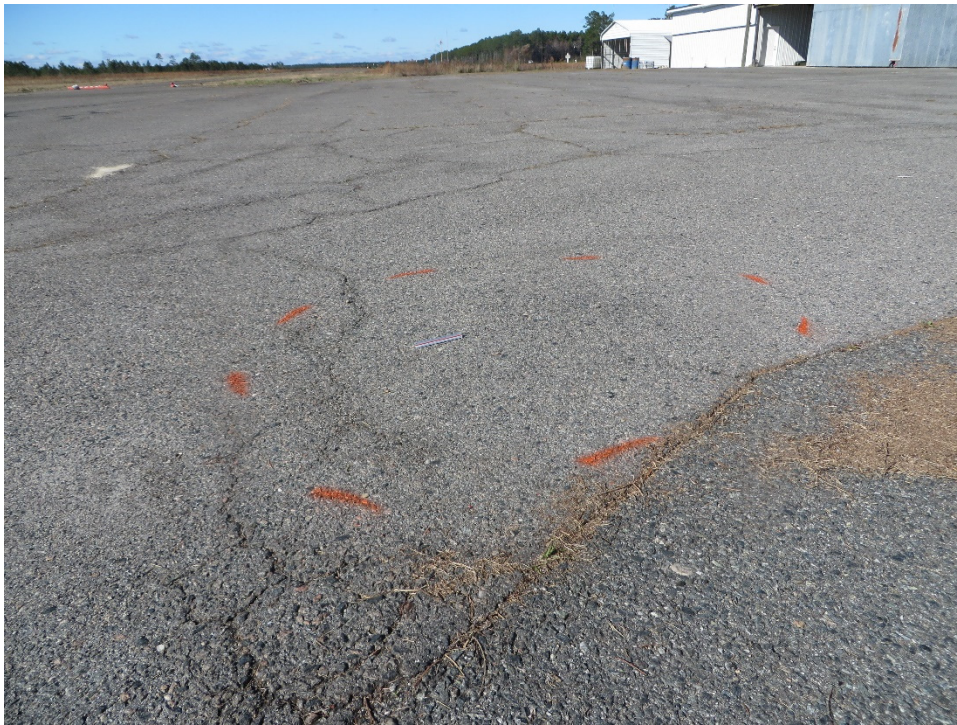
A01HO-10. Swelling (Sample Unit No. 02).

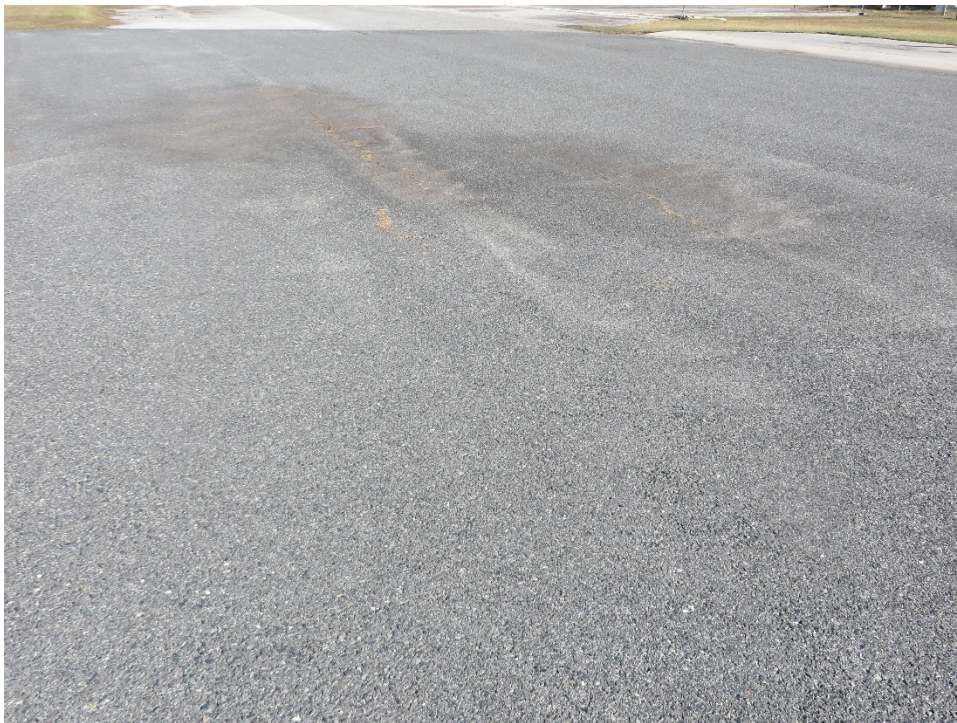
A01HO-20. Overview.

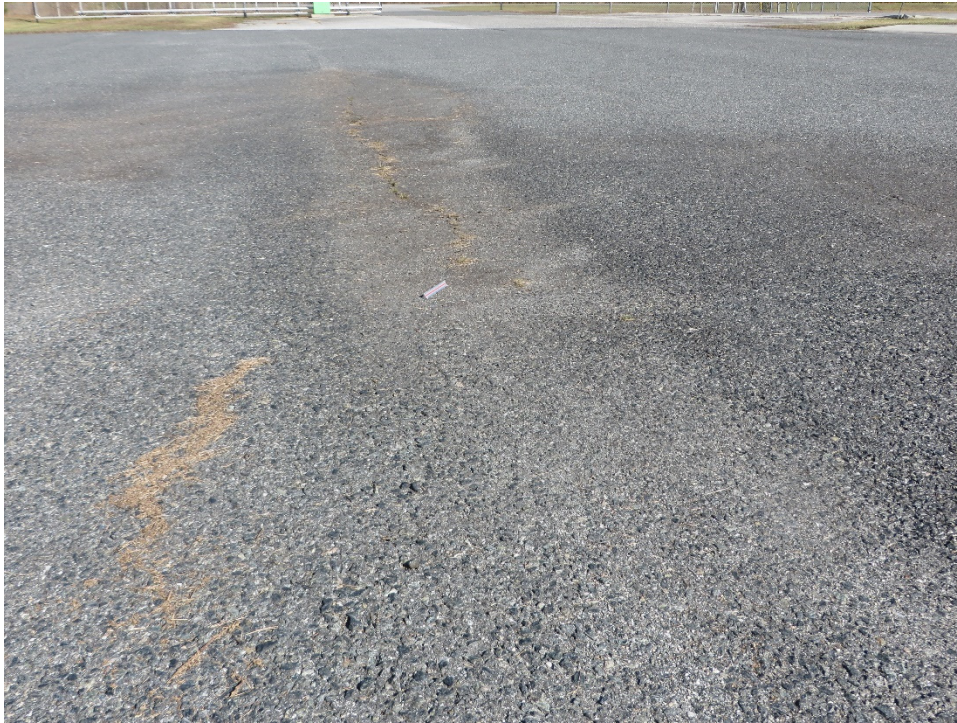
A01HO-20. Rutting (Sample Unit No. 01).

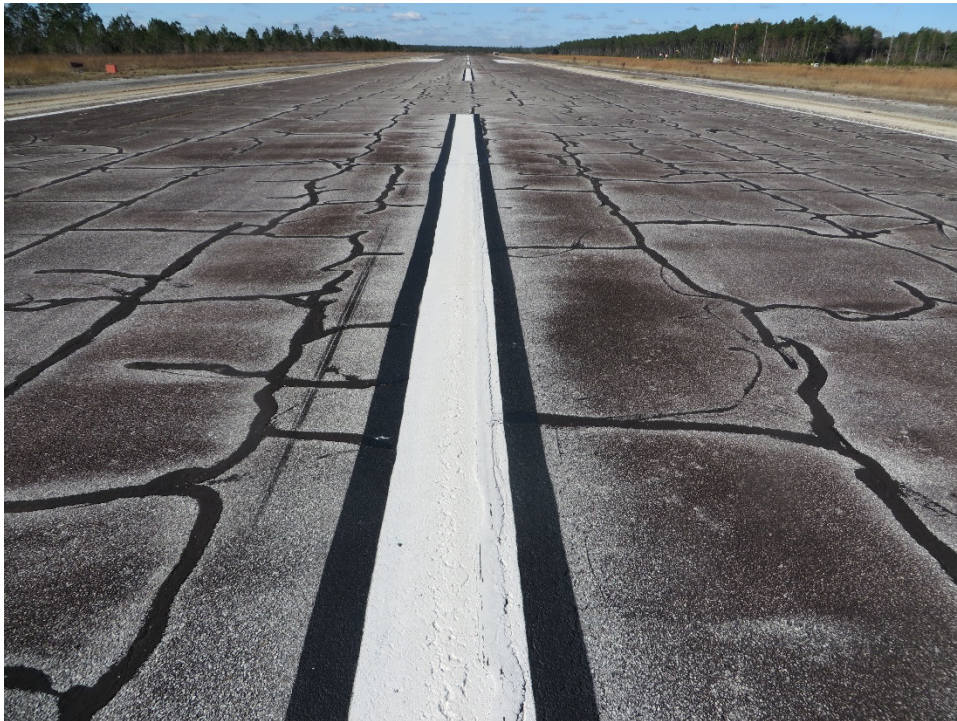
R1432HO-10. Overview.

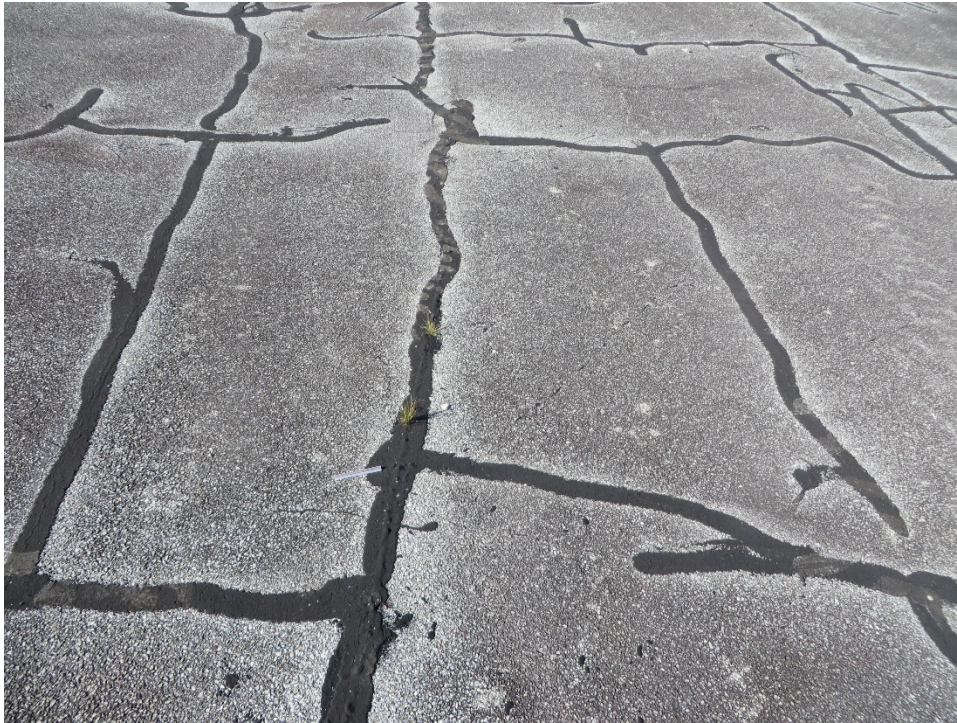
R1432HO-10. Block Cracking (Sample Unit No. 48).

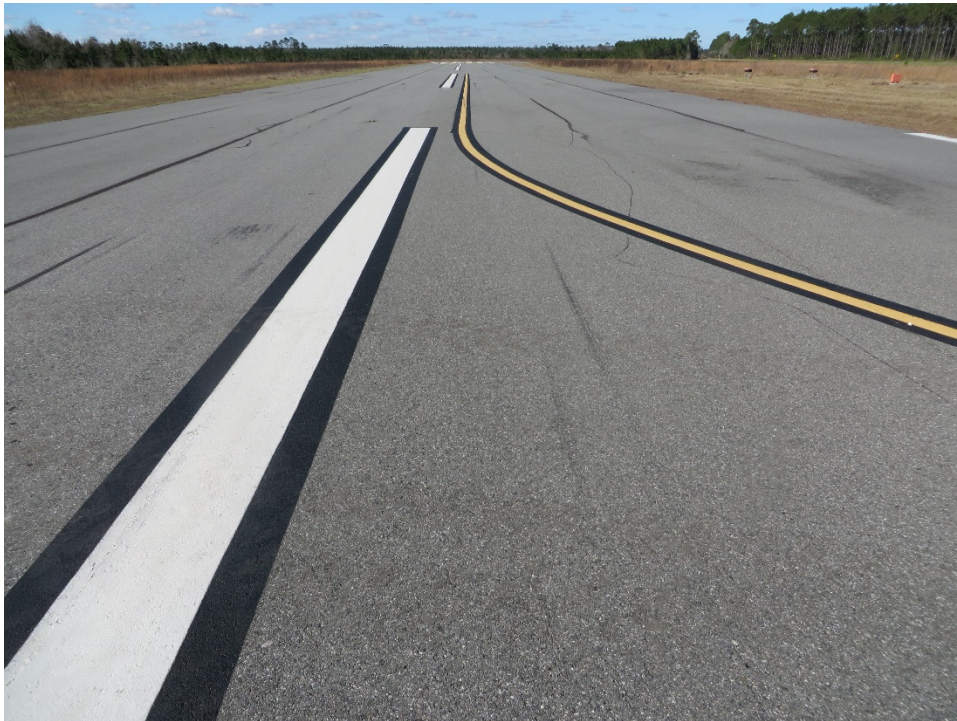
R1432HO-20. Overview.

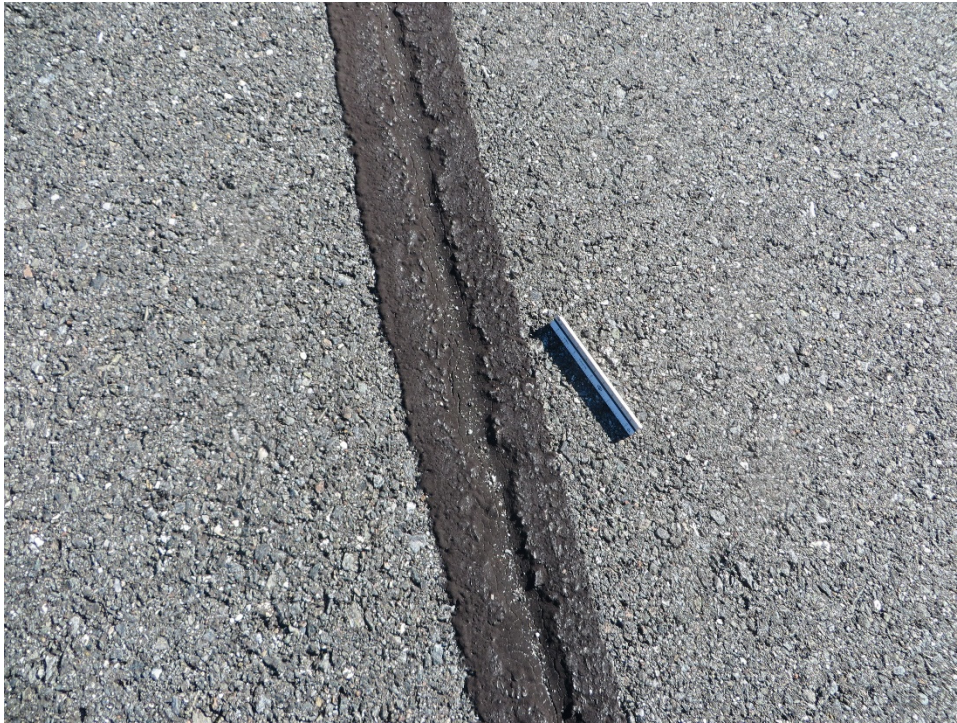
R1432HO-20. L&T Cracking (Sample Unit No. 12).

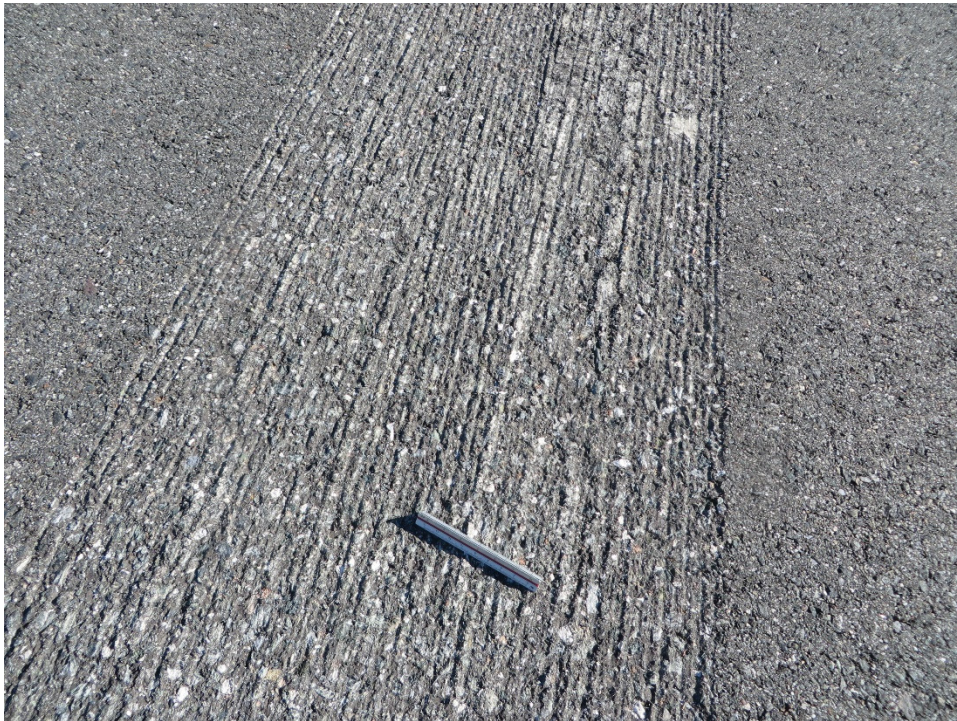
R1432HO-20. Weathering (Sample Unit No. 12).

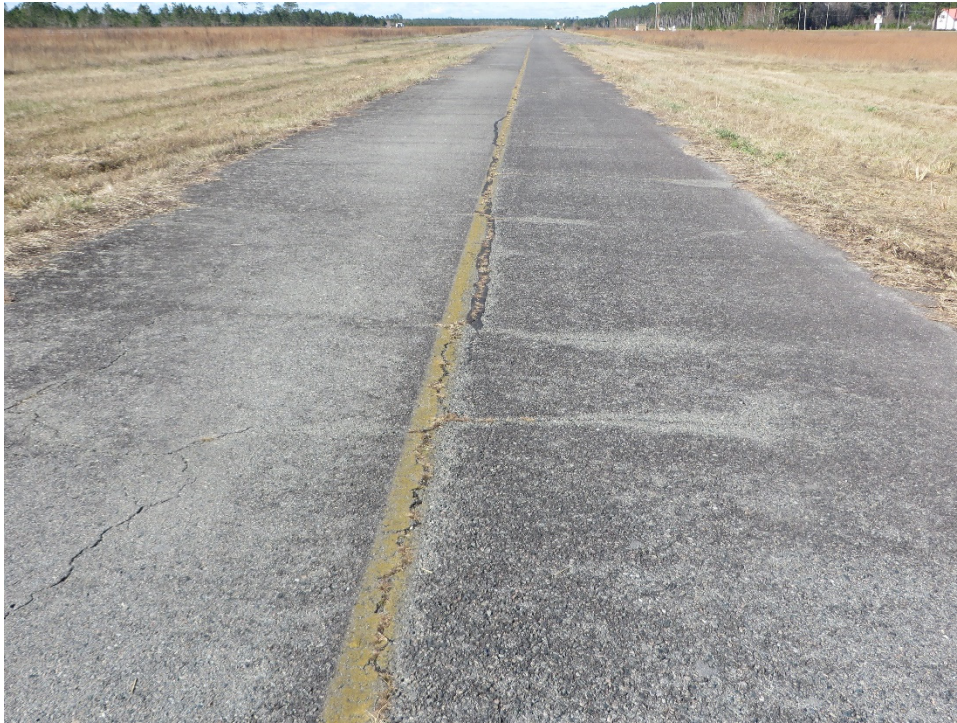
TAHO-10. Overview.

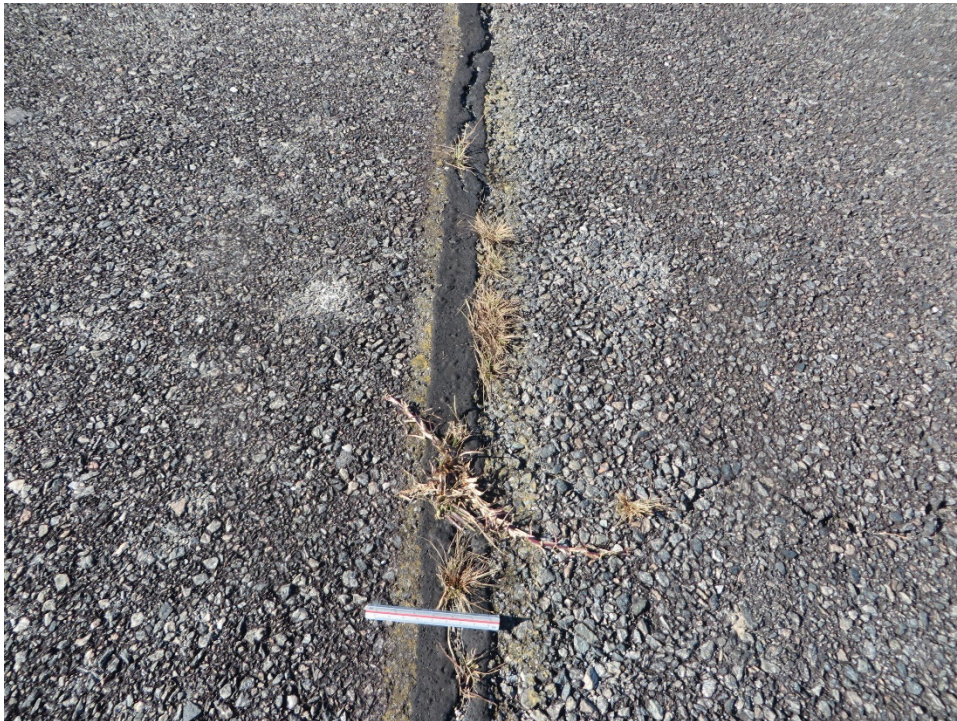
TAHO-10. L&T Cracking (Sample Unit No. 03).

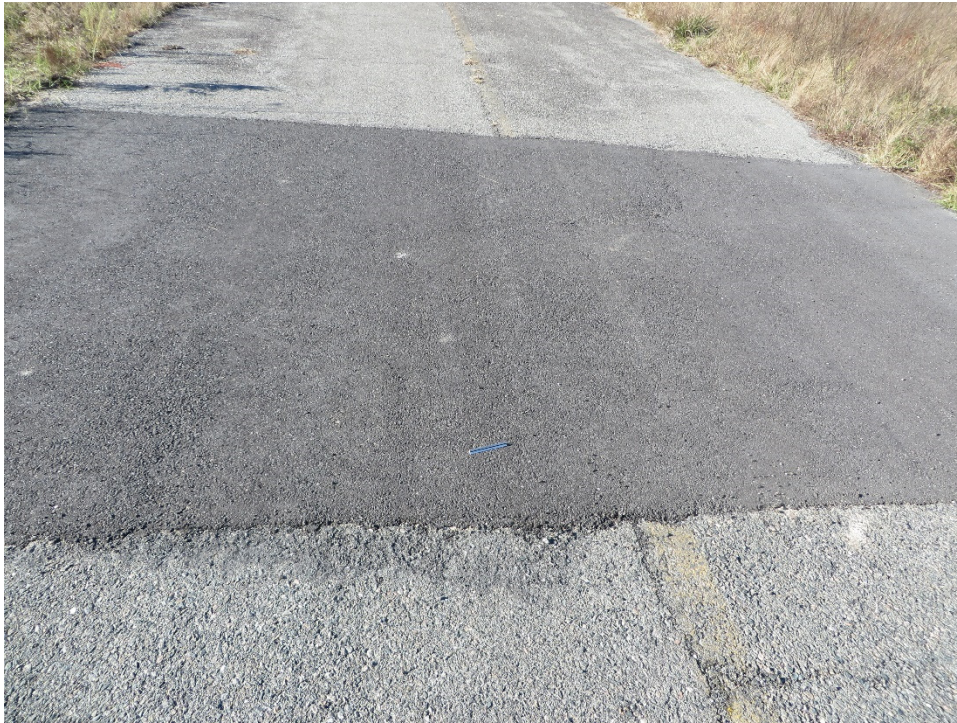
TAHO-10. Patching (Additional Sample Unit No. 02).
