Report:

Millen Airport Pavement Management Plan

PRESERVING
GEORGIA'S
CRITICAL
PAVEMENT
INFRASTRUCTURE

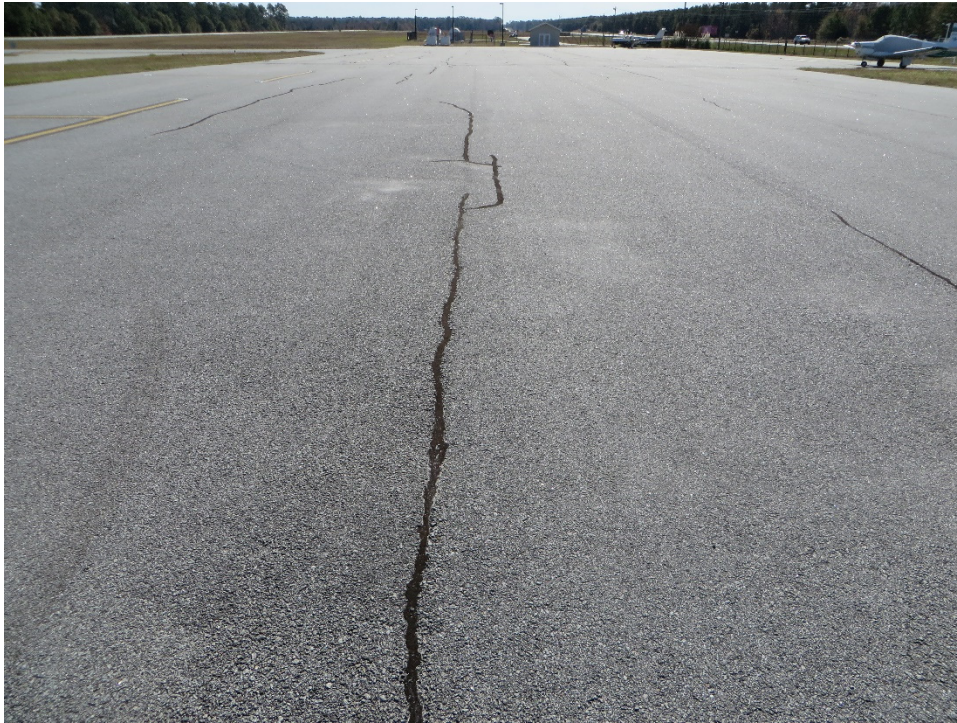
A01ML-10. Overview.

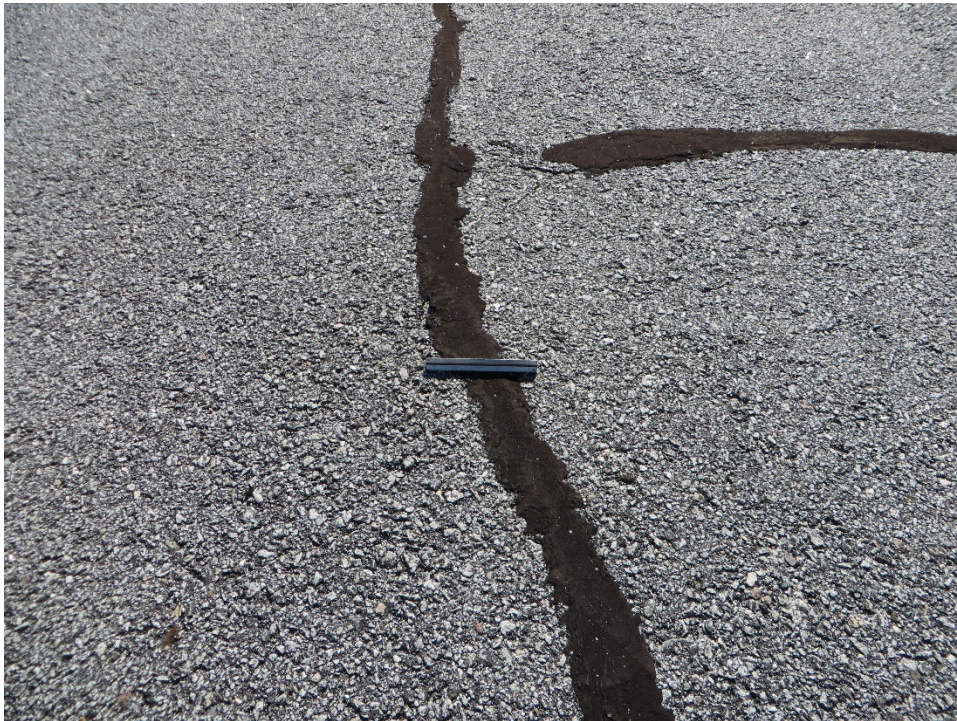
A01ML-10. L&T Cracking (Sample Unit No. 05).

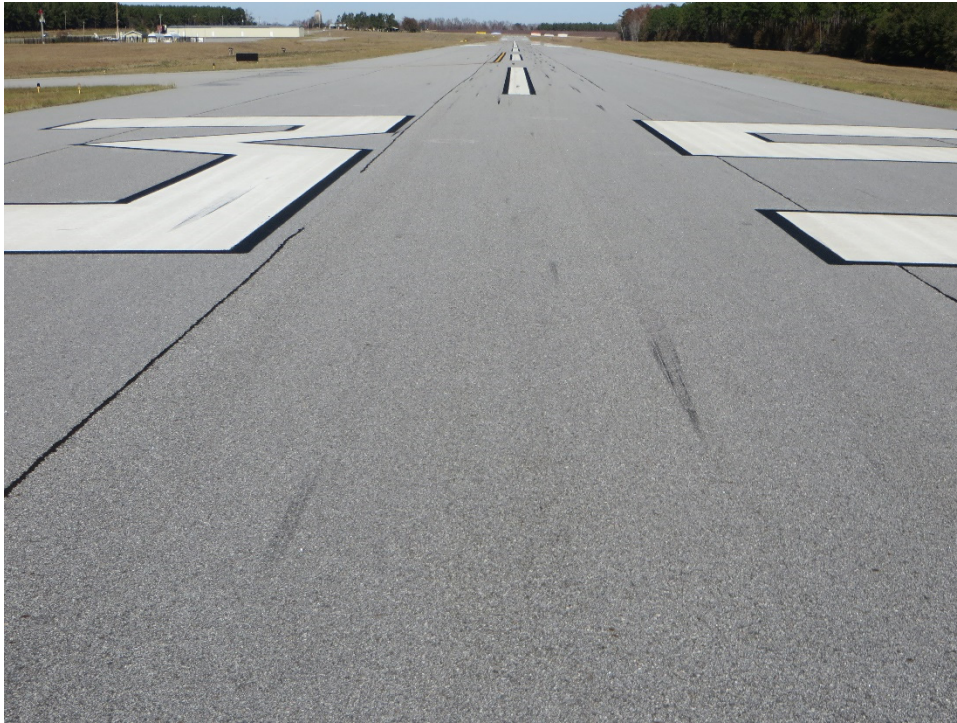
R1735ML-10. Overview.

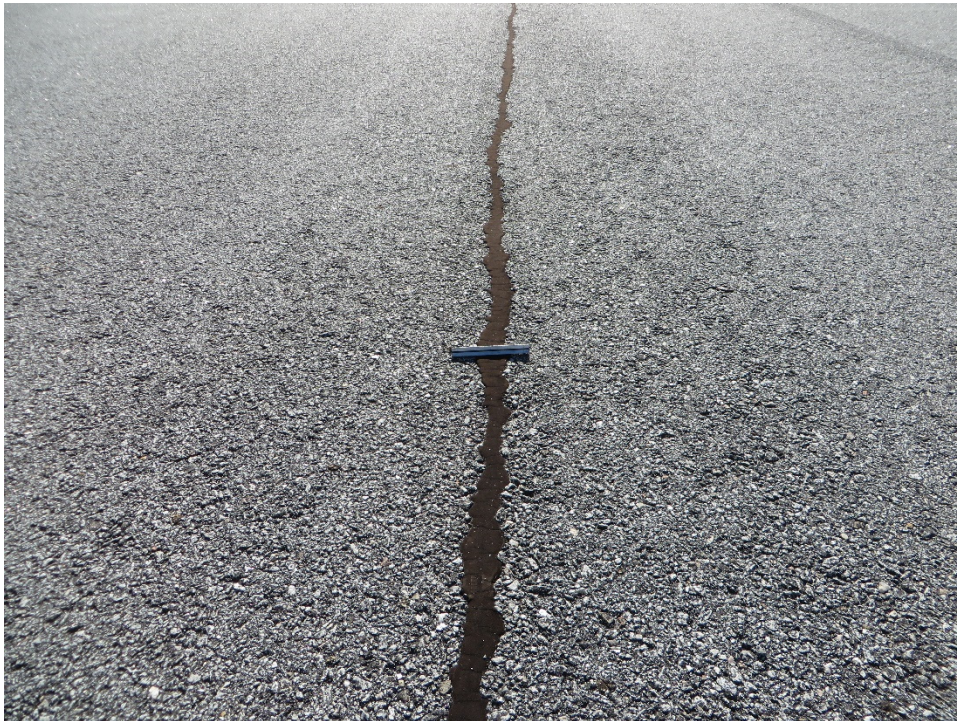
R1735ML-10. L&T Cracking (Sample Unit No. 10).

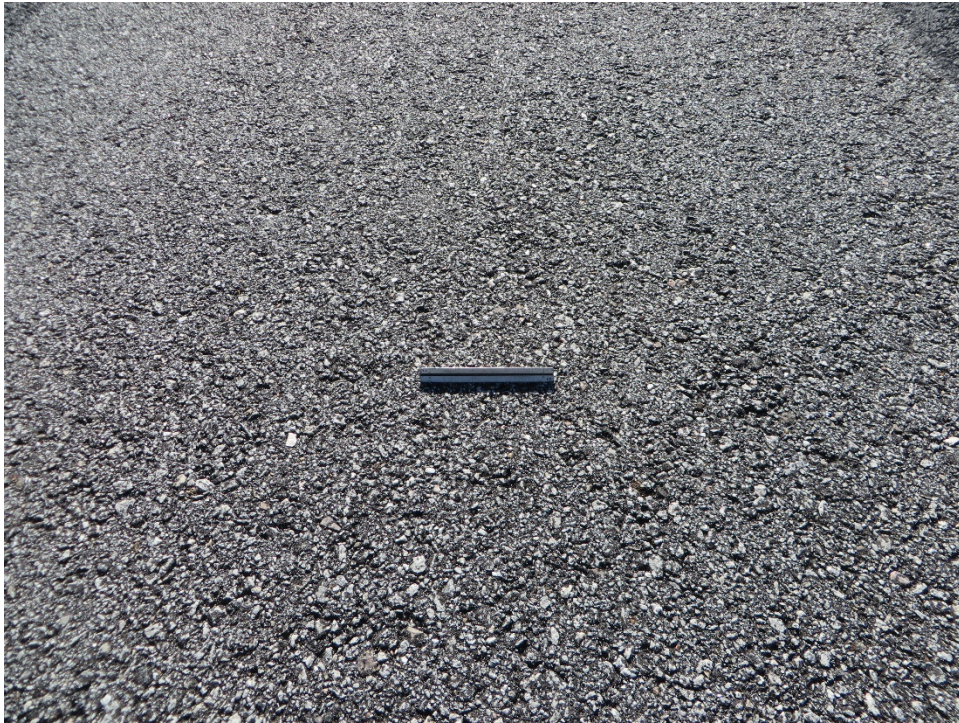
R1735ML-10. Weathering (Sample Unit No. 02).

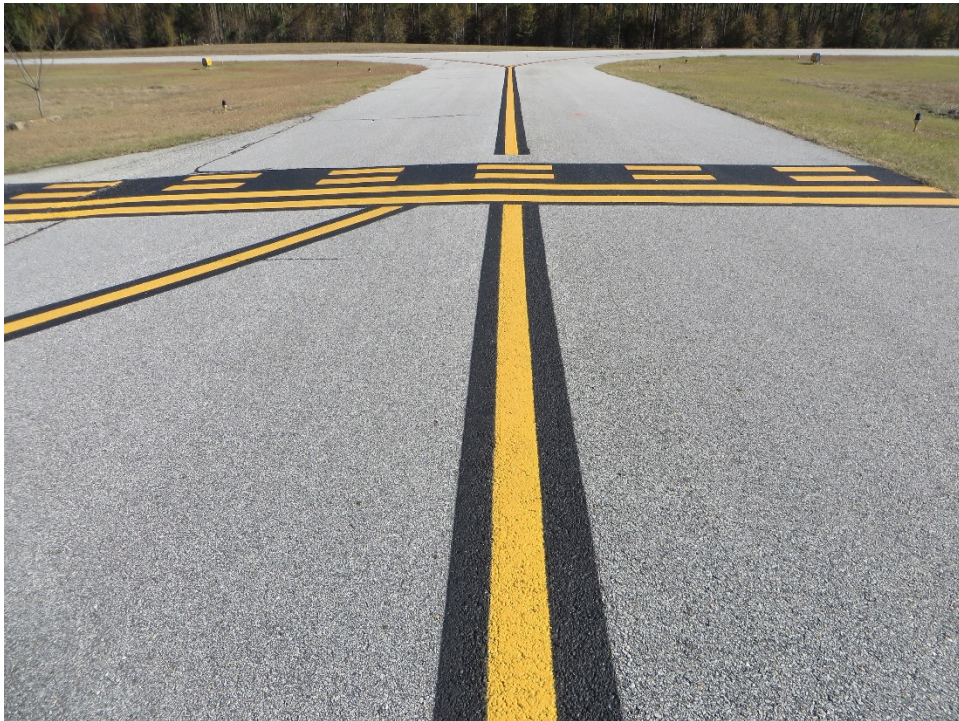
TAML-10. Overview.

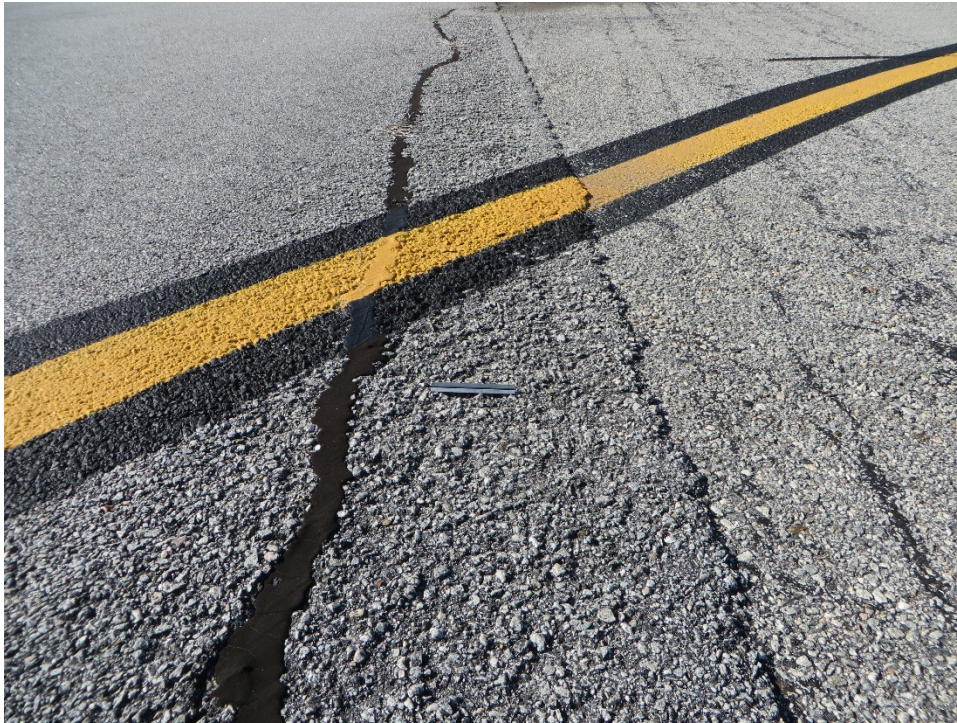
TAML-10. Raveling (Sample Unit No. 02) (1).

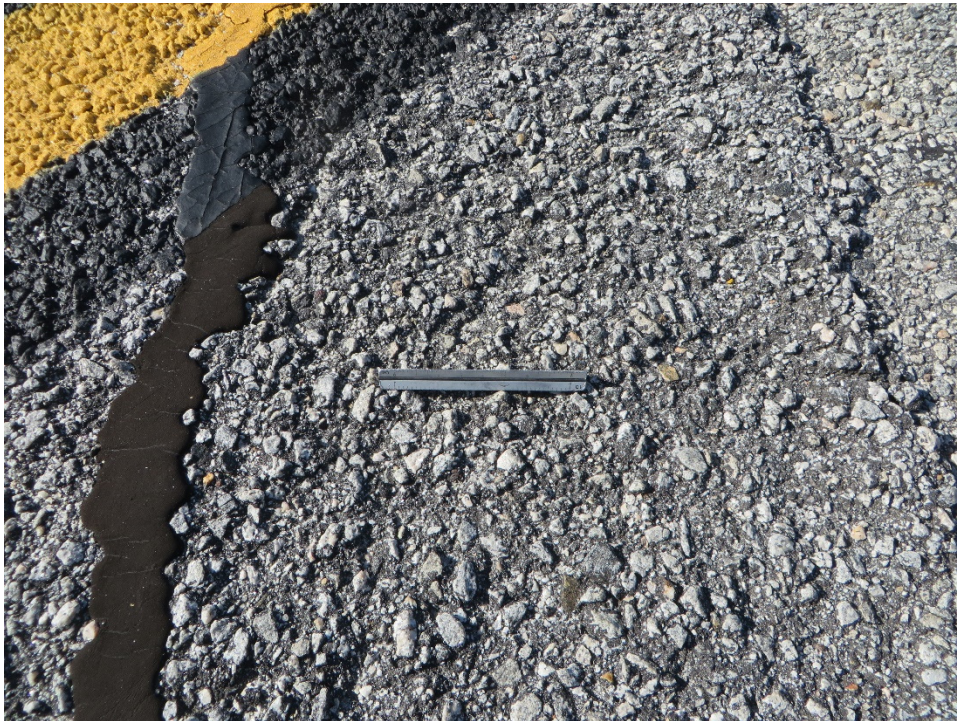
TAML-10. Raveling (Sample Unit No. 02) (2).

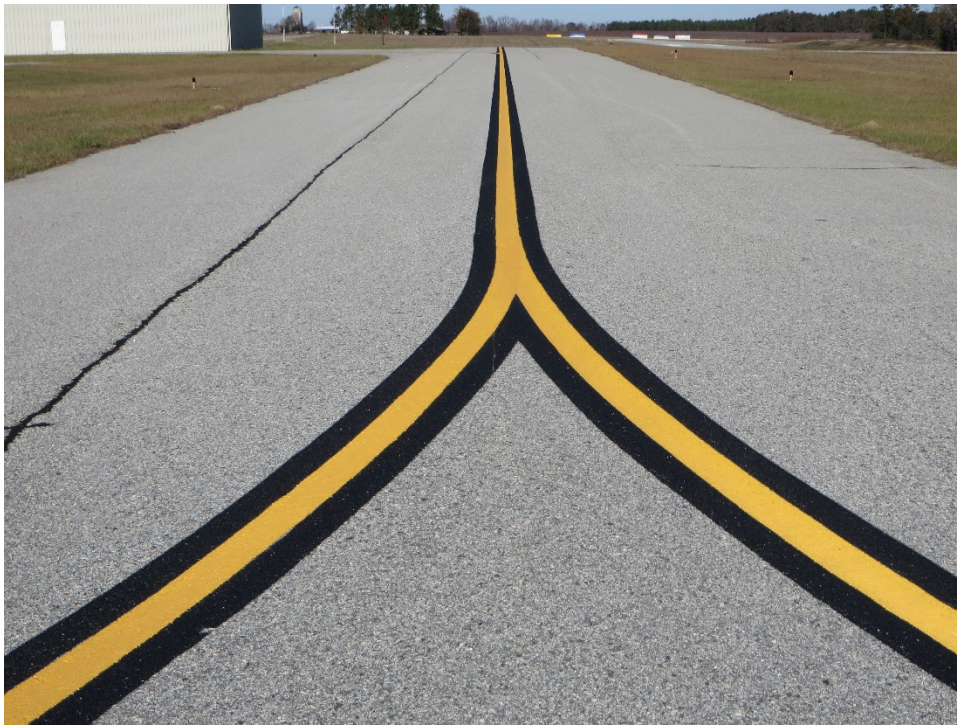
THANGML-10. Overview.

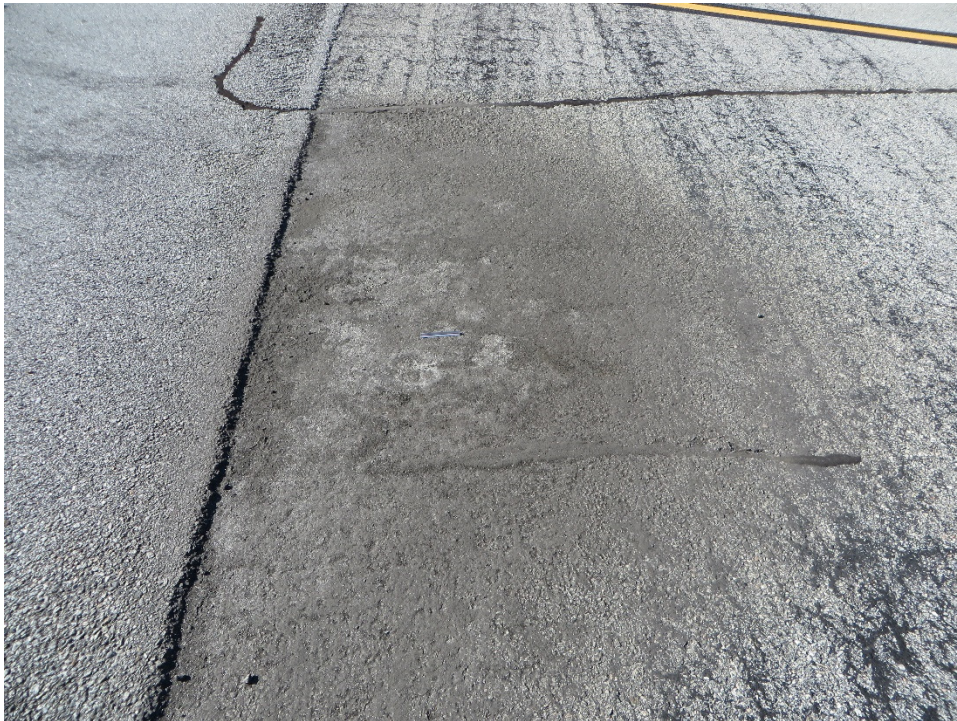
THANGML-10. Depression (Sample Unit No. 01).

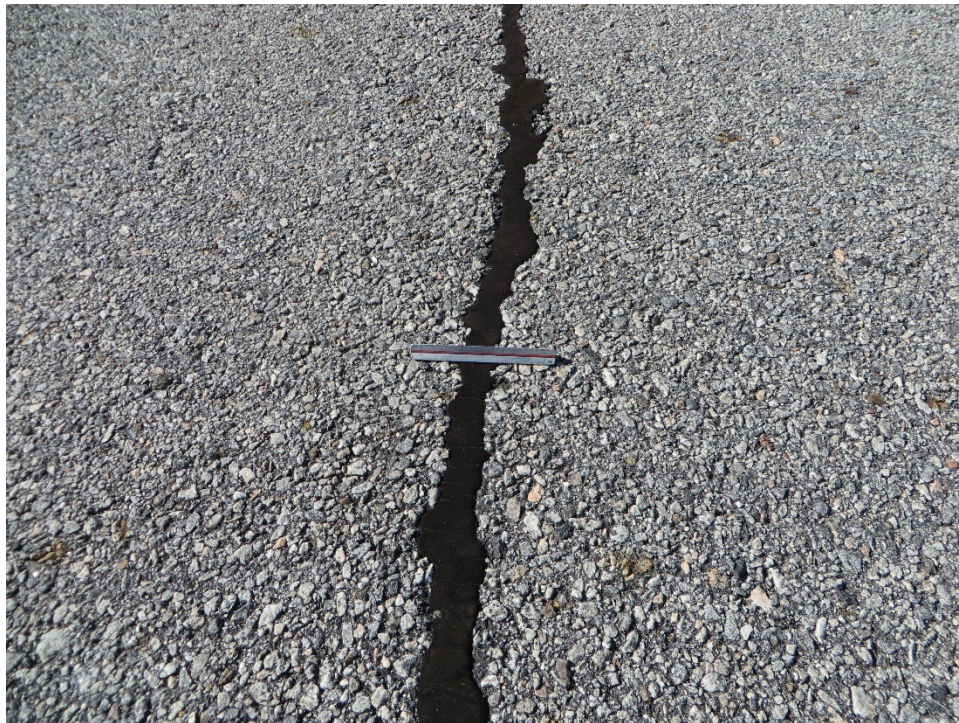
THANGML-10. L&T Cracking (Sample Unit No. 05).

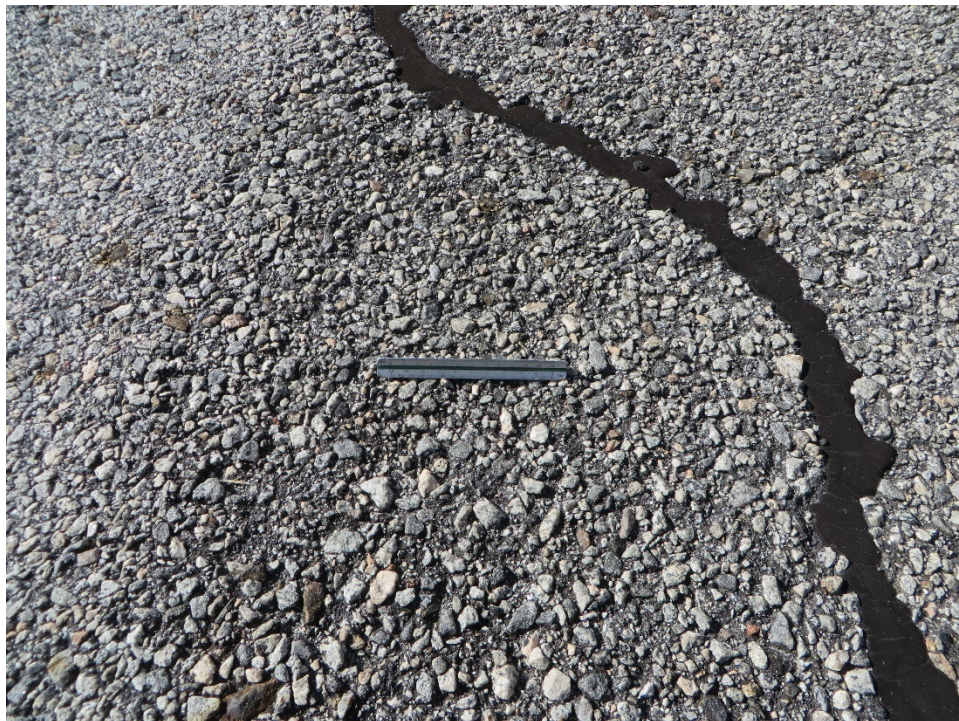
THANGML-10. Raveling (Sample Unit No. 05).
