**SAVANNAH HILTON HEAD INTERNATIONAL AIRPORT
PAVEMENT MANAGEMENT REPORT**

**2007 GEORGIA AIRPORT
PAVEMENT MANAGEMENT REPORT**

SAVANNAH HILTON HEAD INTERNATIONAL AIRPORT

PAVEMENT MANAGEMENT REPORT

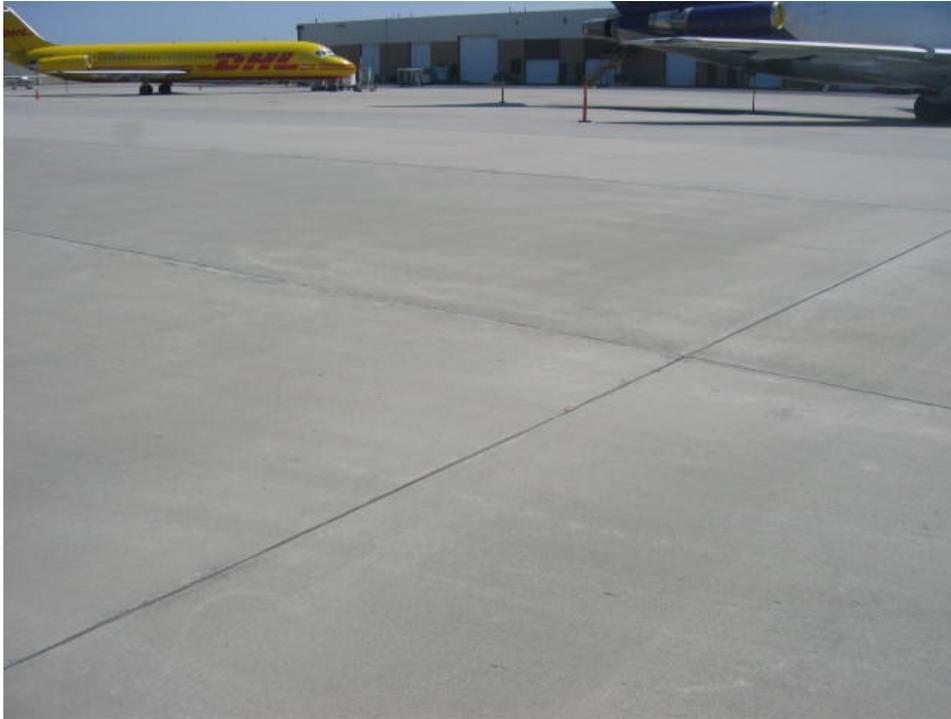
ACARGOSV-10. Overview.

The cargo apron area at Savannah Hilton Head International Airport consists of a single pavement section. Section ACARGOSV-10 is in excellent condition with a PCI value of 97. Small quantities of low-severity patching, linear cracking, and corner spalling were observed. Additionally, instances of medium-severity patching were recorded. Shrinkage cracking was also identified on a number of slabs.

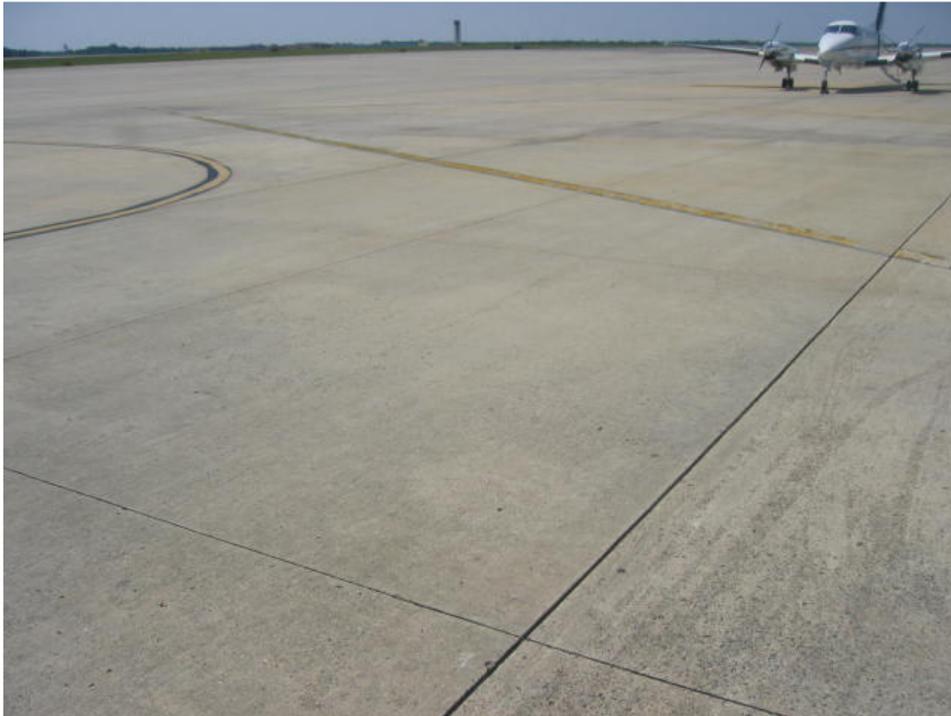
AOLDTERM-10. Overview.

The old terminal apron area is composed of a single pavement section. Section AOLDTERMSV-10 is in good condition with a PCI value of 89. Distresses observed in this section include all severity levels of joint seal damage, all severity levels of small patching, low-severity corner spalling, medium-severity joint spalling, and shrinkage cracking.

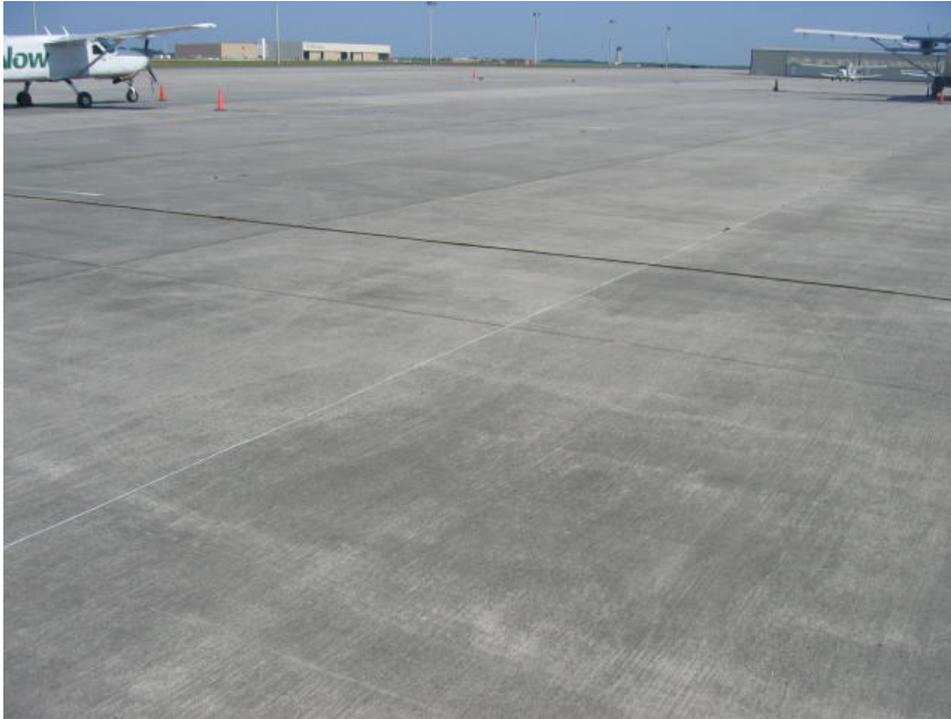
ASAVAIRSV-10. Overview.

The Savannah Air Center apron consists of a single pavement section. Section ASAVAIRSV-10 is in good condition with a PCI value of 91. Distresses observed in this section include all severity levels of joint seal damage, medium-severity corner spalling, medium-severity joint spalling, low-severity small and large patching, low-severity linear cracking, and shrinkage cracking.

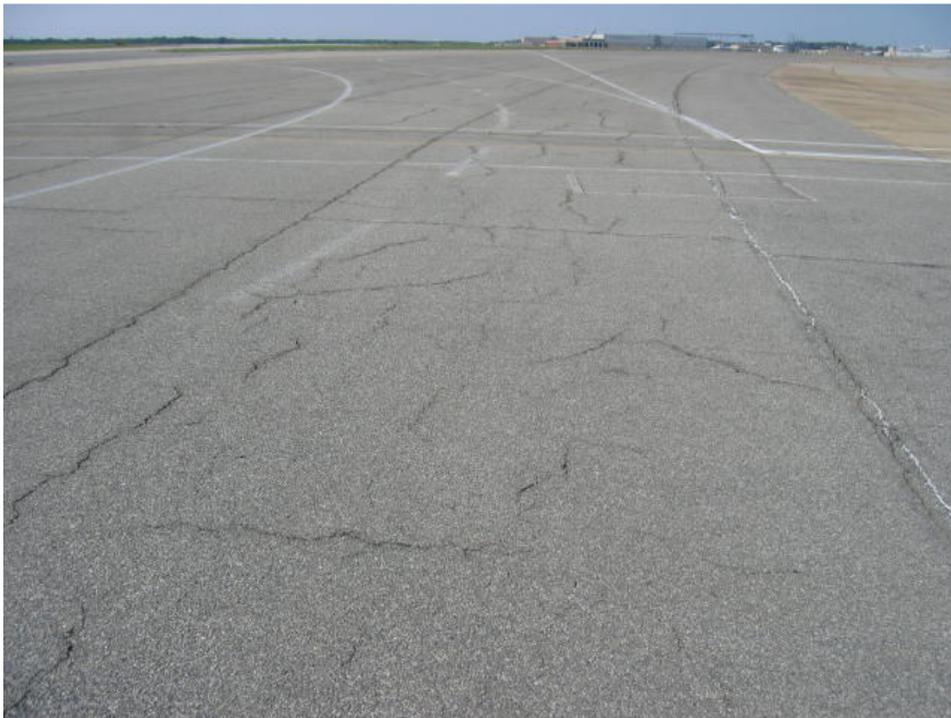
ASIGNORSV-10. Overview.

The North Signature apron consists of two pavement sections. Section ASIGNORSV-10 is in poor condition with a PCI value of 30. A large quantity of low-severity block cracking, medium and high-severity joint reflective cracking, low and medium-severity raveling and weathering, and low and medium-severity L&T cracking was observed in this section. Additionally, low-severity swelling, depression, and bleeding were identified.

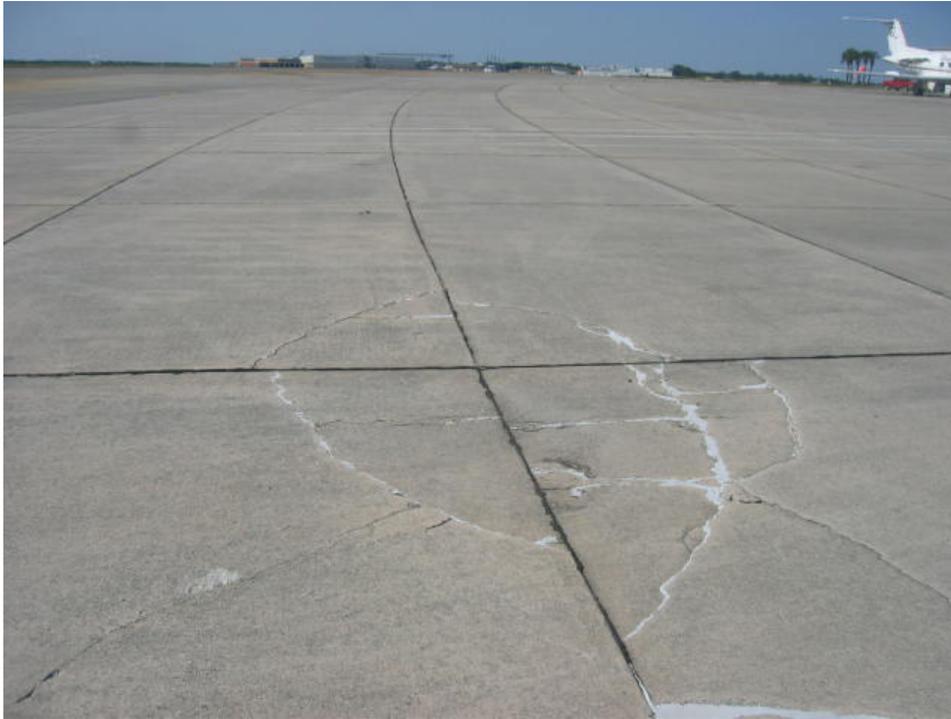
ASIGNORSV-20. Overview.

Section ASIGNORSV-20 is in poor condition with a PCI value of 45. Distresses observed in this section include low and medium-severity faulting, all severity levels of corner spalling, joint spalling, and shattered slabs, high-severity joint seal damage, medium-severity patching, low and medium-severity linear cracking, and shrinkage cracking.

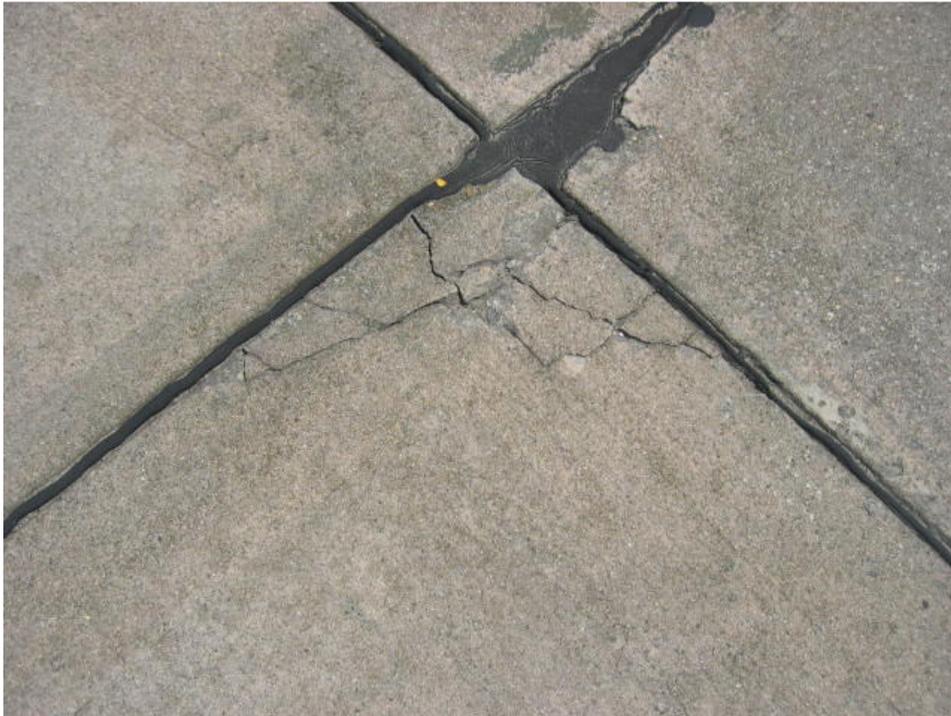
The South Signature apron consists of two pavement sections. Section ASIGSTHSV-10 is in fair condition with a PCI value of 66. Distresses observed in this section include medium-severity corner breaks, medium and high-severity corner spalling, low and high-severity joint seal damage, medium and high-severity joint spalling, low and medium-severity linear cracking, low and high-severity patching, and shrinkage cracking.

ASIGSTHSV-10. Corner spall.

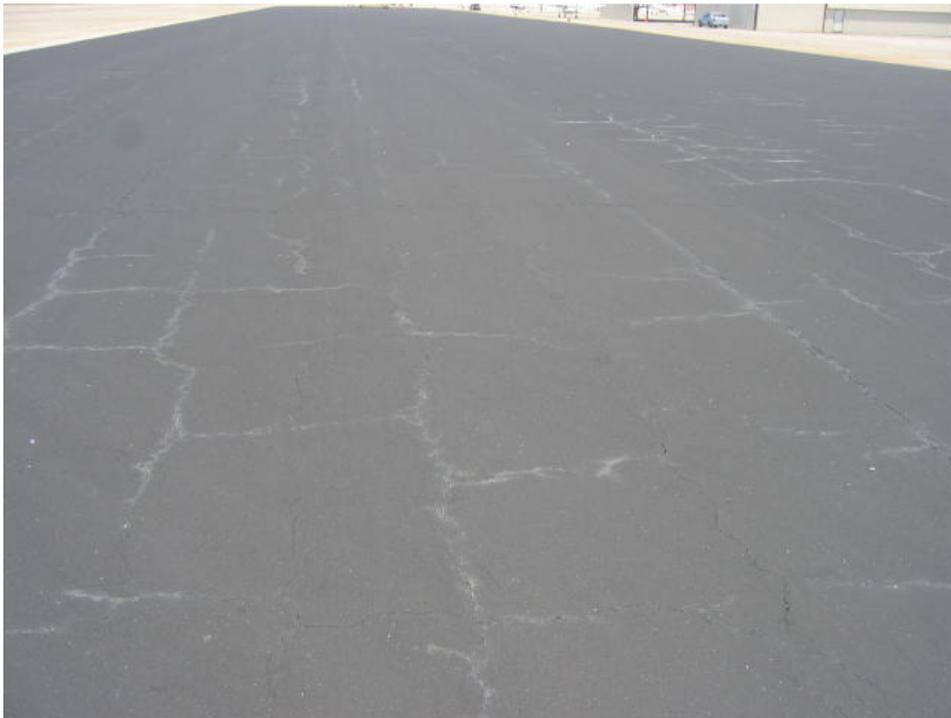
ASIGSTHSV-20. Overview.

Section ASIGSTHSV-20 is in poor condition with a PCI value of 52. Low-severity block cracking was observed throughout this section. Additionally, a substantial amount of low and medium-severity joint reflection cracking was observed.

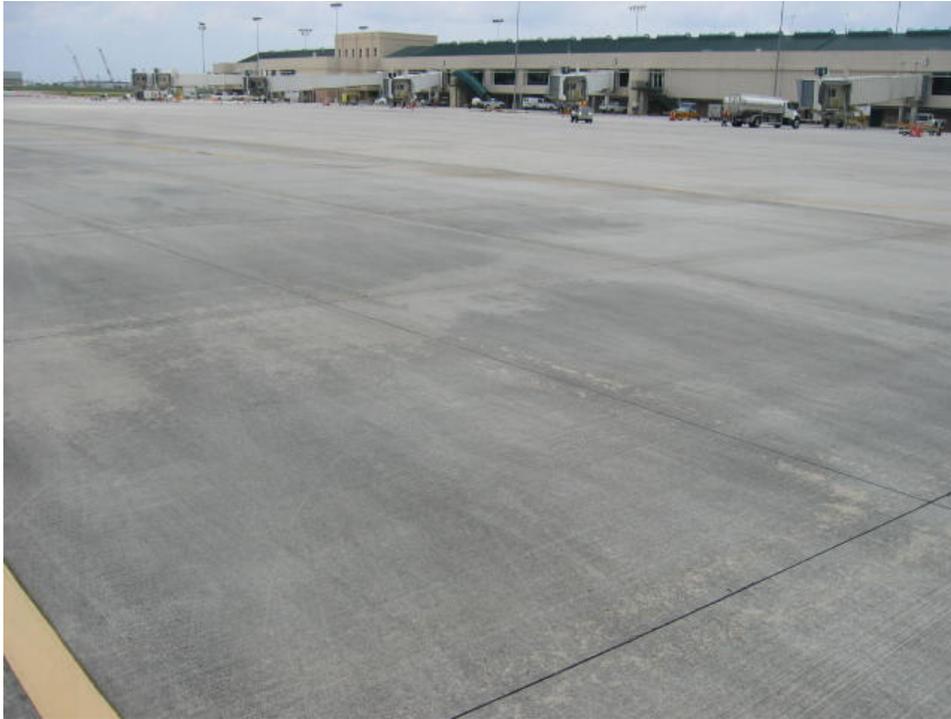
ATERMSV-20. Overview.

Sections ATERMSV-20 and ATERMSV-30 are recently constructed pavements in excellent condition, each having a PCI value of 100. No distresses were observed in these sections.

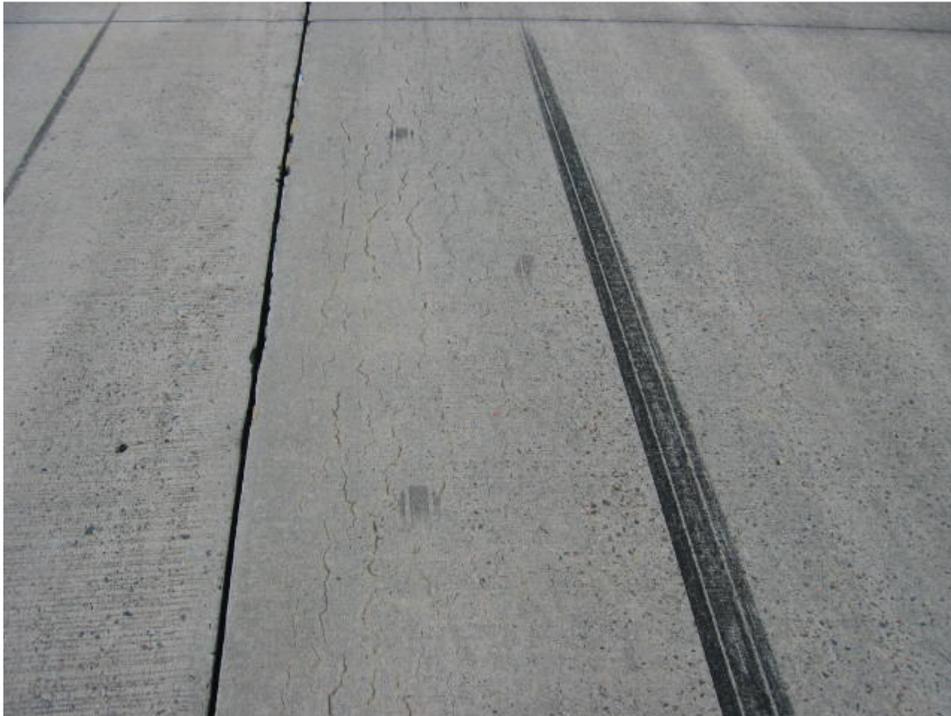
Section R1836SV-10C is in good condition with a PCI value of 86. Joint seal damage of all severity levels, medium and high-severity joint spalling, and low and high-severity patching were observed in this section.

R1836SV-10C. Map cracking.

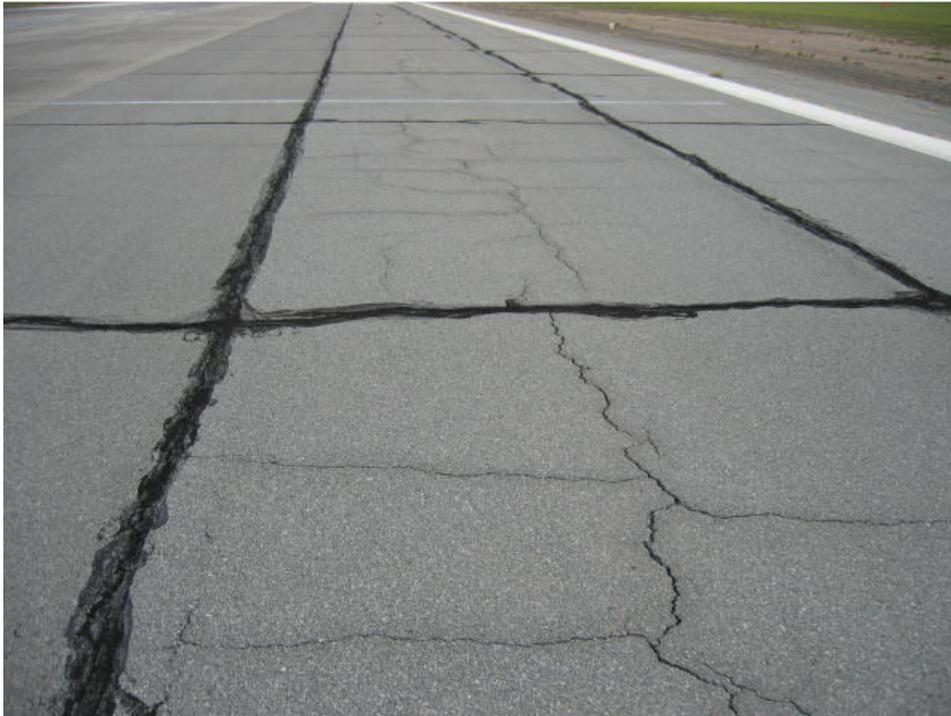
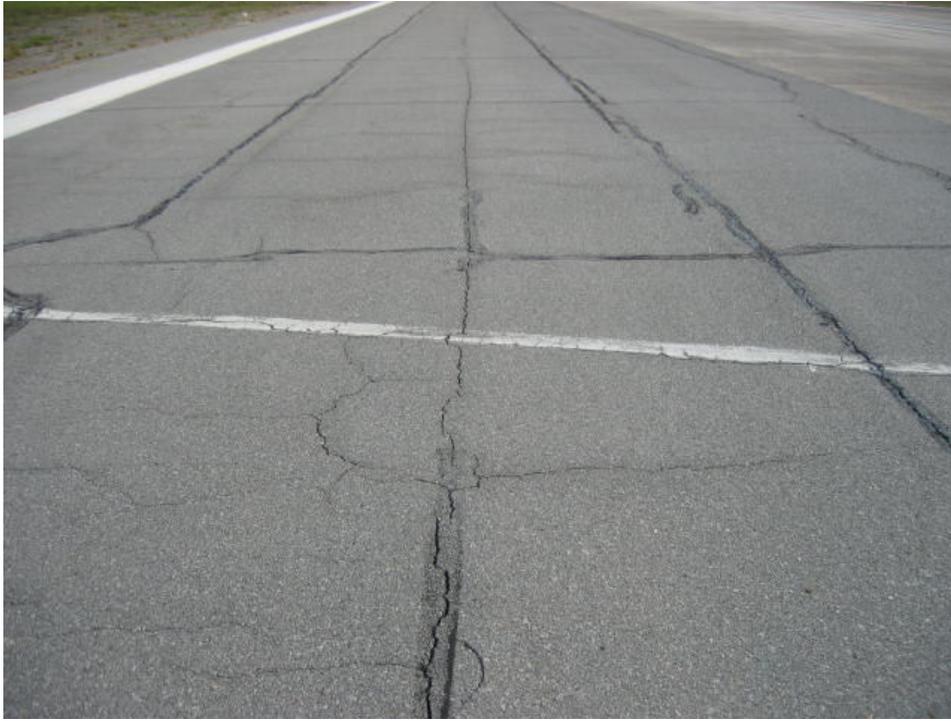
Sections R1836SV-10E and R1836SV-10W are in poor condition with PCI values of 48 and 45, respectively. Substantial amounts of low-severity block cracking, medium-severity joint reflection cracking, low and medium-severity longitudinal and transverse (L&T) cracking, and low-severity raveling and weathering were among the distresses observed in these sections. Small amounts of low-severity swelling and high-severity joint reflection cracking were also identified.

R1836SV-10E. Overview.

R1836SV-10W. Overview.

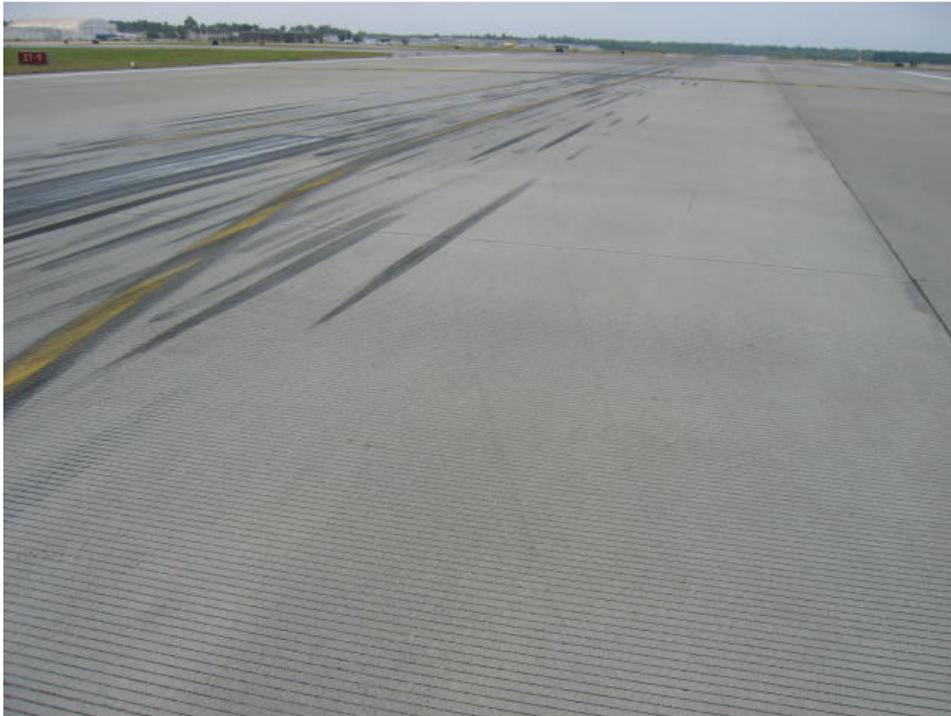
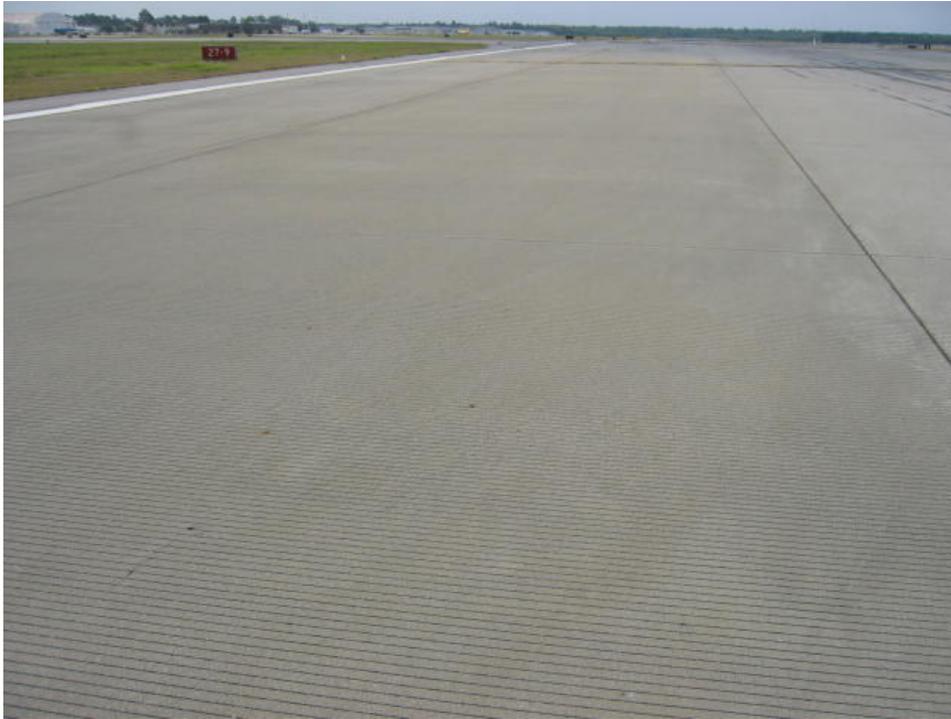
Sections R1836SV-20C, R1836SV-20E and R1836SV-20W are in excellent condition with PCI values of 99, 96 and 99, respectively. Small amounts of patching, corner spalling and shrinkage cracking were identified in these sections.

R1836SV-20C. Overview.

R1836SV-20E. Overview.

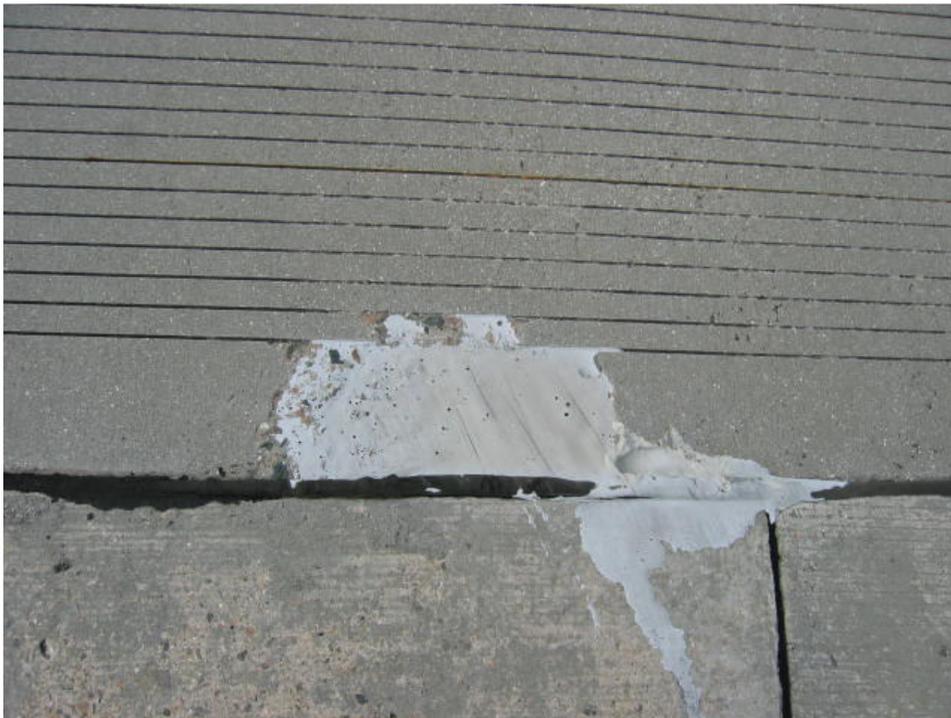
R1836SV-20W. Joint spall.

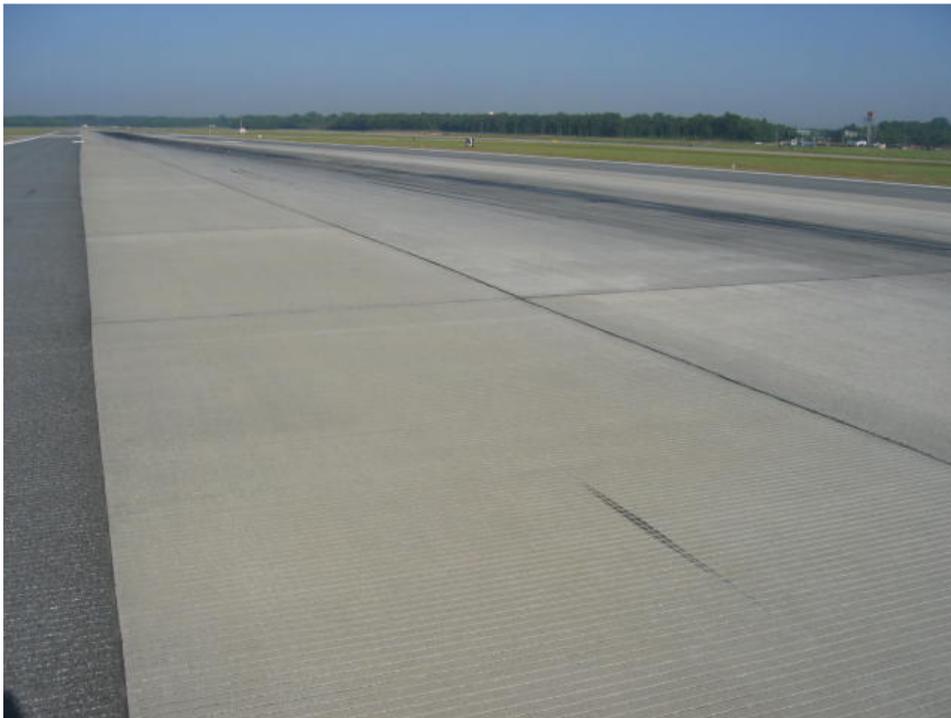
R927SV-10C. Overview.

Runway 9-27 consists of three pavement sections. Section R927SV-10C is in excellent condition with a PCI value of 95. Small amounts of joint spalling, patching, and shrinkage cracking were observed in this section. Additionally, medium-severity joint seal damage was identified in several areas in this section.

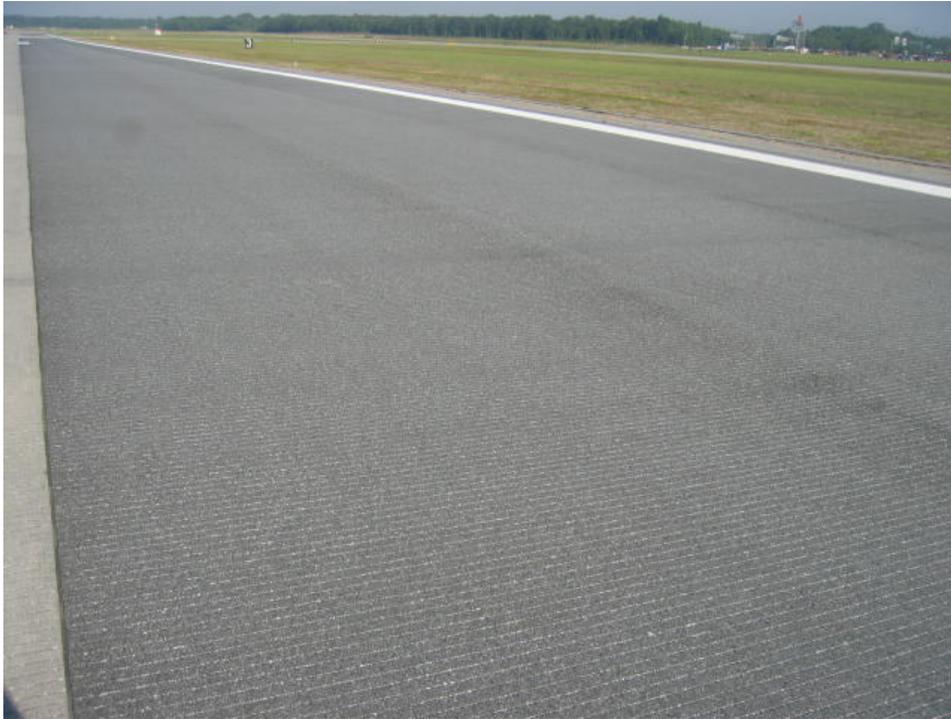
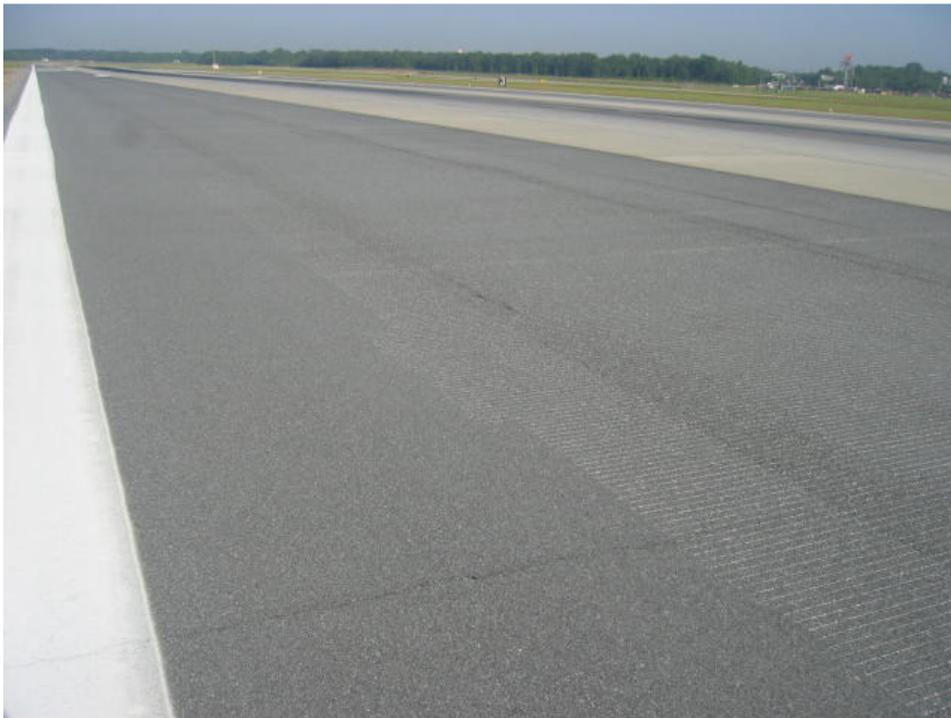
Sections R927SV-10N and R927SV-10S are in good condition, each having a PCI value of 80. Distresses observed in each of these sections included low and medium-severity L&T cracking and low-severity swelling. Additionally, low-severity rutting was identified in section R927SV-10N.

R927SV-10N. Overview.

R927SV-10S. Overview.

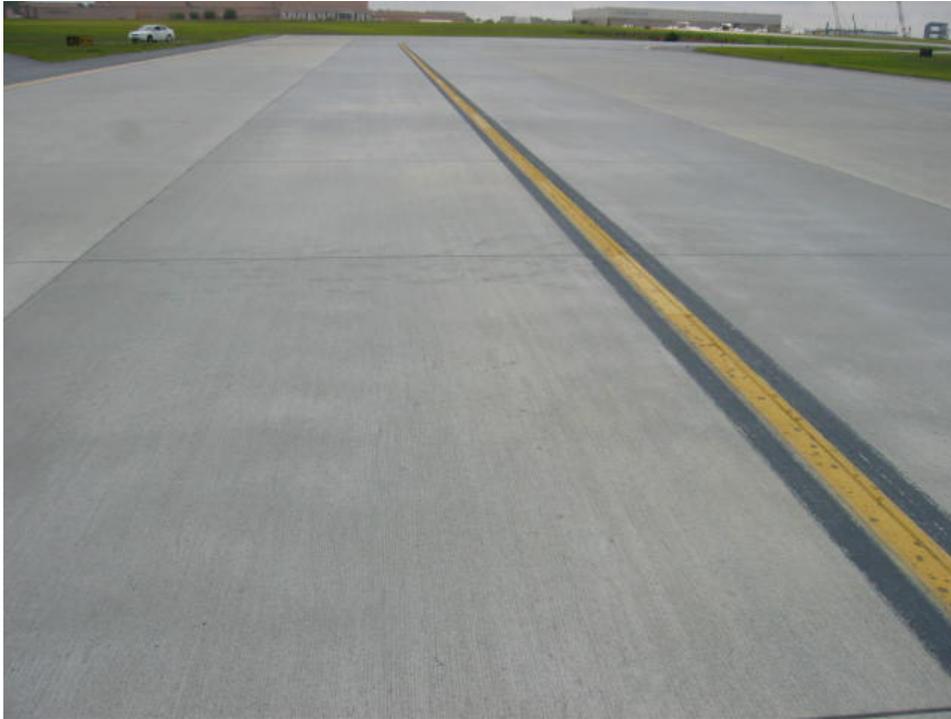
TA1SV-10. Overview.

Taxiway A1 at Savannah Hilton Head International Airport is composed of a single pavement section. Section TA1SV-10 is in excellent condition with a PCI value of 99. A small number of medium-severity joint spalls were the only distresses observed in this section.

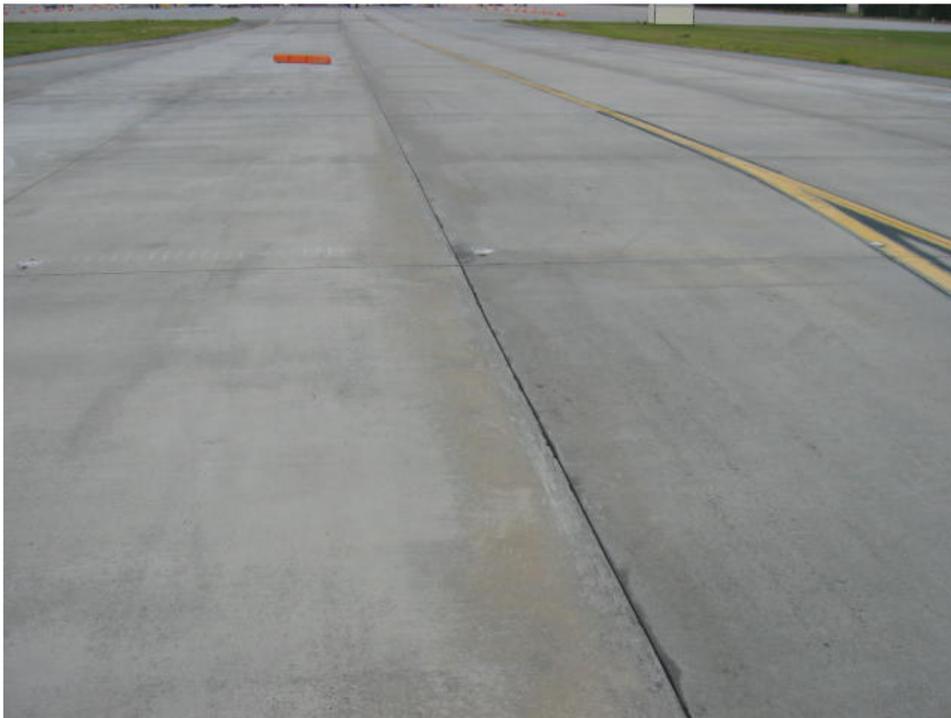
TA2SV-10. Overview.

Taxiway A2 is composed of two pavement sections. Section TA2SV-10 is in satisfactory condition with a PCI value of 78. Low-severity joint seal damage, pumping, and low-severity small patching were recorded in this section.

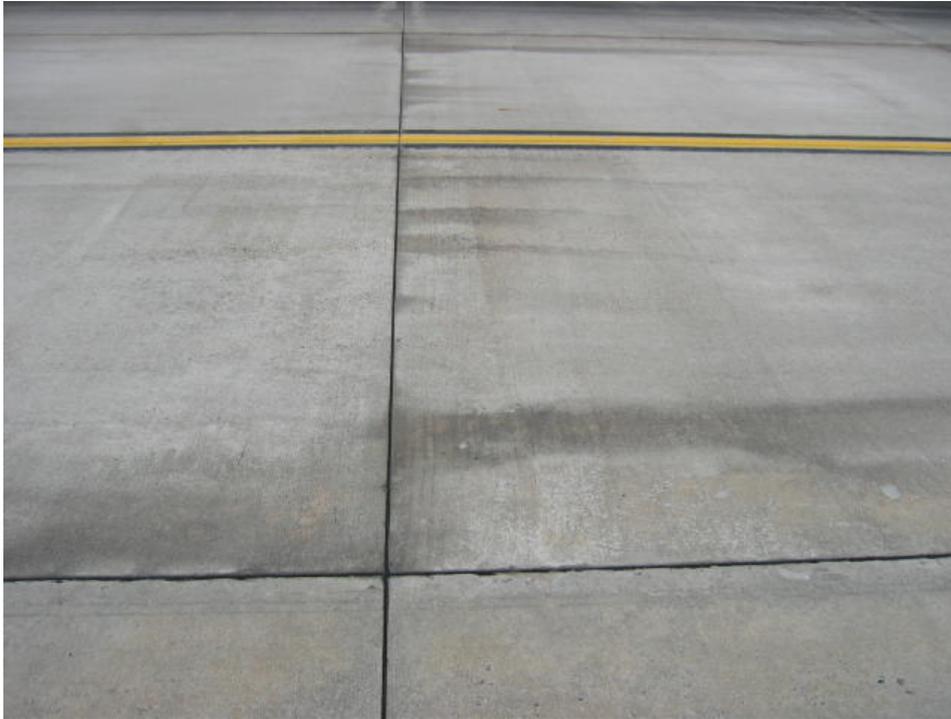
TA2SV-10. Pumping.

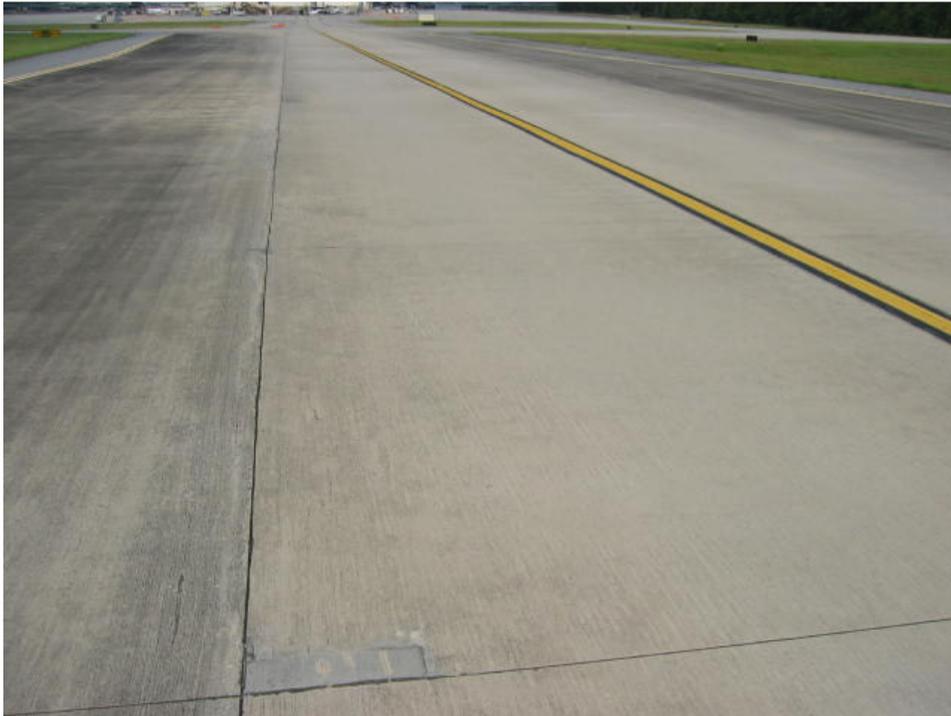
TA2SV-20. Overview.

Section TA2SV-20 is in good condition with a PCI value of 93. Distresses observed in this section include medium-severity blow-ups and low and medium-severity joint spalls and small patching.

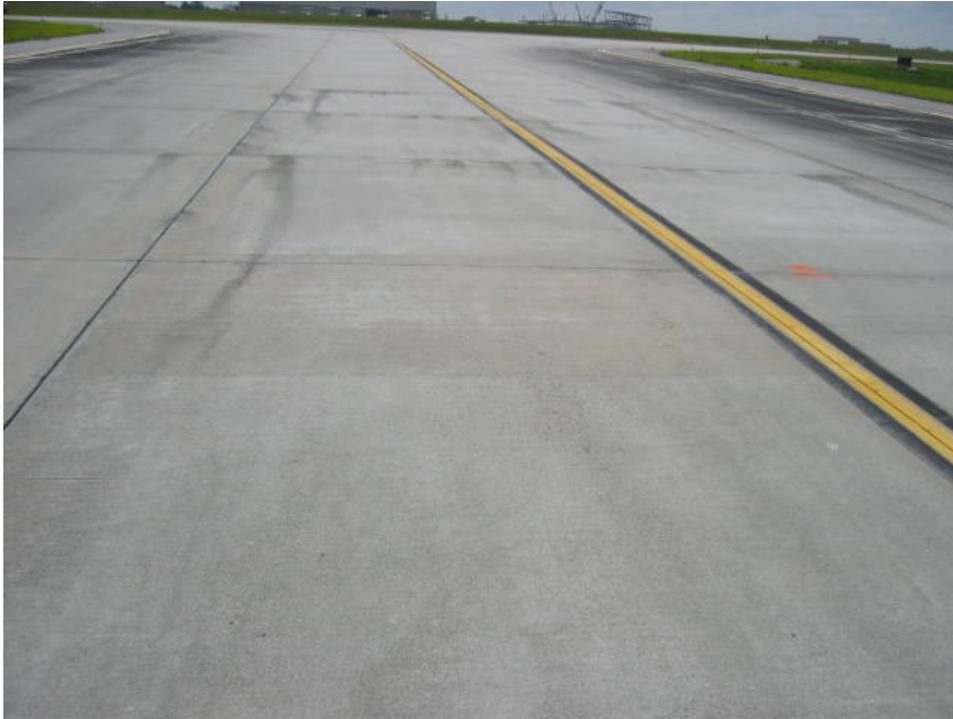
TA3SV-10. Overview.

Taxiway A3 consists of a single pavement section. Section TA3SV-10 is in fair condition with a PCI value of 74. Instances of pumping, shrinkage cracking, and low-severity faulting and small patching were observed in this section. Additionally, low-severity joint seal damage was identified.

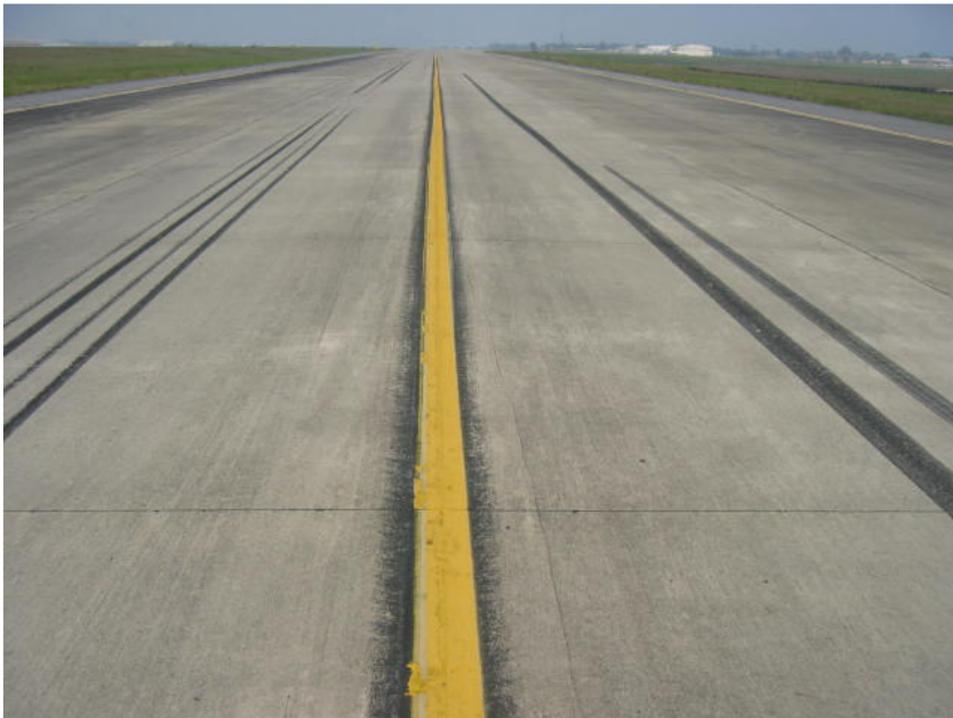
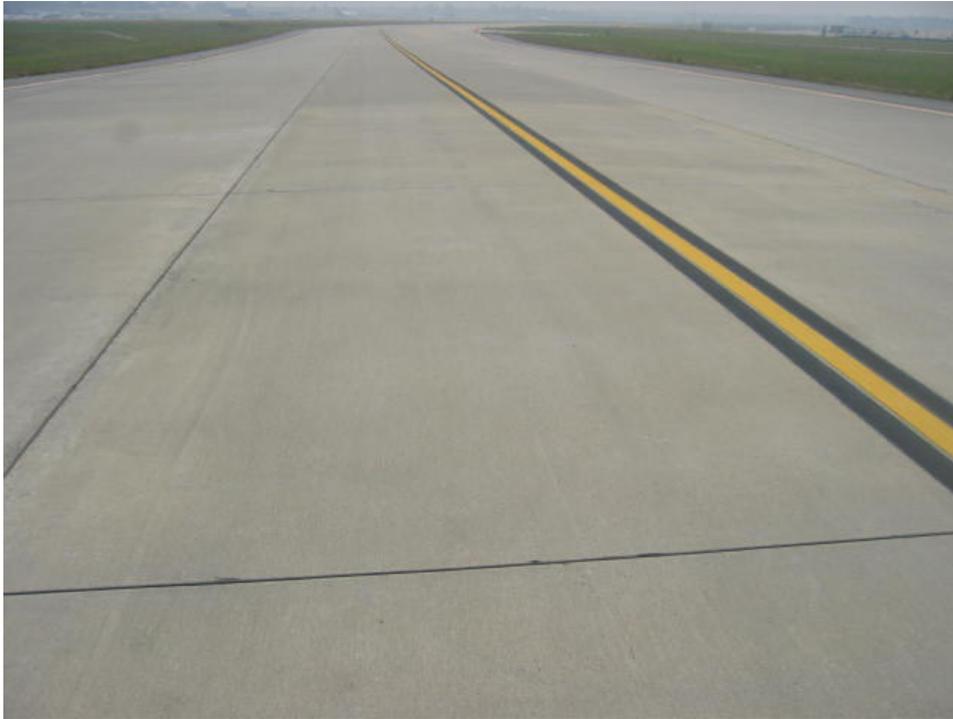
Taxiway A is composed of six sections. Sections TASV-10, TASV-20, TASV-30, TASV-40, TASV-50, and TASV-60 are all in excellent condition with PCI values of 100, 98, 95, 90, 100, and 100, respectively. Sections TASV-10, TASV-50, and TASV-60 had no distresses. Sections TASV-20, TASV-30, and TASV-40 had small amounts of joint spalling, corner spalling and small patching. Low-severity joint seal damage was also observed in section TASV-40.

TASV-40. Overview.

TASV-50. Overview.

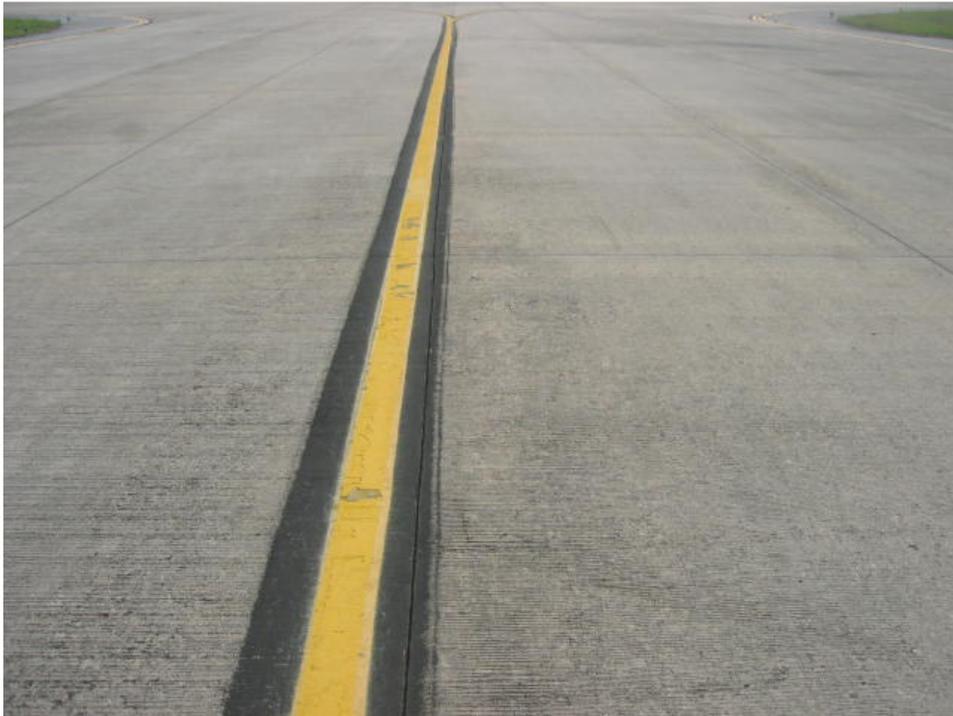
TB1SV-10. Overview.

Taxiway B1 is composed of a single section. Section TB1SV-10 is in good condition with a PCI value of 90. Distresses observed in this section include medium-severity corner spalling, low and medium-severity joint spalling, patching at all severity levels, low-severity scaling, and low-severity joint seal damage.

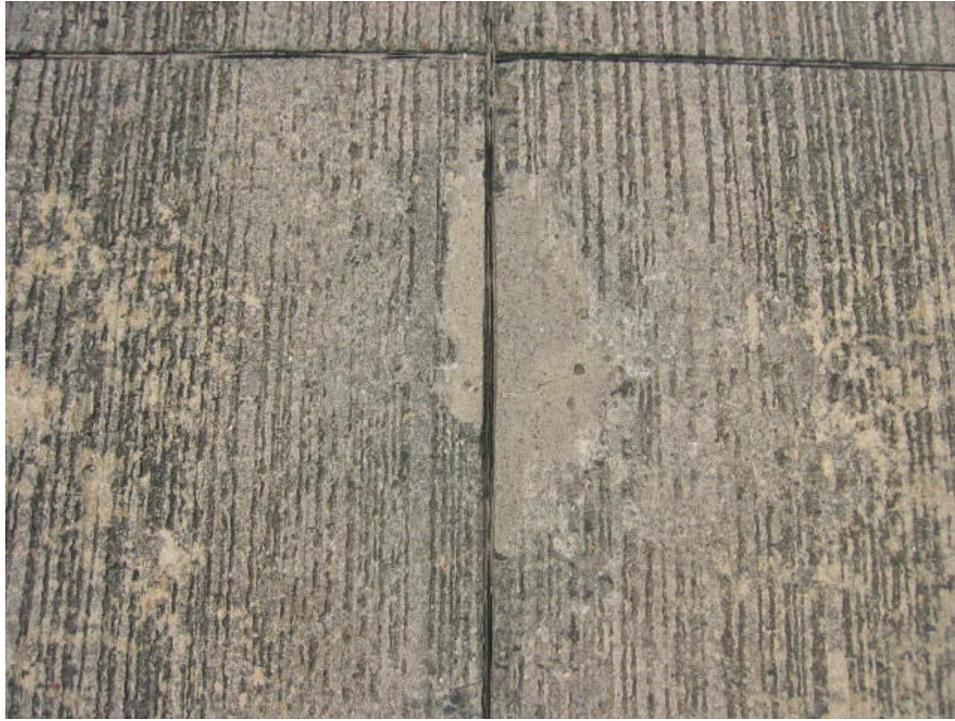
TB1SV-10. Small patch.

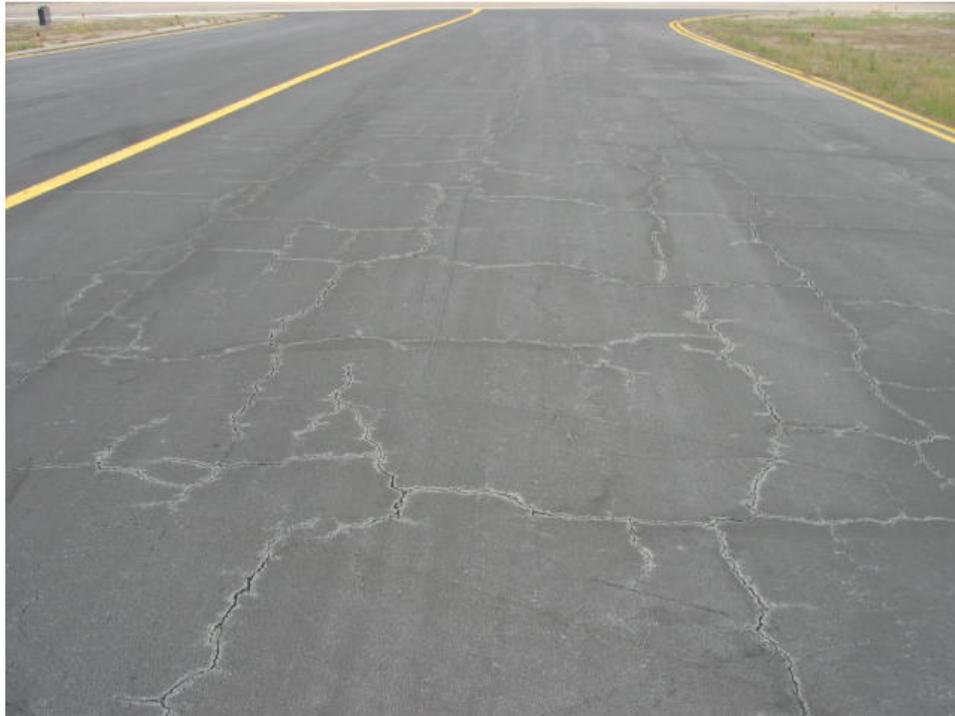
TB2SV-10. Overview.

Taxiway B2 consists of a single section. Section TB2SV-10 is in poor condition with a PCI value of 55. A significant quantity of both low and medium-severity block cracking was observed in this section. Additionally, substantial areas of low-severity swelling were identified.

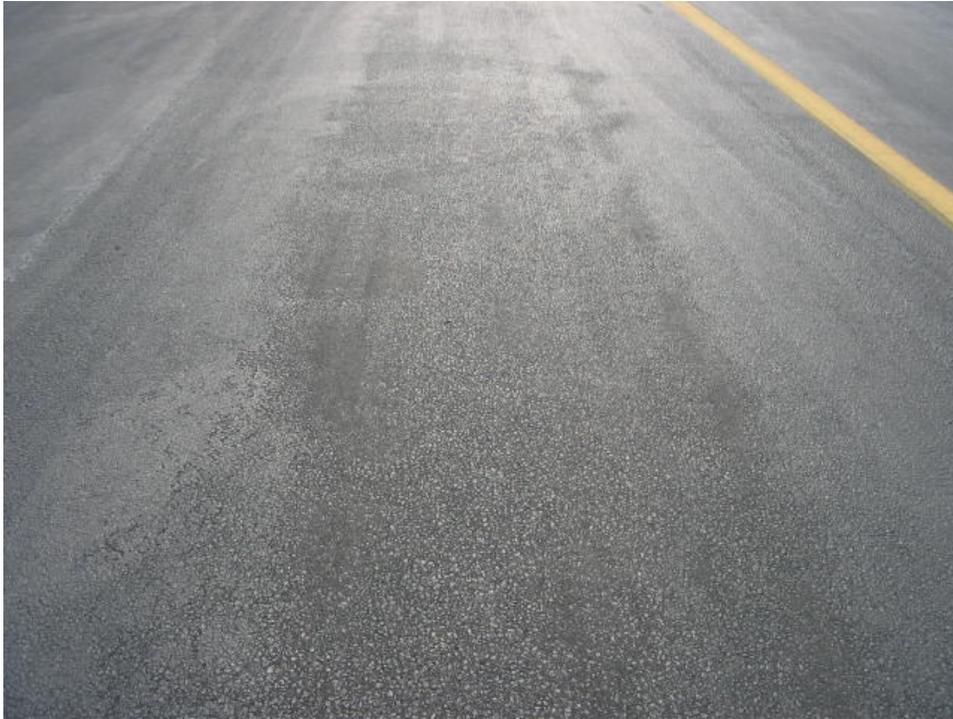
Taxiway B is composed of two pavement sections. Section TBSV-10 is in poor condition with a PCI value of 43. Distresses observed in this section include low-severity alligator cracking, low-severity block cracking, low and medium-severity joint reflection cracking, low-severity L&T cracking, low-severity swelling, and bleeding. Additionally, a significant amount of low-severity rutting was identified.

TBSV-10. Bleeding.

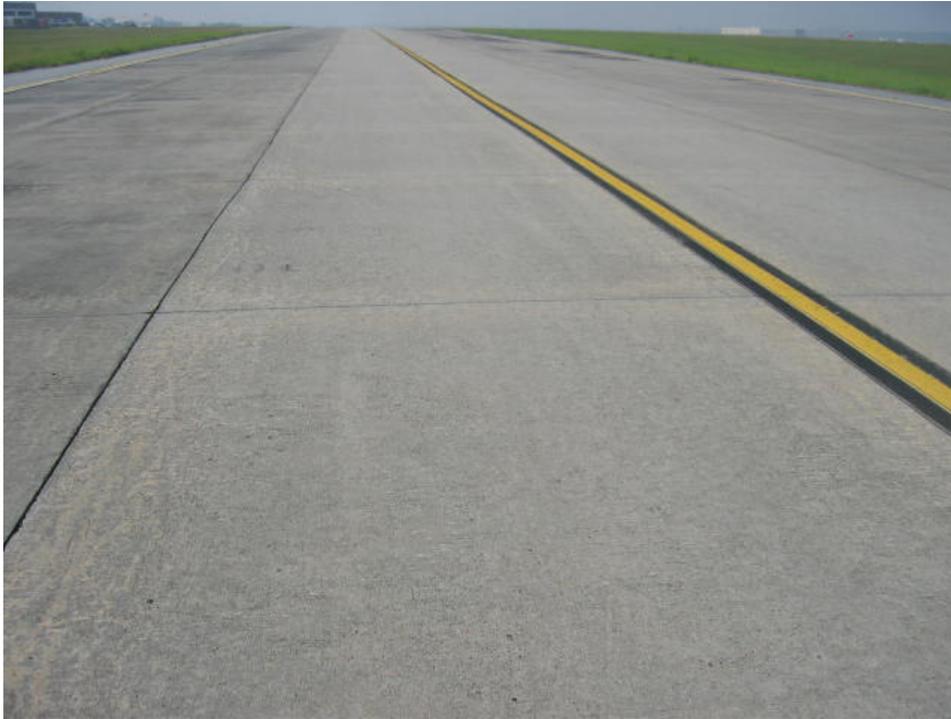
TBSV-20. Overview.

Section TBSV-20 is in good condition with a PCI value of 93. Distresses observed in this section include medium-severity corner spalling, low and medium-severity joint spalling, all severities of patching, and low-severity scaling. Additionally, low-severity joint seal damage was identified in this section.

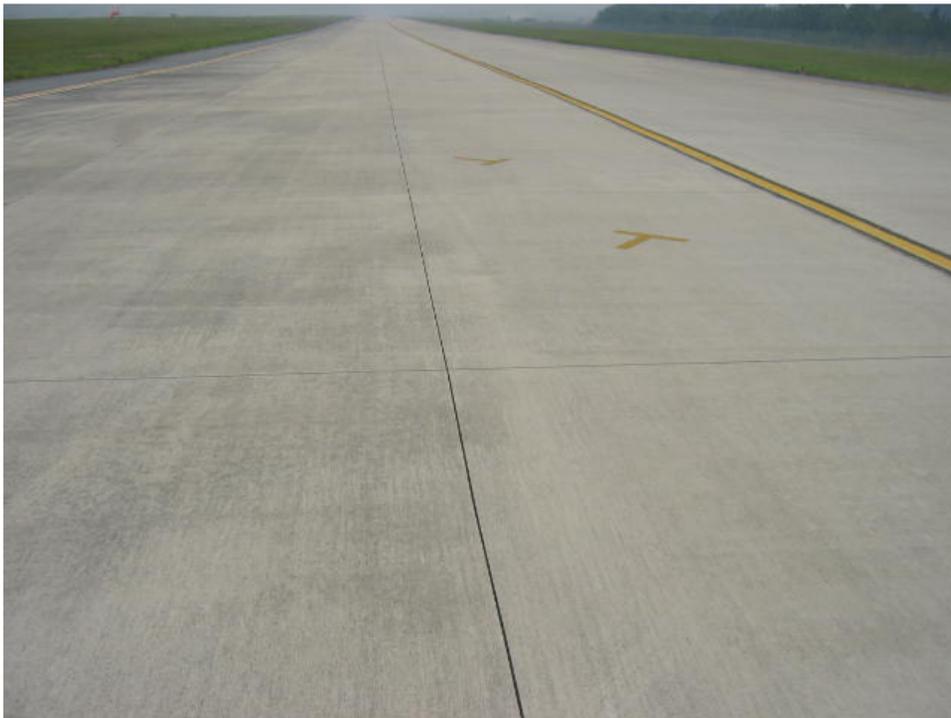
TC1SV-10. Overview.

Taxiway C1 consists of a single section. Section TC1SV-10 is in good condition with a PCI valued of 92. Medium-severity corner breaks, medium-severity joint spalling, and low and medium-severity patching were observed in this section. Low and medium-severity joint seal damage was also noted.
