**SAVANNAH HILTON HEAD INTERNATIONAL AIRPORT
PAVEMENT MANAGEMENT REPORT**

**2007 GEORGIA AIRPORT
PAVEMENT MANAGEMENT REPORT**

SAVANNAH HILTON HEAD INTERNATIONAL AIRPORT

PAVEMENT MANAGEMENT REPORT

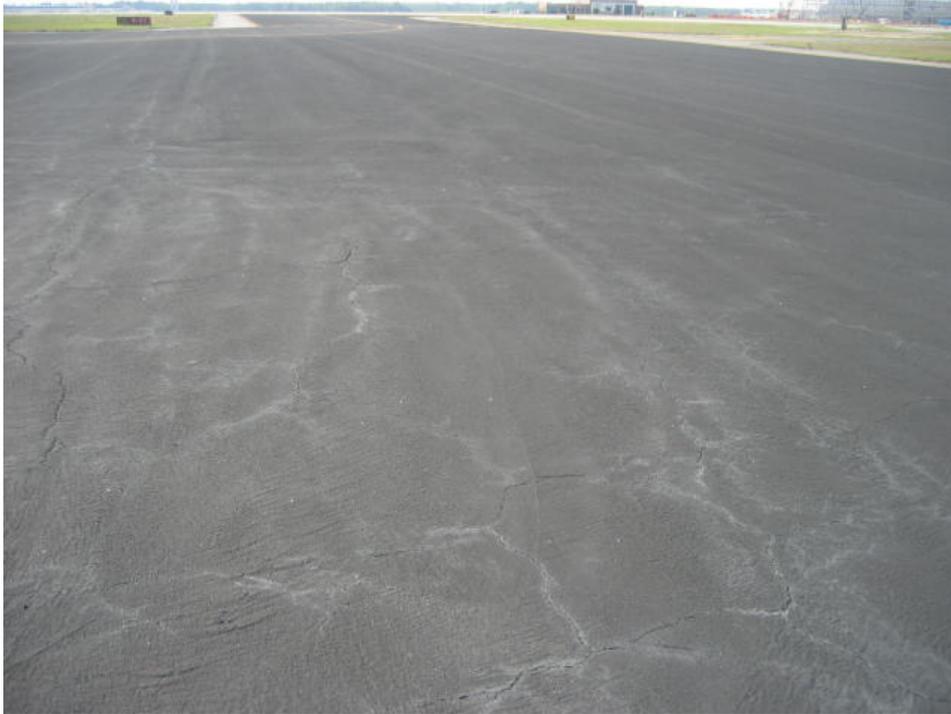
TC2SV-10. Overview.

Taxiway C2 consists of a single section. Section TC2SV-10 is in satisfactory condition with a PCI value of 62. This section recently received a slurry seal. However, a significant amount of low-severity block cracking and L&T cracking was visible and was recorded. A significant amount of low-severity swelling was also identified.

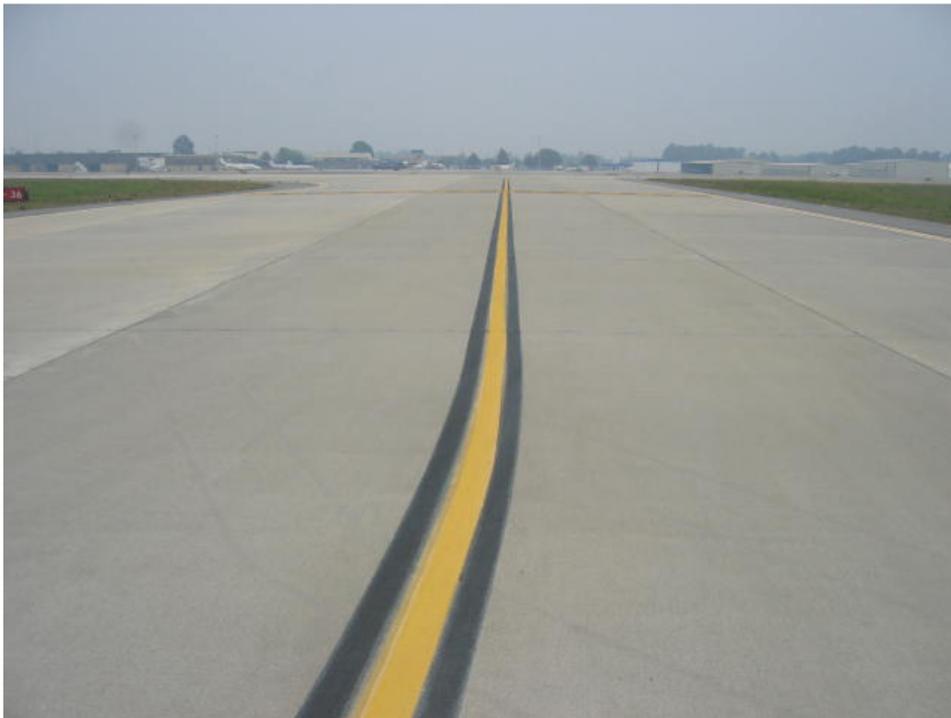
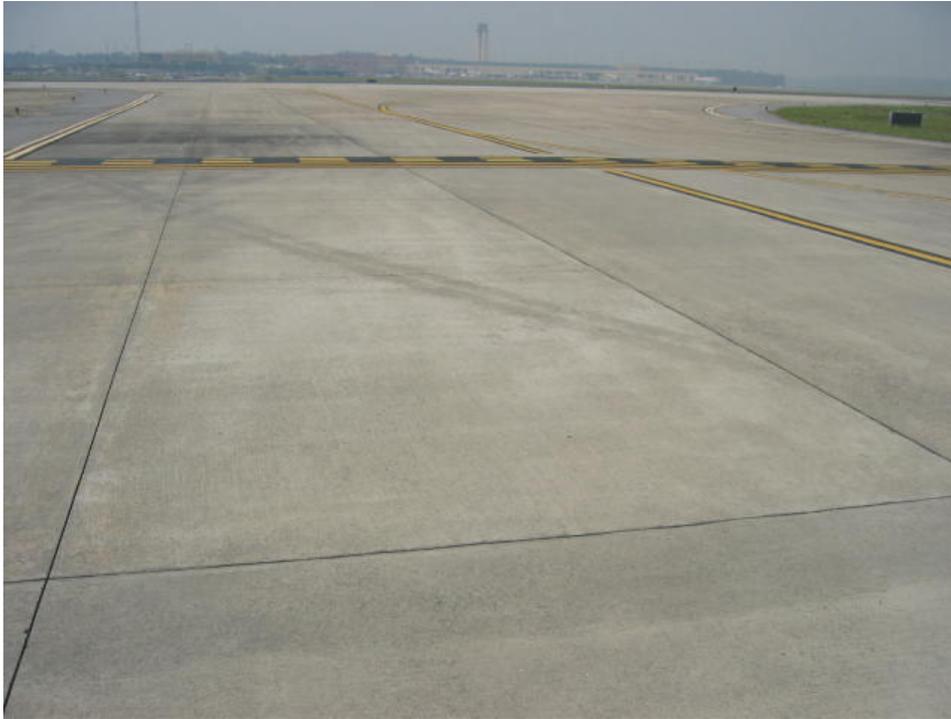
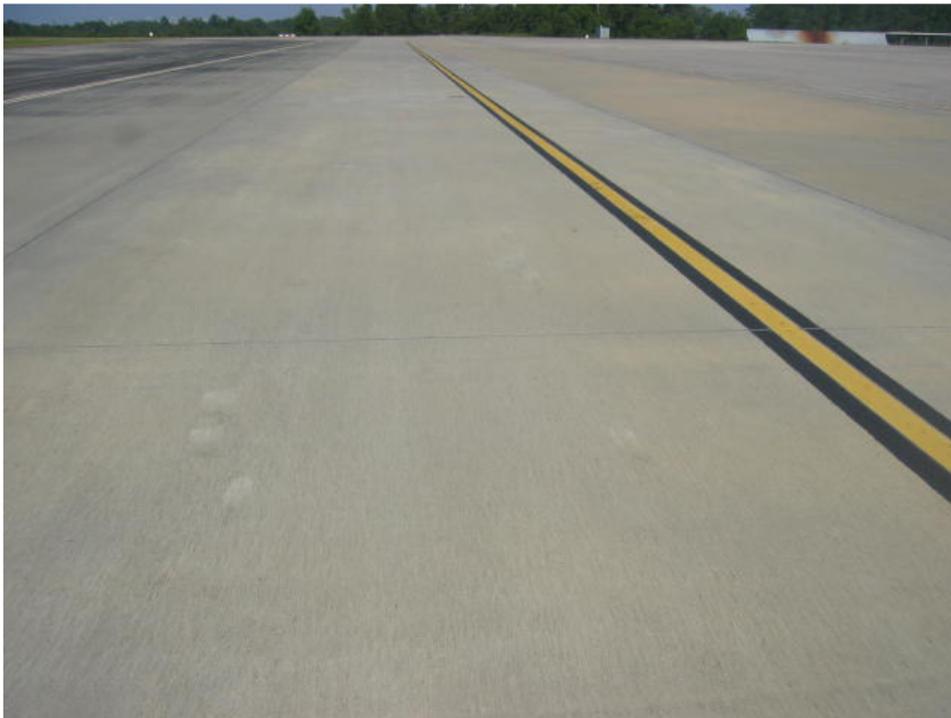
Taxiway C is composed of six sections. Sections TCSV-10, TCSV-20 and TCSV-50 are each in excellent condition with PCI values of 95, 100 and 100, respectively. Small quantities of corner spalling, patching, linear cracking and low-severity joint seal damage were observed in sections TCSV-10 and TCSV-20. No distresses were observed in section TCSV-50.

TCSV-10. Overview.

TCSV-20. Overview.

TCSV-50. Overview.

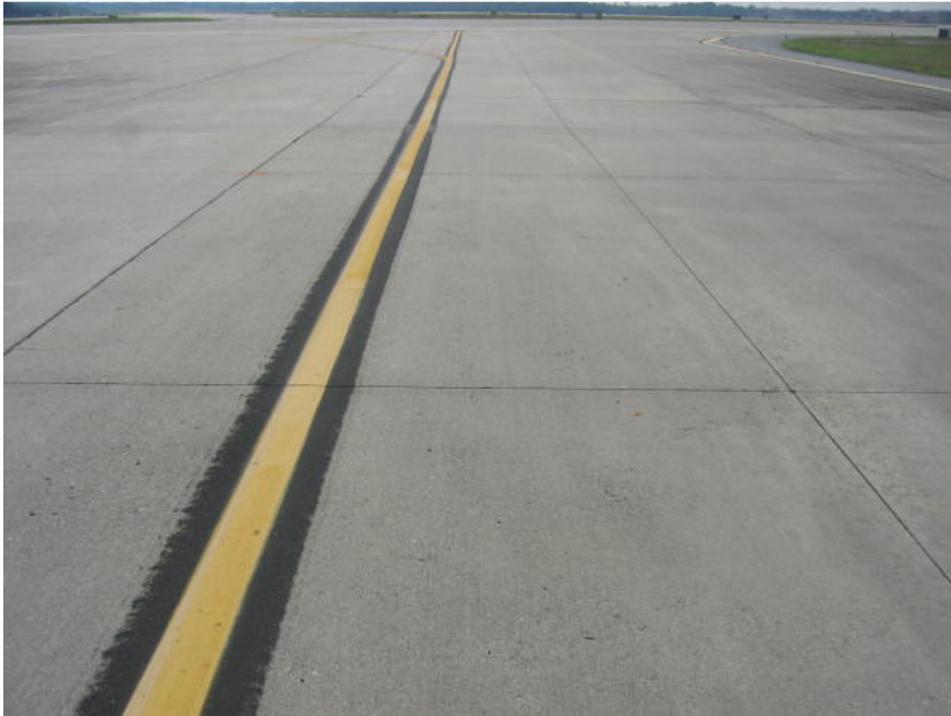
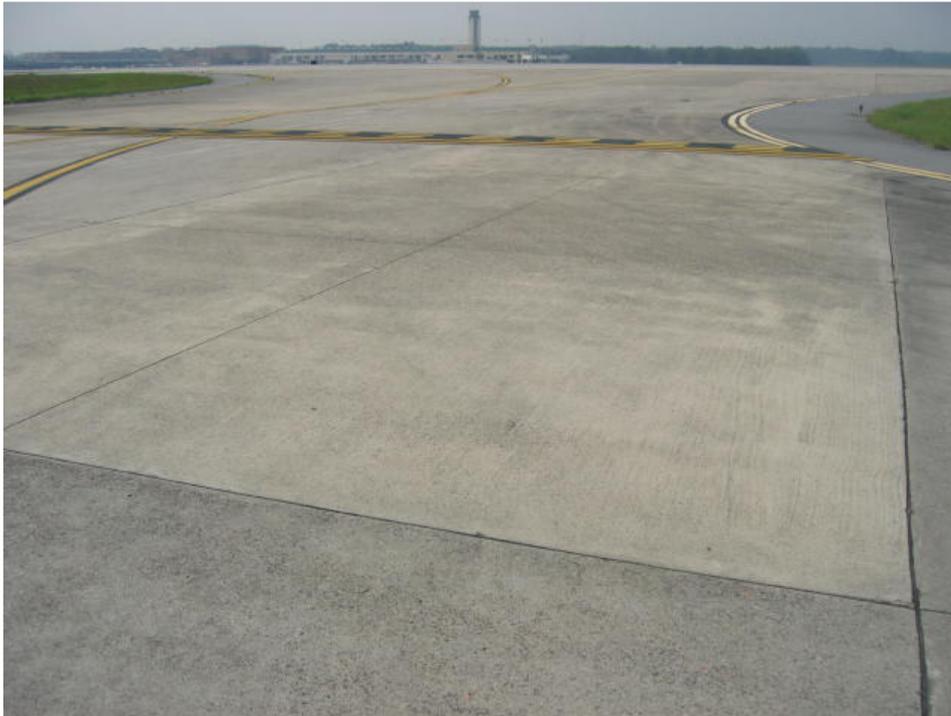
Sections TCSV-30 and TCSV-40 are each in good condition, each having a PCI value of 94. Quantities of high-severity corner spalling, medium-severity joint spalling, patching, and low and medium-severity joint seal damage were observed in these sections.

TCSV-30. Overview.

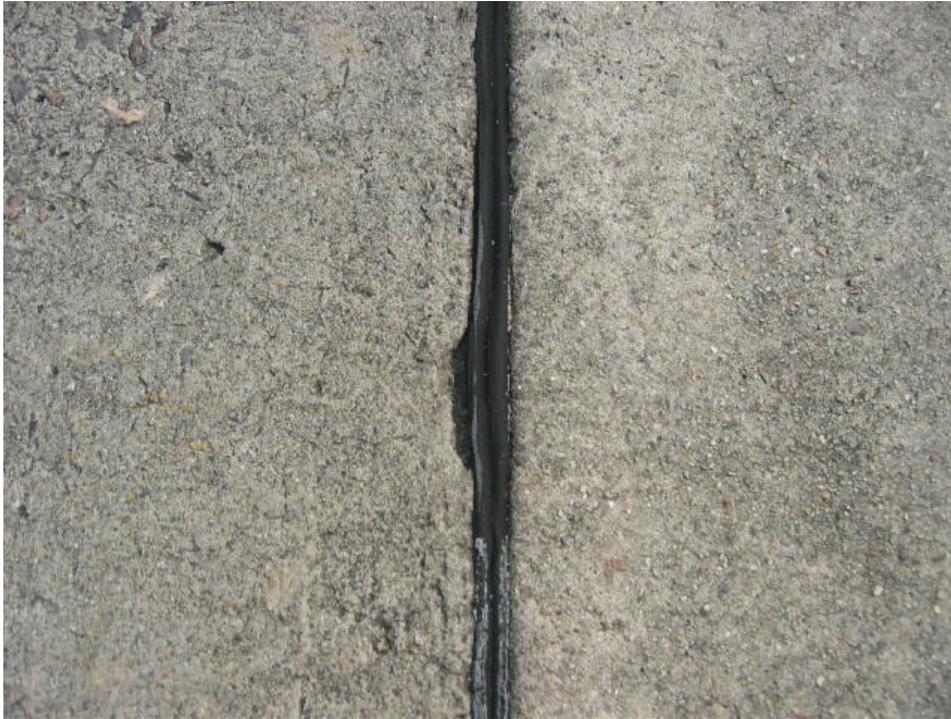
TCSV-30. Joint seal damage.

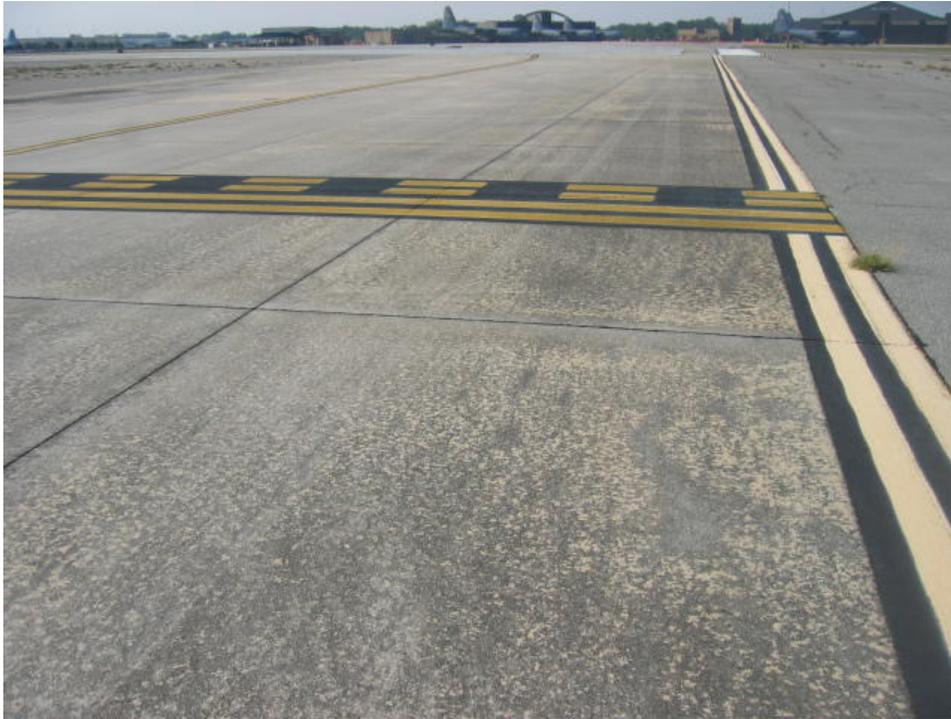
TCSV-60. Overview.

Section TCSV-60 is in good condition with a PCI value of 87. Distresses observed in this section include low-severity patching, medium-severity joint spalling, and high-severity joint seal damage.

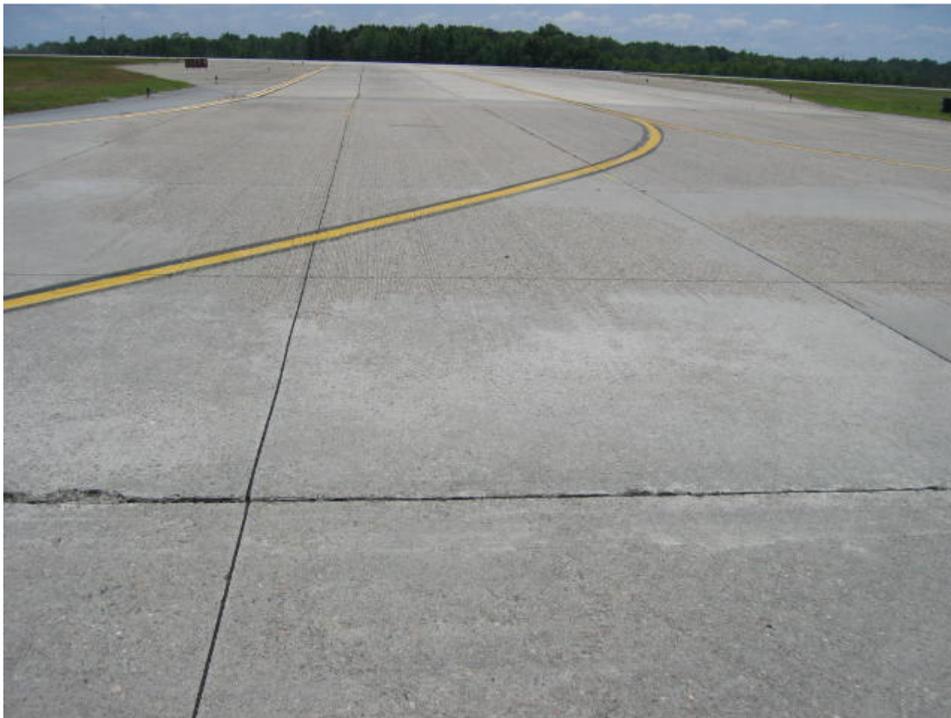
TE1SV-10. Overview.

Taxiway E1 consists of a single section. Section TE1SV-10 is in poor condition with a PCI value of 54. Distresses observed in this section include low and high-severity corner breaks, corner spalling of all severity levels, medium and high-severity joint seal damage, medium-severity joint spalling, all severity levels of patching, low-severity linear cracking, and shrinkage cracking.

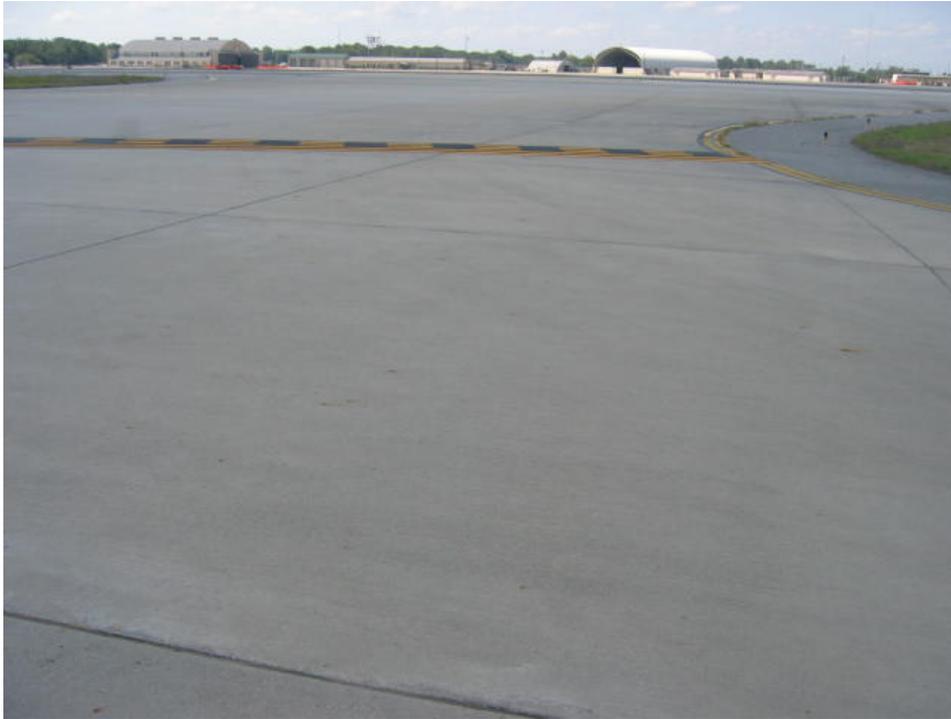
TE2SV-10. Overview.

Taxiway E2 consists of a single section. Section TE2SV-10 is in excellent condition with a PCI value of 98. Small quantities of low-severity patching as well as high-severity corner spalling were observed in this section.

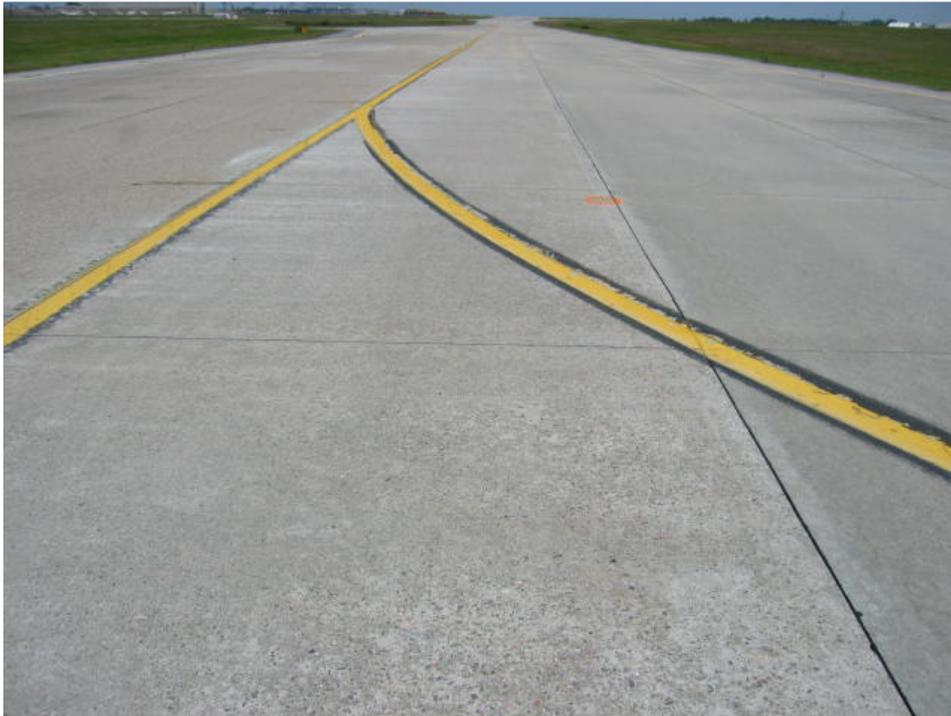
TESV-20. Overview.

Section TESV-20 is in good condition with a PCI value of 90. Medium-severity corner spalling and low severity joint seal damage were observed in this section. Also, all severities of both small and large patching were identified.

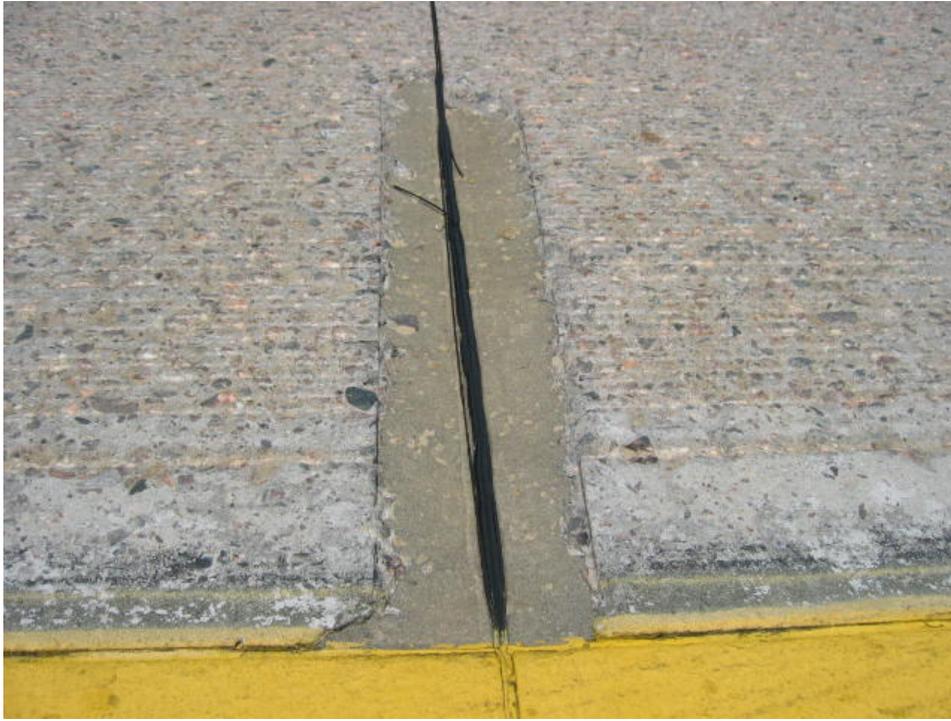
TESV-20. Small patch.

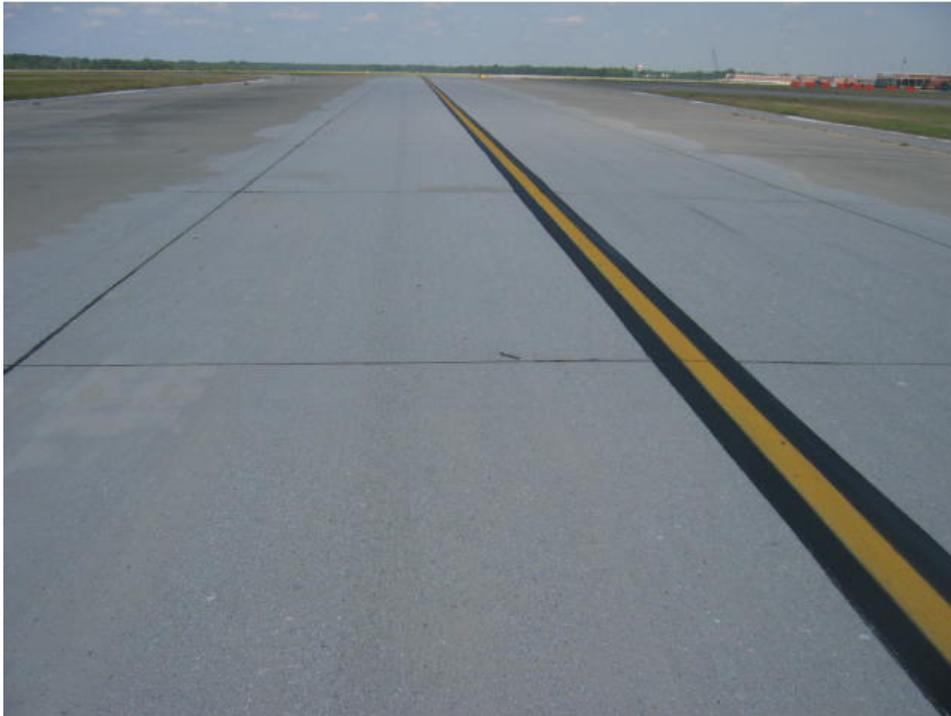
TESV-40. Overview.

Section TESV-40 is in excellent condition with a PCI value of 98. Small quantities of low-severity linear cracking and patching as well as medium-severity joint spalling were observed.

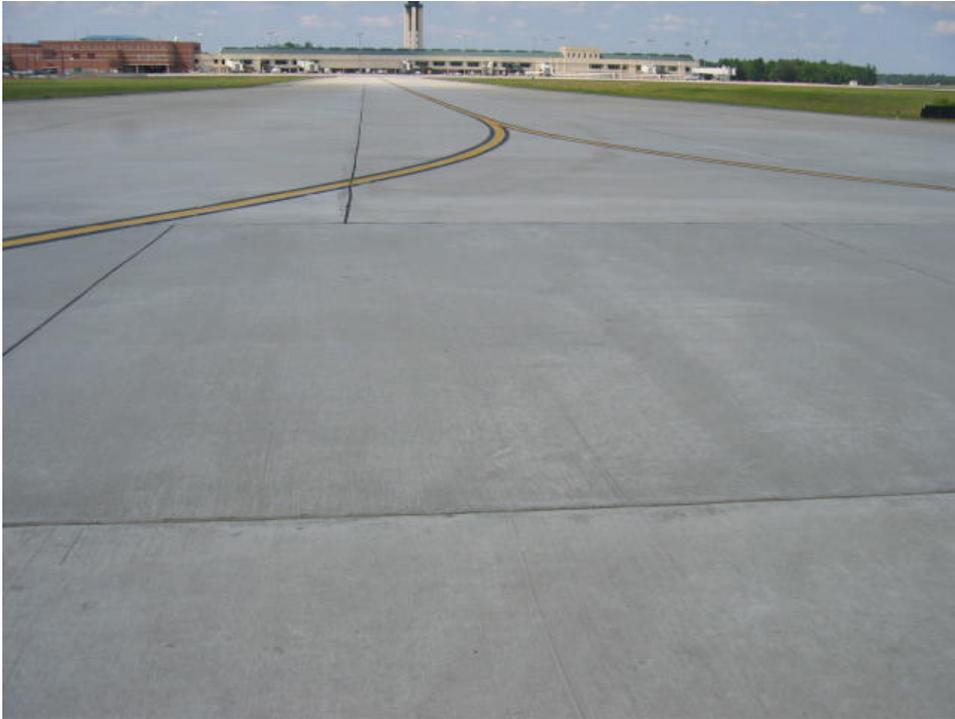
TFSV-10. Overview.

Taxiway F consists of a single section. Section TFSV-10 is in excellent condition with a PCI value of 97. Small amounts of high-severity corner spalling, medium-severity joint spalling as well as both low and medium-severity patching were observed in this section.

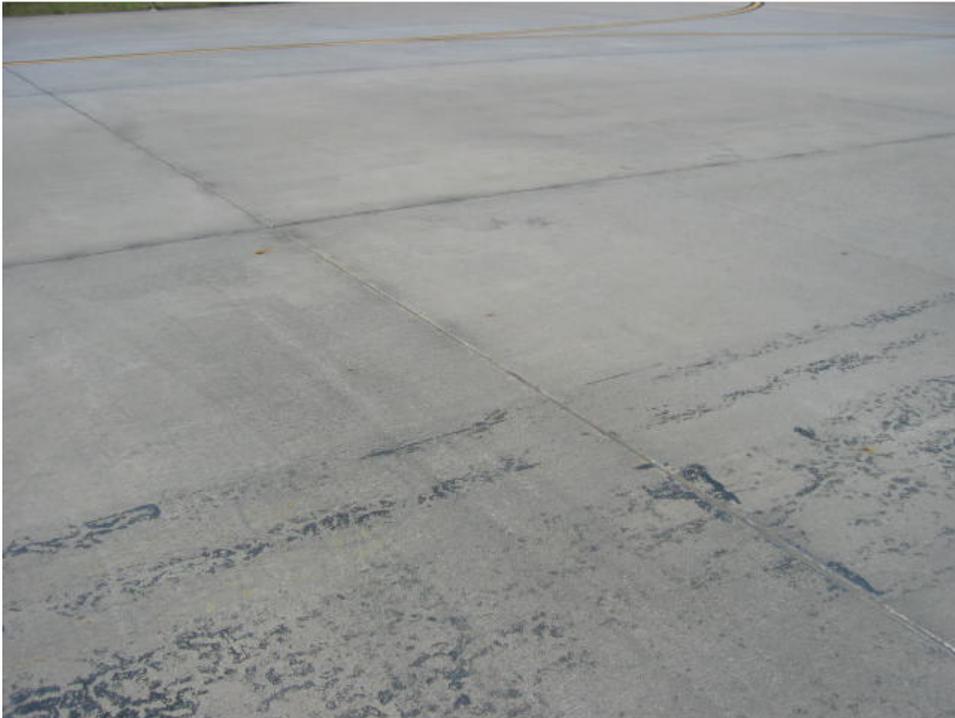
TGASV-10. Overview.

Taxiway GA consists of a single section. Section TGASV-10 is in excellent condition with a PCI value of 100. No distresses were observed in this section.
