VIDALIA REGIONAL AIRPORT
PAVEMENT MANAGEMENT REPORT

2007 GEORGIA AIRPORT PAVEMENT MANAGEMENT REPORT

VIDALIA REGIONAL AIRPORT

PAVEMENT MANAGEMENT REPORT

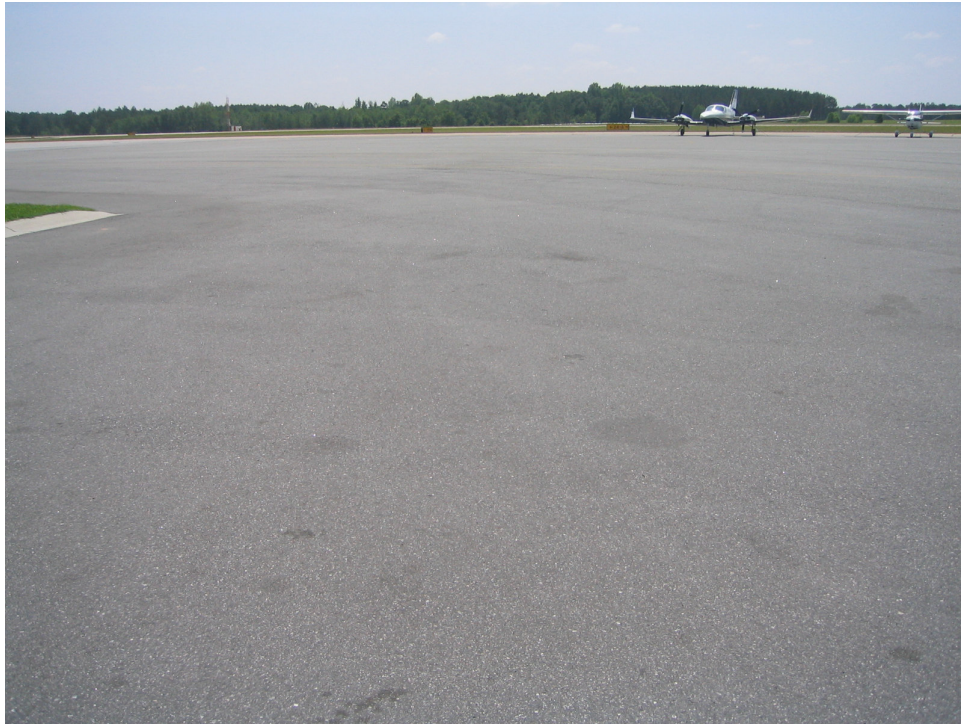
The apron consists of one section, A01VD-10, that is in good condition with a PCI value of 87. Small amounts of unsealed low-severity L&T cracking and raveling and weathering were observed along with low-severity block cracking and alligator cracking.

A01VD-10. Overview.

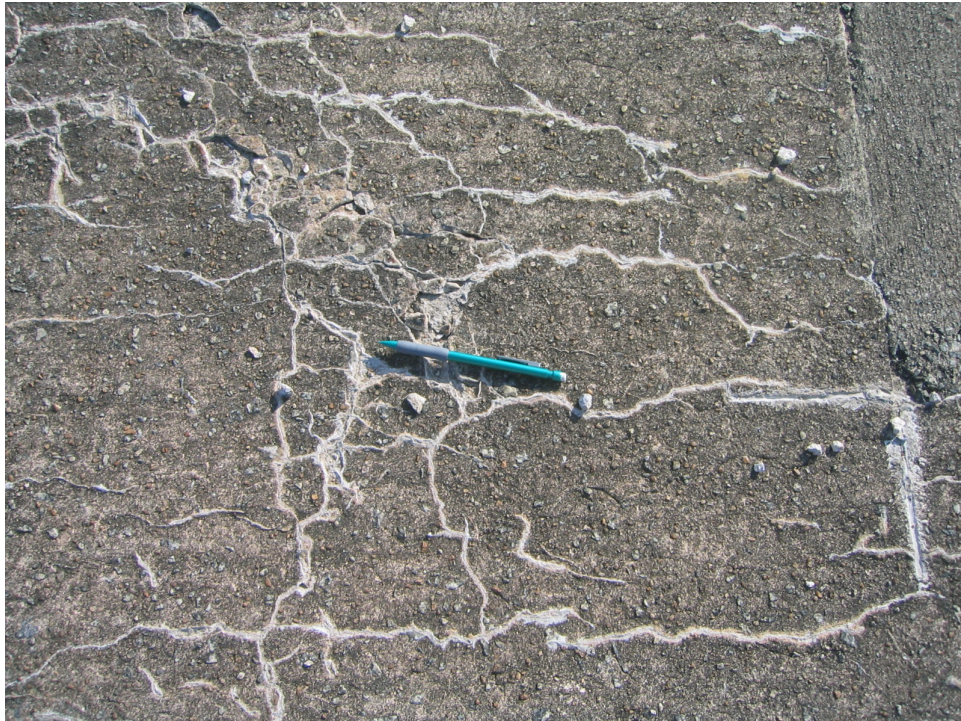
Runway 13-31 is defined by one section, R1331VD-10, and is in poor condition with a PCI value of 50. There was a wide variety of distresses observed, the most significant of which included low and medium-severity joint seal damage, low, medium and high-severity scaling/crazing and durability cracking.

R1331VD-10. Durability cracking.

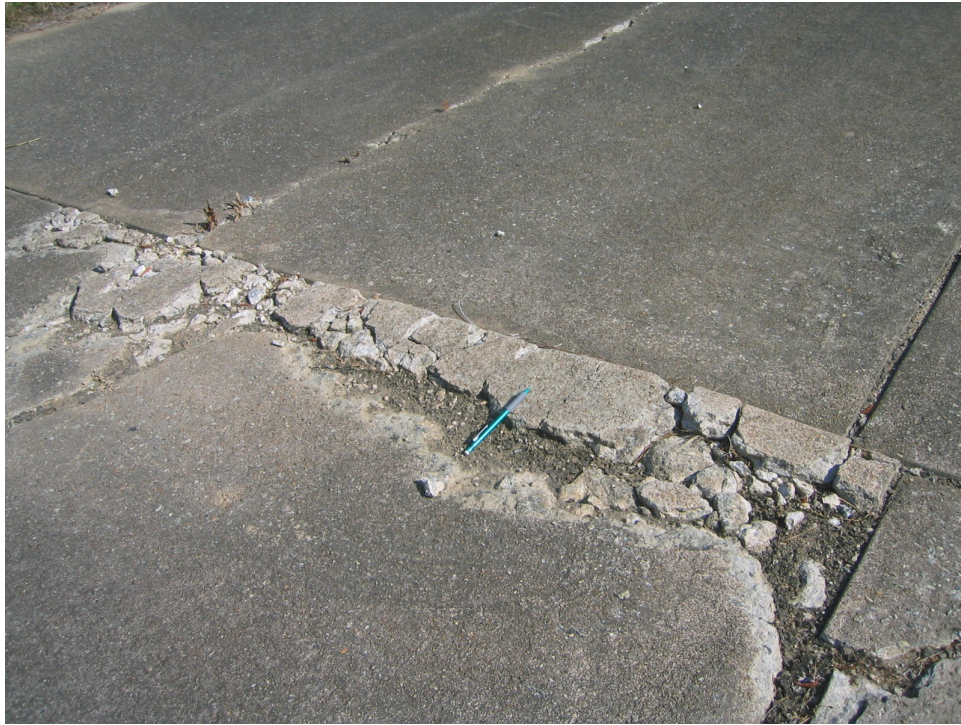
R1331VD-10. Joint spall.

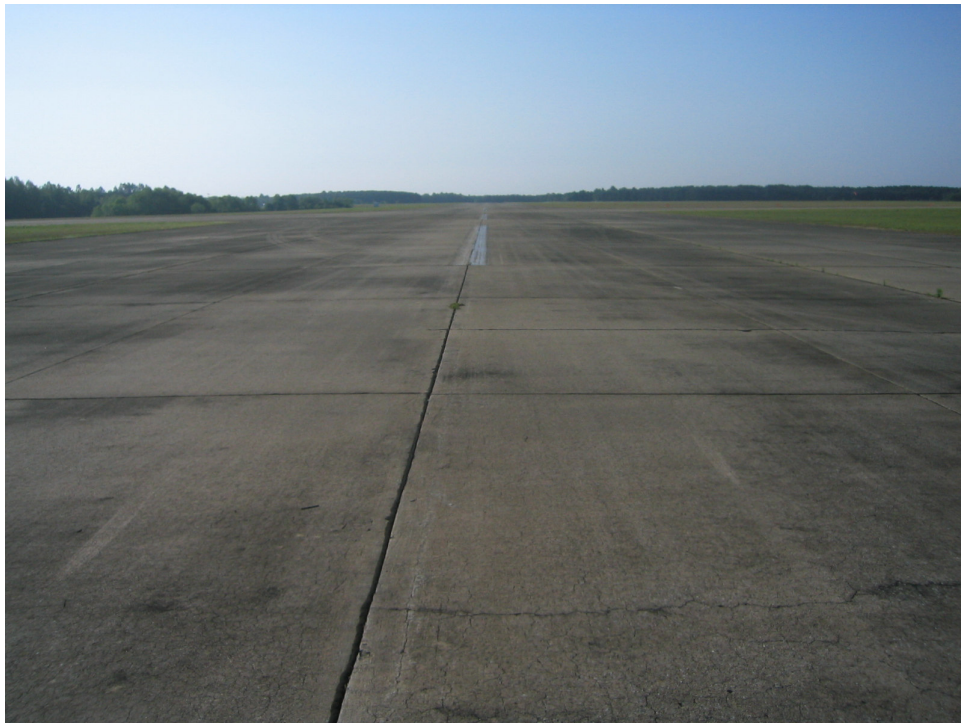
R1331VD-10. Overview.

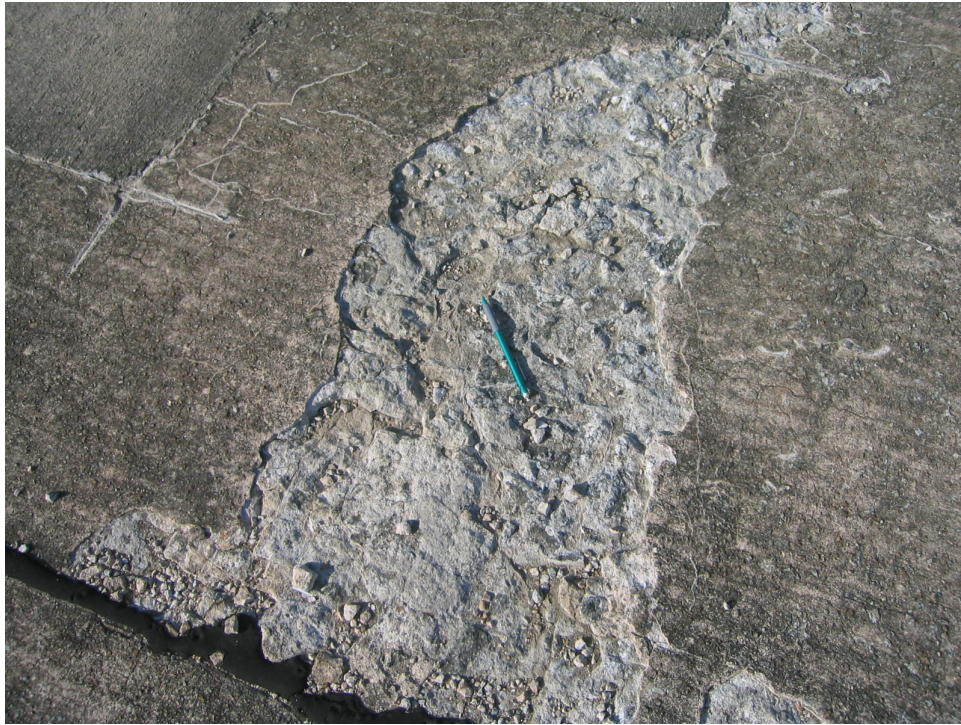
R1331VD-10. Scaling.

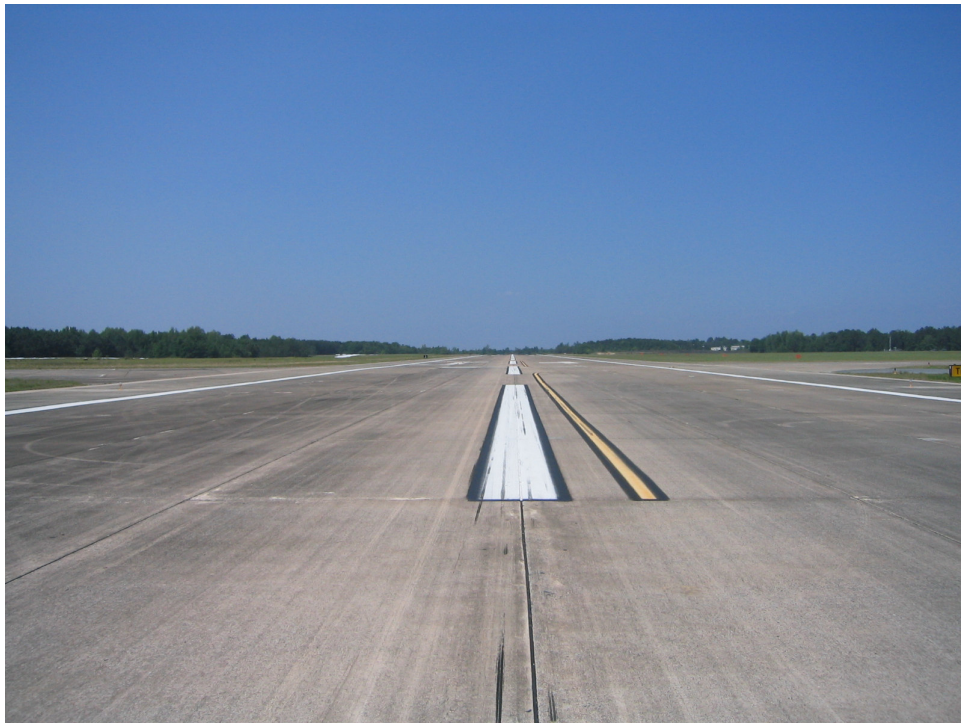
Runway 6-24 is comprised of one section, R624VD-10, and is in fair condition with a PCI value of 73. There was a wide variety of distresses observed, the most common of which included low-severity joint seal damage, scaling/crazing and linear cracking.

R624VD-10. Overview.

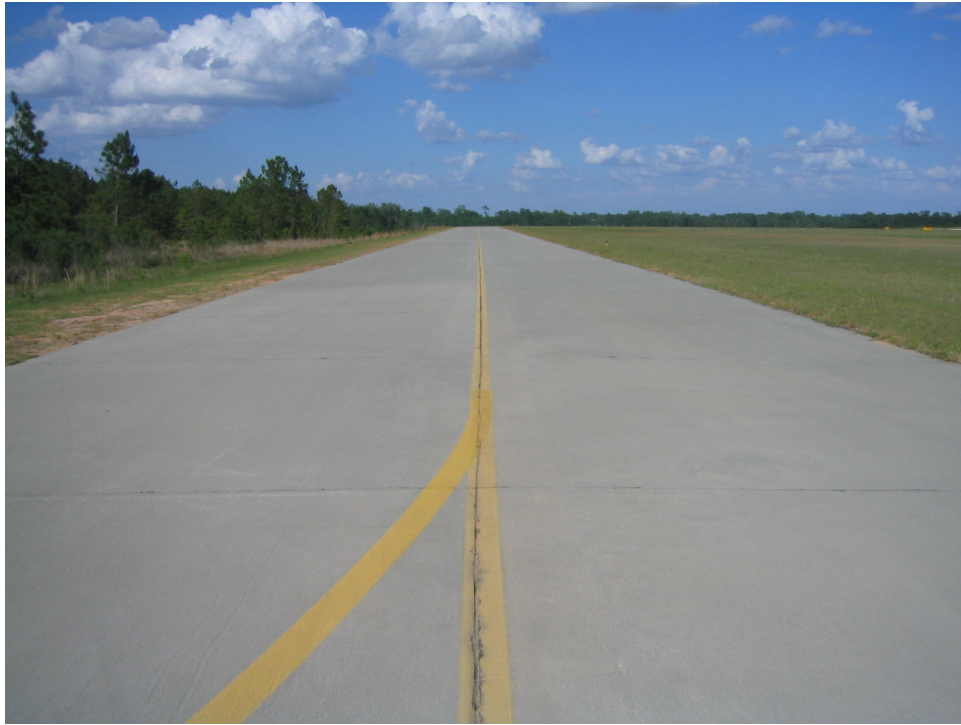
Taxiway A is defined by two sections that are both in excellent condition with PCI values of 98 and 100, respectively. The only distress observed in TAVD-10 was low-severity joint seal damage. No distress was observed in TAVD-20 at the time of inspection.

TAVD-10. Overview.

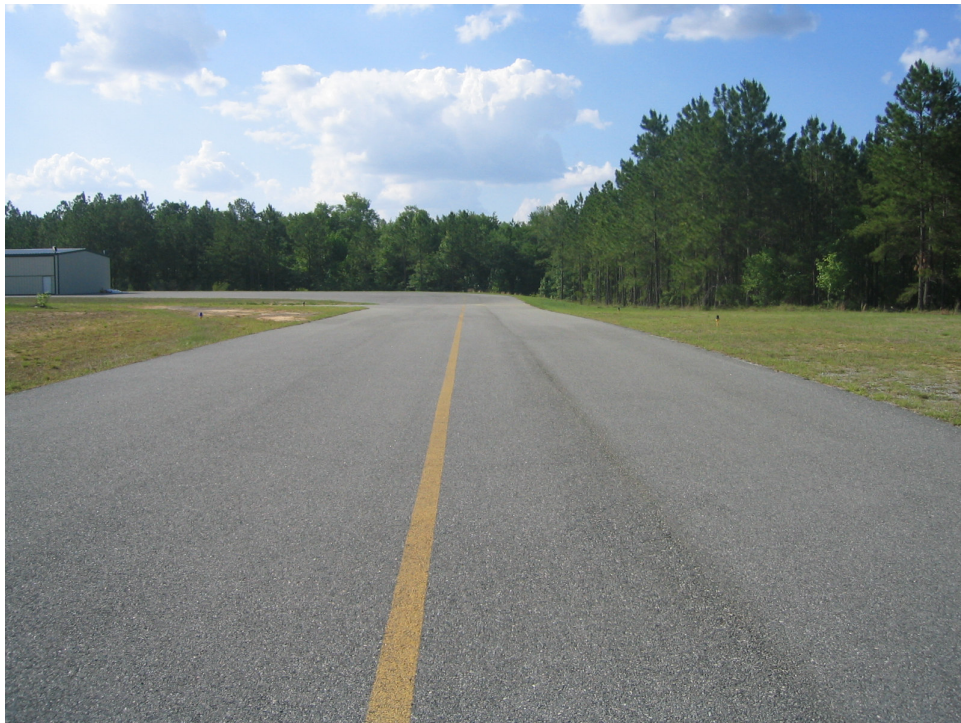
TAVD-20. Overview.

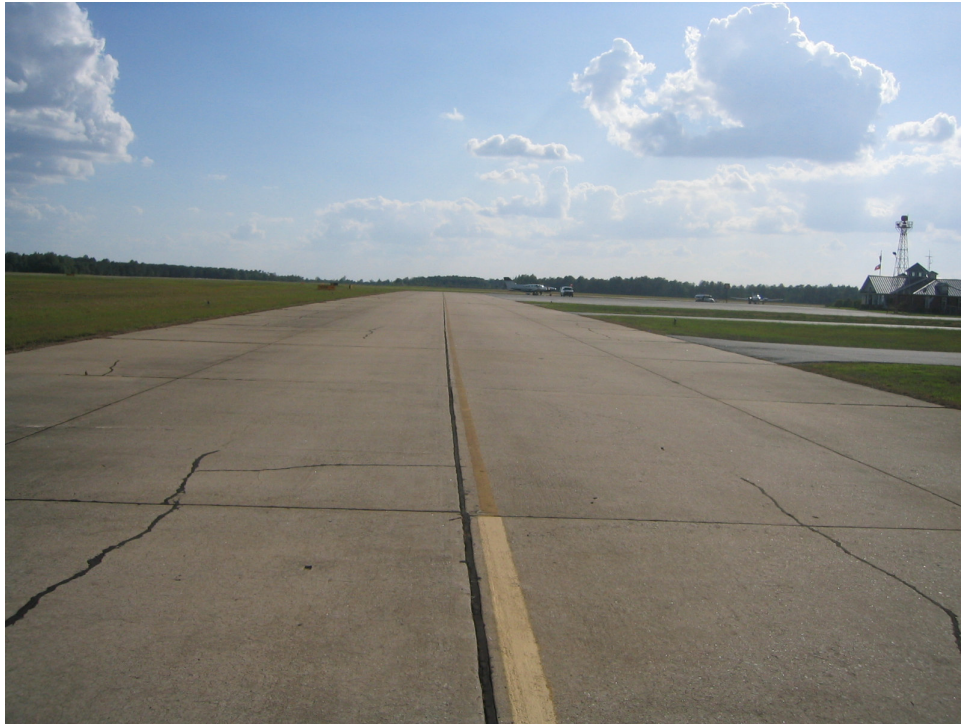
Taxiway B consists of one section, TBVD-10, that is in poor condition with a PCI value of 52. Significant quantities of shrinkage cracking and low and medium-severity scaling/crazing and linear cracking were recorded along with smaller amounts of low-severity shattered slabs and low and medium-severity corner and joint spalling.

TBVD-10. Overview.

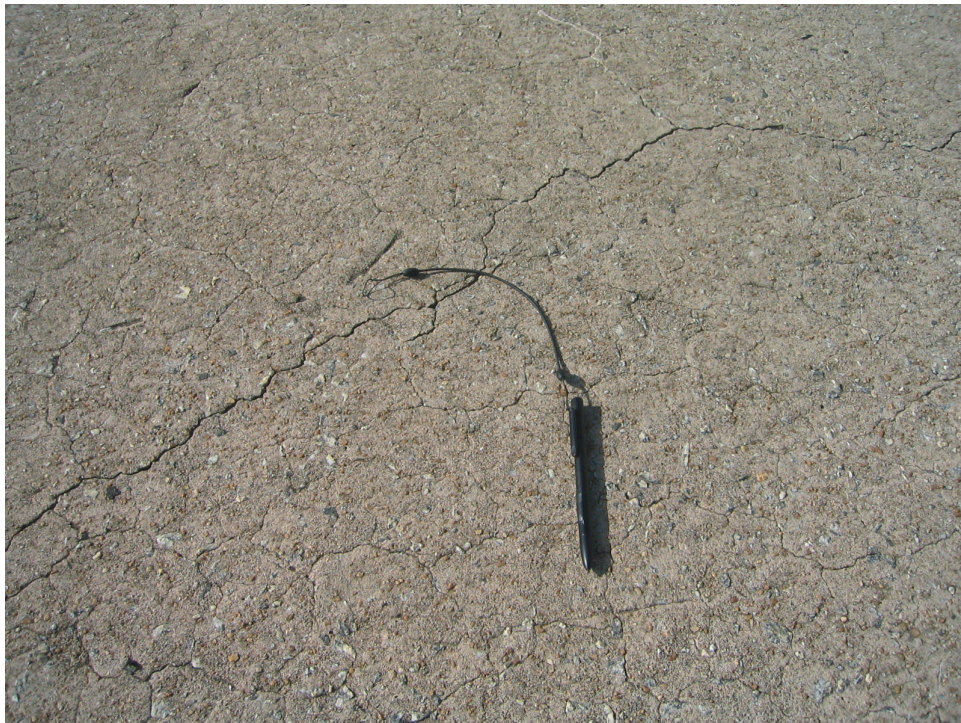
TBVD-10. Scaling.

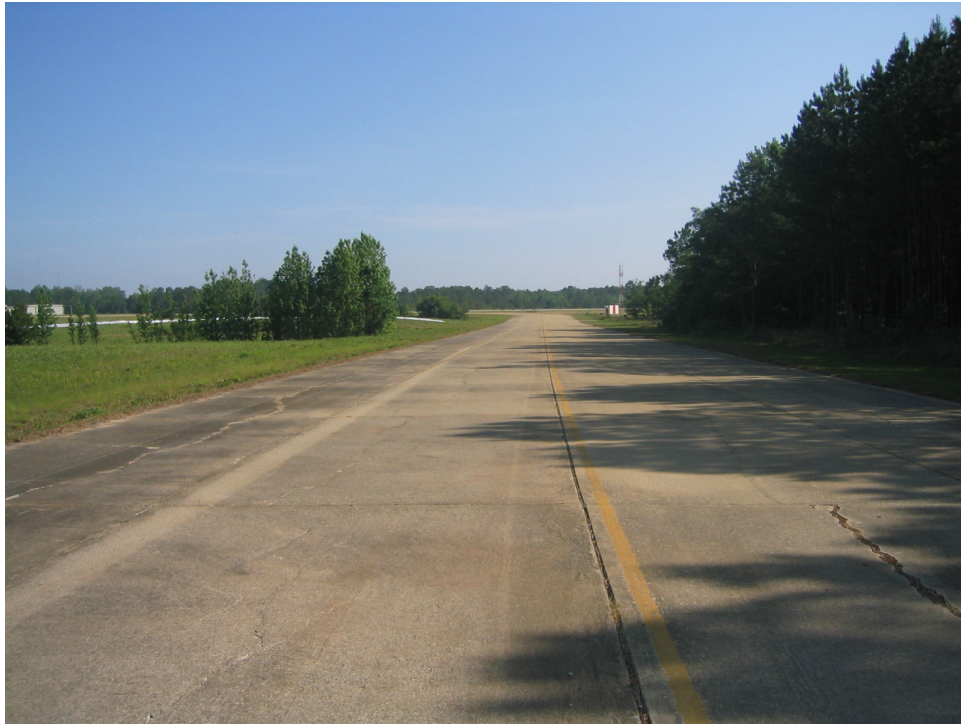
Taxiway C is comprised by one section, TCVD-10, that is in poor condition with a PCI value of 39. Shrinkage cracking, durability cracking, faulting, scaling/crazing, joint seal damage, shattered slabs and linear cracking at various severities were observed in this section.

TCVD-10. Overview.

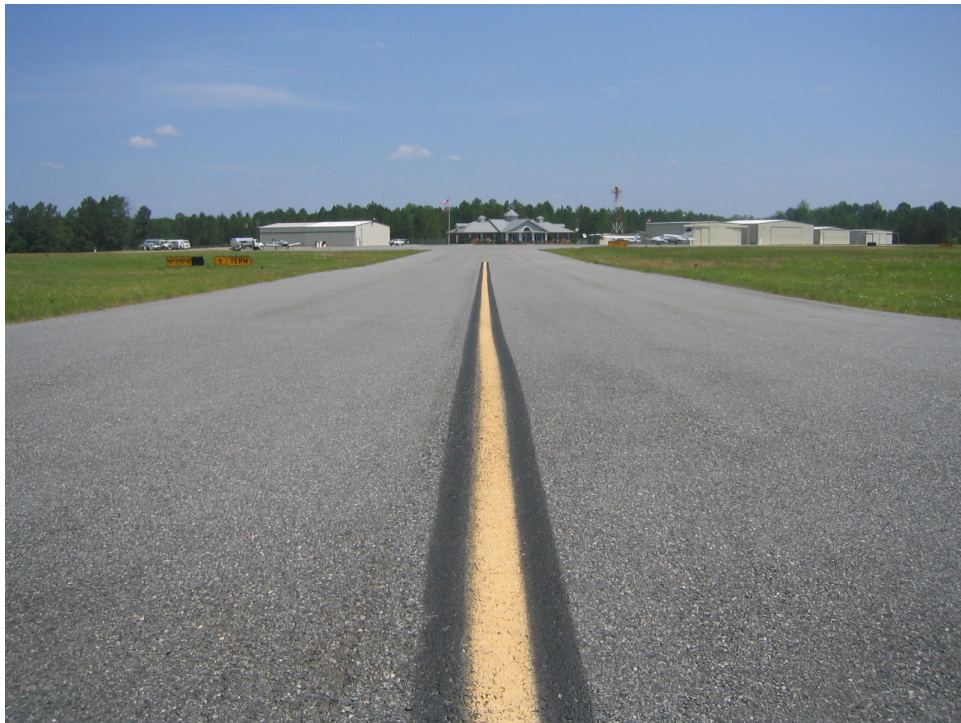
Taxiway D is defined by one section that is in excellent condition with a PCI value of 100. No distress was observed in TDVD-10 at the time of inspection.

TDVD-10. Overview.
