Report:

Barrow County Airport Pavement Management Plan

JULY 2019

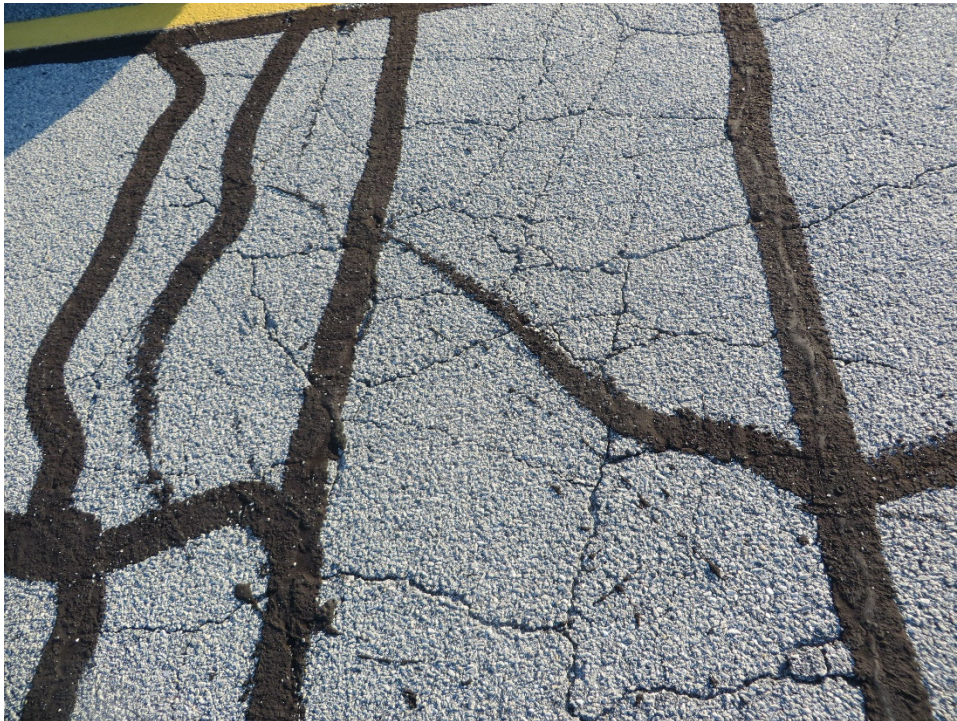
A01WI-10. Alligator Cracking (Sample Unit No. 30).

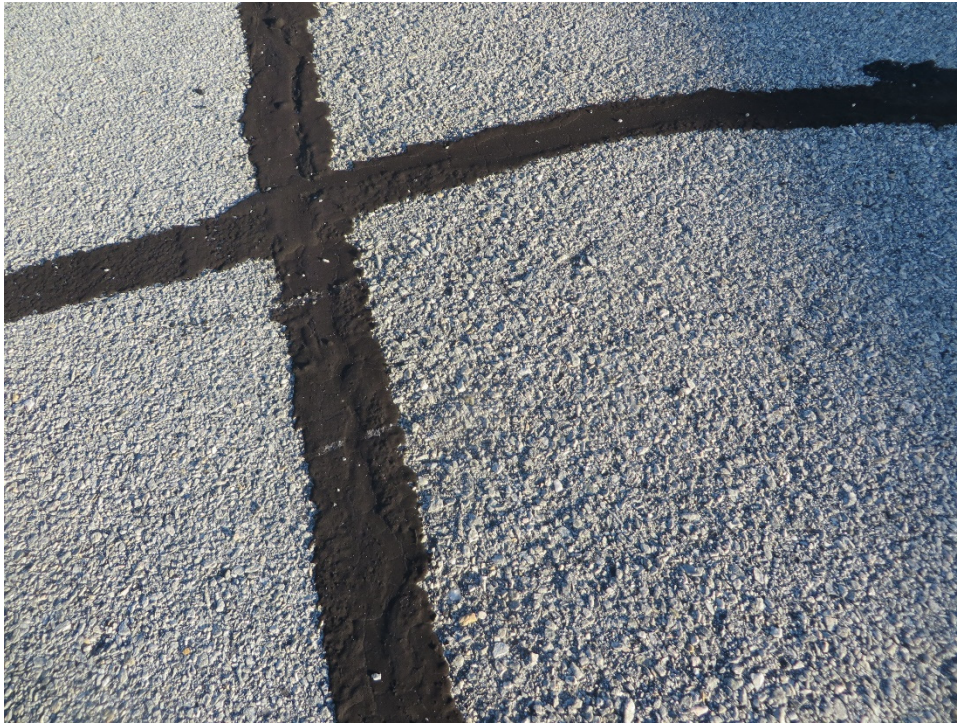
A01WI-10. L&T Cracking (Sample Unit No. 16).

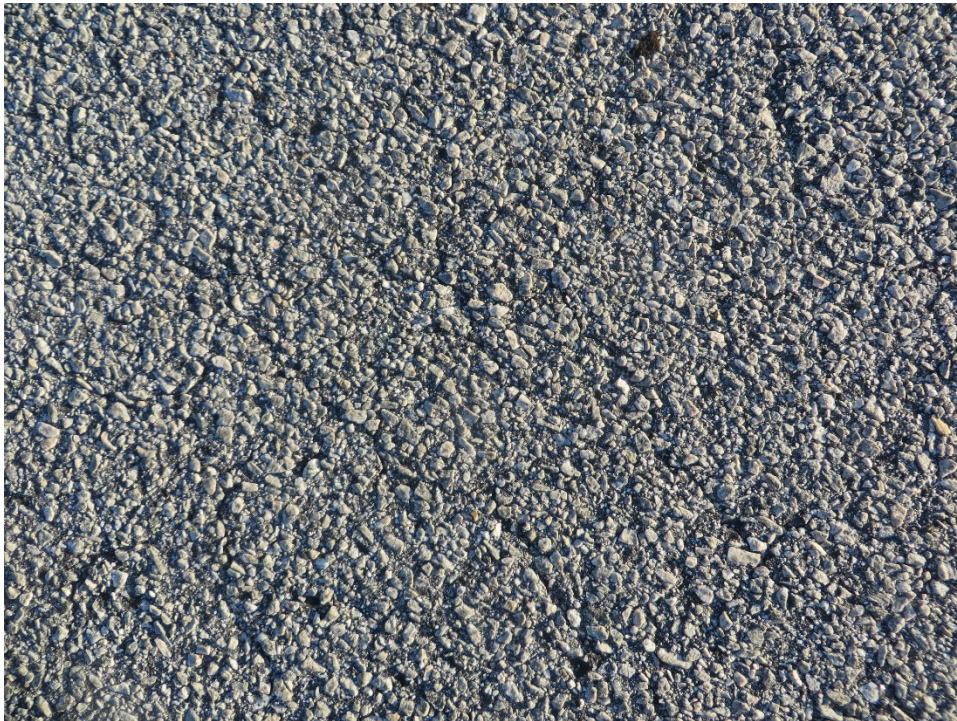
A01WI-10. Weathering (Sample Unit No. 30).

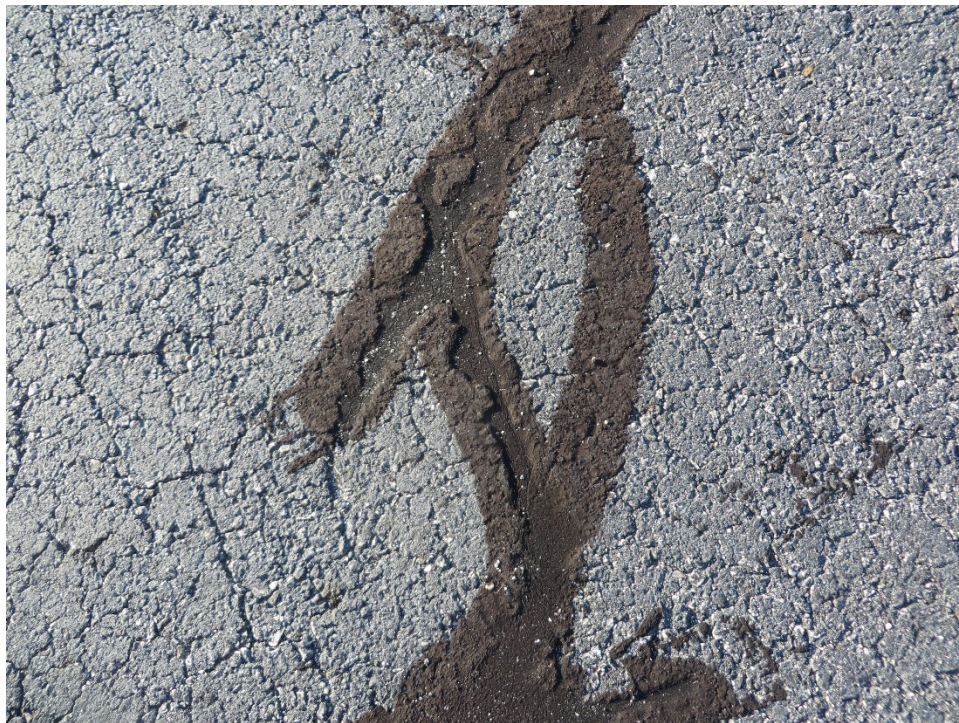
A01WI-20. L&T Cracking (Sample Unit No. 02).

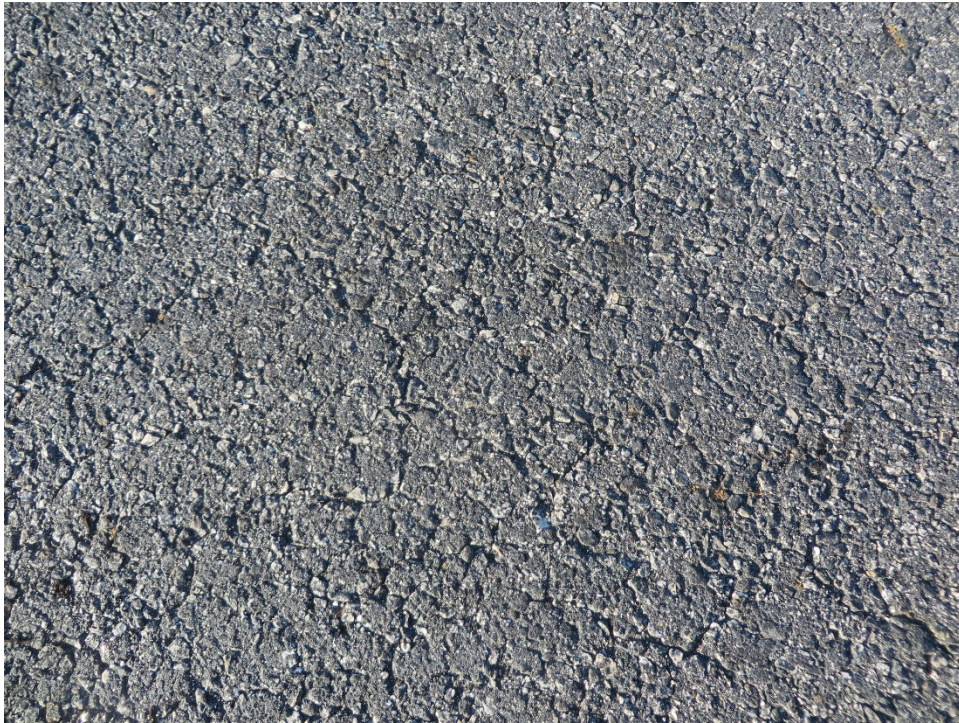
A01WI-20. Weathering (Sample Unit No. 02).

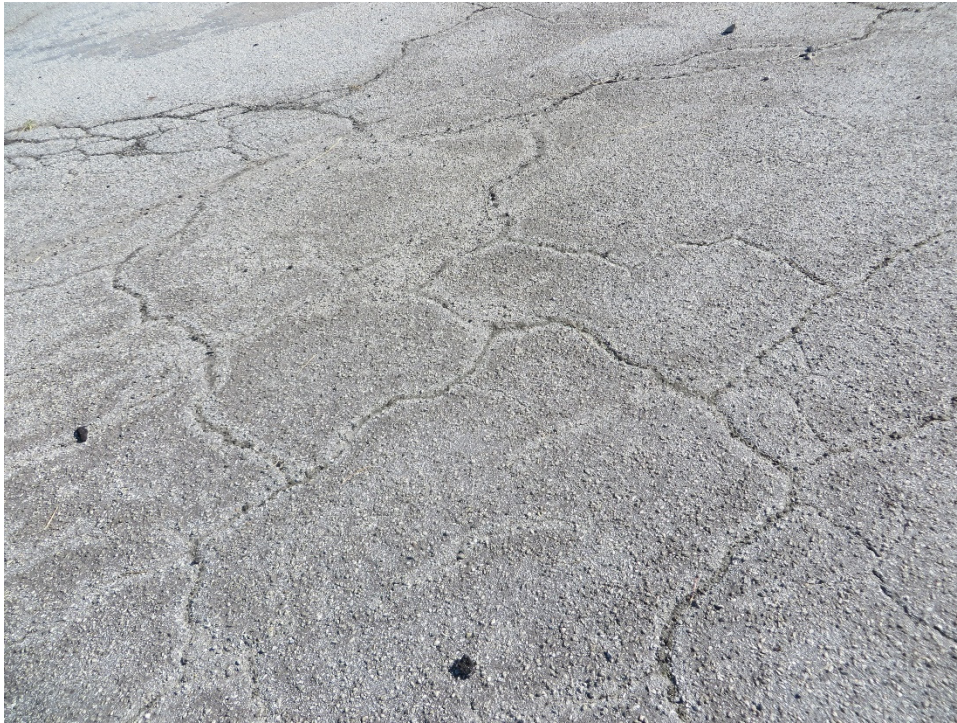
A02WI-10. Block Cracking (Sample Unit No. 03).

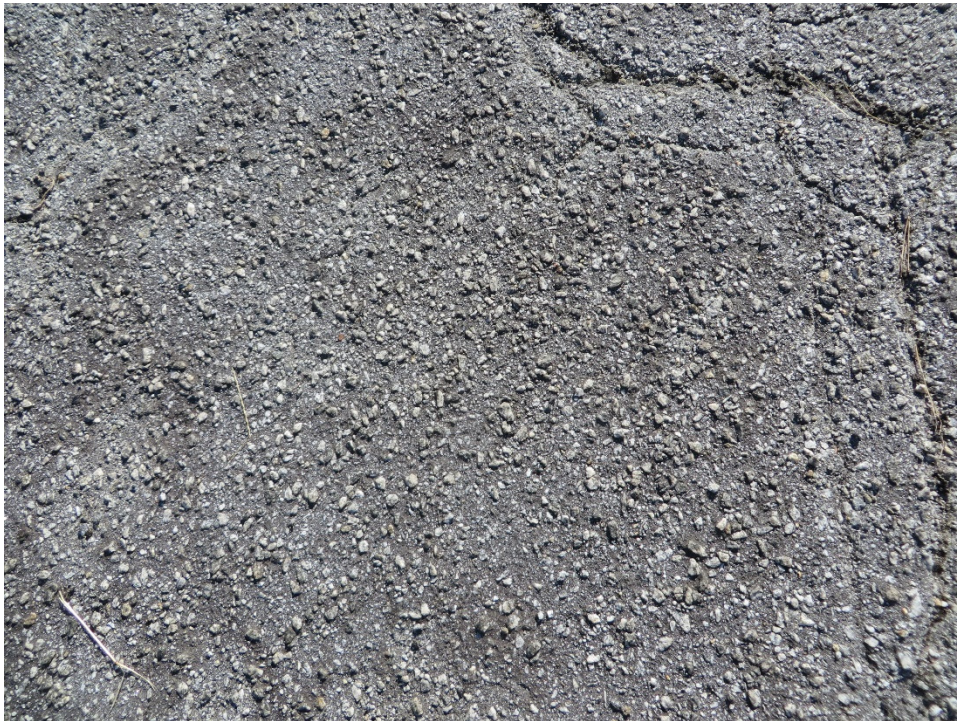
A02WI-10. Weathering (Sample Unit No. 03).

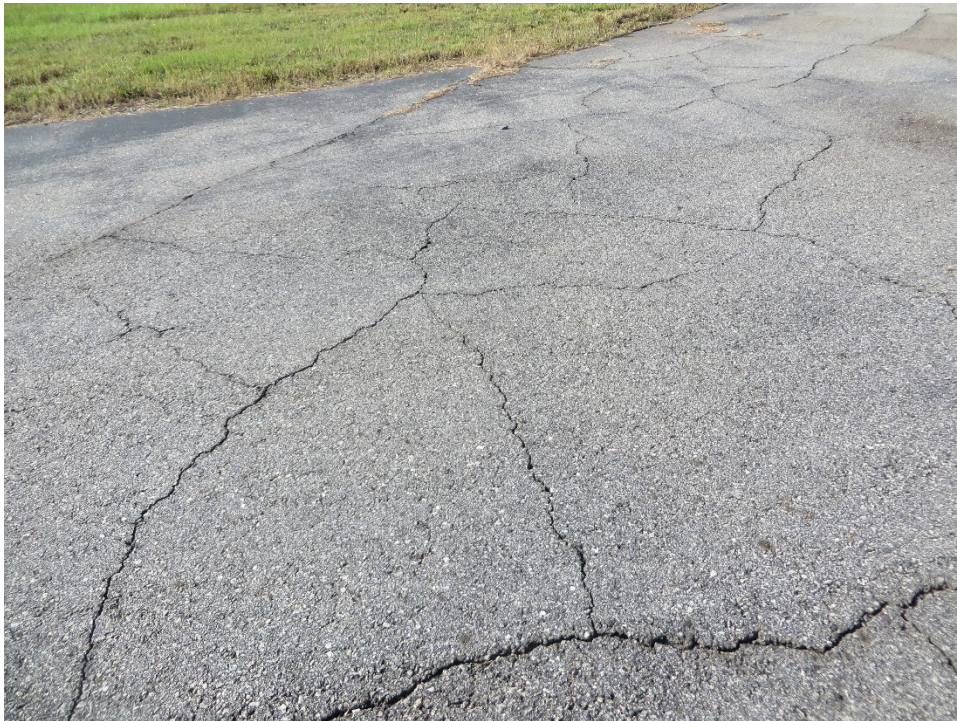
A02WI-20. Block Cracking (Sample Unit No. 05).

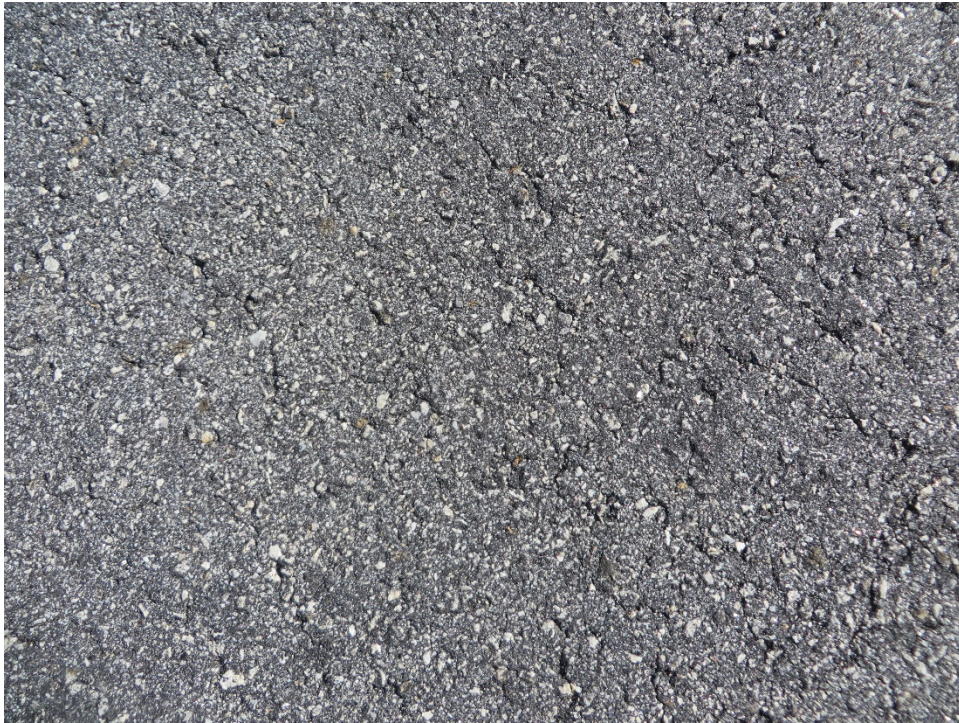
A02WI-20. Weathering (Sample Unit No. 01).

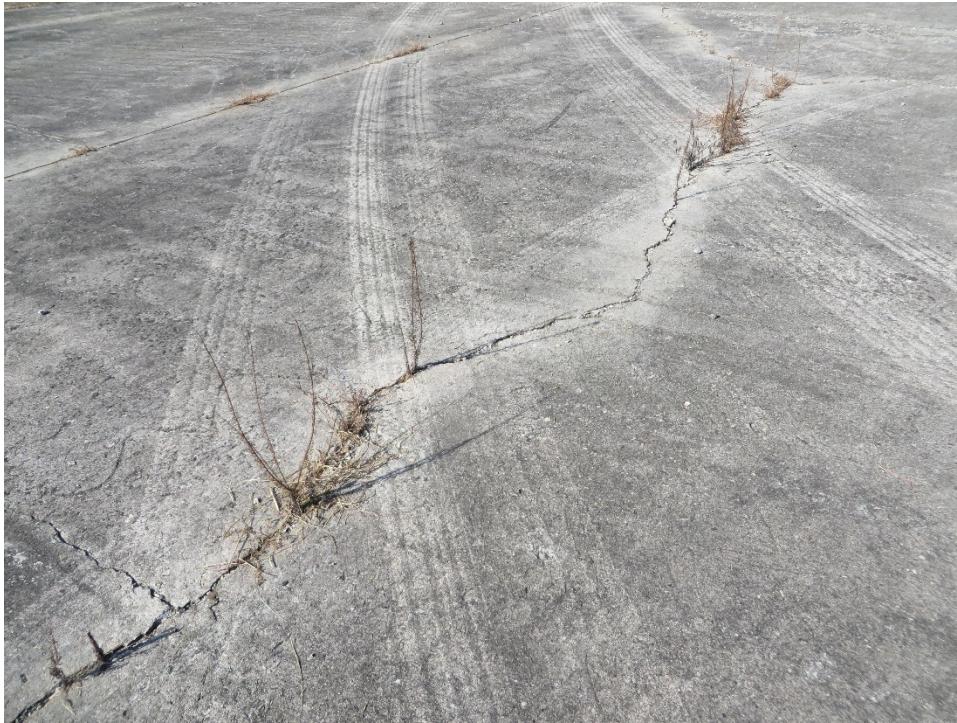
A02WI-30. LTD Cracking (Sample Unit No. 06).

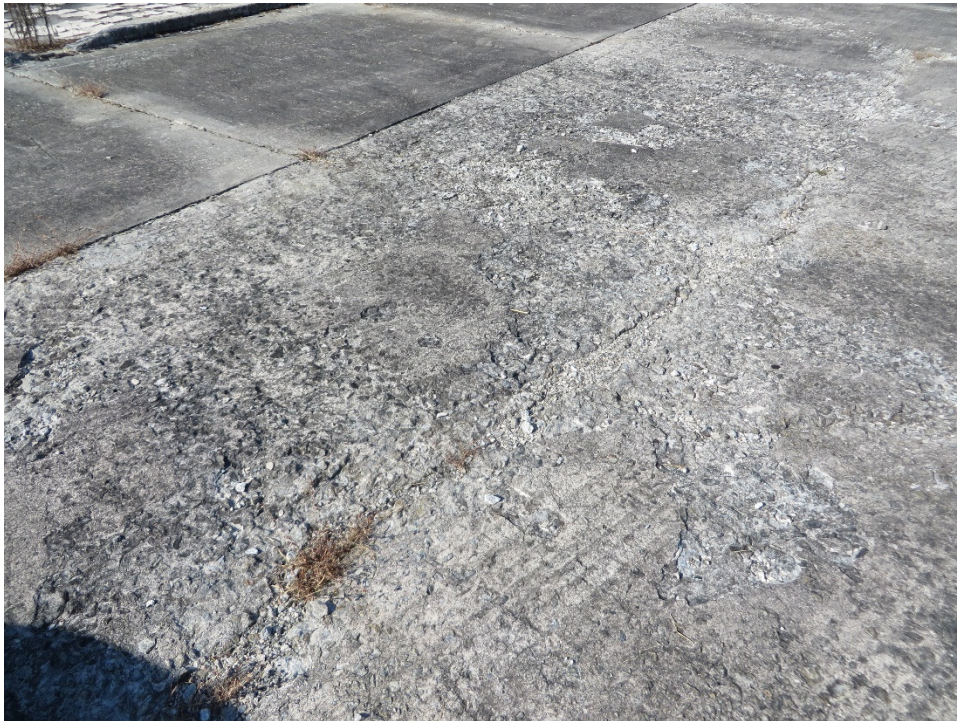
A02WI-30. Scaling (Sample Unit No. 02).

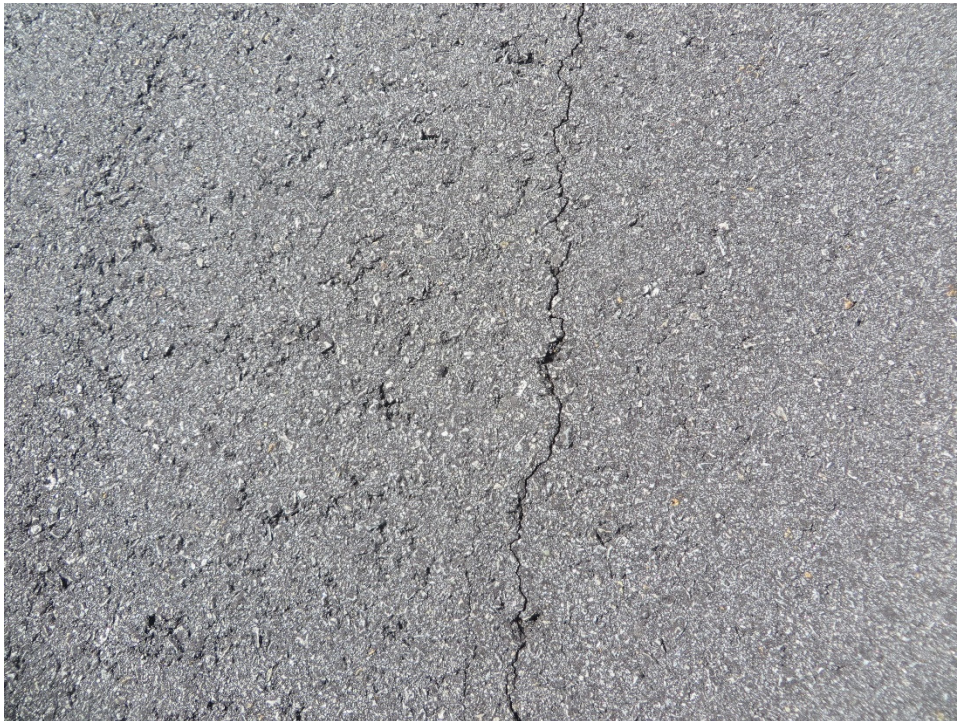
R1331WI-10. L&T Cracking (Sample Unit No. 13).

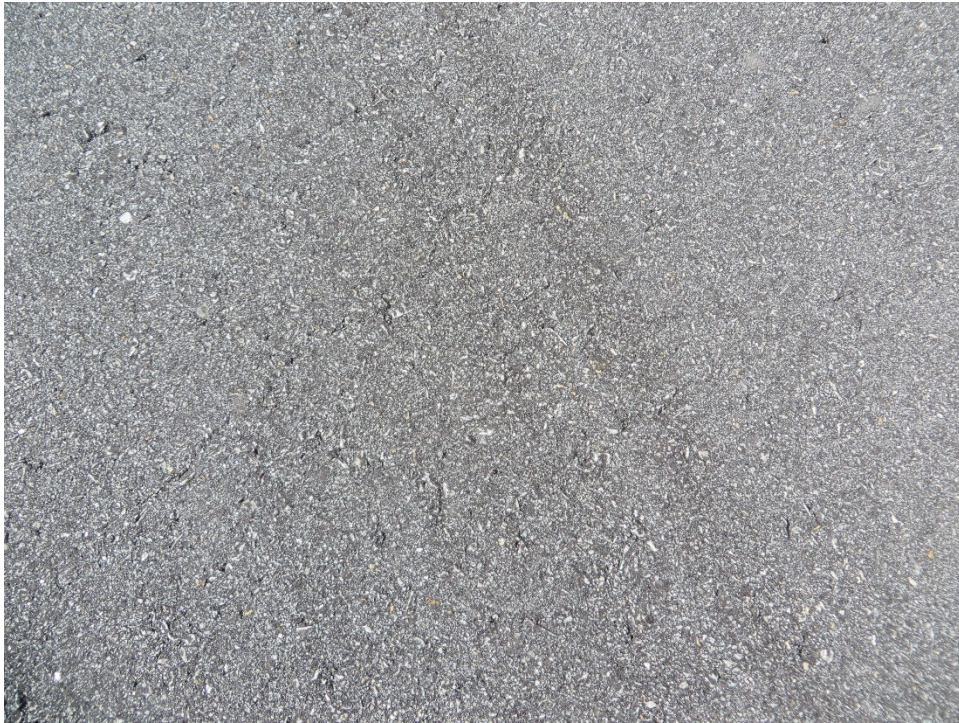
R1331WI-10. Raveling (Sample Unit No. 13).

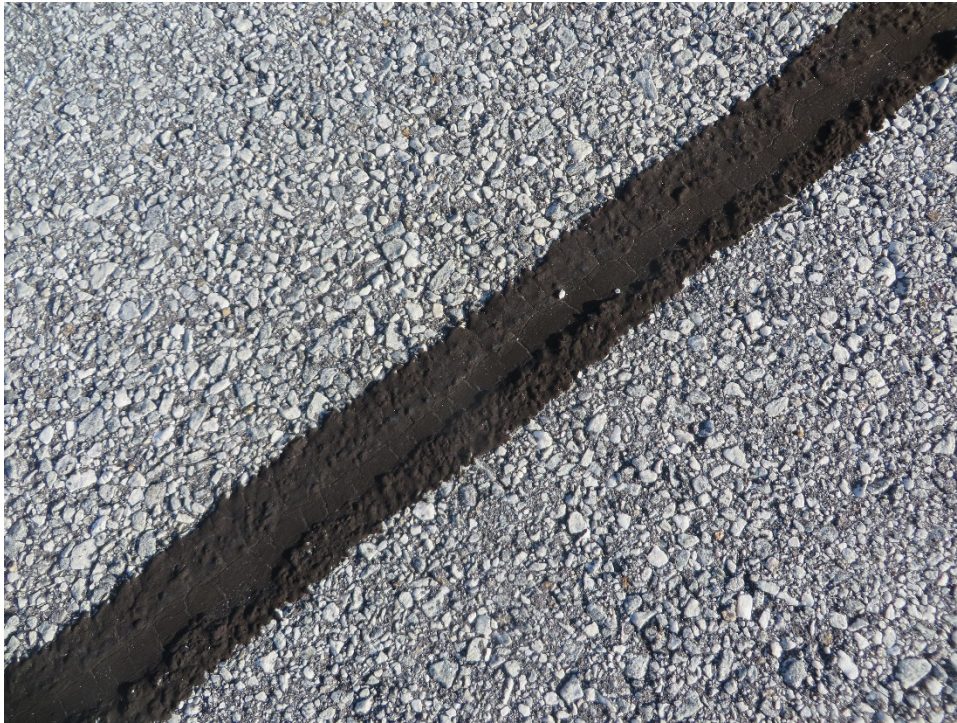
R523WI-10. L&T Cracking (Sample Unit No. 04).

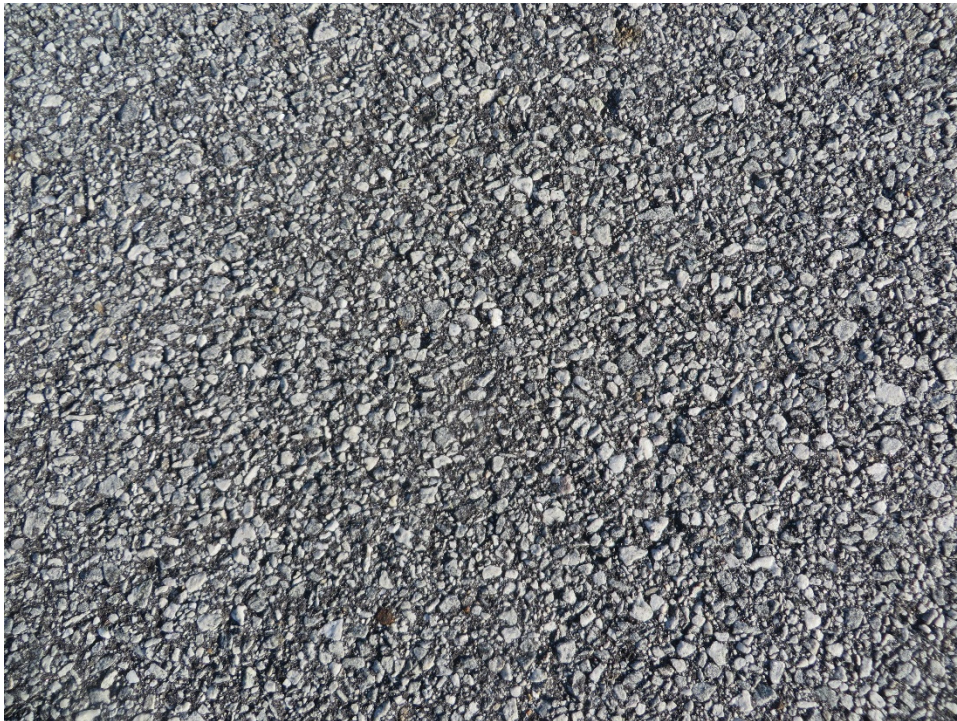
R523WI-10. Weathering (Sample Unit No. 04).

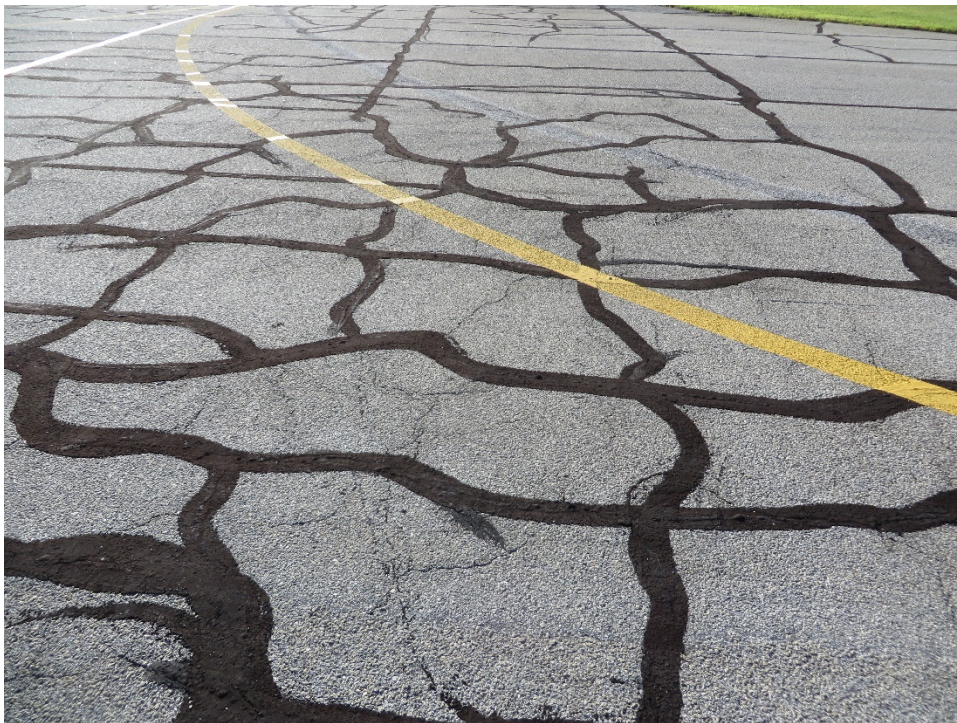
R523WI-20. Block Cracking (Sample Unit No. 02).

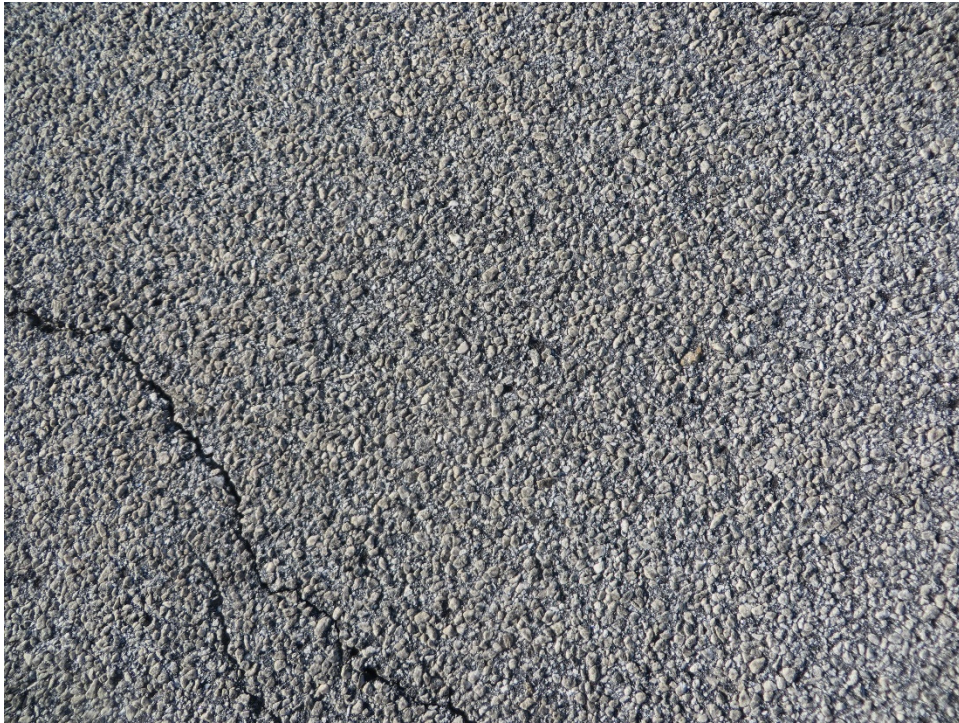
R523WI-20. Weathering (Sample Unit No. 02).

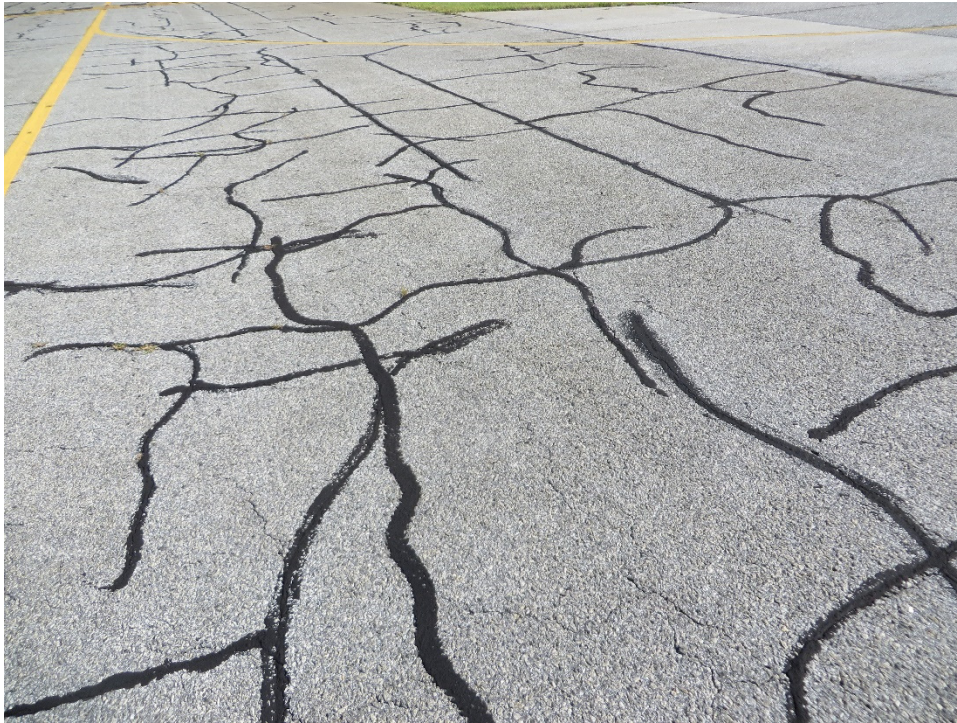
TAWI-10. Block Cracking (Sample Unit No. 25).

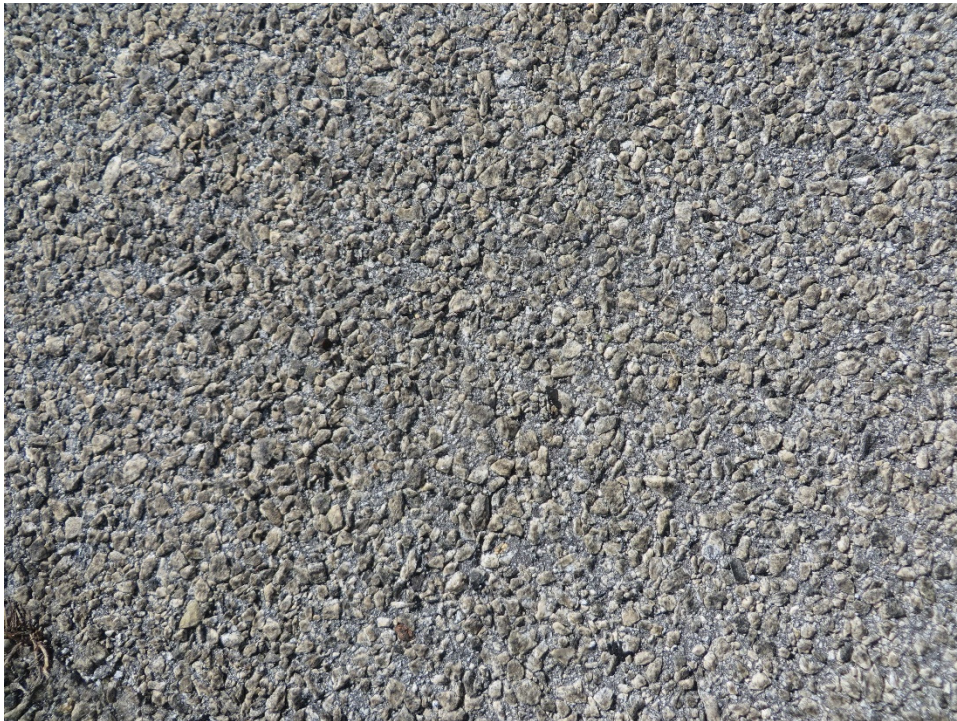
TAWI-10. Weathering (Sample Unit No. 45).

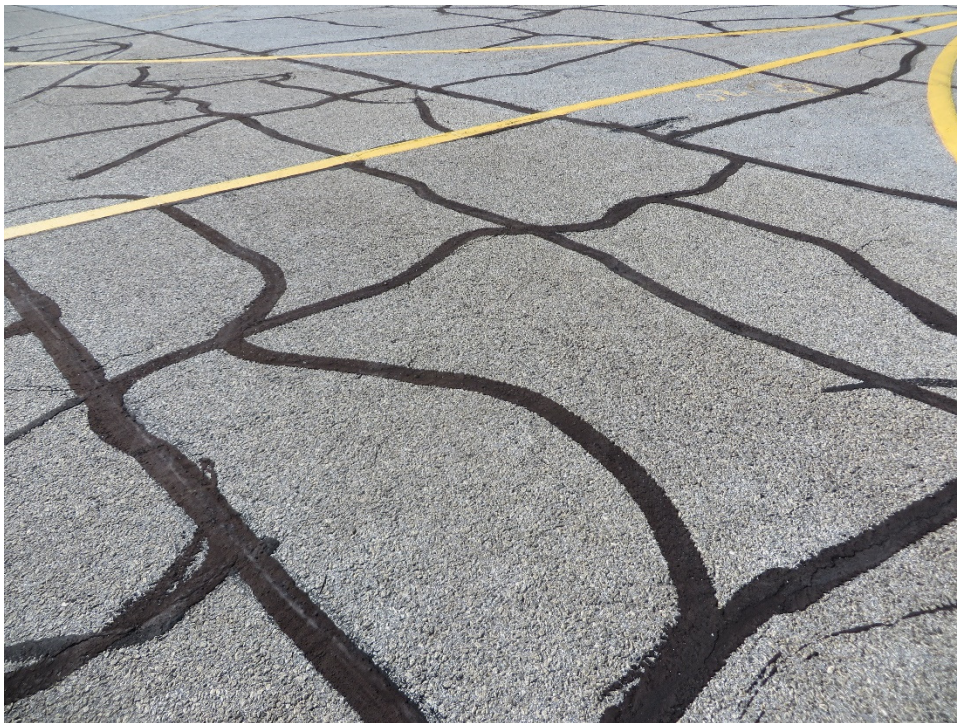
TBWI-10. Block Cracking (Sample Unit No. 43).

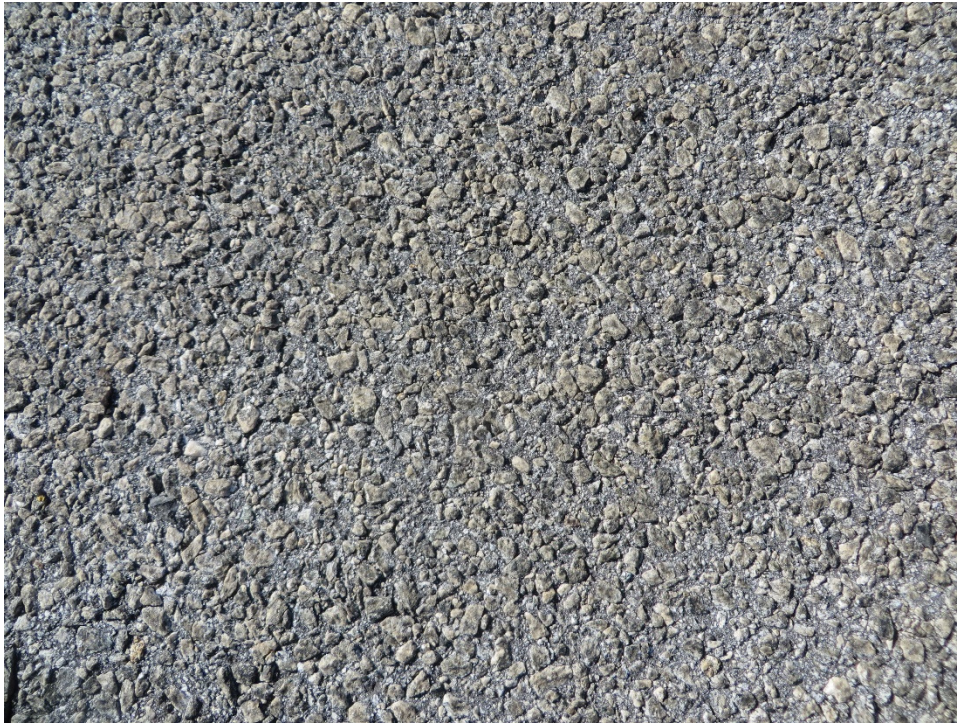
TBWI-10. Weathering (Sample Unit No. 43).

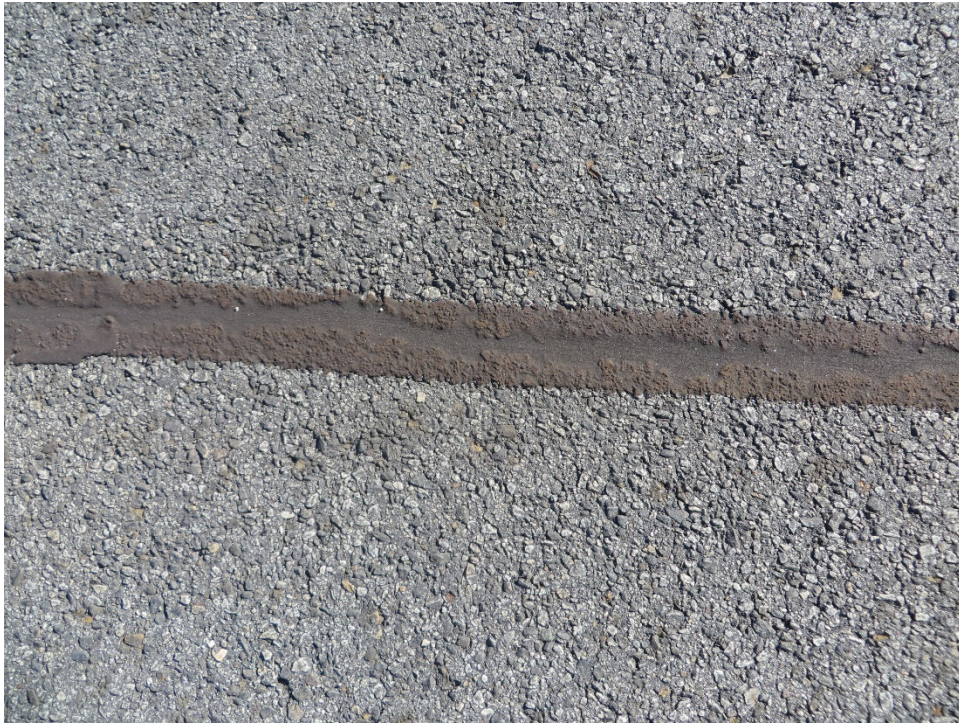
TBWI-20. L&T Cracking (Sample Unit No. 03).

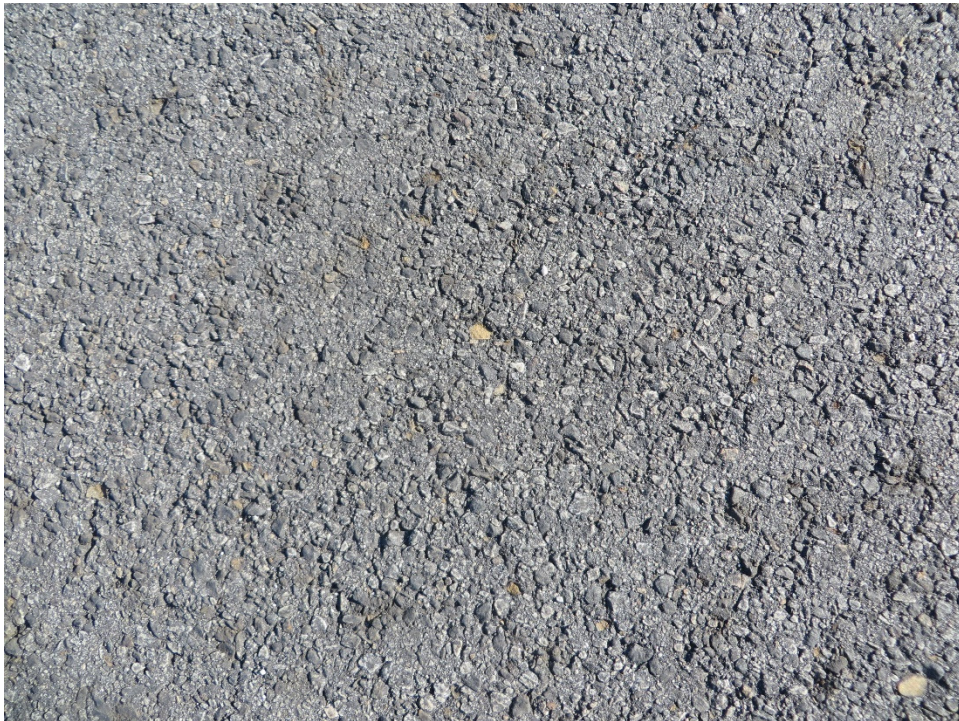
TBWI-20. Weathering (Sample Unit No. 03).

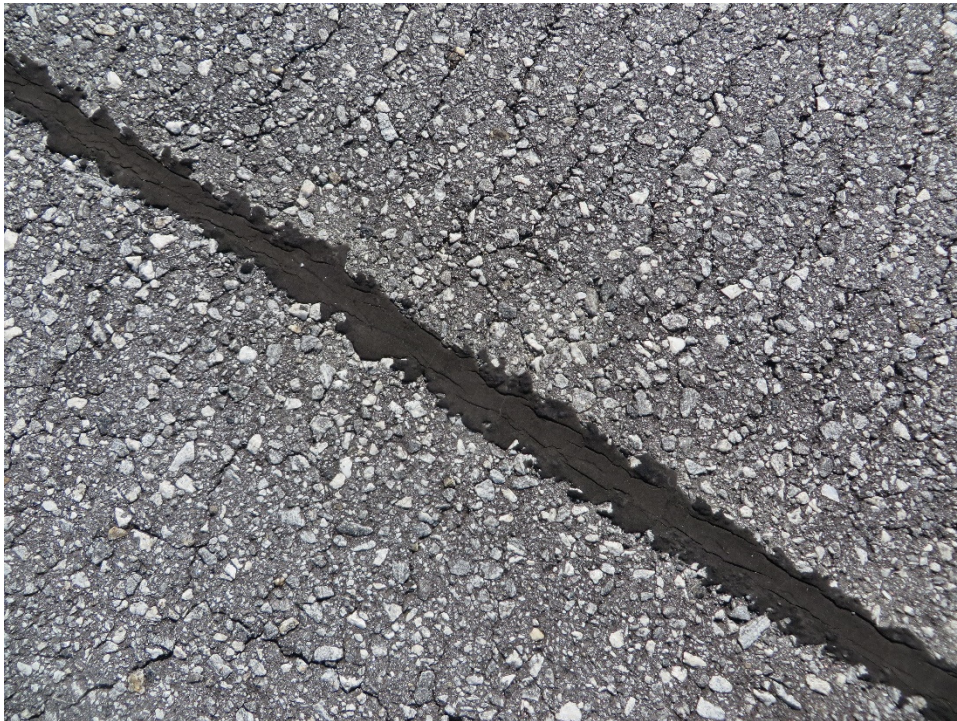
TDWI-10. L&T Cracking (Sample Unit No. 22).

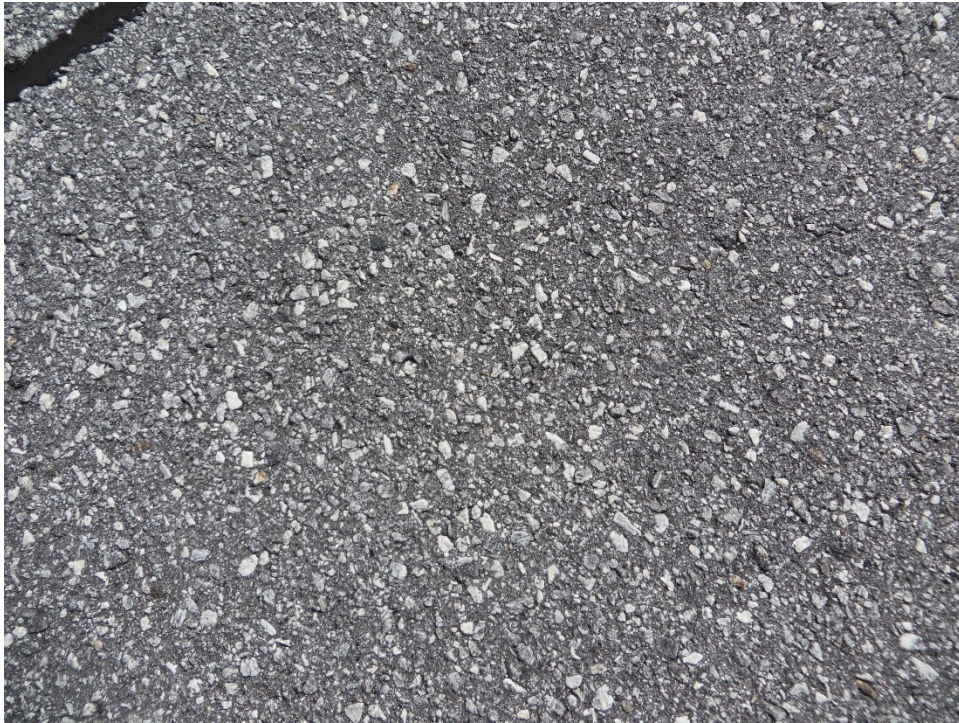
TDWI-10. Weathering (Sample Unit No. 22).

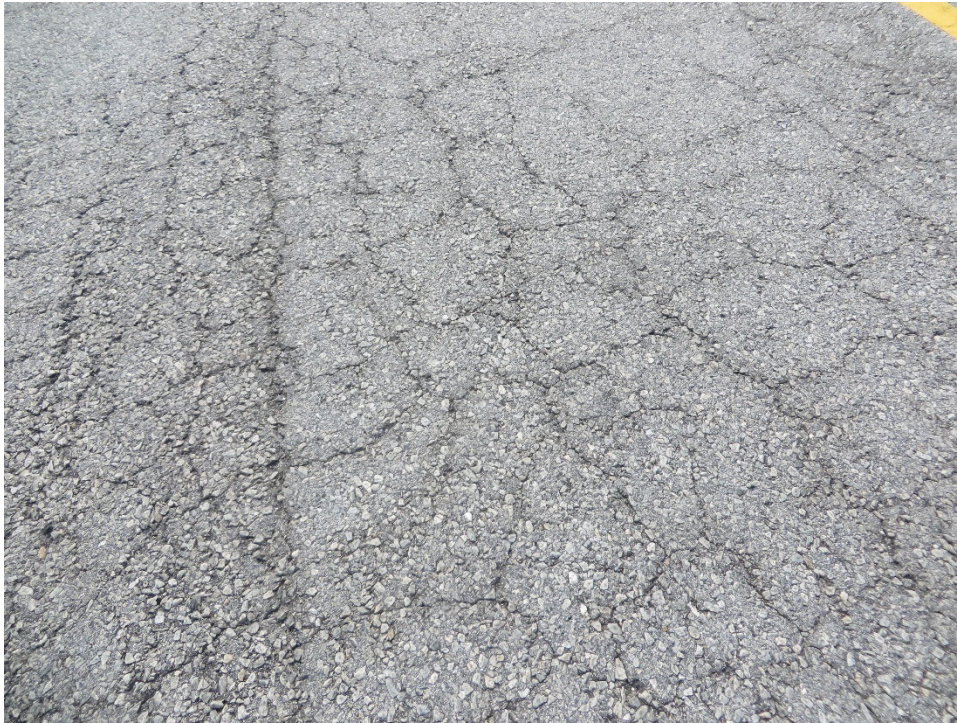
TDWI-20. Alligator Cracking (Sample Unit No. 01).

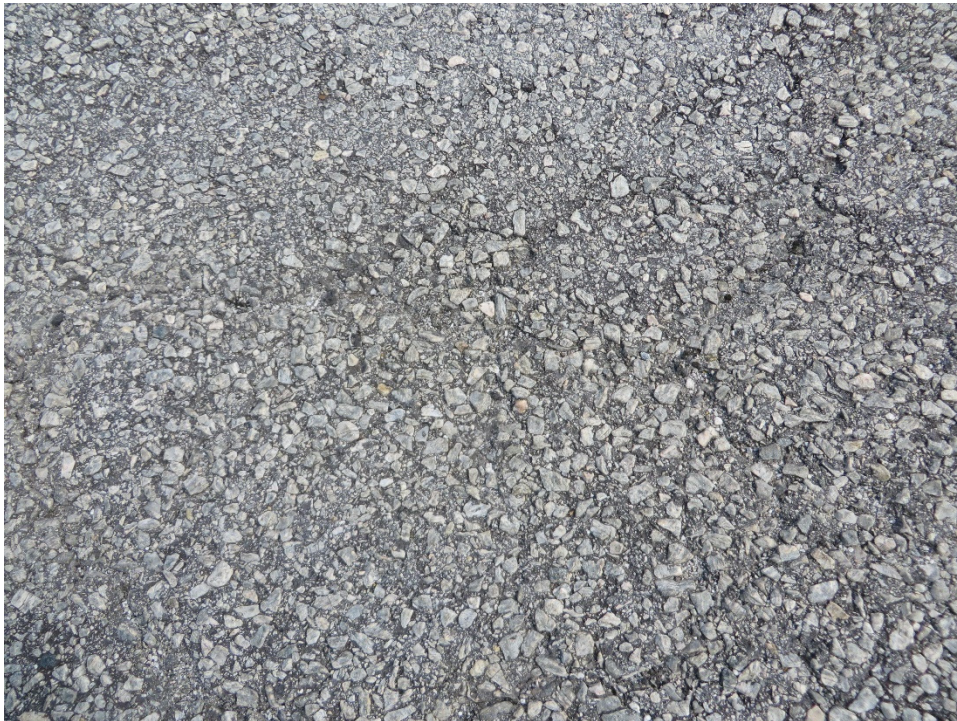
TDWI-20. Weathering (Sample Unit No. 01).

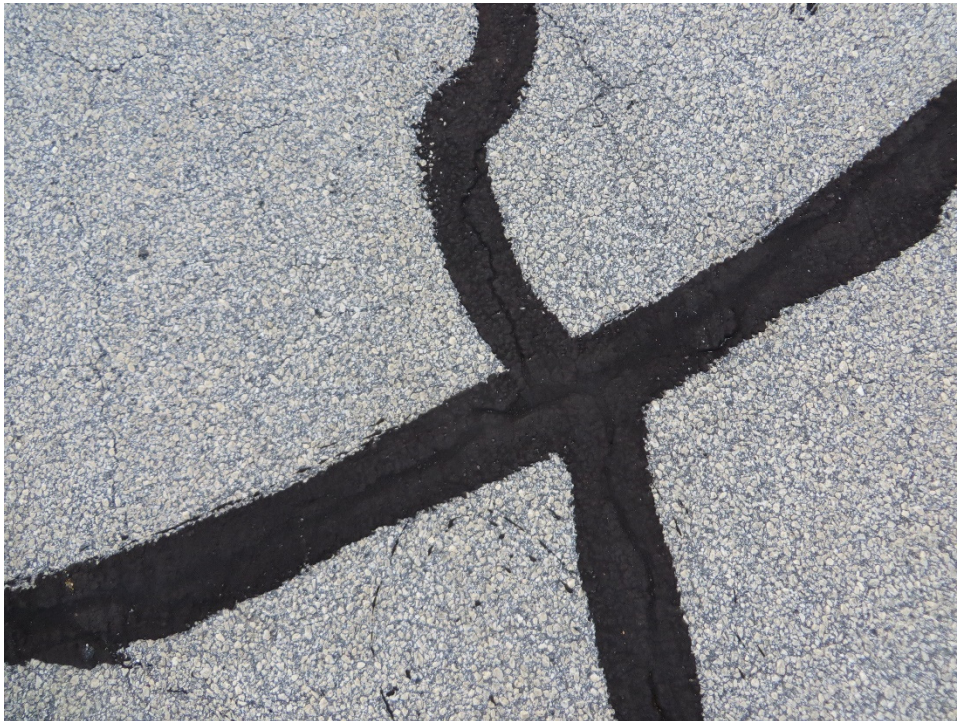
TDWI-30. L&T Cracking (Sample Unit No. 01).

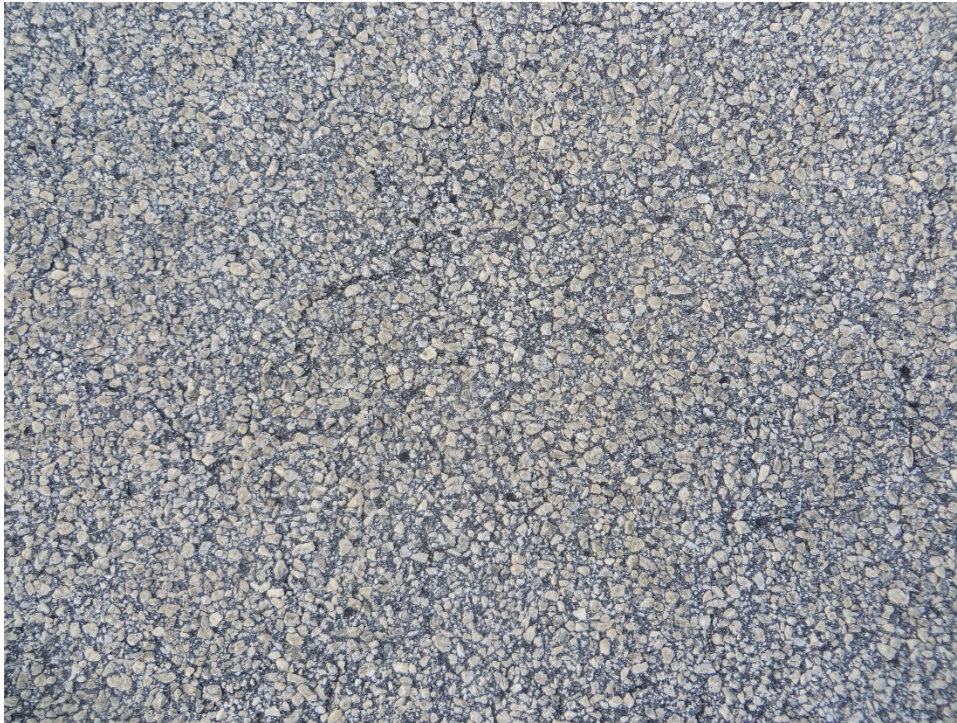
TDWI-30. Weathering (Sample Unit No. 01).

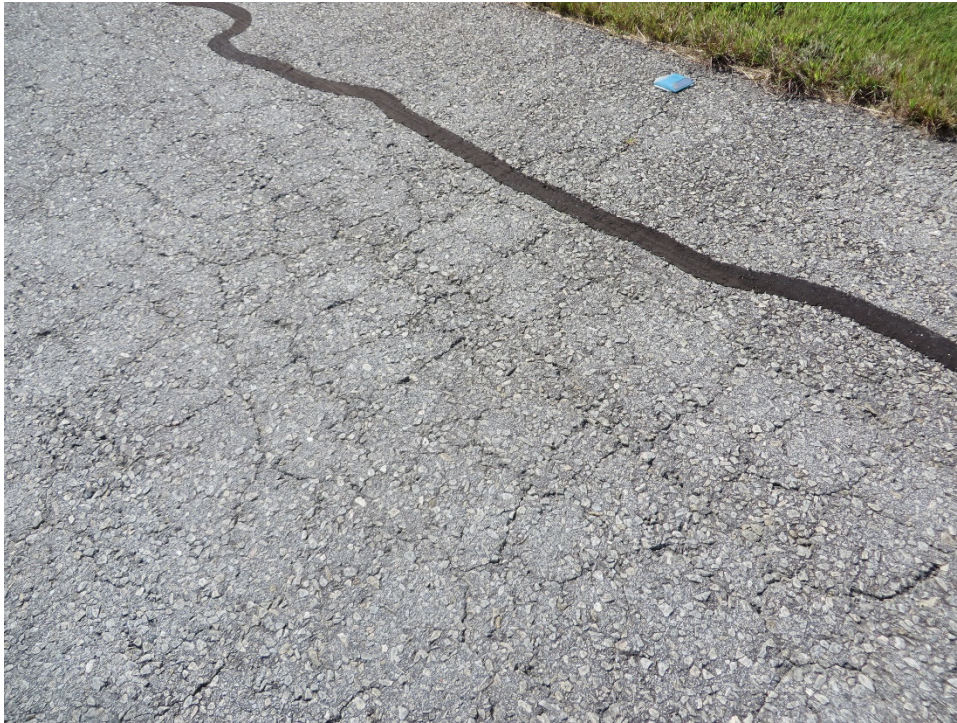
THANGWI-10. Alligator Cracking (Sample Unit No. 02).

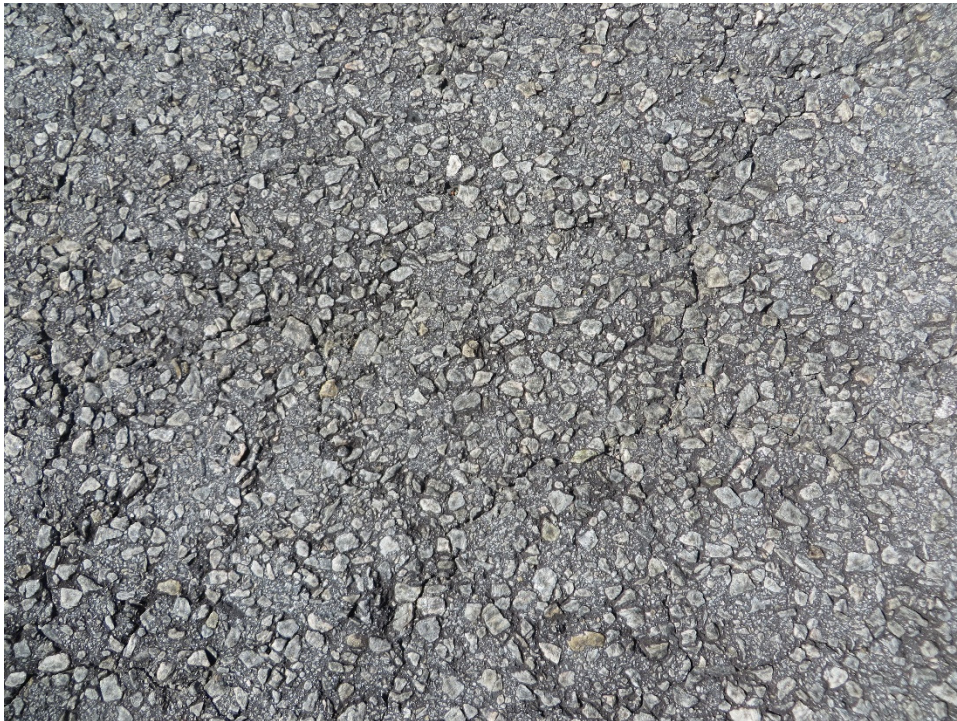
THANGWI-10. Weathering (Sample Unit No. 02).

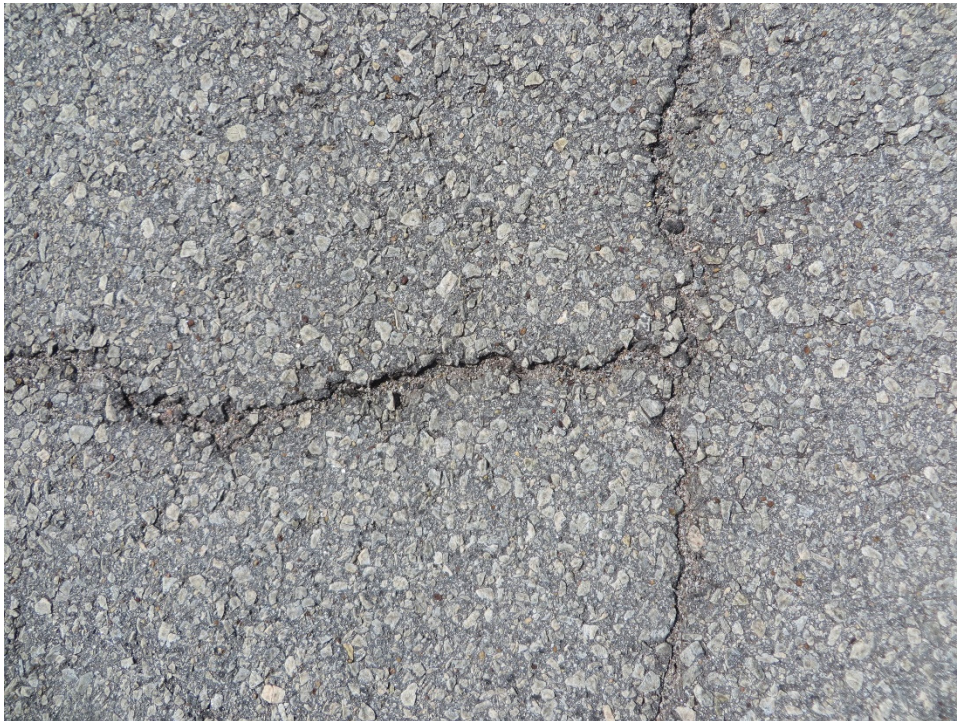
THANGWI-20. L&T Cracking (Sample Unit No. 17).

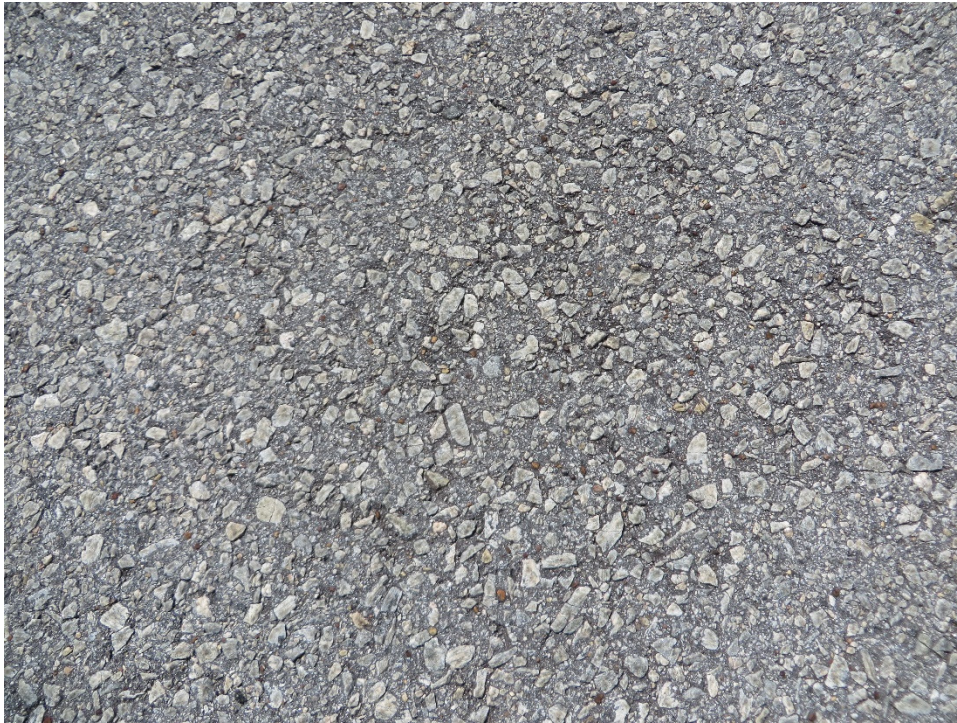
THANGWI-20. Weathering (Sample Unit No. 17).
