Report:

Barrow County Airport Pavement Management Plan

JULY 2019

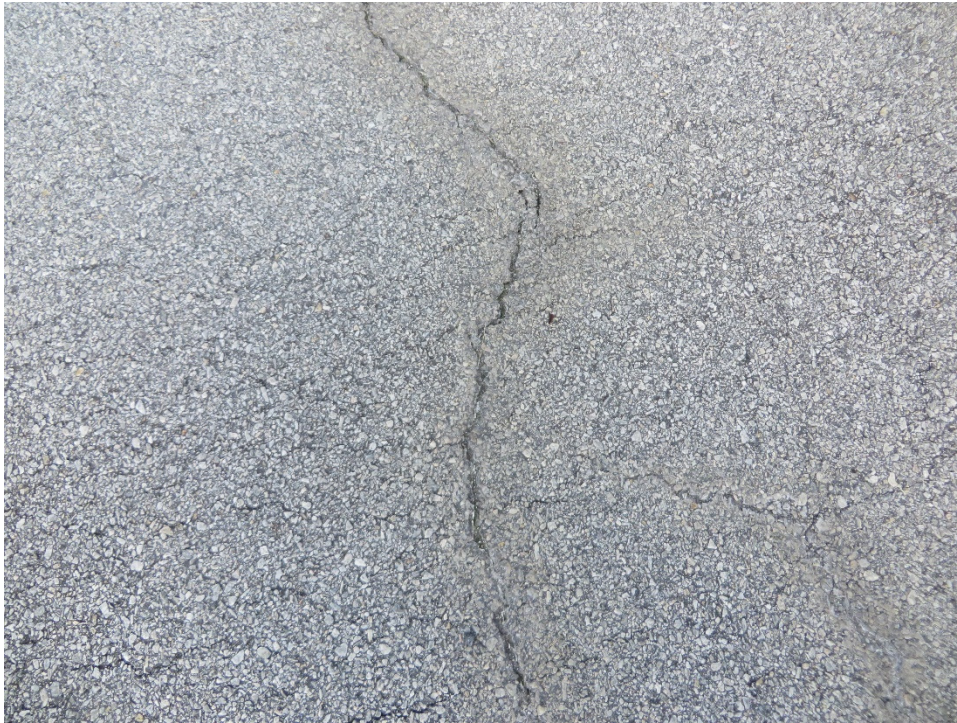
THANGWI-30. L&T Cracking (Sample Unit No. 02).

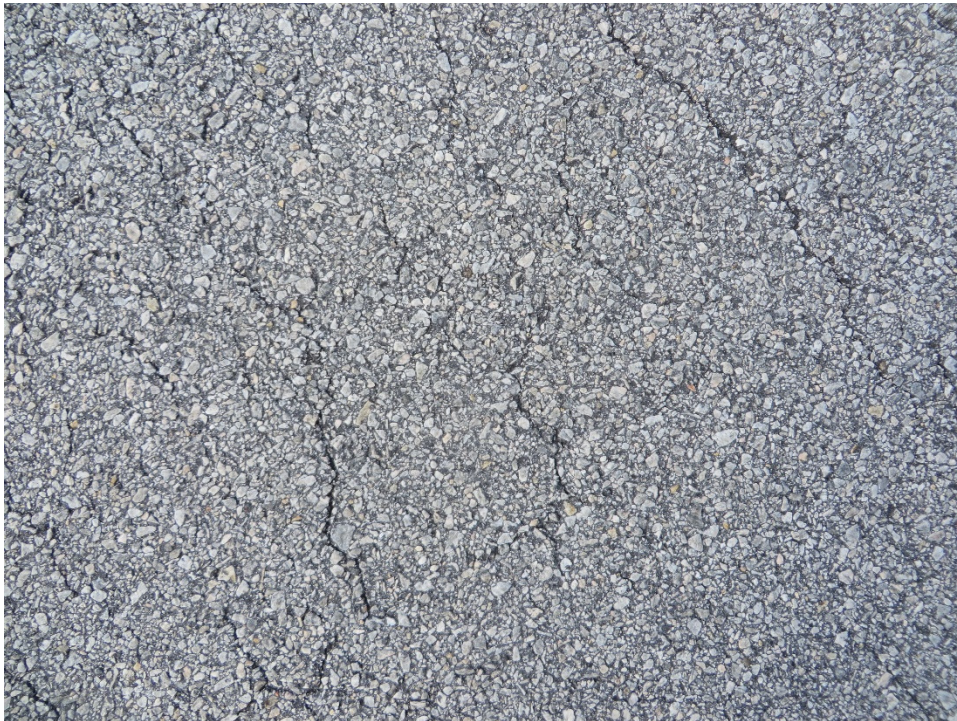
THANGWI-30. Weathering (Sample Unit No. 02).
