GEORGIA DOT RESEARCH PROJECT 2047 FINAL REPORT

**DEVELOPMENT OF AN AUTOMATED
PAVEMENT CRACK SEALING SYSTEM**

Contract Research
GDOT Research Project No. 2047
Final Report
DEVELOPMENT OF AN AUTOMATED PAVEMENT CRACK SEALING SYSTEM

December, 2010

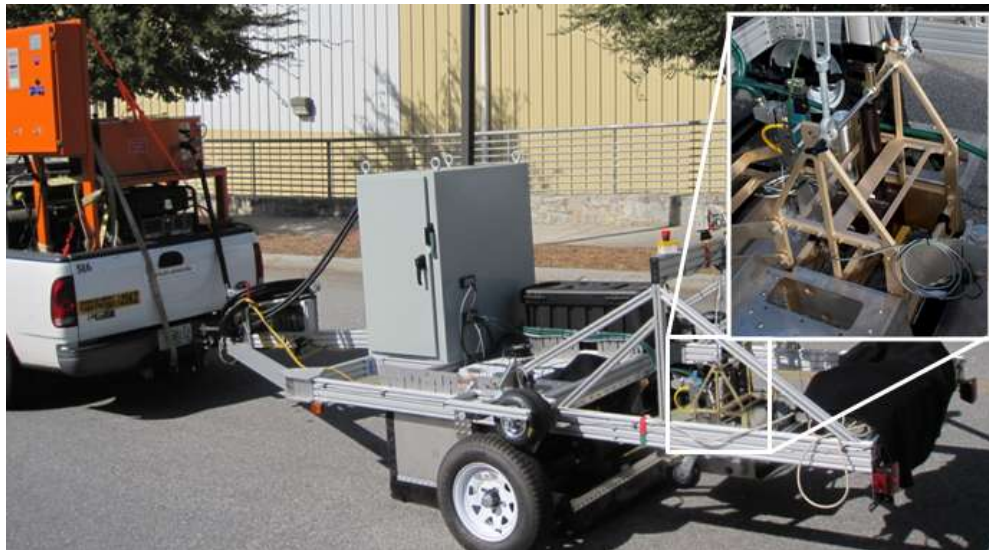
Figure 2. Prototype Crack Sealing Hardware with Detail of Applicators

The crack sealing system consisted of a number of components described in Section 1. The demonstration prototype used consisted of a tow vehicle pulling a custom trailer constructed from a T-slot aluminum framing system. The pickup bed had a large generator and a melter-pumping system installed, and a custom trailer housed all other components of the system. The entire system is shown in Figure 2 below. Each of the major subsystems is described in detail in the following subsections.

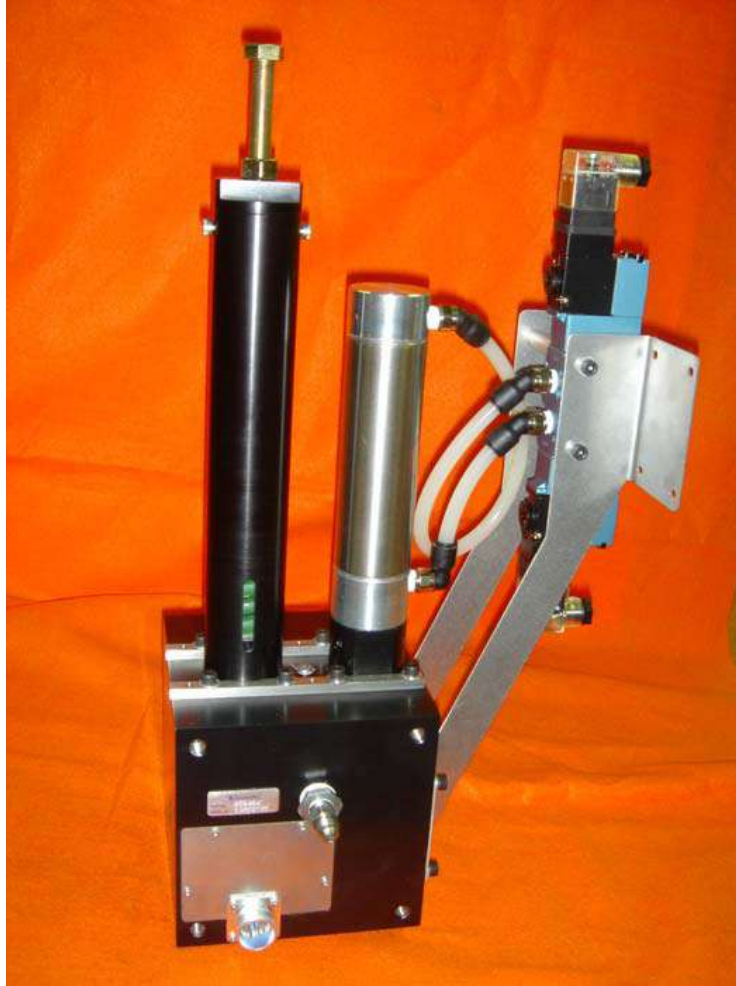
Figure 3. Single Sealant Applicator

The unit shown in the figure above was used as a basis for the snap open testing described in the Single Applicator Performance Testing section of this document. Observations from these tests led to decisions made about timing of shots in the initial parking lot tests. These initial tests also lead to modifications to reduce excess fluid from being fired in shots by reducing the volume of the crack sealant passage.

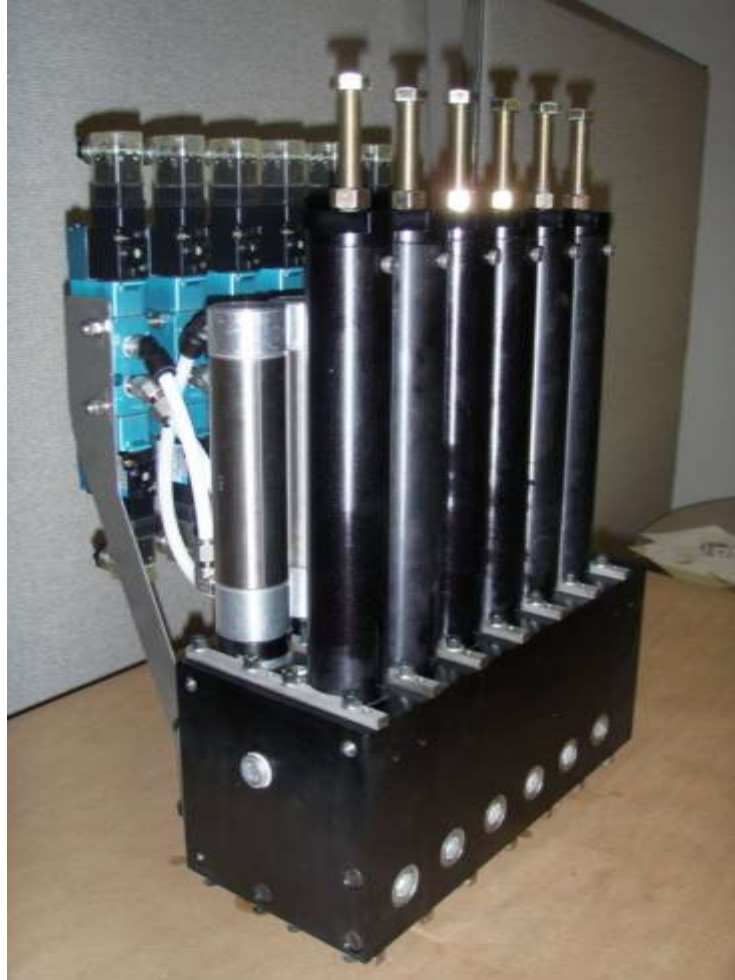
Figure 4. Applicator Manifold

passages, heater bores, RTD bore, electrical cavity, etc. were also moved to accommodate this change. Shop drawings were developed for the six-applicator manifold and for five other parts that were either new or different from the parts of the single-applicator module.

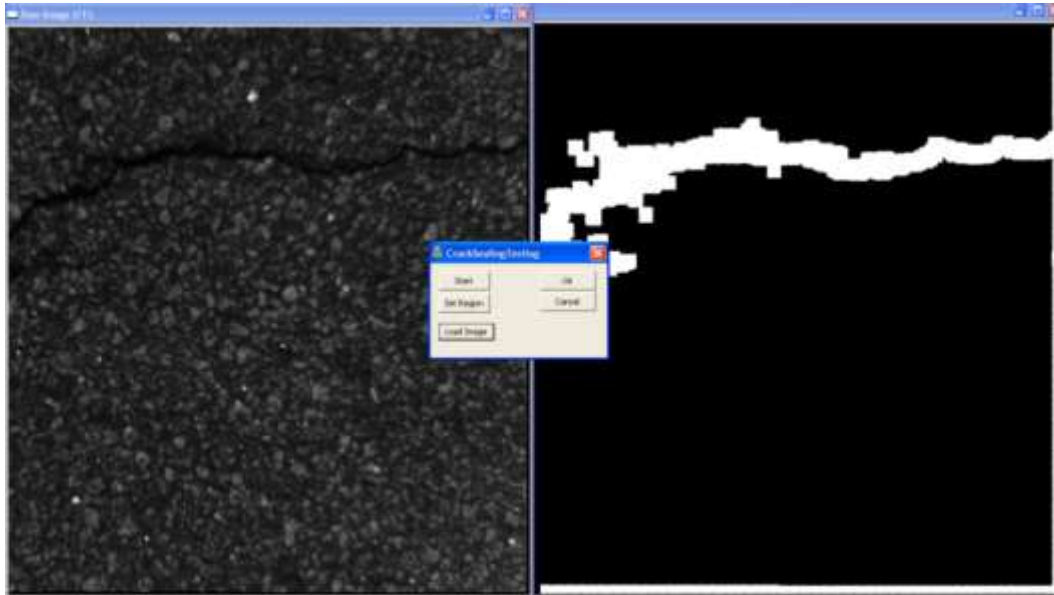
Figure 6. User Interface Screenshot

The vision processing sub-system is written entirely in Microsoft Visual C++. In addition to running the crack detection routines, this sub-system also provides a user interface for control and monitoring of the overall system during operation. The interface allows the user to start and stop the system, as well as view the images and crack maps as they are processed and generated. Figure 6 shows a screen capture of the interface.

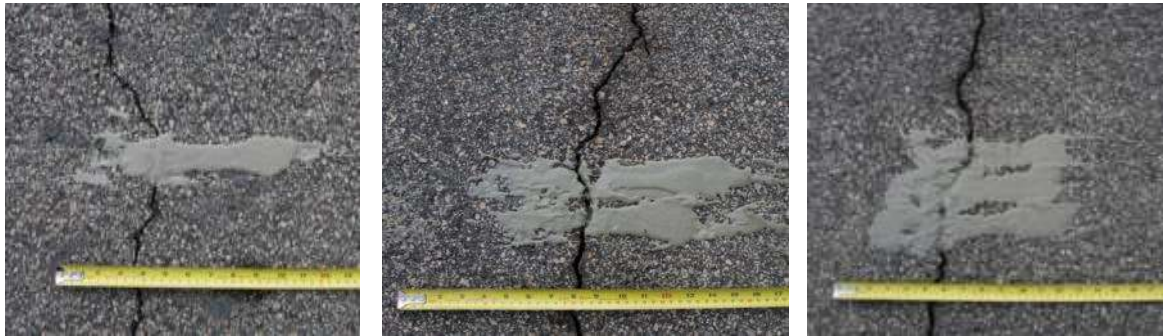
Figure 13. Examples of Sealant Dispensed In Pavement Crack From System Parking Lot Tests

Once the offsets and odometer wheel circumferences were corrected such that the Navigator was illuminating the LEDs as they passed over the cracks, the first system trial that included dispensing was conducted. The system was able to dispense material in pavement cracks in motion at around 2.8 mph. An example of the shots is shown in Figure 13.
