Durability of Precast Prestressed Concrete Piles in Marine Environment, Part 2 Volume 1: Concrete

Final Report

Office of Materials and Research
Georgia Department of Transportation

GDOT Research Project No. 10-26
Task Order No. 02-78

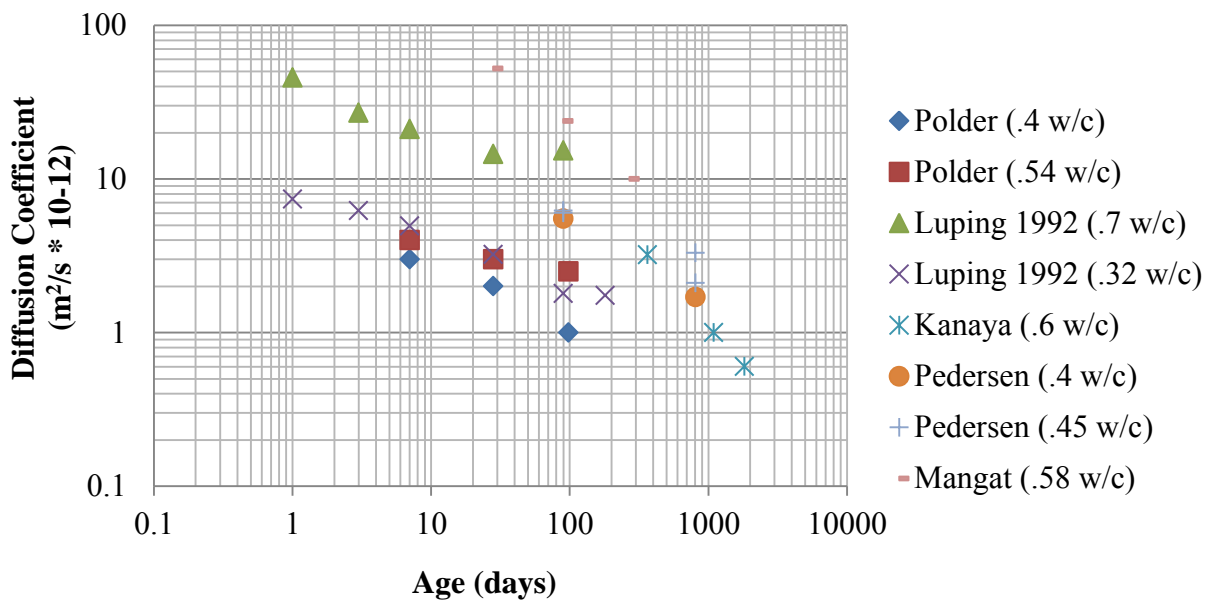
Figure 2.5: Effect of age of exposure on diffusion coefficient in plain portland cement concrete

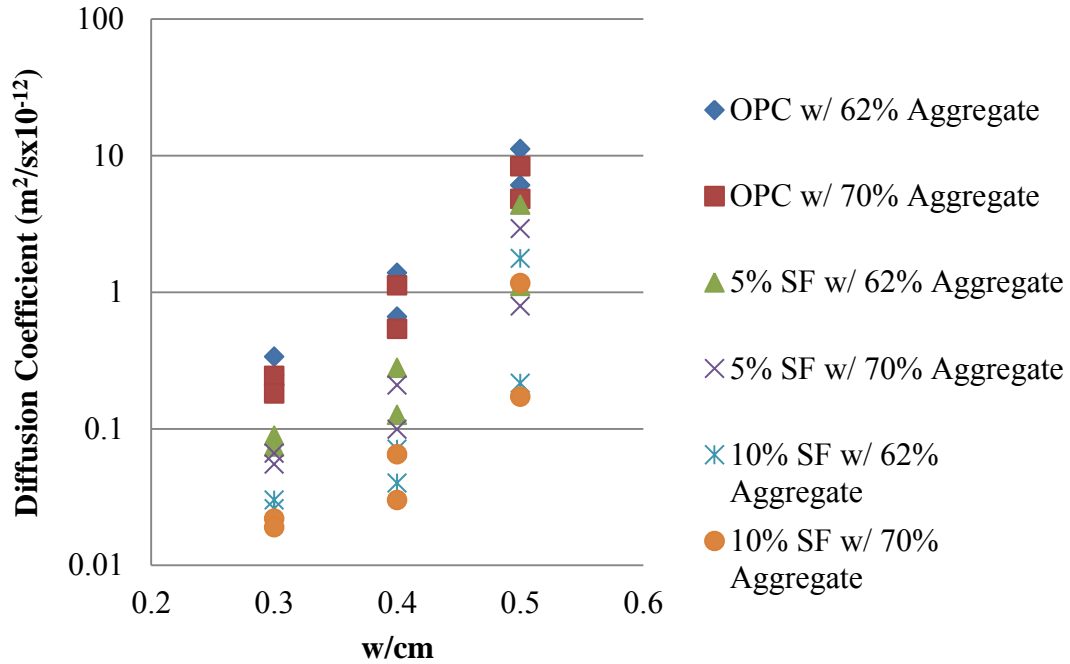
Figure 2.7: Effect of silica fume content on diffusion coefficient

Silica fume has been shown capable of decreasing the diffusion coefficient by orders of magnitude by Bentz (2000), Bleszynski, et al. (2002), Mangat and Molloy (1994), Papadakis (2000), Saleem, et al. (2010), Smith (2001), and Thomas, et al. (1999). Figure 2.7 shows the results of studies performed by Bentz (2000), where the decrease in diffusion coefficient is plotted for various replacement levels of silica fume. This result is in contradiction to the findings of Basheer, et al. (2002), who found that silica fume resulted in an approximately 30% decrease in the diffusion coefficient from a plain portland cement concrete.

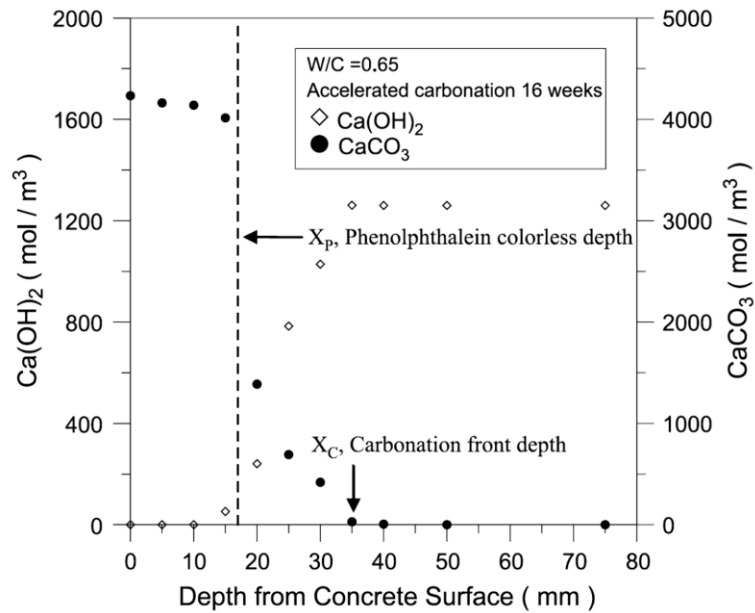
Figure 2.9: $\text{Ca}(\text{OH})_2$ concentration as an indicator of carbonation depth measured using thermogravimetric analysis (Chang and Chen, 2006)

the pH to approximately 8 to 9 (Broomfield, 2007). Once the pH drops to this range at the depth of reinforcing, carbonation induced corrosion will occur as the passive film on the surface of the steel becomes unstable (Broomfield, 2007). Figure 2.9 illustrates a typical distribution of pH with carbonation depth.

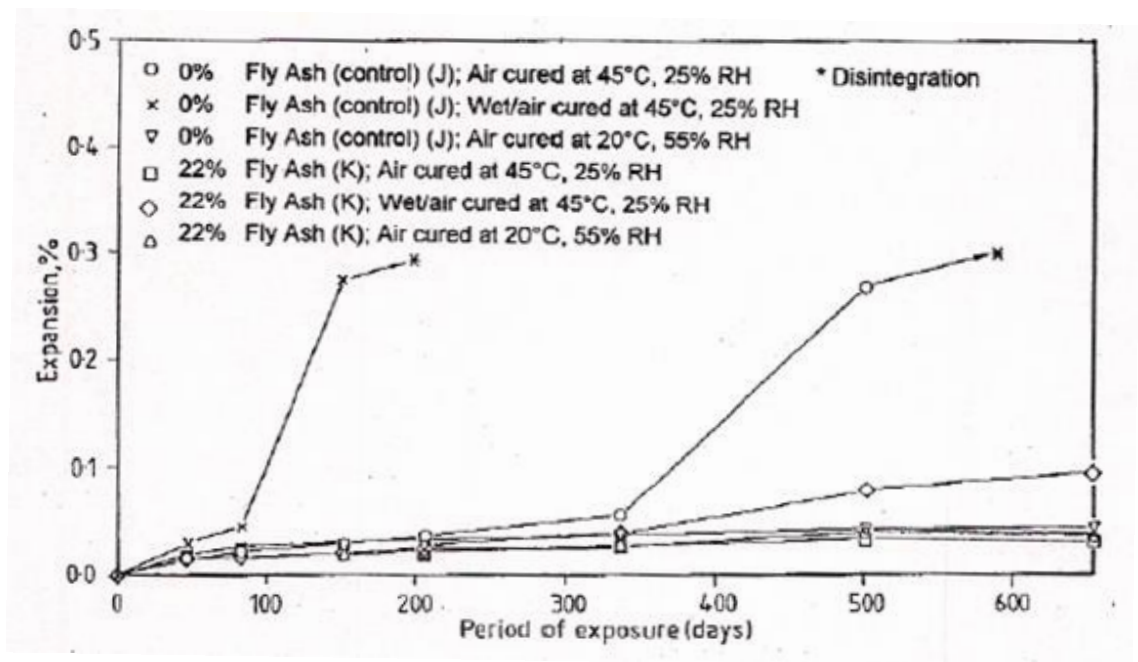
Figure 2.13: Expansion results for cements replaced with fly ash (Mangat and Khatib, 1995)

The research of Mangat and El-Khatib (1995) demonstrated similar findings, and that replacement levels of 0% and 22% with a low CaO fly ash led to dramatic improvement in sulfate resistance, as shown in Figure 2.13. It was found that an 11% replacement level had deleterious effects to the sulfate resistance. Monteiro and Kurtis (2003) demonstrated similarly that replacement levels between 25% and 45% with a low CaO fly ash led to improved sulfate resistance.

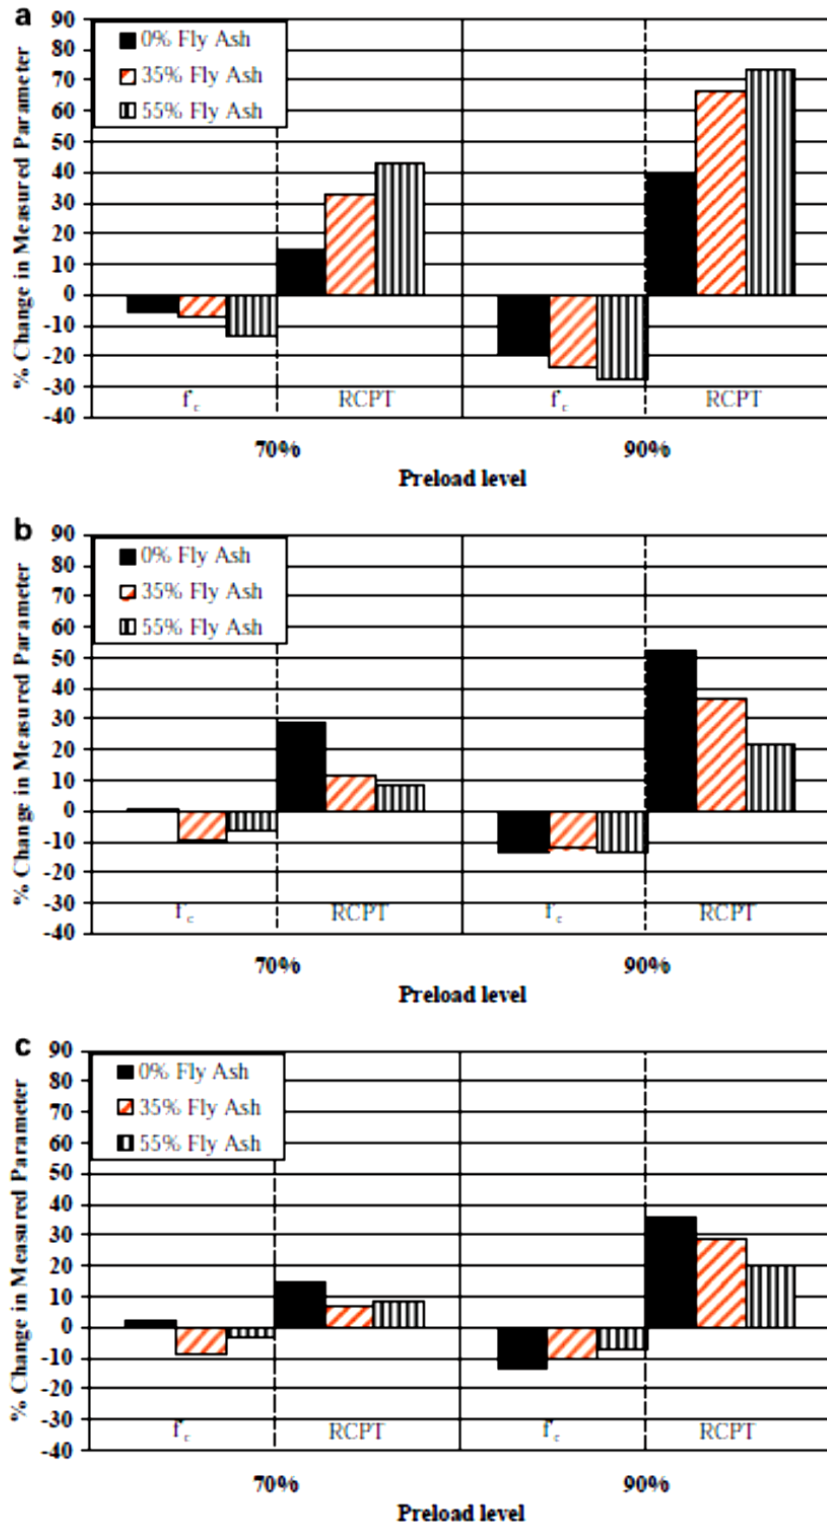
Figure 2.23: Effect of self-healing on RCPT samples before (a) no healing, (b) 15 days of healing, and (c) 30 days of healing (Sahmaran, et al., 2008)

Sahmaran, et al. (2008) studied the behavior of high volume fly ash self-consolidating concrete (SCC) subjected to microcracking from compressive loading. Cylinder samples were loaded to 70% and 90% of the max compression stress, then soaked in water for up to 30 days; then the rapid chloride permeability and compressive strength were measured for samples containing 0, 35, and 55% cement replacement with a low CaO fly ash. The results of the study are shown in Figure 2.23. It was found that fly ash samples recovered significantly more of the chloride resistance after 15 and 30 days of healing than plain portland cement concrete samples. It was proposed that the cause of this was that the high volume replacement with fly ash led to unhydrated fly ash being available along the crack surface for self-healing and the formation of secondary C-S-H across the crack.

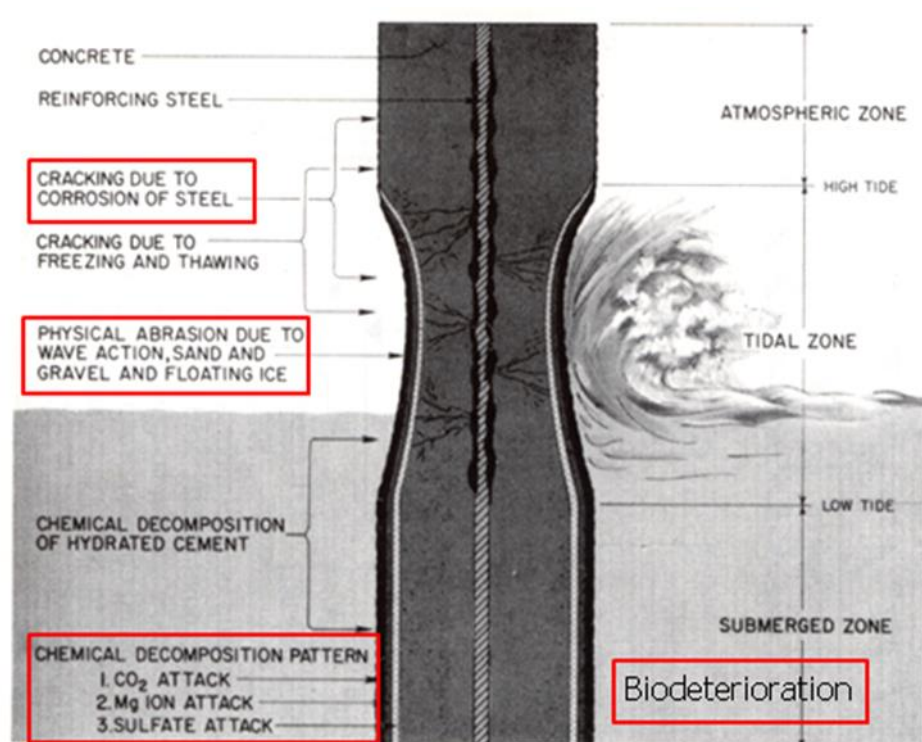
Figure 3.1: Typical degradation mechanisms in coastal concrete piling (Mehta, 1991)

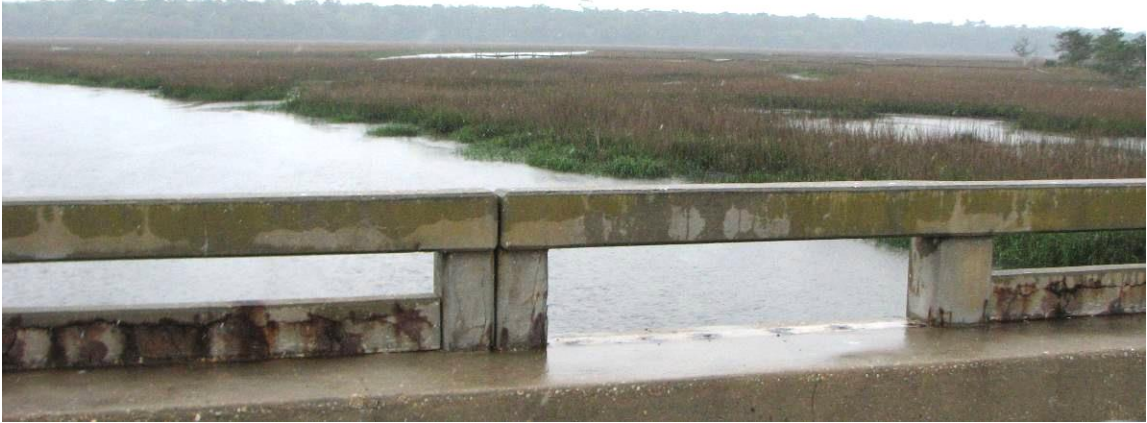
Figure A.3: Corrosion Damage in Cast-in-Place Barrier of Harriett's Bluff Road at Deep Creek Bridge (Bridge No. 039-0049)

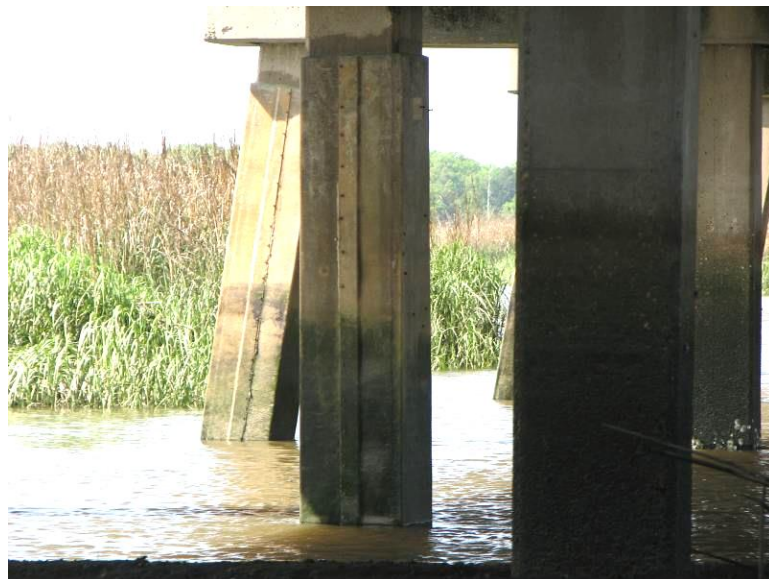
Figure A.9: Corrosion Damaged Piling with FRP Jacket Retrofit on US 17 at Back River
Bridge (Bridge No. 051-0059)

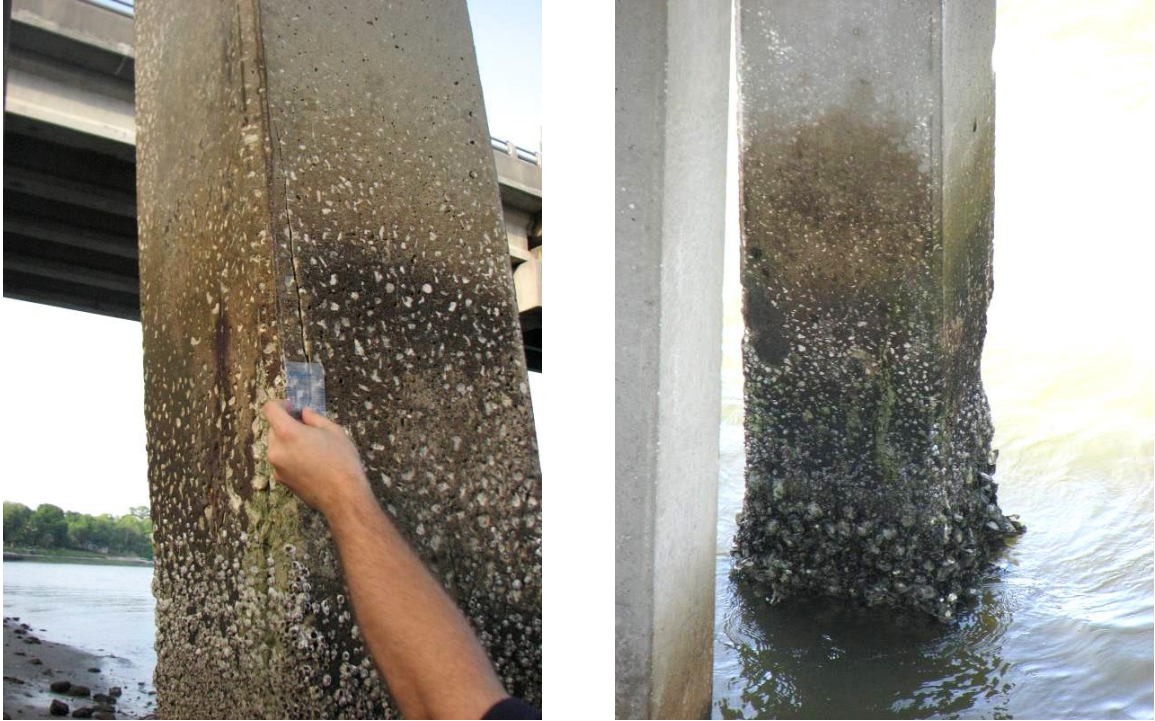
Figure A.15: Severe Damage to Concrete Piling on Island Expressway at Wilmington River Bridge (Bridge No. 051-0132)

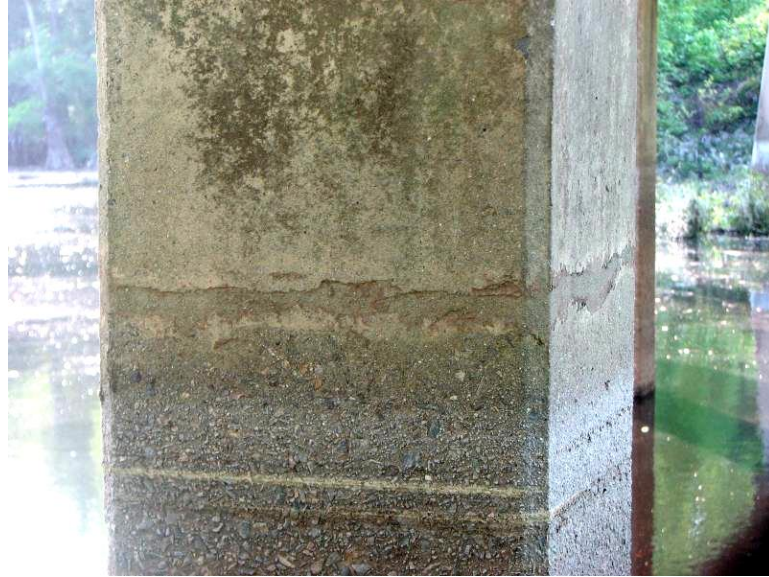
Figure A.19: Grout Repair of Transverse Cracking Likely Caused by Overdriving on Long Bridge Road at Ebenezer Creek Bridge (Bridge No. 103-0030)

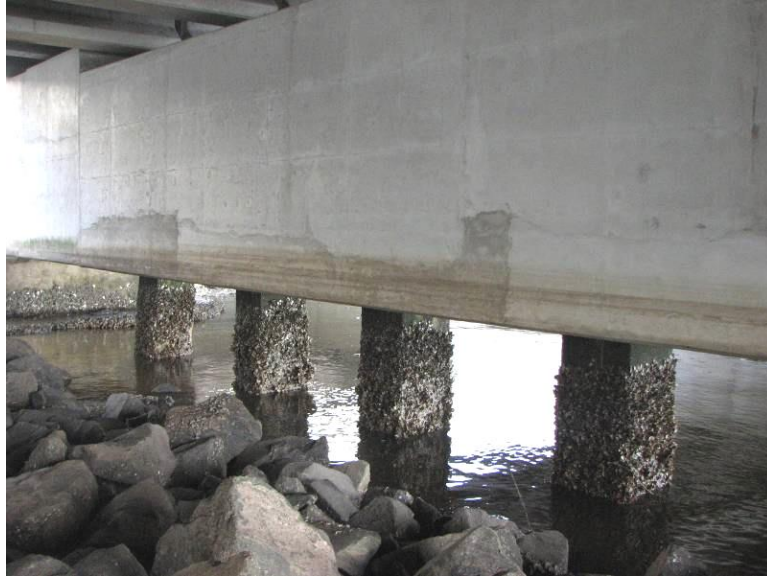
Figure A.22: Transfer Beam with Original Piles Left In-Place on I-95 at Turtle River Bridge (Bridge No. 127-0052)

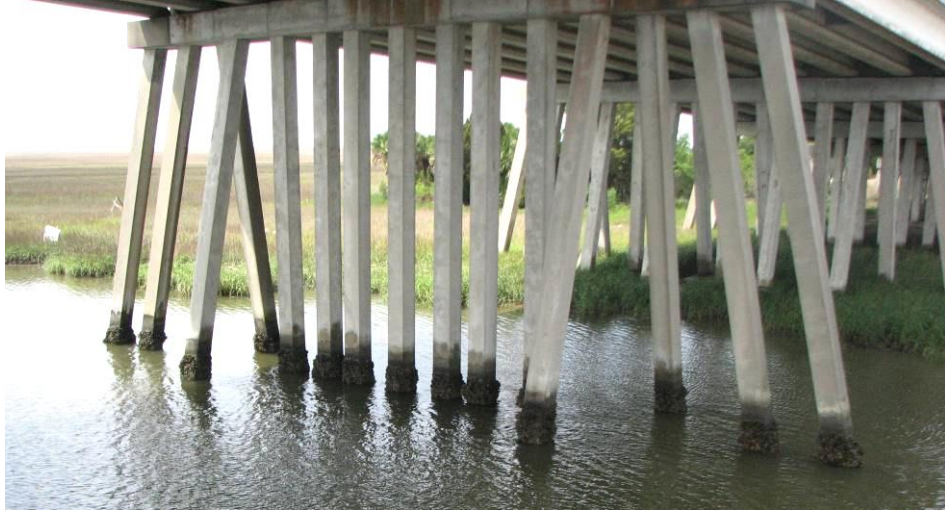
Figure A.24: Pile-Bent on Torras Causeway at Little River Bridge (Bridge No. 127-0063)

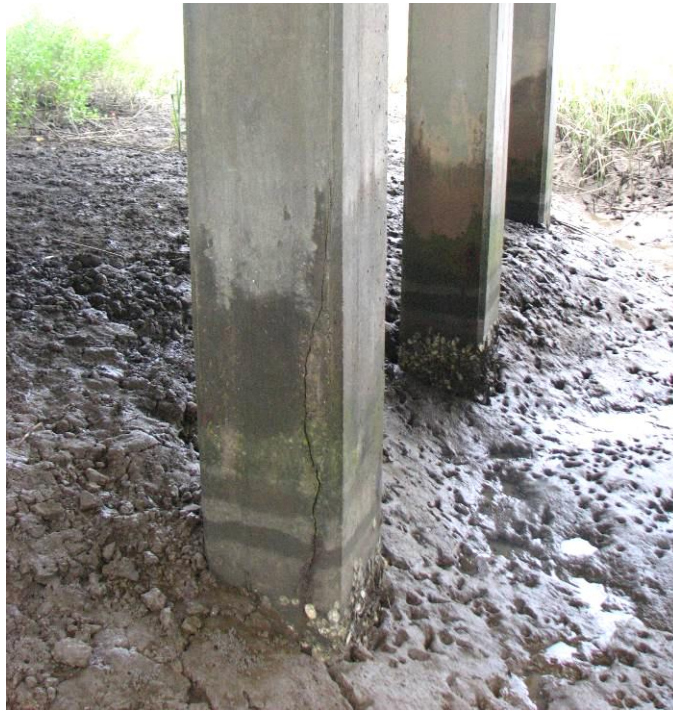
Figure A.25: Corrosion Damage in Original Torras Causeway at Little River Bridge

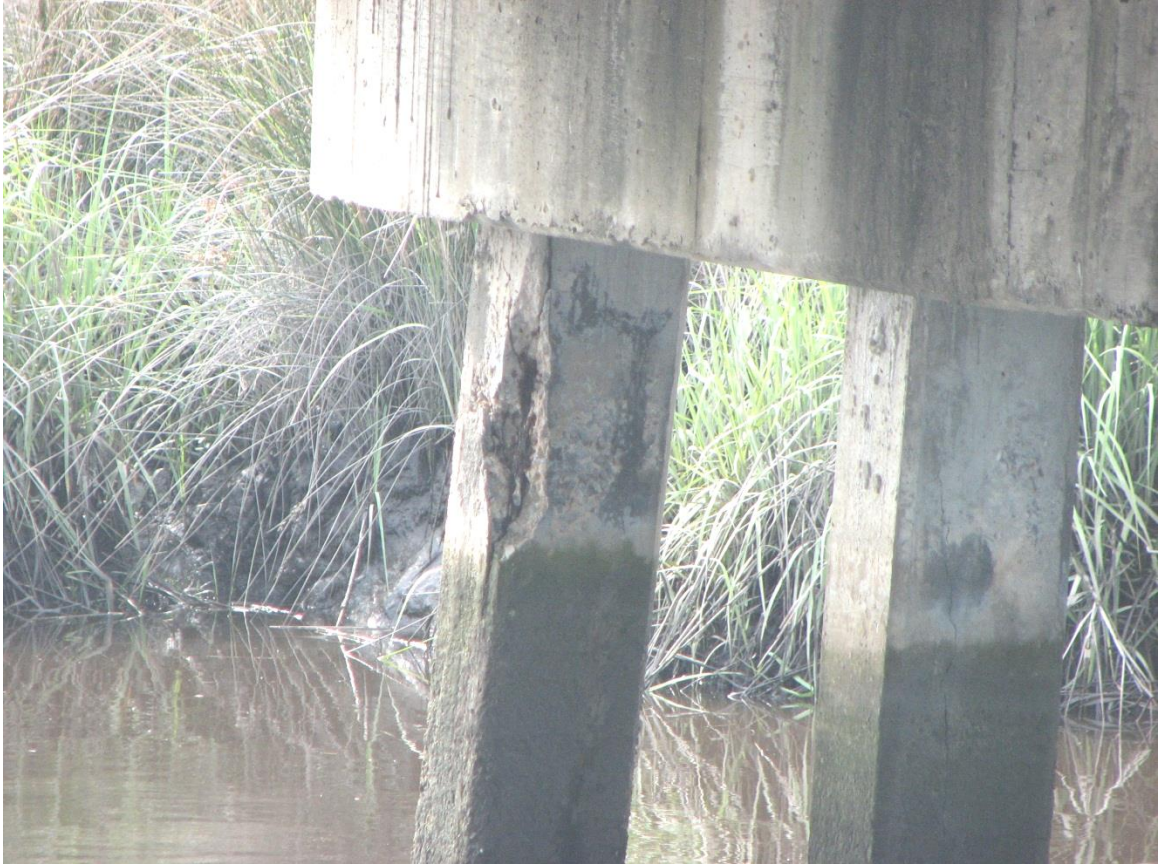
Figure A.27: Deterioration of Precast Concrete Piles in Substructure of Ocean Highway at Riceboro Creek Bridge (Bridge No. 179-0005)

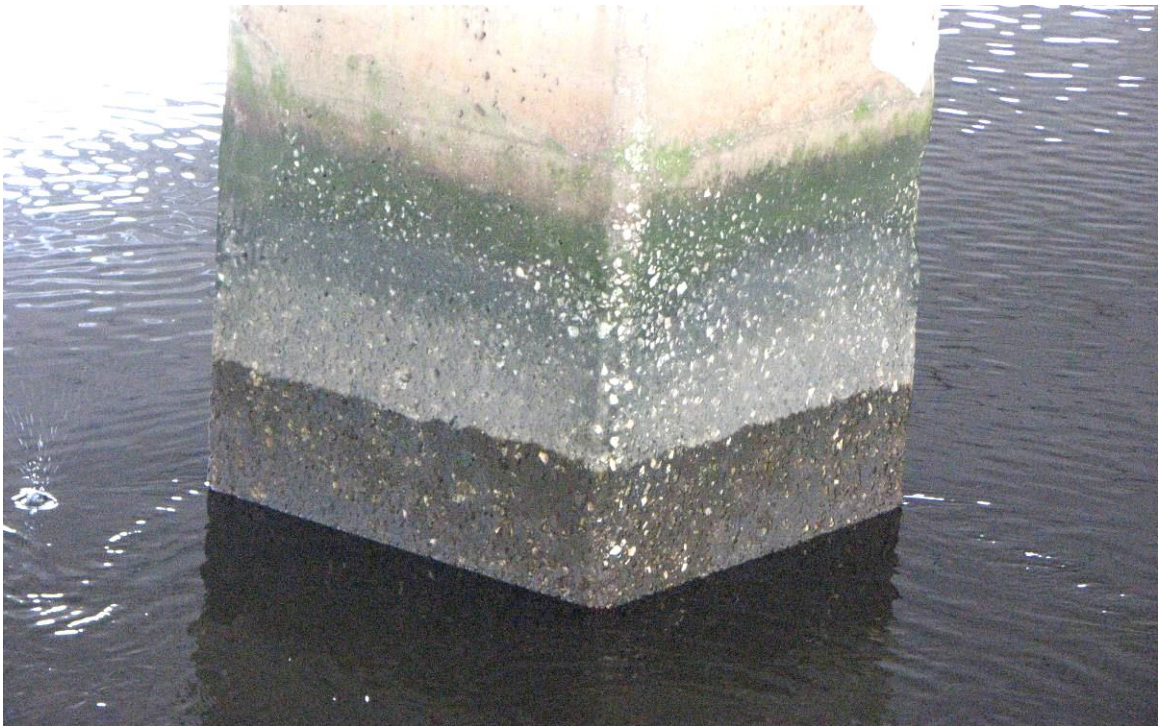
Figure A.30: Typical Surface Abrasion of Concrete on Ocean Highway at Champney's River Bridge (Bridge No. 191-0005)

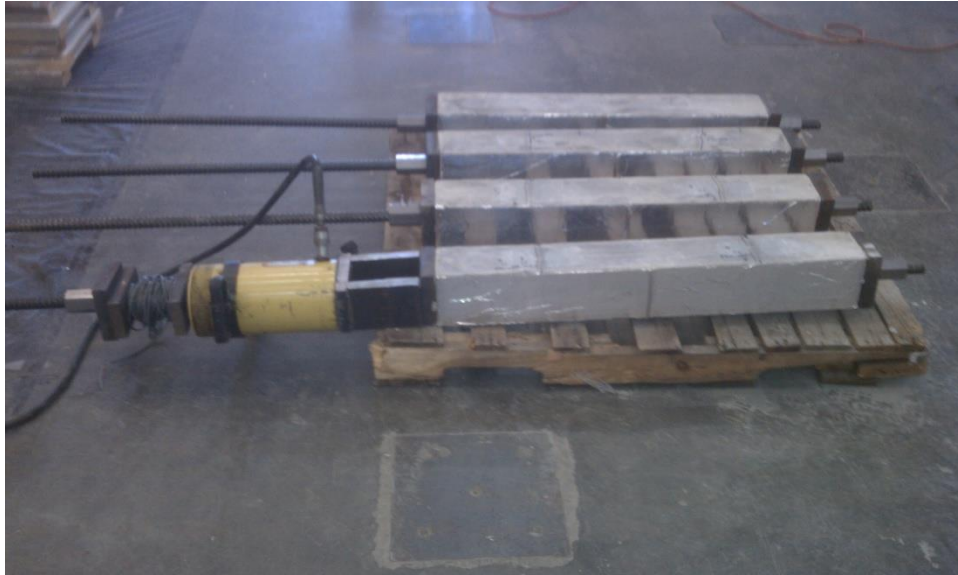
Figure F.1: Post-tensioning of specimens

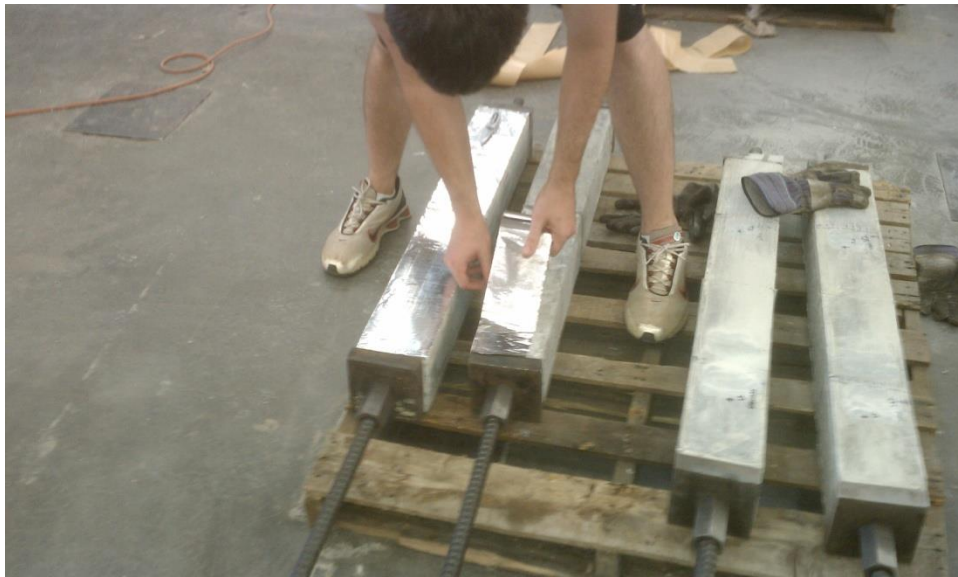
Figure F.4: Graduate student sealing the sides of specimens with aluminum tape

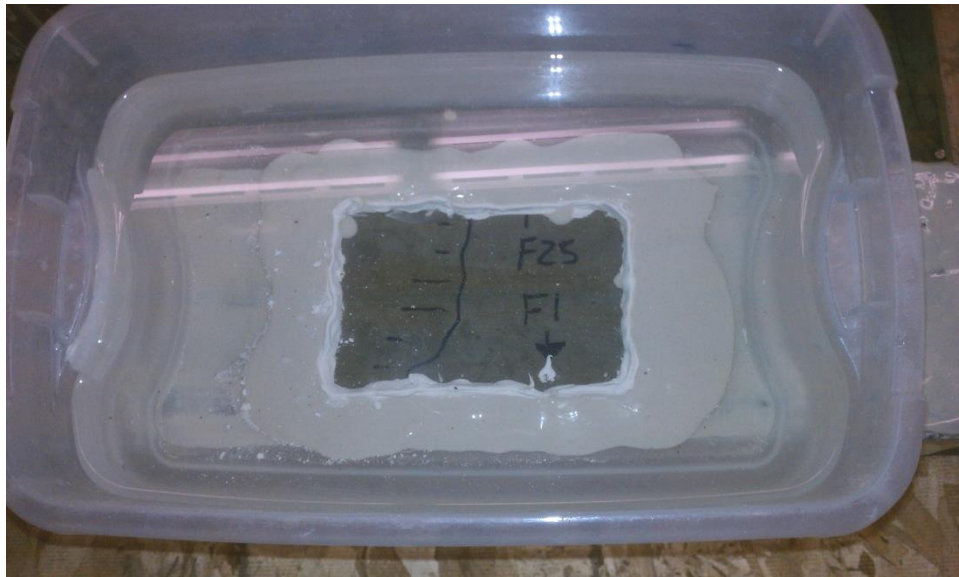
Figure F.6: Exposure surface inside of ponding container with simulated seawater solution
