Martha L. Teall

Edwards-Pitman Environmental, Inc.

HISTORIC FARMS IN PAULDING COUNTY: AN AGRICULTURAL CONTEXT SURVEY

Occasional Papers in Cultural Resource Management #18

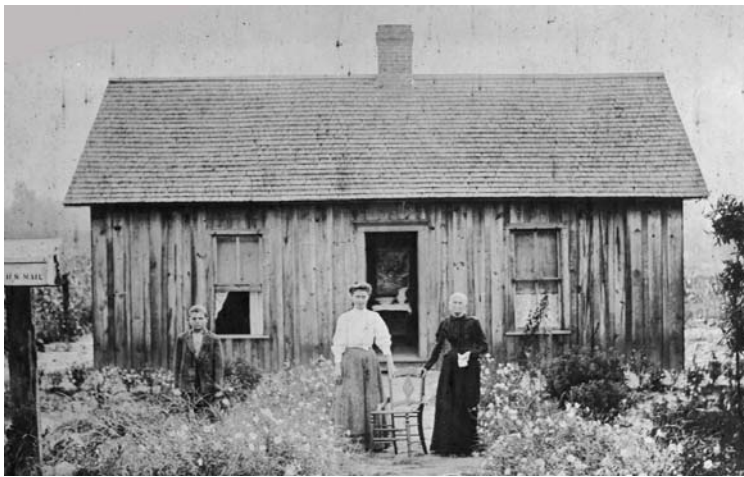
A Saddlebag farmhouse was comprised of two rooms of unequal size, with a central chimney, c. 1910.

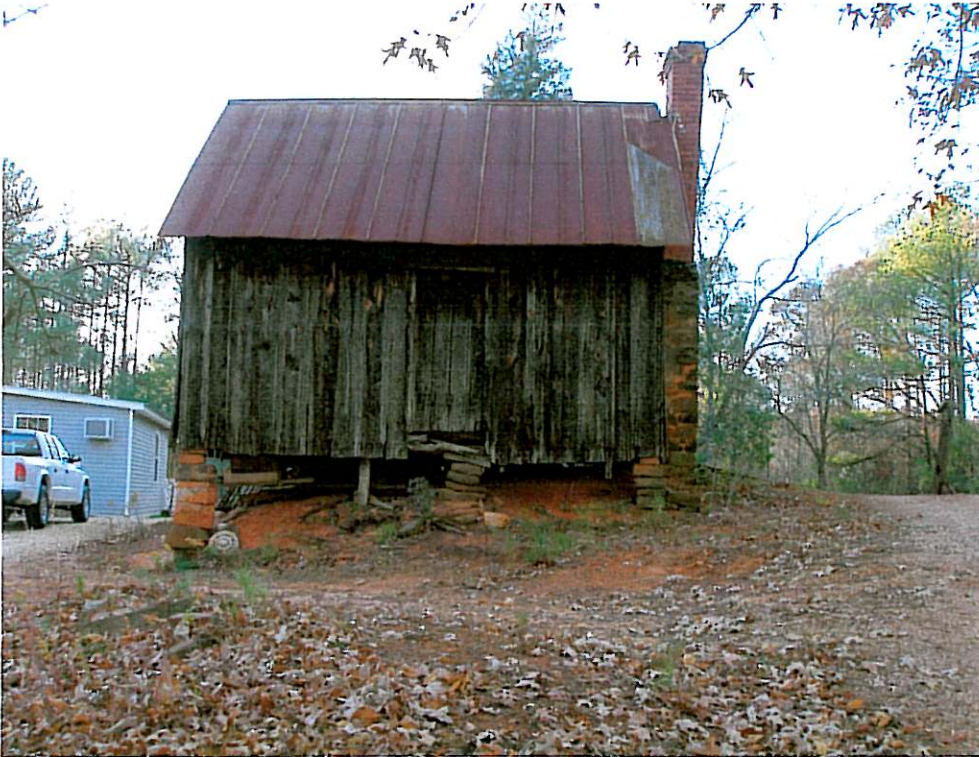
One of the oldest houses in Paulding County dates to c. 1870. The dwelling on the left is a frame Single Pen or one-room house (seen at left) on Bill Carruth Highway. Additions have been made on the rear elevation.

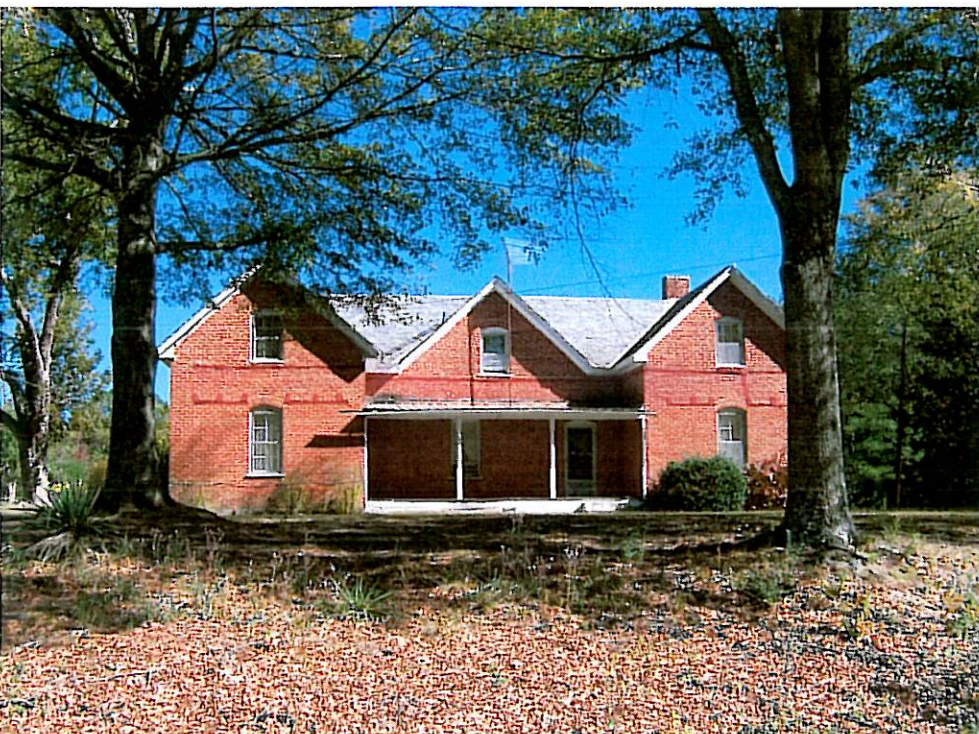
Another early and unique farm house on New Vinson Mountain Road also dates to c. 1870 and is significant for its handmade brick.

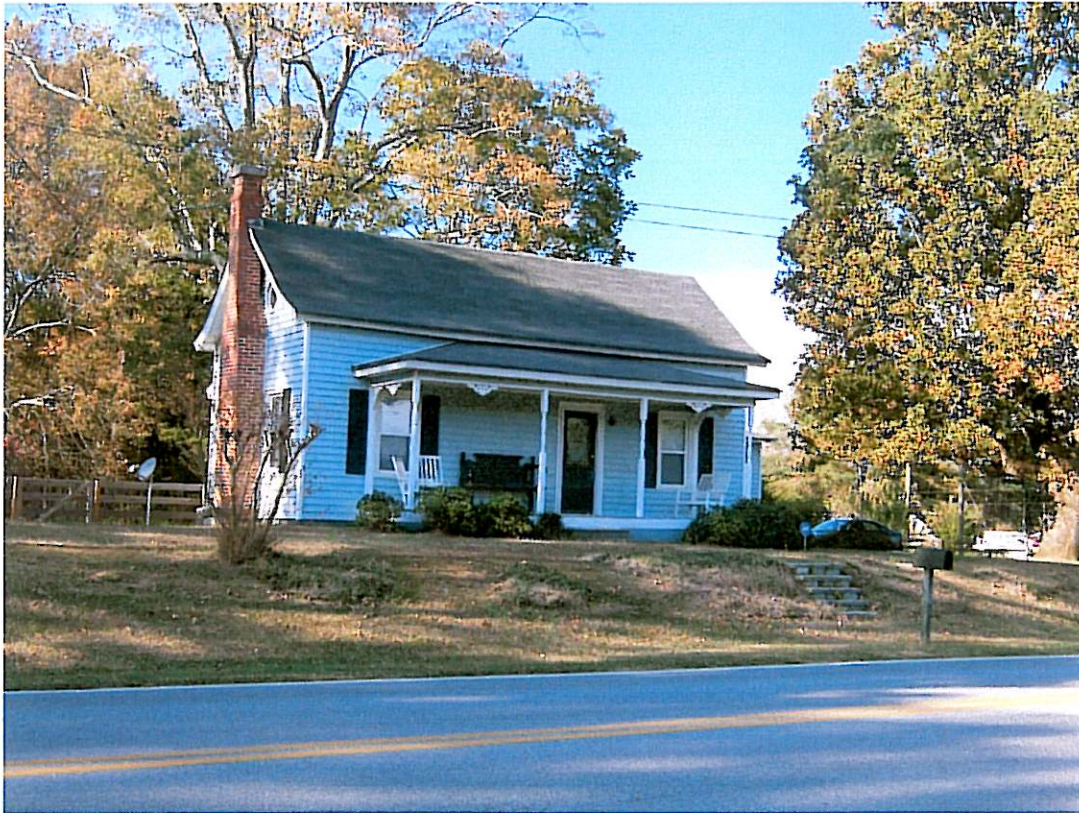
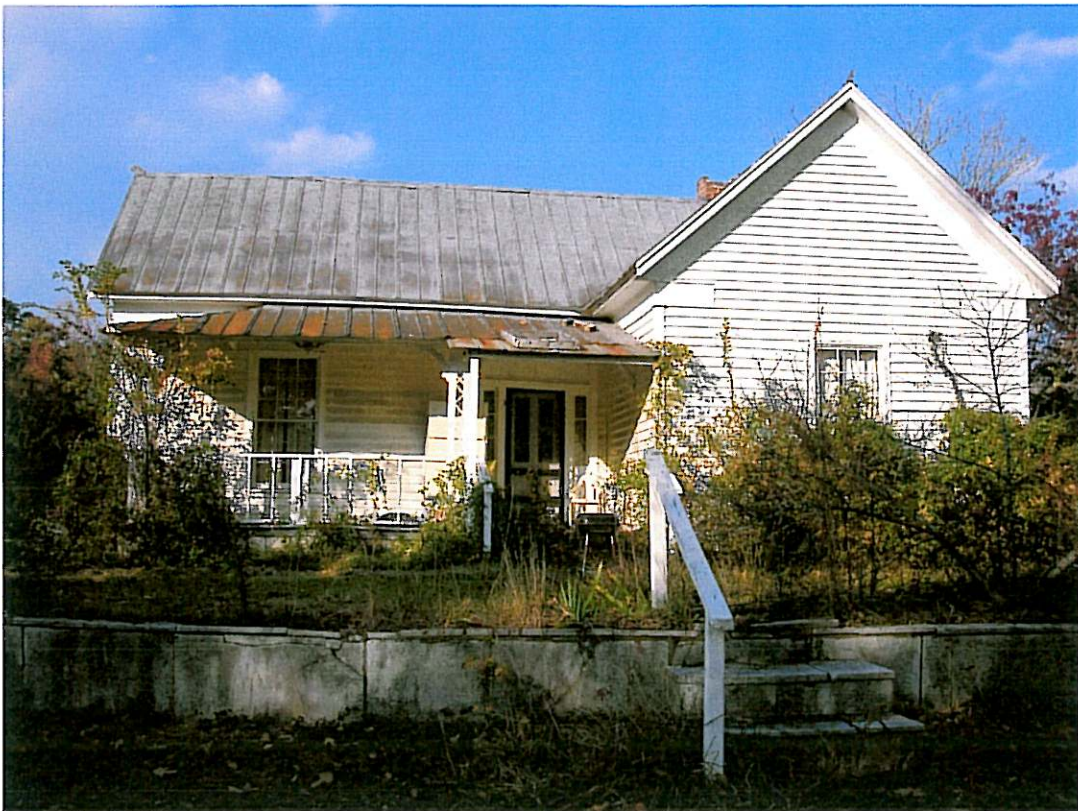
*The 1886 Hall-Parlor house above on Marshall Fuller Road was enlarged with an original rear ell.
Below is a Gabled-Wing Cottage on North Flat Rock Road, from c. 1920.*

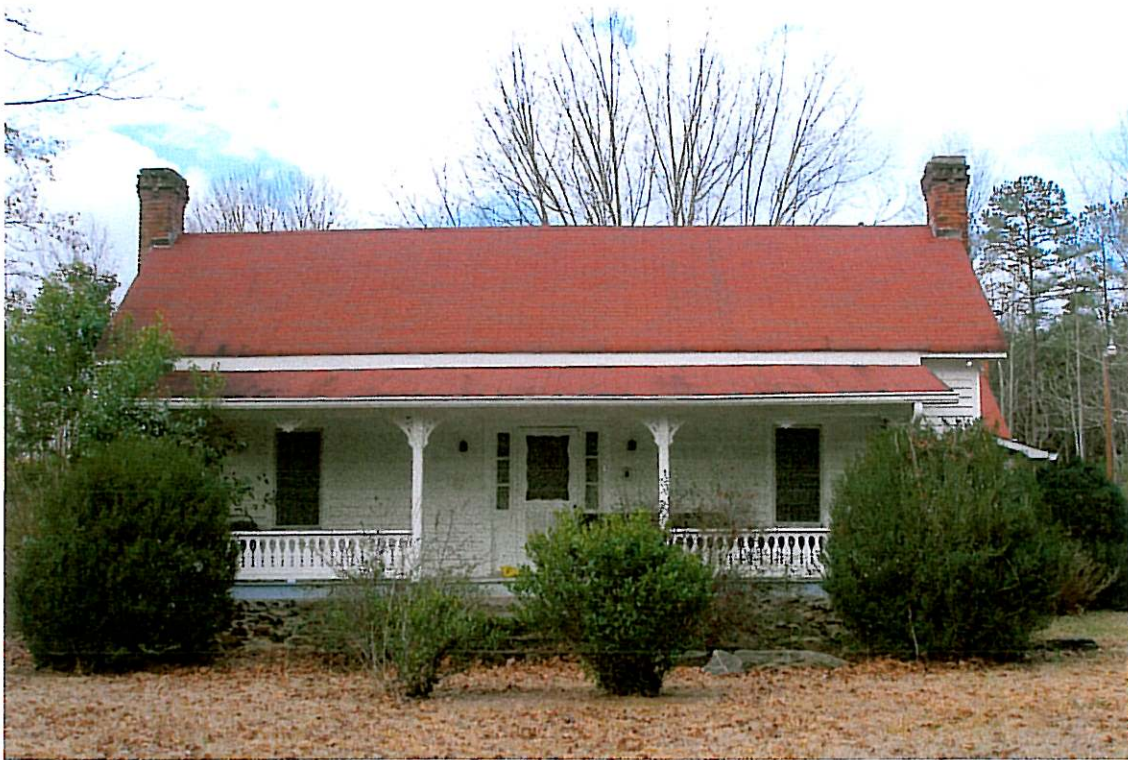
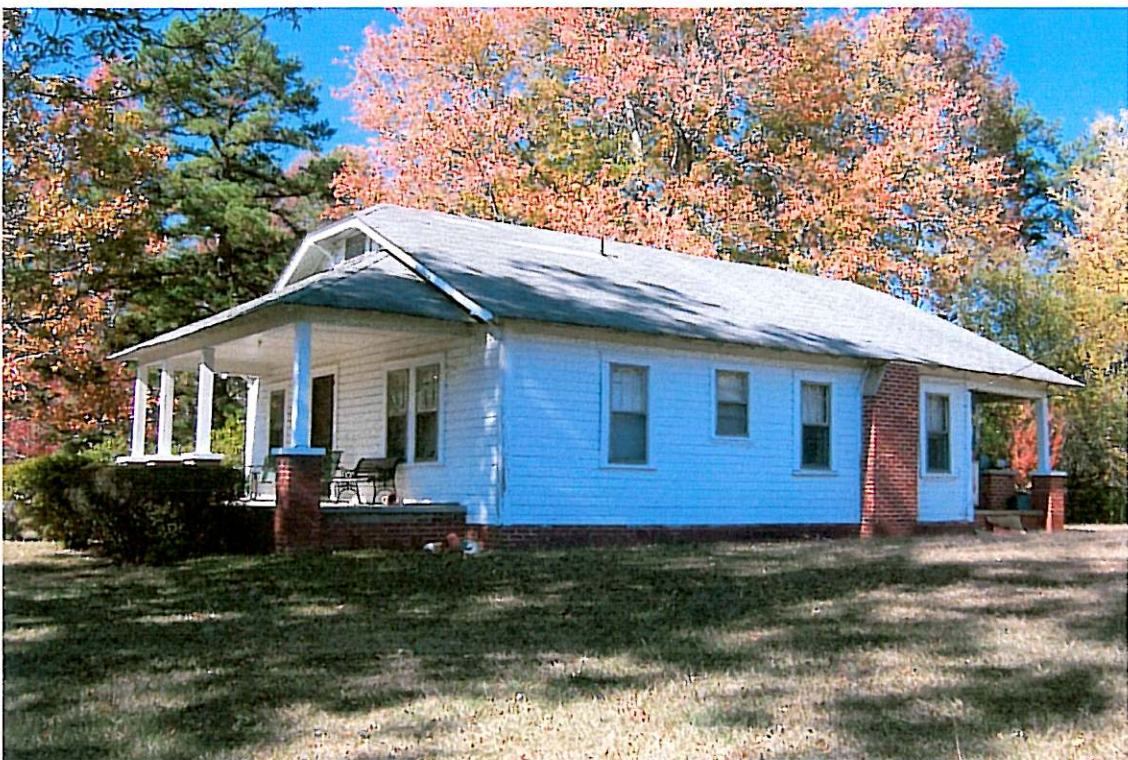
*A Central Hallway with two gable-end chimneys, 1881, above,
and a long and low Front-Gabled Bungalow, 1936, below.*

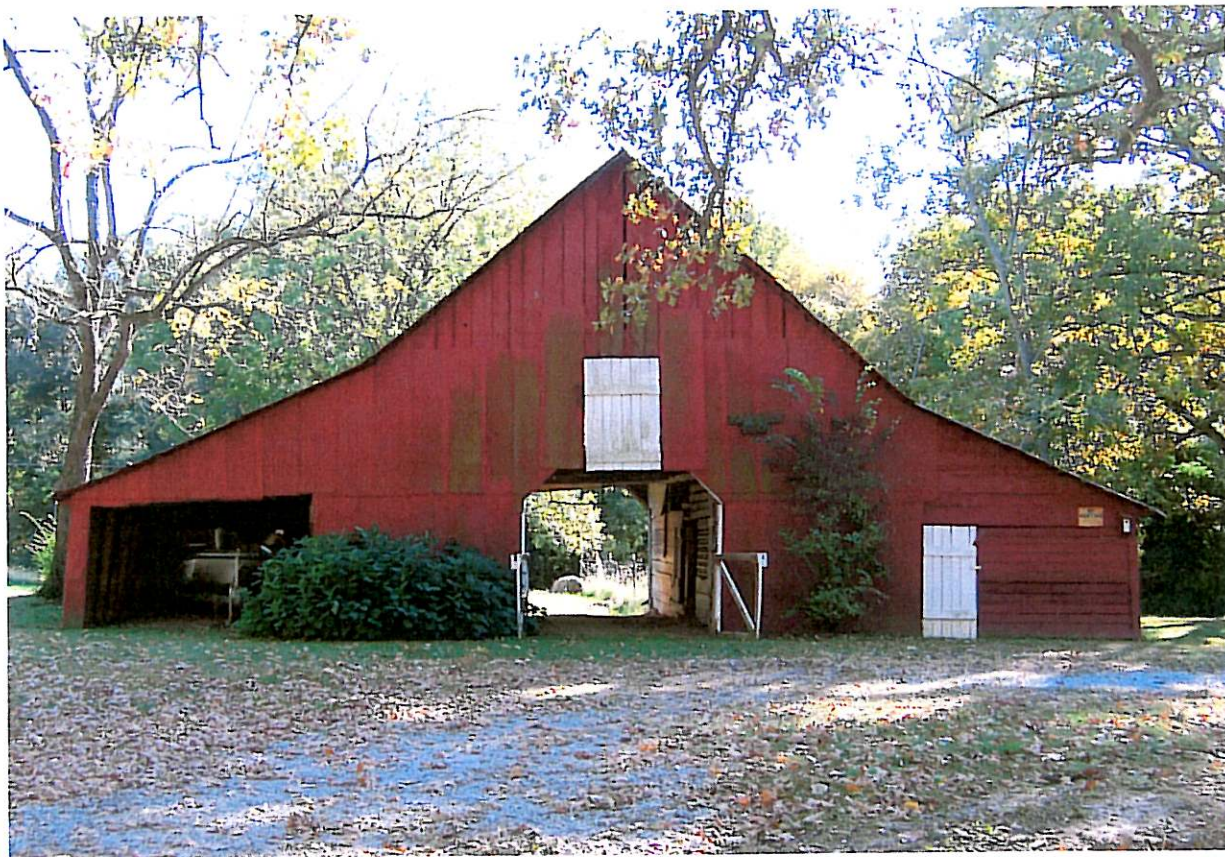
Transverse Crib barn on Crossroads Church Road

Typical Georgia farm outbuildings include the Single Crib, the Double Crib, and the Transverse Crib barns. Almost half (49%) of the farms have Transverse Crib, about one-quarter (23%) have the small Single Crib, and 10% have the Double Crib barn types. One example of a Drive-In Crib was located. Four Crib barns, an evolution of the Double Crib barn were also identified. Very few of these structures are used now for their original purpose. Many serve as storage facilities or remain unused and are falling into disrepair.

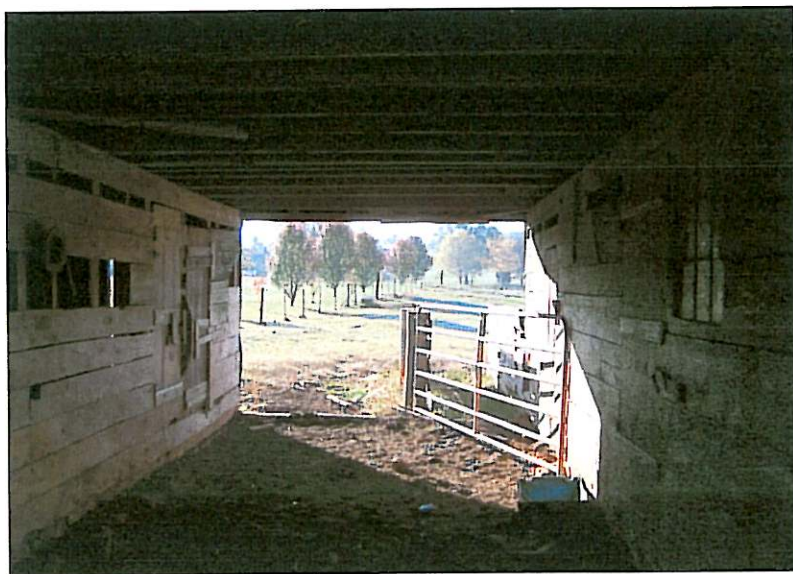
Interior stalls of Transverse Crib barn on Buchanan Highway

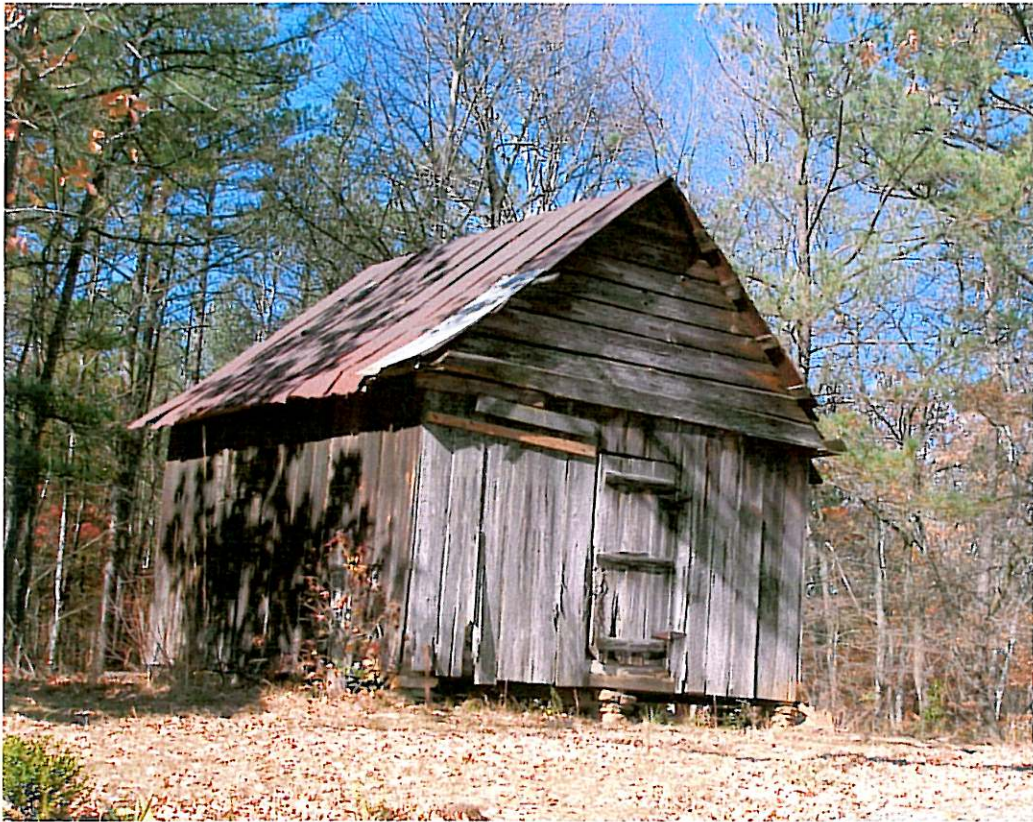
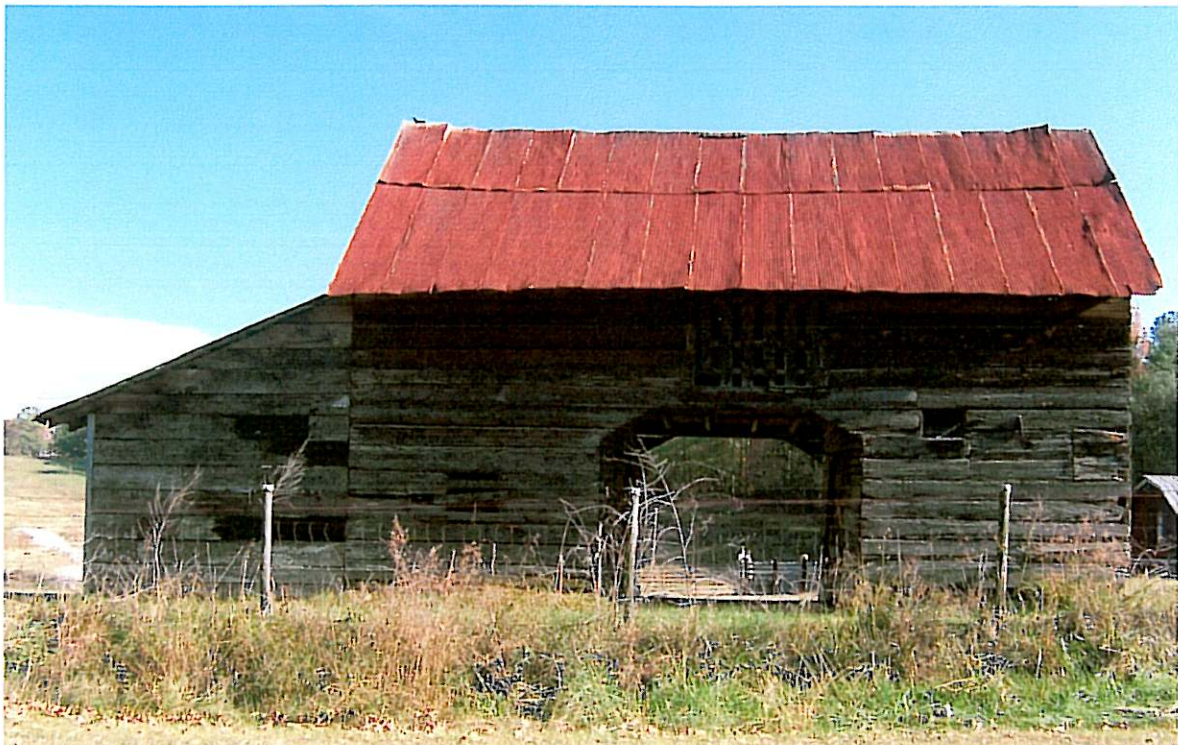
Single Crib barn on Harmony Grove Church Road, above, and a Double Crib barn on Marshall Fuller Road, below

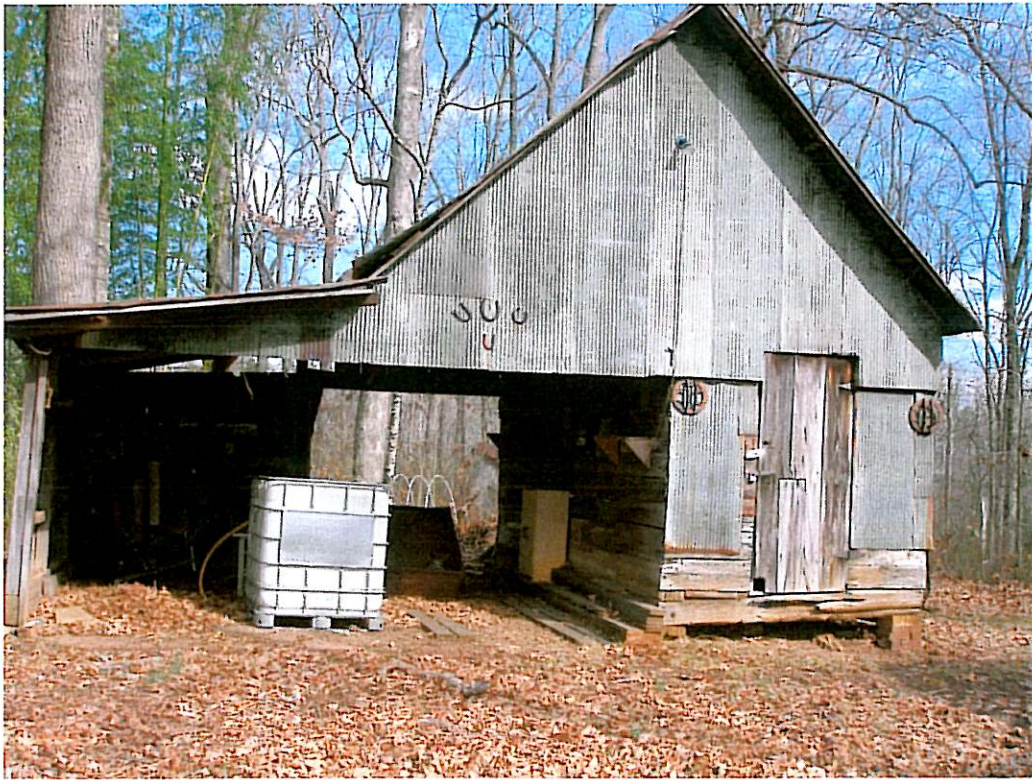
A Drive-In Crib with a single enclosed pen on the right and a side bay on the left, on Hay Renfroe Road.

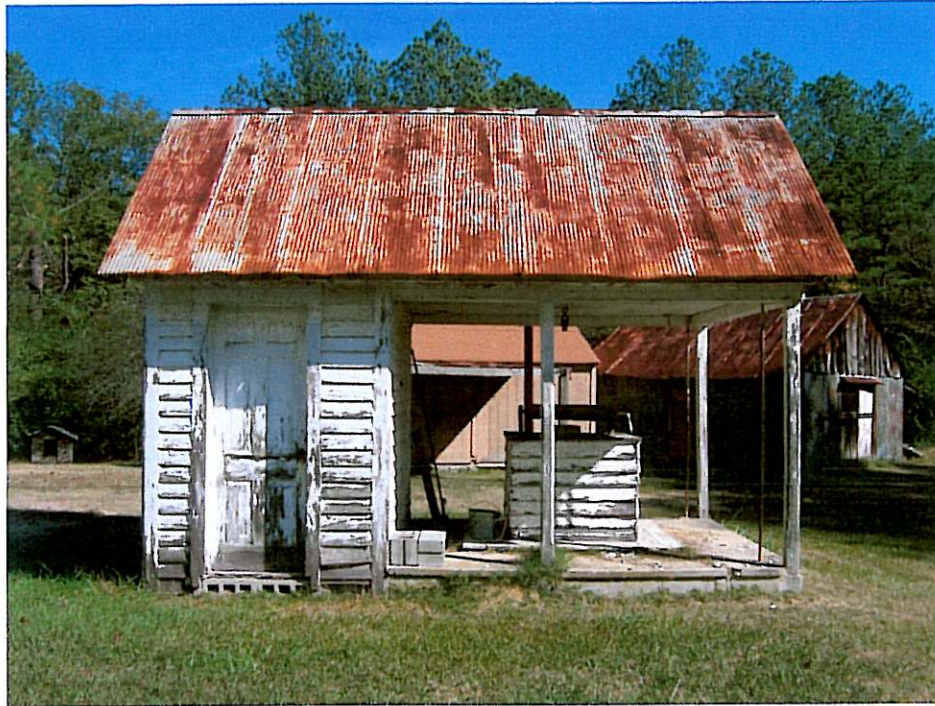
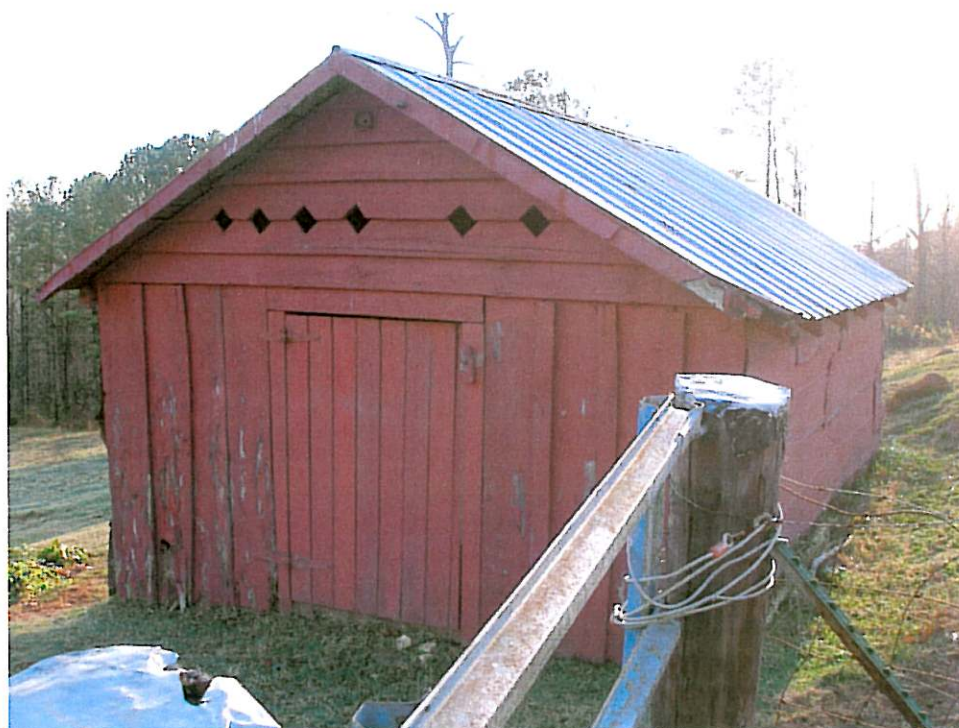
A well house on Gore Lakes Road, above, is the only one of its type located, and a smokehouse on Dabbs Bridge Road is pictured below.

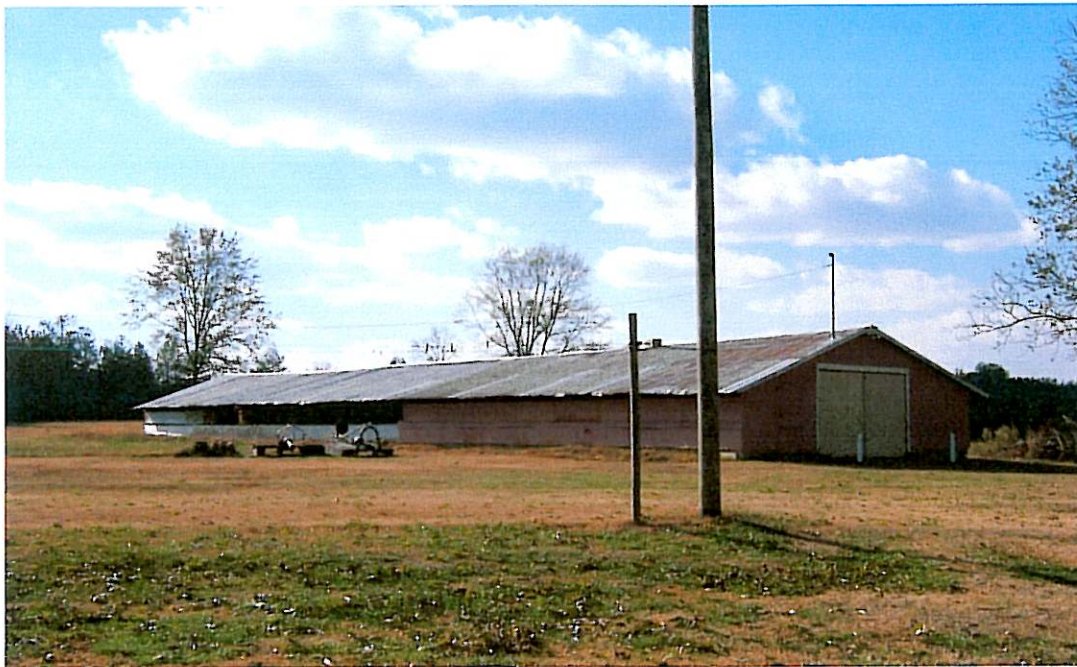
A c. 1950 chicken house, above, on Weaver Road and a former chicken house converted to a horse barn, left, on Roper Road.

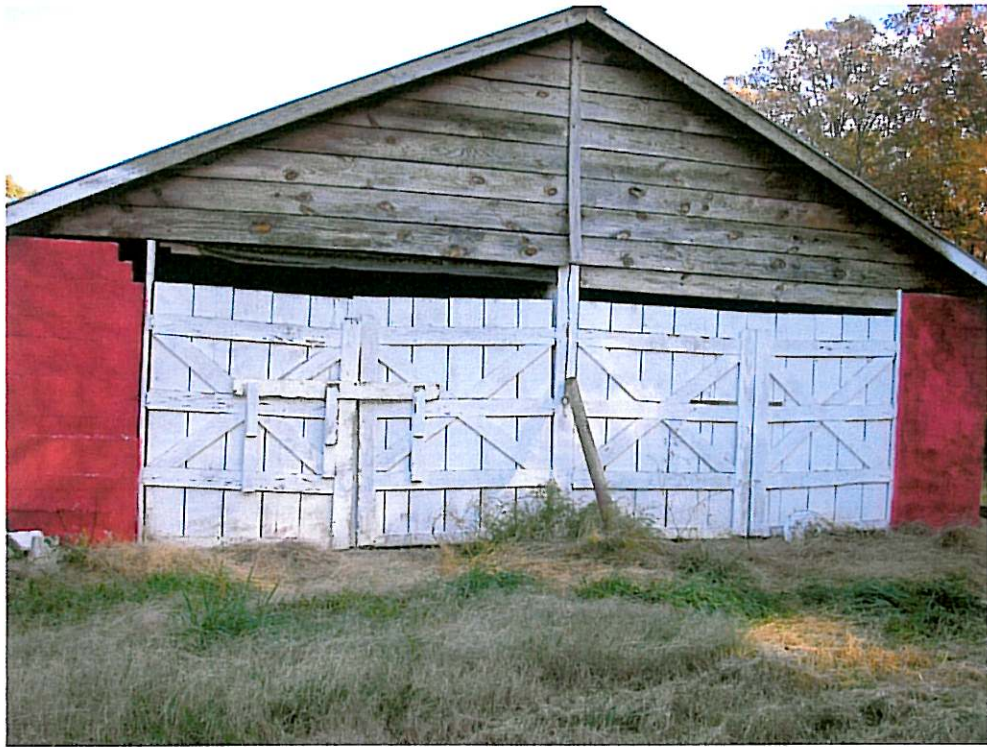
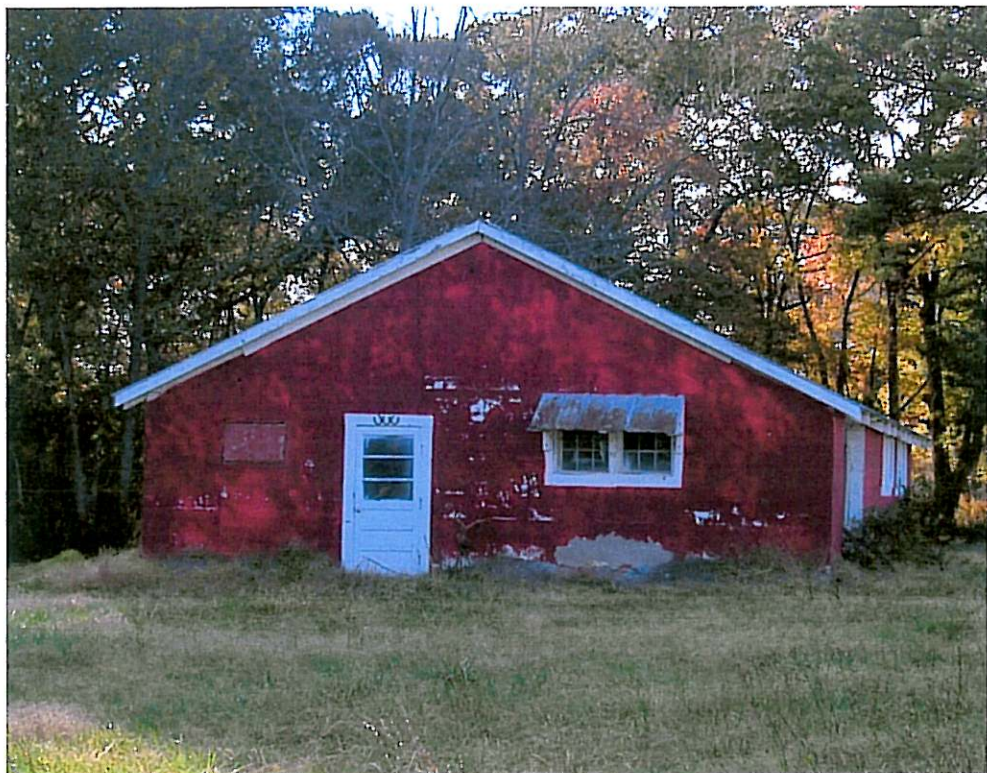
*A combined dairy barn, above, where the cows were kept,
and dairy house, below, where the milk was processed, on SR 92.*

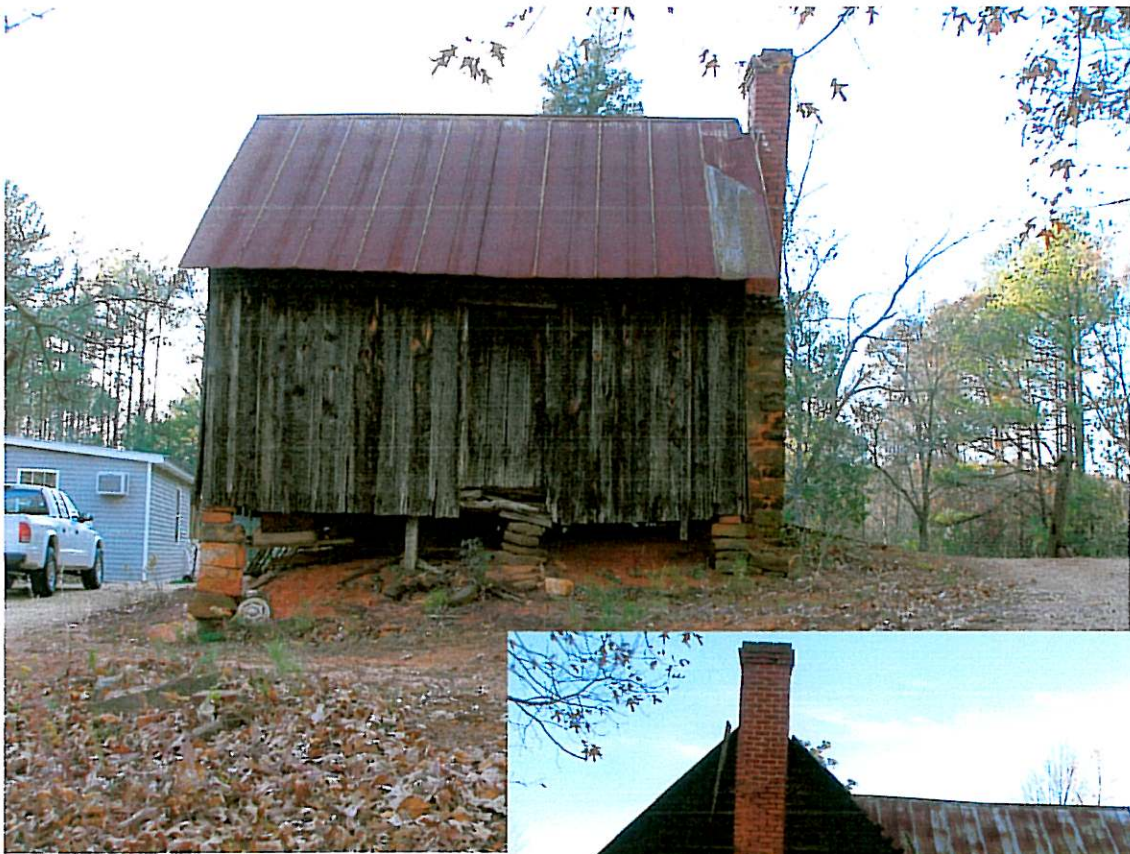
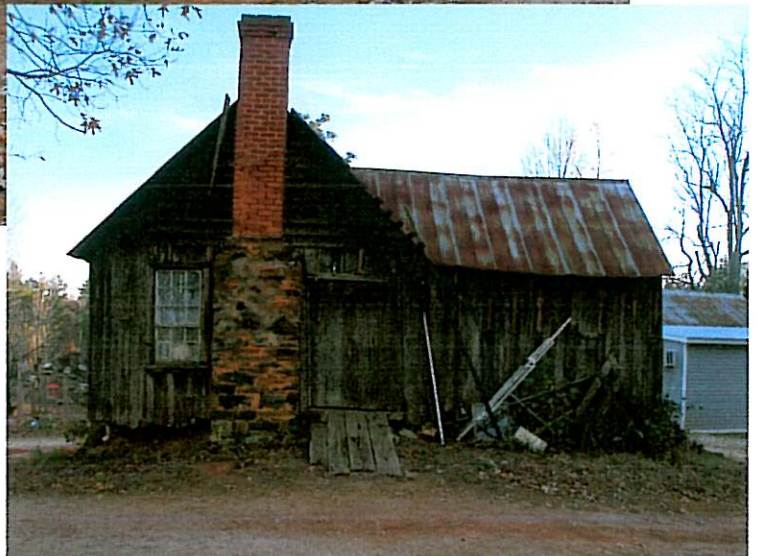
This Single Pen house originally had one room heated with a stone chimney. A gabled addition was enlarged the dwelling on the rear elevation.

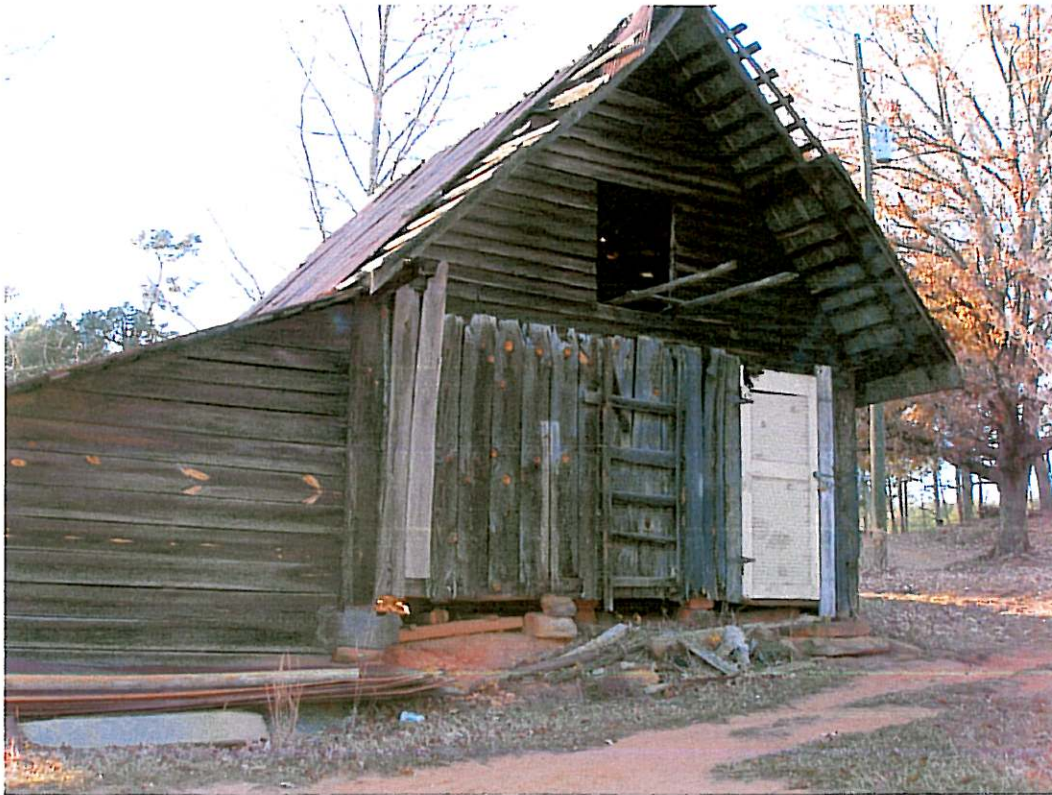
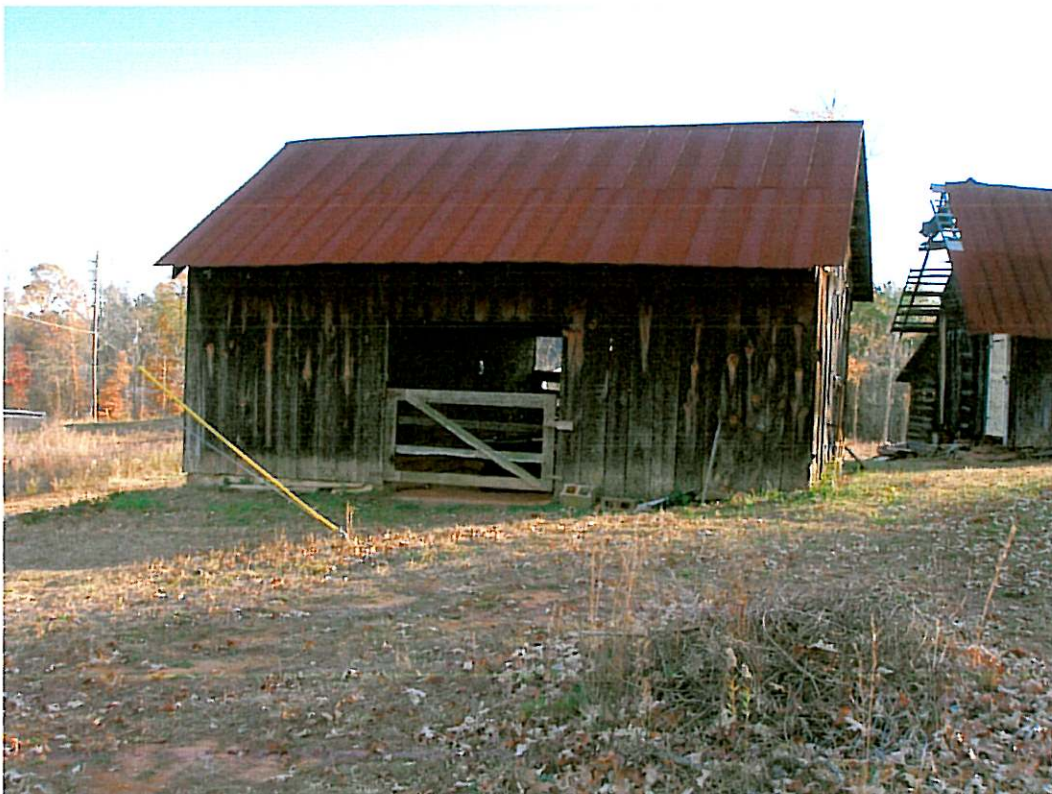
*The use of this barn is unknown but has an altered façade and an added side bay.
A Double Crib barn with a central aisle and cribs on each side is seen below.*

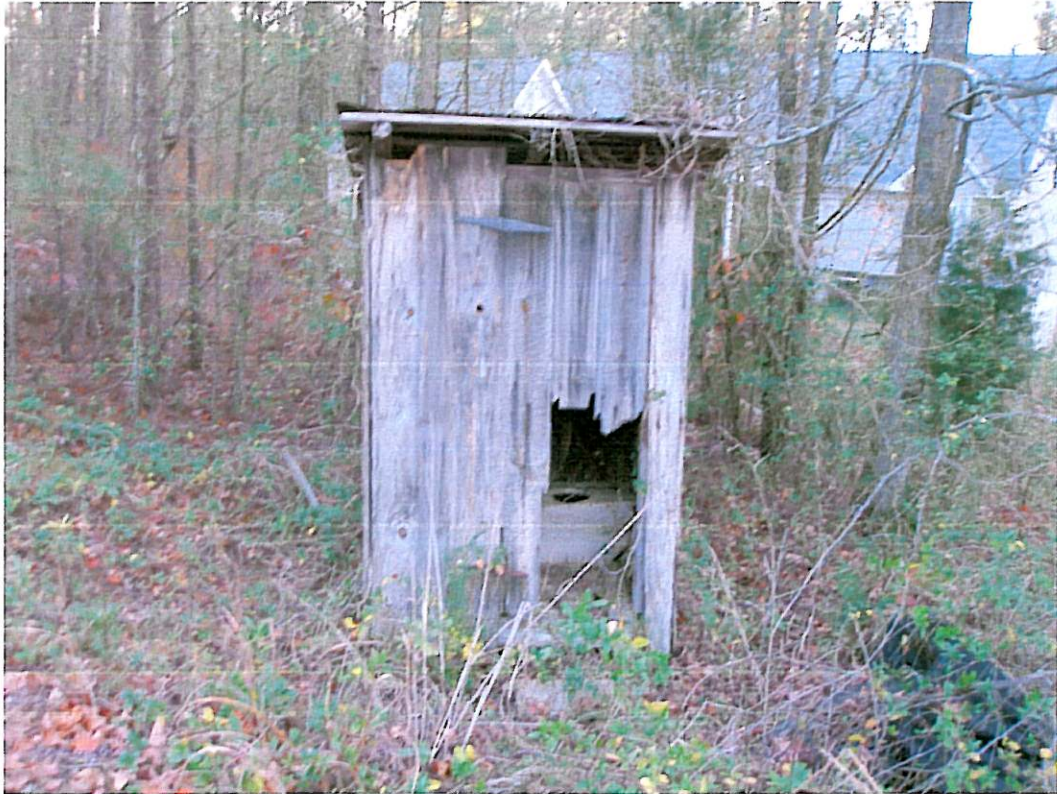
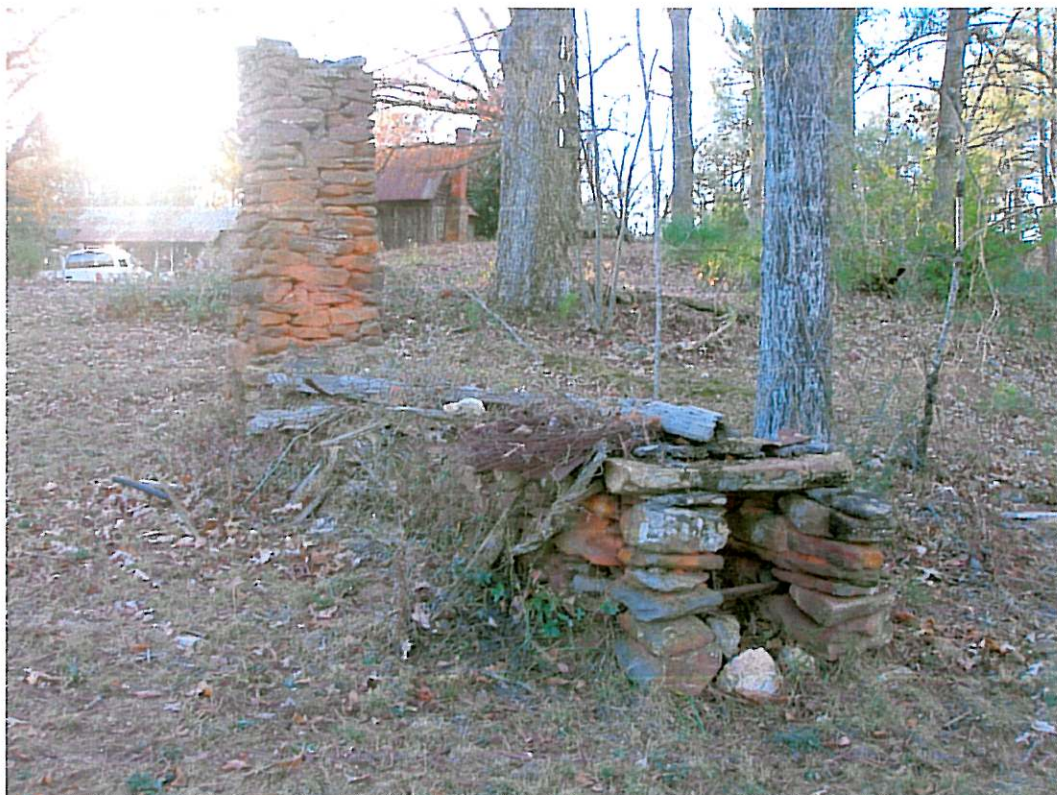
A privy is seen above, and the chimney remains supporting a syrup-making operation are seen below.

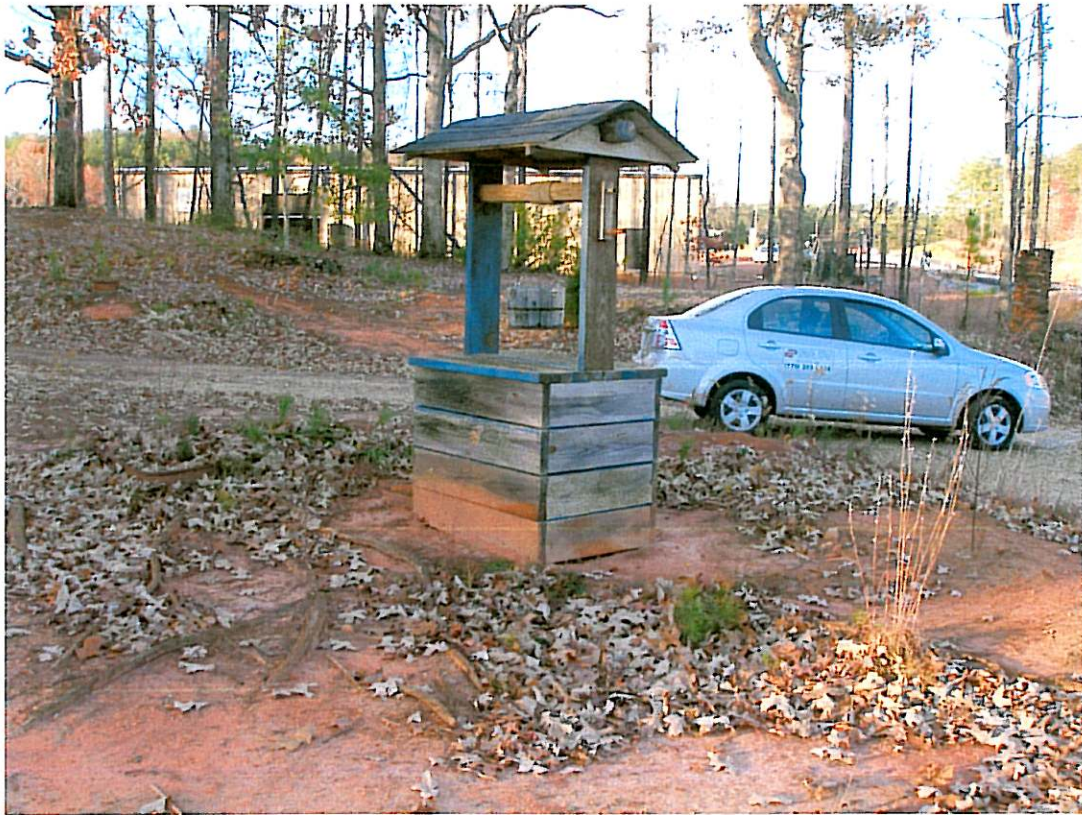
The enclosure of this well appears to have been replaced over time, but would have provided an essential source of water to the farm.

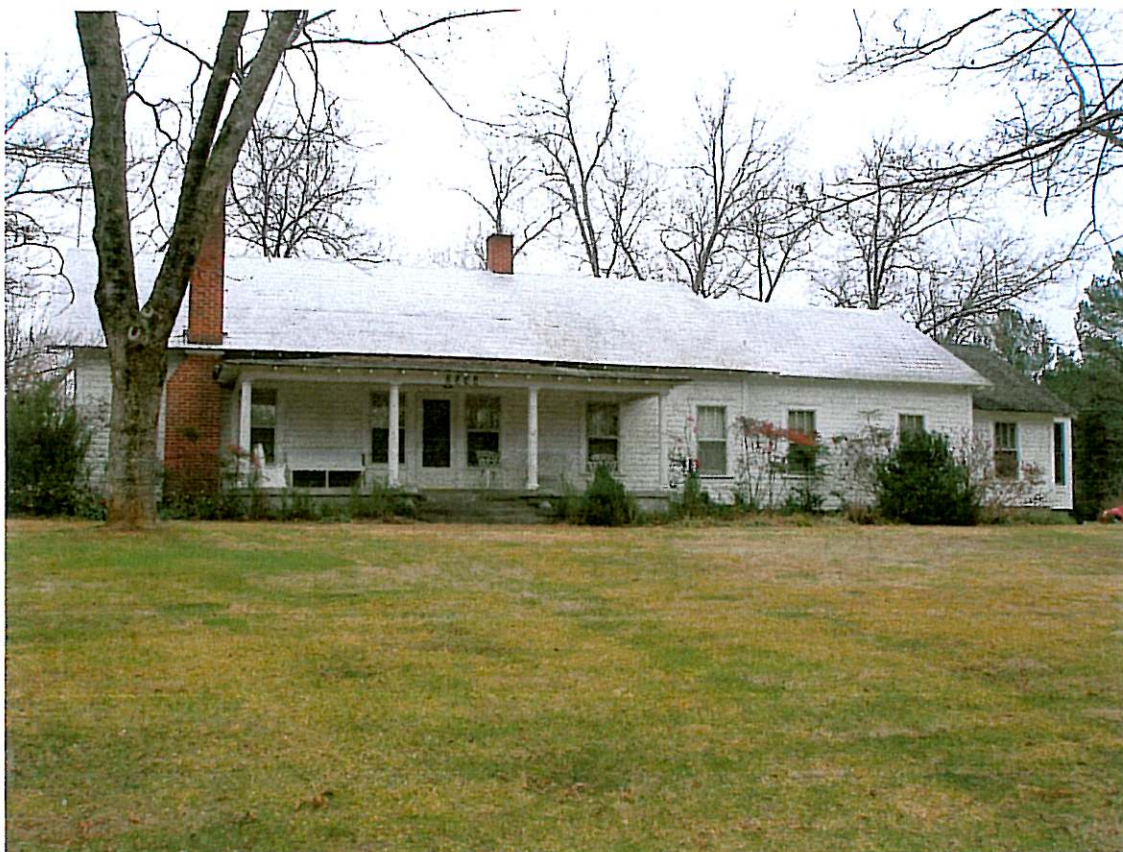
The rear of this 1927 farmhouse (pictured above) became the front with a new porch and brick steps when Dallas-Acworth Highway was paved through the back pastures of this 63-acre property in 1939. Several additions have enlarged the dwelling. Supporting historic structures were also moved to the new rear of the property. Crops included cotton, corn, vegetables, and peanuts. Syrup cane was produced, and cows, hogs and chickens were raised.

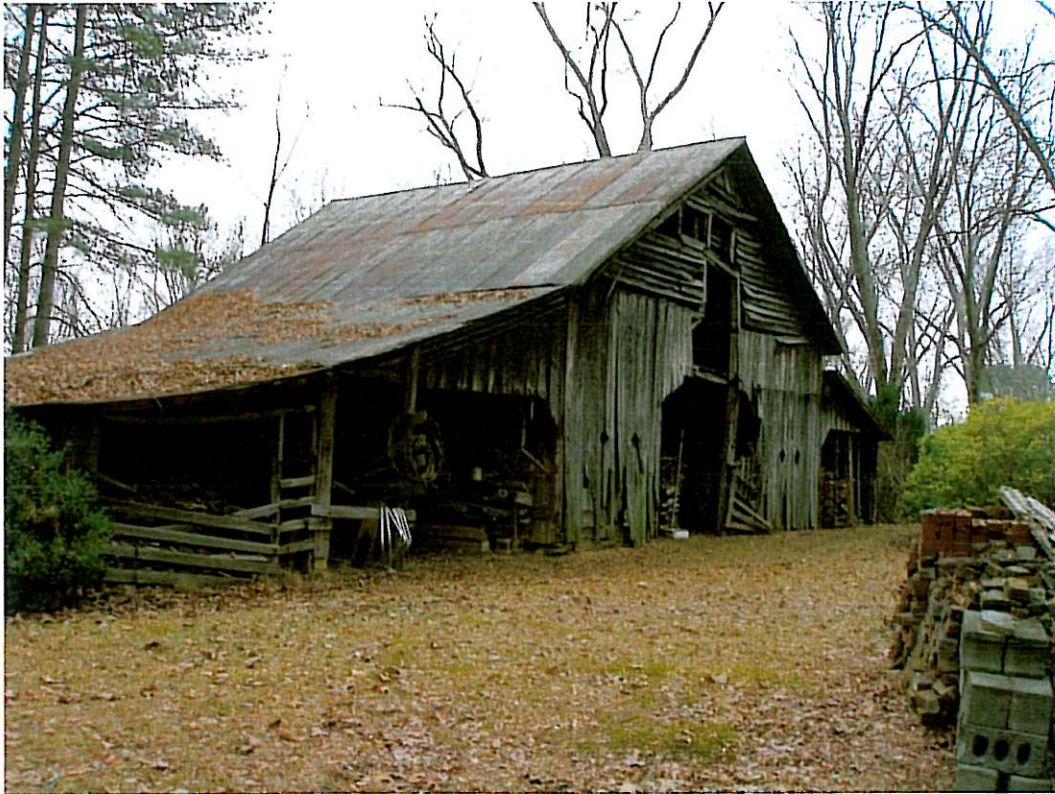
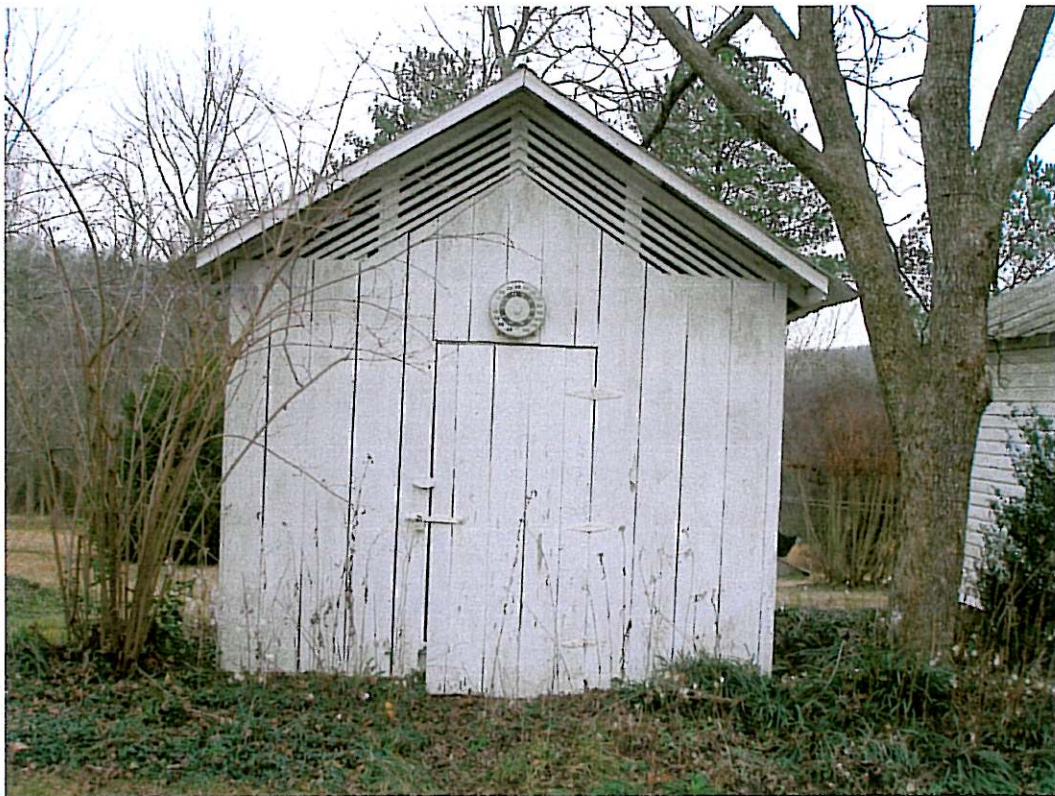
According to the owner, this Transverse Crib barn was used to shelter livestock and may date to before the second house was built in 1927, but was never moved, despite the paving of the new road. Below is the smokehouse.
