Martha L. Teall

Edwards-Pitman Environmental, Inc.

HISTORIC FARMS IN PAULDING COUNTY: AN AGRICULTURAL CONTEXT SURVEY

Occasional Papers in Cultural Resource Management #18

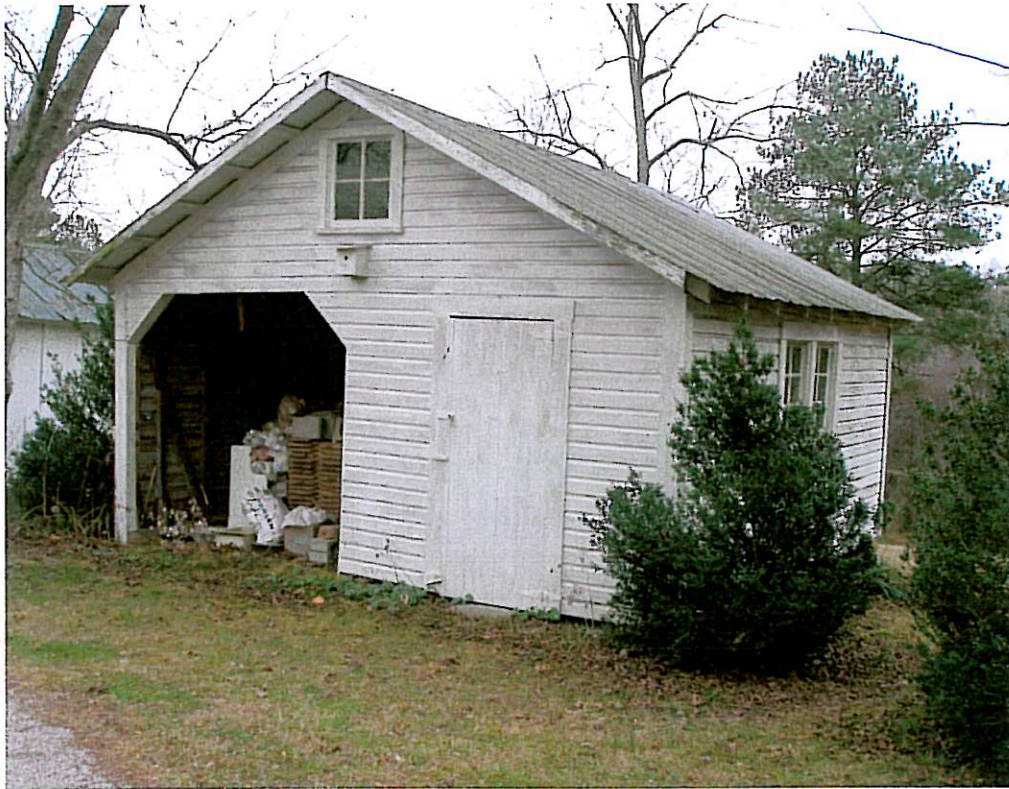
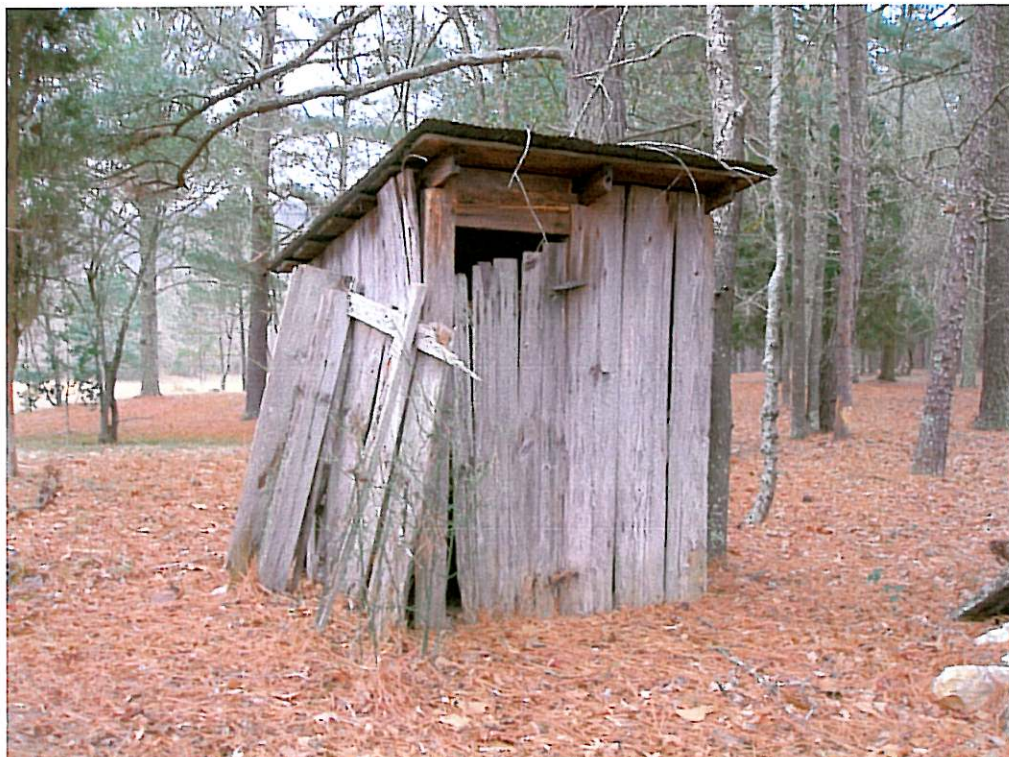
The small structure above was used as part of a small dairy. Here milk was strained and bottles were washed. The privy is seen below.

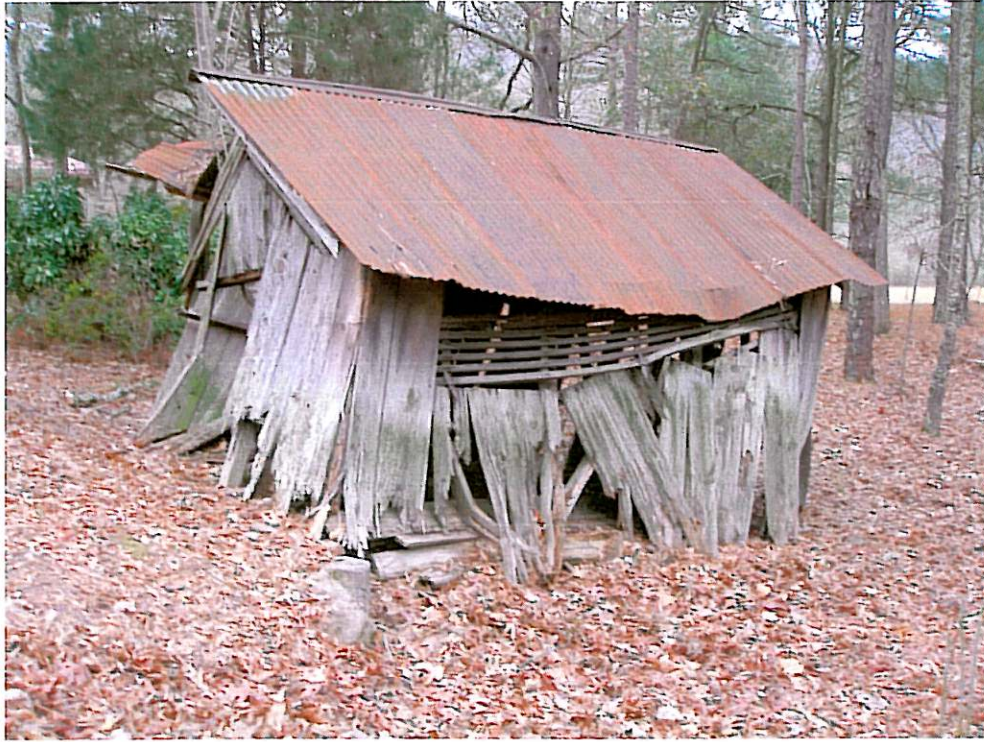
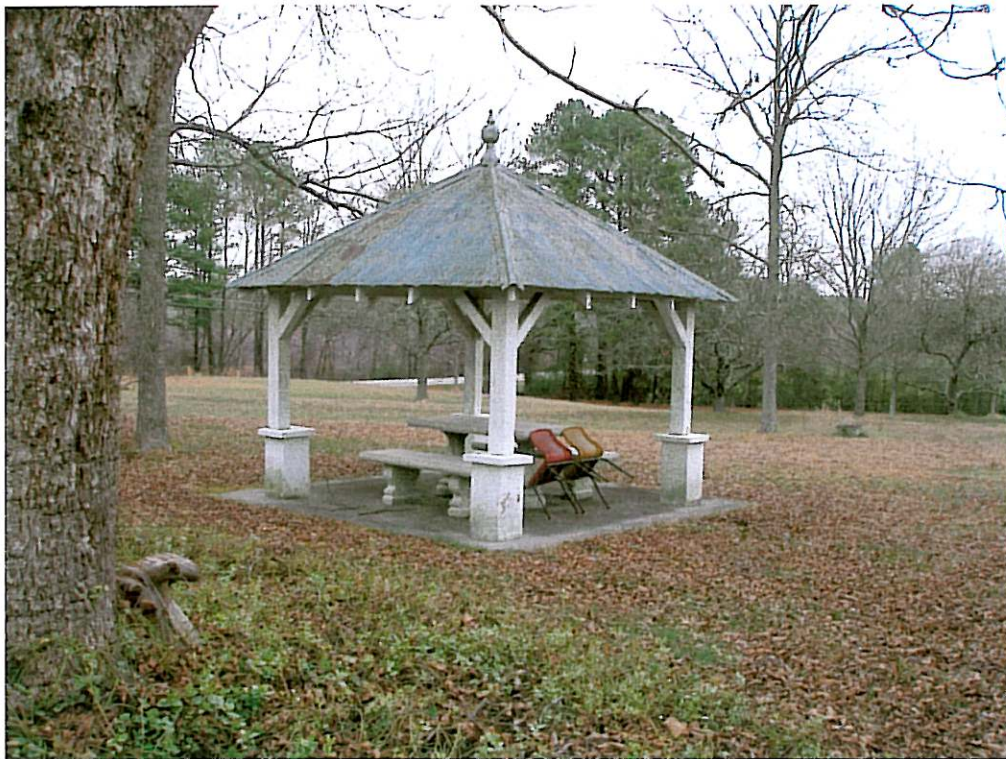
Above are the remains of a former chicken coop and below the former well shelter has become a gazebo.
