**Durability of Precast Prestressed Concrete Piles in
Marine Environment, Part 2
Volume 2: Stainless Steel Prestressing Strand
and Wire**

Office of Materials and Research
Georgia Department of Transportation

GDOT Research Project No. 10-26
Task Order No. 02-78

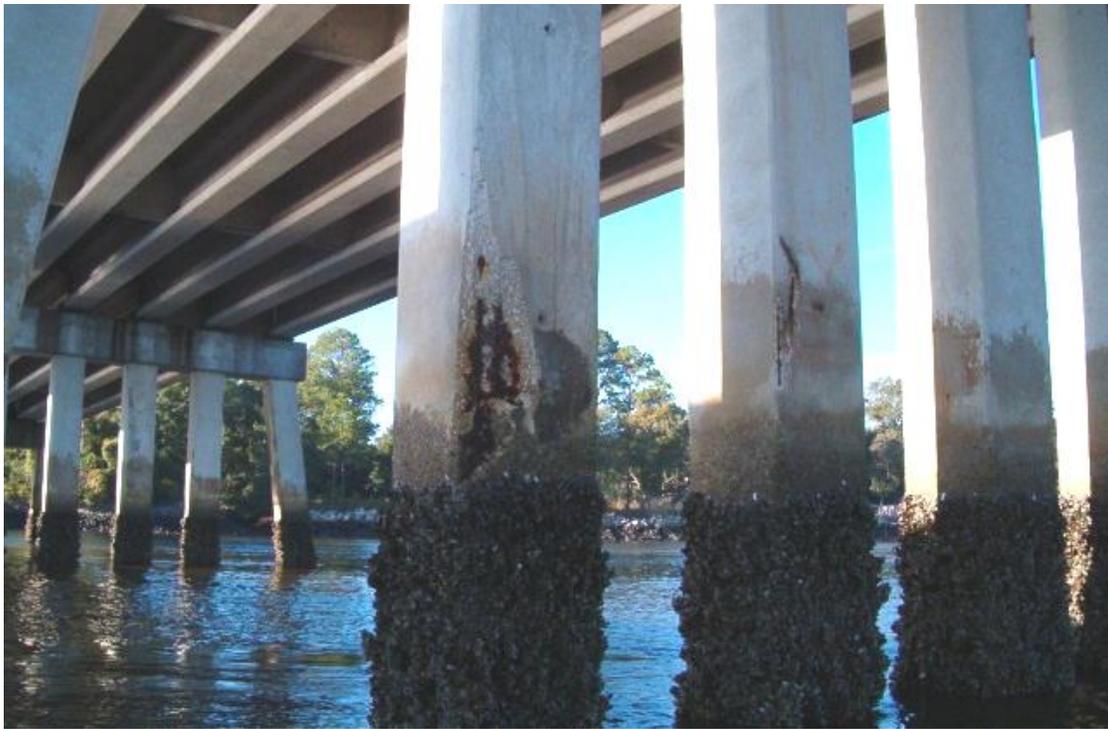
Figure 1.2 Spalling of cover concrete in splash zone of PSC piling caused by corrosion of prestressing strand and ties. Location: I-95 over the Turtle River in Brunswick, GA

service lives and eventually to structural deficiencies, making premature repair or replacement necessary. In PSC structures, EAC mechanisms (e.g., stress corrosion cracking and hydrogen embrittlement) may also lead to damage by the synergistic interaction between corrosion propagation and tensile stress, ultimately leading to brittle fracture (Hope and Nmai, 2001a). Figure 1.2 depicts typical corrosion-induced spalling in the splash zone of a precast prestressed concrete substructure of a coastal bridge.
