**DEPARTMENT OF TRANSPORTATION
STATE OF GEORGIA**

SPECIAL INVESTIGATION RESEARCH REPORT

Number: 2010-1

**Self Extending Asphalt Paver Screeds
Georgia's Experience**

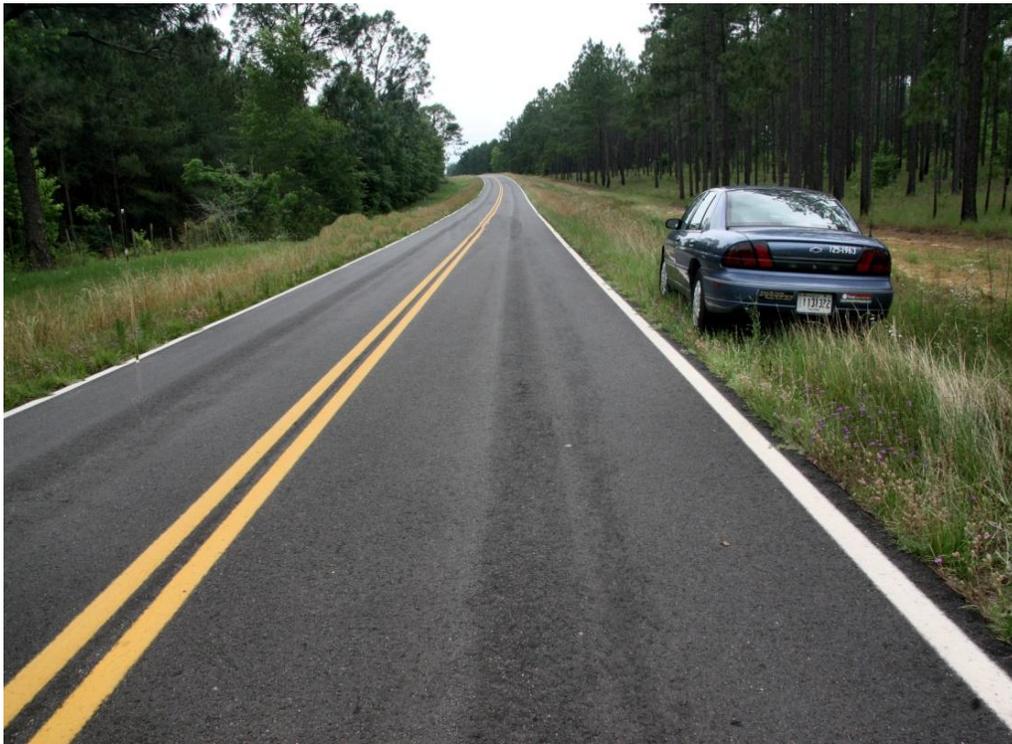
During the past year, the Office of Materials and Research’s Bituminous Construction Branch has investigated numerous premature HMA roadway failures across South Georgia. For all of these projects, the final asphalt surface wearing course, consisting of either 12.5 mm or 9.5 mm Superpave mix, was in place. Many of the roadways had been paved for only a few months before the first indications of failure were apparent. Most of the distresses that have been observed are in the form of variable width longitudinal streaking (See Photo #1).

Photo 1- Longitudinal Streaks Now Raveling Under Traffic

The more severe failures were associated with top down cracking and raveled out surface aggregate. While investigating these premature HMA failures, one common factor was apparent throughout all of the projects evaluated. On every failing pavement section evaluated for this report, a paver equipped with a hydraulically extendable screed was used for placing the HMA.

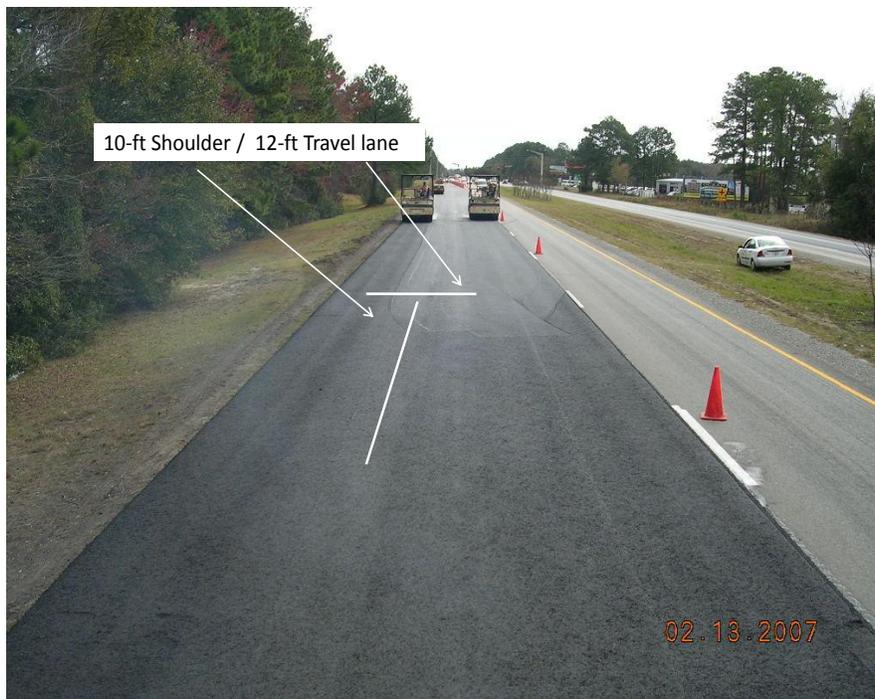
Construction inspection reports in conjunction with photographs taken during mix placement in the original test sections were reviewed and compared to current pavement wearing course conditions. One very significant detail was discovered. It was determined that slight texture shadowing or streaking observed in the un-compacted mat during placement that was considered of minimum importance does in fact have detrimental long term consequences once opened to traffic. Photo 2 depicts a project photographed during construction in 2007.

Photo 2 – Project during Construction 2007

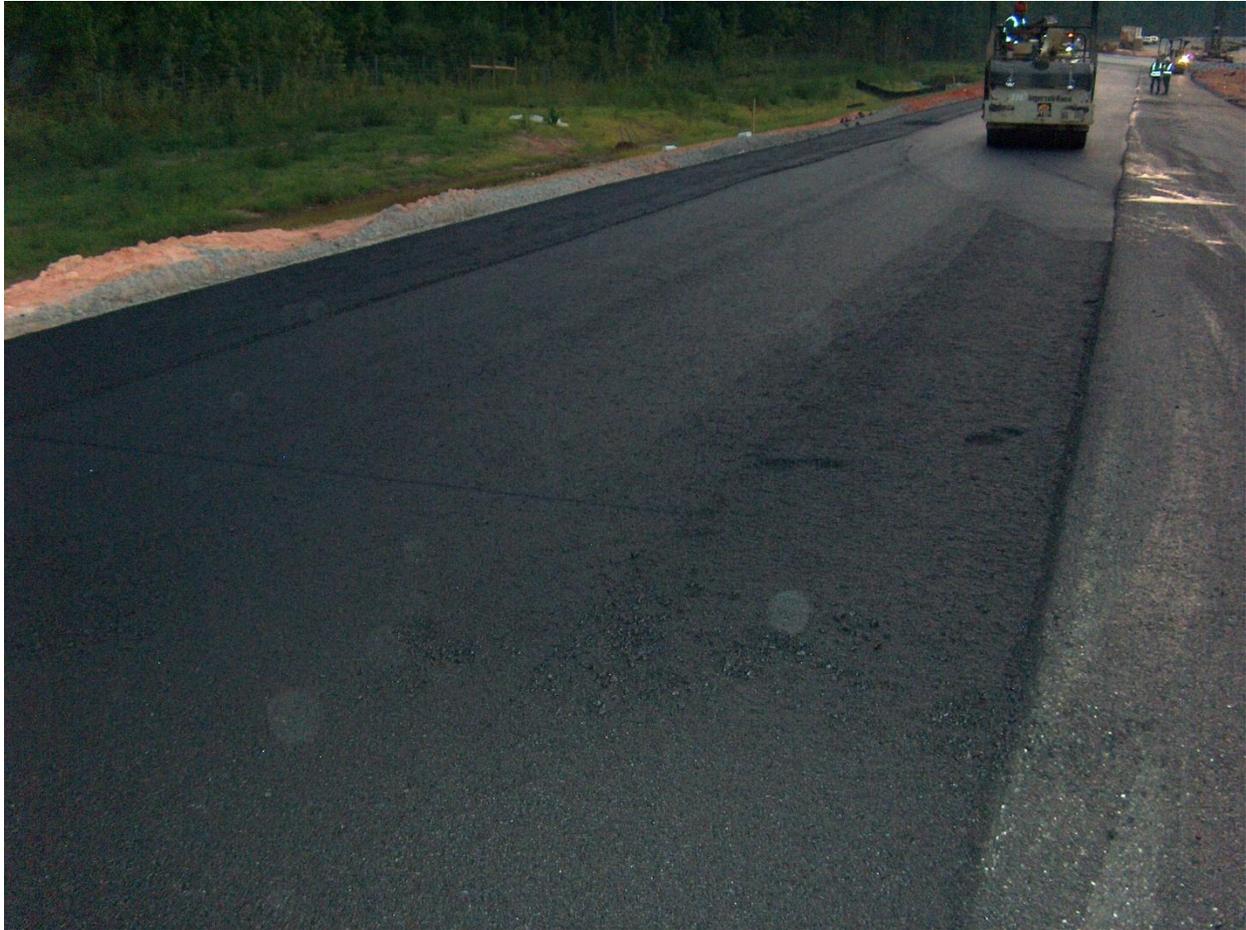
While this observation was only substantiated within the surface (wearing) course during GDOT's investigation, subsurface mixes exhibiting these same deficient properties have been investigated during construction on other projects. Base and intermediate lifts that have been investigated because of similar longitudinal streaking or shadowed textures have yielded unacceptable and inconsistent density or erratic profile when measured transversely across the mat. In the most recent occurrences, the unacceptable pavement was removed and paving was interrupted until screed adjustments were made that yielded acceptable results (See Photo 4).

Photo 4-Paving Project with Inconsistent Mat Texture

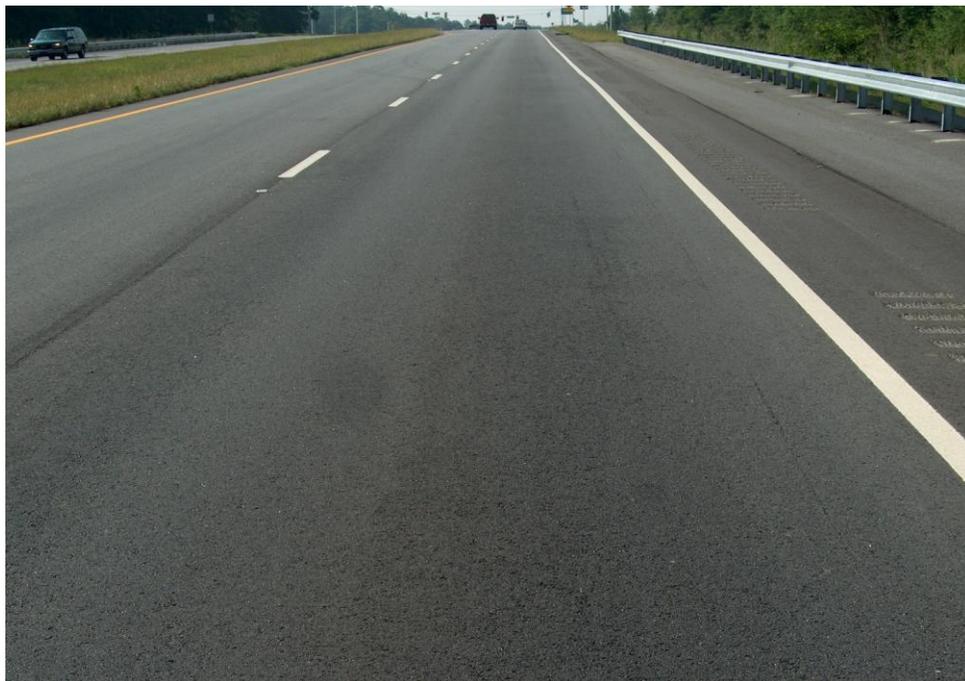
To ensure that the information documented in Table 1 was not influenced by any form of mixture gradation segregation, several projects were evaluated by taking three cores across the mat for extraction and to determine gradation. The following photographs of these projects depict the type of texture inconsistency found. These pictures are followed by the core gradation results.

Photo 5-Open Textured Pavement

The above results proved that the mixture composition as related to gradation and AC content was uniform across the full mat width and verified that the unacceptable mat texture originated from a poorly adjusted and/or operated screed. Therefore, GDOT's standard segregation specification may not be sufficient to address the screed related deficiencies.

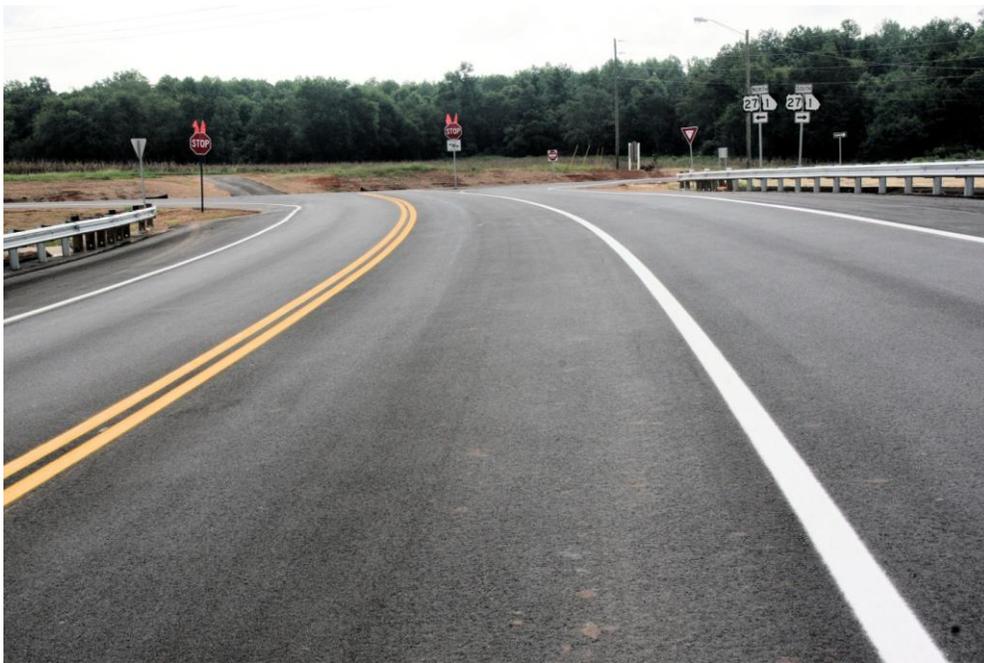
Photo 6-Very Streaked Texture

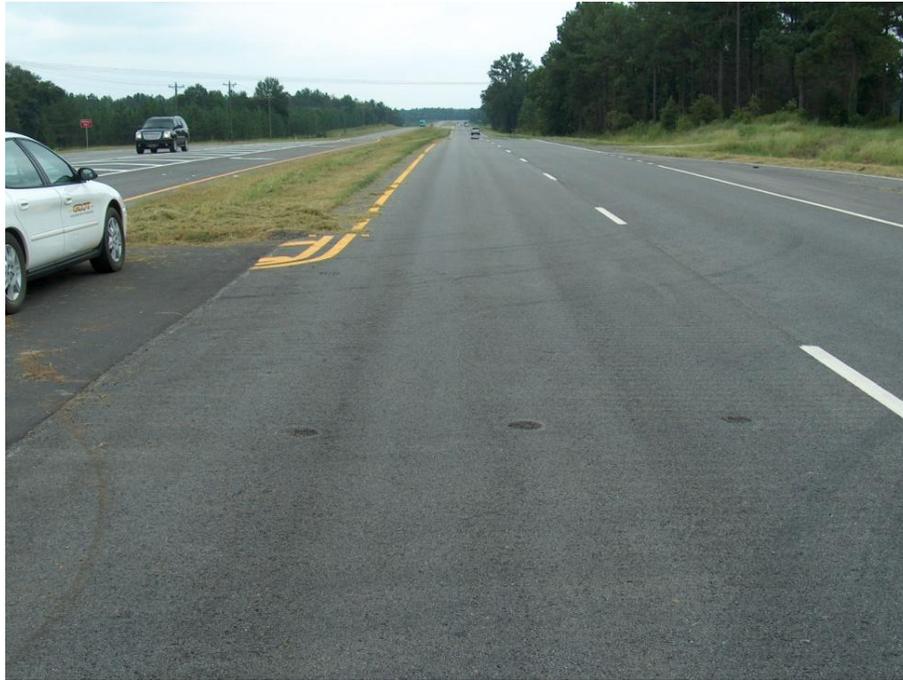
Photo 7-Core Locations Taken on Streaked Project

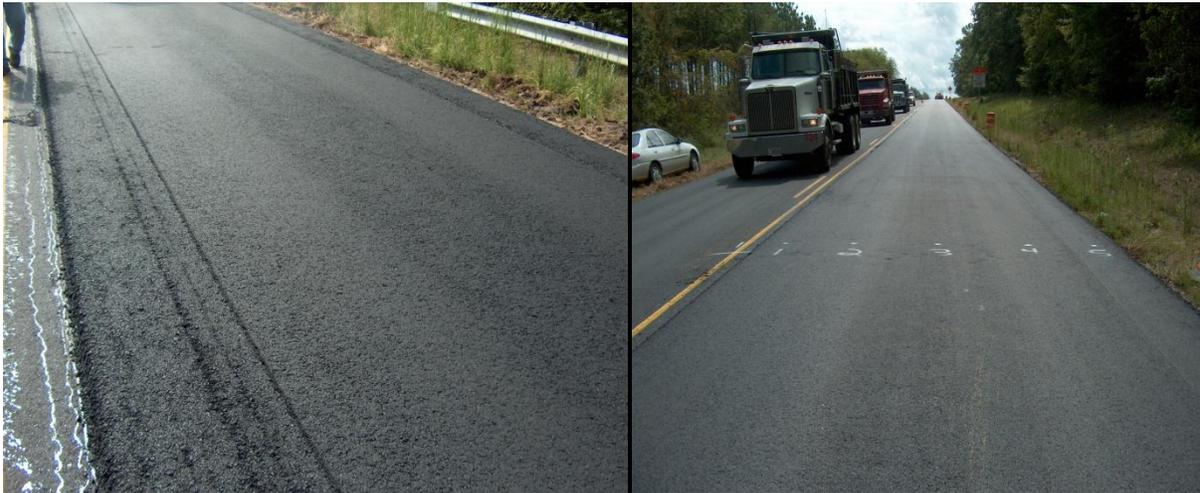
Trailing and leading extension screed plates must travel on a precise plane in relation to the main screed in order to prevent inconsistent levels of pre-compaction or double screeding. Inconsistent final mat density and various longitudinal texture streaks are typically associated with the failure to properly maintain this level plane. The following pictures (Photos 8-10) and illustration (Illustration 4) depicts such an occurrence when pre-compaction varies.

Photo 8, Un-compacted Mat Behind Front Extension

Photo 9-Compacted Mat Behind Front Extension

The previous photographs were taken on a project where the front extendable screed being used exhibited poor alignment of the extension to the main screed. Photo 8 displays the inconsistent pre-compaction and un-compacted material volume across the 14-ft lane. As detailed in the thermal imaging picture (Photo 10), this texture inconsistency was supported by the 31 degree variance measured across the mat. The final compacted pavement continued to exhibit these inconsistencies in the form of longitudinal streaking after the rolling operation as displayed in Photo 9. The following data was collected across the un-compacted and compacted mat with a calibrated nuclear gauge. The five locations taken transversely across the mat are shown in Photo 6 above and correlated to the front extendable screed in Illustration 4.

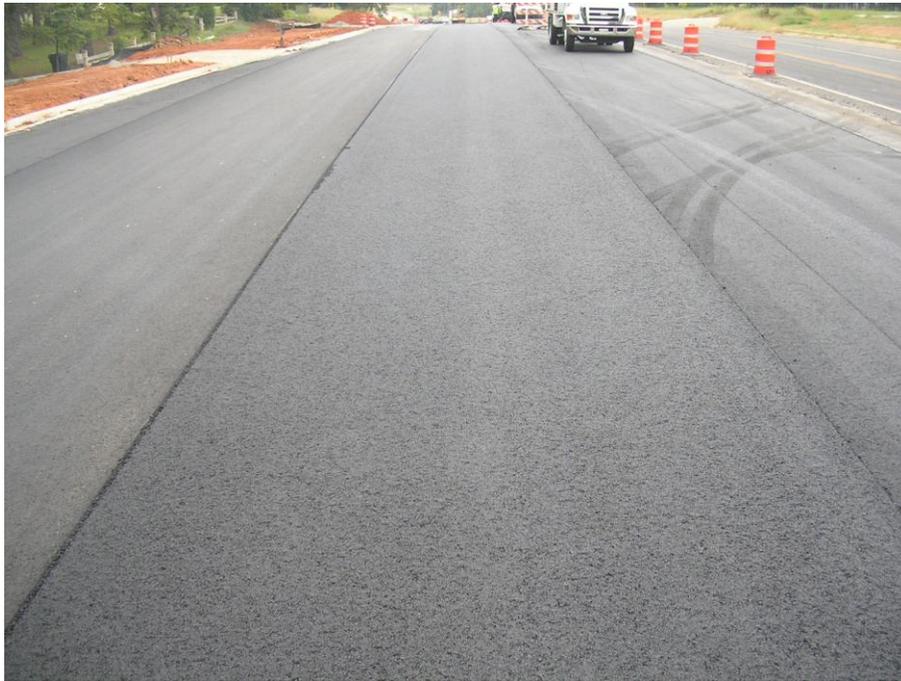
In contrast and as previously relayed in the introduction of this report, there have been acceptable projects constructed in Georgia using extendable screed technology. Some of these have even received nationally recognized quality of construction awards that are primarily judged on smoothness and density. Since smoothness is directly correlated with consistent texture, density, and temperature; a similar project was selected to be used as a comparison. Unlike the previously referenced project shown in Photos 8-10 where the mat texture was erratic and unacceptable, the extendable screed used to place the project in Photos 12-13 yielded a visually uniform pavement. Both projects, the deficient one as well as the uniform project, consisted of a fine graded surface mix placed at comparable widths and depths within a day of each other. The ambient air temperature and time of day were also very similar. Both pavers were being assisted by the same manufacturer and type of material transfer vehicle (MTV).

Photo 12-Acceptable Project Placed with Rear Extendable Screenshot

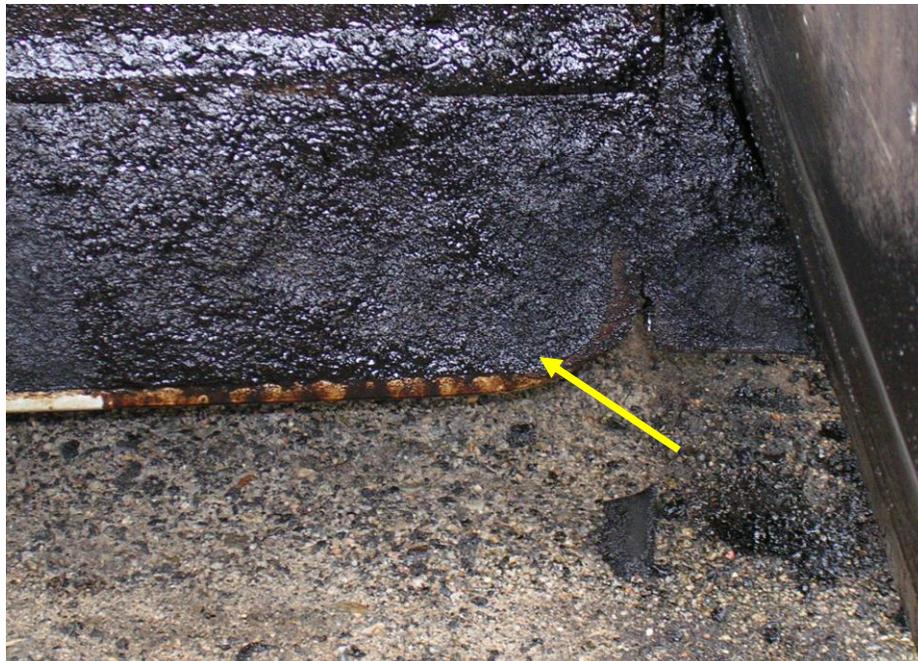
To determine how quickly this wear occurs, a project was selected that required leveling a single layer of surface treatment crack relief interlayer application with a thin lift of 75 lbs/yd² of 9.5mm Superpave mix. Approximately 5000 tons of 9.5 mm Superpave leveling mix was required for the project. The front self extending screed used on this project was equipped with new screed plates on the main and extensions prior to placing the leveling mix. Immediately after the 5000 tons were placed, the screed plate condition was inspected and evaluated. As shown in Photo 14, the rounded nose of the main screed plate was worn to a point of being flat.

Photo 14-Worn Screed Plate after Leveling

As seen in these comparison photographs, the curvature needed to allow mix to freely flow under the plate was flattened to a point of no further use after placing only 5000 tons of thin lift leveling.

Once this circumstance was fully understood by the HMA industry in Georgia; most contractors elected to use an older fixed screed to place the leveling. The self extending screeds are predominately being used now for placement of pavements at uniform thickness and grade. With this better understanding of these screeds and their uses, there has been some improvement in overall mat texture quality.

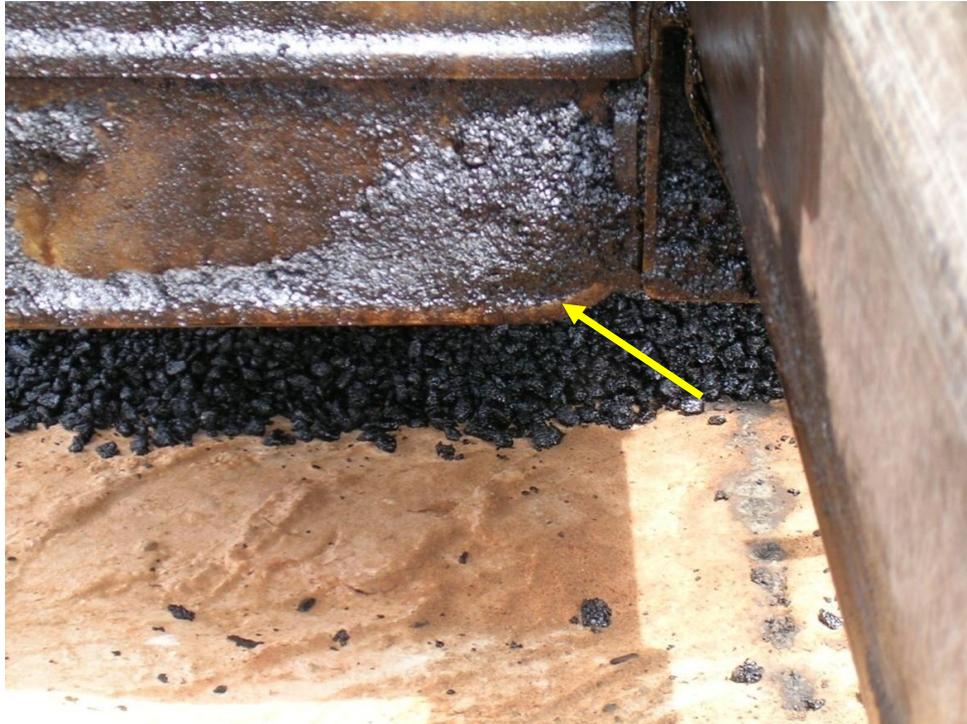
preventing the proper adjustments required to yield an in-place mat with consistent texture. At that time, the plates were again removed and replaced. Photo 15 shows the nose of a new plate after little use.

Photo 15-New Screed Plate

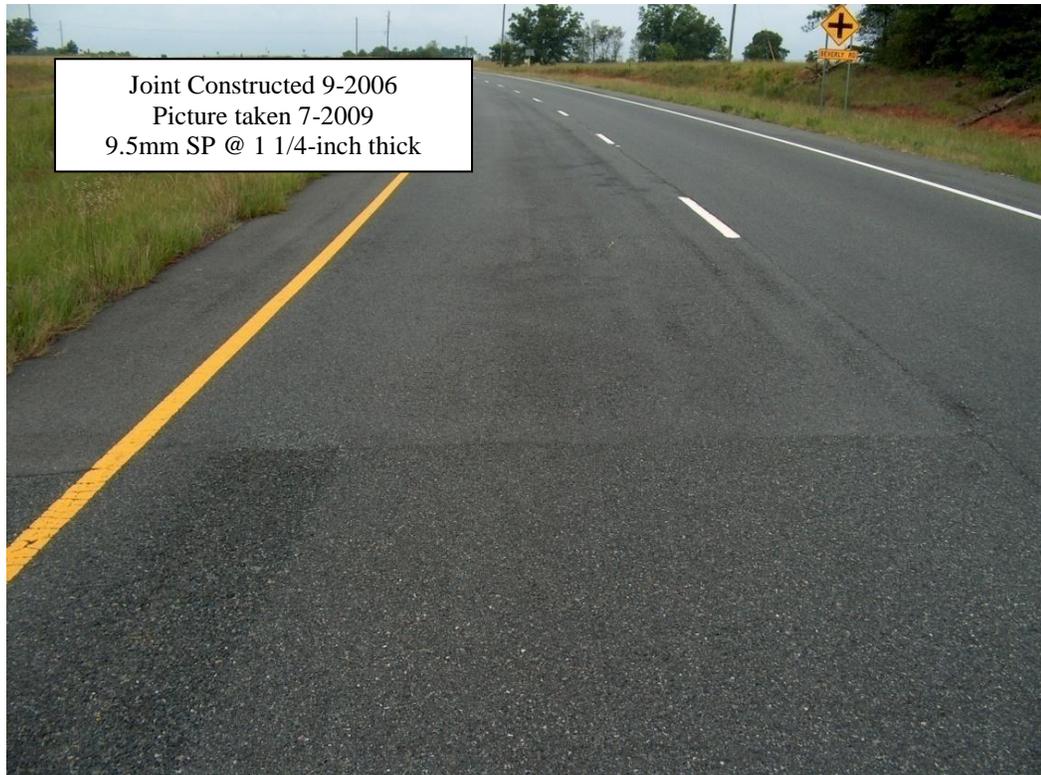
Since the initial introduction of these screeds, another reoccurring issue has been the quality of “start off” transverse joints. Regardless of whether the extension is leading or trailing the main screed, unacceptable joints continue to be a problem. This issue has been apparent whether pulling off the cold joint from the previous day’s pull or coming off of concrete bridge approach slabs (See photo 16-18).

Photo 16-Transverse “Start off” Joint

On the majority of the projects with poor transverse joints, the pulling and tearing displayed in the three related photographs (Photos 16-18) continued for approximately 100-ft before the mat texture became uniform.

previous photographs (16-17). This construction deficiency has been related to poorly adjusted extensions, severely warped or worn plates, or a cold screed when observed on current projects under construction. These heavy self extenders with three screeds that must operate in unison have multiple heating elements and thermostats. They are especially sensitive to temperature differentials across the width of the assembly. As you are aware, a screed's reaction is dependent on the support of the hot mix flowing under it. When the screed plate temperature is not sufficiently warm or consistent across all plates, the screed reacts erratically. Under these conditions, the screed falls as it pulls off the rigid cold mat from the previous day's end joint. In response, the screed operators make rapid and drastic adjustments by turning the grade screws. These attempted corrections, usually results with irregular low or high places in the mat within 20 - 30 feet of the action.

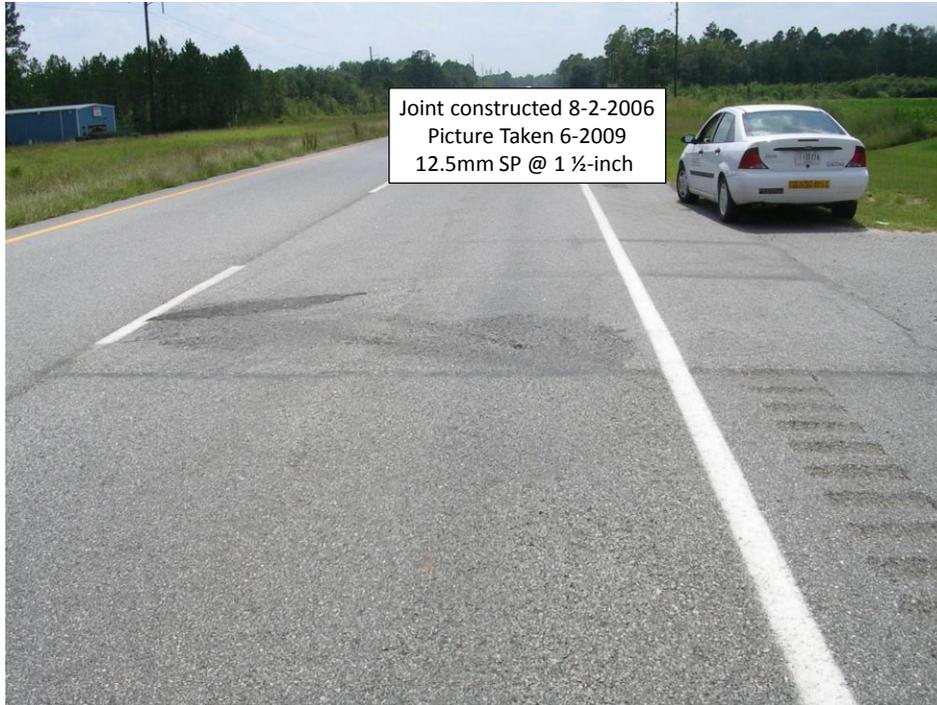
Photo 17- Transverse “Start off” Beginning Joint

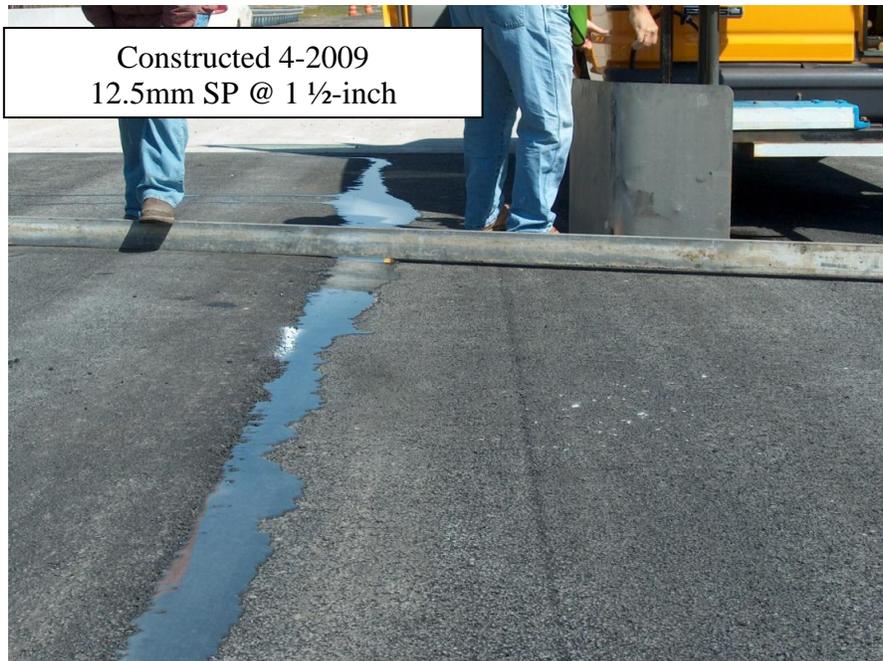
Photo 18- Transverse Joint at Concrete Bridge

The Georgia Department of Transportation has historically evaluated the 100 foot tie-in at bridges for smoothness acceptance using the Reinhart Profilograph. Since extendable screeds have achieved common use status in Georgia, there have been numerous Specified smoothness requirement failures within these bridge tie-ins. Most documented failures have occurred when the paver starts off at a bridge and not where it ties into one. To address this issue, some contractors have elected to use the paver's electronics referencing an established string line when pulling off the bridge ends. Unfortunately, this technique does not seem to account for or correct poor screed set-up. The project detailed in Photo 18 supports this finding in that it was constructed using the electronics referencing a string line. Within this bridge end area, the outside lane was ½-inch higher than the inside lane at the adjoining longitudinal joint. The roadway was constructed with a 2 percent cross slope across both lanes towards the outside shoulder and a water damming effect was evident in the inside lane. Additionally, approximately 40 feet from the bridge deck in the outside lane; a ½ inch irregular knot or bump was measured with a 10-ft straight edge. Ultimately, the contractor had to mill and replace the pavement in order to satisfy the profile index value established in the GDOT Standard Specifications for bridge approach ride quality.

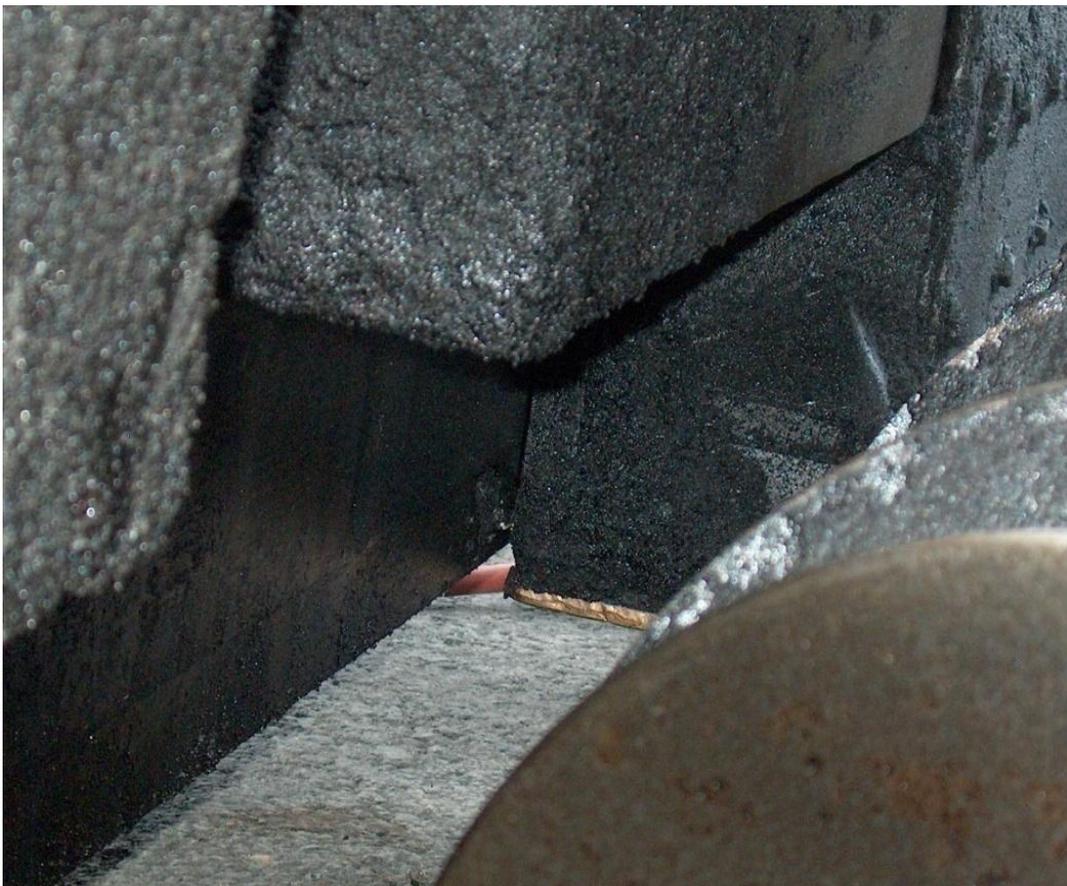
Over the last seven years of using them, it has been determined that self extending screeds possess multiple dead areas or corners between the extensions where cool material collects. This build up appears to be worse with the use of front extendable versions due to the center trapping mix between the extensions (Photo 19). As you are aware, the temperature of the mix flowing under the screed determines its relative height and movement.

Photo 19- Area between Screeds

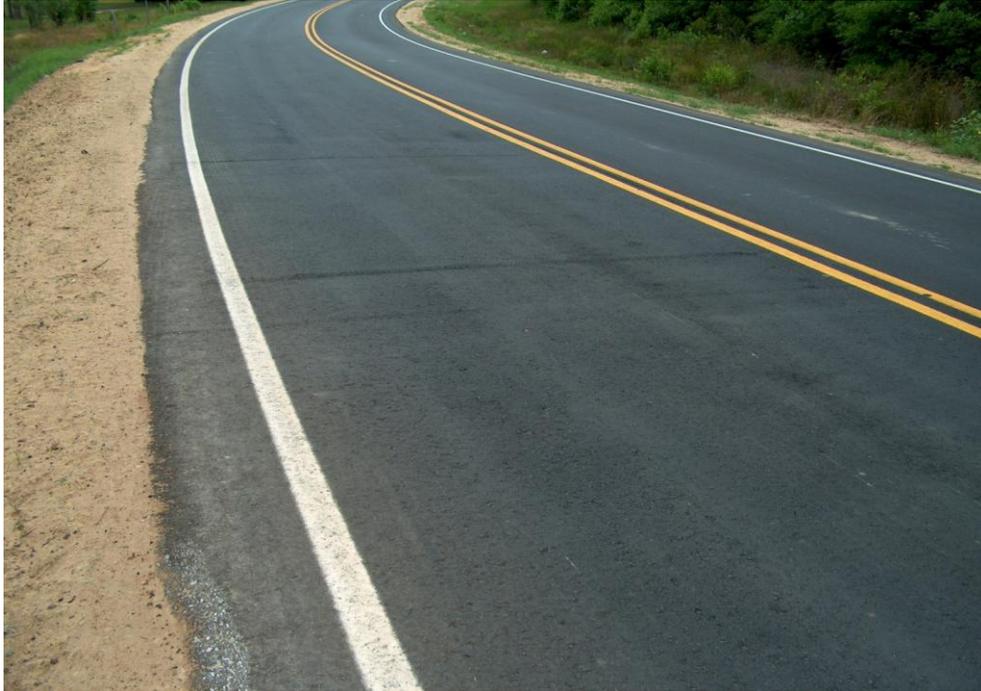
As detailed in Photo 20, the referenced resurfacing project exhibited severe streaking, pulling and tearing from cold lumps of mix and screed marks/knots throughout the entire length.

Photo 20-Project with Streaks Placed with Front Extendable Screed

This project was located more than 40 miles from the plant and the contractor did not supply the correct amount of haul trucks to maintain a continuous placement operation. The tendency for material to be trapped between the extensions seems to be more aggravated with the use of finer mixes placed at thinner lifts without the use of a MTV during cooler ambient temperatures. The project depicted in Photo 21 was placed on a hot summer day with a rear extendable screed.

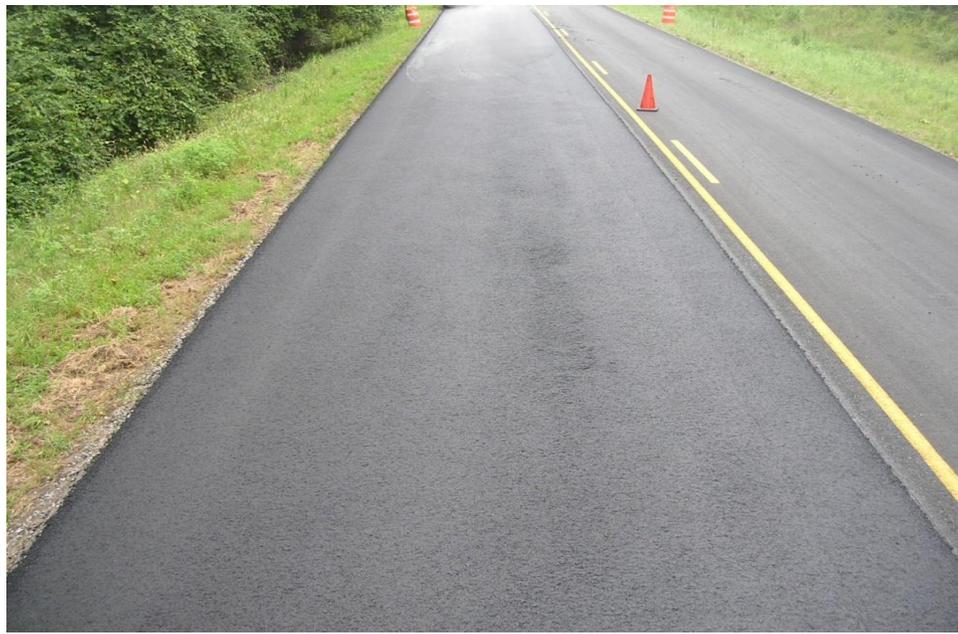
Photo 21-Project Placed with Rear Extendable Screed

Even though the ambient temperature was optimum for paving, the plant was more than 50 miles away and a MTV was not used. There were numerous interruptions in placement and delays while waiting for trucks which allowed the mix accumulated in the dead areas to cool. Poor ride quality, unacceptable bumps and knots, and marginal density were the results. When using self extending screeds, it is imperative to maintain a continuous operation; especially with finer dense graded mixes as previously mentioned in this report.
