*Archaeological Mitigation at the 17A Derelict Vessel Site
on Back River, Chatham County, Georgia*

Project No. NH-009-2(93)
P. I. No. 522920

Dr. Gordon P. Watts, Jr.
Principal Investigator
Tidewater Atlantic Research, Inc.
Post Office Box 2494
Washington, North Carolina 27889

12 October 2008

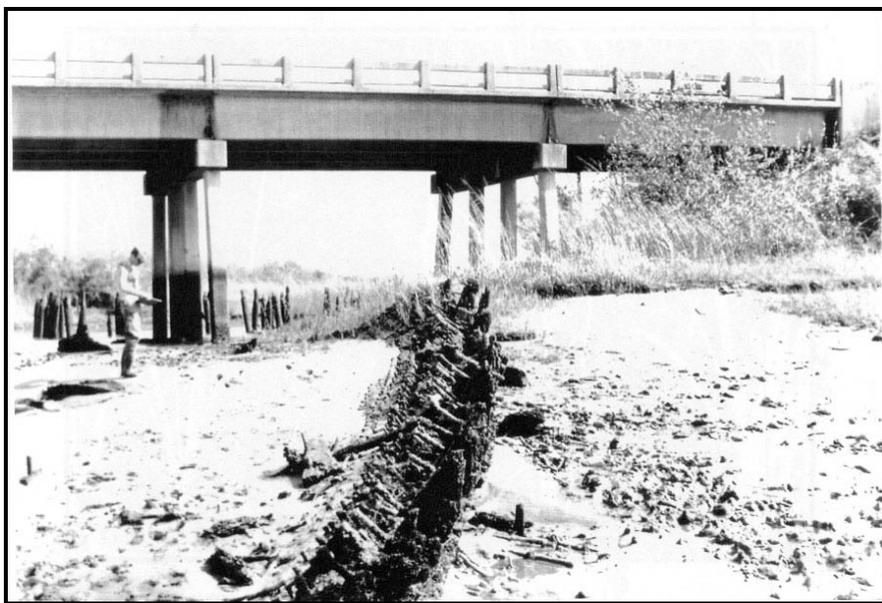
Figure 29. Exposed remains of the GA BR 17 derelict in 1991.

During the 1991 TAR survey GA BR 17 (Figure 29) was identified as a heavily constructed sailing vessel that measured 121 feet in length and 26 feet 8 inches in width (Figure 30). The keelson was 12 inches wide with two possible mast steps. The interior planking measured in random widths, 9 to 11 inches, and were 4 inches thick. The exterior planking measured 2 inches thick. Iron spikes attached the inner planks to the futtocks. The 9- by 9-inch futtocks were located on 1-foot centers. The space between the exterior surface of the outer planking and the inner surface of the ceiling measured 1 foot 5 inches. The construction features suggested the vessel was built sometime in the late 19th or early 20th century. The vessel was determined to be potentially eligible for inclusion in the National Register of Historic Places. Recommendations included additional investigation and monitoring to identify impacts associated with the New Cut Closure Project and opening the Back River Tide Gate (TAR 1995:113).

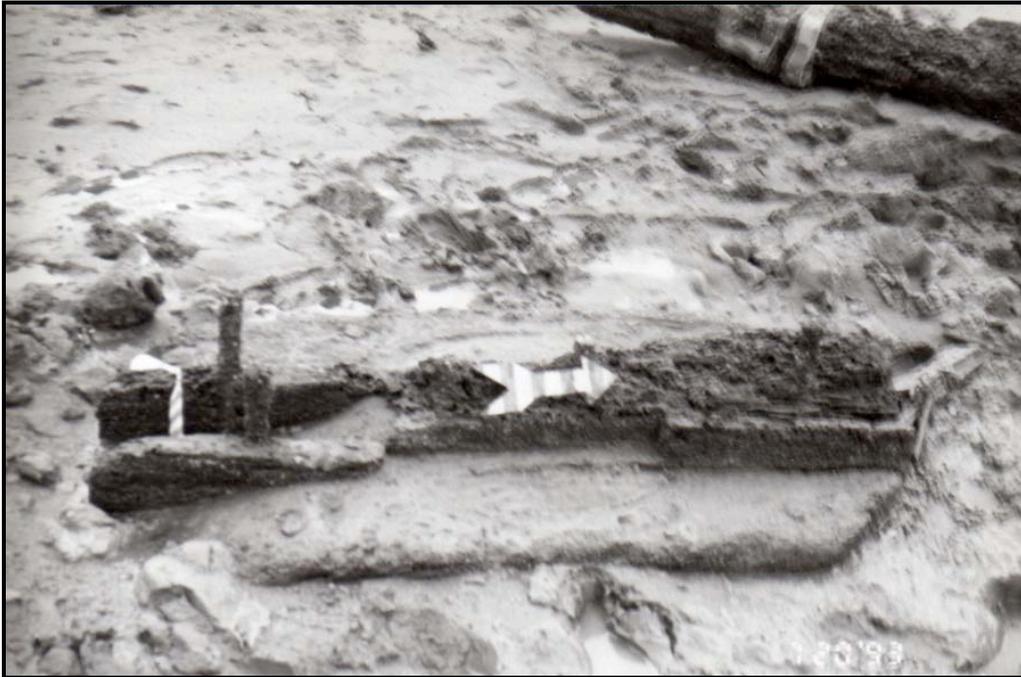
Figure 36. Remains of the mainmast step in 1993 (USACE, Savannah).

Their length was slightly shorter than the step at 4 feet 5 inches. The chocks appeared to have been bolted to timbers attached to either side of the keelson. The diameter of the heel of the mast was calculated to be 19 inches (Figure 36). Based on the step design the heel of the mast would have been rebated to fit into a saddle step (USACE 1994:159-160).

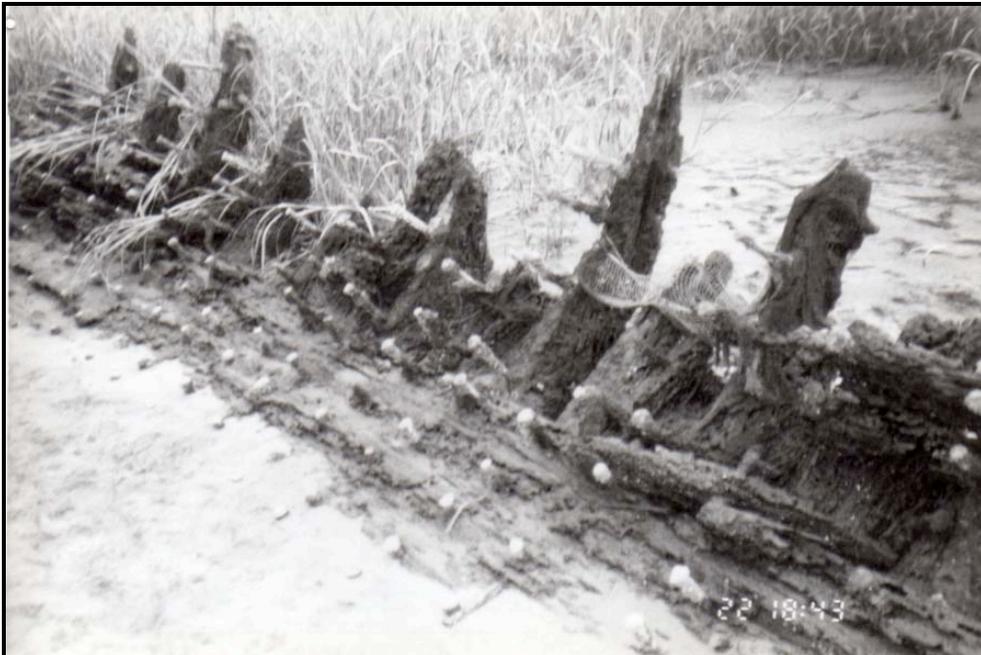
Figure 37. Starboard side of the hull illustrating the futtock and fastener pattern (USACE, Savannah).

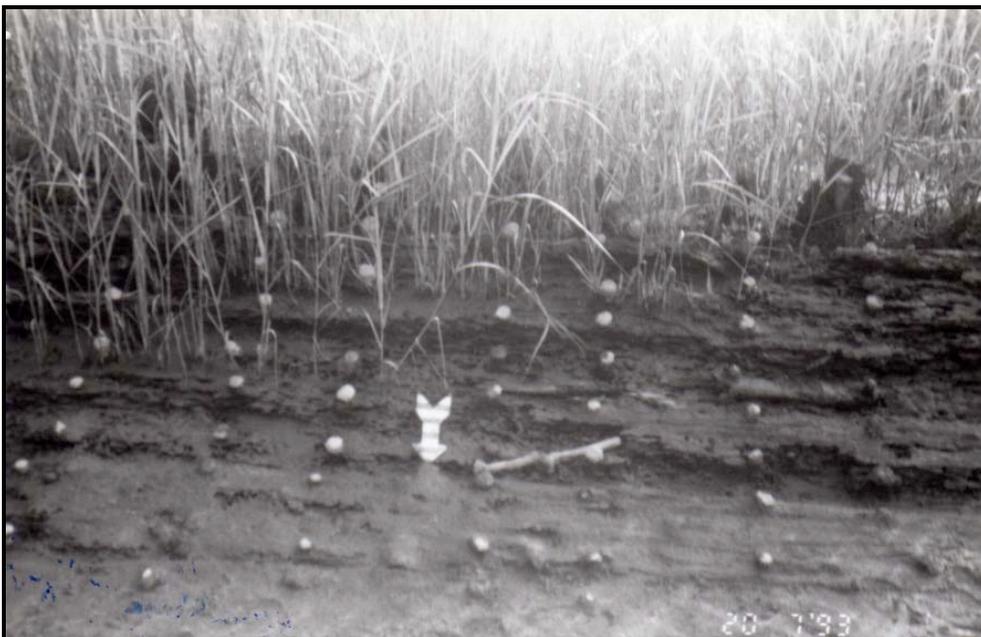
Figure 38. Remains of the starboard bilge wales and fasteners in 1993 (USACE, Savannah).

Leech and Cook reported that the GA BR 17 vessel was fitted with a “double ceiling” with a thickness of 6 inches (Figure 38). A sample of that material proved to be spruce. Iron drift bolts, 1 inch in diameter and 12 inches in length attached the ceiling to the futtocks. Two bolts were employed per ceiling strake on the centerline of every futtock. Wedged black locust trunnels, 1 1/4 inches in diameter and 17 inches in length, were also occasionally employed to attach the ceiling (USACE 1994:161).

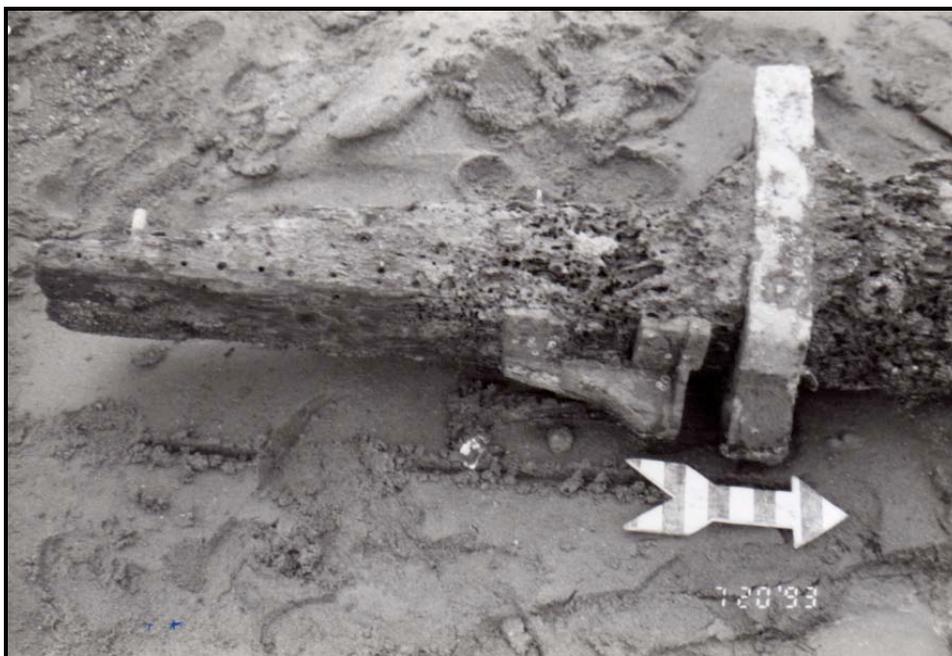
Figure 39. Lower section of sternpost with gudgeon and pintle stop (USACE, Savannah).

While not addressed in the text, illustrations in the report documented the partial remains of the inner sternpost, sternpost and rudder. Both elements of the wreck structure were found disarticulated and lying inside the hull remains. The fragment of inner sternpost and sternpost (Figure 39) measured 11 feet in length contained a brass or possibly Muntz metal gudgeon strap and pintle stop. The smaller section of the rudder (Figure 40) measured approximately 5 feet in length and contained a matching brass or possibly Muntz metal pintle (USACE 1994:162).

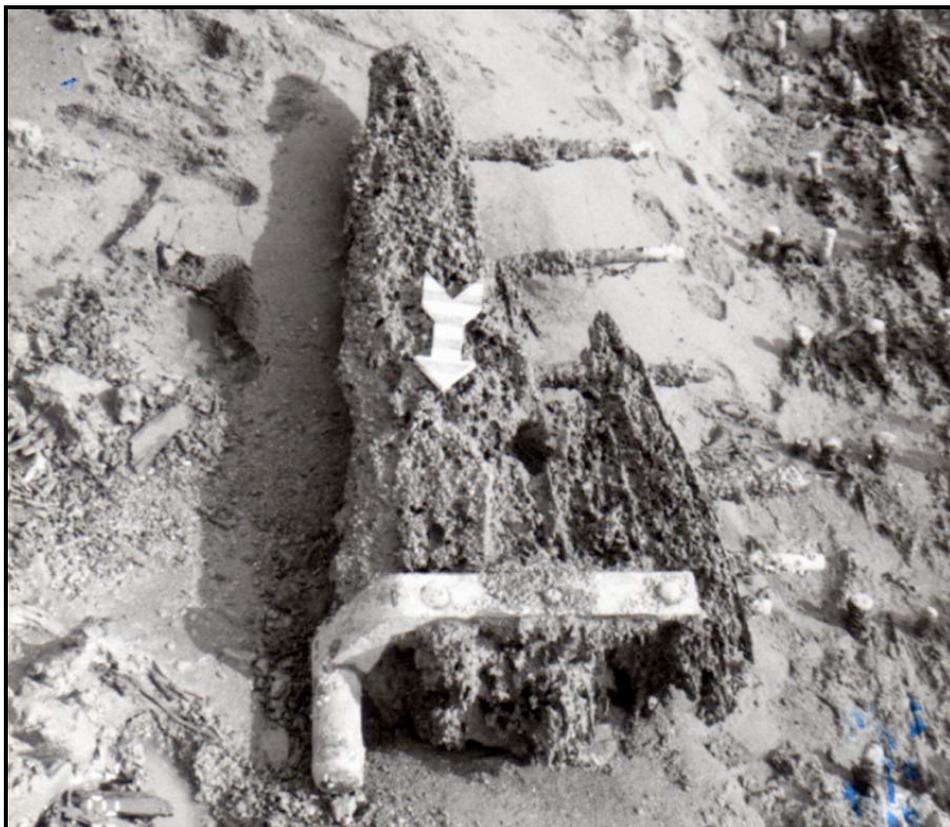
Figure 40. Section of the rudder with pintle attached (USACE, Savannah).

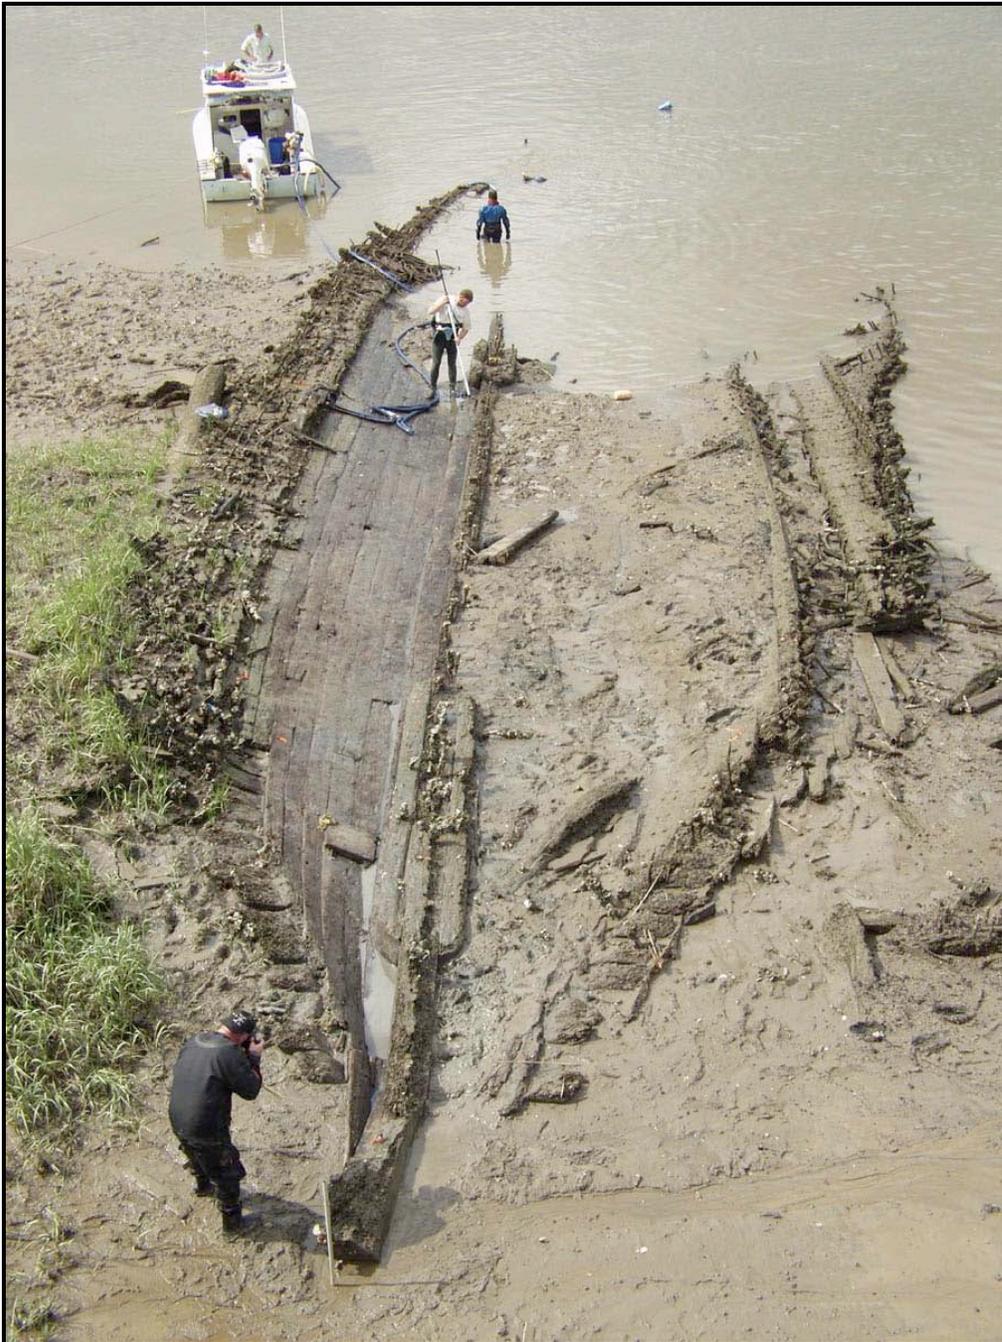
Figure 52. Extent of surviving hull remains in 2008.

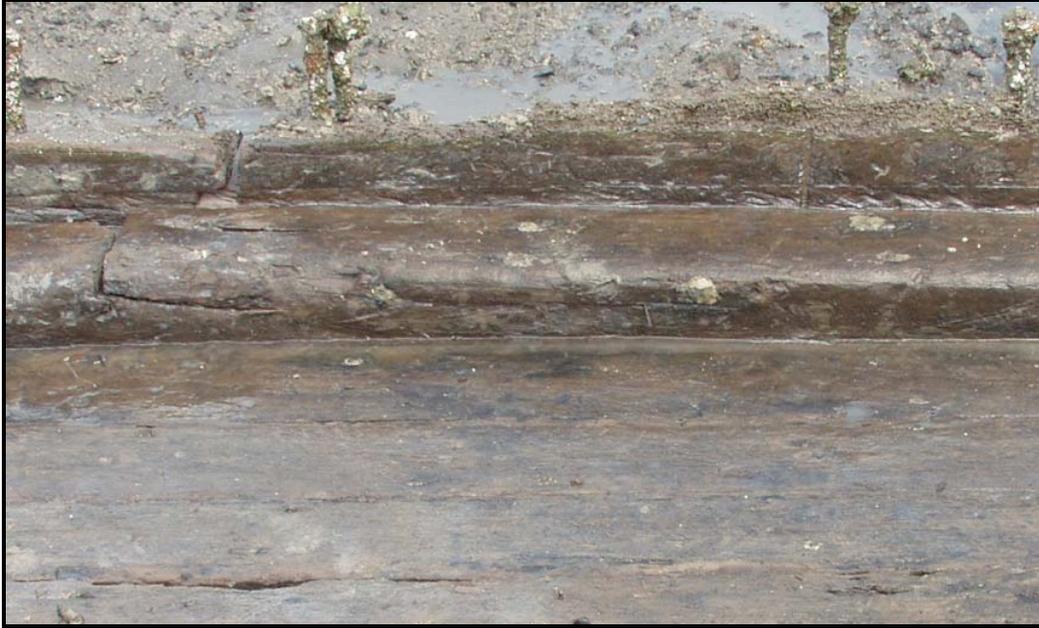
Figure 53. Bilge ceiling, keelson, rider keelson and starboard sister keelson showing scarfs and fastening pattern.

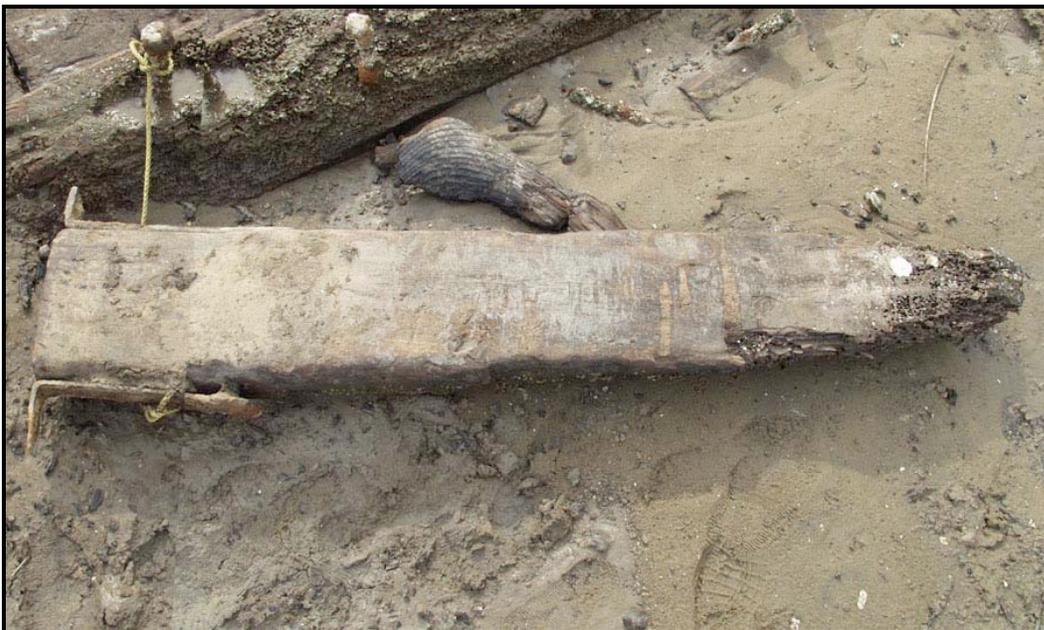
Figure 54. Stanchion found inside the hull.

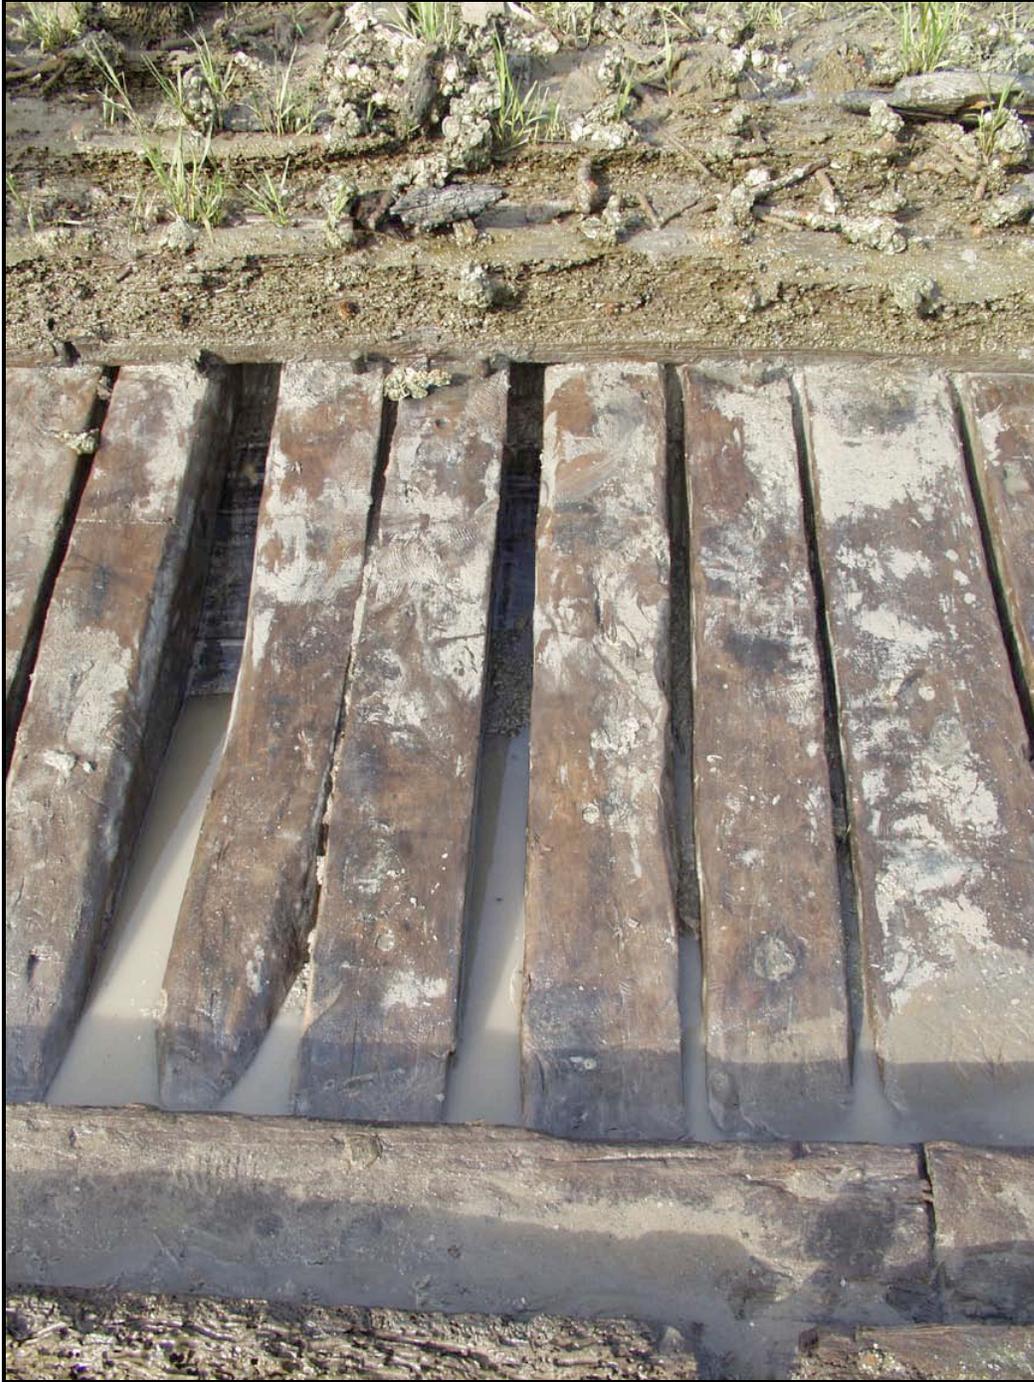
Figure 55. Pattern of floors and first futtocks exposed on the starboard side of the hull.

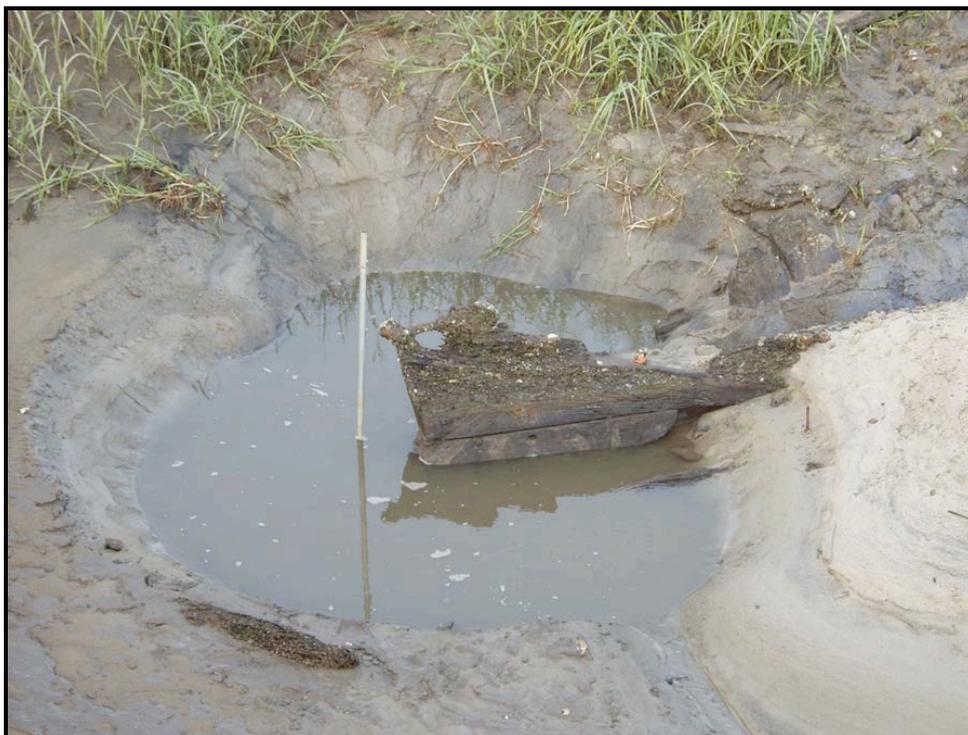
Figure 56. Remains of the bow with deadwood and knee visible.

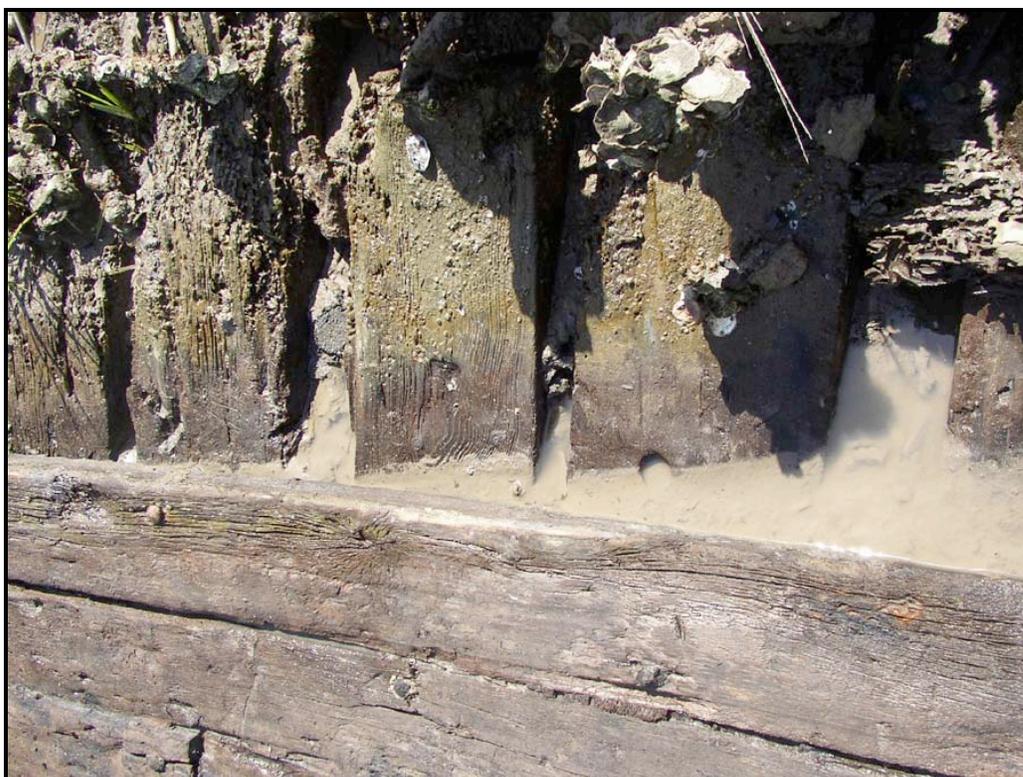
Figure 58. Cant frames on the starboard bow.

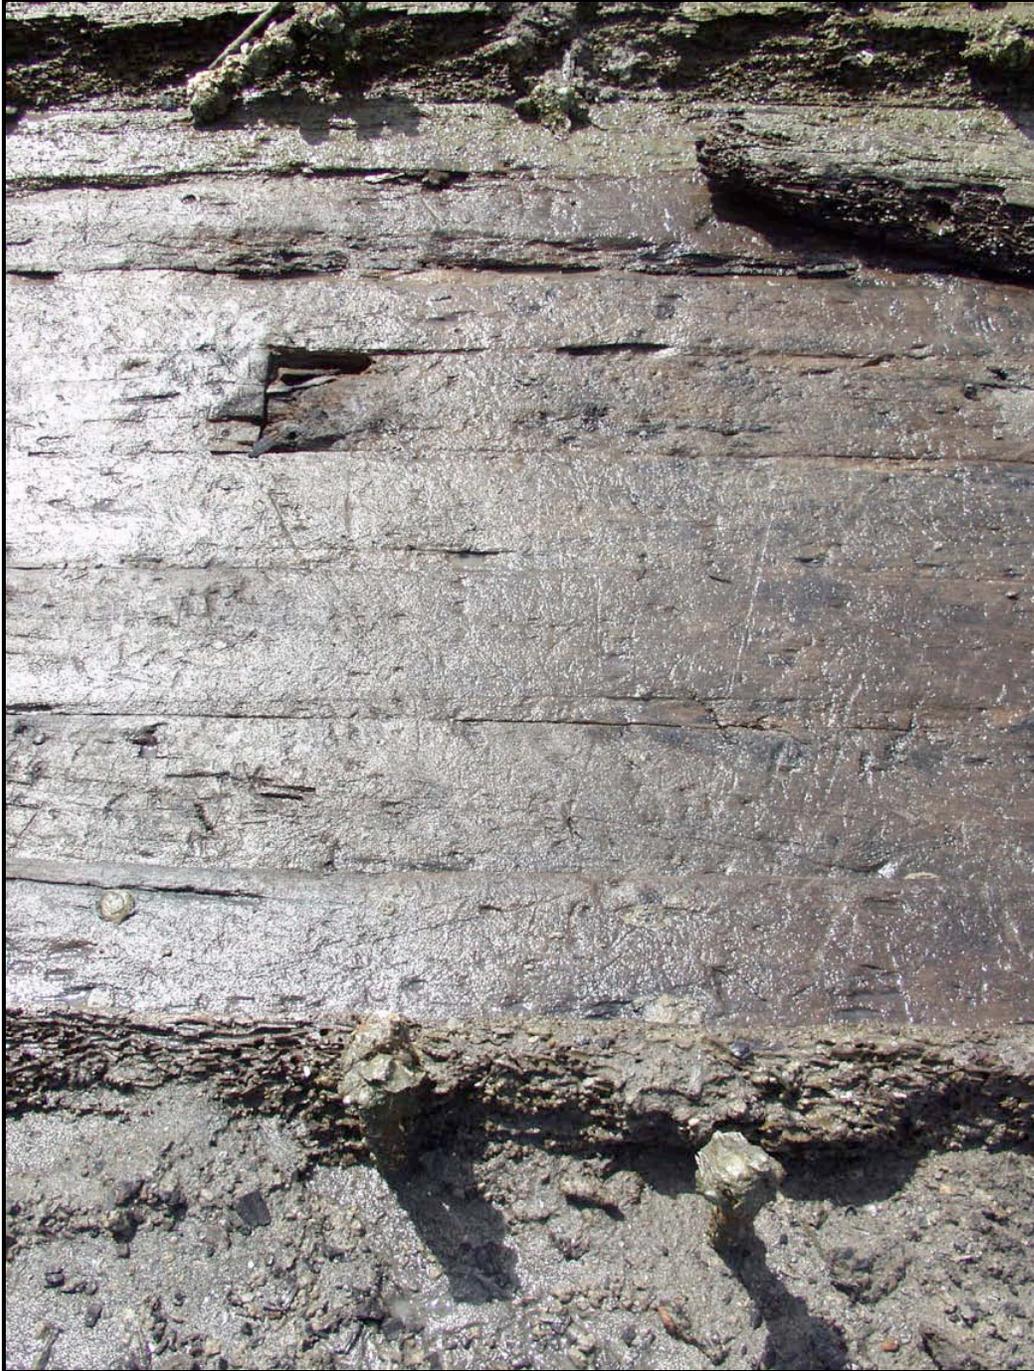
Figure 60. Bilge ceiling planking adjacent to the foremast.

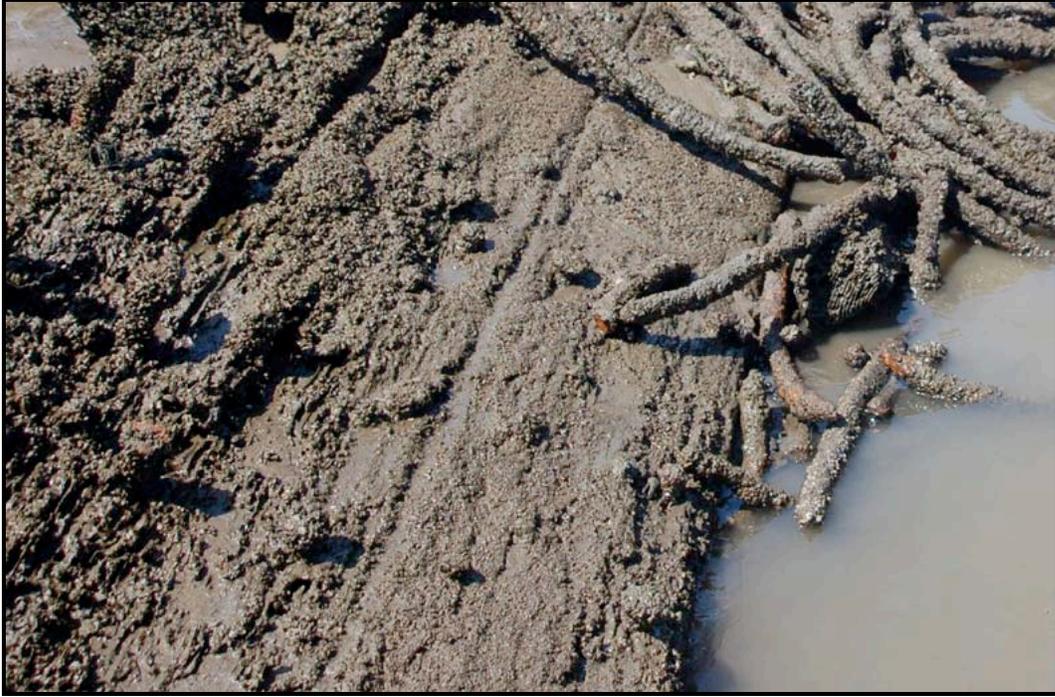
Figure 61. Configuration of the bilge wales aft of the mainmast on the starboard side.

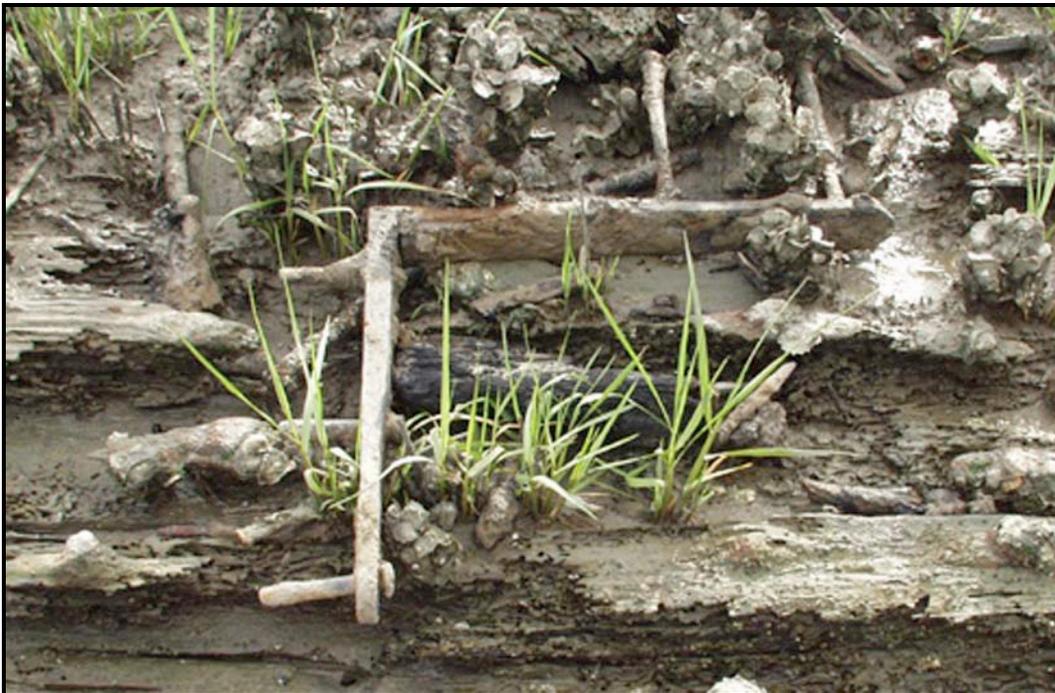
Figure 62. Single disarticulated iron knee recovered from the bilge ceiling near the foremast.

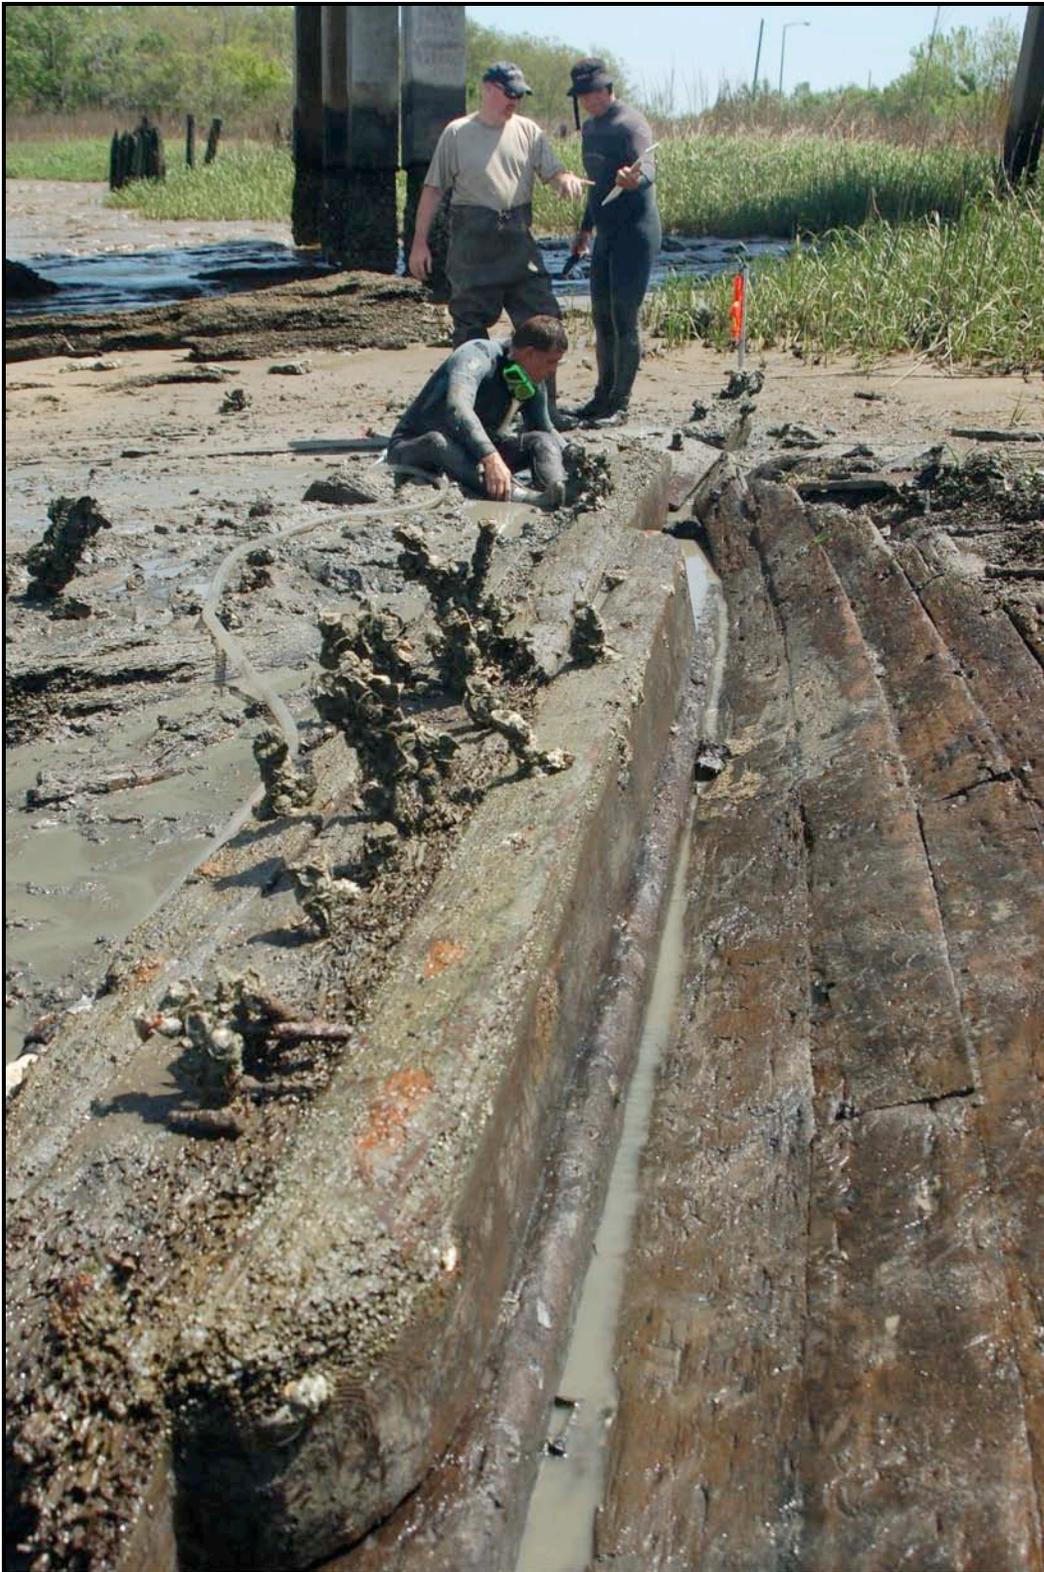
Figure 63. Butters for the foremast step.

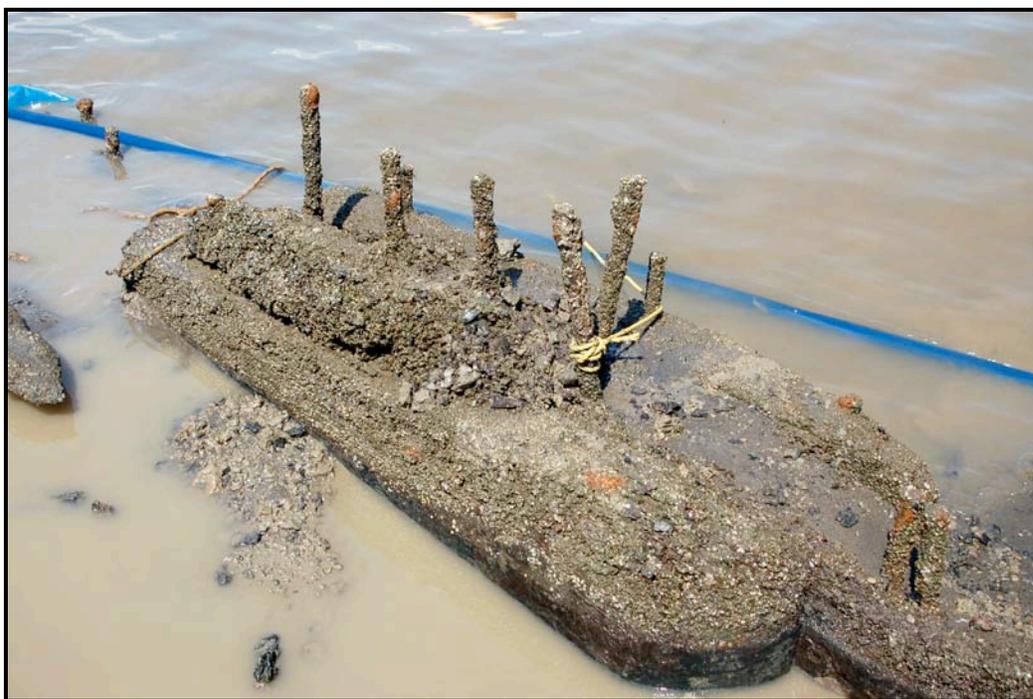
Figure 64. Mainmast showing buttresses.

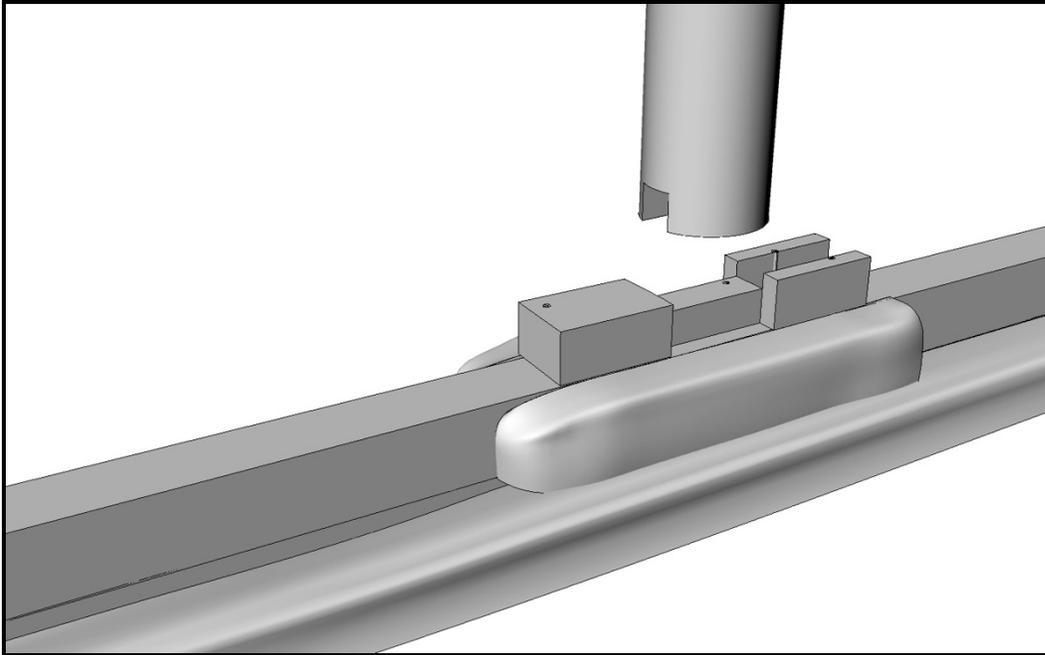
Figure 65. Configuration of the mainmast step and heel of the mast.

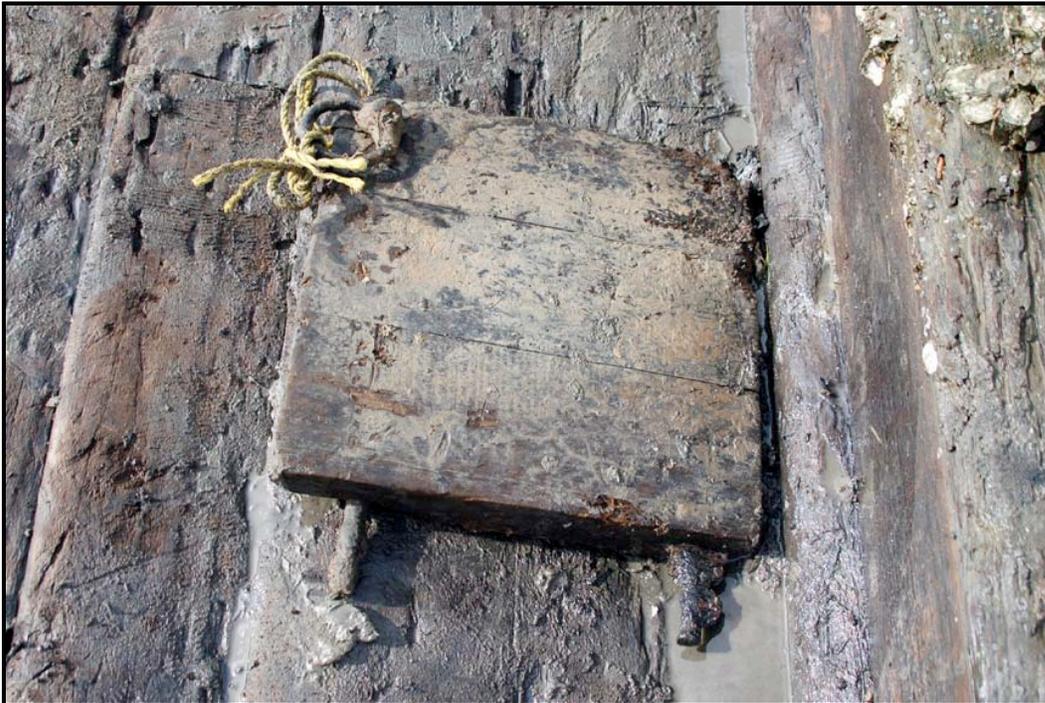
Figure 66. Hatch for lumber port.

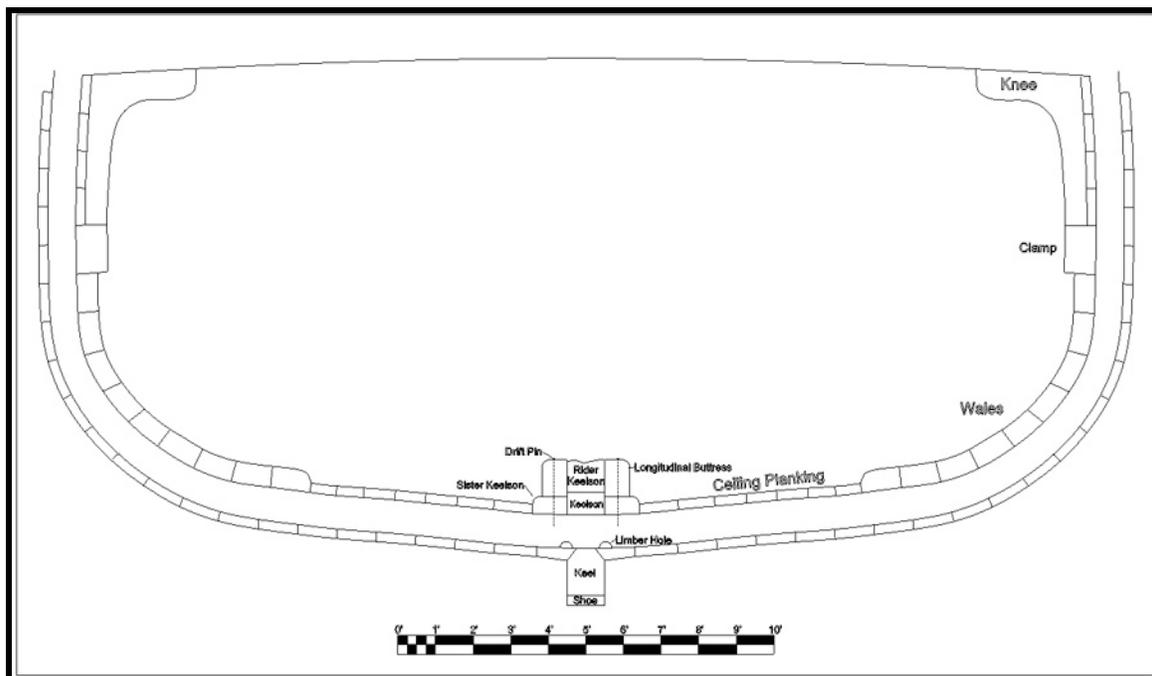
Figure 101. Hull section reconstruction at the mainmast step.

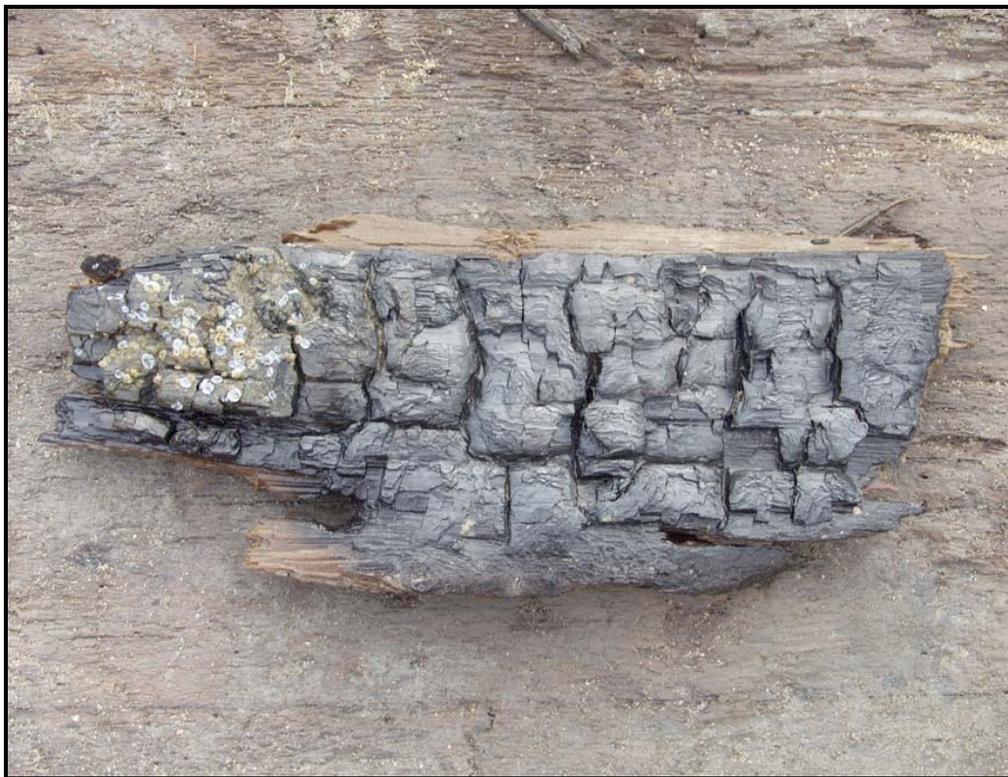
Figure 102. Example of charred wood from the hull.

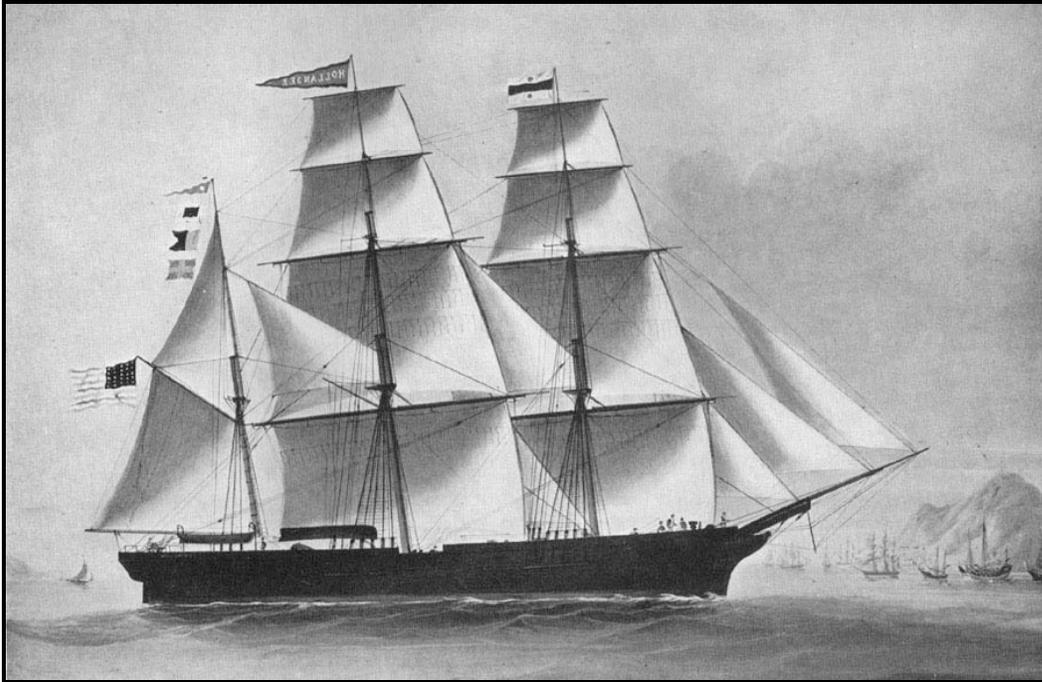
Figure 103. Mast placement on the bark *Hollander* built at Newburyport, Massachusetts in 1849 (Robinson and Dow 1924:405)

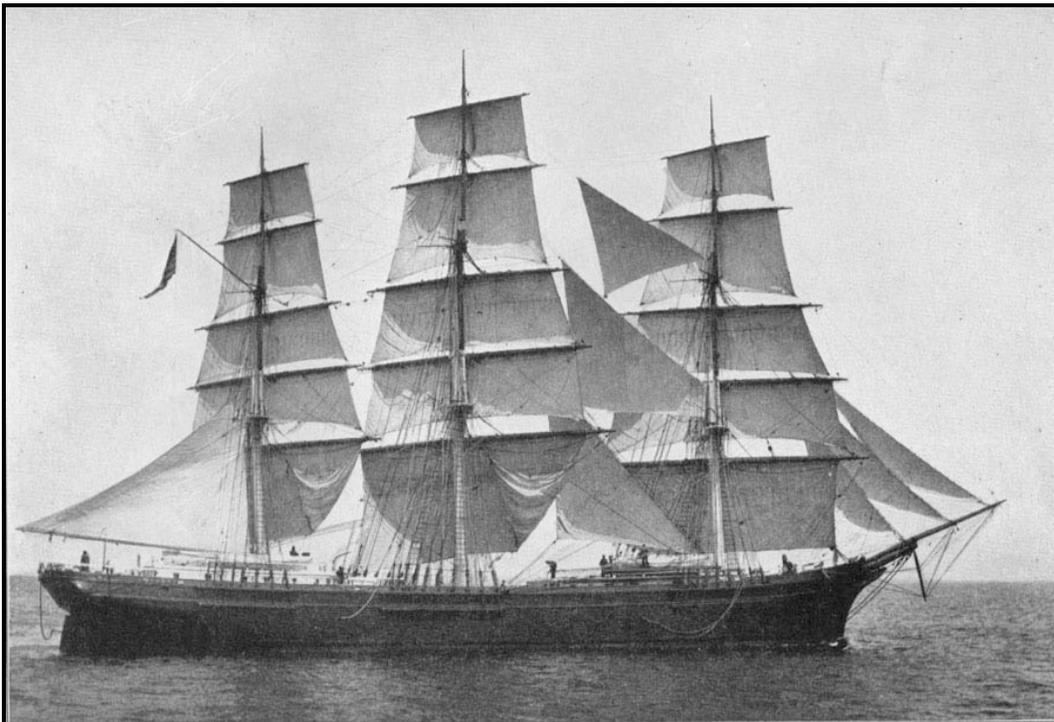
Figure 104. Mast placement on the ship *Panay* built at East Boston in 1877 (Robinson and Dow 1924:471).

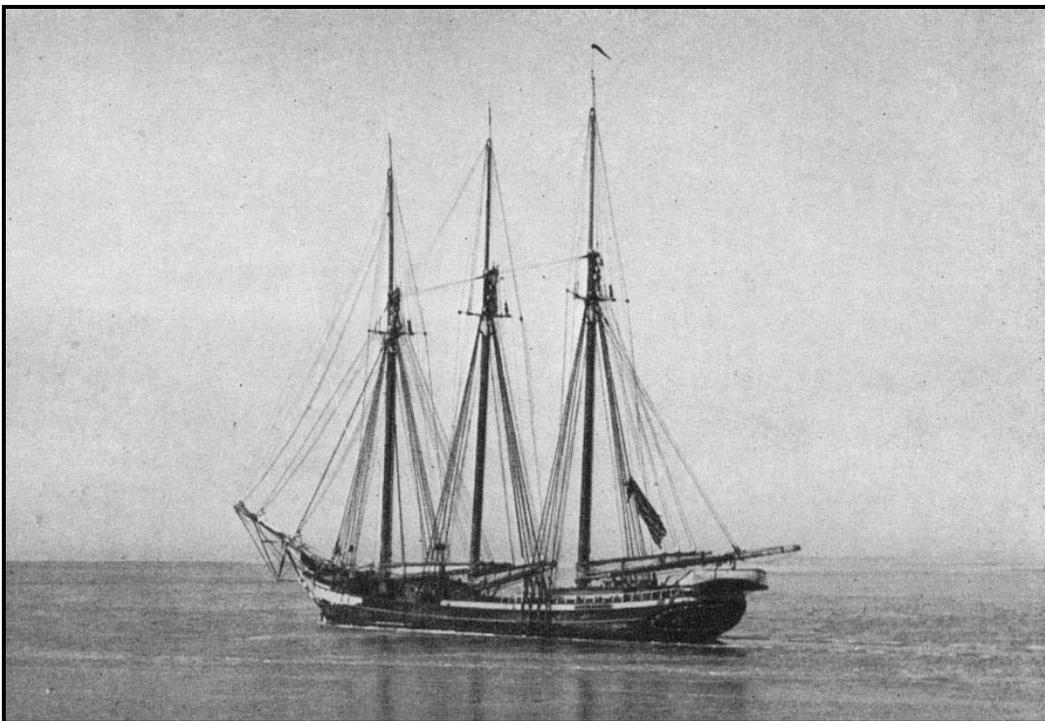
Figure 105. Mast placement on the tern schooner Peter H. Crowell built at East Boston in 1873 (Robinson and Dow 1924:473).

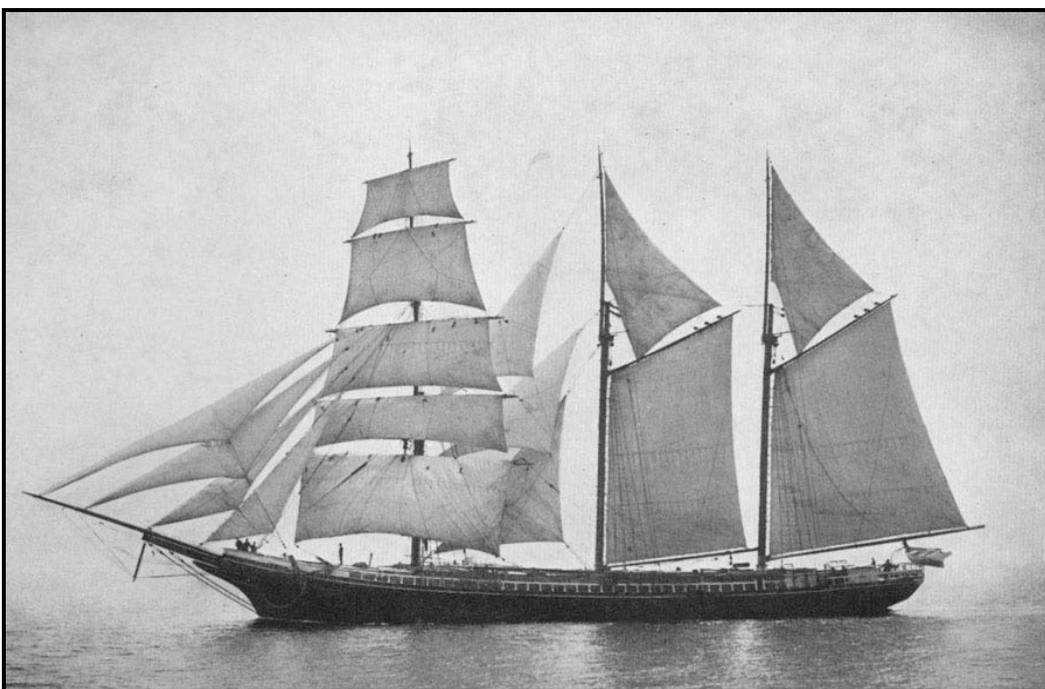
Figure 106. Mast placement on the barkentine Rachel Emory built at Waldoborough, Maine in 1883 (Richardson and Dow 1924:487).

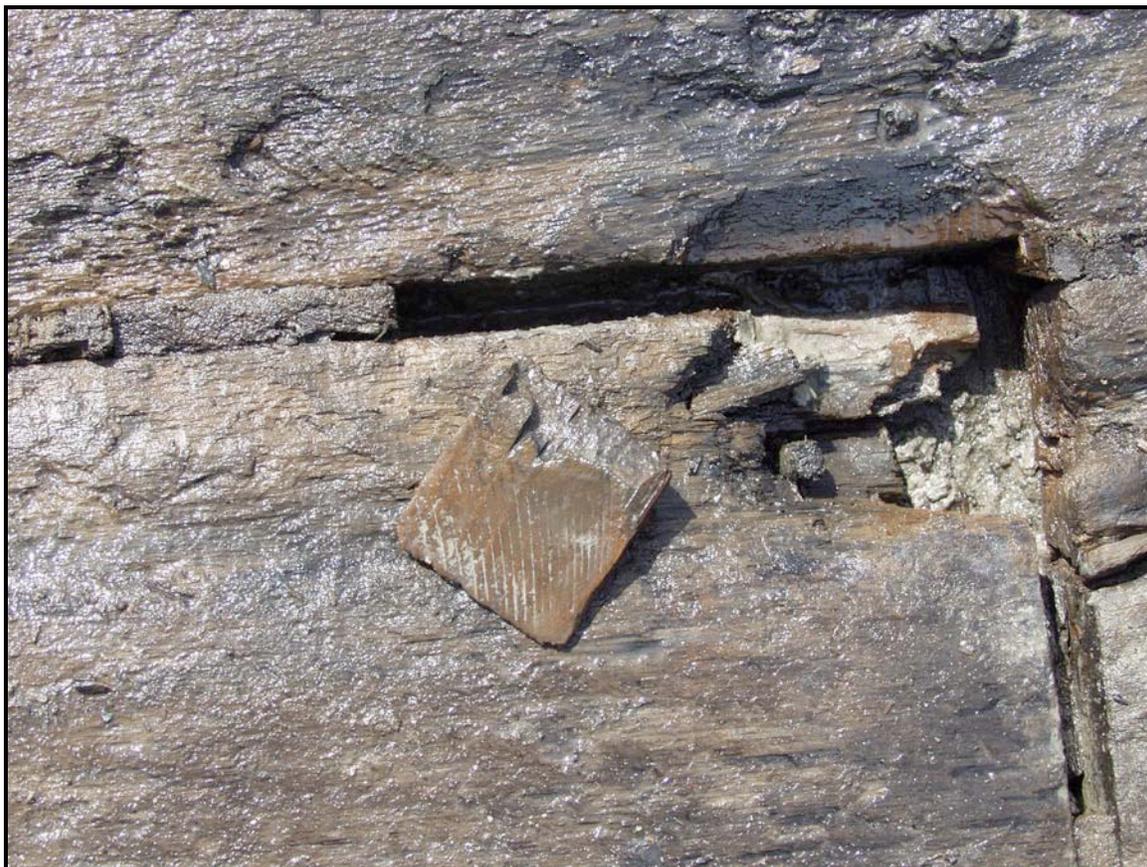
Figure 107. Bilge ceiling wedges with circular saw marks.
