*Archaeological Mitigation at the 17A Derelict Vessel Site
on Back River, Chatham County, Georgia*

Project No. NH-009-2(93)
P. I. No. 522920

Dr. Gordon P. Watts, Jr.
Principal Investigator
Tidewater Atlantic Research, Inc.
Post Office Box 2494
Washington, North Carolina 27889

12 October 2008

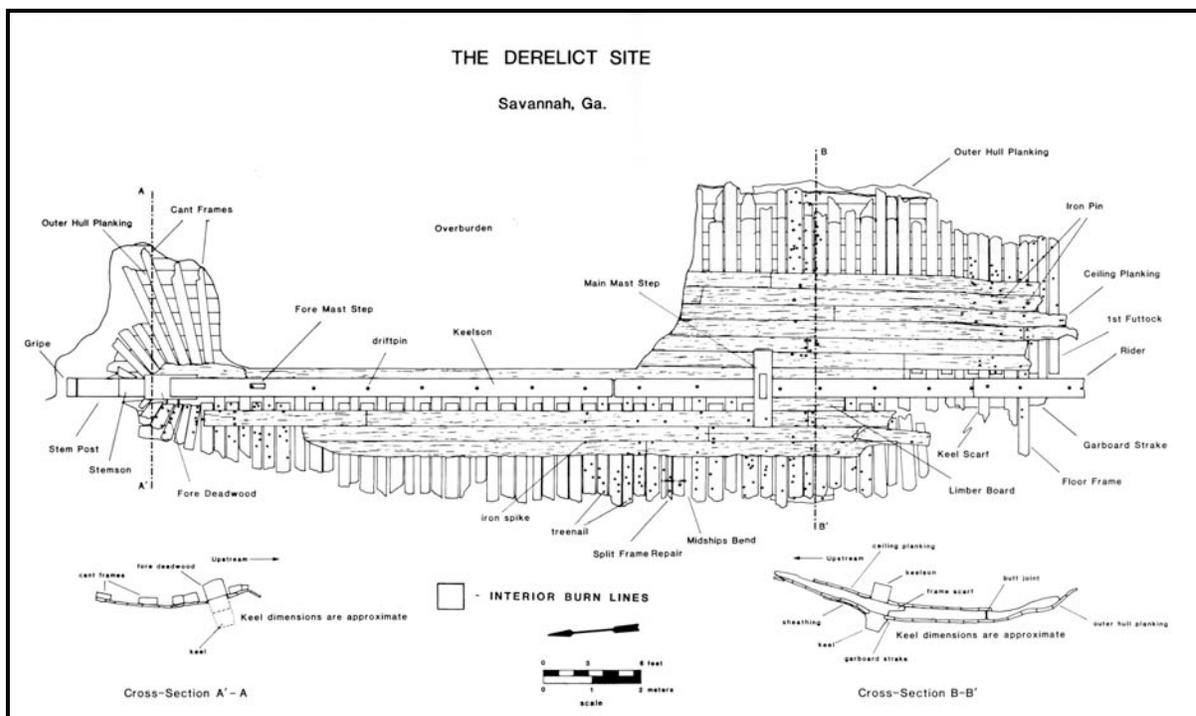
Figure 108. Plan of the derelict vessel excavated by OSM Archaeological Consultants, Inc., in 1987.

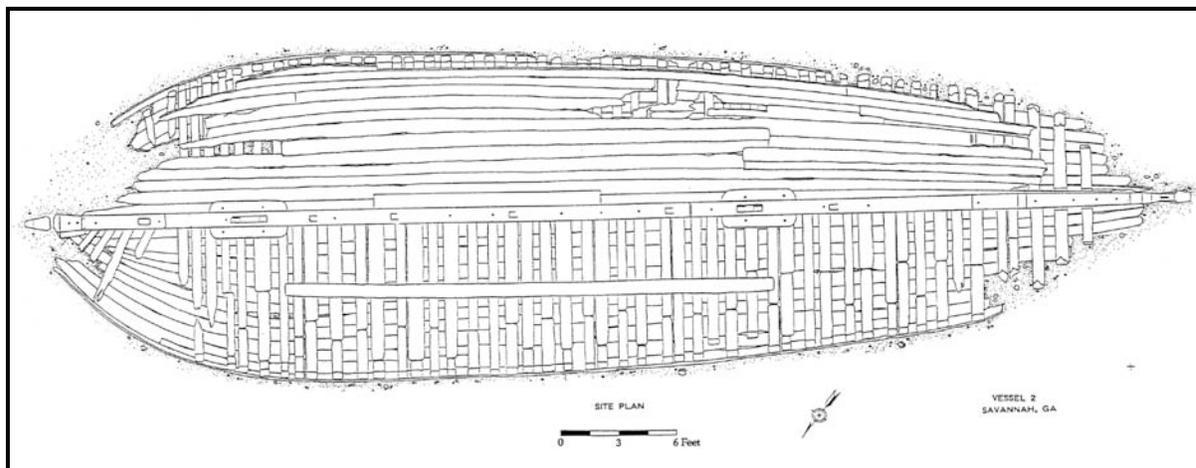
Figure 109. Plan of derelict vessel No. 2 excavated by Tidewater Atlantic Research, Inc., in 1993.

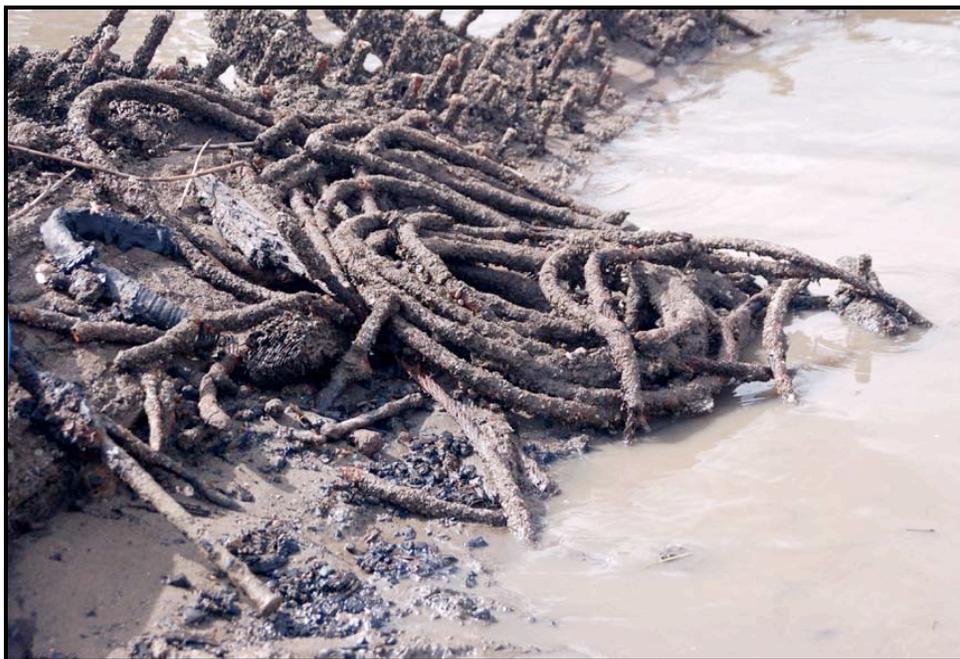
Figure 110. Wire rope, apparently standing rigging removed and stowed when the vessel burned.

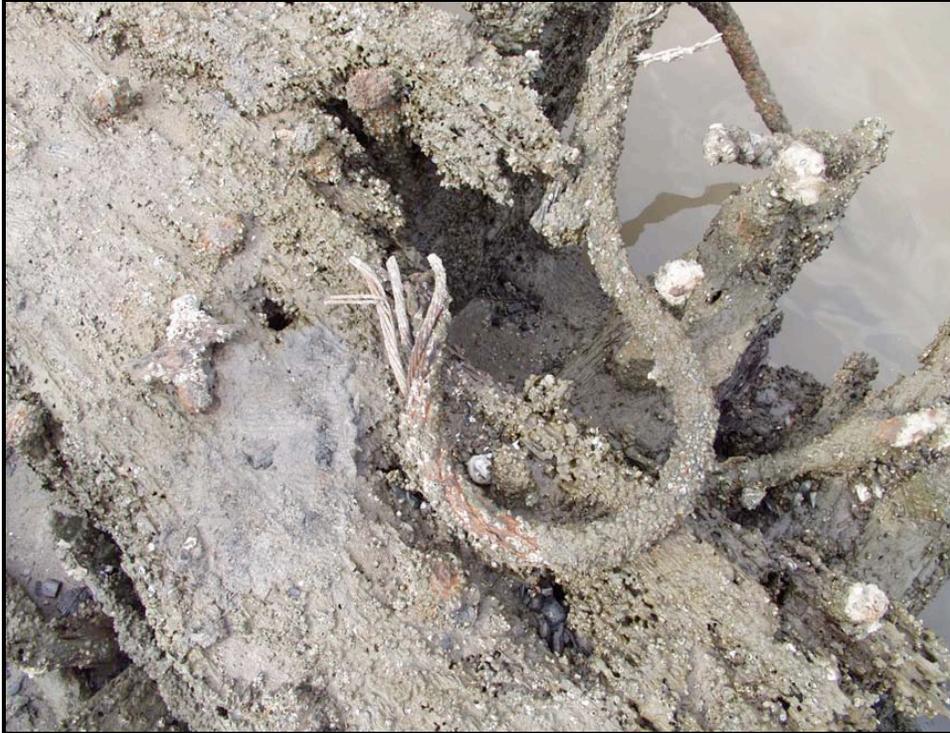
Figure 111. Wire rope on the port side of the hull cut to remove a deadeye.

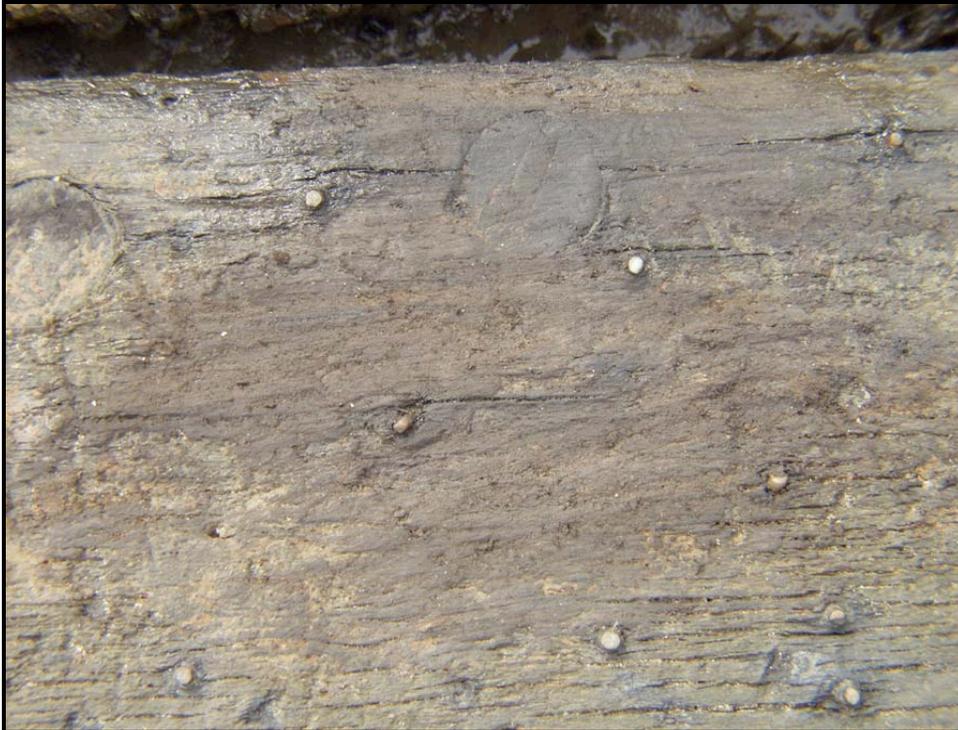
Figure 112. Headless tacks illustrate the method of removing sheathing from the hull.
