TRAFFIC ENGINEERING STUDY

PRIMARY ROUTE: SR 154 / Memorial Dr

SECONDARY ROUTE: Vannoy St to Oakridge Ave

PREPARED BY: AECOM

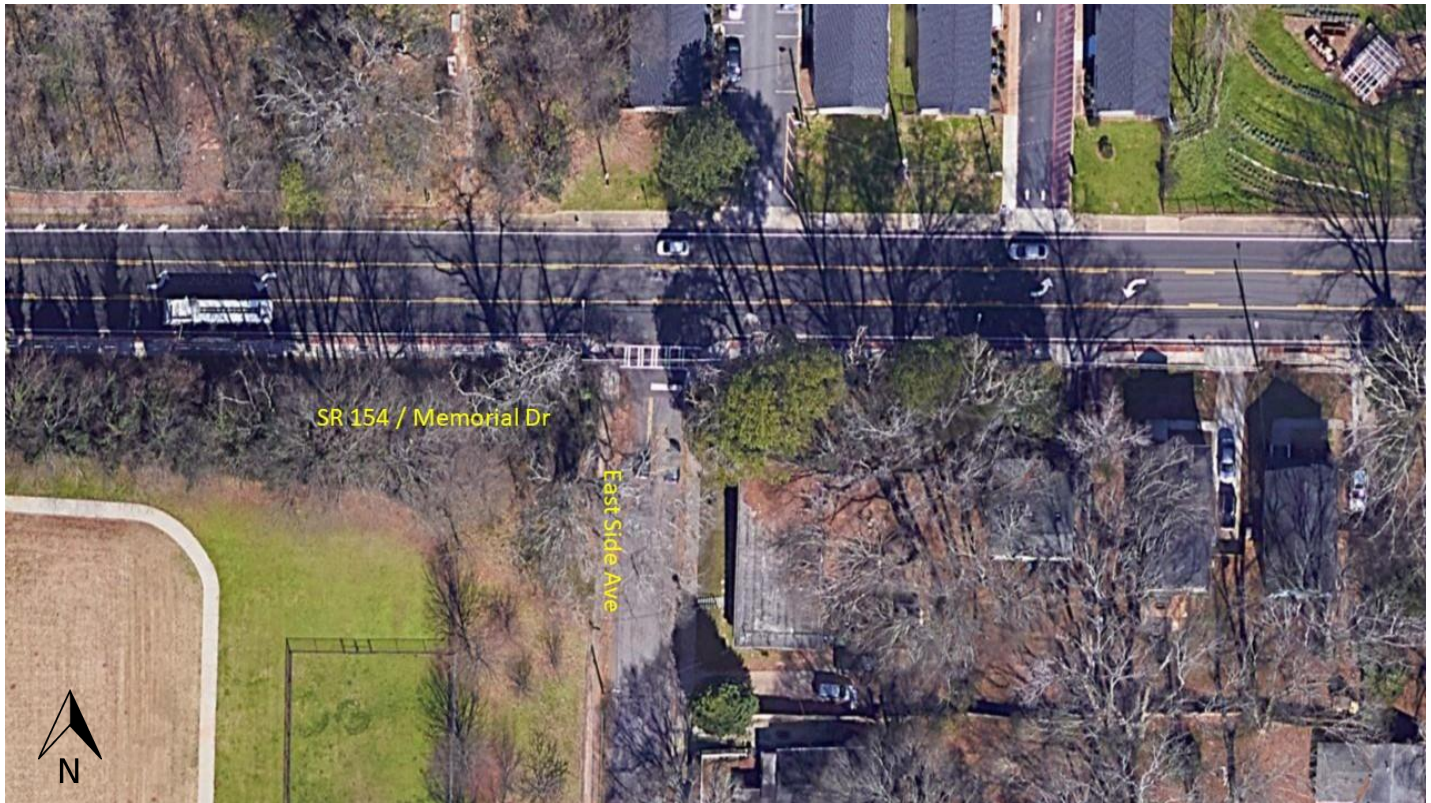
Intersection #4: East Side Ave

SR 154 and East Side Ave converge at approximately 90° to form a 3-leg intersection with at least 36' of width along the mainline. There is one (1) painted crosswalk across East Side Ave on the south side of SR 154.

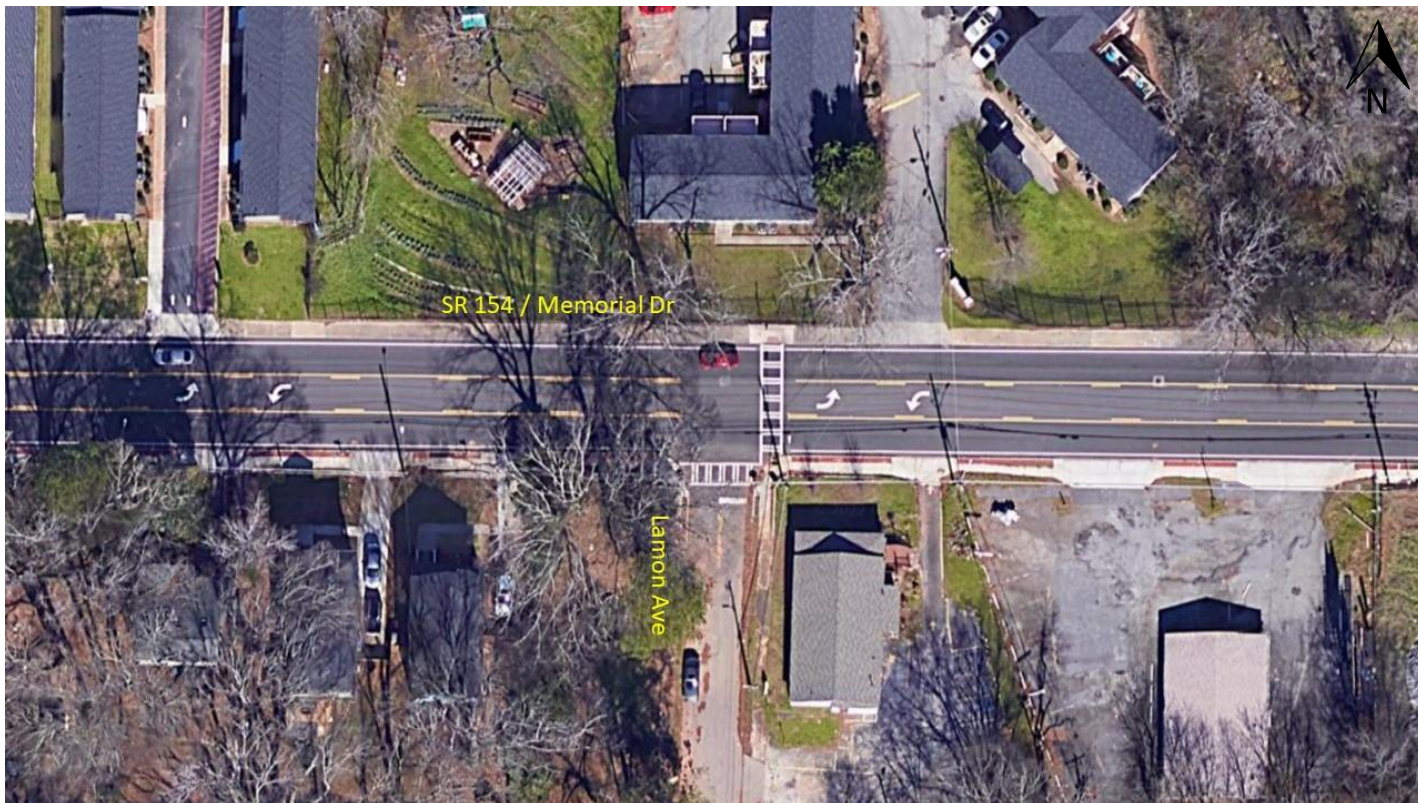
Intersection #5: Lamon Ave

SR 154 and Lamon Ave converge at approximately 90° to form a 3-leg intersection with at least 36' of width along the mainline. There is one (1) painted crosswalk across Lamon Ave on the south side of SR 154 and one (1) painted crosswalk across SR 154 on the east side of Lamon Ave with two (2) high-visibility pedestrian crossing (W11-2) signs.

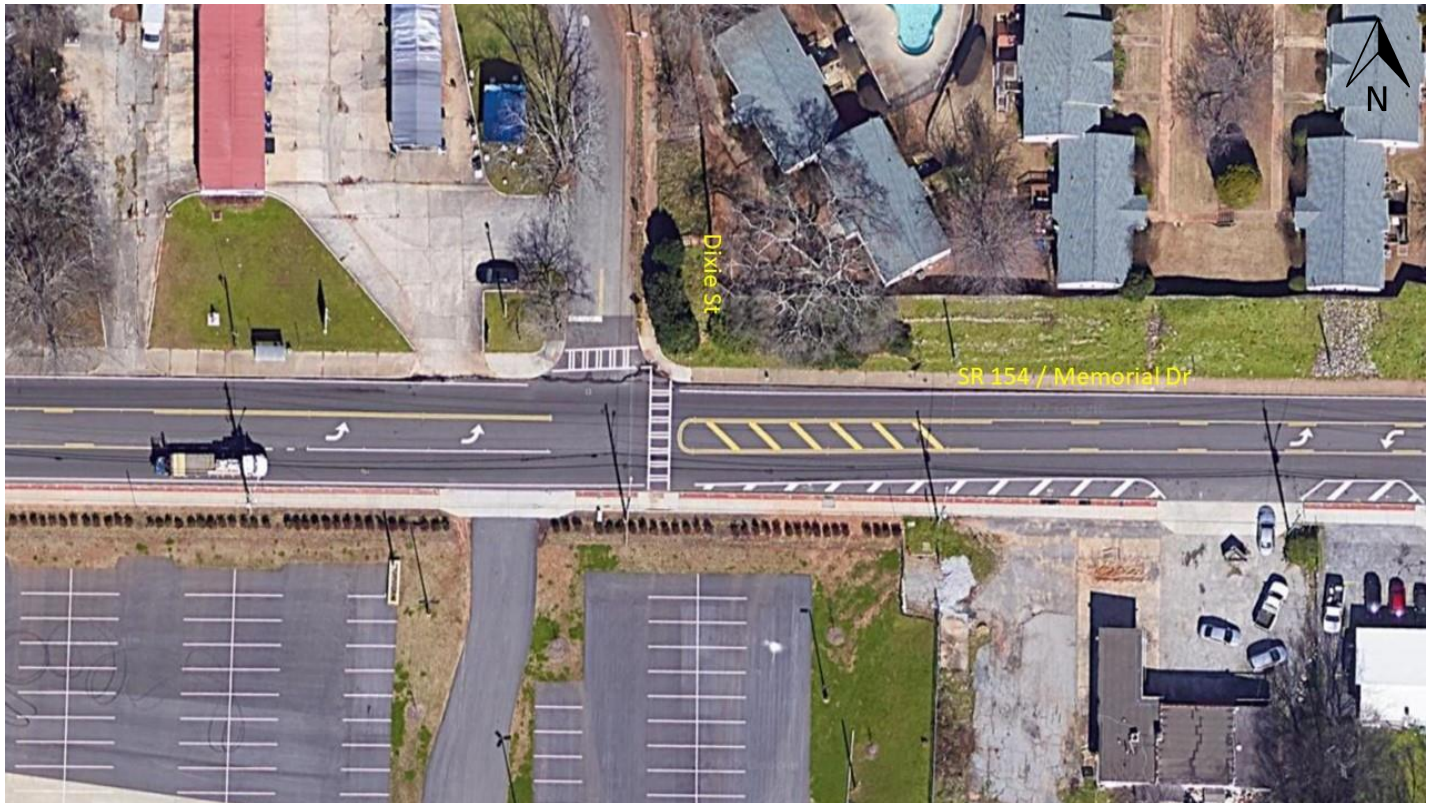
Intersection #6: Dixie St

SR 154 and Dixie St converge at approximately 90° to form a 3-leg intersection with at least 36' of width along the mainline. There is one (1) painted crosswalk across Dixie St on the north side of SR 154 and one (1) painted crosswalk across SR 154 on the east side of Dixie St. A dedicated eastbound left turn lane is provided on SR 154.

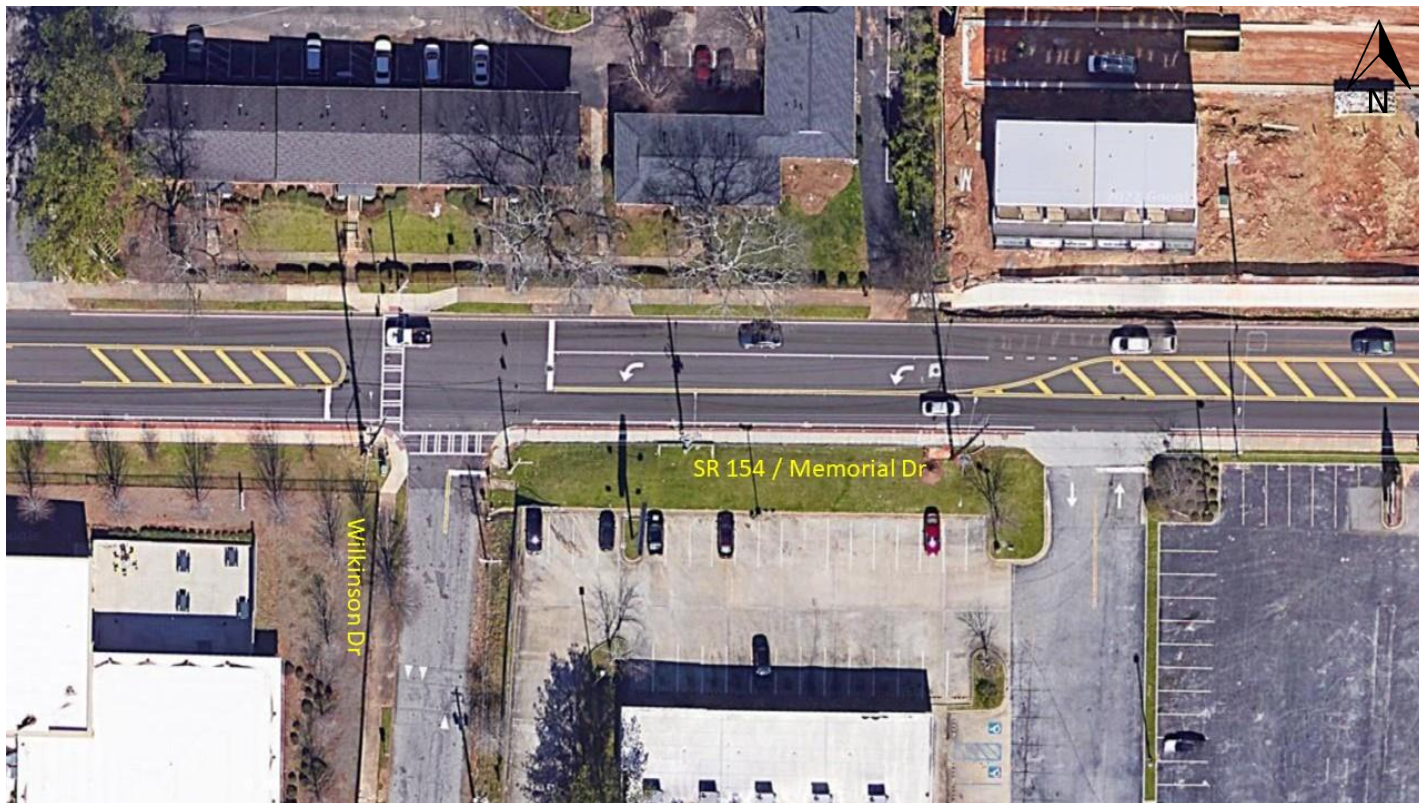
Intersection #7: Wilkinson Dr

SR 154 and Wilkinson Dr converge at approximately 90° to form a 3-leg intersection with at least 36' of width along the mainline. There is one (1) painted crosswalk across Wilkinson Dr on the south side of SR 154 and one (1) painted crosswalk across SR 154 on the west side of Wilkinson Dr. A dedicated westbound left turn lane is provided on SR 154.

This intersection is fully signalized with all left turn, through, and right turn movements allowed. Pedestrian signal heads are present for all crosswalks. Traffic control signs and signal conditions are described below.

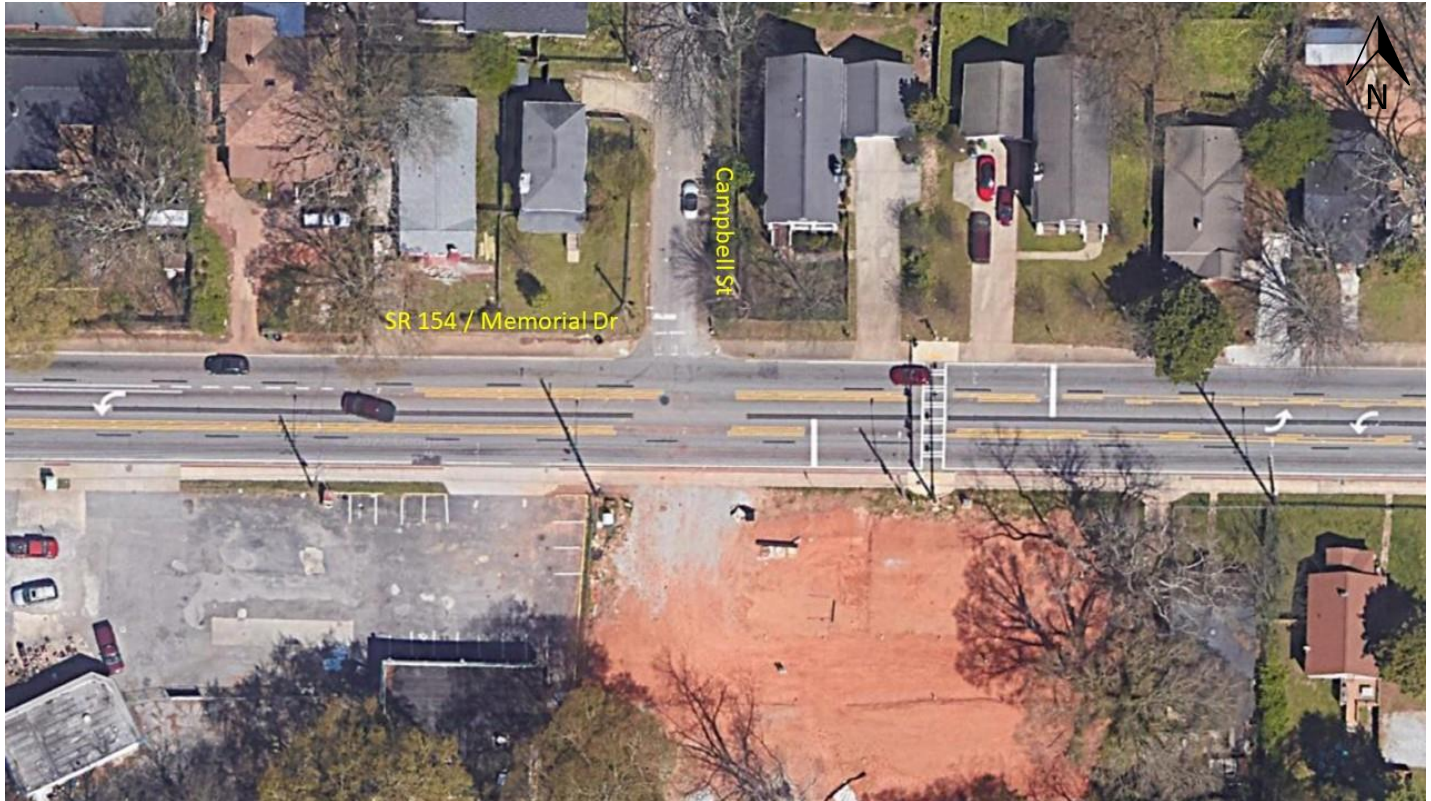
Intersection #10: Campbell St

SR 154 and Campbell St converge at approximately 90° to form a 3-leg intersection with at least 38' of width along the mainline. There is one (1) painted crosswalk across Campbell St on the north side of SR 154. There is also a pedestrian hybrid beacon crosswalk across SR 154 approximately 80' to the east of the intersection.

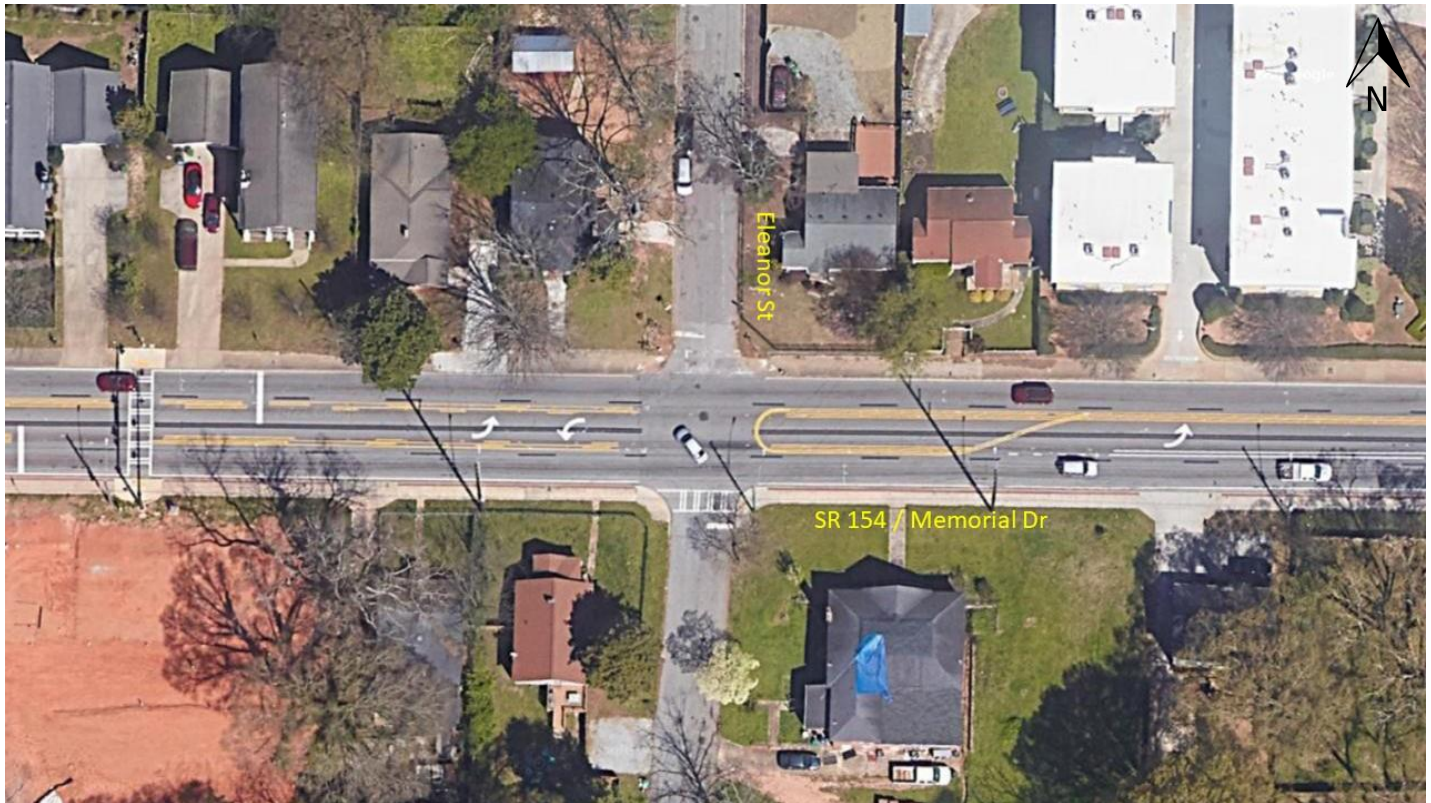
Intersection #11: Eleanor St

SR 154 and Eleanor St converge at approximately 90° to form a 4-leg intersection with at least 38' of width along the mainline. There is two (2) painted crosswalk across Eleanor St on both sides of SR 154.

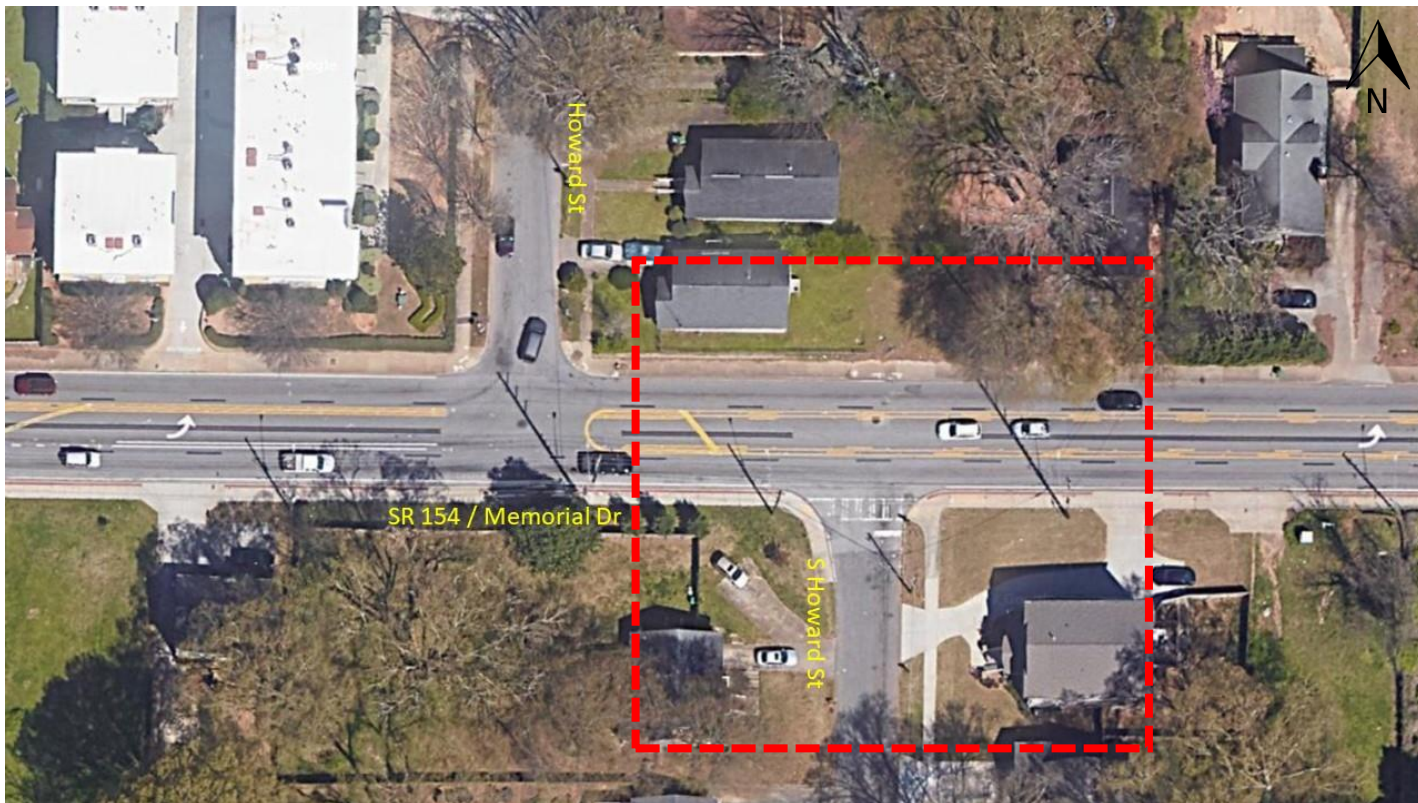
Intersection #13: S Howard St

SR 154 and S Howard St converge at approximately 90° to form a 3-leg intersection with at least 38' of width along the mainline. There is one (1) painted crosswalk across S Howard St on the south side of SR 154.

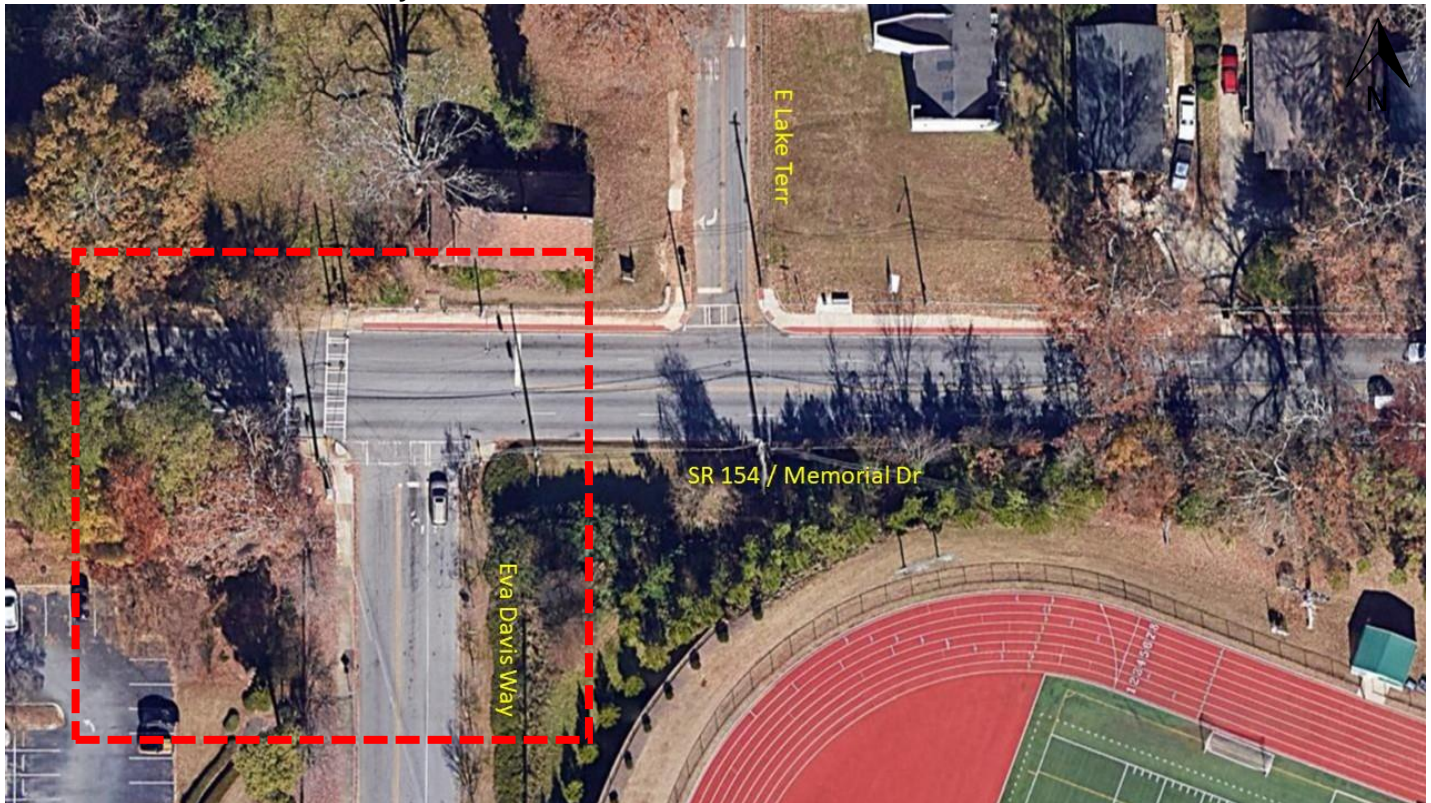
Intersection #16: Eva Davis Way

SR 154 and Eva Davis Way converge at approximately 90° to form a 3-leg intersection with at least 38' of width along the mainline. There is one (1) painted crosswalk across Eva Davis Way on the south side of SR 154 and two (2) painted crosswalks across SR 154 on both sides of Eva Davis Way. A dedicated westbound left turn lane is provided on SR 154.

This intersection is fully signalized with all left turn, through, and right turn movements allowed. Pedestrian signal heads are present for all crosswalks. Traffic control signs and signal conditions are described below.

- Westbound – SR 154 has one (1) 4-section Flashing Yellow Arrow signal head with “Left Turn Yield on Flashing Yellow Arrow” sign for protected and permissive left turn movements and two (2) standard 3-section heads for through movements. There is one (1) high-visibility school crosswalk (S1-1) sign for the western crosswalk across SR 154.
- Eastbound – SR 154 has one (1) 4-section Flashing Yellow Arrow signal head with “Right Turn Yield on Flashing Yellow Arrow” sign for right turn movements, one (1) “No Left Turn” (R3-2) sign, and two (2) standard 3-section heads for all movements. There is one (1) high-visibility school crosswalk (S1-1) sign for the western crosswalk across SR 154.
- Northbound – Eva Davis Way has two (2) standard 3-section heads for all movements. There is one (1) “Turning Traffic Must Stop for Pedestrians” sign.

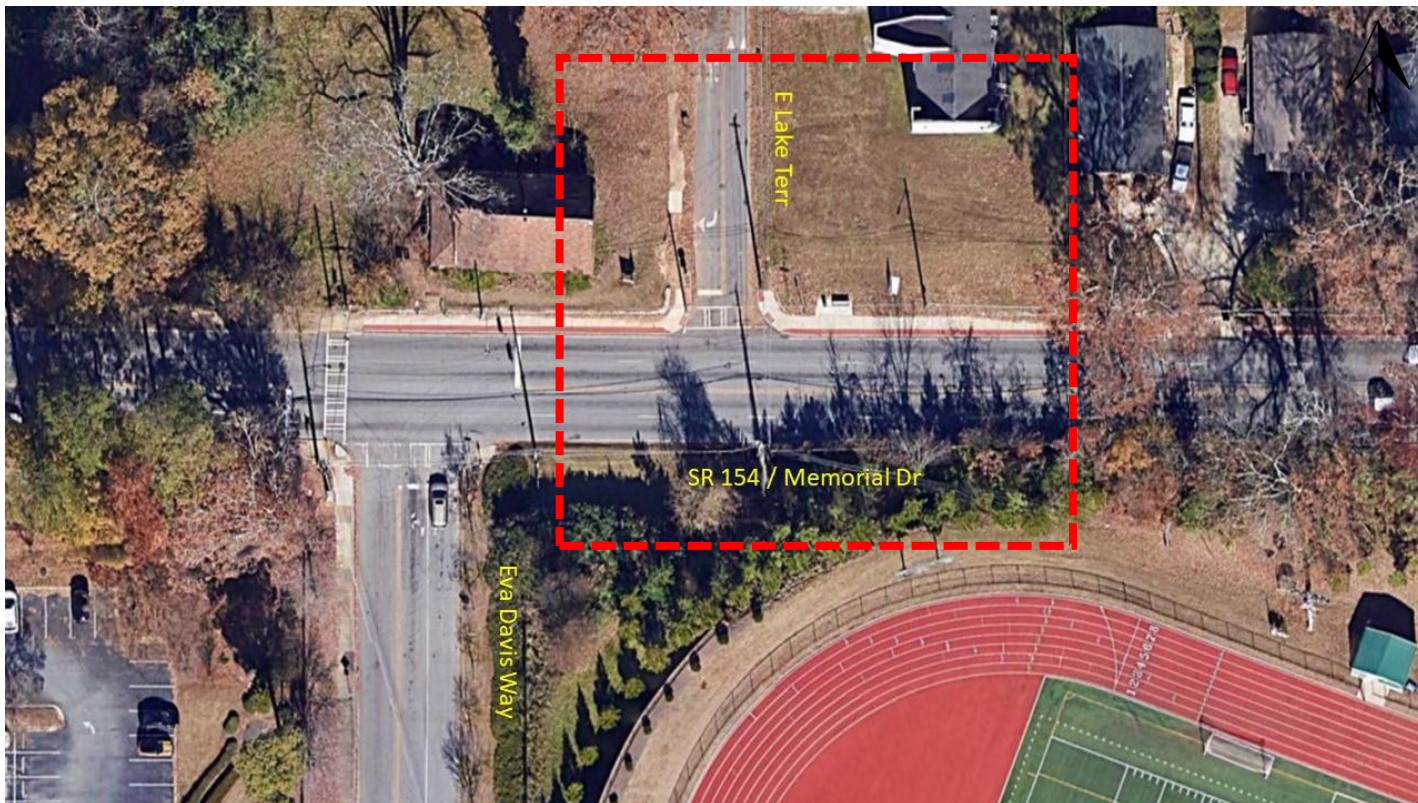
Intersection #17: E Lake Terr

SR 154 and E Lake Terr converge at approximately 90° to form a 3-leg intersection with at least 38' of width along the mainline. There is one (1) painted crosswalk across E Lake Terr on the north side of SR 154.

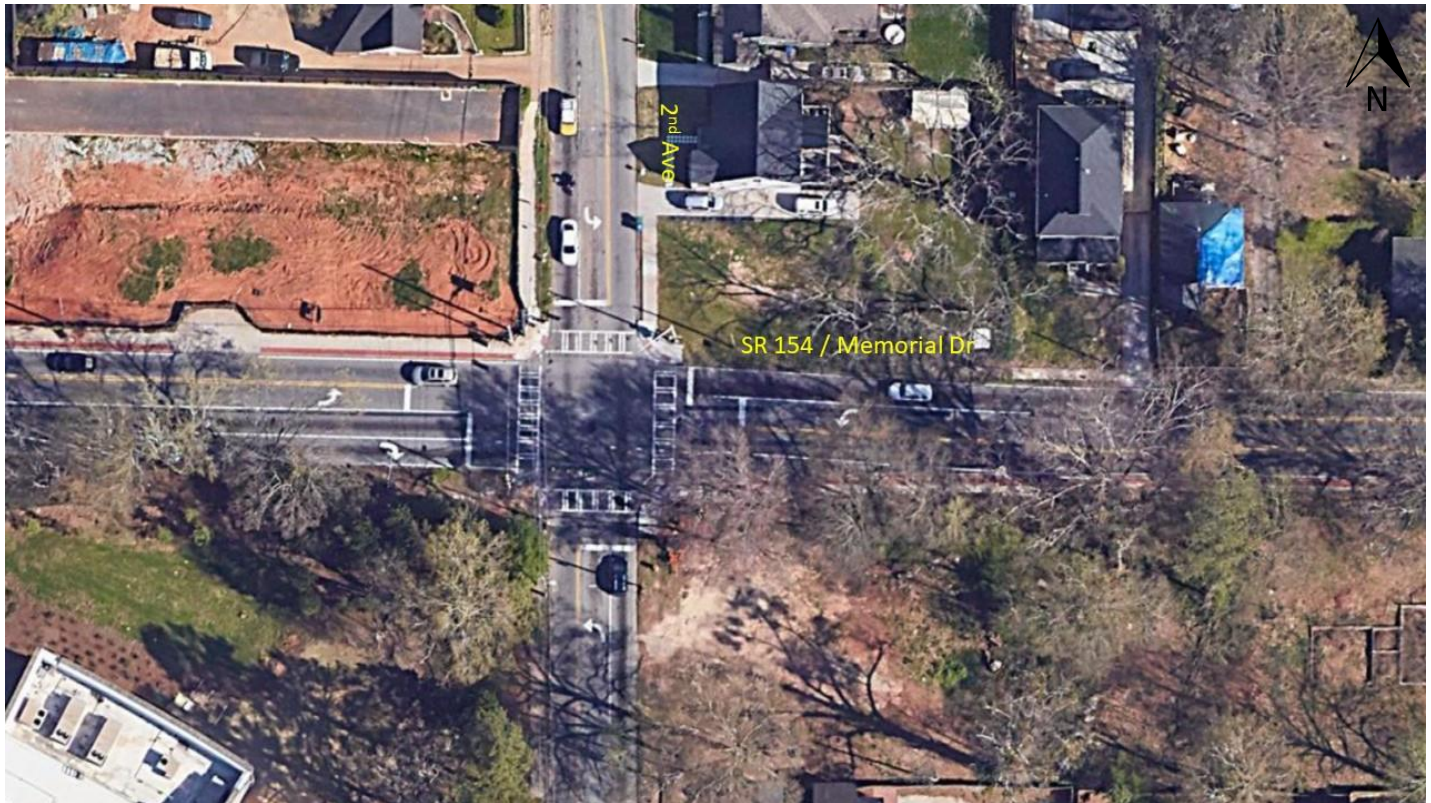
Intersection #19: 2nd Ave

SR 154 and 2nd Ave converge at approximately 90° to form a 4-leg intersection with at least 38' of width along the mainline. There are four (4) painted crosswalks across all intersection approaches. Dedicated left turn lanes are provided on SR 154 in both directions as well as for both directions of 2nd Ave. A dedicated right turn lane is also provided for eastbound vehicles.

This intersection is fully signalized with all left turn, through, and right turn movements allowed. Pedestrian signal heads are present for all crosswalks. Traffic control signs and signal conditions are described below.

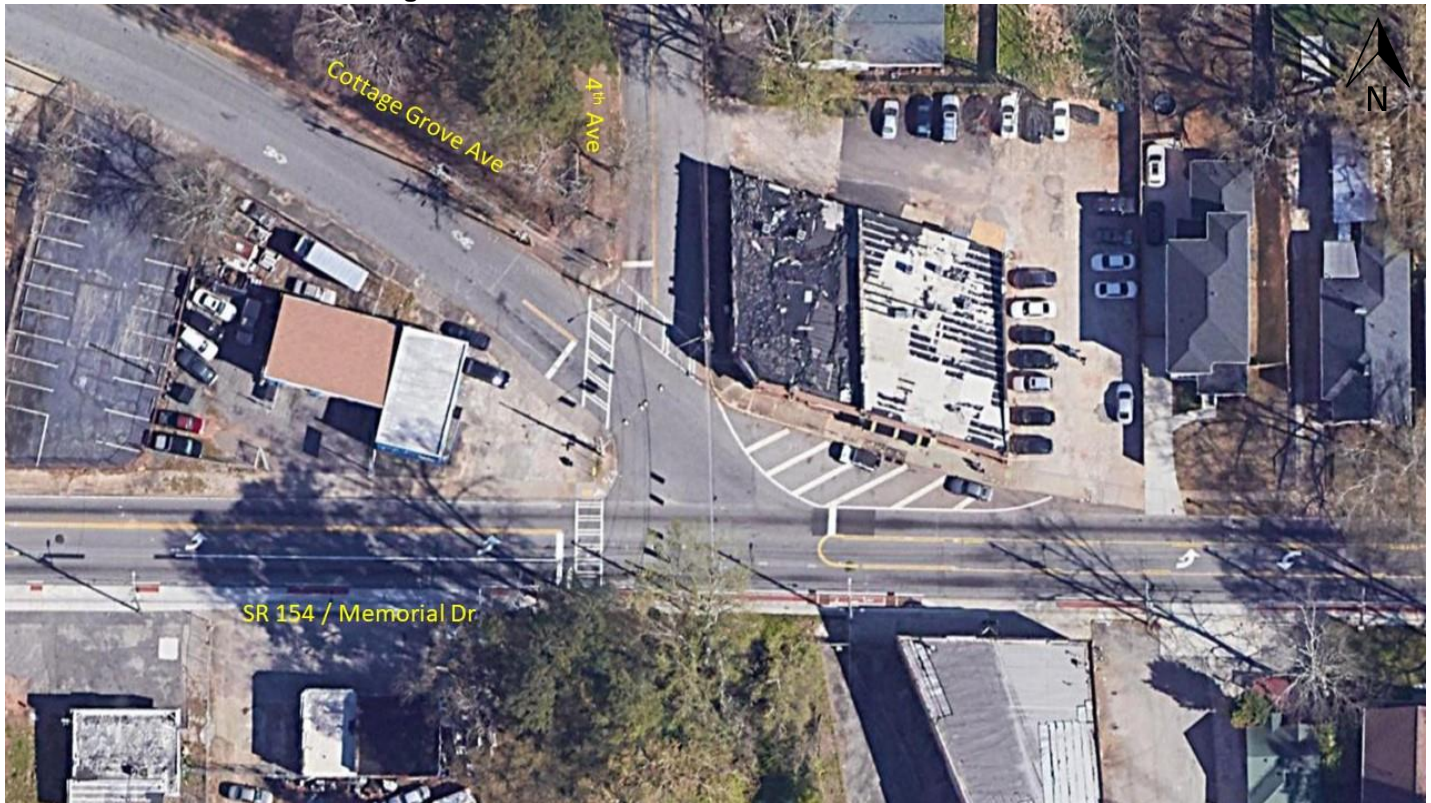
Intersection #21: 4th Ave / Cottage Grove Ave

SR 154 and 4th Ave converge at approximately 90°, while Cottage Grove Ave intersects at approximately 50°, to form a 4-leg intersection with at least 30' of width along the mainline. There is one (1) painted crosswalk across 4th Ave on the north side of SR 154, one (1) painted crosswalk across Cottage Grove Ave, and one (1) painted crosswalk across SR 154 on the west side of 4th Ave. A dedicated eastbound left turn lane is provided on SR 154.

This intersection is fully signalized with all left turn, through, and right turn movements allowed. Pedestrian signal heads are present for all crosswalks. Traffic control signs and signal conditions are described below.

- Southbound on 4th Ave – 4th Ave has two (2) standard 3-section heads for all movements. There is a “No Turn on Red” (R10-11a) sign.
- Southeast-bound on Cottage Grove Ave – Cottage Grove Ave has two (2) standard 3-section heads for all movements.

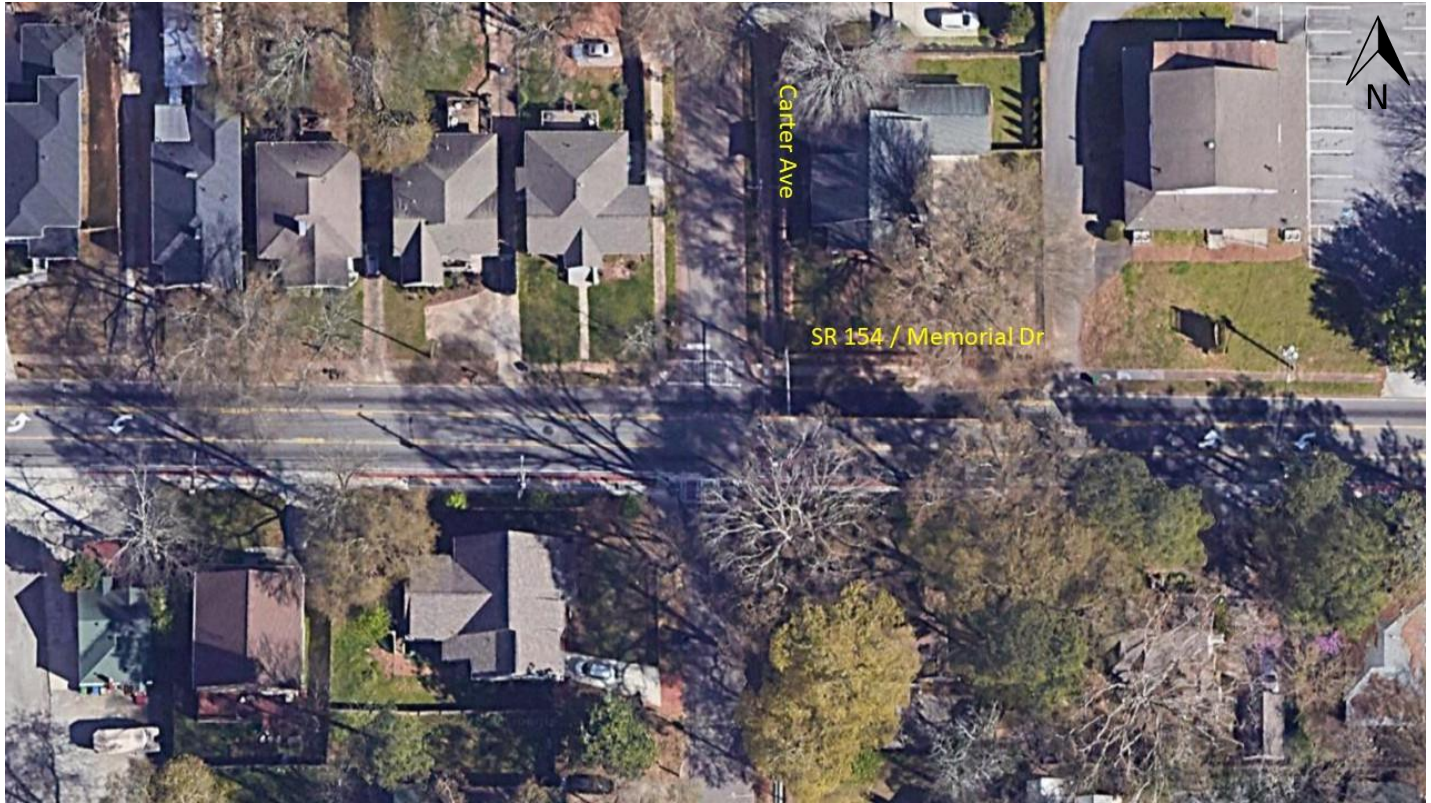
Intersection #22: Carter Ave

SR 154 and Carter Ave converge at approximately 90° to form a 4-leg intersection with at least 30' of width along the mainline. There are two (2) painted crosswalk across Carter Ave on both sides of SR 154.

This intersection is unsignalized with one-way stop control. There are stop signs at the northbound and southbound stop bars on Carter Ave. There are two (2) no trucks over 18 tons or over 30 ft in length (R5-2) signs for entering traffic onto northbound Carter Ave. The two-way left turn median breaks across this intersection indicating that all movements are allowed to and from Carter Ave. There is one (1) high-visibility school crosswalk ahead (S1-1, W16-9P) sign (for westbound drivers) to the west of the intersection.

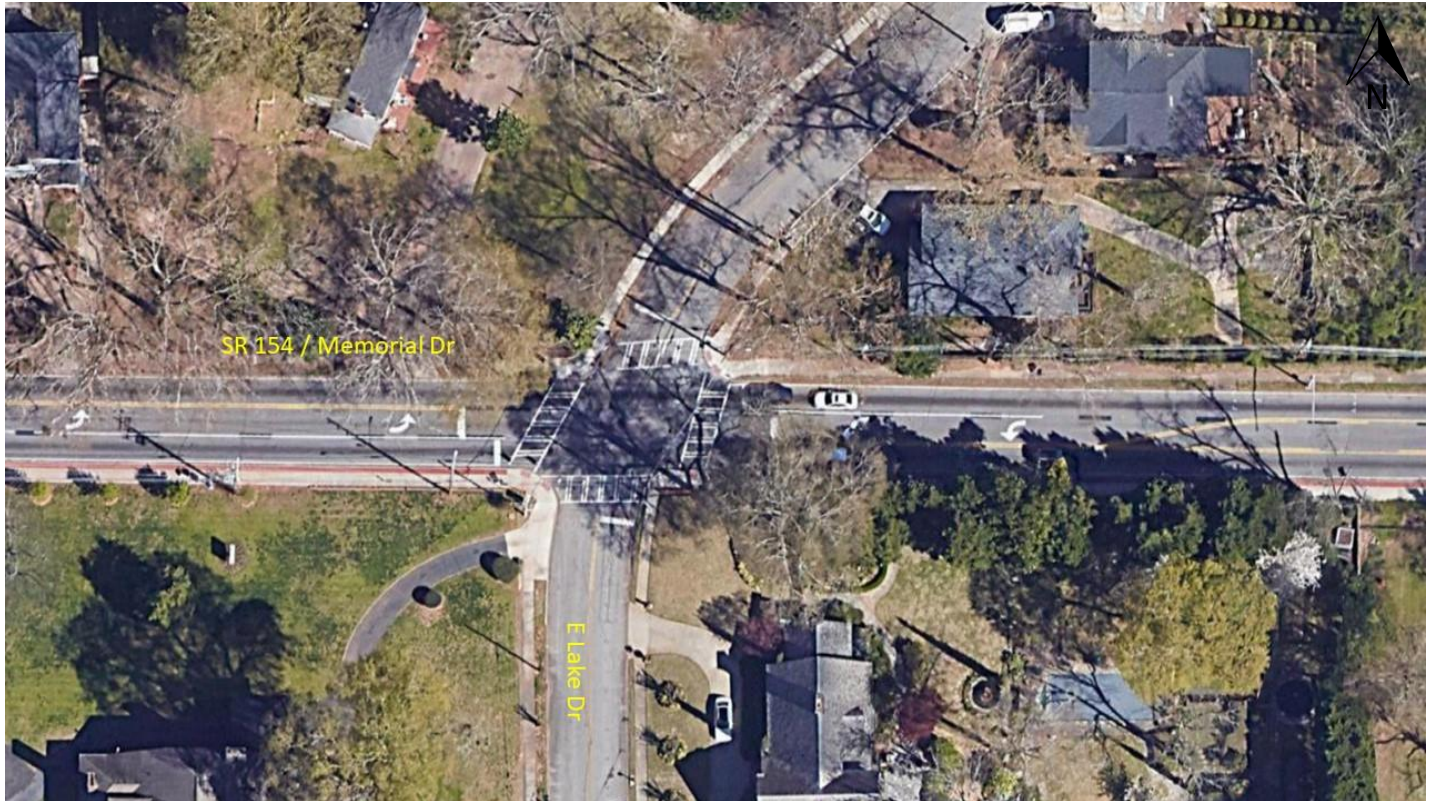
Intersection #23: E Lake Dr

SR 154 and E Lake Dr converge at approximately 85-90° (50° for the north leg) to form a 4-leg intersection with at least 30' of width along the mainline. There is four (4) painted crosswalks across all intersection approaches.

This intersection is fully signalized with all left turn, through, and right turn movements allowed. Pedestrian signal heads are present for all crosswalks. Traffic control signs and signal conditions are described below.

- Westbound – SR 154 has one (1) 3-section Flashing Yellow Arrow signal head with “Left Turn Yield on Flashing Yellow Arrow” sign for left turn movements and two (2) standard 3-section heads for through and right turn movements.
- Eastbound – SR 154 has one (1) 3-section Flashing Yellow Arrow signal head with “Left Turn Yield on Flashing Yellow Arrow” sign for left turn movements and two (2) standard 3-section heads for through and right turn movements. There is one (1) high-visibility pedestrian crossing (W11-2) sign at the crosswalk across SR 154.
- Northbound – E Lake Dr has two (2) standard 3-section heads for all movements.
- Southbound – E Lake Dr has two (2) standard 3-section heads for all movements.

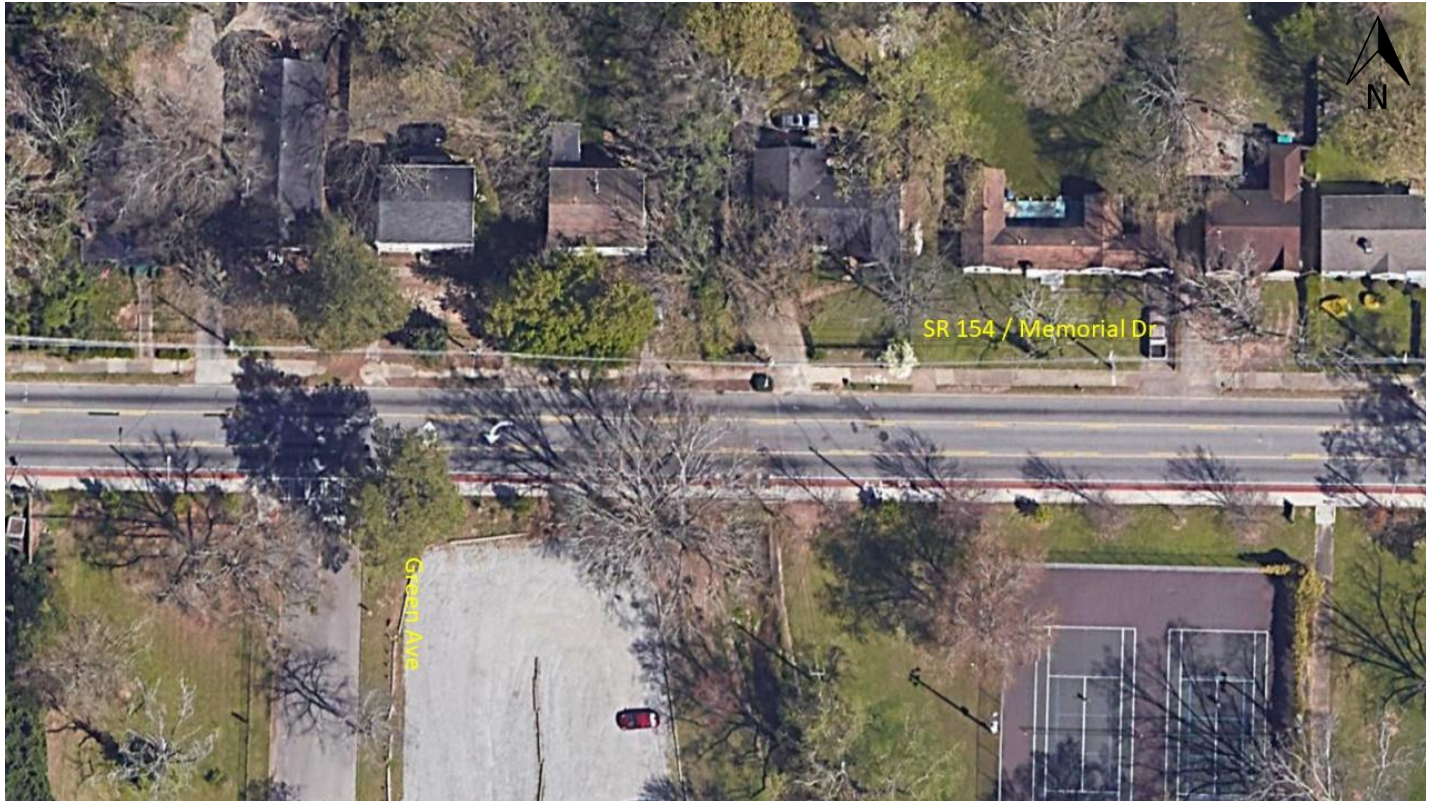
Intersection #24: Green Ave

SR 154 and Green Ave converge at approximately 90° to form a 3-leg intersection with at least 30' of width along the mainline. There is one (1) painted crosswalk across Green Ave on the south side of SR 154.

This intersection is unsignalized with one-way stop control. There is a stop sign at the northbound stop bar on Green Ave. There is also one (1) "No Parking" sign on Green Ave. There is one (1) "No Left Turn" (R3-2) sign on westbound SR 154 and (1) one on northbound Green Ave. There is one (1) playground (W15-1) sign on eastbound SR 154. Flex tube has been installed in the median across this intersection to indicate that left turns are not allowed to or from Green Ave.

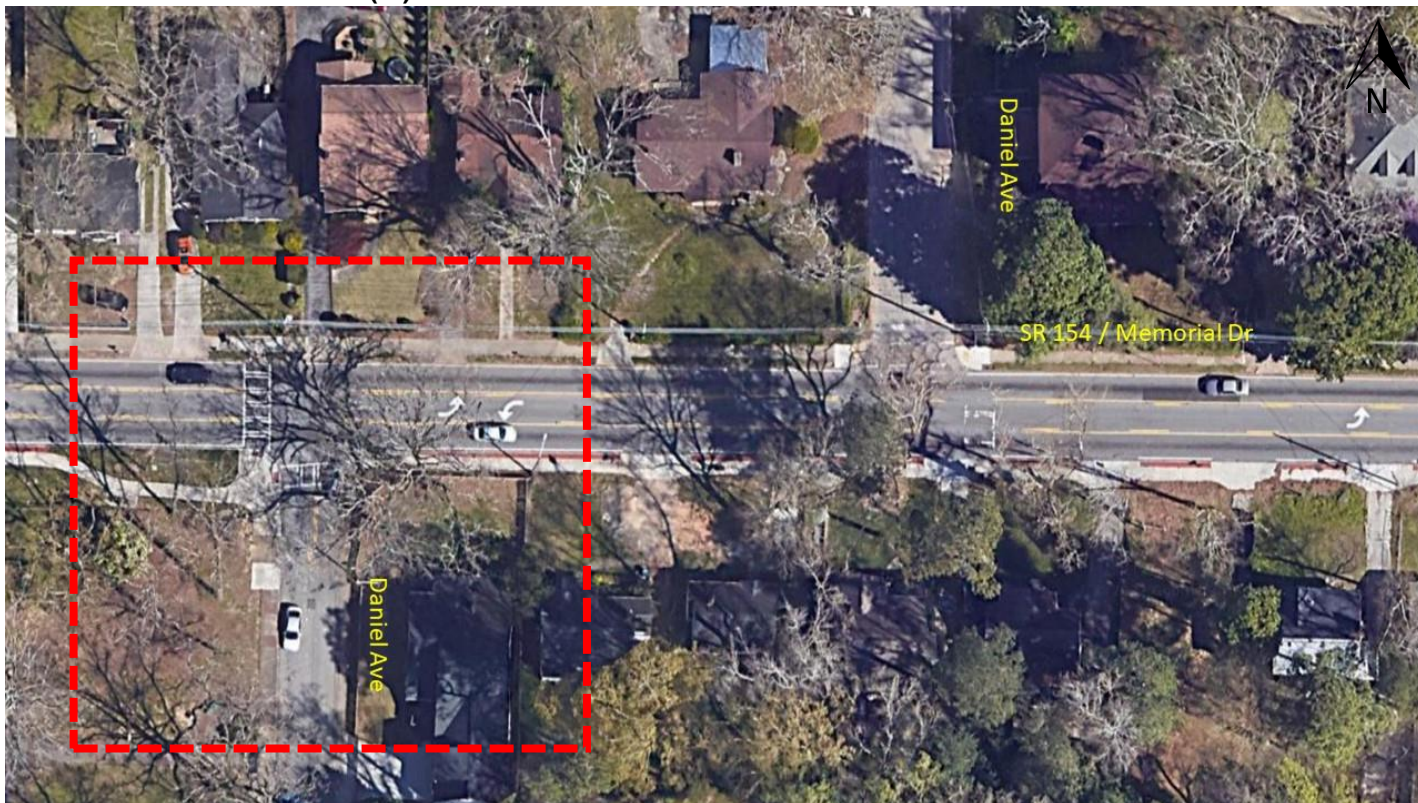
Intersection #25: Daniel Ave (W)

SR 154 and Daniel Ave converge at approximately 90° to form a 3-leg intersection with at least 30' of width along the mainline. There is one (1) painted crosswalk across Daniel Ave on the south side of SR 154 and one (1) painted crosswalk across SR 154 on the west side of Daniel Ave. There are two (2) high-visibility pedestrian crossing (W11-2) signs at the crosswalk, as well as one (1) crosswalk advance warning sign (W11-2, W16-9P) for each mainline approach.

This intersection is unsignalized with one-way stop control. There is a stop sign at the northbound stop bar on Daniel Ave. The two-way left turn median breaks across this intersection indicating that all movements are allowed to and from Daniel Ave.

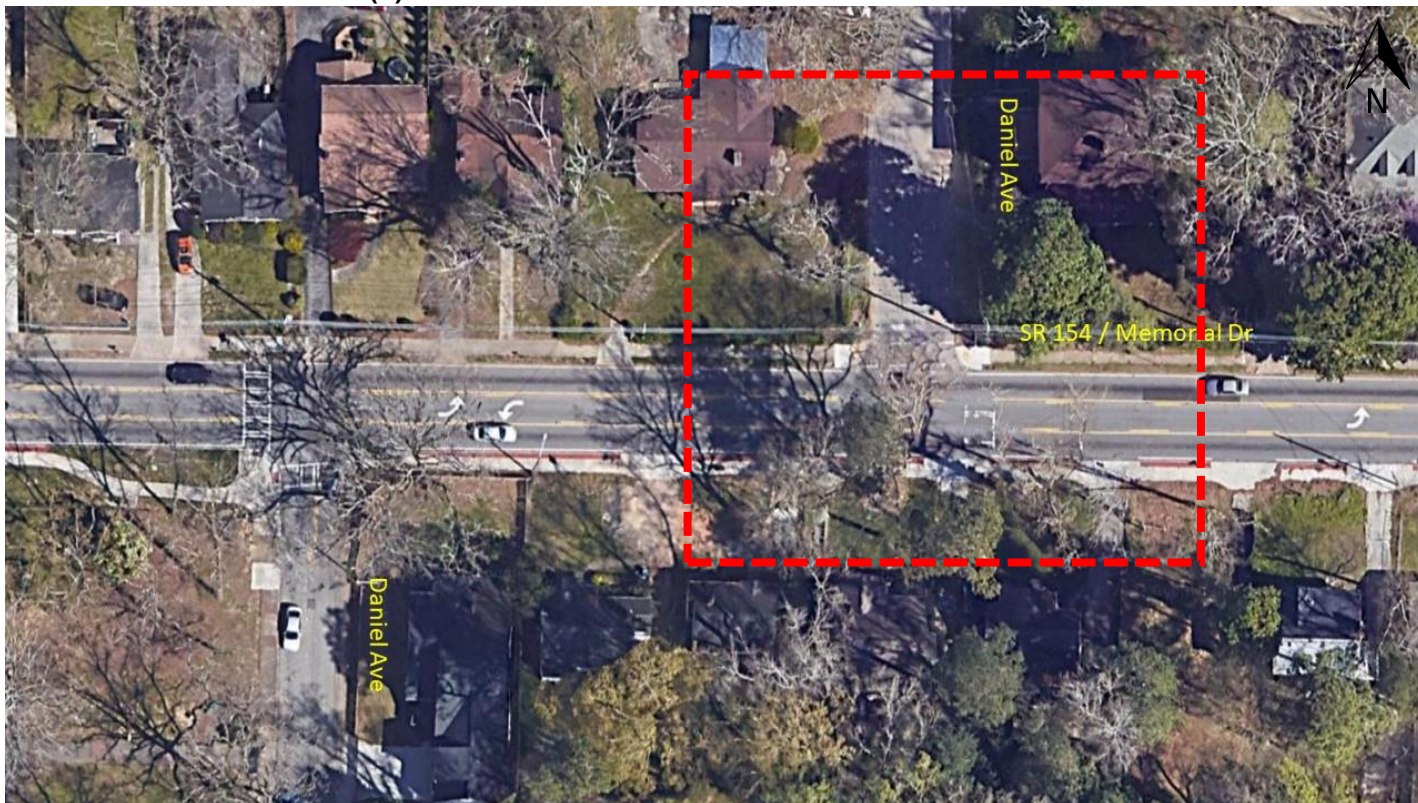
Intersection #26: Daniel Ave (E)

SR 154 and Daniel Ave (E) converge at approximately 90° to form a 3-leg intersection with at least 30' of width along the mainline. There is one (1) painted crosswalk across Daniel Ave (E) on the north side of SR 154 and one (1) painted crosswalk across SR 154 on the east side of Daniel Ave (E).

This intersection is unsignalized with one-way stop control. There is a stop sign at the southbound stop bar on Daniel Ave. There is one (1) high-visibility pedestrian crossing (W11-2) sign for the crosswalk across SR 154 (for westbound drivers only). The two-way left turn median breaks across this intersection indicating that all movements are allowed from Daniel Ave (E).

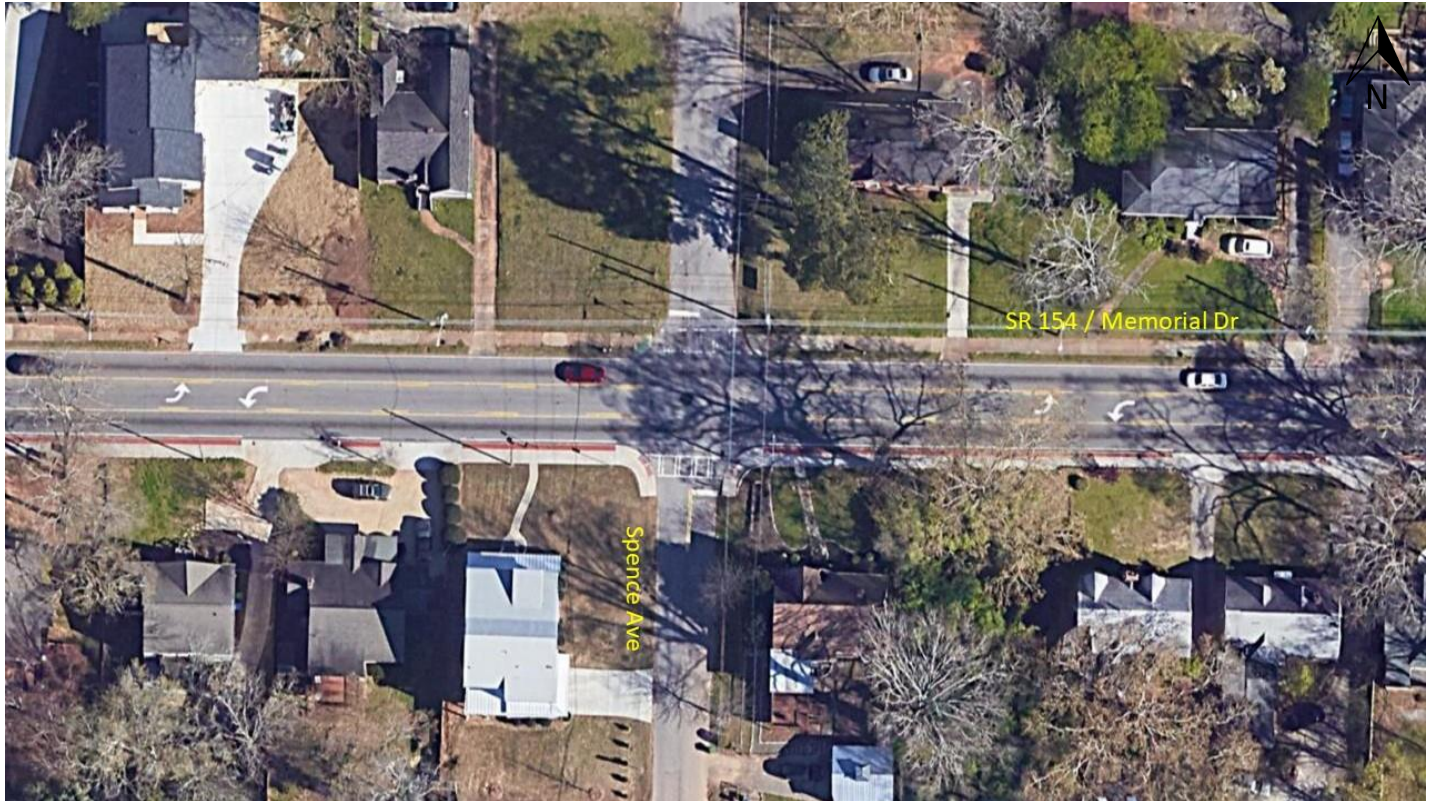
Intersection #27: Spence Ave

SR 154 and Spence Ave converge at approximately 90° to form a 4-leg intersection with at least 30' of width along the mainline. There are two (2) painted crosswalks across Spence Ave on both sides of SR 154.

This intersection is unsignalized with one-way stop control. There are stop signs at the northbound and southbound stop bars on Spence Ave. The two-way left turn median breaks across this intersection indicating that all movements are allowed to and from Spence Ave.
