TRAFFIC ENGINEERING STUDY

PRIMARY ROUTE: SR 154 / Memorial Dr

SECONDARY ROUTE: Vannoy St to Oakridge Ave

PREPARED BY: AECOM

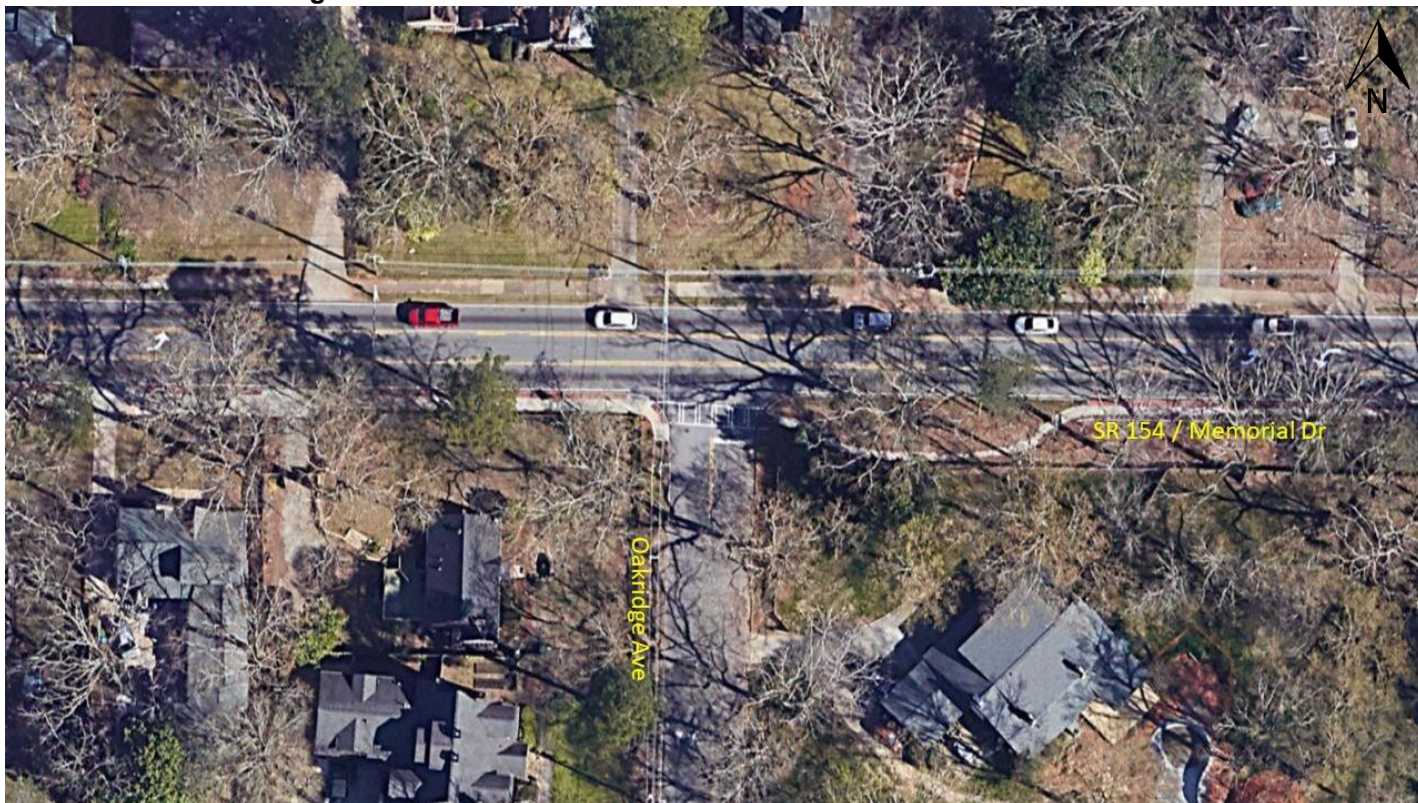
Intersection #28: Oakridge Ave

SR 154 and Oakridge Ave converge at approximately 90° to form a 3-leg intersection with at least 30' of width along the mainline. There is one (1) painted crosswalk across Oakridge St on the south side of SR 154.

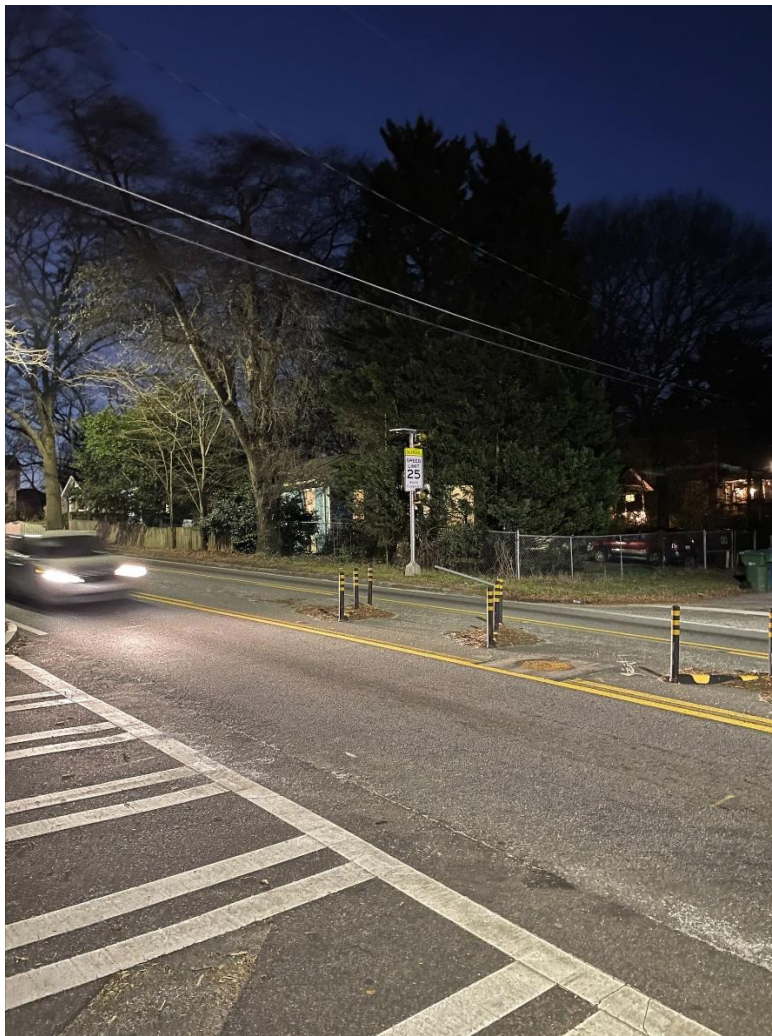
The Georgia Department of Transportation completed a corridor resurfacing and restriping project (PI M005724), which included a road diet, removal of the reversible lane, and installation of turn lanes throughout the study corridor, at the end of June 2019. Safety countermeasures installed as part of this project included new signals with retroreflective backplates, mast arms, and signage (including several flashing yellow arrow signal heads and signs), and pedestrian countdown signals and crosswalks with accessible ramps at all signalized intersections. As a result of the recent signal and pedestrian upgrades, the signalized intersections now include signal heads with reflective backplates as well as the signage and infrastructure needed to meet current GDOT standards. Further, several unsignalized intersections have been previously converted to right-in, right-out access through signage and installation of flexible delineators in the flush median, as shown in **Figure 2** below.

Figure 2 - Example of Road Diet and Right-in Right-out Conversion

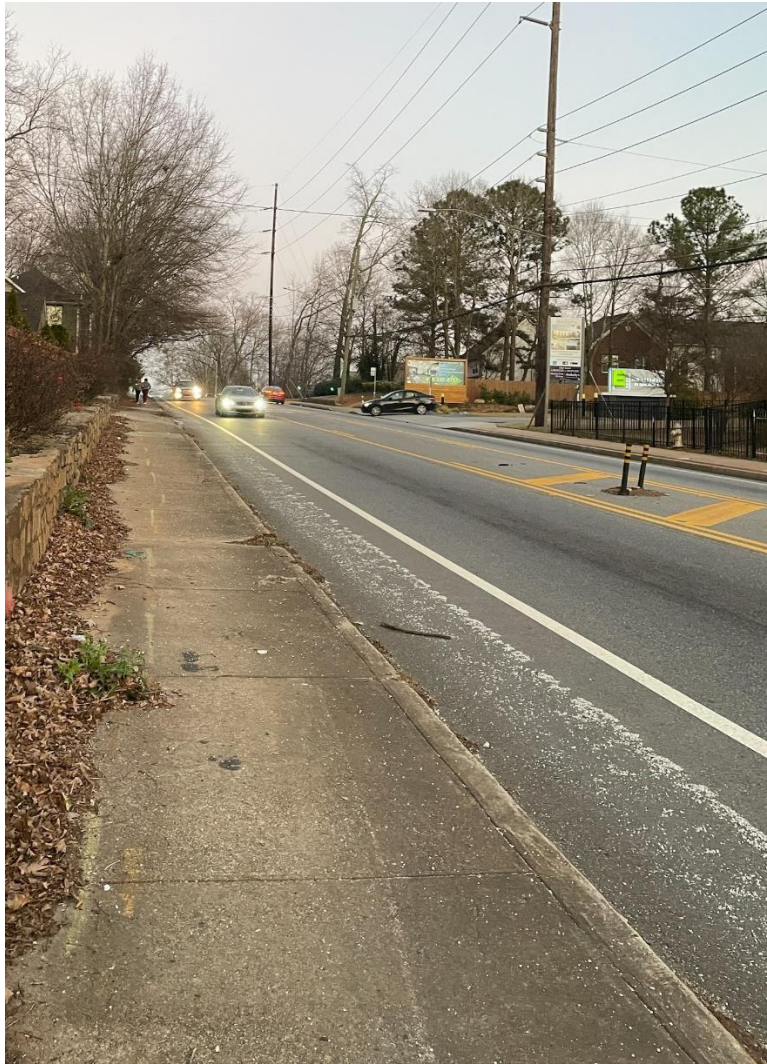
Although the study corridor is straight in the horizontal direction, there are notable vertical grades that would impact future projects. Hills along the corridor create vertical crests that limit sight distances at several locations, which results in substandard sight distances given the posted 35 mph speed limit, as shown in **Figure 3** below.

Figure 3 - Vertical Grade Example at SR 154 and Palatka St

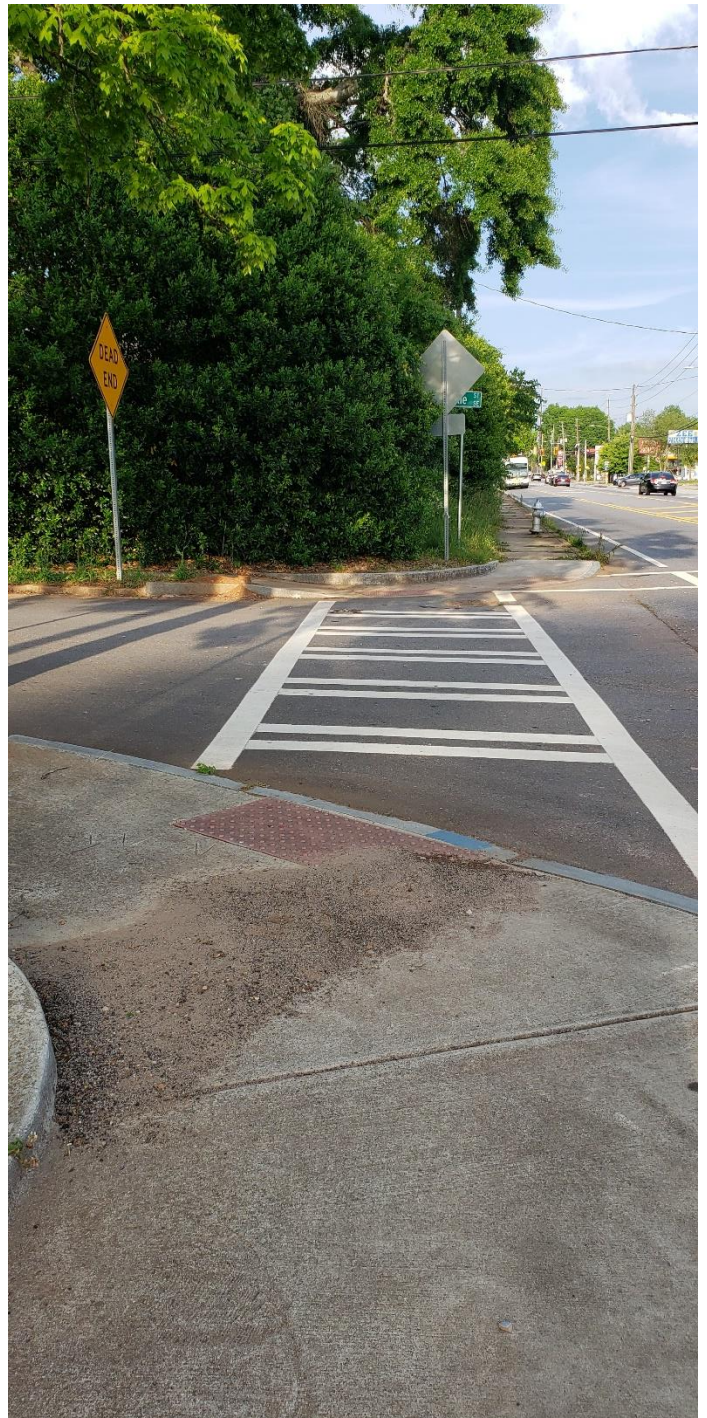
Figure 4 - Examples of Pedestrian Infrastructure in Study Area

Pedestrians and a variety of multimodal travelers are frequently found in the study area. These vulnerable users were most often walking along sidewalks in the study area but were also seen crossing at crosswalks as well as outside of crosswalks. There are currently four (4) unsignalized crosswalks with no pedestrian refuge island across SR 154 in the study area. Sidewalks are present along both sides of SR 154 / Memorial Dr, but the sidewalk condition is more consistently up to GDOT standards along the south side of SR 154 as shown in **Figure 4** below. GDOT project PI 0012597 will replace many sections of deteriorated or missing sidewalk along the north and south sides of SR 154.

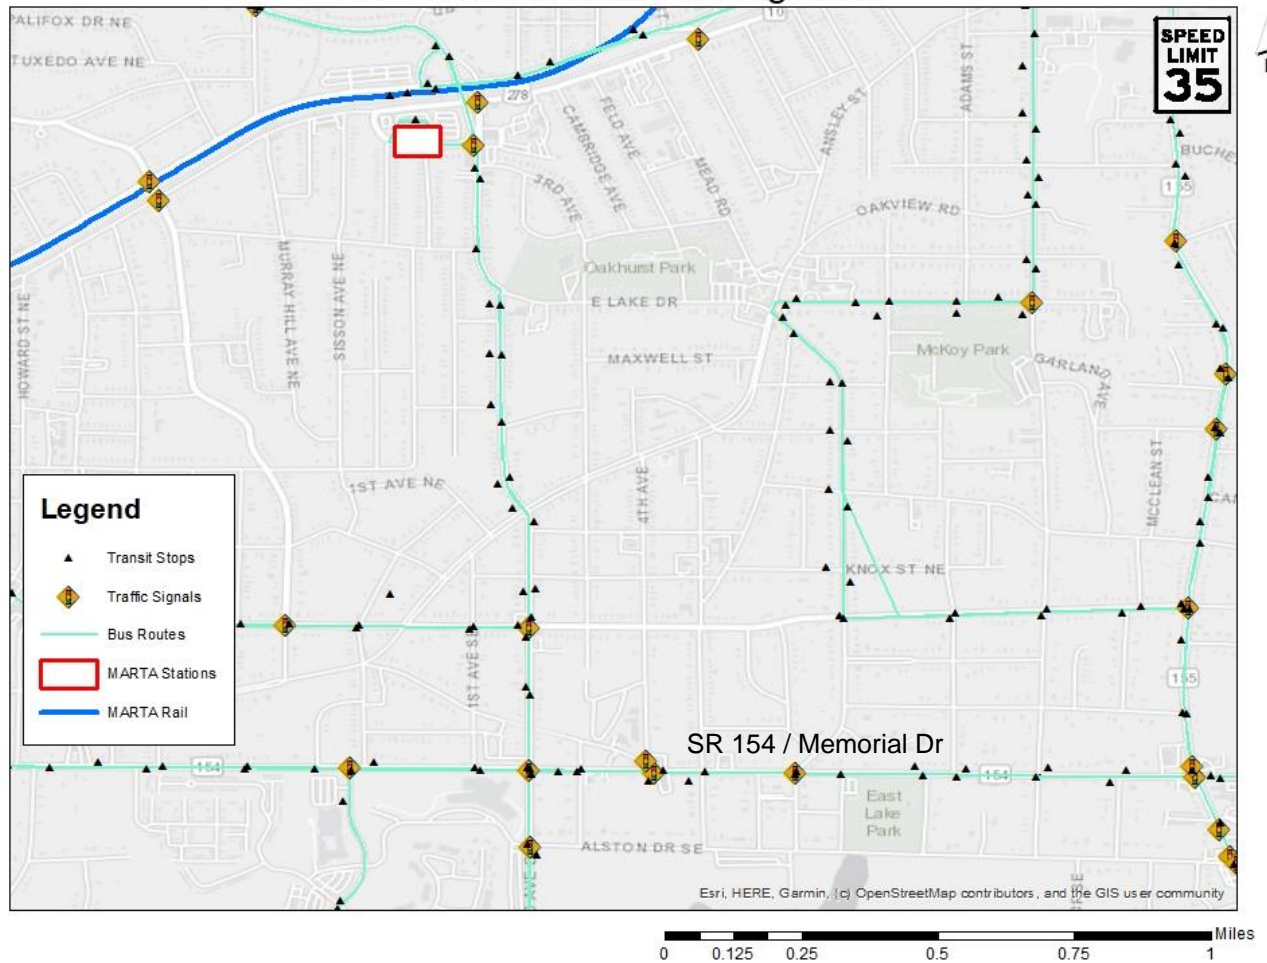
Figure 8 - Transit Routes and Stations in the Study Area (Howard St to Oakridge Ave)

MARTA transit buses operate throughout the entire study corridor, including Route 21 (Memorial Drive), which connects between Five Points Station and Kensington Station on the MARTA Blue and Green rail lines. See **Figure 7** and **Figure 8** for illustrative transit maps.

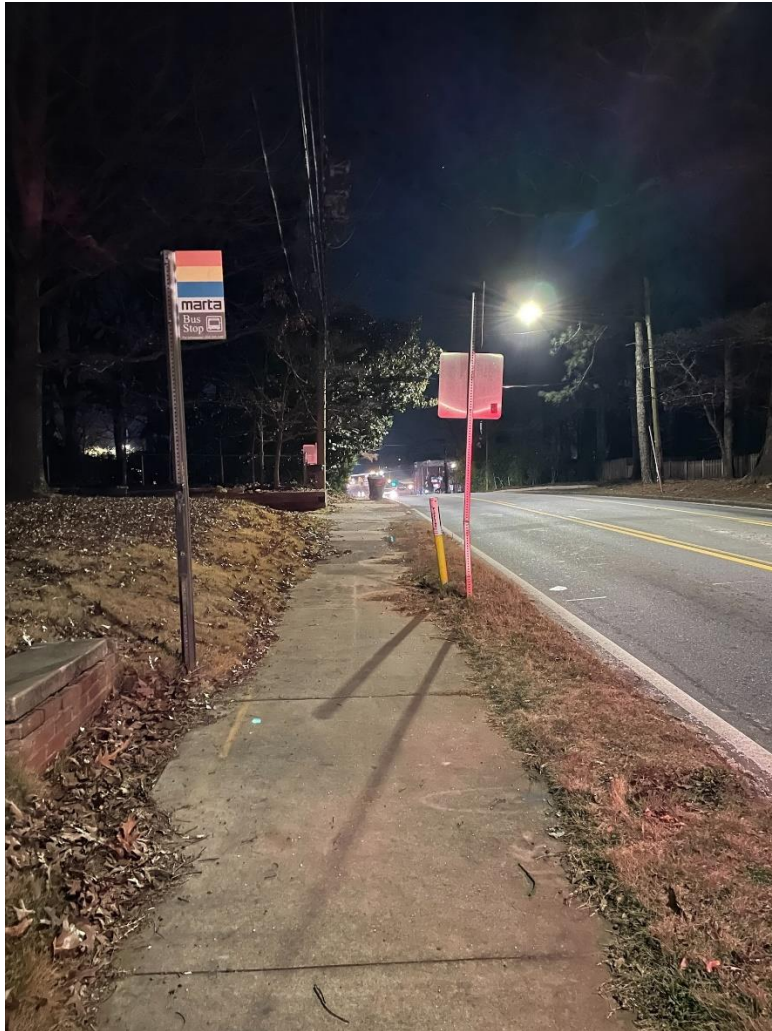
Lighting conditions were assessed in January 2022 and found to be adequate, but with some room for improvement throughout the corridor. Although streetlights and nearby buildings provided enough light to illuminate the street, pedestrian-scale lighting was more limited in the study area. An example of lighting conditions found in the study area is shown in **Figure 9**.

Figure 9 - Example of Adequate Intersection Lighting along SR 154 / Memorial Dr

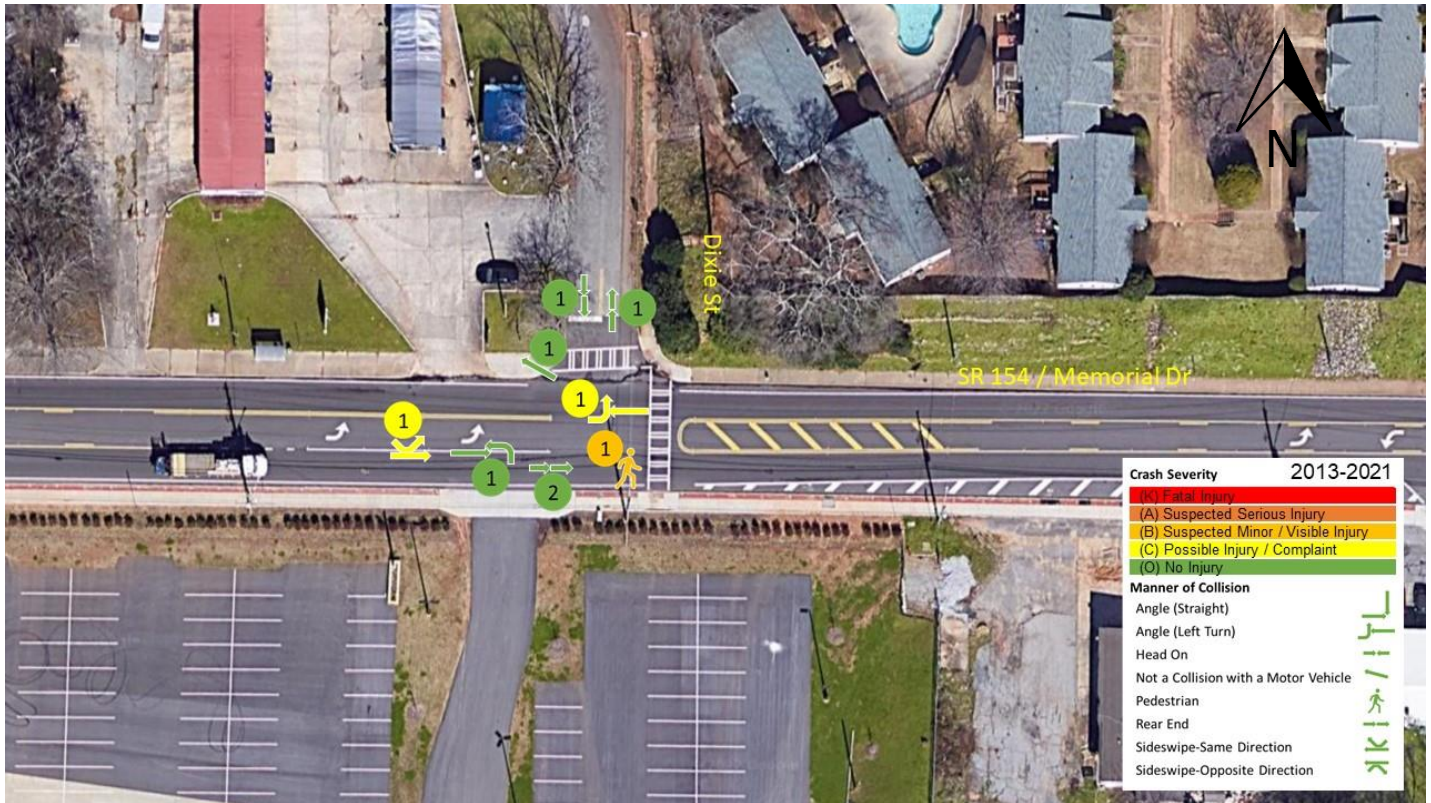
Figure 11 - Crash Diagram for SR 154 at Dixie St

SR 154 / Memorial Dr at Dixie St had zero (0) crash patterns with five (5) or more crashes during the 9-year analysis period from 2013-2021, as shown in **Table 46**. One (1) pedestrian was injured by an eastbound vehicle while crossing across SR 154 outside of the marked crosswalk. This crash pattern could be addressed through safety countermeasures including enhanced crosswalk with RRFB and refuge.

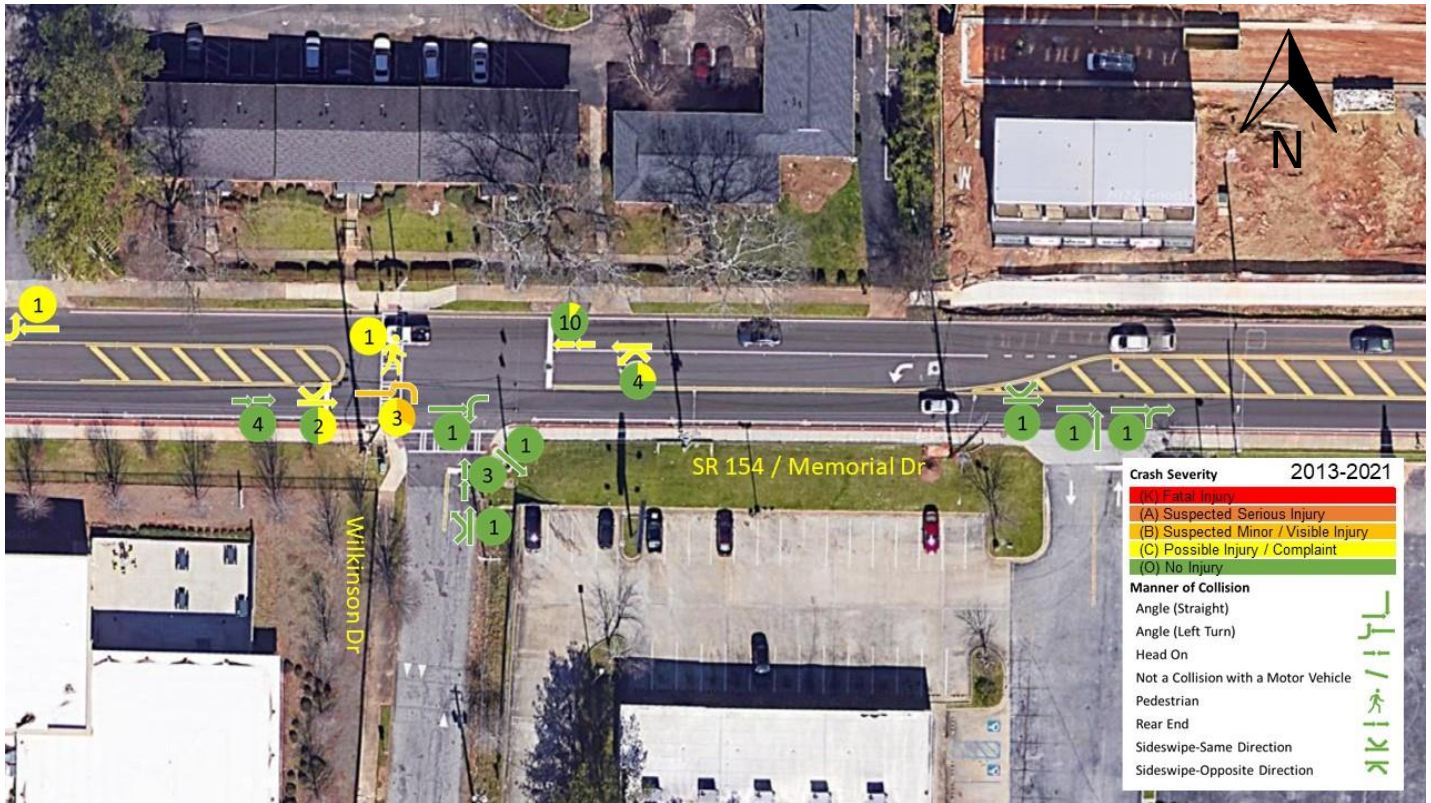
Figure 12 - Crash Diagram for SR 154 at Wilkinson Dr

SR 154 / Memorial Dr at Wilkinson Dr had one (1) crash pattern with five (5) or more crashes during the 9-year analysis period from 2013-2021, as shown in **Table 47**. The most frequent crash pattern was found to be rear end crashes for the westbound approach. This could be addressed by providing advance signing and marking to alert drivers of the traffic signal. One (1) pedestrian was injured by a westbound vehicle while attempting to cross the western leg of SR 154. This crash pattern could be addressed through safety countermeasures including enhanced crosswalk with RRFB and pedestrian refuge island.

Crash Patterns	Crashes	K	A	B	C	O	Countermeasure(s)
1. Rear End – Westbound	10	0	0	0	1	9	Advance signing and marking, Left-turn lane (added in 2019)
2. Pedestrian in Crosswalk	1	0	0	0	1	0	Leading pedestrian interval, Pedestrian refuge island

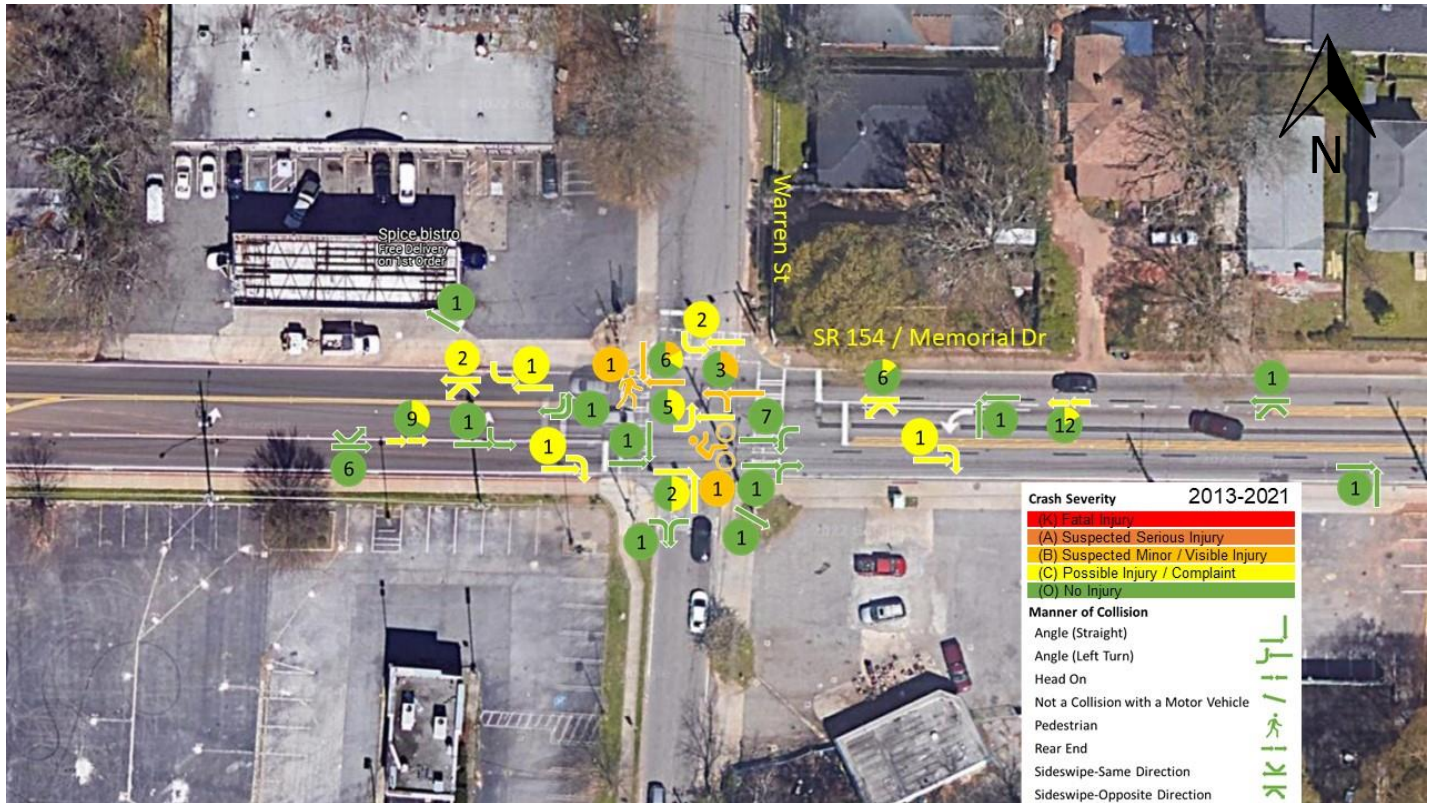
Figure 13 - Crash Diagram for SR 154 at Warren St

SR 154 / Memorial Dr at Warren St had seven (7) crash patterns with five (5) or more crashes during the 9-year analysis period from 2013-2021, as shown in **Table 48**. The most frequent crash patterns were found for the westbound and eastbound approaches, including rear end, left turn angle, and sideswipe-same direction crashes. These crash patterns could be addressed through safety countermeasures including dedicated turn lanes (added 2019) and protected turn phases for the mainline approaches. One (1) pedestrian was injured by a westbound vehicle while crossing SR 154 west of the intersection. One (1) cyclist was also injured by a northbound turning vehicle while attempting to cross SR 154. These crash patterns could be addressed through safety countermeasures including leading pedestrian interval and dedicated bicycle facilities.

Crash Patterns	Crashes	K	A	B	C	O	Countermeasure(s)
1. Rear End – Westbound	12	0	0	0	2	10	Dedicated westbound turn lane(s) (added 2019)
2. Rear End – Eastbound	9	0	0	0	3	6	Dedicated eastbound turn lane(s) (added 2019)
3. Angle – Westbound Left vs. Eastbound	7	0	0	0	0	7	Protected westbound left turn phase, Roundabout
4. Angle – Westbound vs. Southbound	6	0	0	1	1	4	Increase yellow and/or all-red time, Roundabout
5. Sideswipe-Same Direction – Westbound	6	0	0	0	1	5	Dedicated westbound turn lane(s) (added 2019)
6. Sideswipe-Same Direction – Eastbound	6	0	0	0	0	6	Dedicated eastbound turn lane(s) (added 2019)
7. Angle – Eastbound Left vs. Westbound	5	0	0	0	2	3	Protected eastbound left turn phase, Roundabout
8. Pedestrian	1	0	0	1	0	0	Leading pedestrian interval
9. Cyclist	1	0	0	1	0	0	Dedicated bicycle facilities

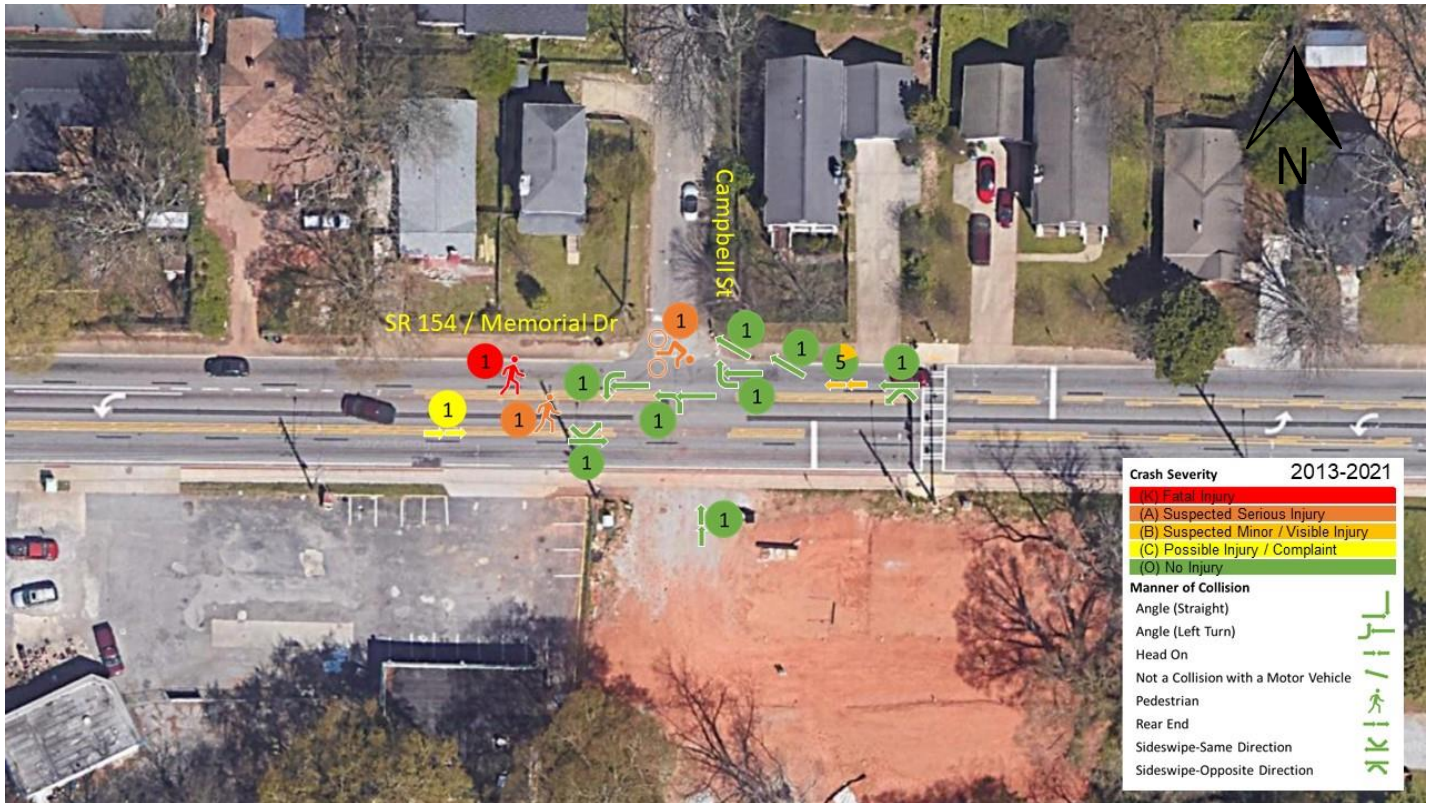
Figure 14 - Crash Diagram for SR 154 at Campbell St

SR 154 / Memorial Dr at Campbell St had one (1) crash pattern with five (5) or more crashes during the 9-year analysis period from 2013-2021, as shown in **Table 49**. The most frequent crash pattern was found to be rear end crashes for the westbound approach. This crash pattern could be addressed through safety countermeasures including signing and marking improvements. One (1) pedestrian was severely injured (serious injury crash) by a westbound left-turning vehicle while crossing SR 154 west of the intersection, and one (1) resulted in a fatality caused by a westbound left-turning vehicle striking the pedestrian crossing SR 154, west of the intersection. One (1) cyclist was also severely injured by a westbound left-turning vehicle while making a southbound right turn. These crash patterns could be addressed through safety countermeasures including enhanced crosswalk with RRFB and dedicated bicycle facilities.

Crash Patterns	Crashes	K	A	B	C	O	Countermeasure(s)
1. Rear End – Westbound	5	0	0	1	0	4	Signing and marking improvements
2. Pedestrian	2	1	1	0	0	0	Enhance crosswalk with refuge island
3. Cyclist	1	0	1	0	0	0	Dedicated bicycle facilities

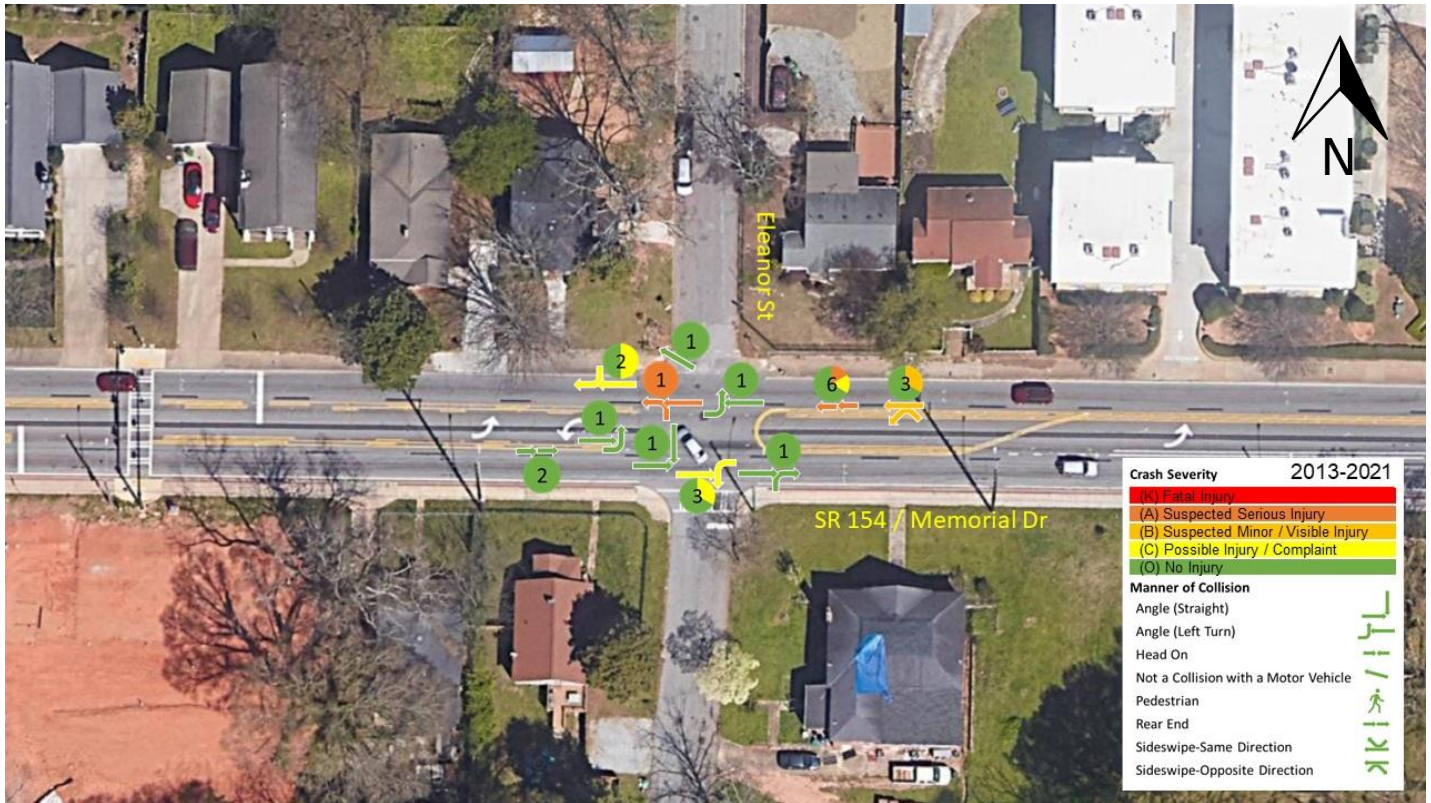
Figure 15 - Crash Diagram for SR 154 at Eleanor St

SR 154 / Memorial Dr at Eleanor St had one (1) crash pattern with five (5) or more crashes during the 9-year analysis period from 2013-2021, as shown in **Table 50**. The most frequent crash pattern was found to be rear end crashes for the westbound approach. This crash pattern indicate rear end collisions caused by following too closely was an issue at this intersection, which could be addressed through turn lane additions or a right-in right-out at the intersection.

Crash Patterns	Crashes	K	A	B	C	O	Countermeasure(s)
1. Rear End – Westbound	6	0	1	0	1	4	Right-turn lane, RIRO

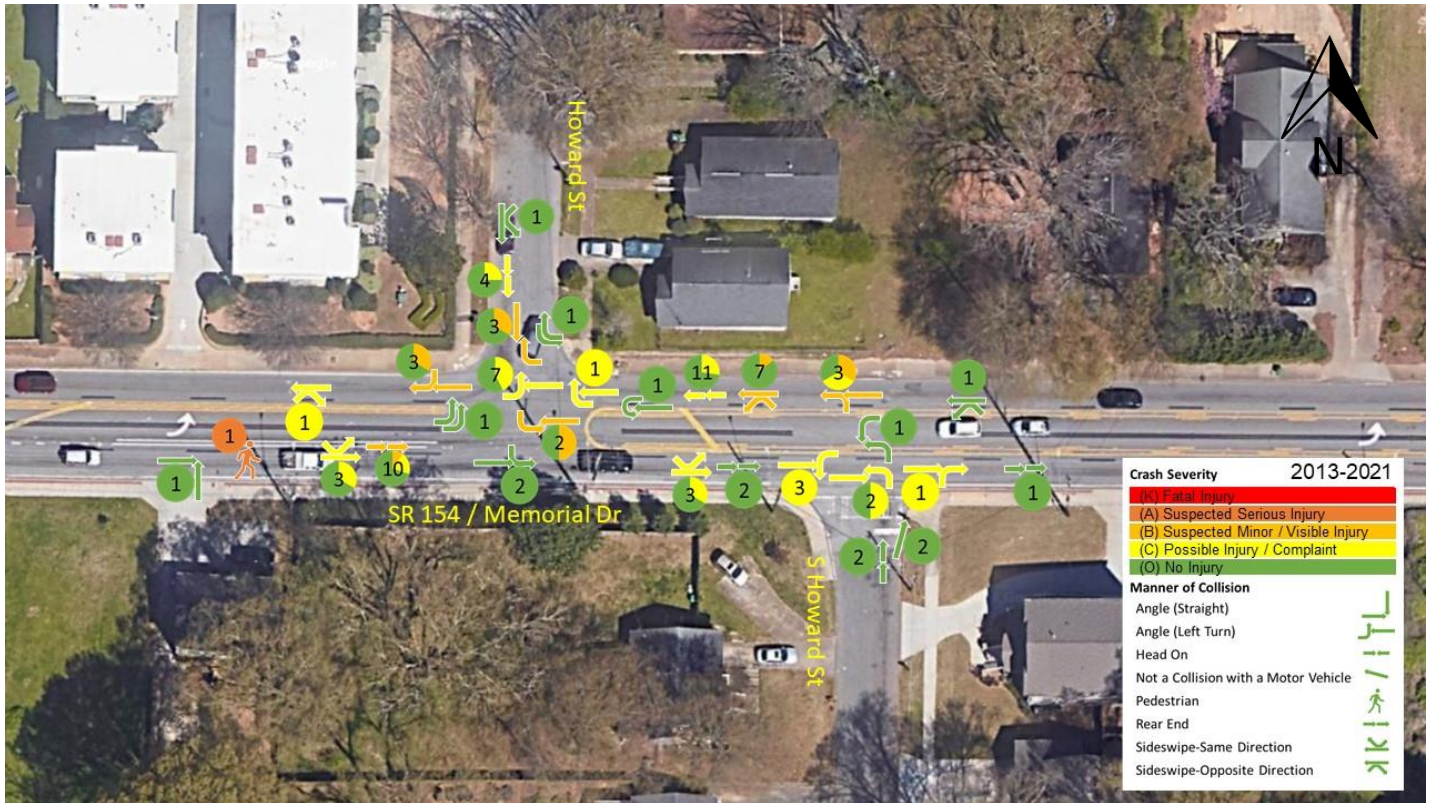
Figure 16 - Crash Diagram for SR 154 at Howard St and S Howard St

SR 154 / Memorial Dr at Howard St and S Howard St had four (4) crash patterns with five (5) or more crashes during the 9-year analysis period from 2013-2021, as shown in **Table 51**. The most frequent crash patterns were found to be rear-end crashes for the westbound and eastbound approaches, followed by left turn angle crashes, and sideswipe-same direction crashes at the intersection of SR 154 and Howard St. These crash patterns could be addressed through safety countermeasures including dedicated turn lane, restricted crossing U-turns (RCUTs) or right-in right-out (RIRO)s with flex tube delineators or median. One (1) pedestrian was injured by an eastbound vehicle while crossing across the western leg of SR 154 (west of Howard St).

Crash Patterns	Crashes	K	A	B	C	O	Countermeasure(s)
1. Rear End – Westbound	11	0	0	0	3	8	Right-turn lane
2. Rear End – Eastbound	9	0	0	0	2	7	Left-turn lanes (added in 2019)
3. Angle – Eastbound Left vs. Westbound	7	0	0	0	3	4	RCUT, RIRO
4. Sideswipe-Same Direction – Westbound	7	0	0	1	0	6	Right-turn lane
5. Pedestrian	1	0	1	0	0	0	RRFB crosswalk

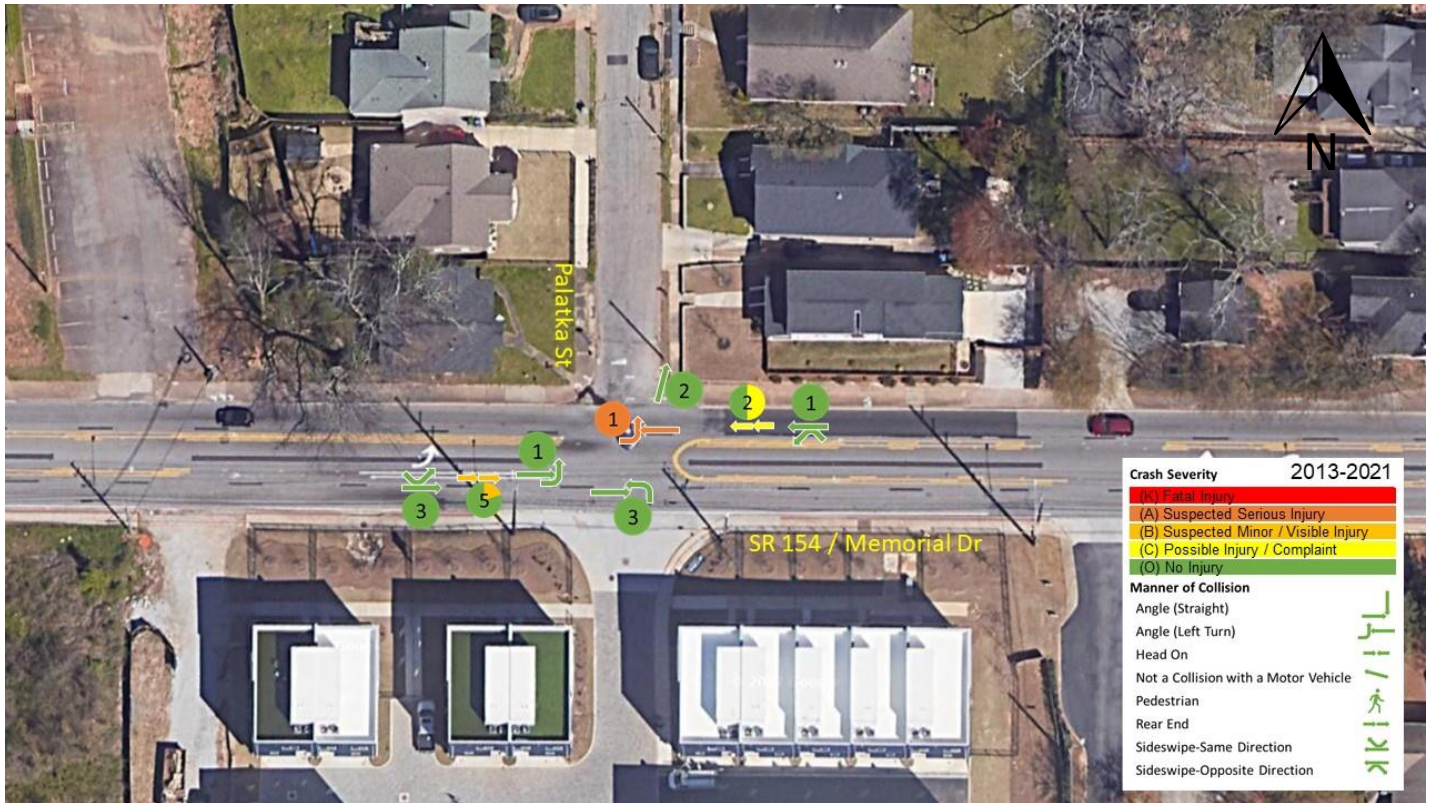
Figure 17 - Crash Diagram for SR 154 at Palatka St

SR 154 / Memorial Dr at Palatka St had one (1) crash patterns with five (5) or more crashes during the 9-year analysis period from 2013-2021, as shown in **Table 52**. The most frequent crash patterns were found to be rear-end crashes on the eastbound approach. These crash patterns, as well as sideswipe-same direction and rear-end crashes for the other approaches, could be addressed through adding left-turn lanes on SR 154.

Crash Patterns	Crashes	K	A	B	C	O	Countermeasure(s)
1. Rear End – Eastbound	5	0	0	1	0	4	Eastbound left-turn lane

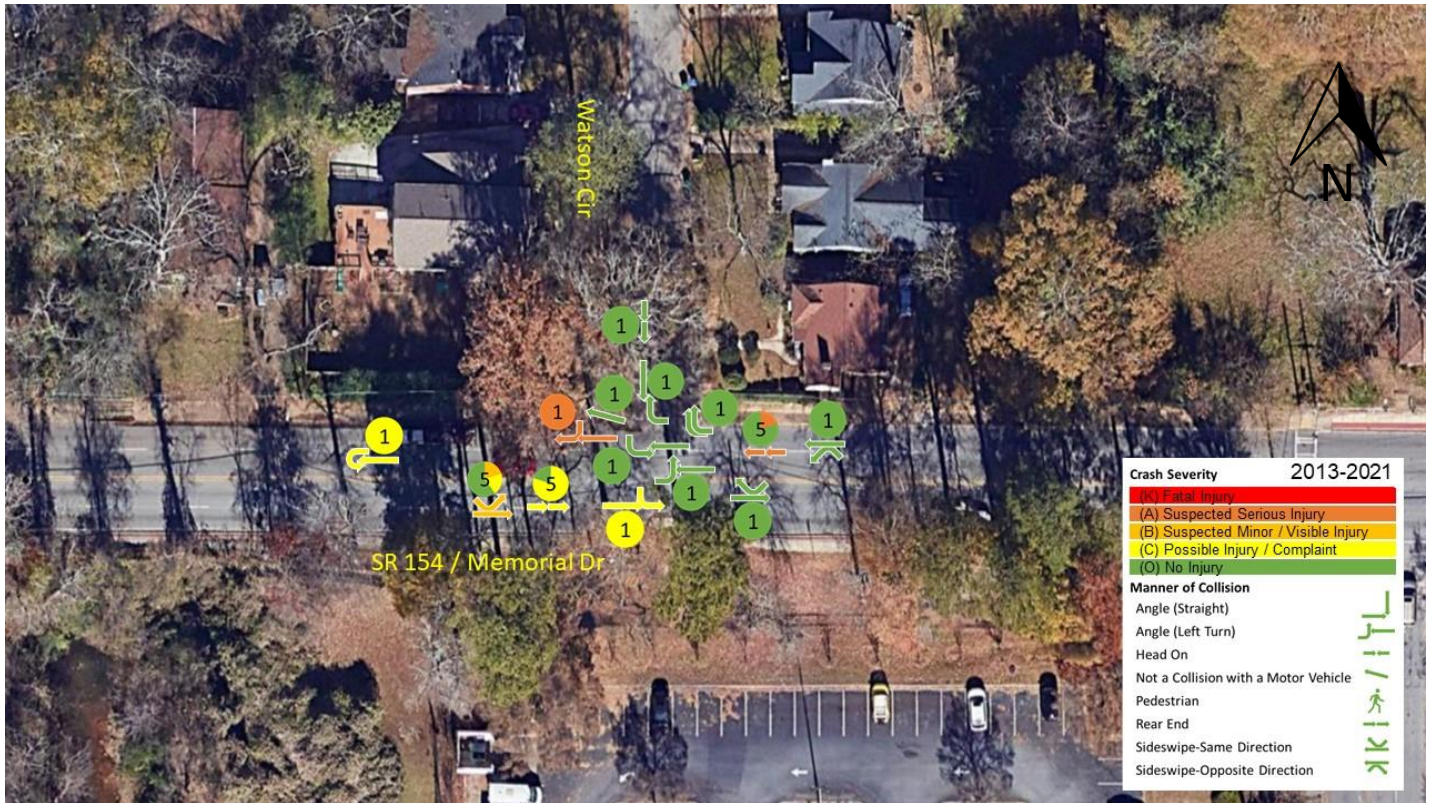
Figure 18 - Crash Diagram for SR 154 at Watson Cir

SR 154 / Memorial Dr at Watson Cir had three (3) crash patterns with five (5) or more crashes during the 9-year analysis period from 2013-2021, as shown in **Table 53**. The most frequent crash pattern was found to be rear end crashes for the eastbound and westbound approaches and sideswipe-same direction crash pattern for the eastbound vehicles. These crash patterns could be addressed through adding left-turn lanes on SR 154.

Crash Patterns	Crashes	K	A	B	C	O	Countermeasure(s)
1. Rear End – Westbound	5	0	1	0	0	4	Eastbound right-turn lane
2. Sideswipe-Same Direction – Eastbound	5	0	0	0	4	1	Westbound left-turn lane (added in 2019)
3. Rear End – Eastbound	5	0	0	1	1	3	Westbound left-turn lane (added in 2019)

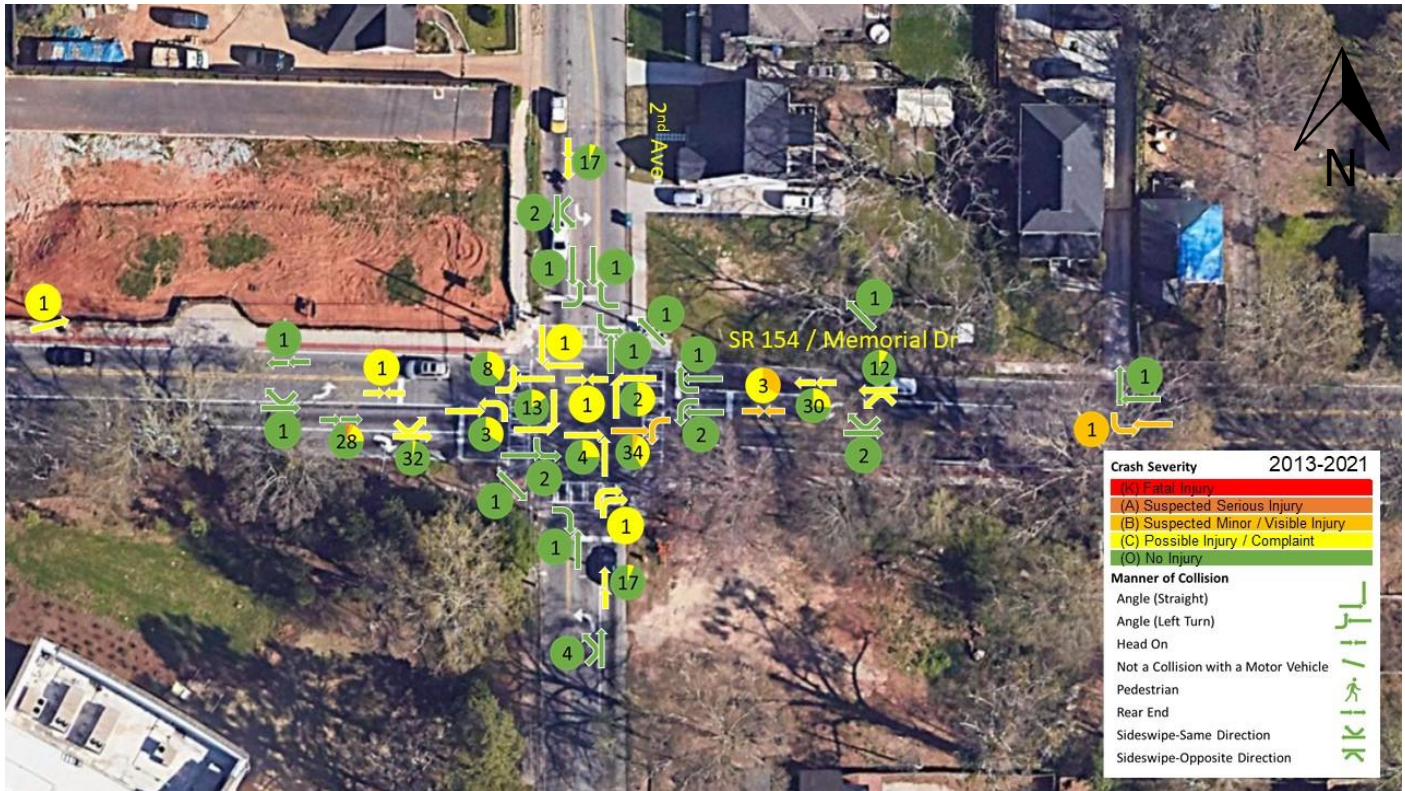
Figure 20 - Crash Diagram for SR 154 at 2nd Ave

SR 154 / Memorial Dr at 2nd Ave has nine (9) crash patterns with five (5) or more crashes during the 9-year analysis period from 2013-2021, as shown in **Table 56**. The most frequent crash pattern was found to be left turning angle crashes caused by westbound left-turning vehicles not yielding to the eastbound though vehicles, followed by rear-end and sideswipe same direction crashes on all approaches. Left-turning angle crashes could be addressed by installing protected only left-turn phasing or a roundabout at the intersection. Rear-end and sideswipe angle crashes could be addressed by adding turn lanes at the intersection or a road diet. Angle crash patterns were identified that indicate red light running as an issue at this intersection, which could be addressed by increasing the yellow time and/or all-red time.

Crash Patterns	Crashes	K	A	B	C	O	Countermeasure(s)
1. Angle – Westbound Left vs. Eastbound	34	0	0	2	12	20	Protected-only left-turn phasing, Roundabout
2. Sideswipe-Same Direction – Eastbound	32	0	0	0	1	31	Turn lanes on SR 154, Road diet (added in 2019)
3. Rear End – Westbound	31	0	0	0	8	23	Turn lanes on SR 154, Road diet (added in 2019)
4. Rear End – Eastbound	28	0	1	1	5	21	Turn lanes on SR 154, Road diet (added in 2019)
5. Rear End – Northbound	17	0	0	0	1	16	Turn lanes on SR 154, Road diet (added in 2019)
6. Rear End – Southbound	17	0	0	0	1	16	Turn lanes on SR 154, Road diet (added in 2019)
7. Angle – Eastbound vs. Southbound	13	0	0	0	2	11	Increase yellow and/or all-red time
8. Sideswipe-Same Direction – Westbound	12	0	0	0	1	11	Turn lanes on SR 154, Road diet (added in 2019)
9. Angle – Eastbound Left vs. Westbound	5	0	0	0	1	4	Protected left-turn phasing, Roundabout

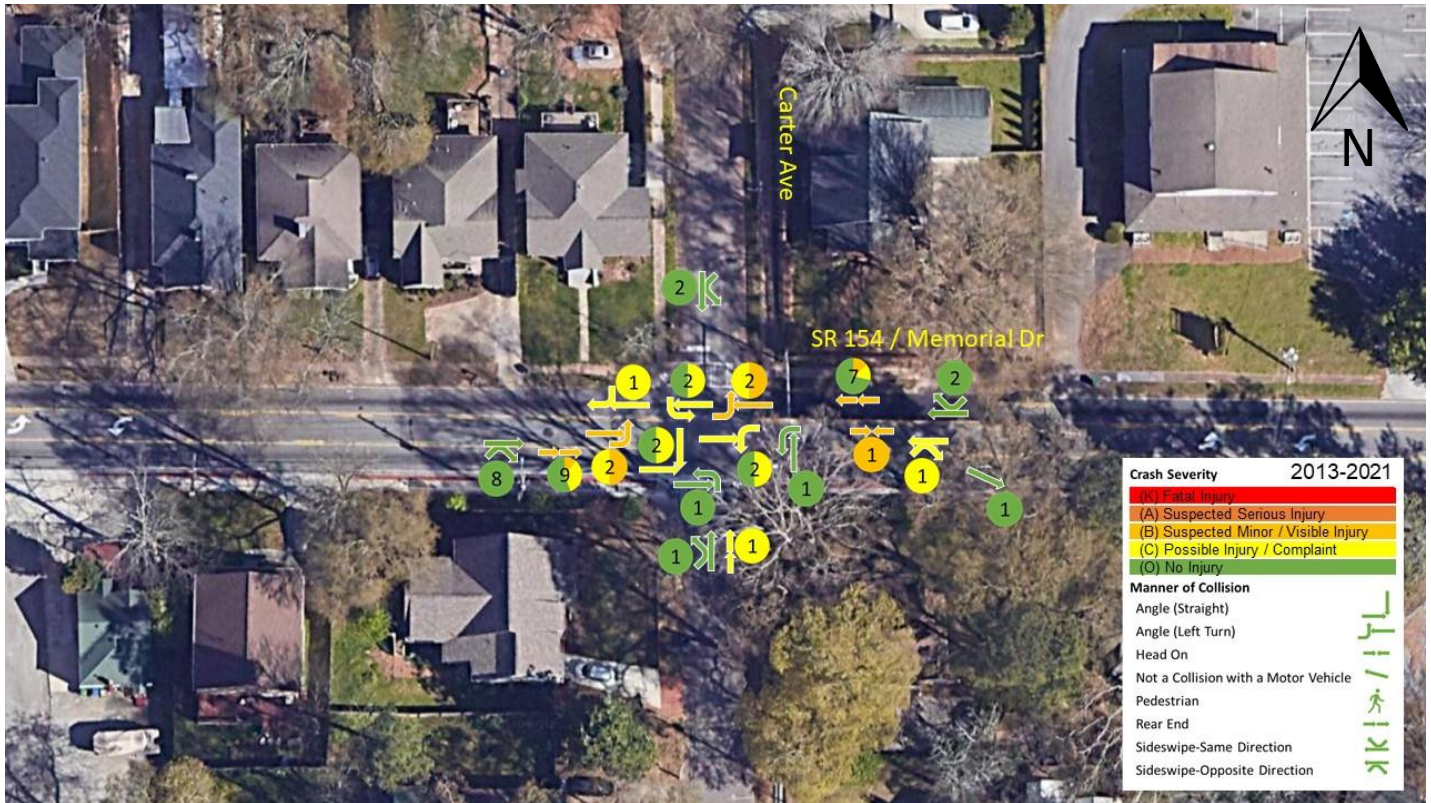
Figure 23 - Crash Diagram for SR 154 at Carter Ave

SR 154 / Memorial Dr at Carter Ave had three (3) crash patterns with five (5) or more crashes during the 9-year analysis period from 2013-2021, as shown in **Table 59**. The most frequent crash patterns were found for the eastbound and westbound approaches, including rear-end and sideswipe-same direction crashes. These crash patterns, as well as those observed for the other approaches, could be addressed through safety countermeasures including a road diet for SR 154 as well as dedicated turn lanes. Left-turning angle crash patterns were identified at the intersection, which could be addressed through safety countermeasures including a right-in right-out with flex-tube delineators or raised median at this intersection.

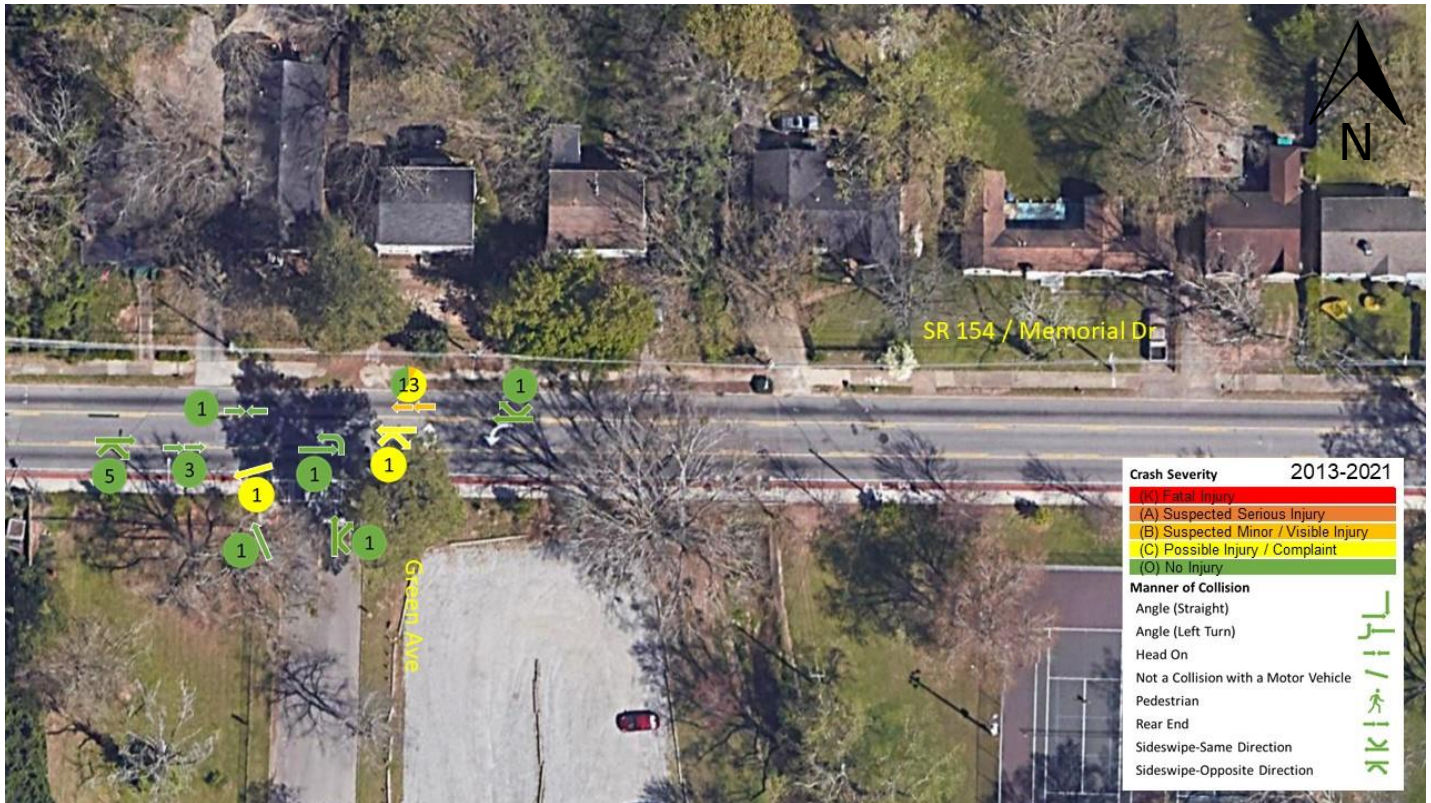
Figure 25 - Crash Diagram for SR 154 at Green Ave

SR 154 / Memorial Dr at Green Ave has two (2) crash patterns with five (5) or more crashes during the 9-year analysis period from 2013-2021, as shown in **Table 61**. The most frequent crash patterns were found to be rear-end and sideswipe-same direction crashes for the eastbound and westbound approaches. These crash patterns, as well as those observed for the other approaches, could be addressed through safety countermeasures including a road diet for SR 154 as well as dedicated turn lanes.

Table 61 - 2013-2021 Crash Patterns for SR 154 at Green Ave

Crash Patterns	Crashes	K	A	B	C	O	Countermeasure(s)
1. Rear End –Westbound	13	0	0	1	7	5	Left turn lane, Road diet (added in 2019)
2. Sideswipe-Same Direction – Eastbound	5	0	0	0	0	5	Right turn lane, Road diet (added in 2019)
