TRAFFIC ENGINEERING STUDY

PRIMARY ROUTE: SR 154 / Memorial Dr

SECONDARY ROUTE: Vannoy St to Oakridge Ave

PREPARED BY: AECOM

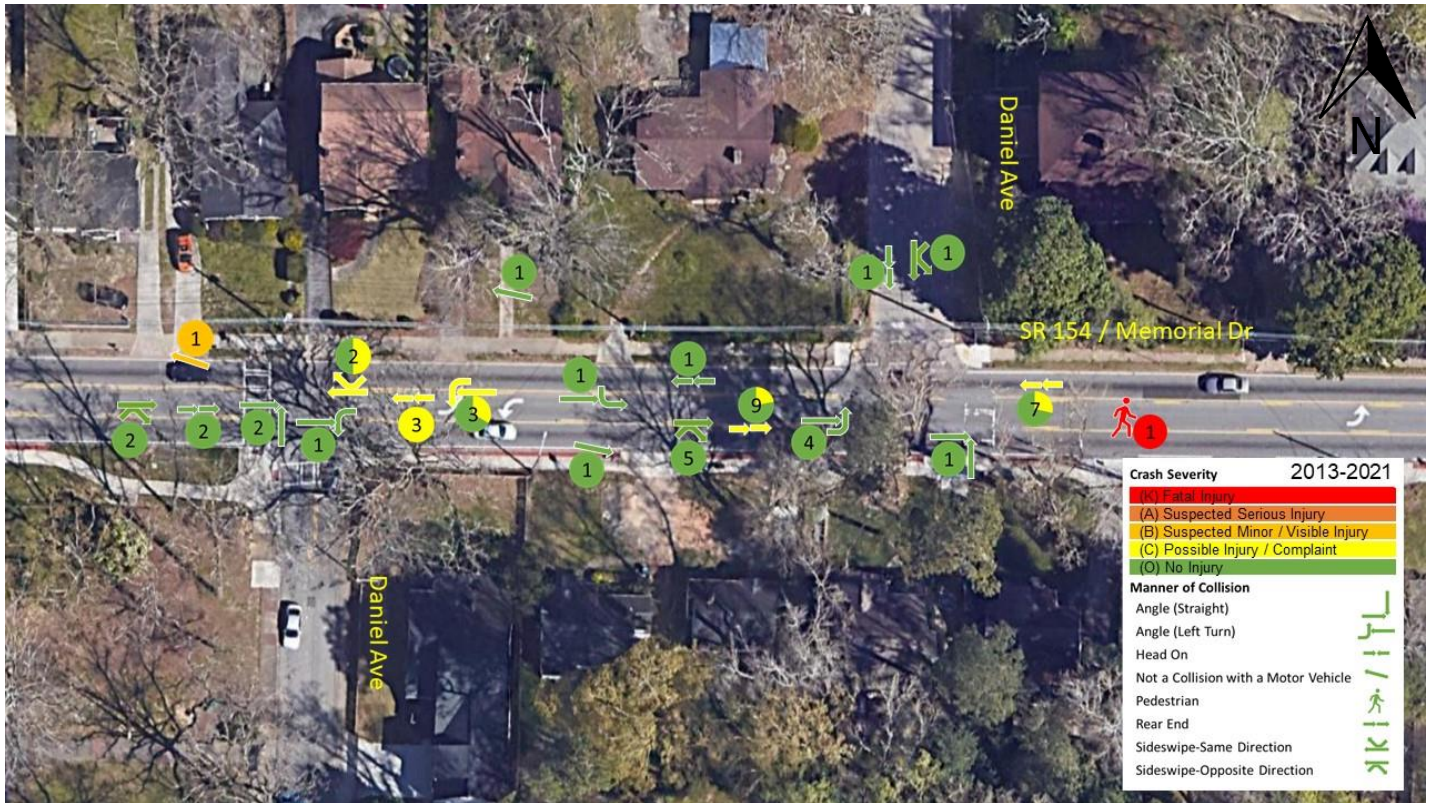
Figure 26 - Crash Diagram for SR 154 at Daniel Ave

SR 154 / Memorial Dr at Daniel Ave had two (2) crash patterns with five (5) or more crashes during the 5-year analysis period from 2013-2021, as shown in **Table 62**. The most frequent crash pattern was rear-end crashes for the eastbound and westbound approaches. This crash pattern, as well as sideswipe-same direction crashes observed for the other approaches, could be addressed through safety countermeasures including a road diet for SR 154 as well as dedicated turn lanes. A pedestrian fatality was recorded on the east leg of SR 154 caused by a pedestrian crossing mid-block across SR 154 and being hit by an eastbound vehicle.

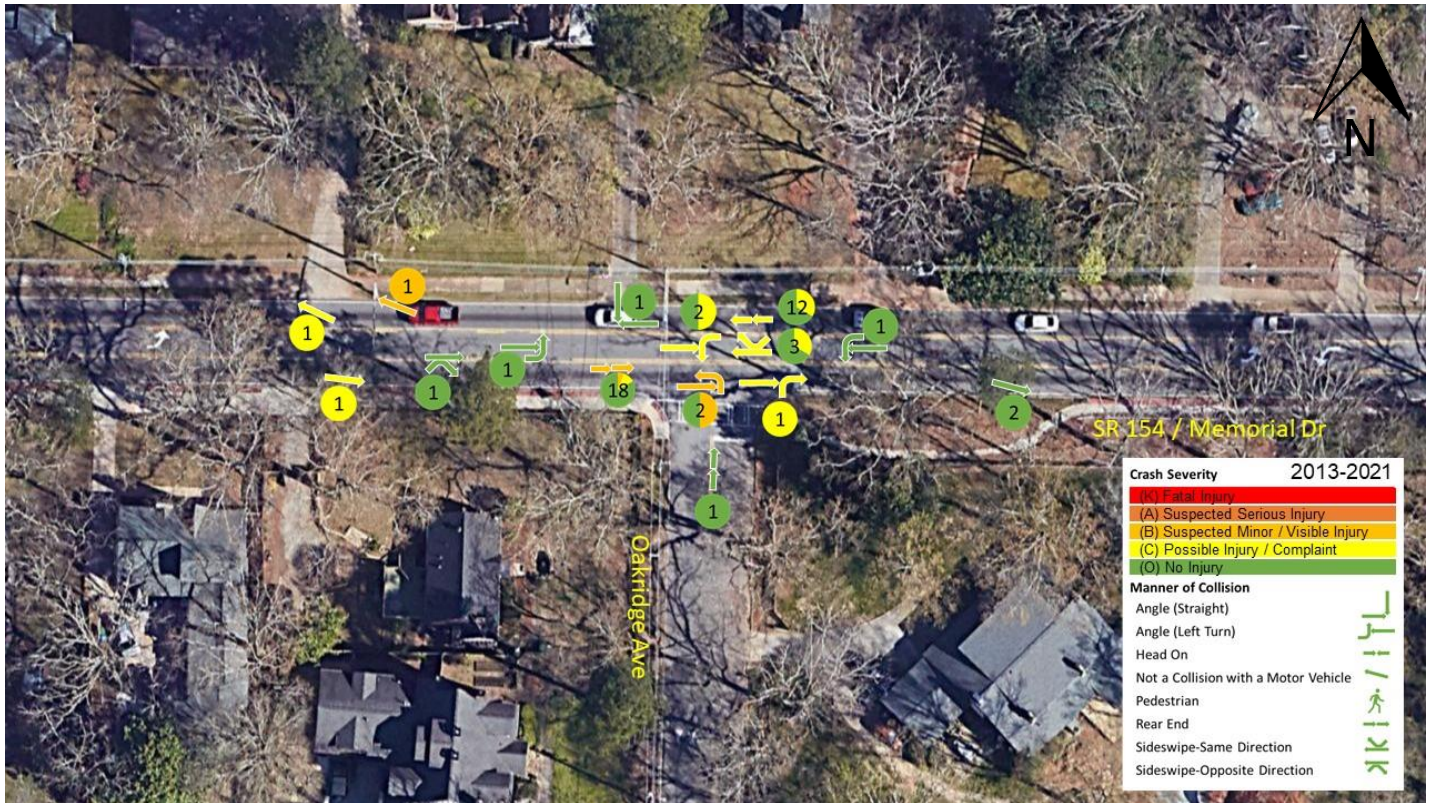
Figure 28 - Crash Diagram for SR 154 at Oakridge Ave

SR 154 / Memorial Dr at Oakridge Rd had two (2) crash patterns with five (5) or more crashes during the 9-year analysis period from 2013-2021, as shown in **Table 64**. The most frequent crash patterns were found to be rear-end crashes on the eastbound and westbound approaches. These crash patterns could be addressed through safety countermeasures including a road diet for SR 154 as well as dedicated turn lanes.

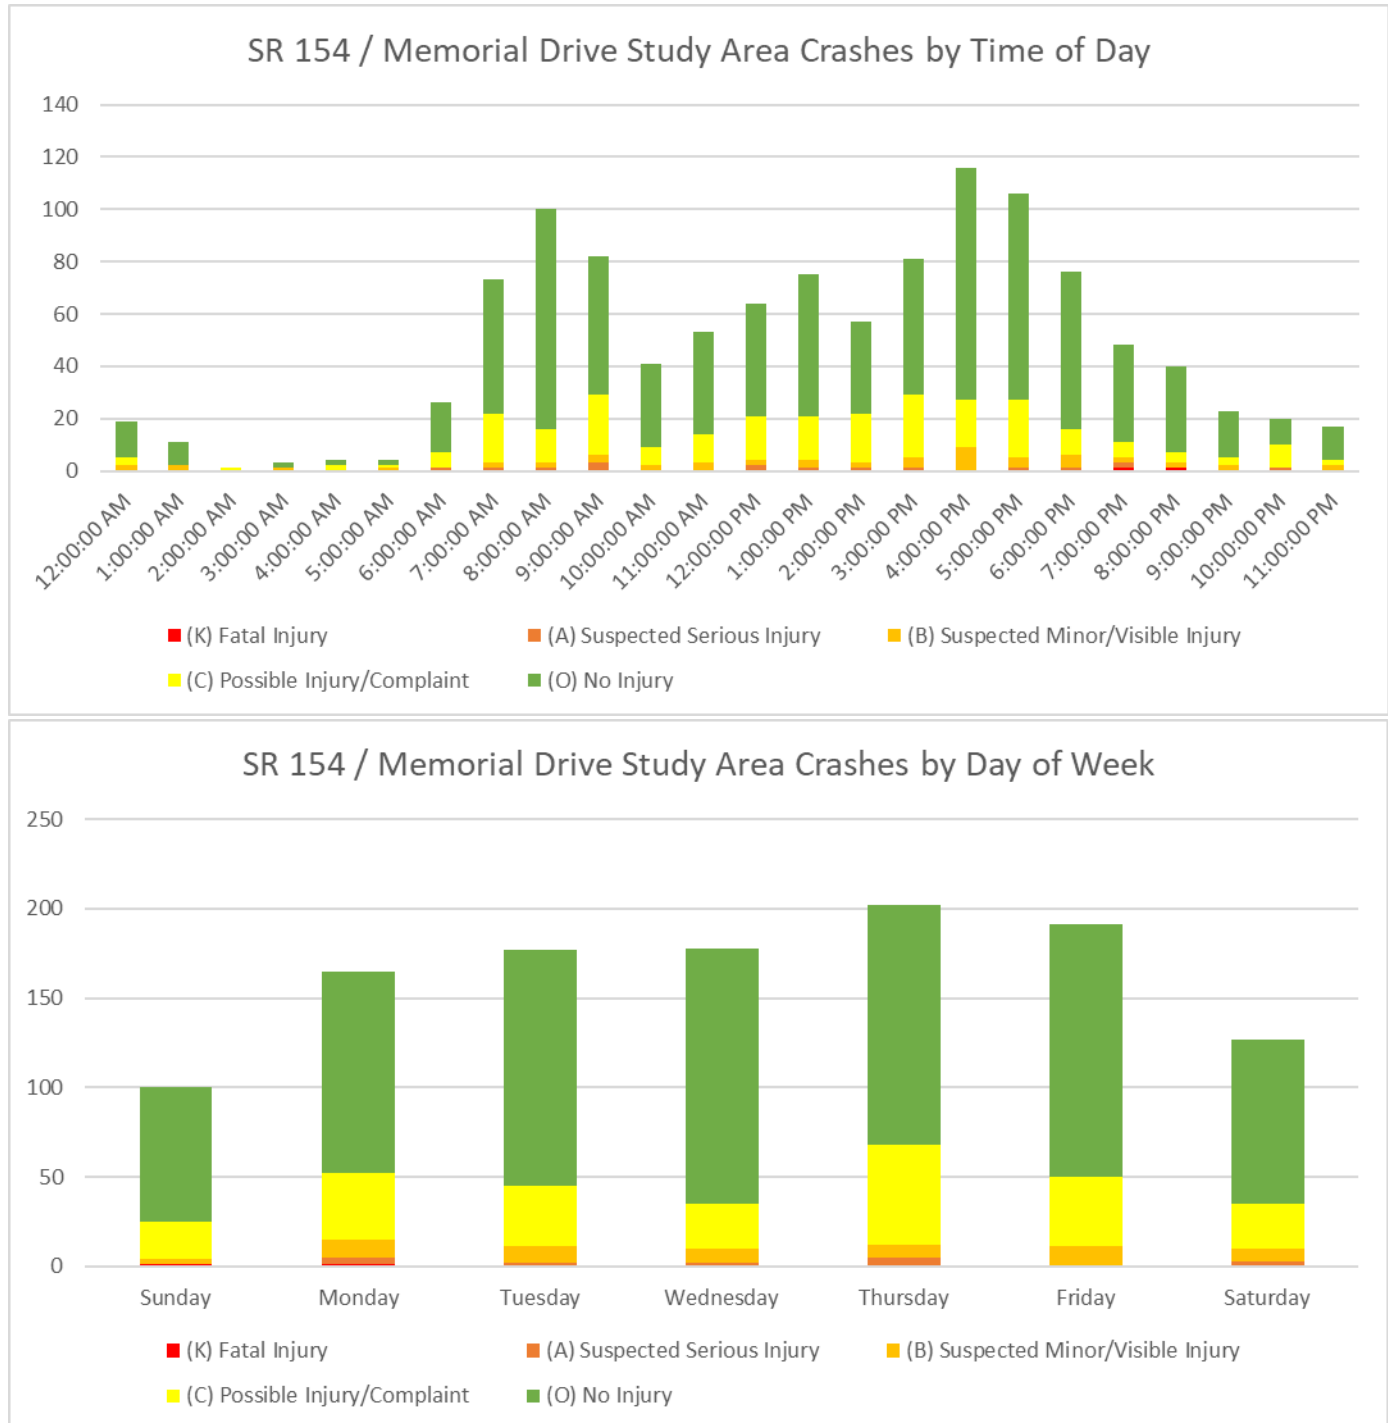
Lastly, crashes for the corridor overall were analyzed by time of day (hour) and day of the week for data from 2013-2021, as shown in **Figure 29**. The afternoon peak hours as well as Thursdays and Fridays appear to have the most crashes, with injury crashes up in midday while fatal crashes occurred during peak AM or night hours (7-9pm).

Figure 29 - Crashes by Hour and Day
