2012 Barwick-Lafayette Airport Pavement Management Plan

BARWICK-LAFAYETTE AIRPORT

PAVEMENT MANAGEMENT REPORT

DECEMBER 2012

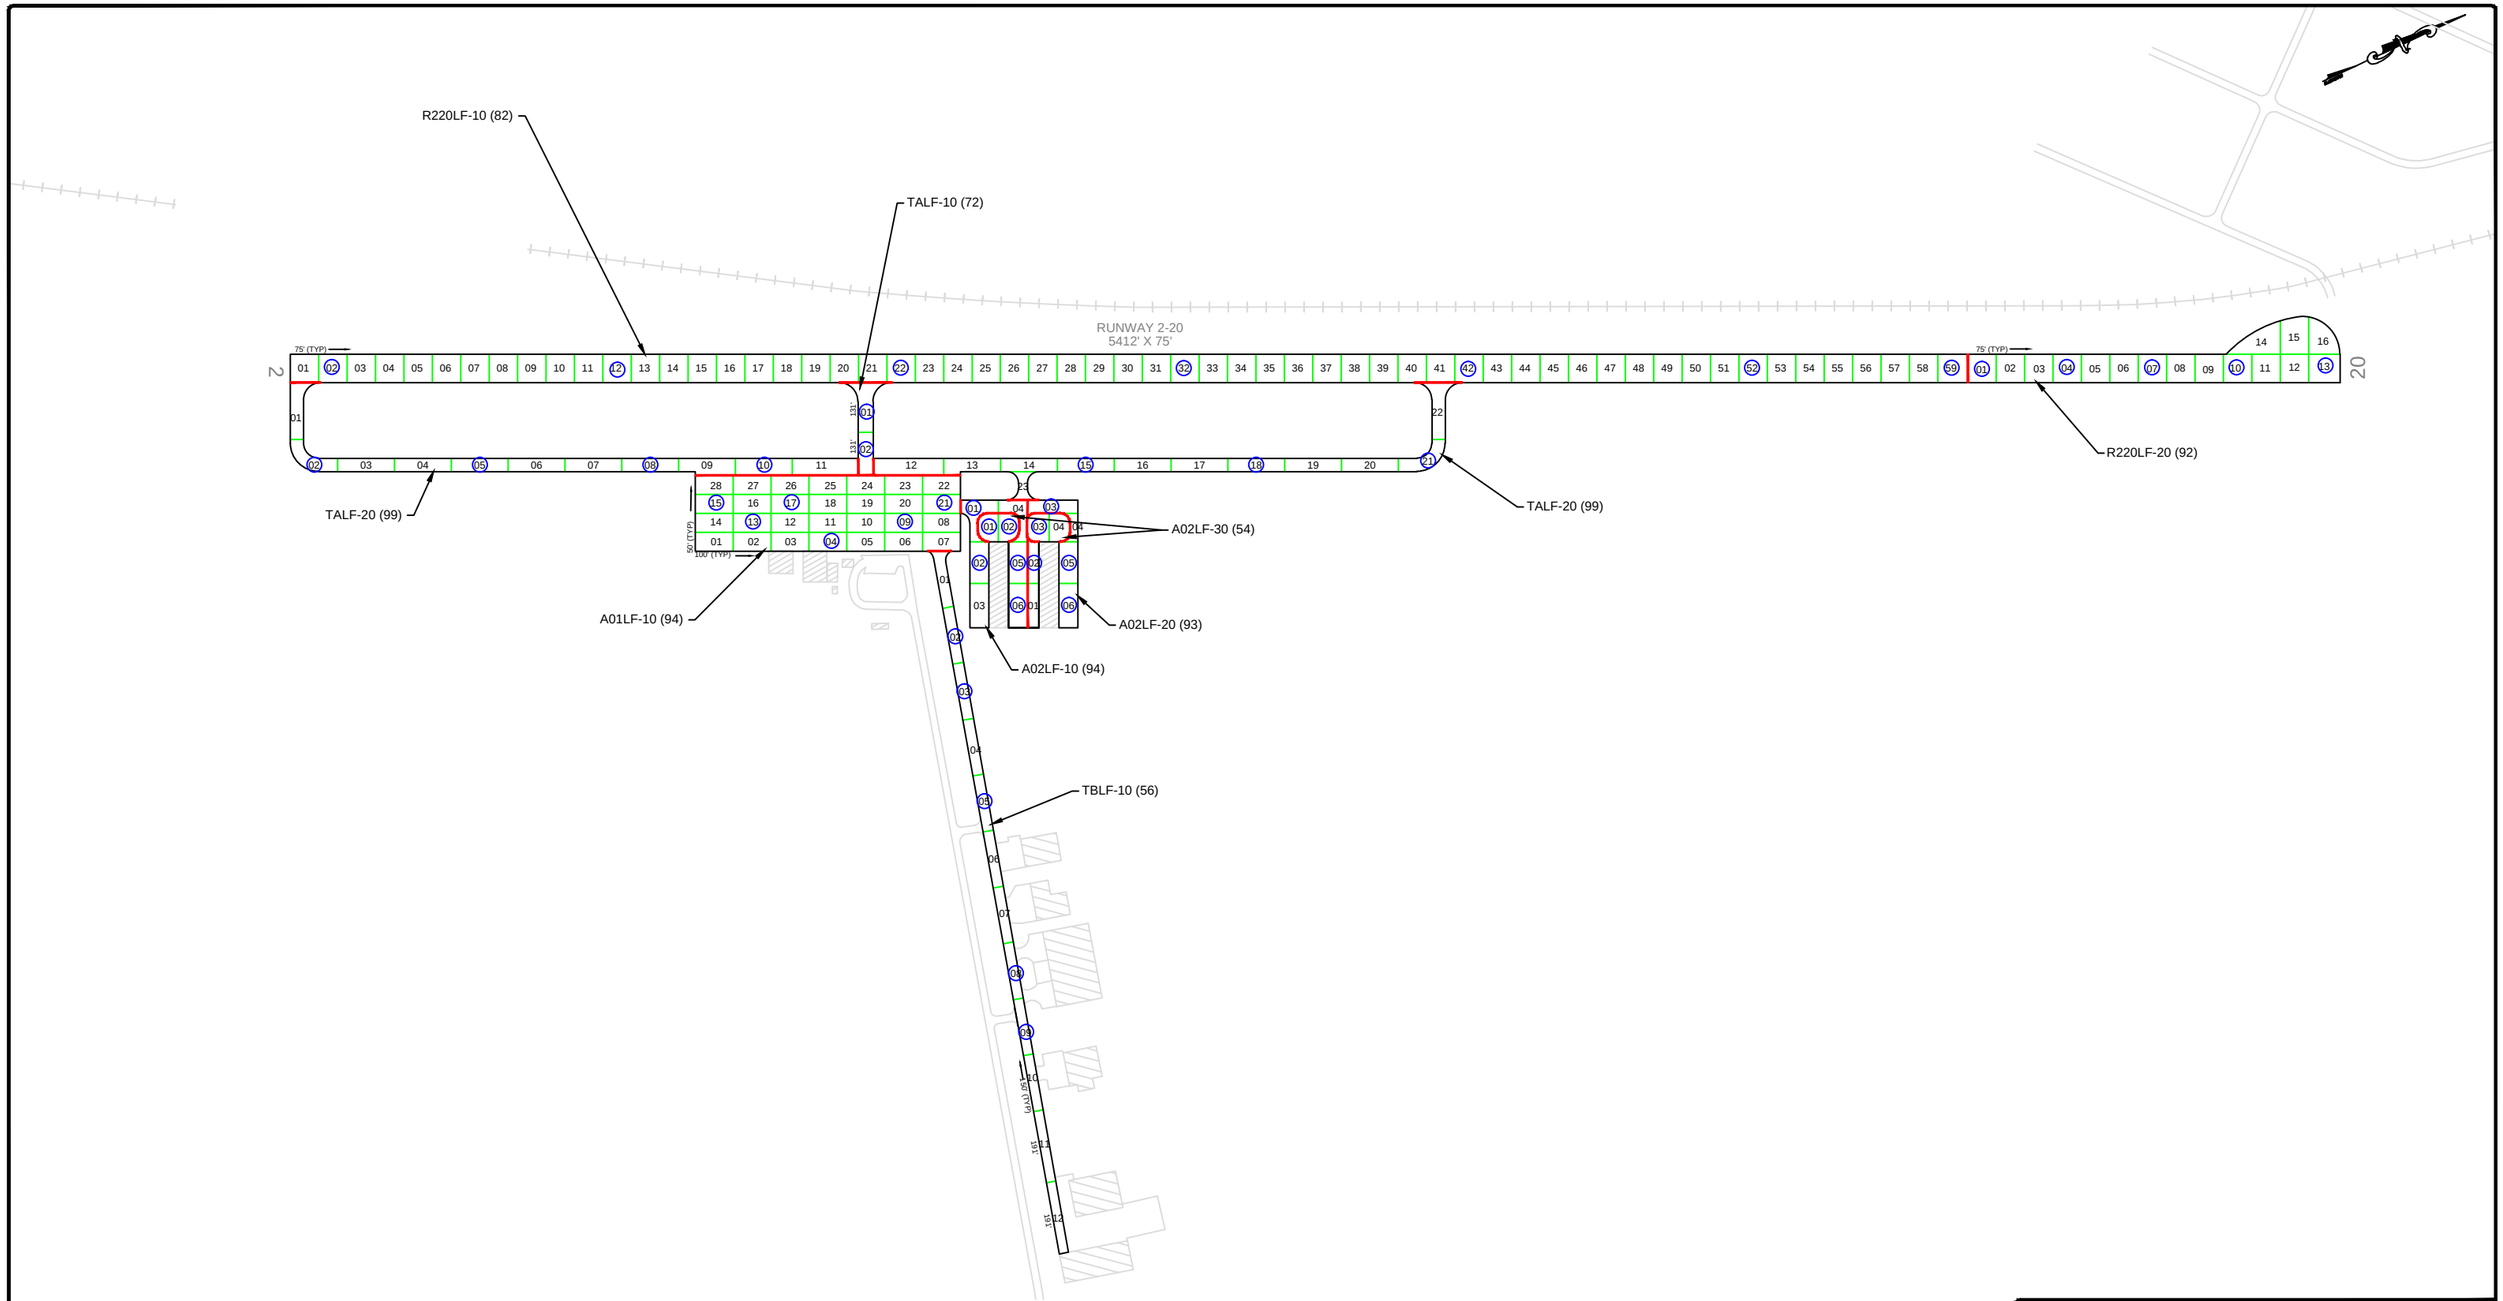
There were nine pavement sections defined during the inspection. Except where noted, the low-severity cracking was unsealed, and the medium-severity cracking was due to unsealed crack widths that exceeded ¼ in.

Runway 2-20 was defined by two sections. Section 10 had a PCI value of 82. Moderate amounts of low-severity longitudinal and transverse (L&T) cracking were identified throughout. The majority of the cracking was recently resealed. Section 20 had a PCI value of 92 with small quantities of low-severity L&T cracking and patching observed.

Taxiway A was comprised of two sections. Section 10 had a PCI value of 72. Moderate quantities of low-severity L&T cracking, weathering, depression, and alligator cracking were recorded. The majority of the cracking was recently resealed. Section 20 had a PCI value of 99 with isolated amounts of low-severity L&T cracking identified.

Taxiway B consisted of one section with a PCI value of 56. Moderate amounts of low- and medium-severity L&T cracking, all severities of alligator cracking, and low-severity patching, depression, and rutting were observed.

The apron 01 area (A01LF) was defined by one section with a PCI value of 94. Only small quantities of low-severity L&T cracking were recorded.

The apron 02 area (A02LF) was comprised of three sections. Sections 10 and 20 had PCI values of 94 and 93, respectively. Small amounts of low-severity L&T cracking were noted in both sections along with isolated areas of low-severity rutting in Section 10. Section 30 had a PCI value of 54. Moderate amounts of low- and medium-severity alligator cracking and low-severity L&T cracking, depression, and rutting were identified.

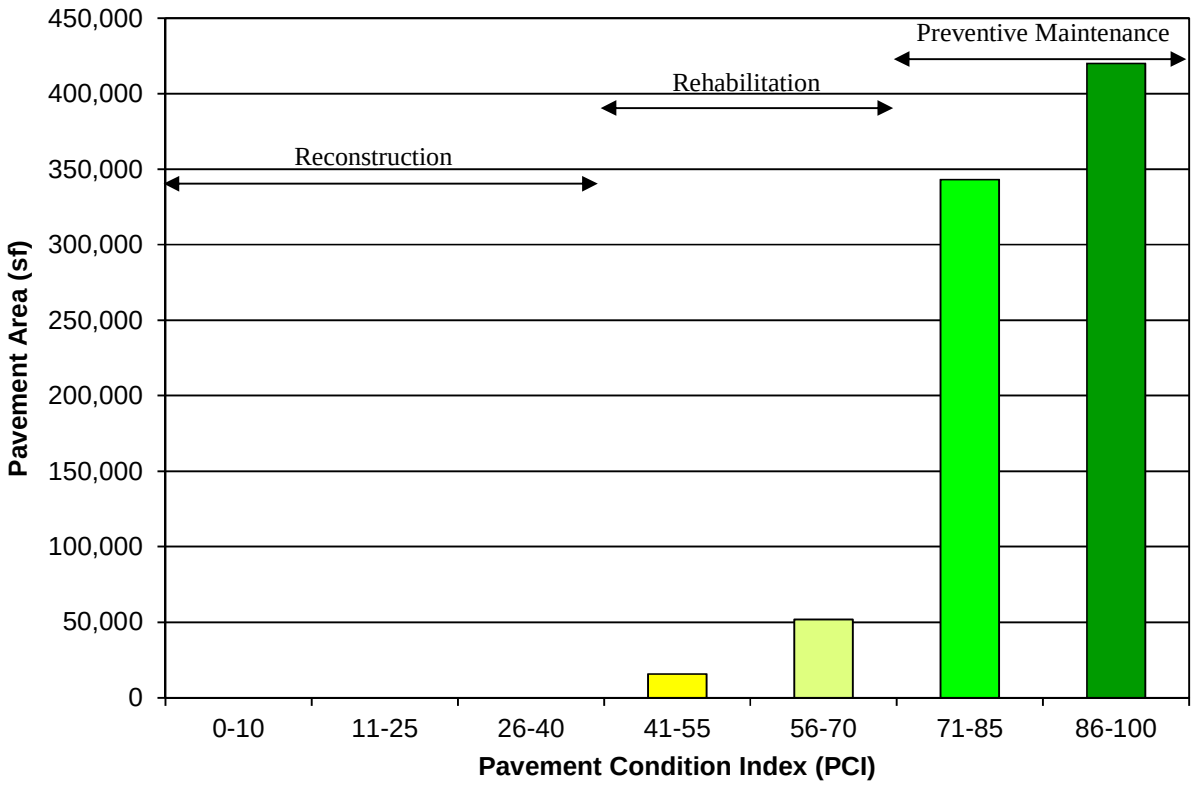
Figure 6. Condition Distribution.

Figures 6 and 7 provide graphs summarizing the overall condition of the pavements at Barwick-Lafayette Airport. Figure 8 is a map that displays the condition of the pavements evaluated. Table 2 summarizes the results of the pavement evaluation and paint assessment and also presents both the 2007 and 2012 PCI values. Please note that modifications have been made to the PCI methodology since the time of the last pavement inspection in 2007, as detailed in ASTM 5340-11. These changes include the separation of the raveling and weathering distress type on asphalt-surfaced pavements into two distress types along with the addition of the alkali silica reaction (ASR) distress type on PCC pavements.

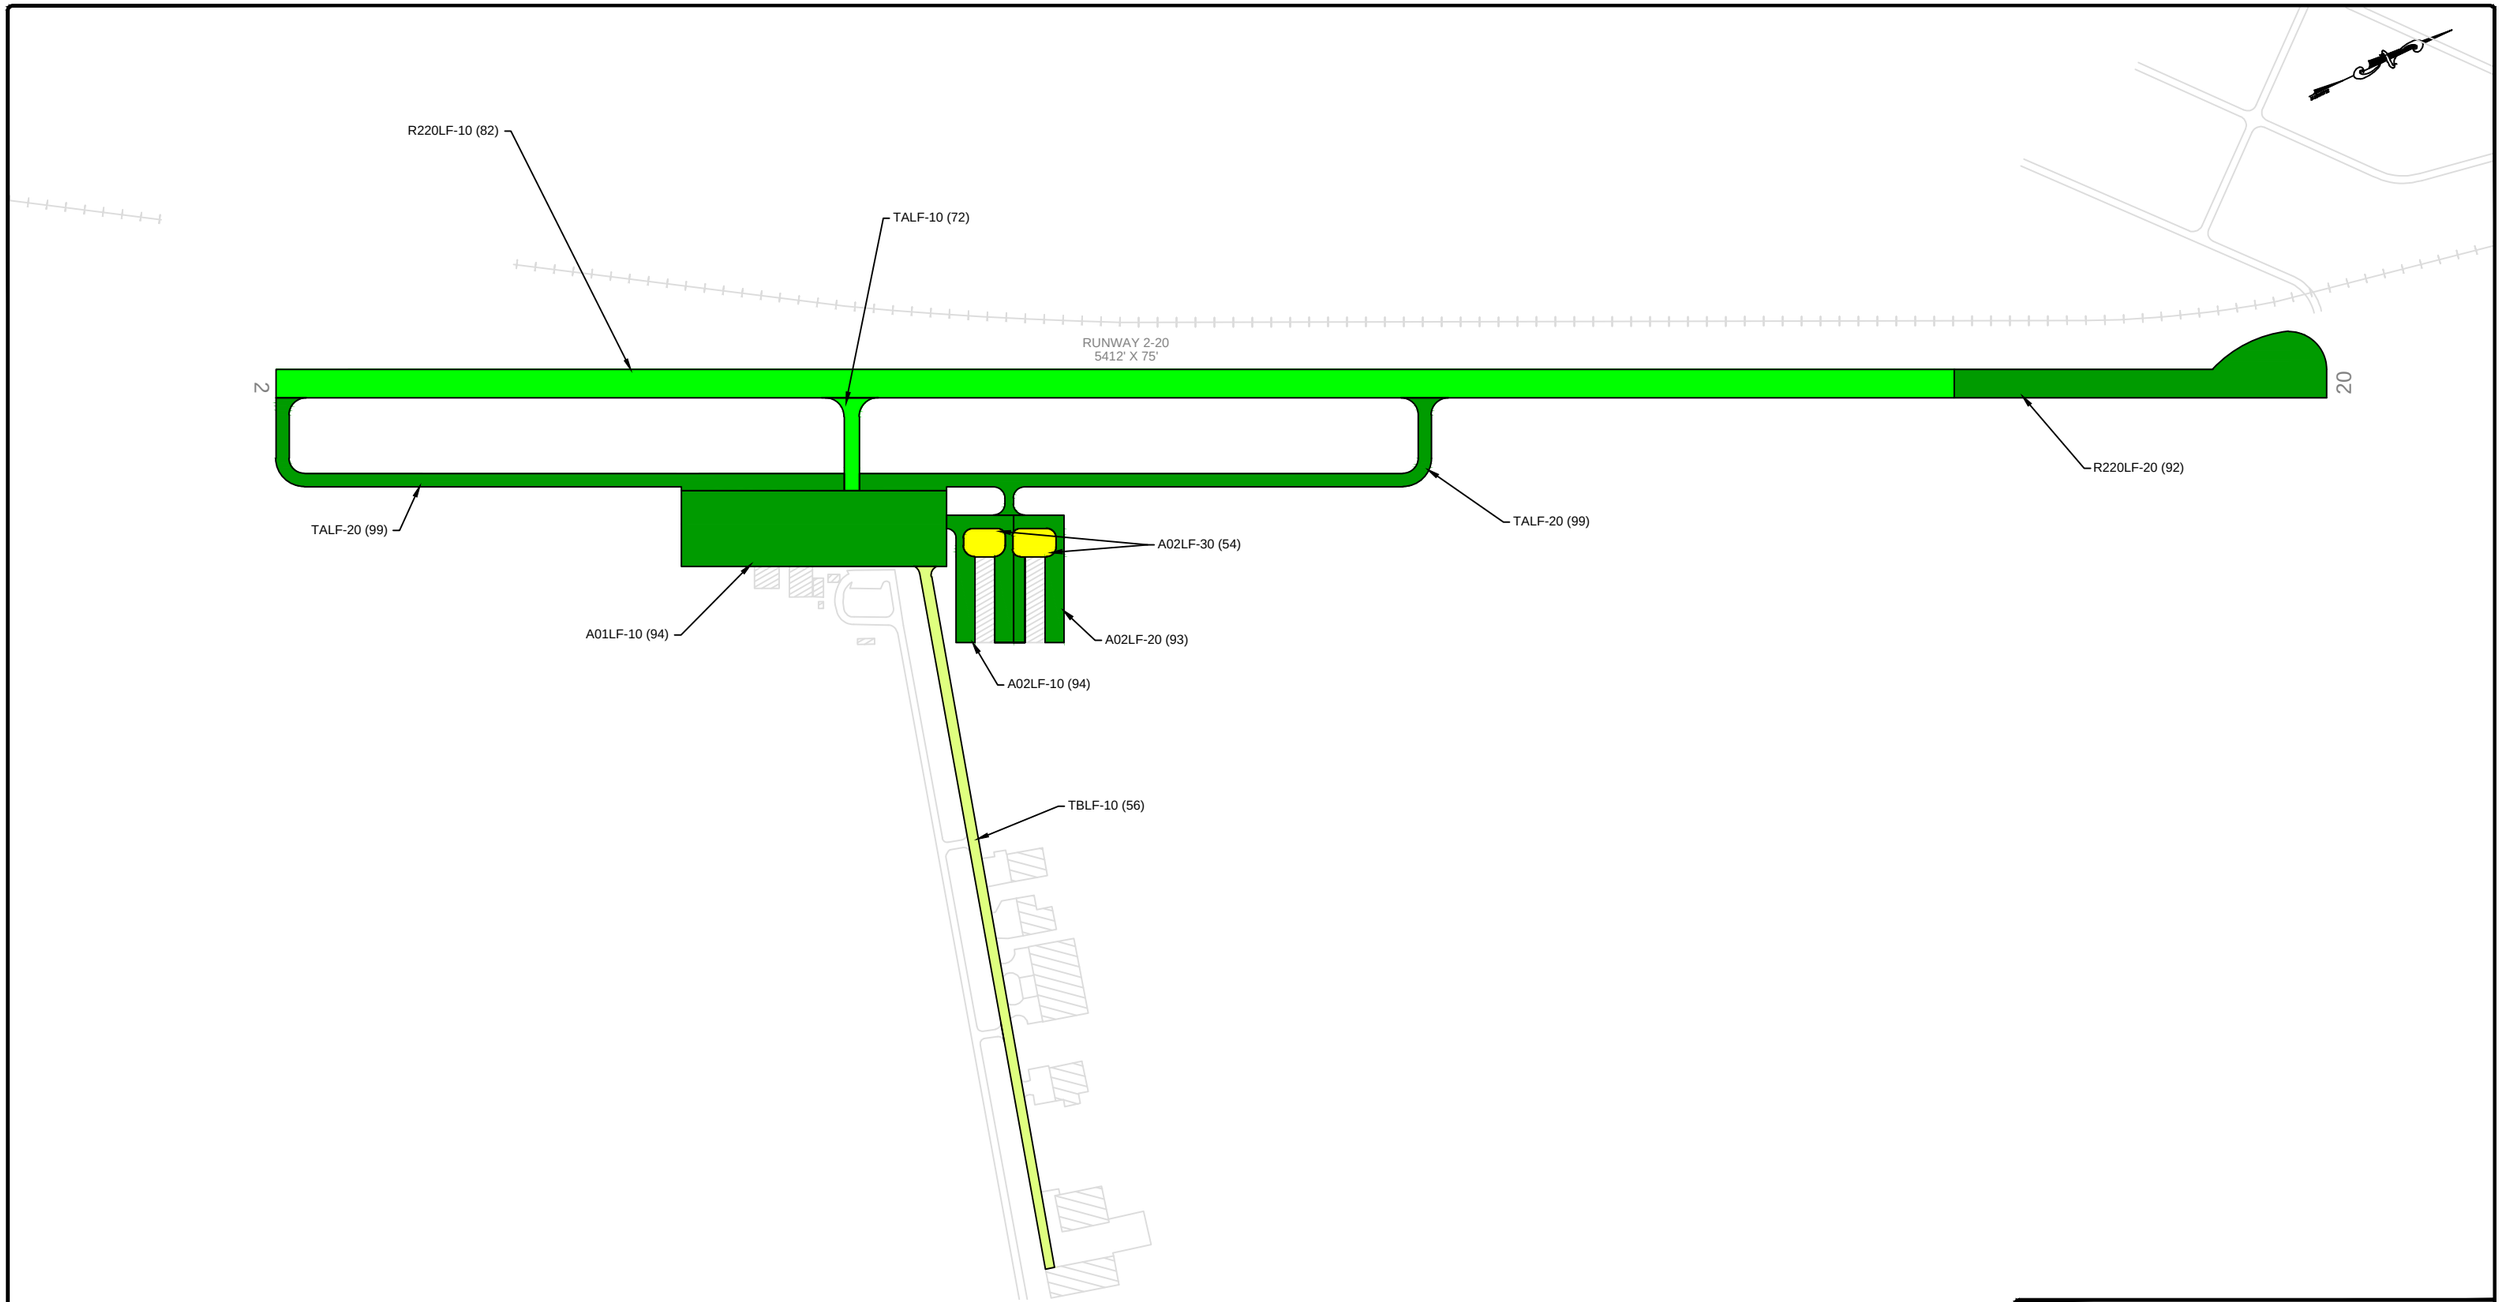
PAGE TITLE: PAVEMENT CONDITION INDEX MAP

The 2012 area-weighted condition of Barwick-Lafayette Airport is 86, with conditions ranging from 54 to 99 [on a scale of 0 (failed) to 100 (excellent)]. This compares to a 2007 PCI of 96.
