2012 Berrien County Airport Pavement Management Plan

BERRIEN COUNTY AIRPORT

PAVEMENT MANAGEMENT REPORT

DECEMBER 2012

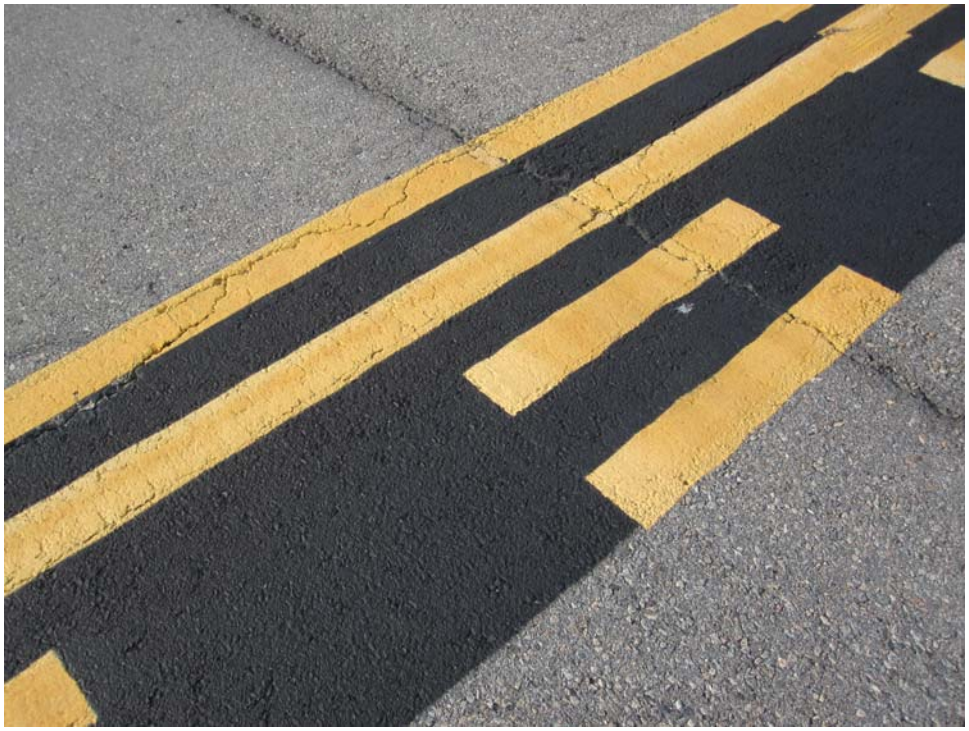
THANGNS-10. Satisfactory Paint.
