Evaluation of Performance and Maximum Length of Continuous Decks in Bridges – Part 2

Office of Materials and Research Georgia Department of Transportation

GDOT Research Project No. 10-29 Task Order No. 02-81

August 2012

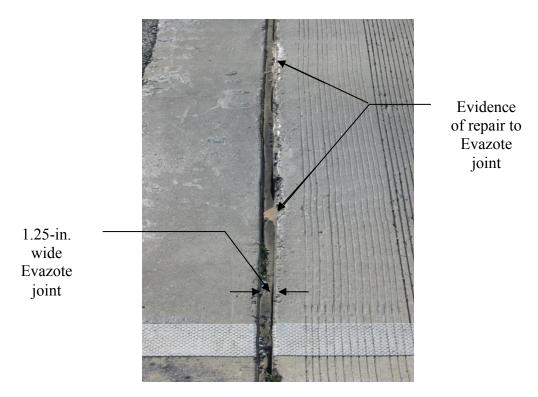
Figure 1.5.1: Evazote expansion joint in field (Structure ID: 015-5123-0)

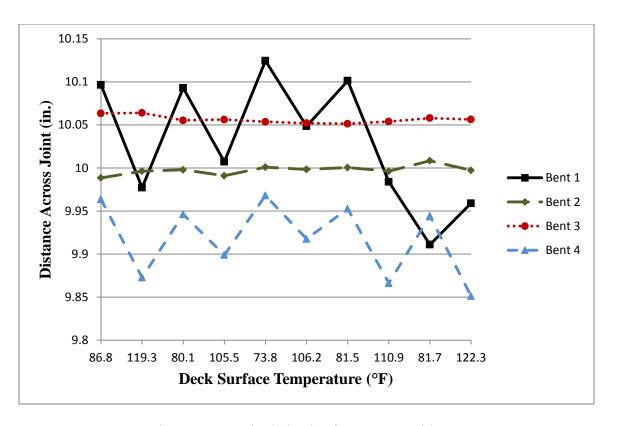
Figure 4.2.2: Joint behavior for Bartow Bridge 1

The data show that, as one would expect, in every case there is larger movement at the expansion joints (Bent 1 and 4) than at the link-slab construction joints. The movement at the expansion joints is also a closing of the joint in every case for temperature increase, which indicates deck expansion with temperature increase as expected. The expansion and contraction is smaller at the link-slab locations. The variations for the construction joints 2 and 3 are approximately the same, indicating that the behavior of the link slab is independent of the type of bearing that it is over (fixed-fixed or expansion-expansion).

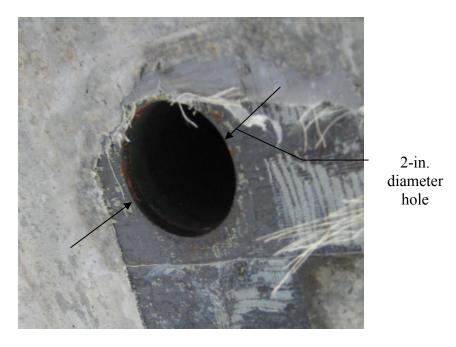
Figure 5.2.3: Hole in the underside of a girder at a fixed bearing

At fixed bearings, the dowel bar connecting the girder and pier cap is placed into a circular hole in the bottom of the girder. A photo of this hole is shown in Figure 5.2.3. The hole is 2 inches in diameter to allow for construction tolerances. The larger dimension of the hole compared to the dowel bar, as seen in Figure 5.2.4, allows for some lateral and longitudinal movement of the girder at the fixed bearing location.

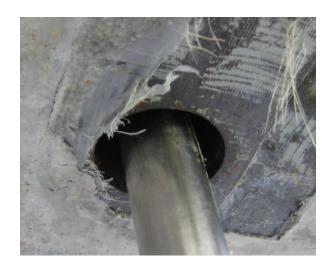
Figure 5.2.4: Dowel bar (1.25-in. diameter) inserted into the 2-in. diameter hole insert at a fixed bearing

At a fixed bearing, there is a 3/8-in. annulus between the dowel and hole if the dowel is in the center of the hole. This means that, on average, this amount of movement can occur without ever having to engage the dowel.

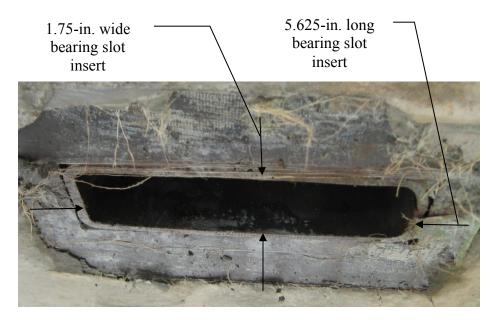
Figure 5.2.5: Bearing slot (1.75 in. x 6.75 in.) insert made of galvanized steel for expansion bearing set-up

elastomeric bearing. Figure 5.2.5 shows the slot on the underside of a girder for the dowel rod at an expansion bearing. The bearing slot insert is approximately 5.625 inches long and 1.75 inches wide. Figure 5.2.6 is a picture of a dowel rod placed into the slot.

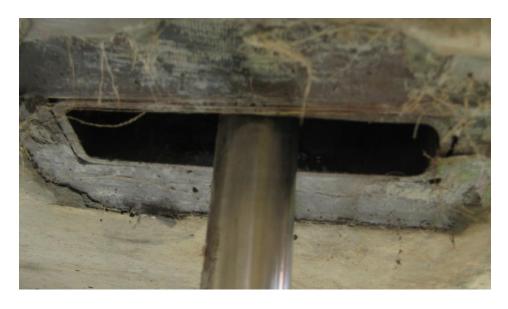
Figure 5.2.6: Dowel rod inserted into expansion bearing slot insert in bottom of girder

The dowel bar in an expansion bearing is placed into a rectangular slot cast into the girder; this slot allows for more longitudinal movement than the fixed bearing. The amount of movement is limited by the length of the slot and the capacity of the
