GLYNCO JETPORT

PAVEMENT EVALUATION REPORT

JULY 2002

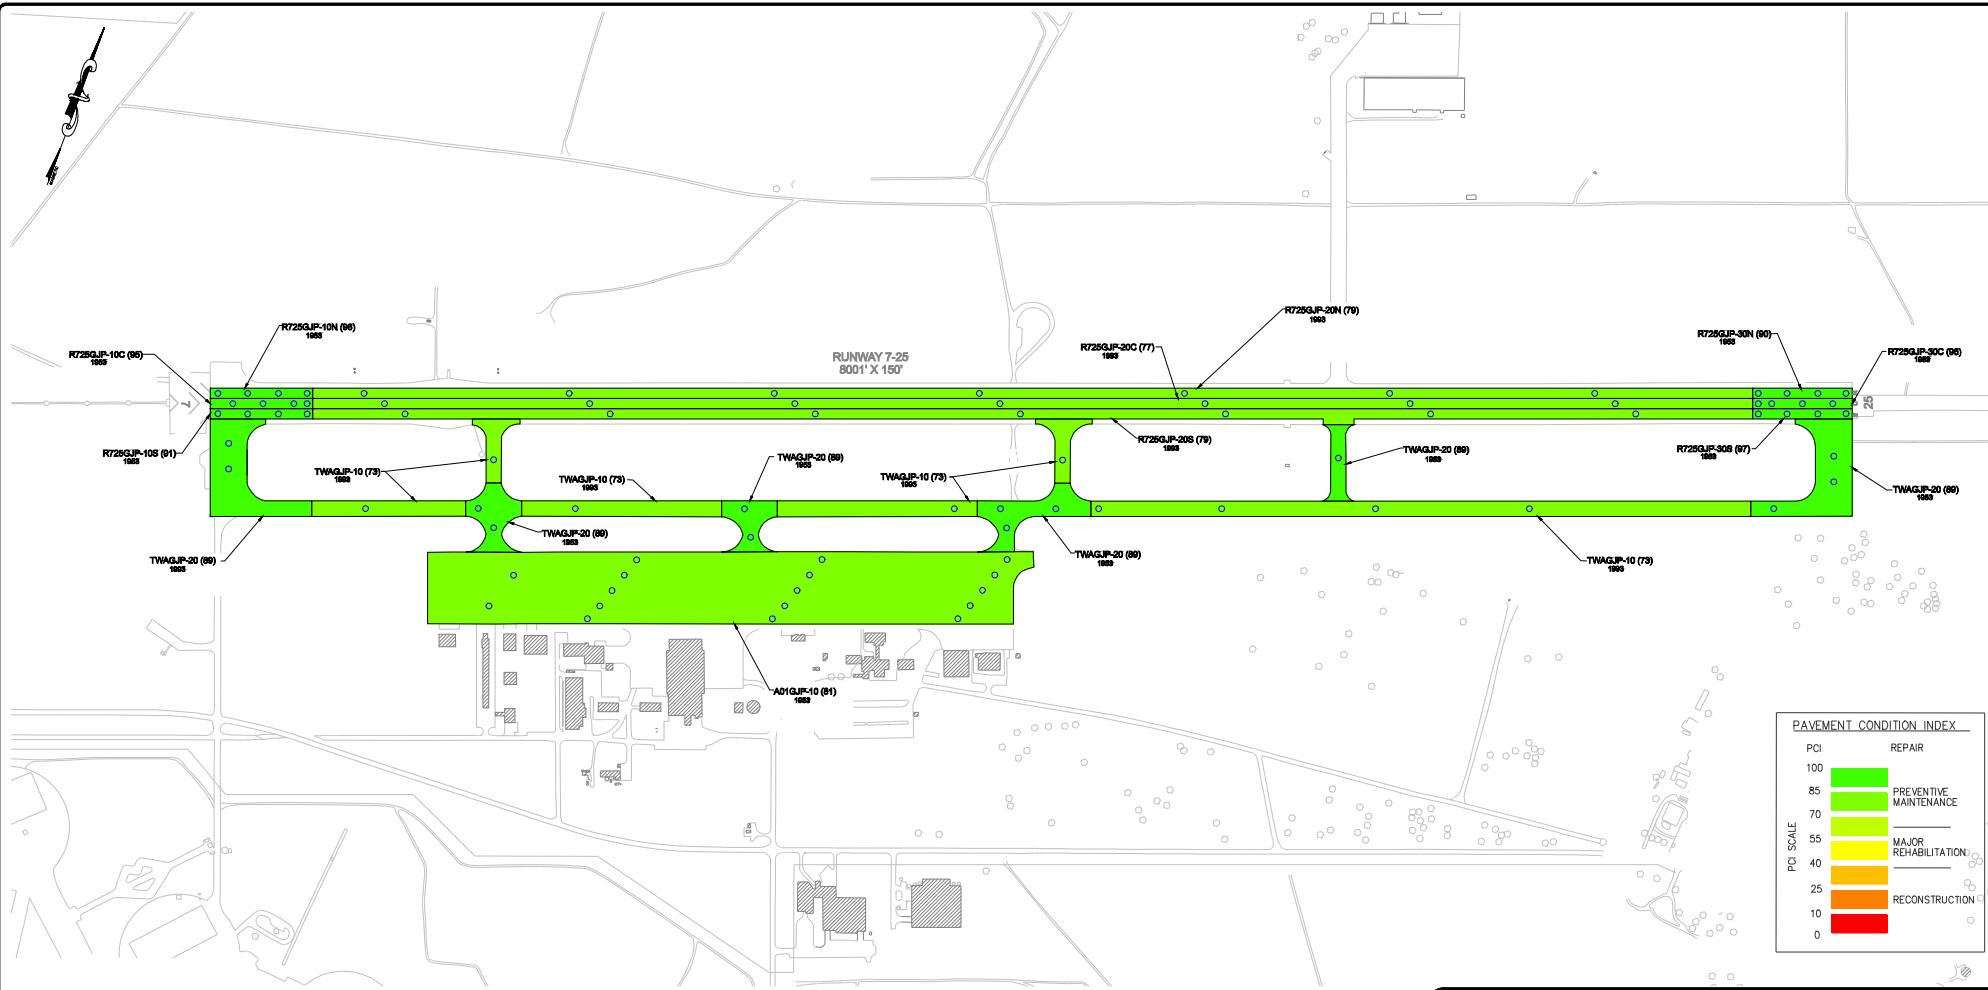
Figure 8. INSERT PCI MAP
(11 x 17)

The 2001 area-weighted condition of Glynco Jetport is 80, with conditions ranging from 73 to 97 [on a scale of 0 (failed) to 100 (excellent)]. Figures 6 and 7 provide graphs summarizing the overall condition of the pavements at Glynco Jetport. Figure 8 is a map that displays the condition of the pavements evaluated. Table 1 summarizes the results of the pavement evaluation.
