GWINNETT COUNTY - BRISCOE FIELD

PAVEMENT EVALUATION REPORT

JULY 2002

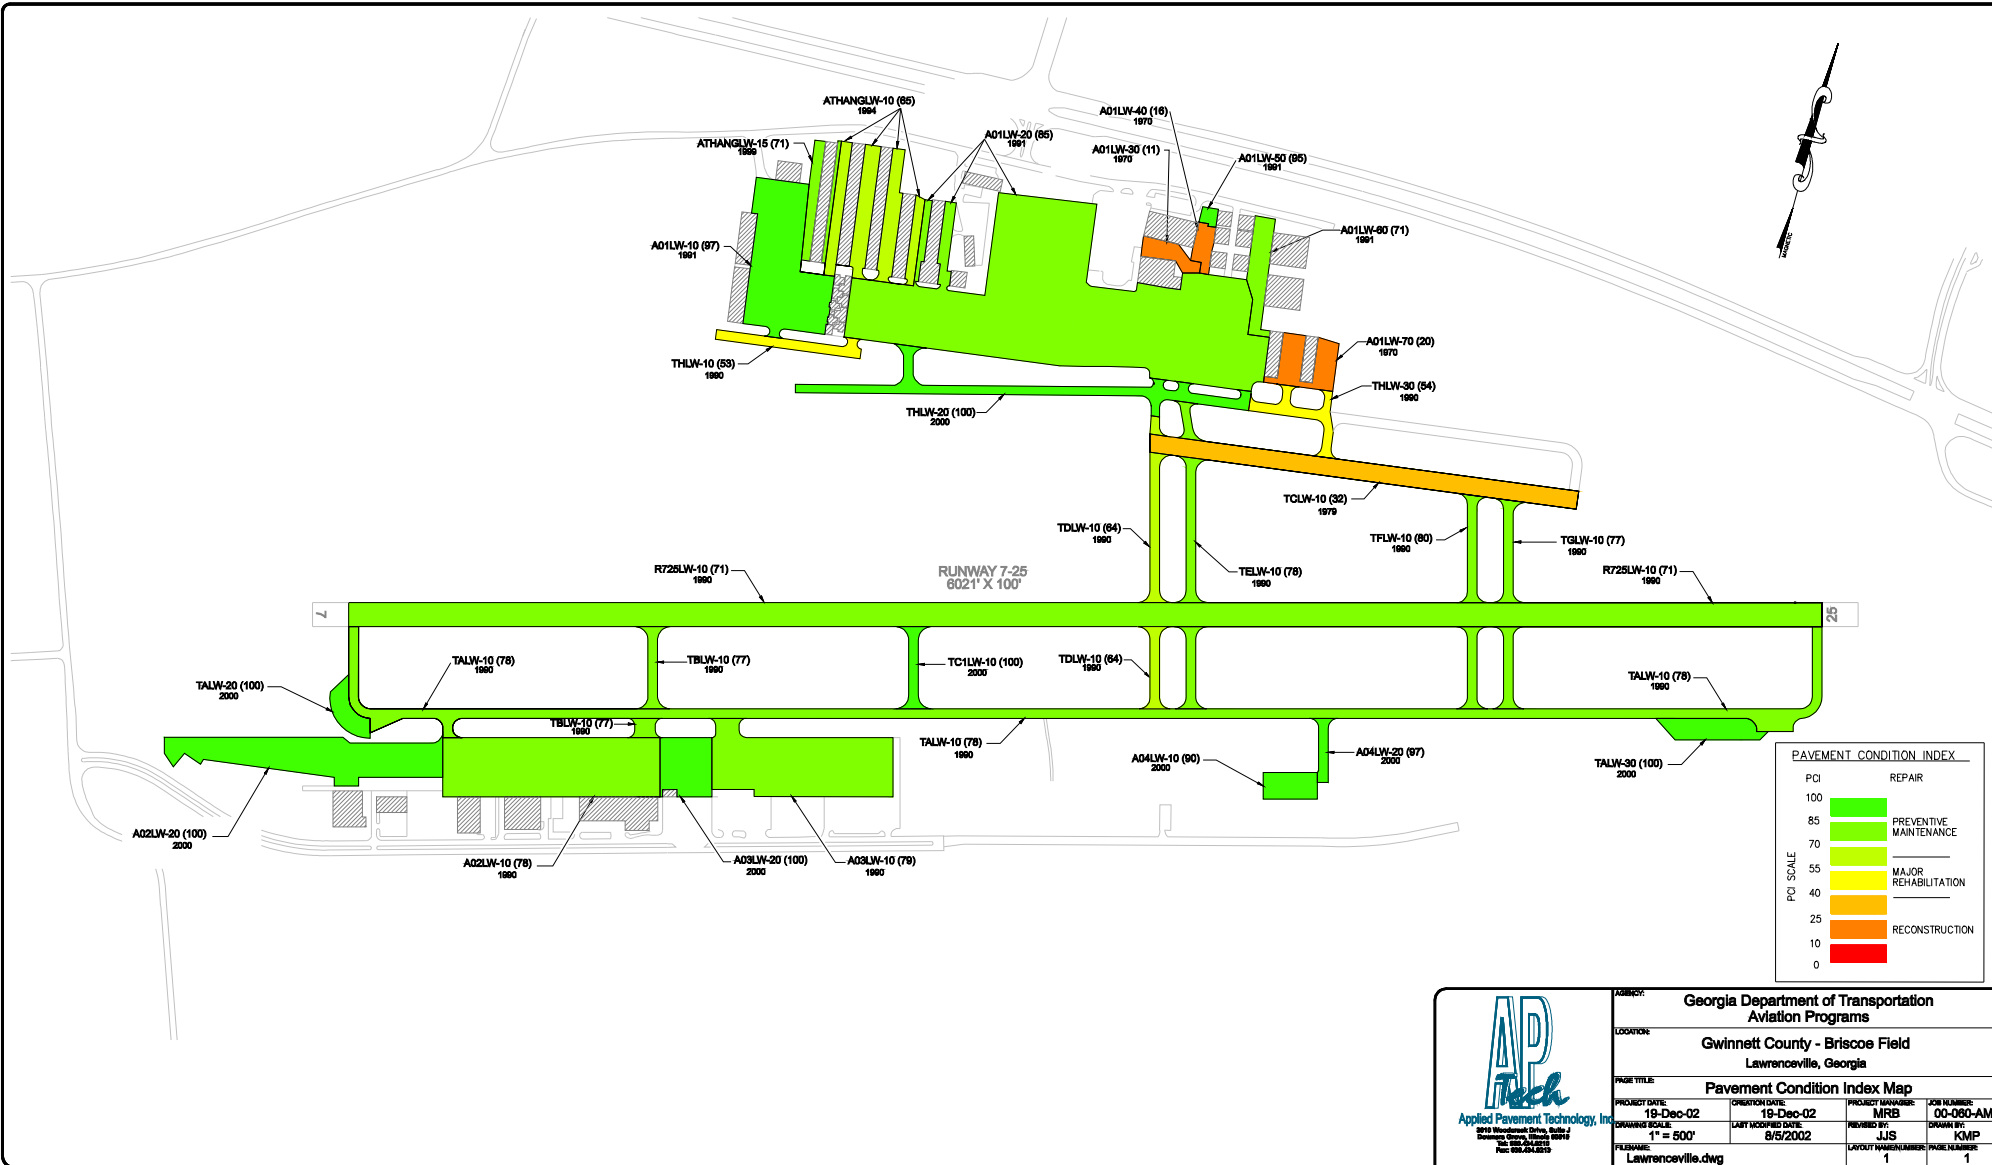
Figure 8. INSERT PCI MAP
(11 x 17)

The 2001 area-weighted condition of Gwinnett County - Briscoe Field is 78, with conditions ranging from 11 to 100 [on a scale of 0 (failed) to 100 (excellent)]. Figures 6 and 7 provide graphs summarizing the overall condition of the pavements at Gwinnett County - Briscoe Field. Figure 8 is a map that displays the condition of the pavements evaluated. Table 1 summarizes the results of the pavement evaluation.
