# MIDDLE GEORGIA REGIONAL AIRPORT

## PAVEMENT EVALUATION REPORT

JULY 2002

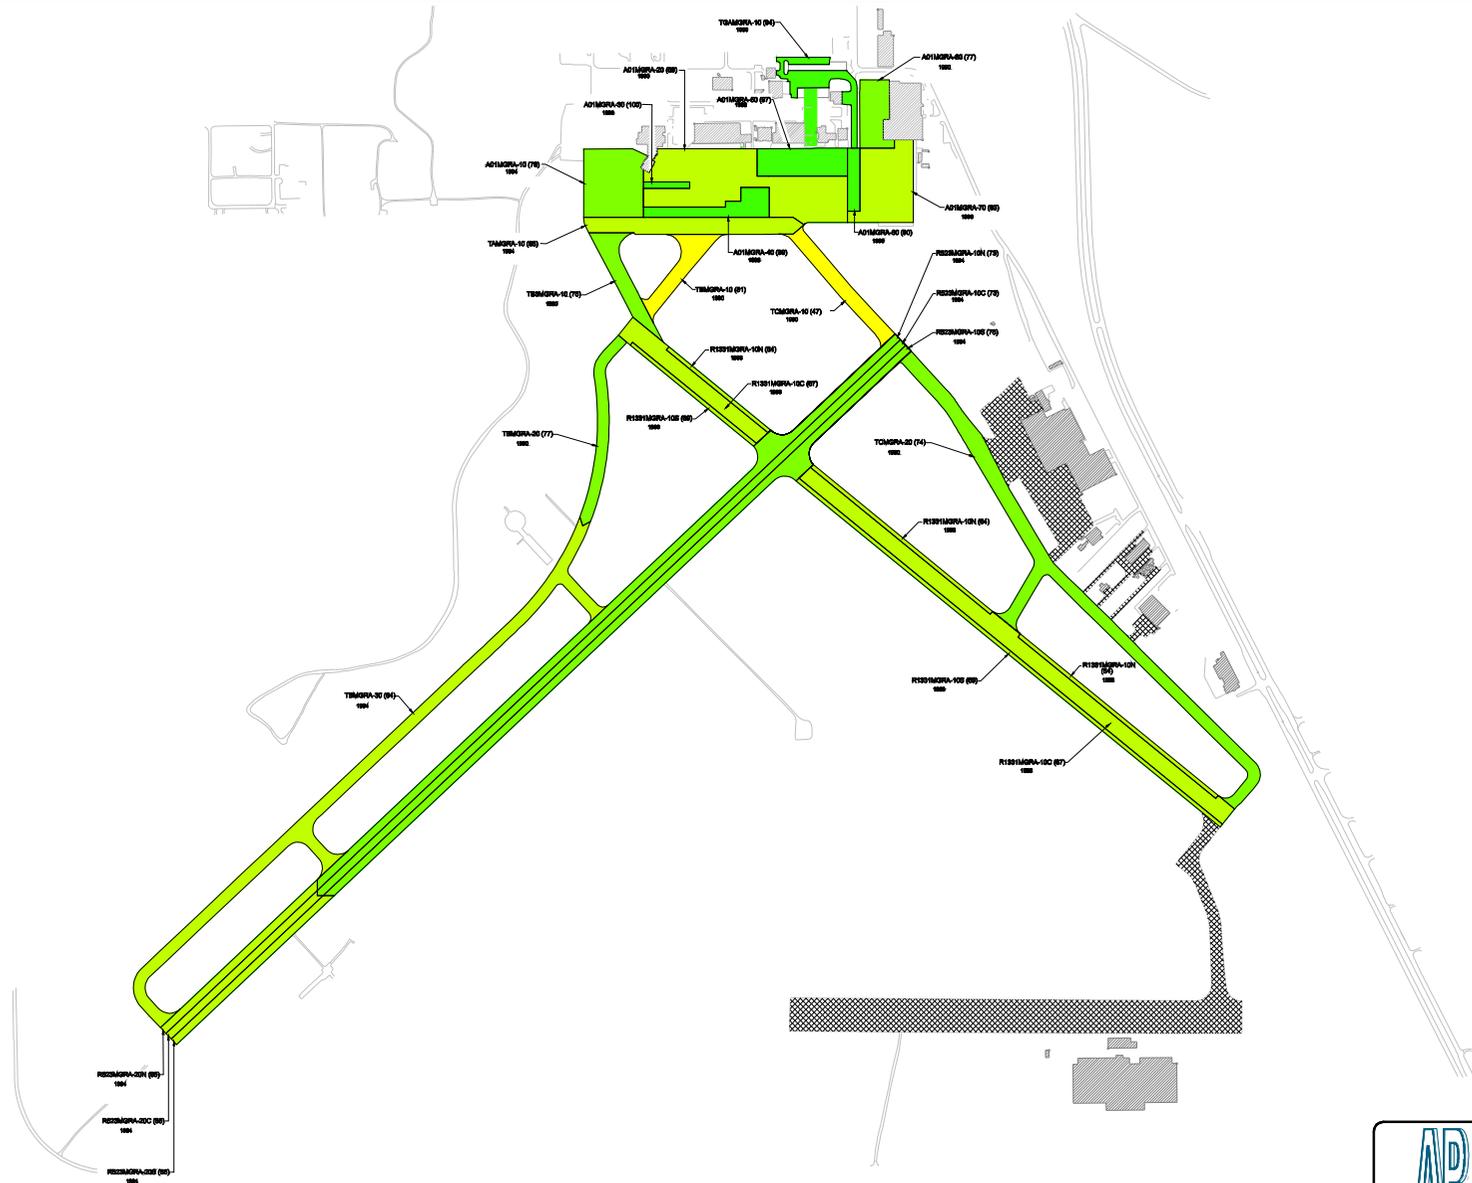
Figure 8. INSERT PCI MAP  
(11 x 17)

The 2001 area-weighted condition of Middle Georgia Regional Airport is 71, with conditions ranging from 47 to 100 [on a scale of 0 (failed) to 100 (excellent)]. Figures 6 and 7 provide graphs summarizing the overall condition of the pavements at Middle Georgia Regional Airport. Figure 8 is a map that displays the condition of the pavements evaluated. Table 1 summarizes the results of the pavement evaluation.
