# WINDER - BARROW AIRPORT

## PAVEMENT EVALUATION REPORT

JULY 2002

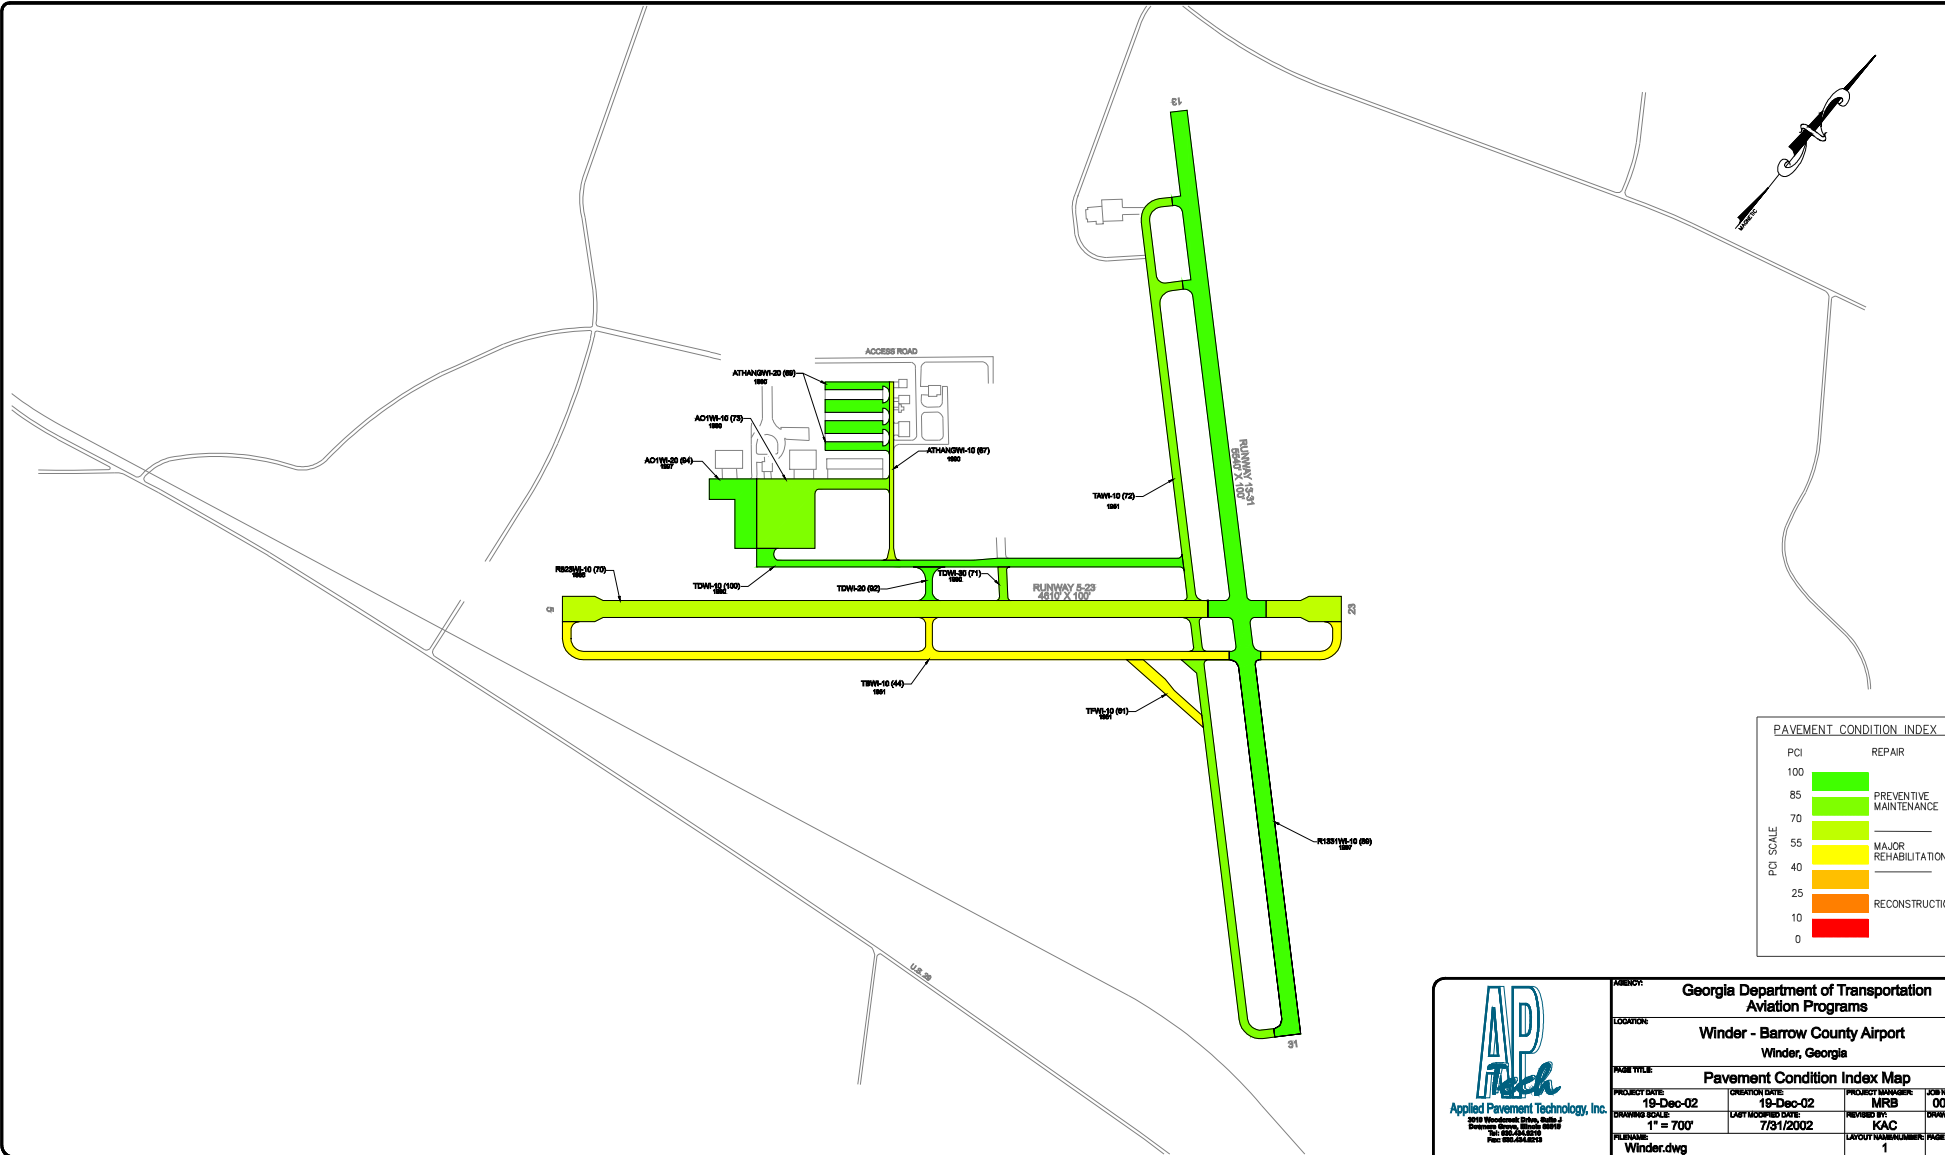
Figure 8. INSERT PCI MAP  
(11 x 17)

The 2001 area-weighted condition of Winder - Barrow Airport is 76, with conditions ranging from 44 to 100 [on a scale of 0 (failed) to 100 (excellent)]. Figures 6 and 7 provide graphs summarizing the overall condition of the pavements at Winder - Barrow Airport. Figure 8 is a map that displays the condition of the pavements evaluated. Table 1 summarizes the results of the pavement evaluation.
