2012 Newnan-Coweta County Airport Pavement Management Plan

NEWNAN-COWETA COUNTY AIRPORT

PAVEMENT MANAGEMENT REPORT

DECEMBER 2012

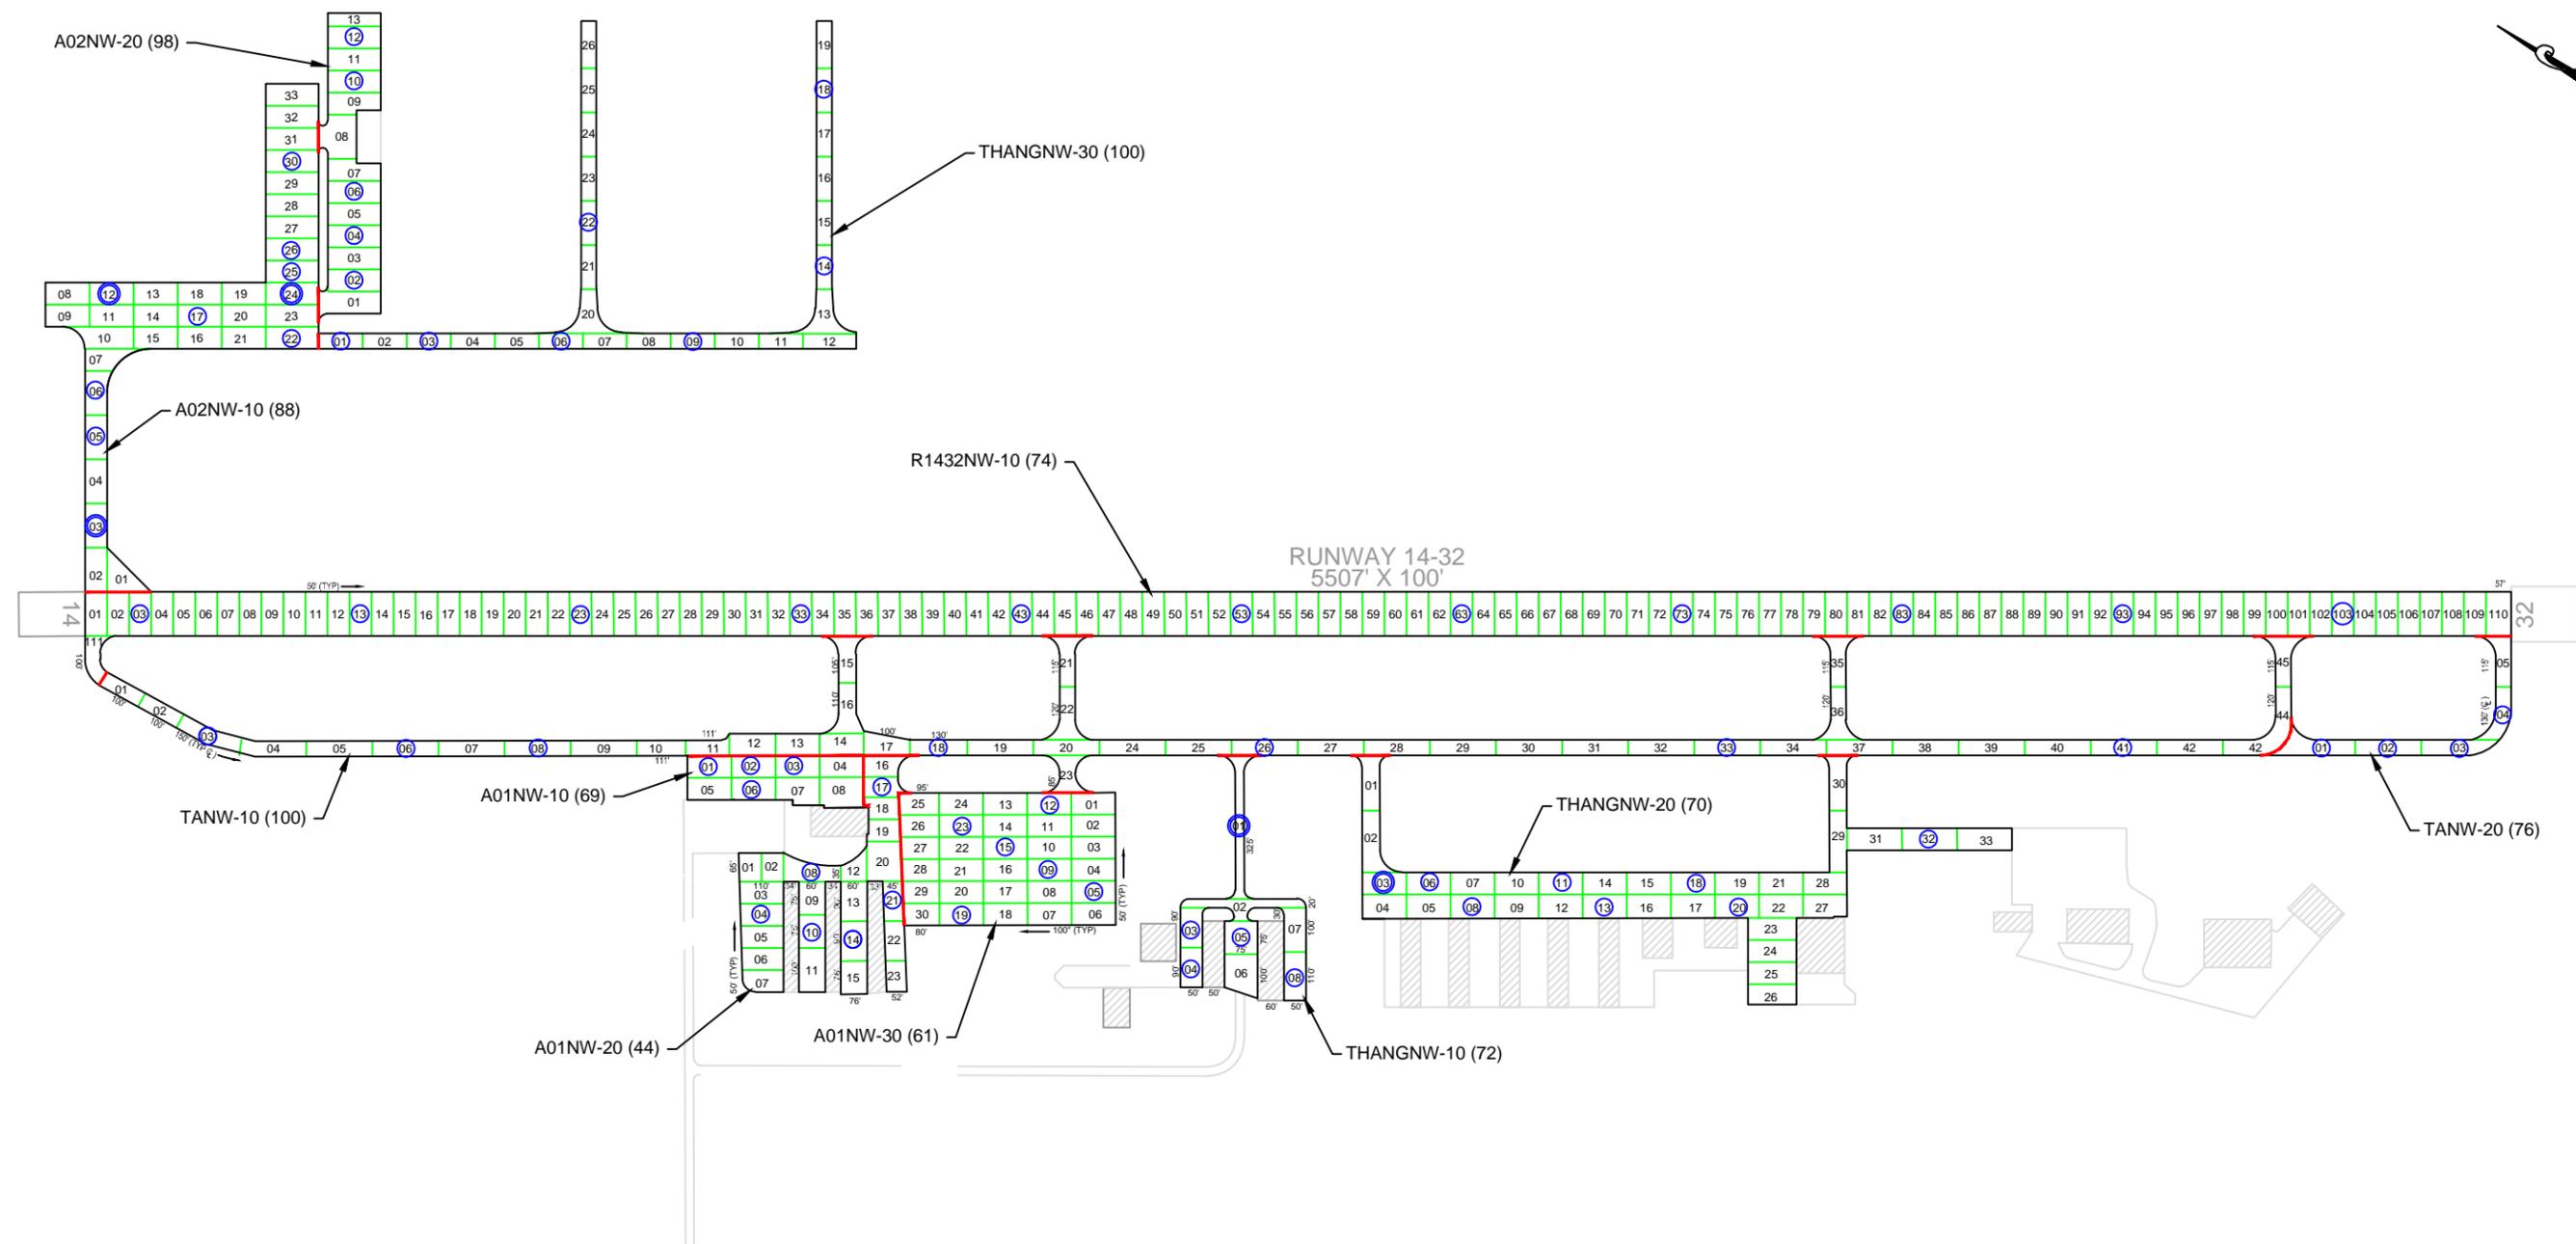
| FILENAME: Atlanta-Newnan.dwg | | LAYOUT NAME/NUMBER: NET. DEF. | FIGURE: 5 |

The inspection of Newnan-Coweta County Airport was completed on April 28, 2012 using the PCI procedure described previously. The map presented in Figure 5 identifies the sample units inspected during the pavement evaluation.

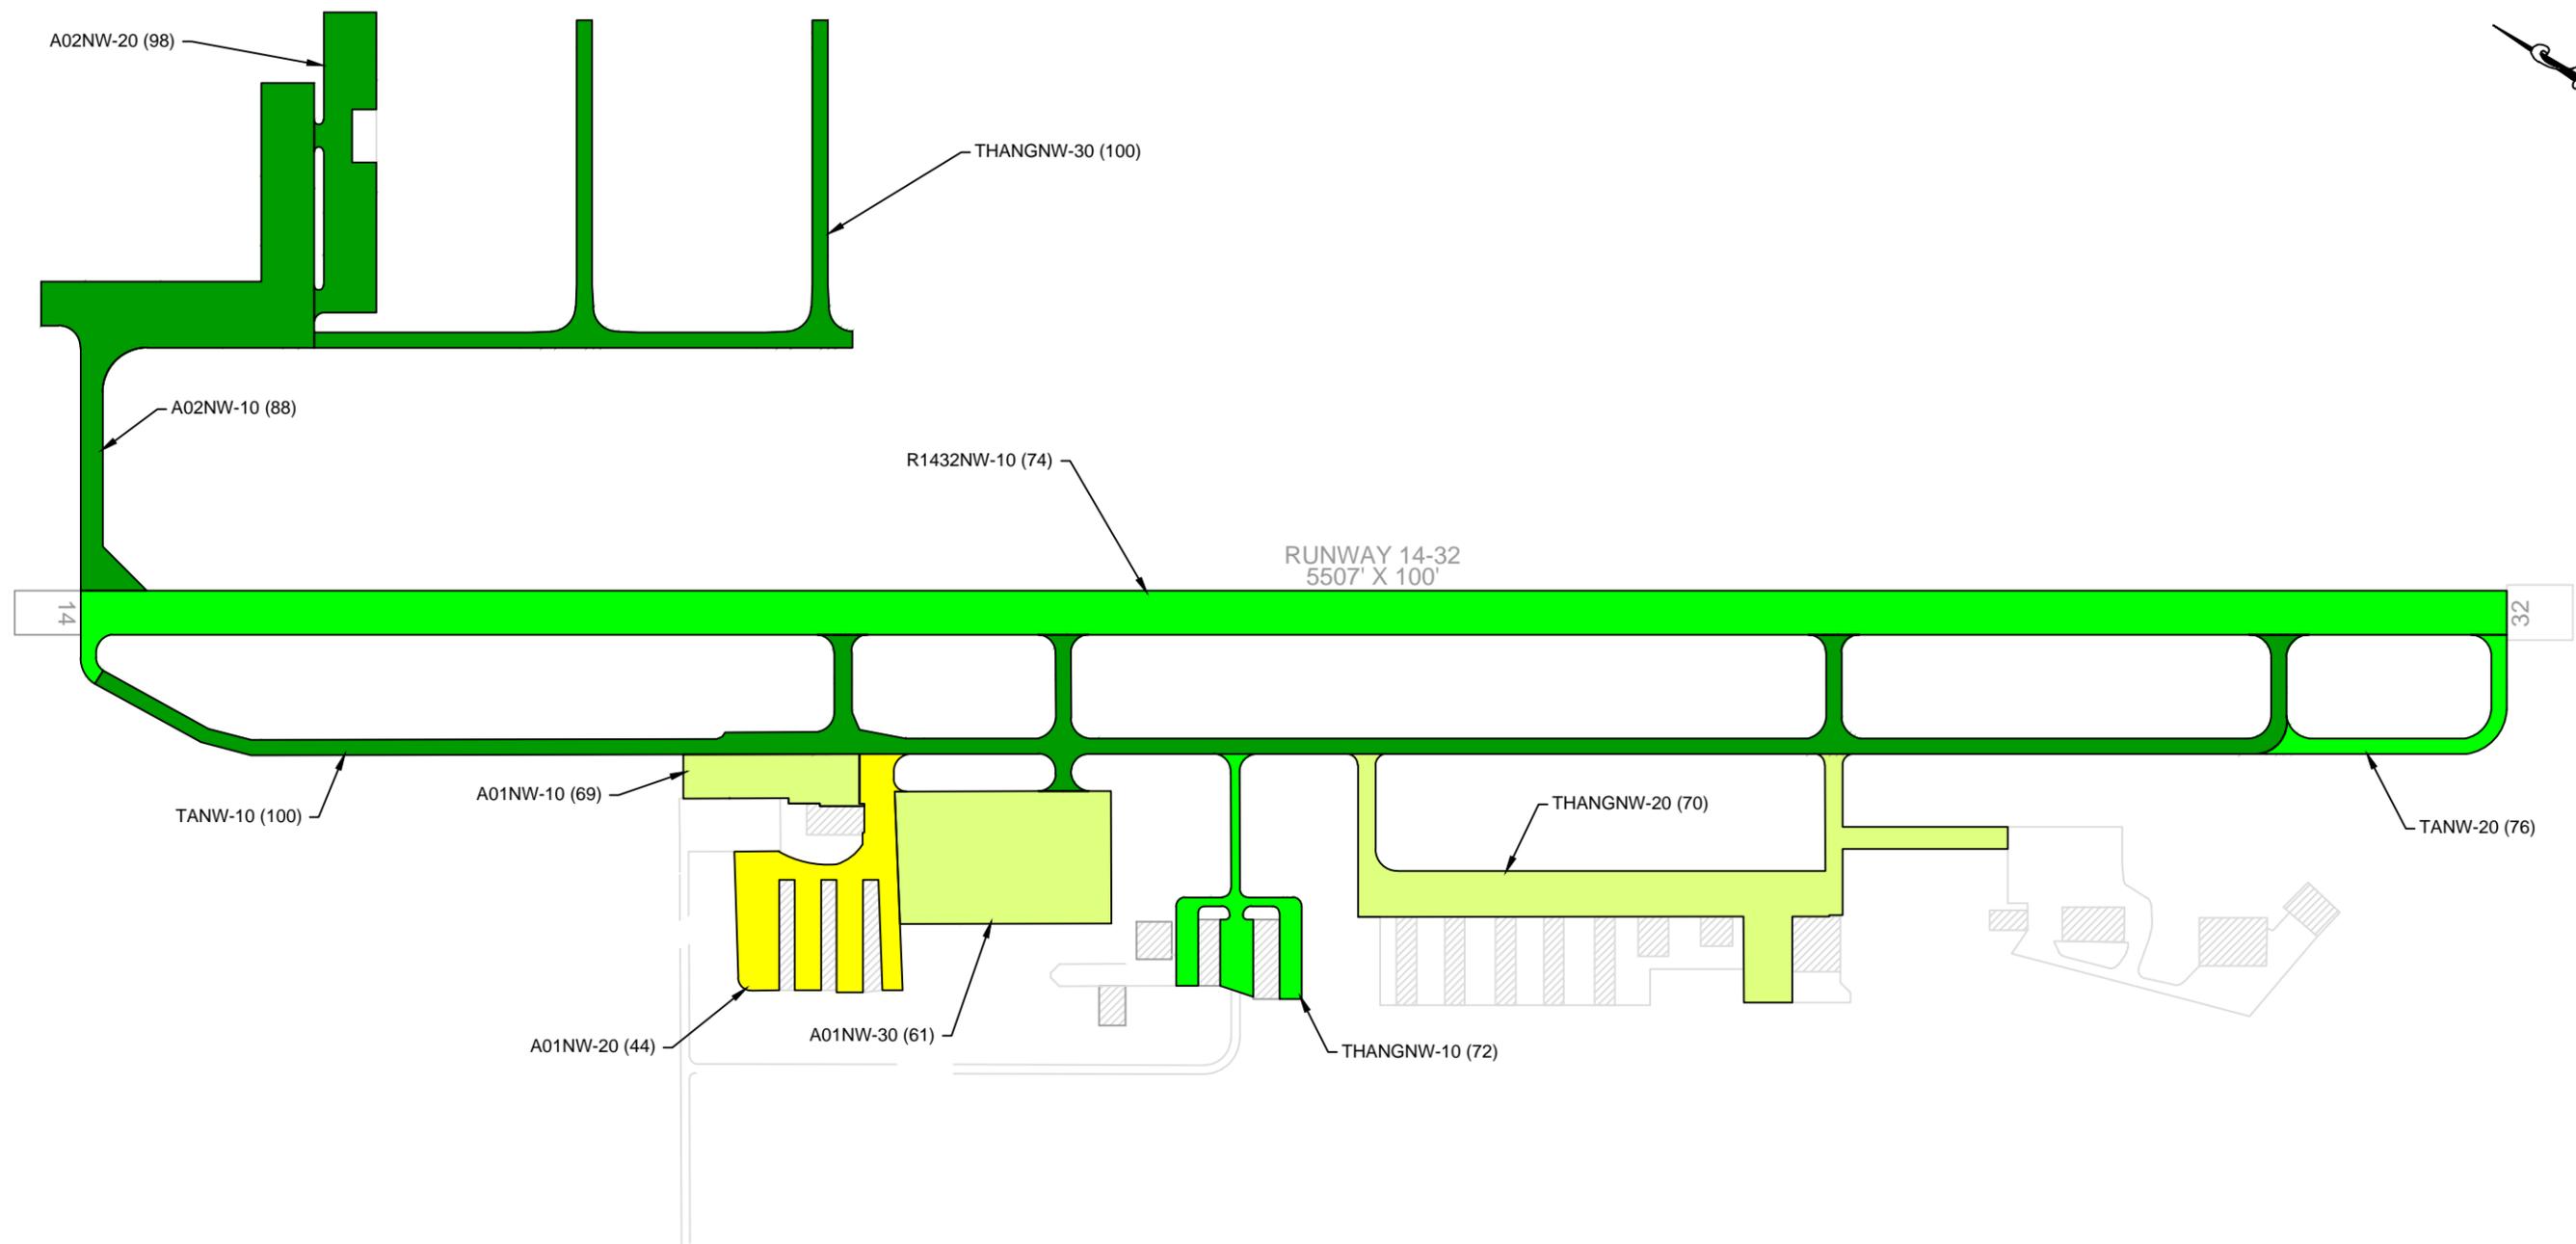
| FILENAME: Atlanta-Newnan.dwg | | LAYOUT NAME/NUMBER: PCI | FIGURE: 8 |

Figures 6 and 7 provide graphs summarizing the overall condition of the pavements at Newnan-Coweta County Airport. Figure 8 is a map that displays the condition of the pavements evaluated. Table 2 summarizes the results of the pavement evaluation and paint assessment and also presents both the 2007 and 2012 PCI values. Please note that modifications have been made to the PCI methodology since the time of the last pavement inspection in 2007, as detailed in ASTM 5340-11. These changes include the separation of the raveling and weathering distress type on asphalt-surfaced pavements into two distress types along with the addition of the alkali silica reaction (ASR) distress type on PCC pavements.
