2012 Daniel Field Pavement Management Plan

DANIEL FIELD

PAVEMENT MANAGEMENT REPORT

DECEMBER 2012

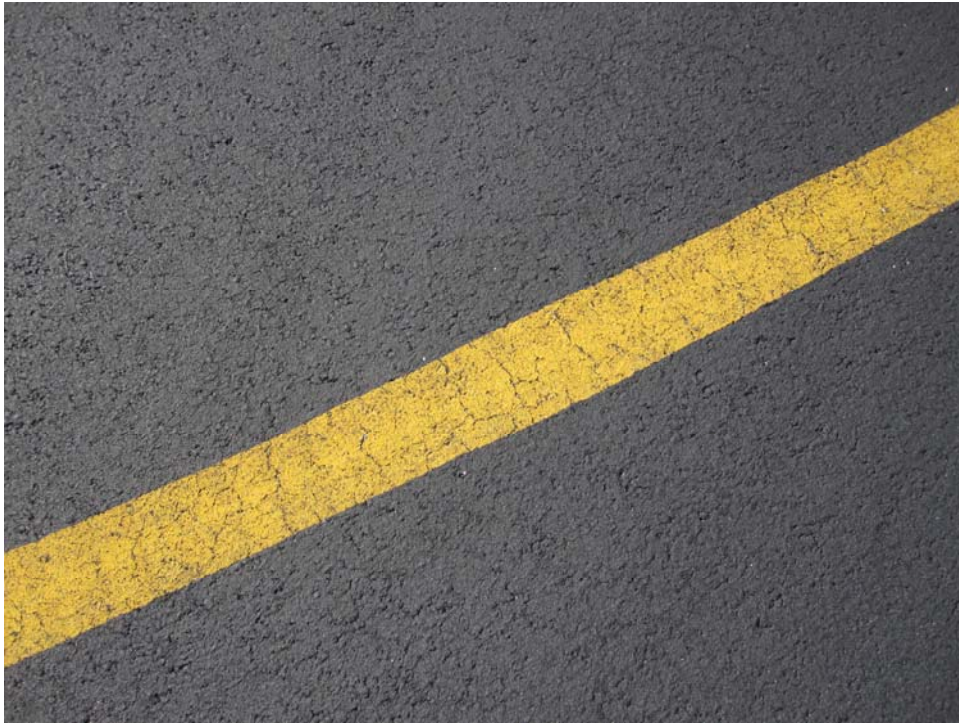
ATERMAG-10. Satisfactory Paint.

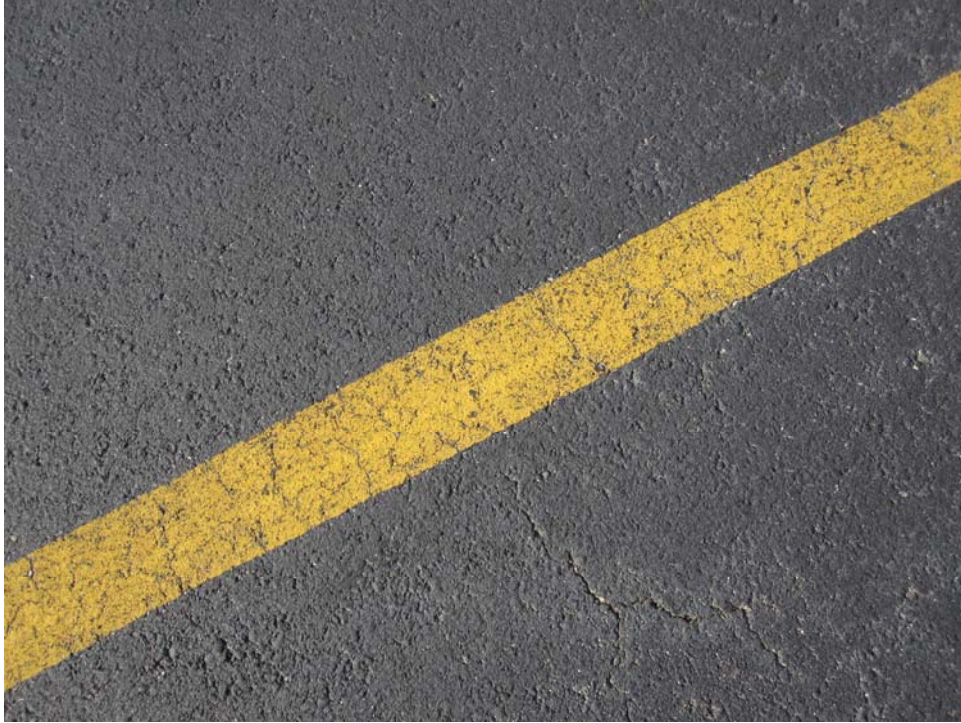
ATERMAG-20. Satisfactory Paint.

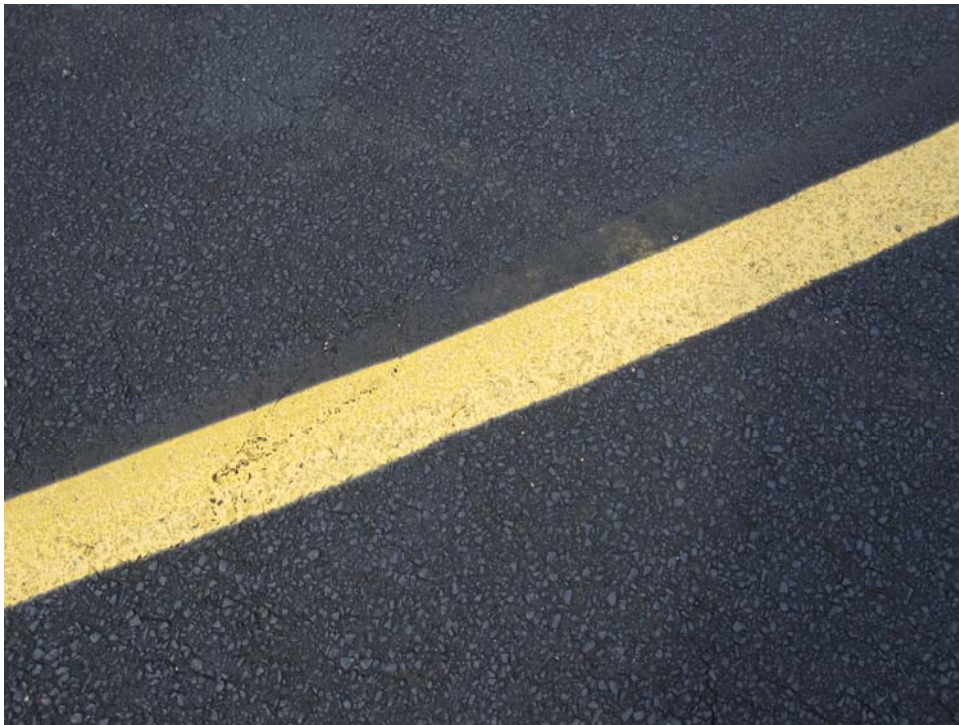
ATERMAG-30. Satisfactory Paint.

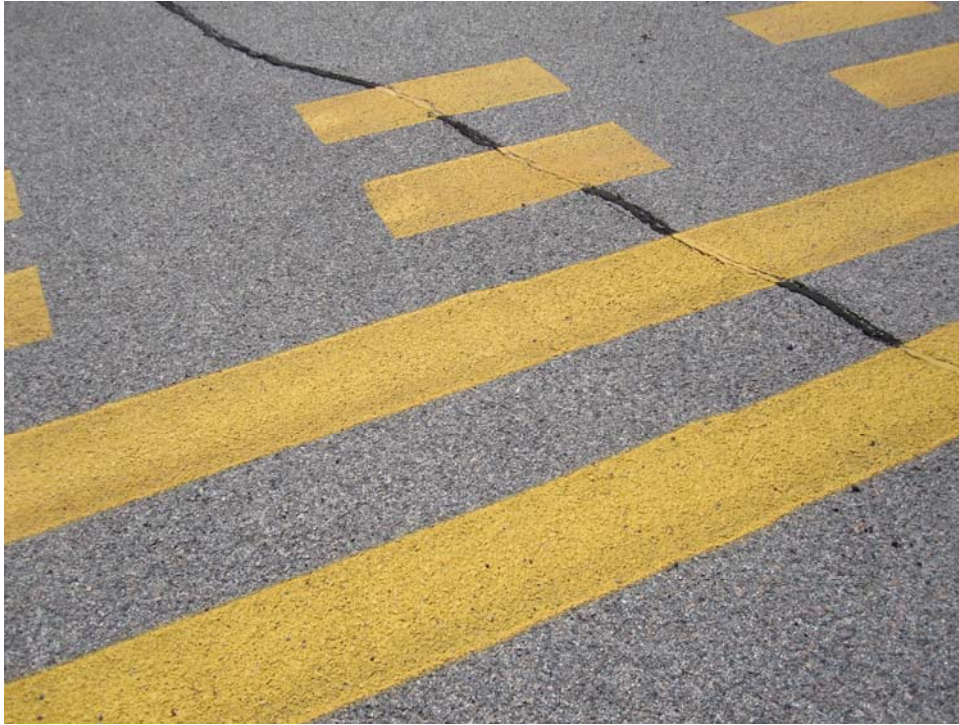
ATOWERAG-20. Satisfactory Paint.

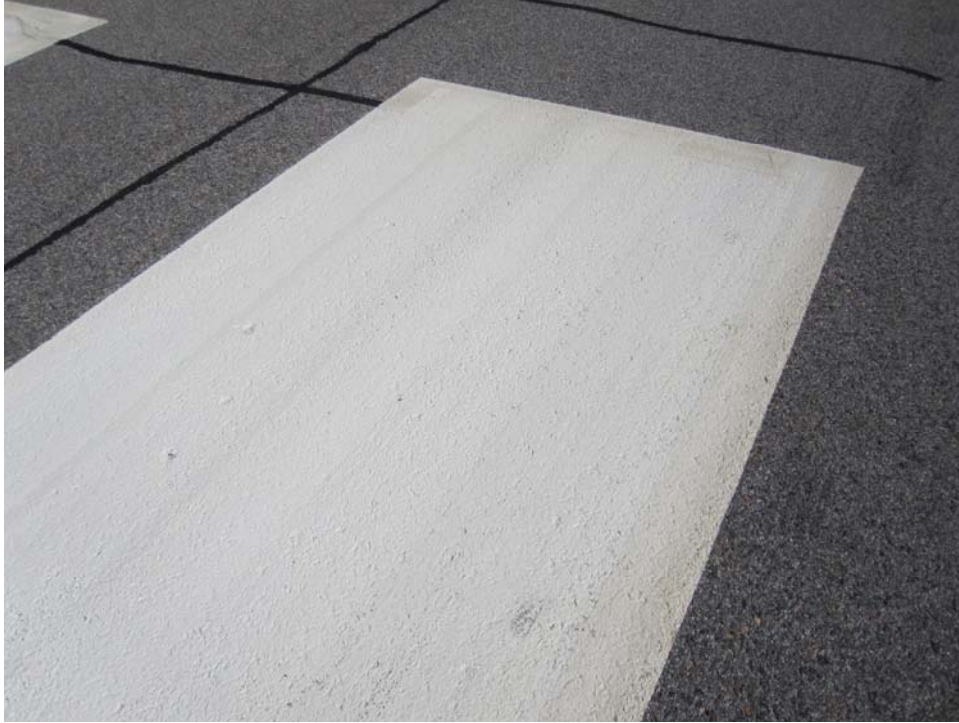
R0523AG-10. Satisfactory Paint.

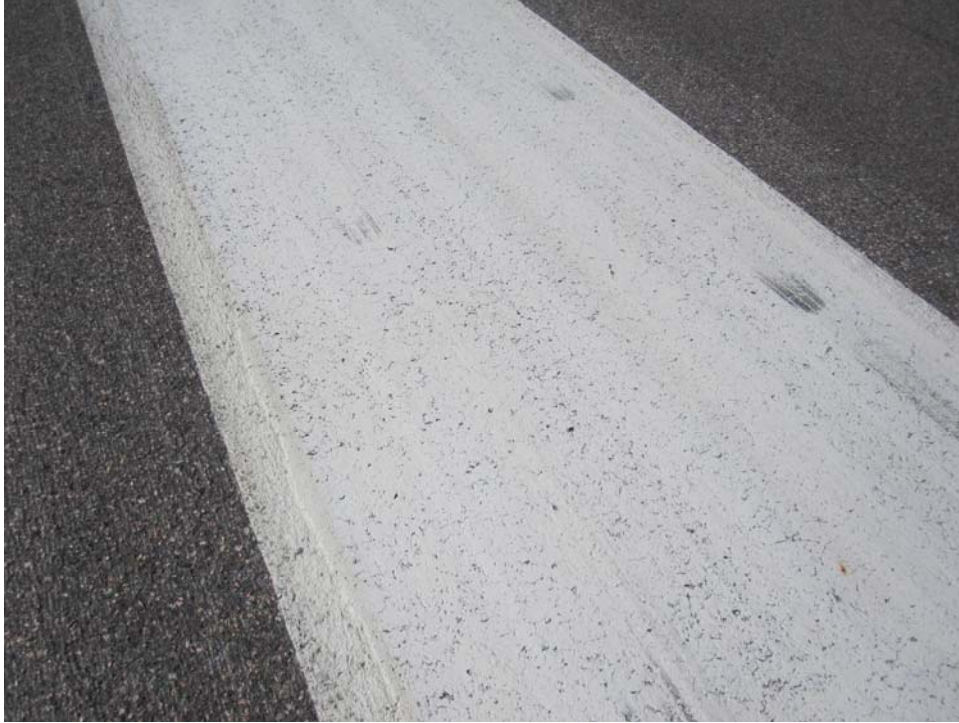
R0523AG-20. Satisfactory Paint.

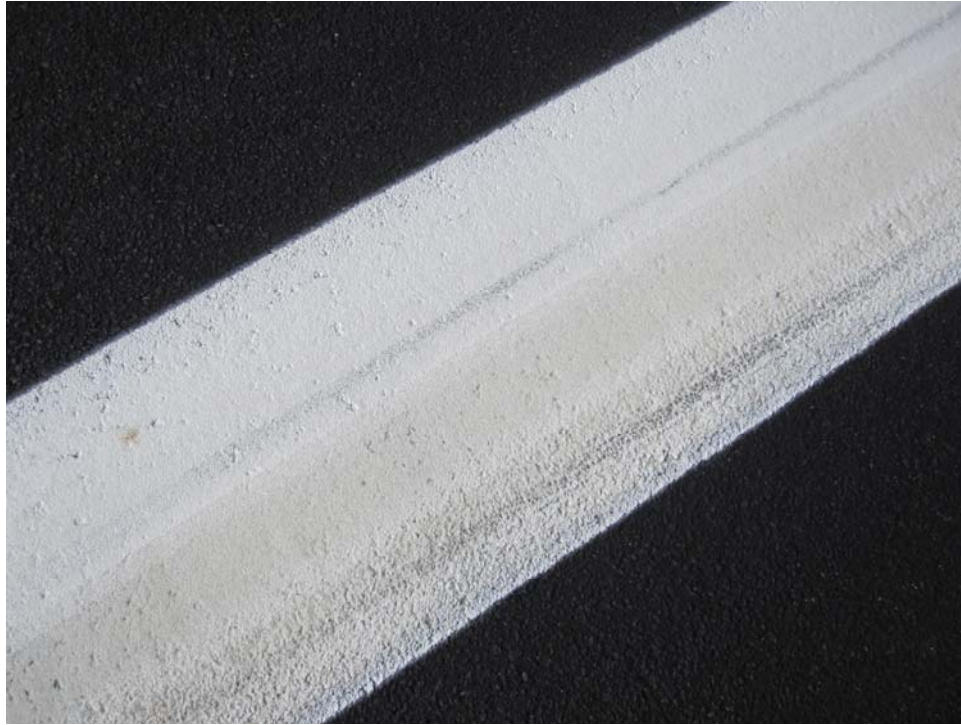
R1129AG-10. Satisfactory Paint.

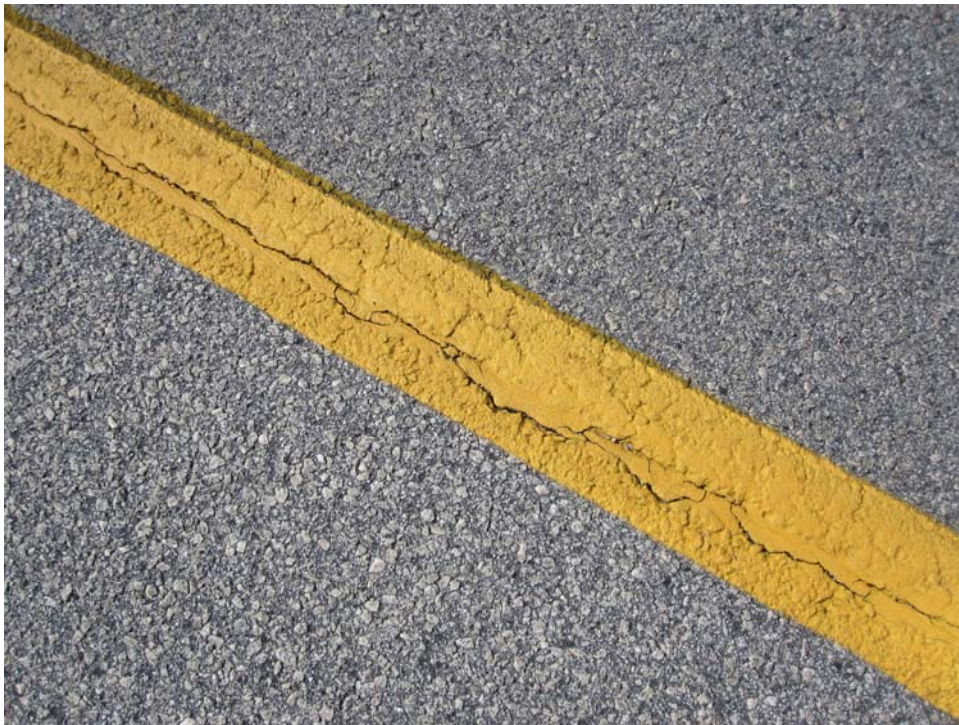
TDAG-10. Satisfactory Paint.

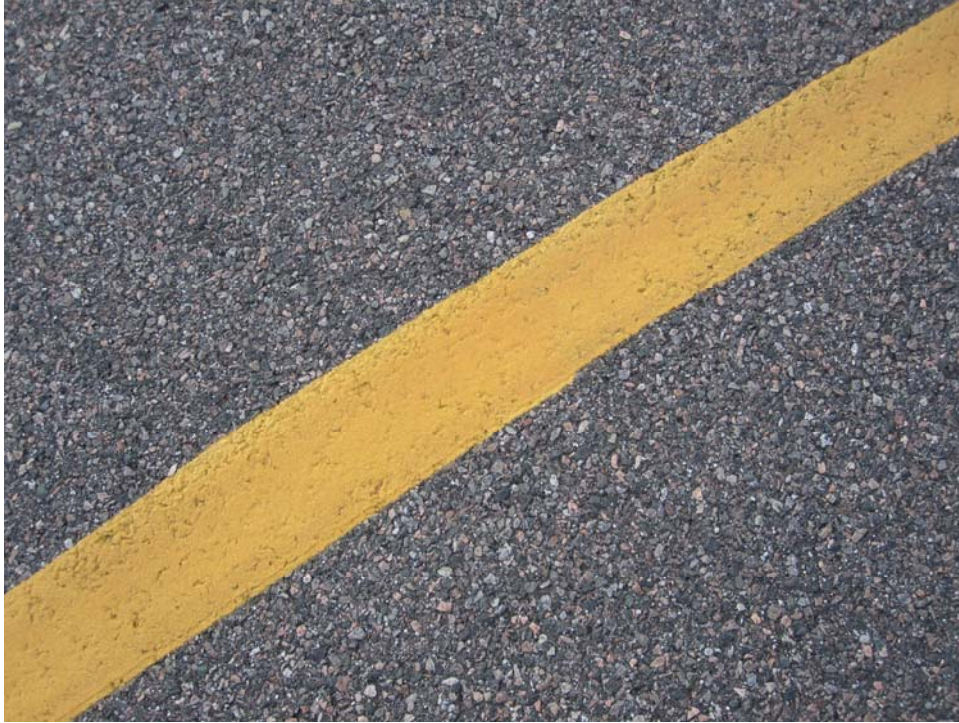
TEAG-10. Satisfactory Paint.
