2012 Greene County Regional Airport Pavement Management Plan

GREENE COUNTY REGIONAL AIRPORT

PAVEMENT MANAGEMENT REPORT

DECEMBER 2012

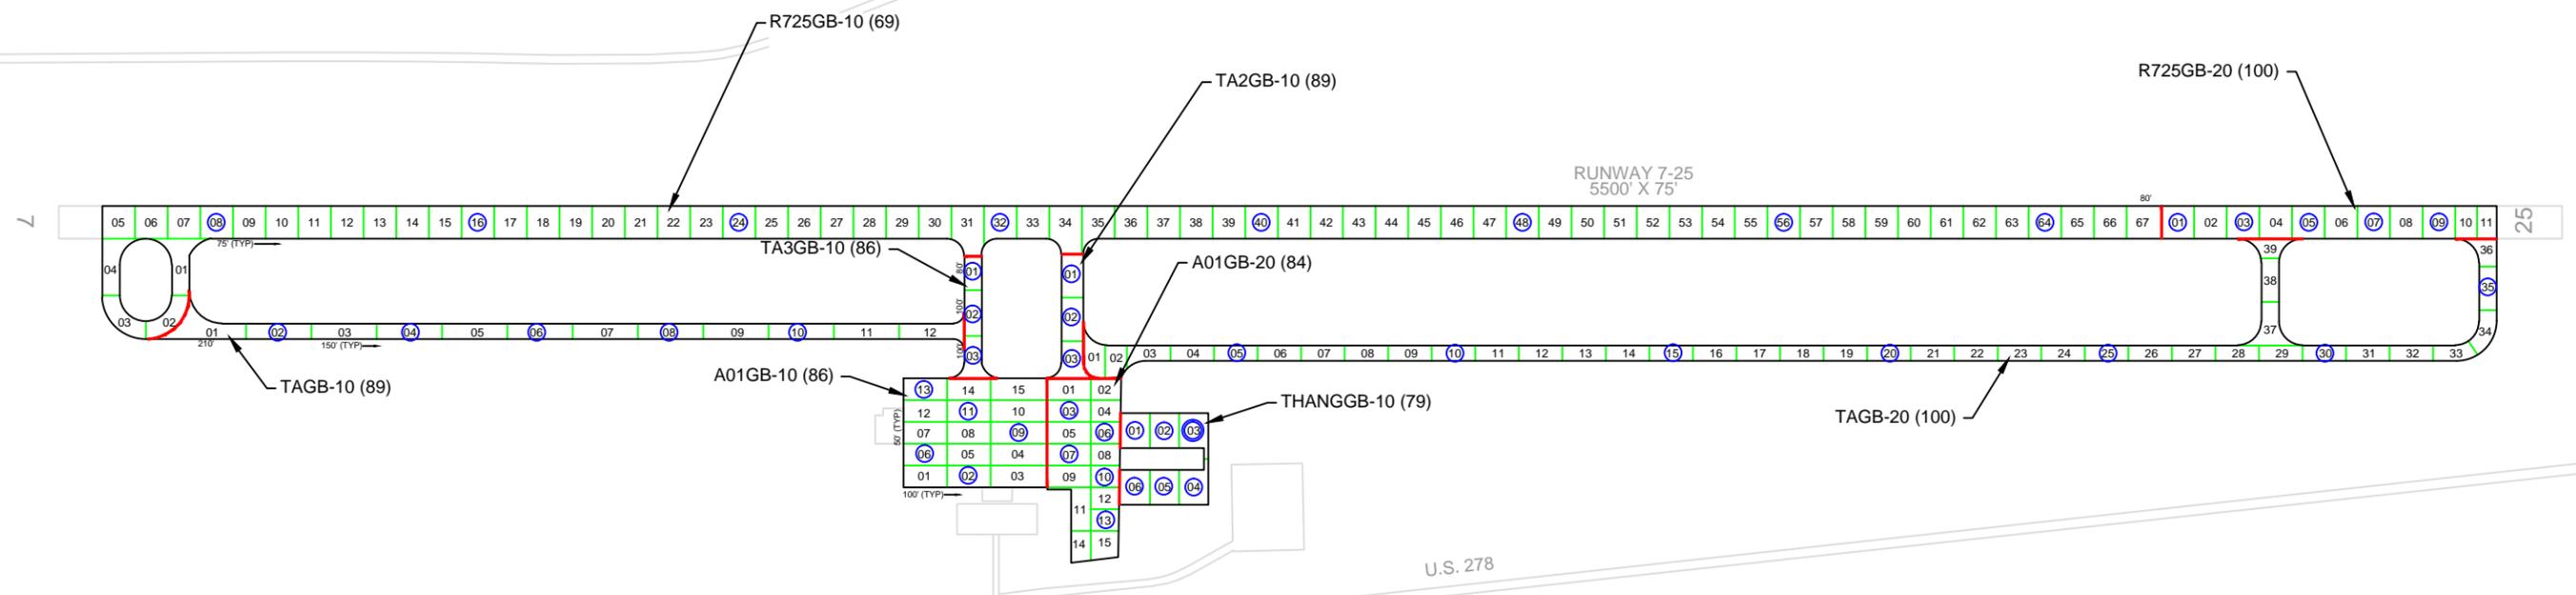
The inspection of Greene County Regional Airport was completed on March 17, 2012 using the PCI procedure described previously. The map presented in Figure 5 identifies the sample units inspected during the pavement evaluation.

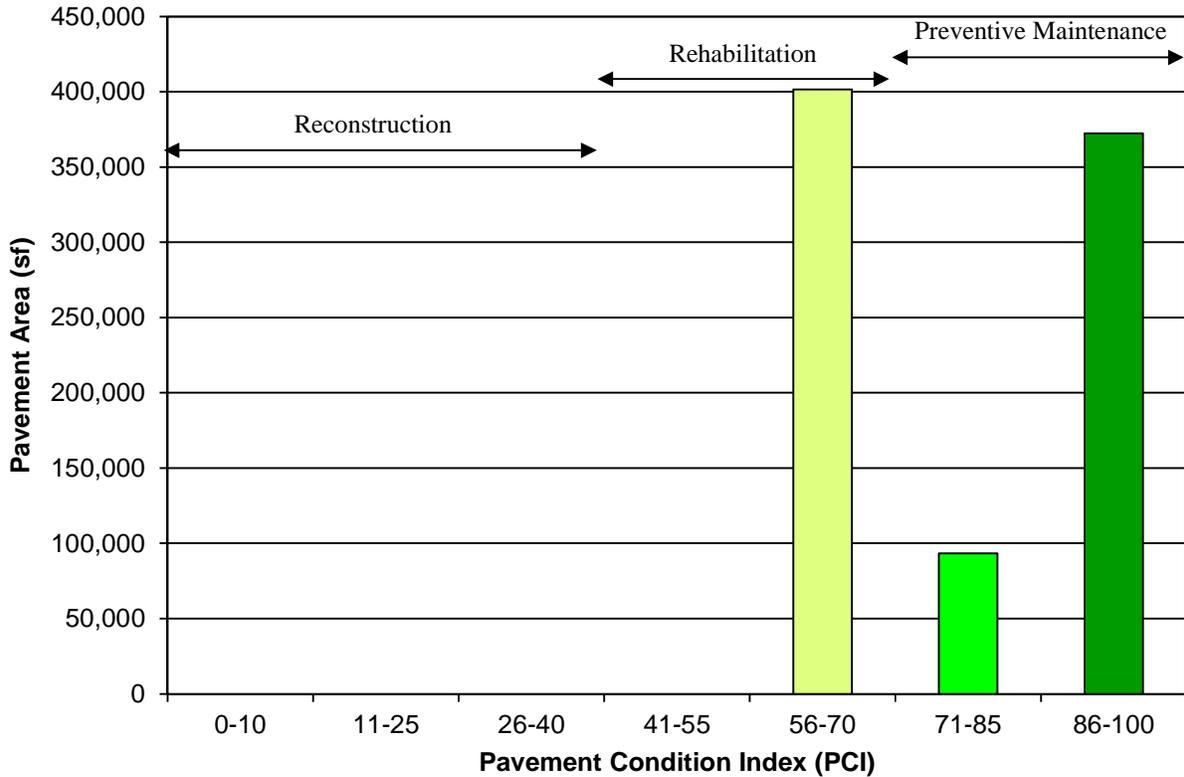
Figure 6. Condition Distribution.

Figures 6 and 7 provide graphs summarizing the overall condition of the pavements at Greene County Regional Airport. Figure 8 is a map that displays the condition of the pavements evaluated. Table 2 summarizes the results of the pavement evaluation and paint assessment and also presents both the 2007 and 2012 PCI values. Please note that modifications have been made to the PCI methodology since the time of the last pavement inspection in 2007, as detailed in ASTM 5340-11. These changes include the separation of the raveling and weathering distress type on asphalt-surfaced pavements into two distress types along with the addition of the alkali silica reaction (ASR) distress type on PCC pavements.
